North Building

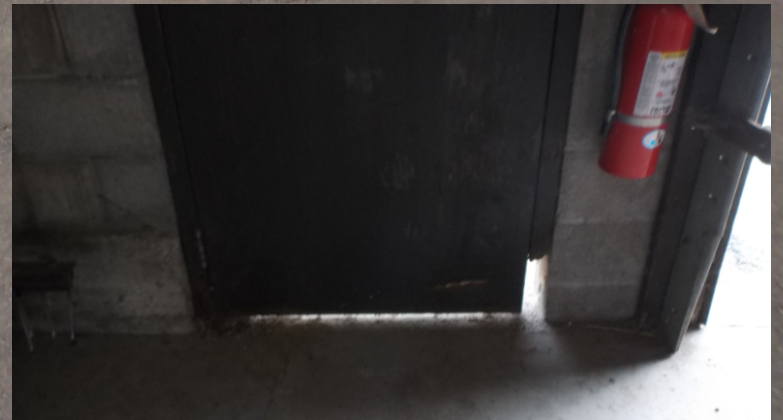
Doors & frame are severely rusted at the bottom

Overhead door will be raised by 2 feet to facilitate fork lift traffic.
