View of building at 114 N Blount Street from southeast

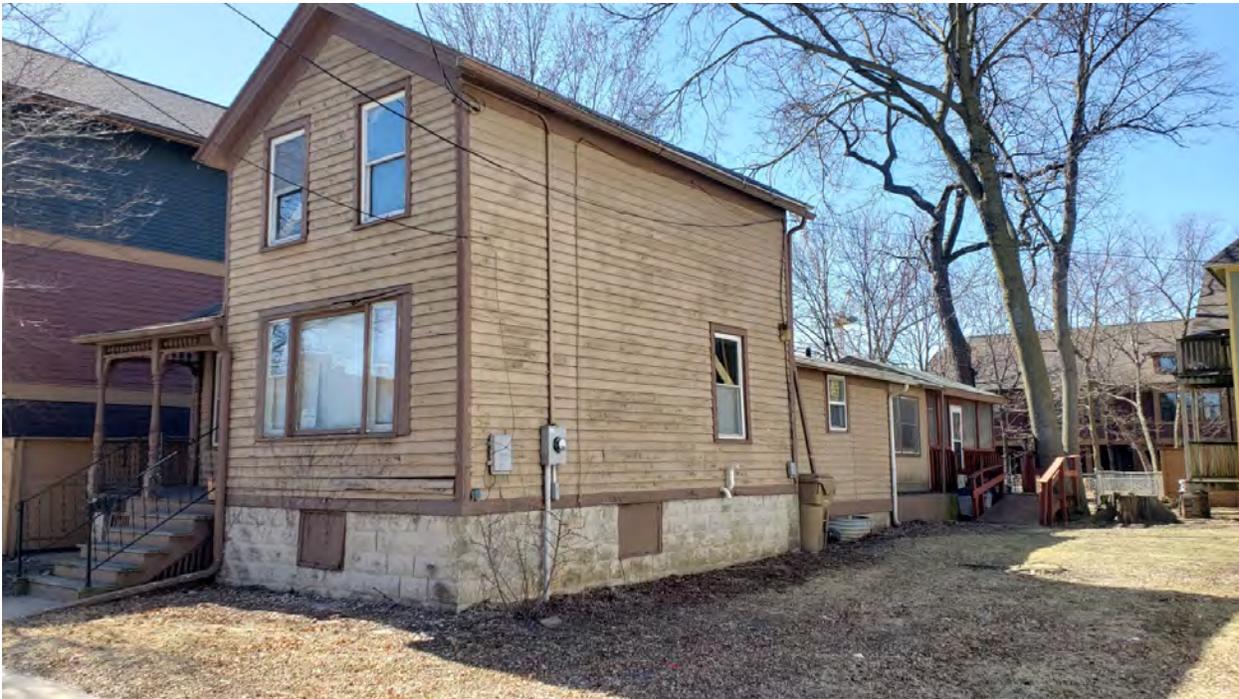
View of building at 114 N Blount Street from northeast

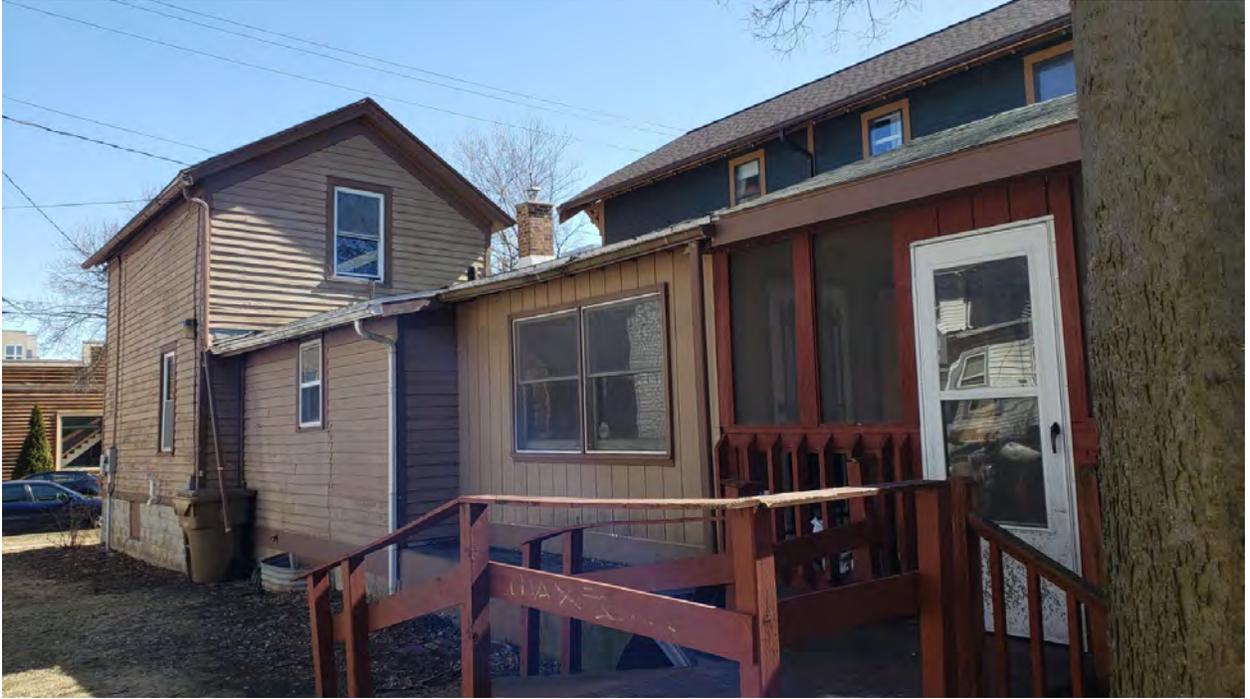
View of building at 114 N Blount Street from northwest

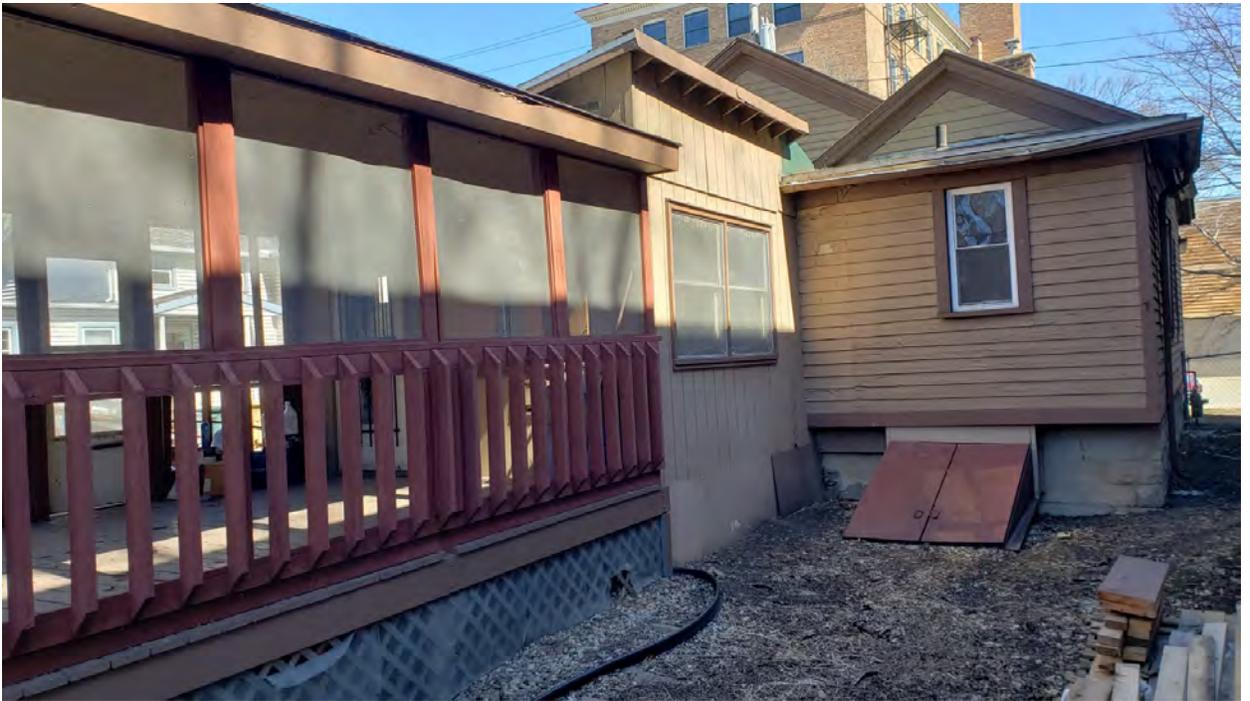
View of building at 114 N Blount Street from southwest

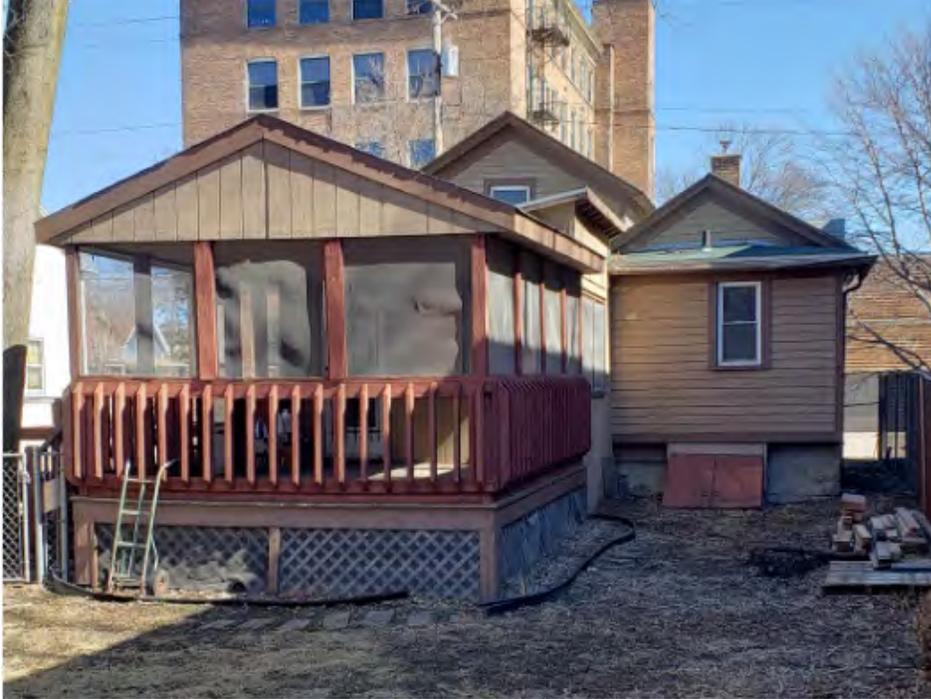
View of building at 114 N Blount Street from southwest

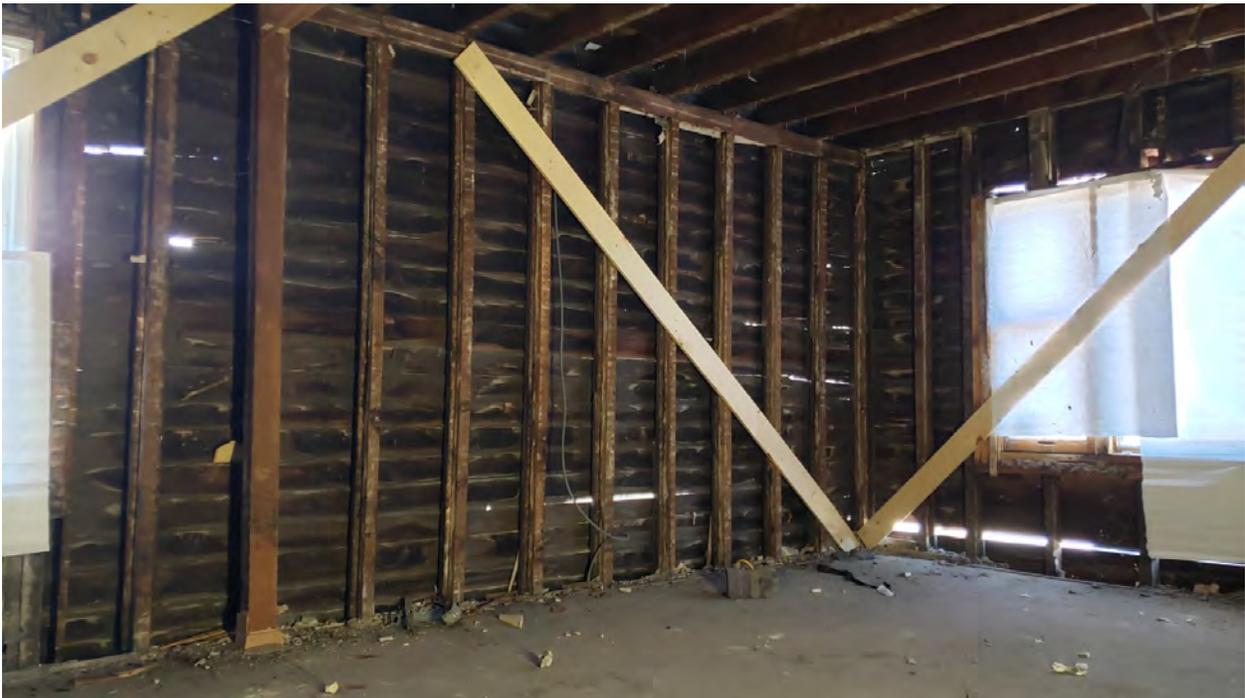
Exterior wall of original structure. The original structure was built without sheathing, which has been a major factor in the many issues this building suffers from.

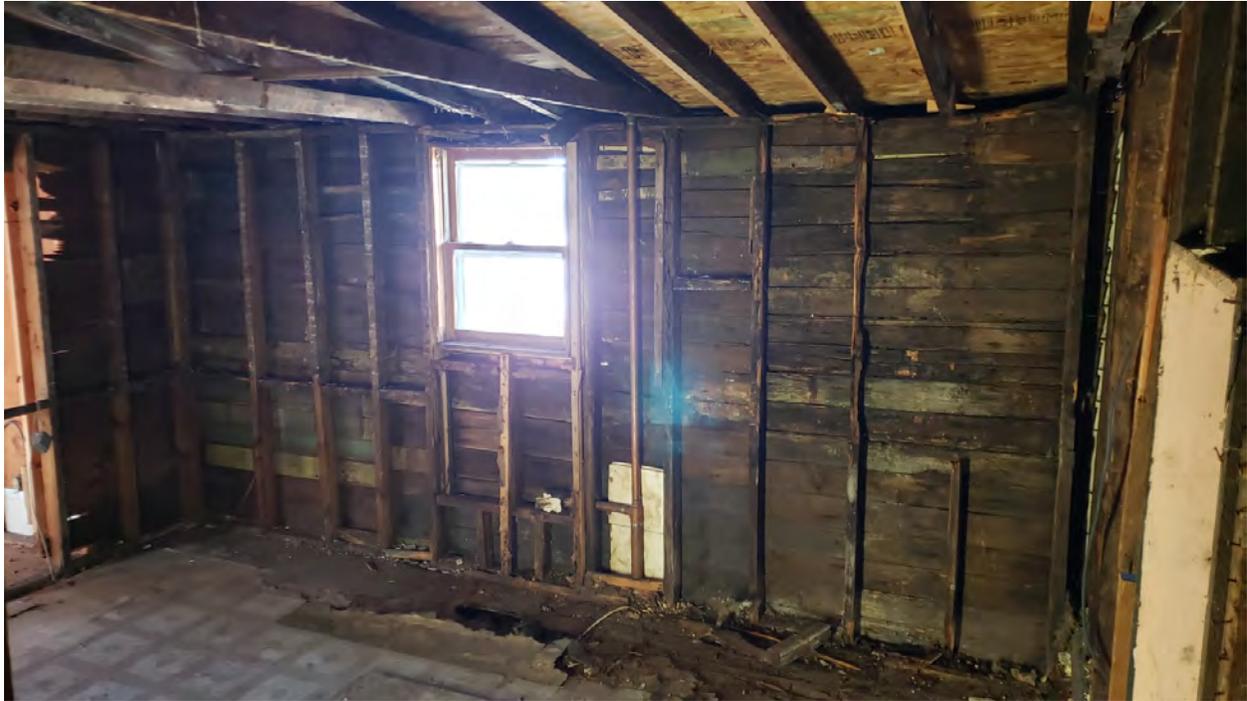
The northwest wall of the building. The structure was neglected for decades, including but not limited to unrepaired roof leaks. This picture shows the rot and collapse of the walls, ceilings, and floor systems on account of a major long-term leak.

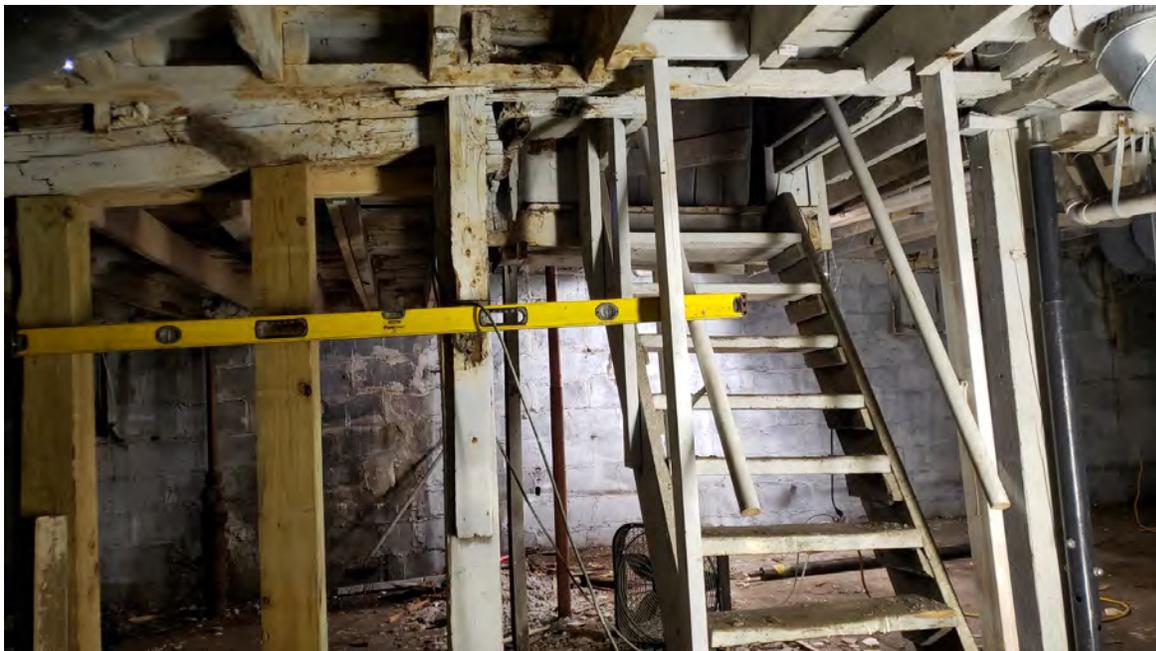
Both intentional and neglectful destruction have played a role in the collapse of the center of the house. Main bearing beams were removed, notched, and left to rot unsupported for decades. The yellow level in the picture is set at level.

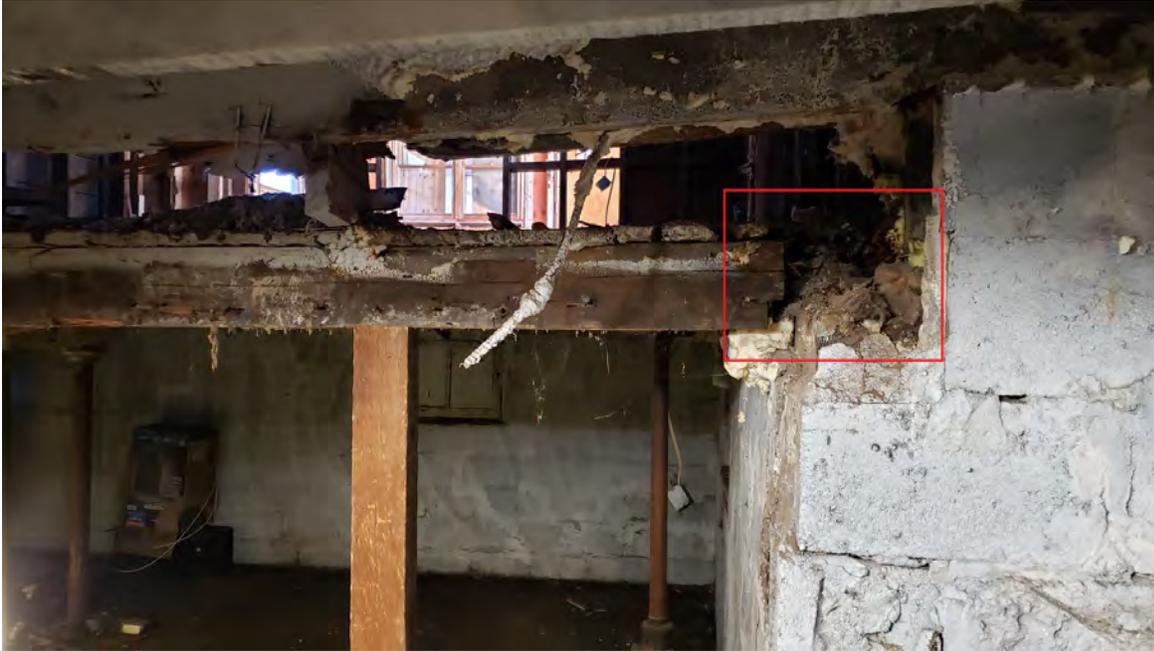
Northwest wall of the basement. The floor systems have been pulled off of the foundation as the center of the house was left unsupported and collapsing after various remodels. Spray foam was added to the outer edge of the building, locking in moisture and promoting rot. Spray foam was removed in the area circled in red, revealing where a structural beam once was located before it rotted away.

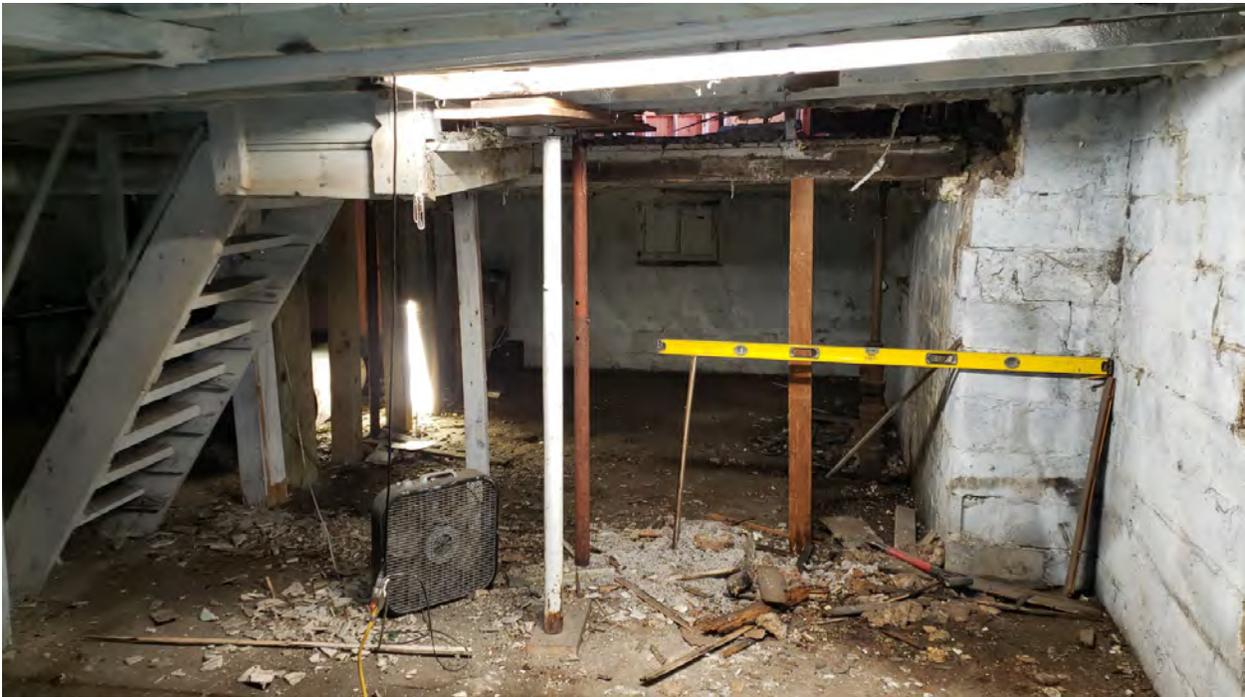
View of basement. Visible collapse of structure around interior basement stairwell addition, and failure of foundation and floor systems. The yellow level in the picture is set at level.

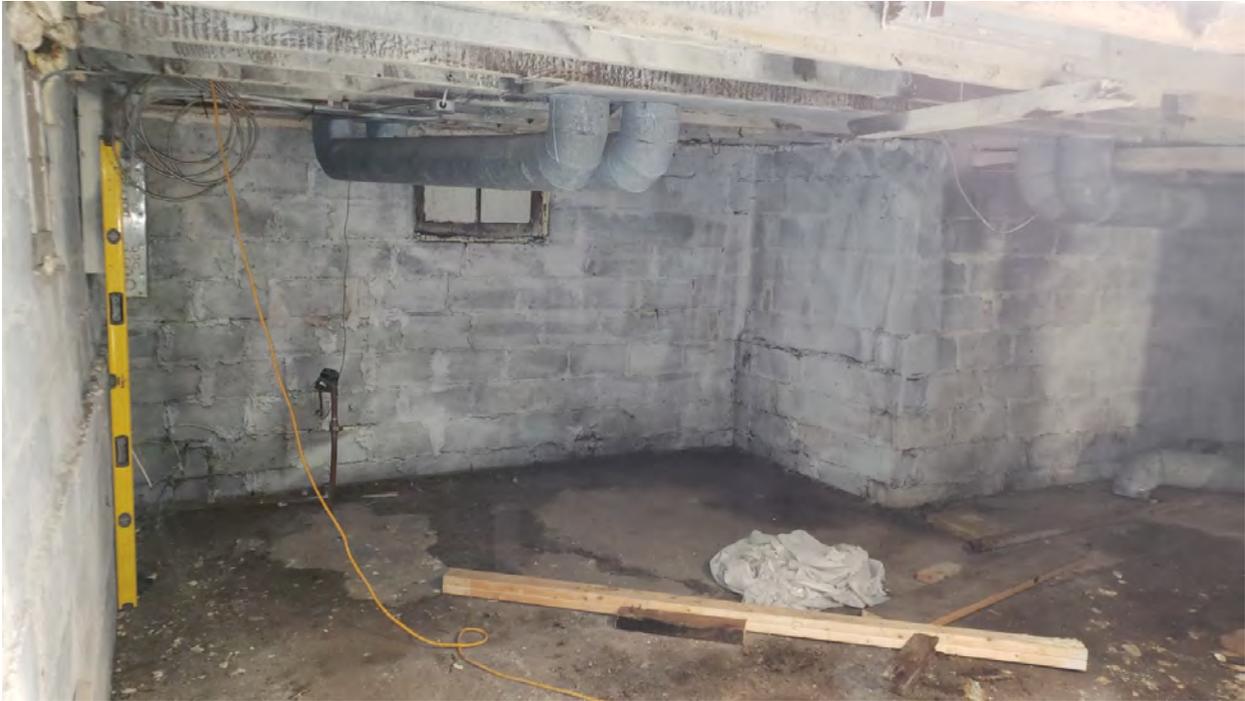
View of northeast wall of basement. The yellow level (at left) is set plumb. The top 5 courses of block were adjusted outward by the original building movers to fit the house upon its delivery to the site. This is a structurally unsound condition that exists throughout the foundation of the original house.

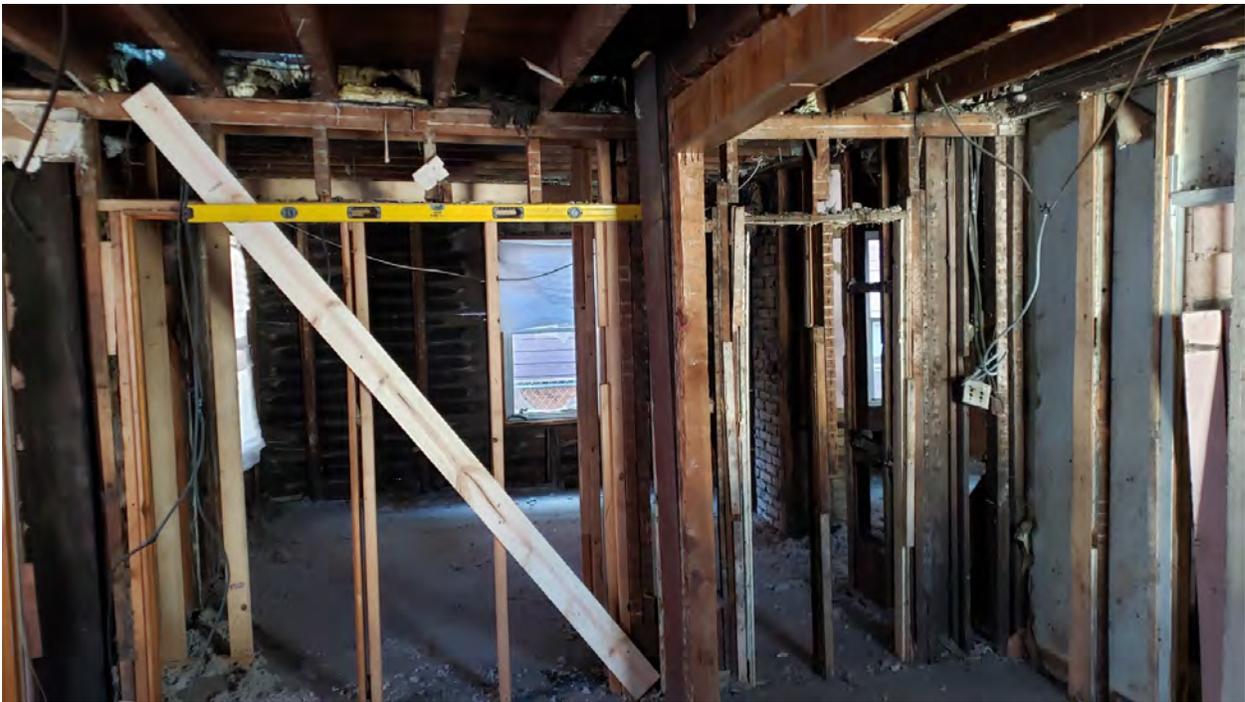
The main interior bearing wall of the original structure's 2nd floor and roof. All load-bearing features were removed or incorrectly altered long ago in both the 1st floor and basement of the building.

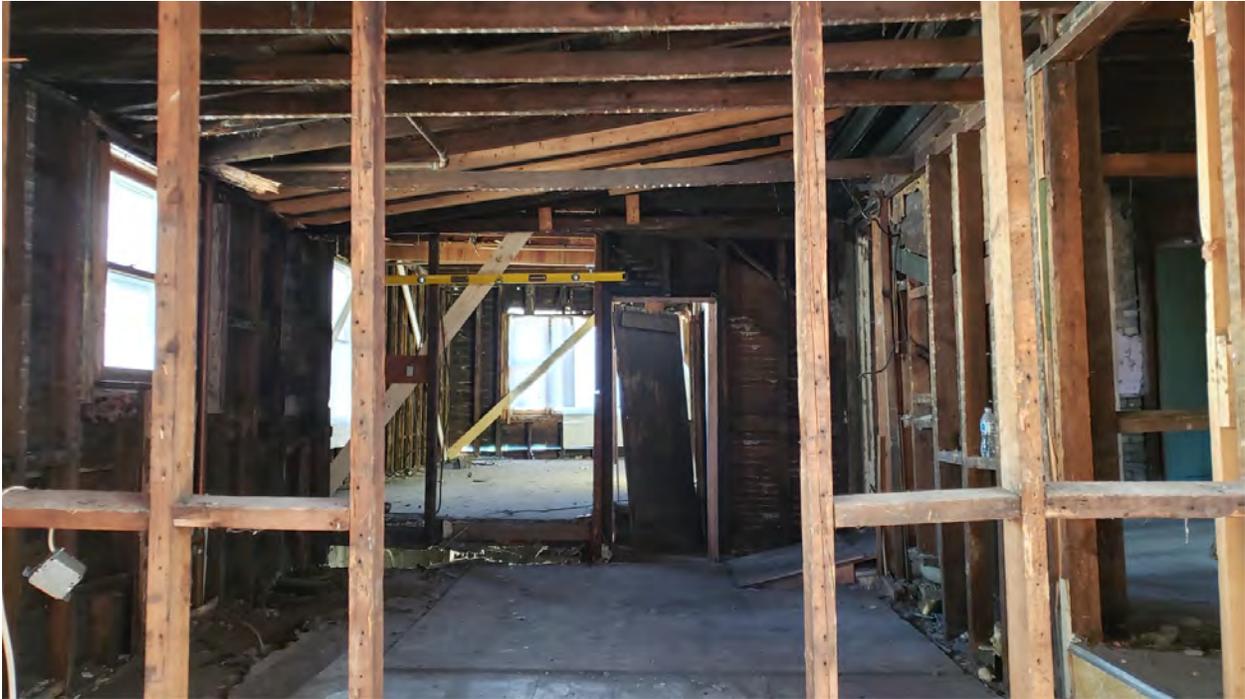
View from rear of building. The southwest addition was built as a lean-to on the southern addition, which led to the 3 rear additions being built at a different height than the original structure.

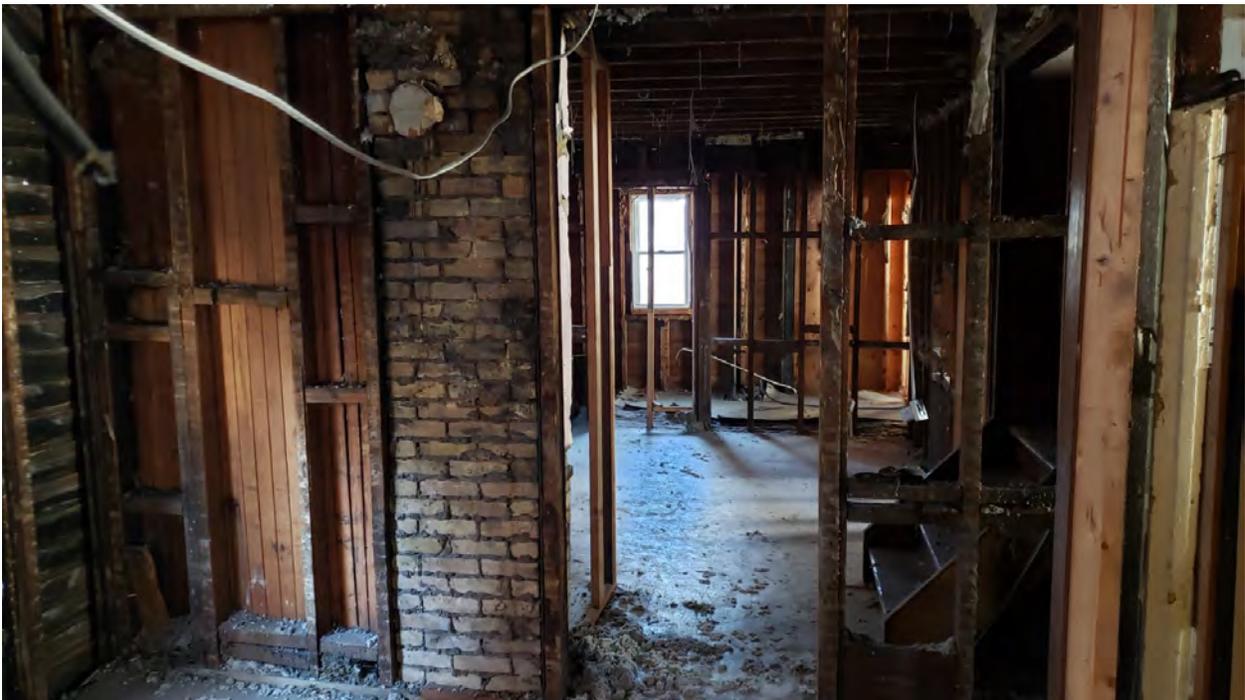
View from eastern corner of the structure.

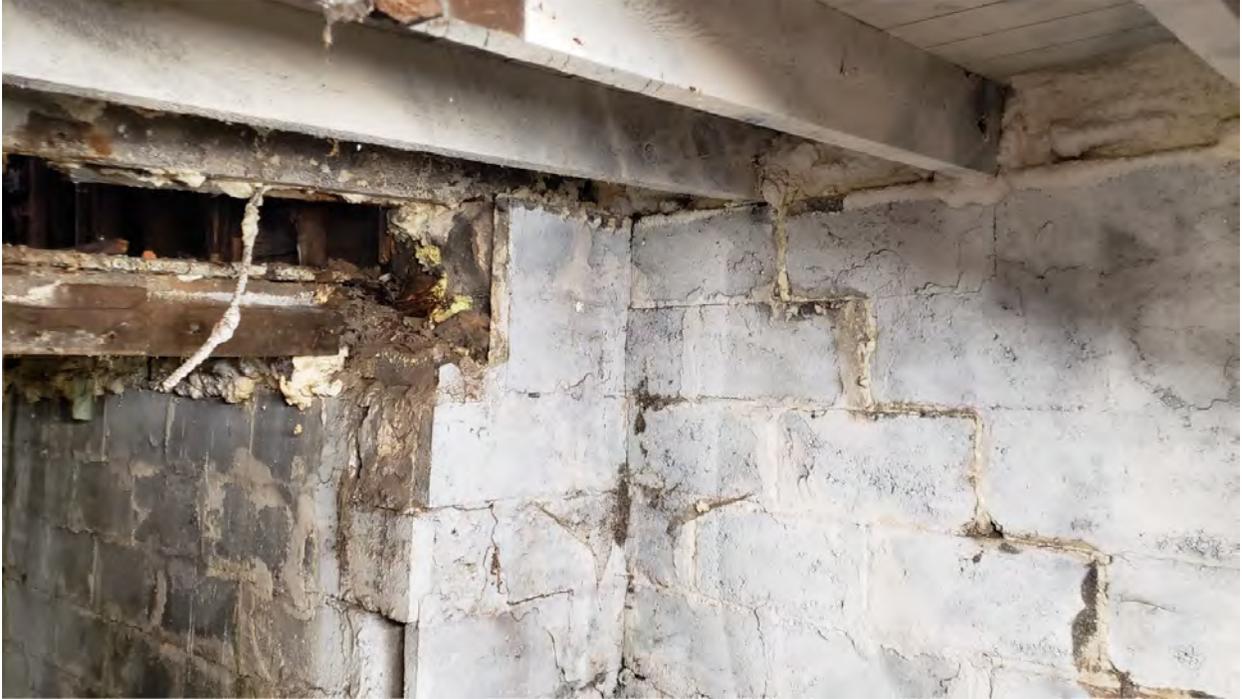
Visible rot where spray foam was removed. Visible step-cracking from the foundation being set on poor footing. Spray foam has been installed in all cavities, promoting rot throughout the structure.

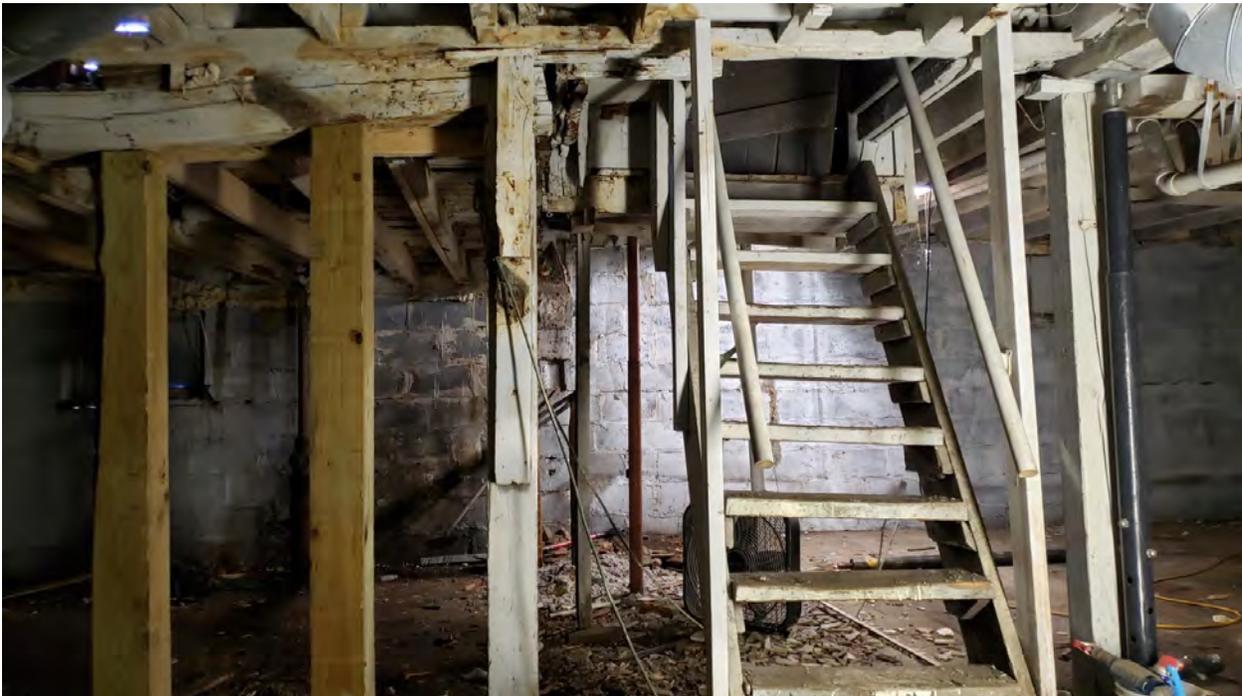
Center stairwell that was added for basement access. Visible main central structural beam both notched for headroom, and broken from neglect. Unsupported floor joists visibly sagging as the house collapses around this centrally located stairwell.

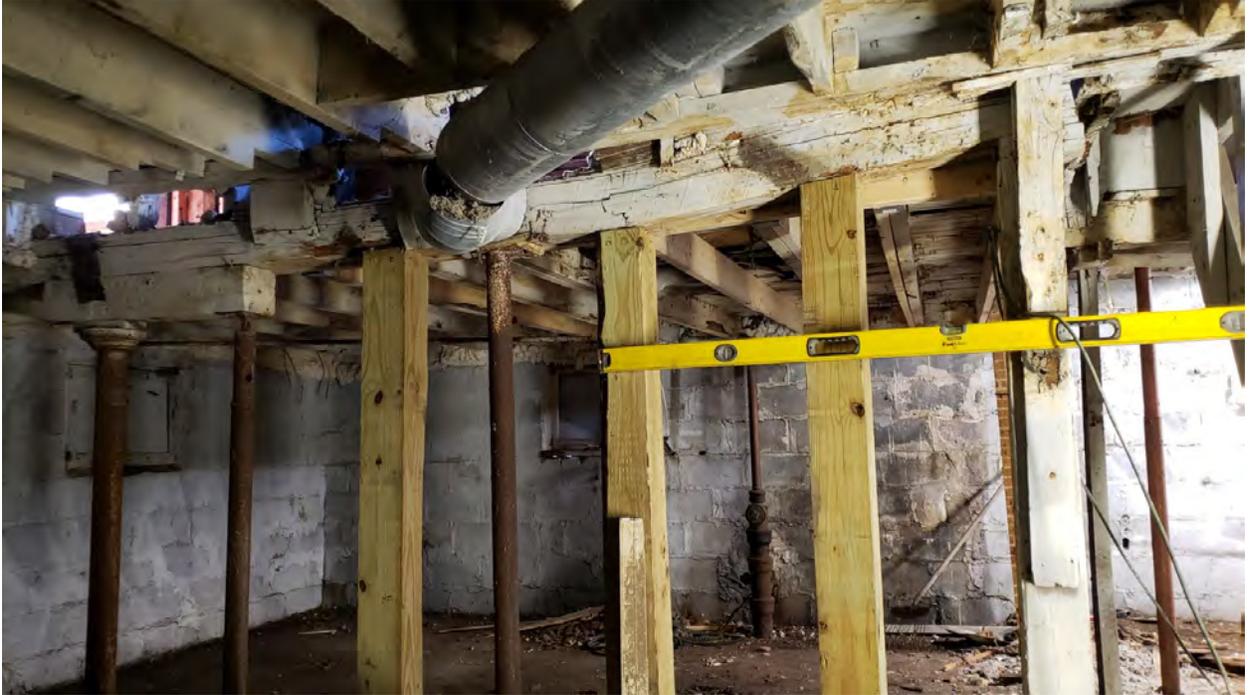
Poorly performed repairs and original construction methods, as well as decades of neglect have led to the thorough destruction of this house. The yellow level in the picture is set at level.
