Charles J. Quagliana, AIA  
Preservation Architect  
5641 Willoughby Road  
Mazomanie, WI 53560

July 8, 2022

Re: Assessment of 615 E Dayton St & 616 E Mifflin St, Madison , WI 53703

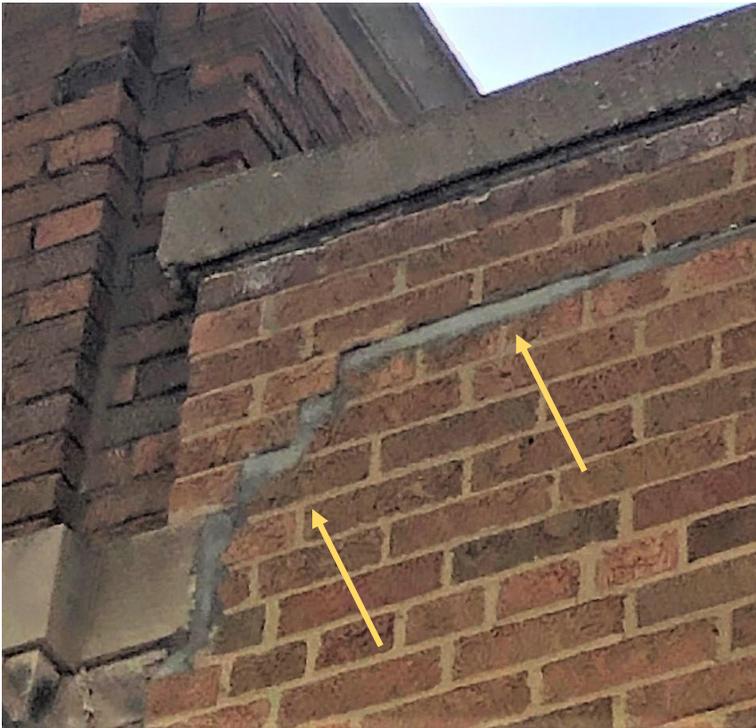
The brick masonry walls were found to be in good condition. Areas of mortar erosion were noted in the brick masonry, as well as some cracking. CMU wall construction appeared to be in relatively good condition; some repointing is recommended for both brick and CMU wall construction. Lintels were found to be in good condition. A larger crack was noted at the parapet between the original building and the brick addition along East Dayton Street.

*Juncture of original building and west addition along Dayton Street.  
Note structural crack and previous repairs.*

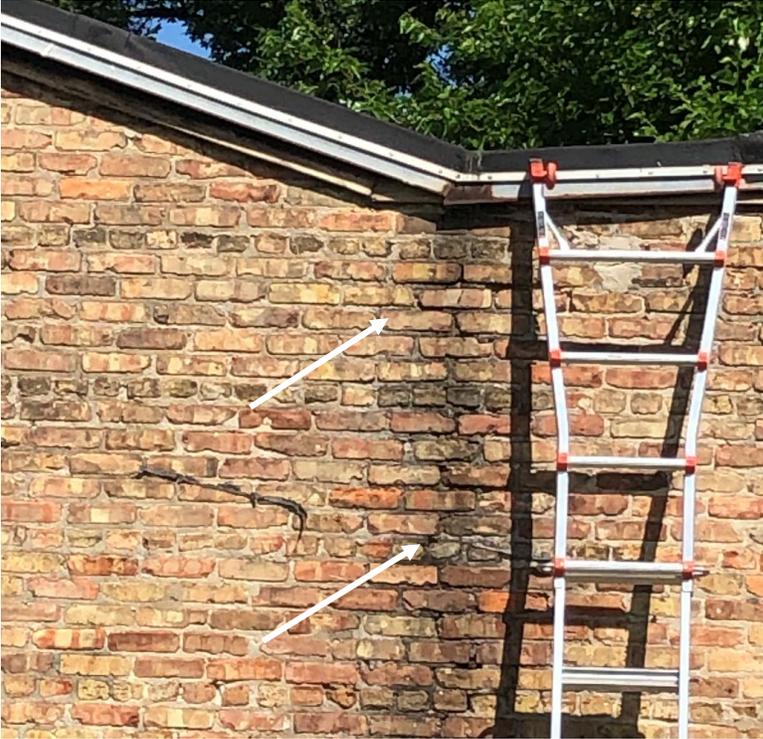
*Mortar erosion along south wall of the original building.*

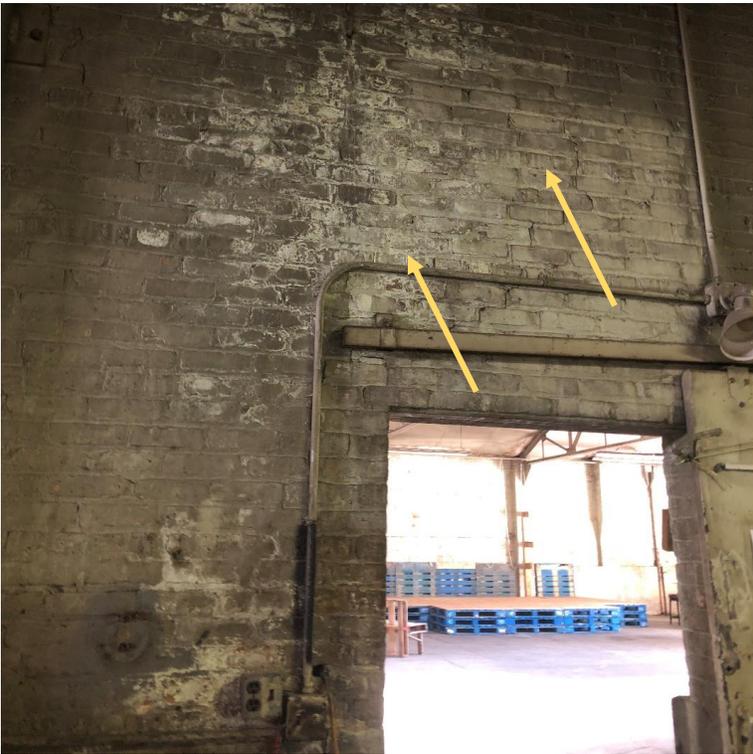
*Image showing possible water infiltration from the roof in the form of calcium salt efflorescence.*

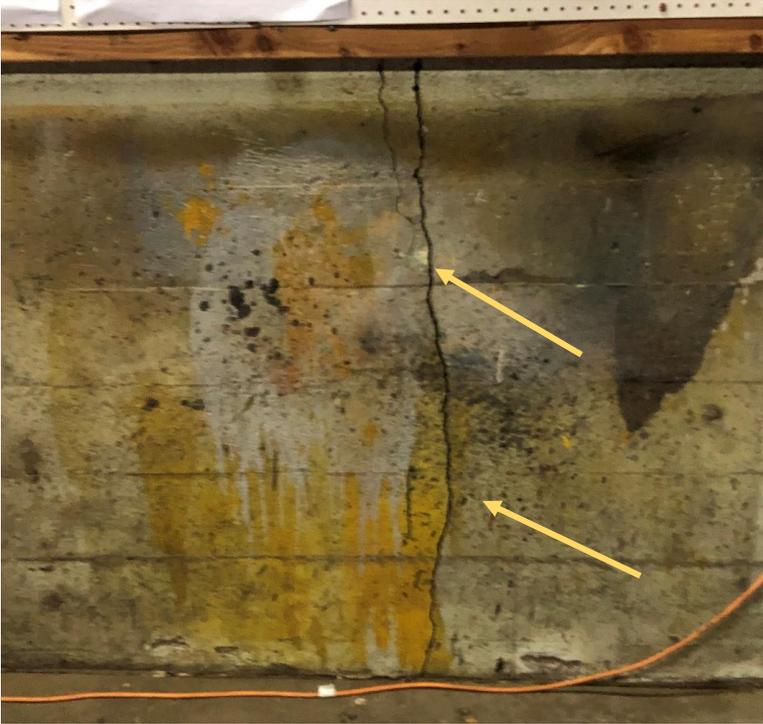
The foundations of the building are of poured concrete. There were a number of vertical cracks in the walls, all relatively minor. Some foam expansion material had been added in several cases presumably to keep out weather. Some cracks had been repaired with caulking.

*Image showing an unrepaired crack in the foundation wall separating the original building from the first addition along East Dayton Street*

Several trees growing along the foundation walls were noted that may be contributing to foundation movements. Removal of these trees is recommended.

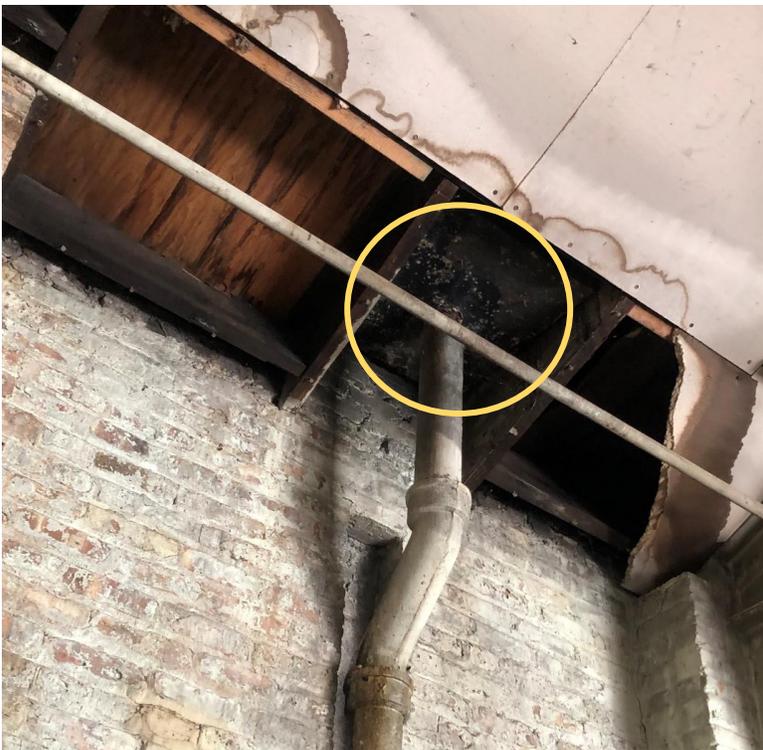
*Image showing minor damage below roof pitch pocket drain pan.*

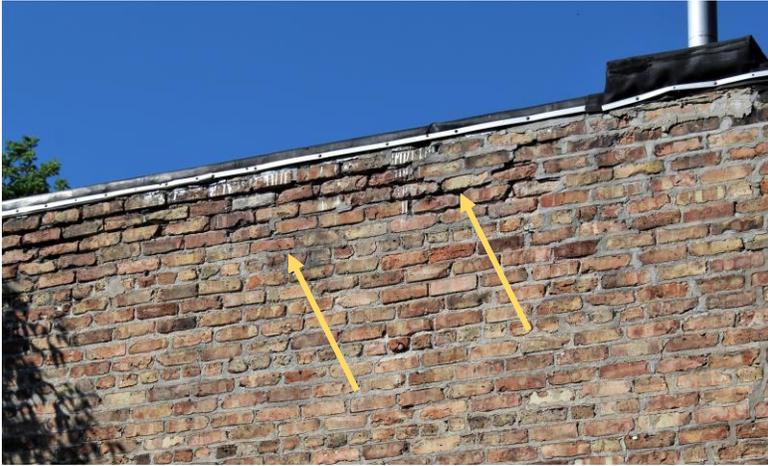
Masonry walls are in good condition with isolated areas of deterioration primarily along the parapets or where rain and snow melt water flow over the masonry. The front façade masonry requires some repainting and repairs to structural cracks.

*Deterioration of the east parapet. Common bond brick pattern.*

Exterior masonry walls are good to fair. Isolated areas of deterioration are noted and will require repointing with some brick replacement. This includes the parapets, chimney and area on the front façade. The roof appears to be relatively new and in serviceable condition. Skylights are relatively new and in good condition.

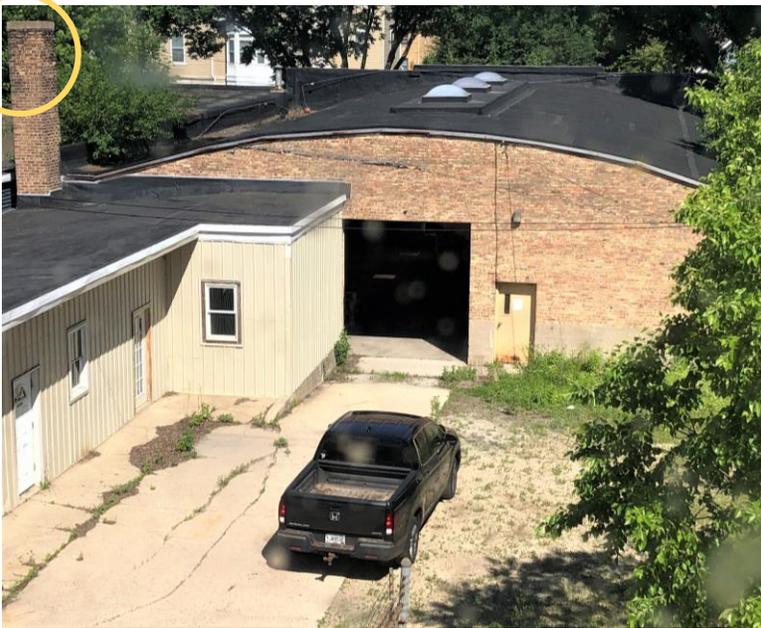
The roof is in good condition and appears to be fairly new. The roof material is EPDM and this warps behind the parapet walls. Roof insulation is within the wood structure.

*View of the EPDM roof on the original building (with new skylights) and south addition. Poor masonry condition at top of chimney.*

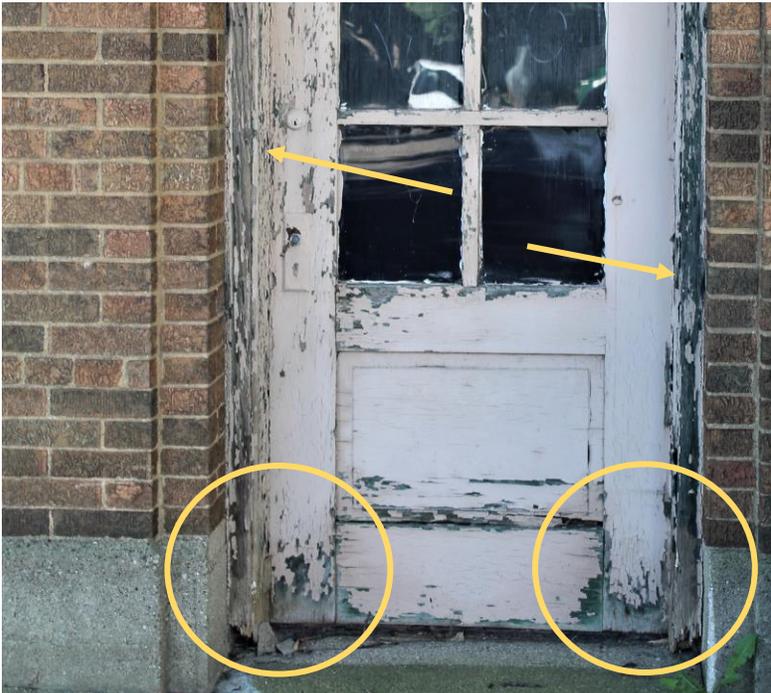
*Deterioration of the right-side front door*

Industrial steel windows are in fair condition requiring refinishing and reglazing. Overhead service doors are in good condition but are an inappropriate style for this building. The man doors require rehabilitation and repairs.

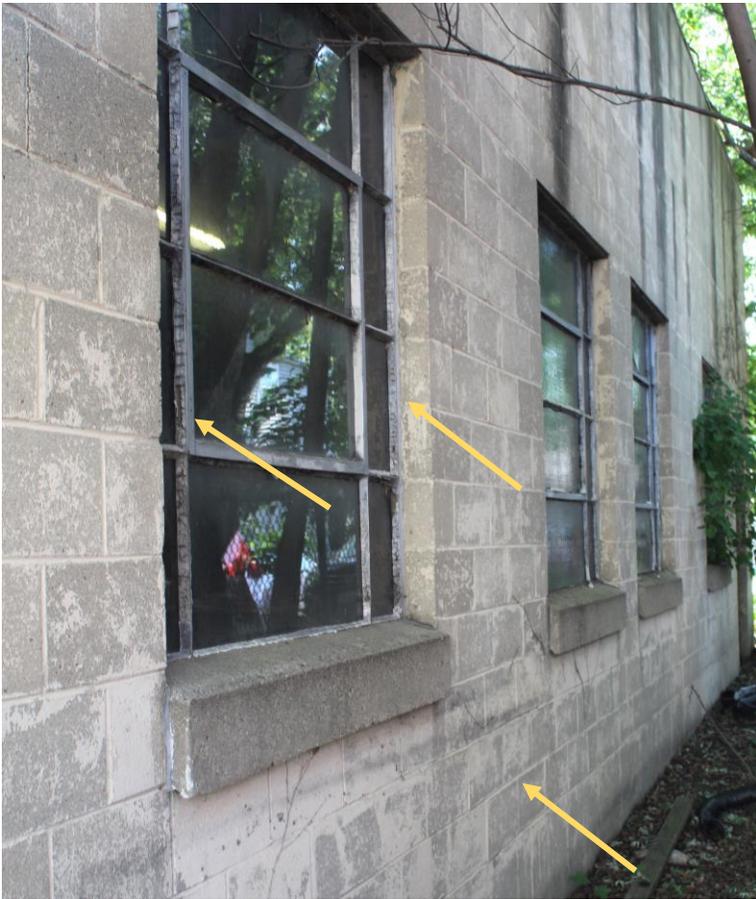
*View of the west side of the west addition. Note the deteriorated steel window glazing and paint finish and the paint finish on the concrete block.*

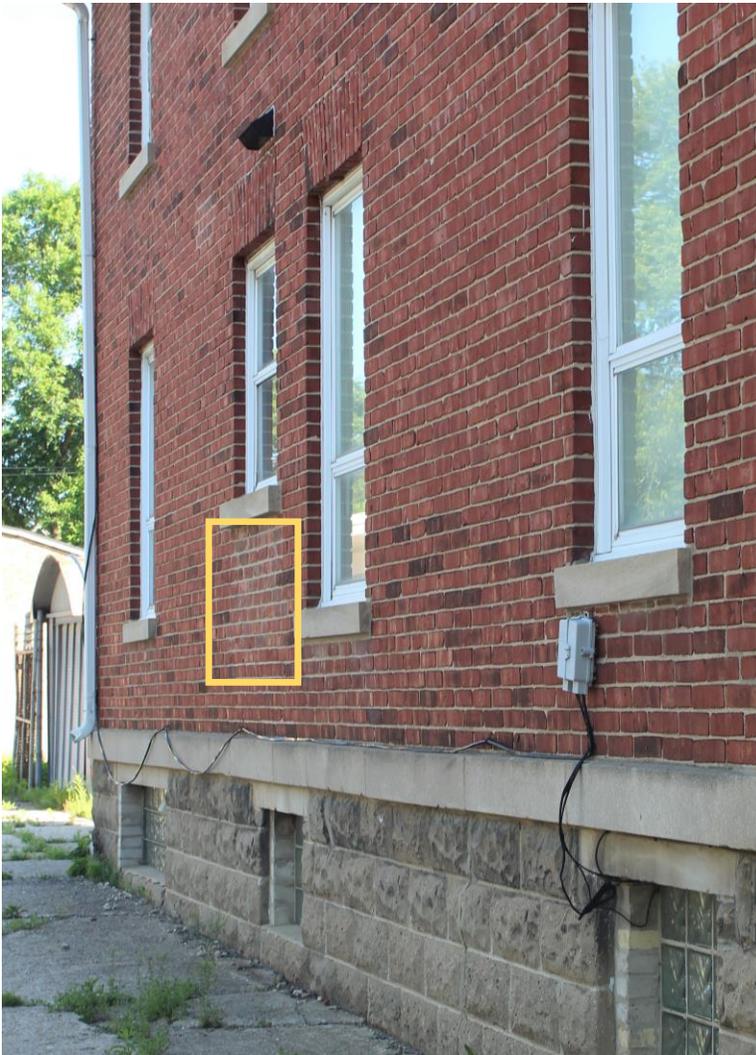
*View of the west façade, note the rusticated concrete block foundation, limestone belt course and running brick masonry with limestone sills. Area of window infill illustrated.*

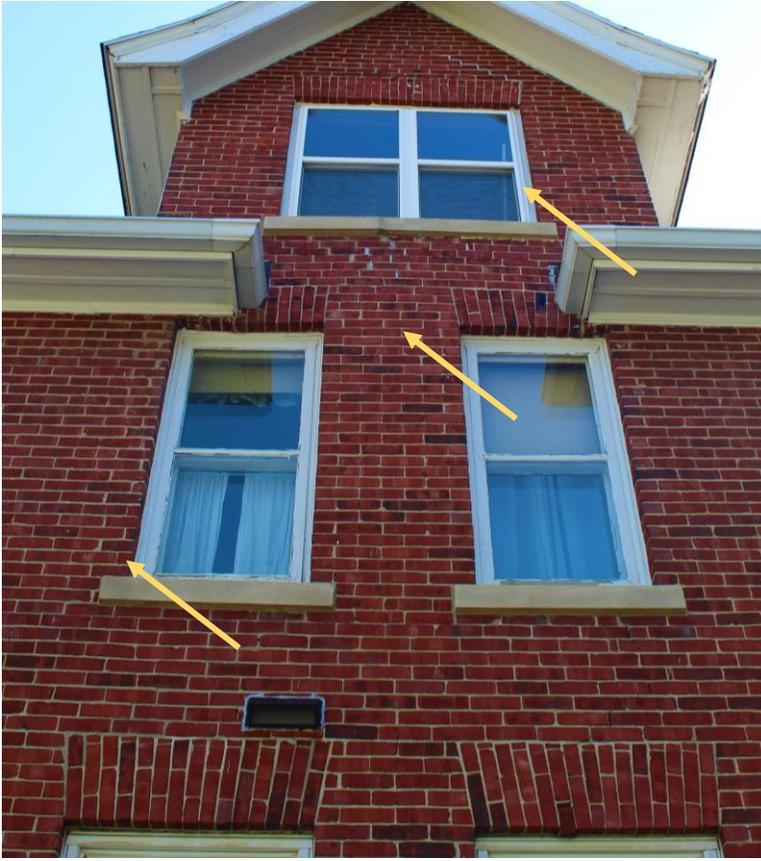
*View of the east façade. Note flat brick arches over windows, decorative soffit treatment and original second floor windows. Areas of inappropriate repointing illustrated.*

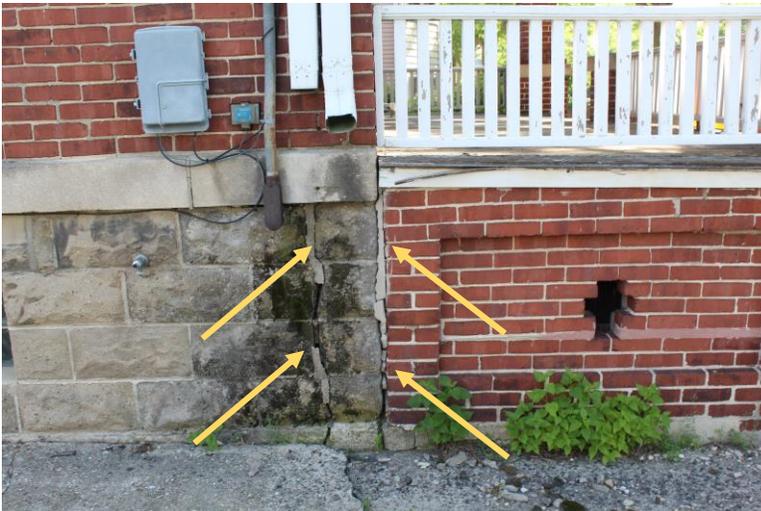
*Area of settlement at southwest corner of house at junction with porch. Significant foundation cracking. Rain and snow melt water ponding here.*

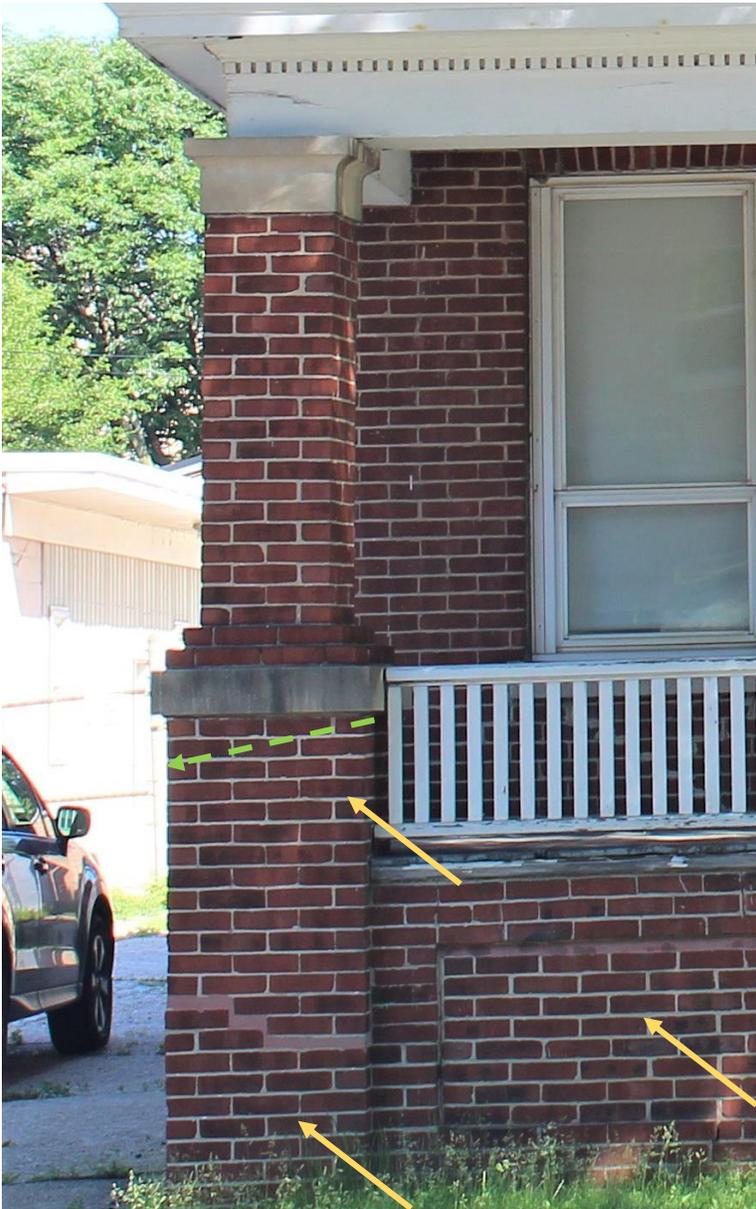
*View of southeast corner of front porch. The limestone pier cap has rotated. Evidence of previous repairs of full mortar replacing brick.*

Some settlement was noted on foundations supporting the front and rear porches. settlement on the front porch appeared to be relatively minor; rotation of the eastern most pier was about one-half" of tilt toward the street and approximately 1" of settlement on the western most front pier. Some oddly configured masonry repairs were added to correct some of the earlier movements.

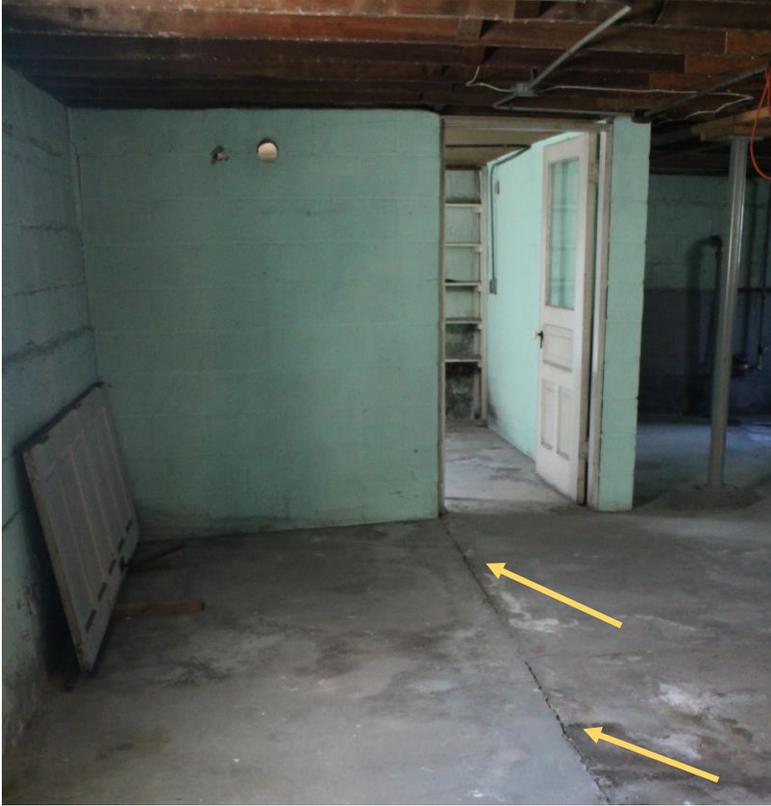
*Unfinished basement area. Line of heaved floor slab shown.*

The slab and interior column footings appear to be supported on heaved soils. The slab along the entire exterior perimeter of the home appears to be 1" to 2" lower than the central areas of the slab and column foundations. We suspect that this is due to the likely presence of relatively poor soils in the neighborhoods along portions of East Washington Ave.

Generally, the house is in good condition and stable with several issues to resolve. Portions of the basement floor slabs will need to be replaced, a new central support beam will be needed for the first floor and multiple isolated areas of masonry repair and repointing are necessary.

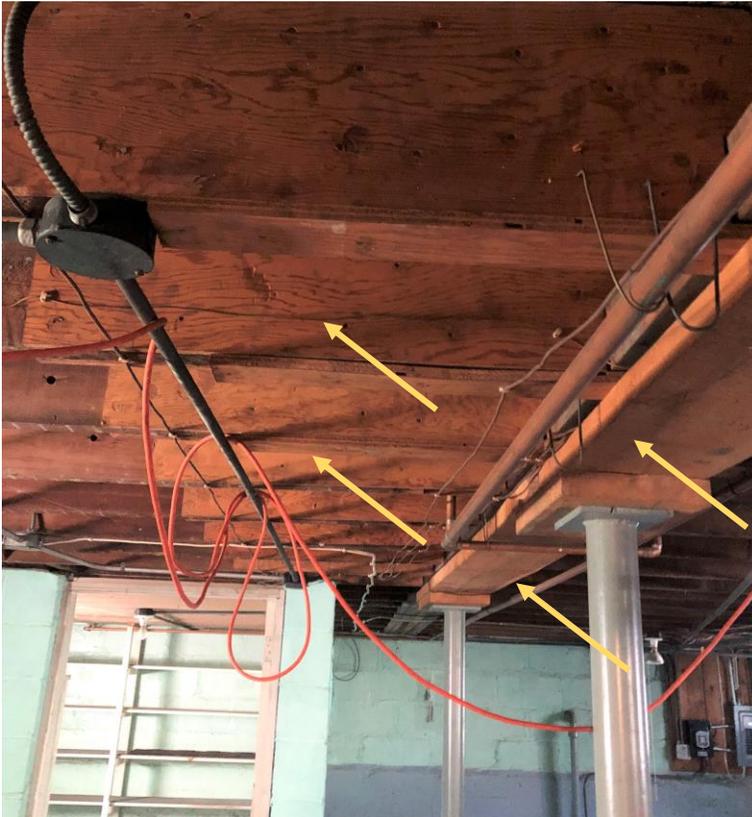
It was noted a significant structural defect in the first-floor framing. Nearly half of the floor joists in the basement were found to have been modified near their support at the central beam. Ends of joists had fastened plywood gussets extending the floor joists to the central beam. The plywood appears to have been placed later than the original home construction; plywood technology became more widely used long after the original build date of the home.

*Modifications to floor joists and main beam in basement.*

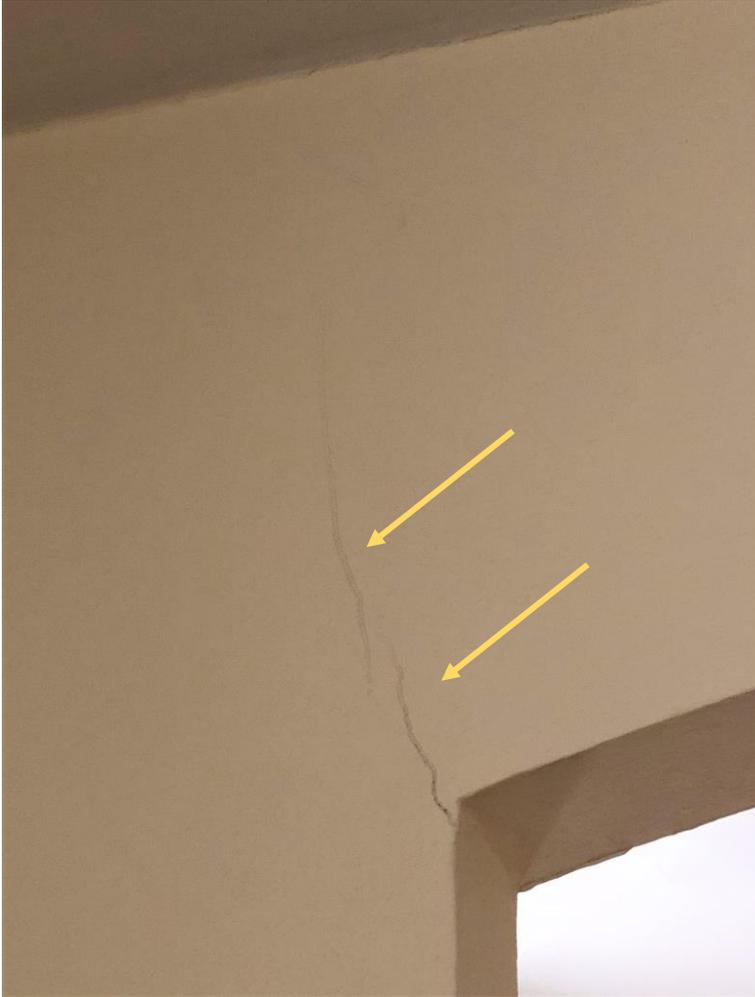
It was noted that partitions on the first floor had several cracks. It is believed that joist framing below these walls is deforming or sagging over time allowing the walls to shift. This a relatively minor issue; one that can be addressed with periodic maintenance.

*Image of crack in first floor plaster wall of living room.*

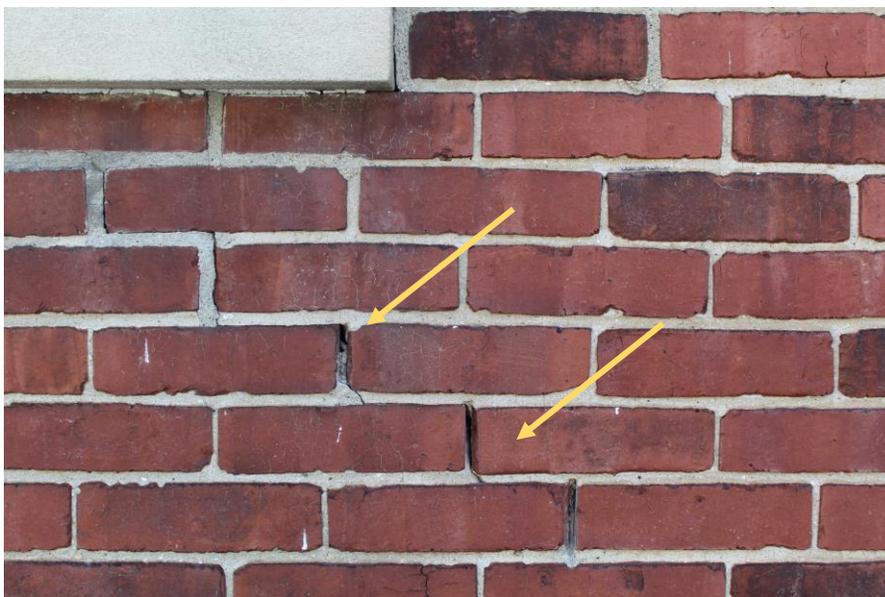
*West masonry wall. Typical area for mortar repointing.*

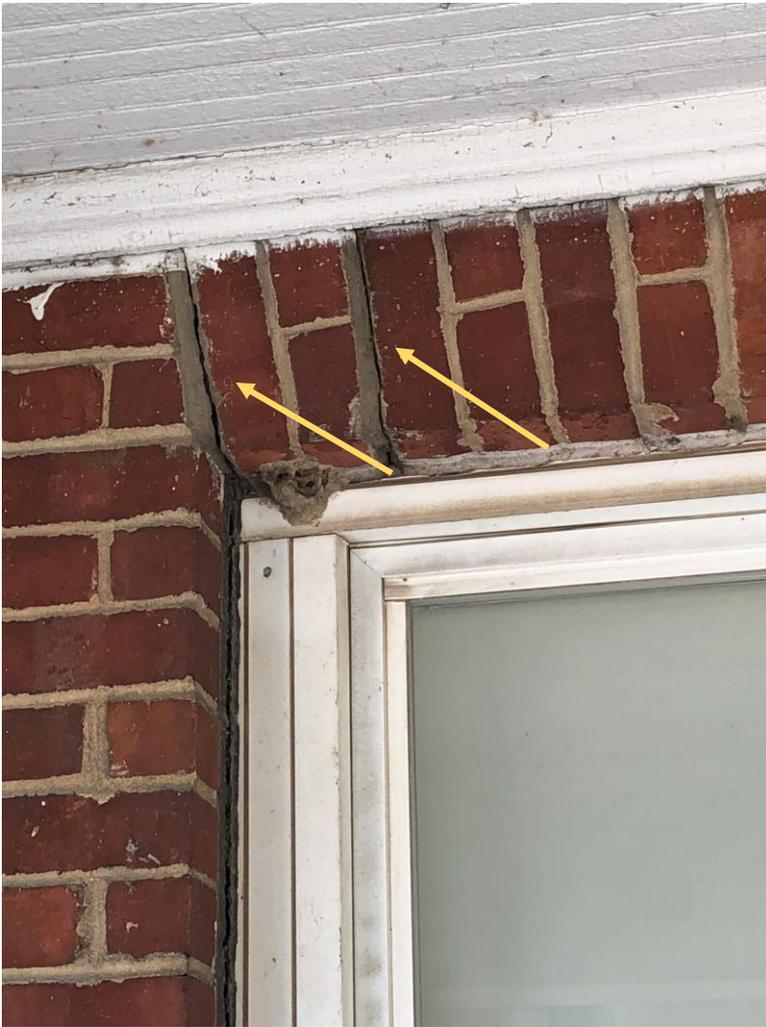
*Typical open joints in flat arch over window.*

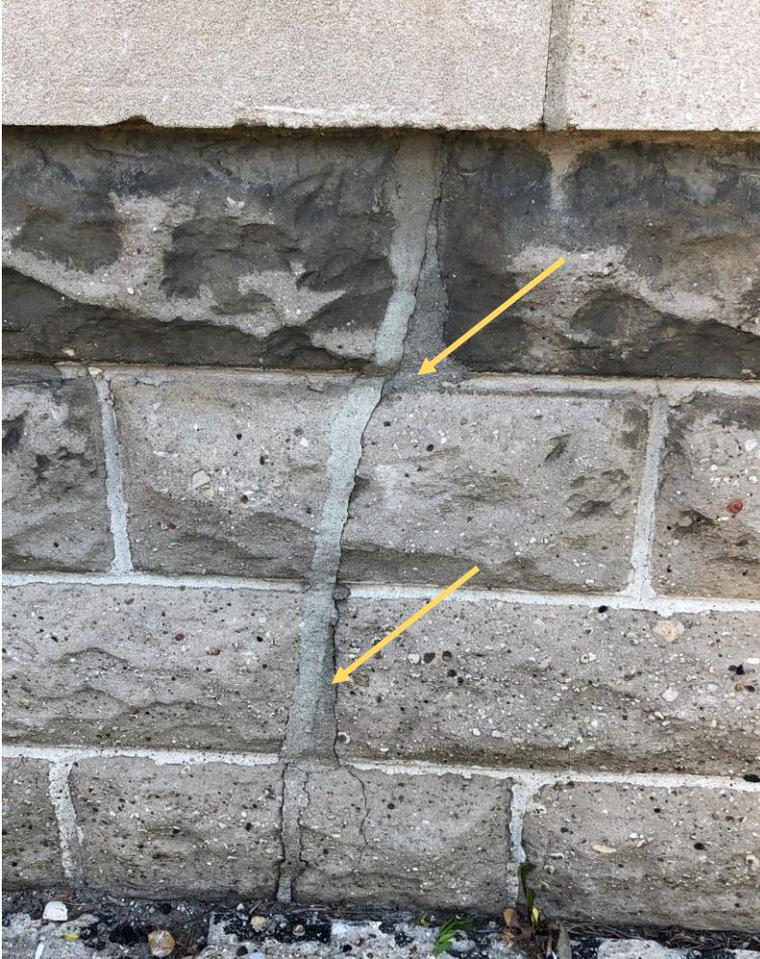
*Crack through foundation wall, repaired with hard Portland mortar.*

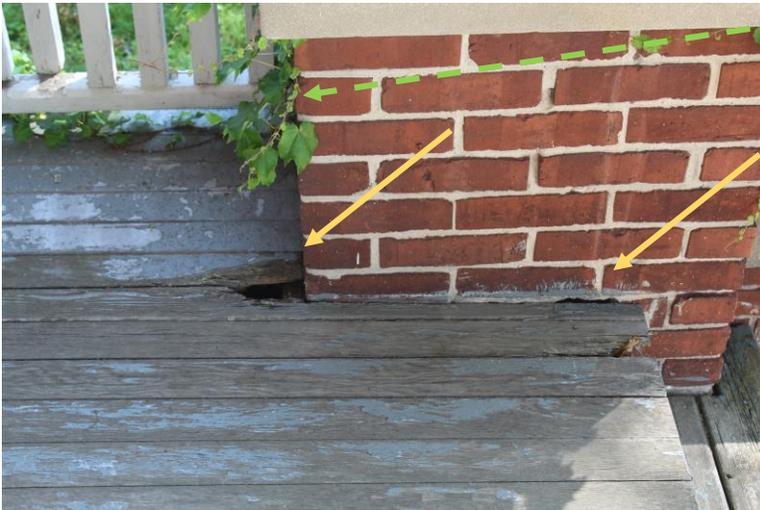
The wood porches are in good to fair condition overall. The flooring is in poor condition and in need of replacement. The architectural shingles of the main roof are in good condition with many years of serviceable life remaining. The porch roofs are original tin with folded joints. These are in good condition and serviceable.

The porch floors appeared to be relatively spongy. We suspect that the framing is relatively lightly framed with 2x's at 16" centers: possibly 2x8's. Some deteriorated decking was noted suggesting that there may be some damage to the porch framing as well.

*Deteriorate front porch floor and tilting brick column.*

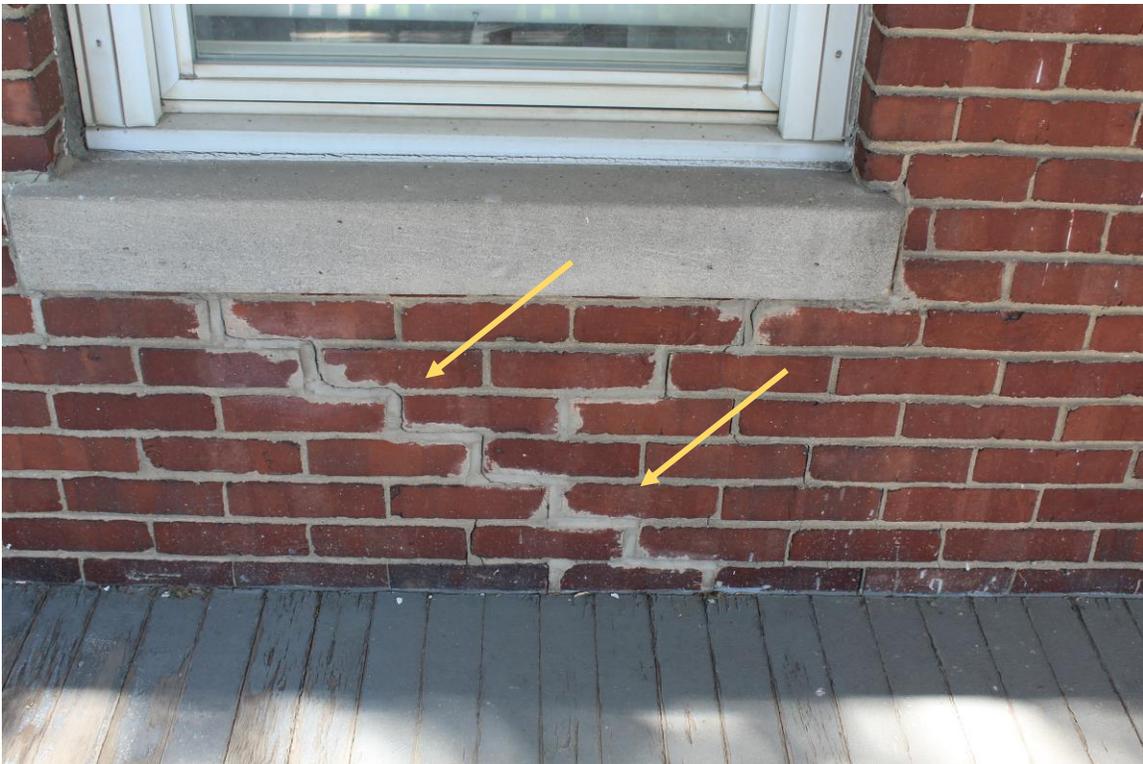
*Step crack in brick masonry at corner of front porch. Inappropriate Portland mortar.*
