**Historic Preservation Assessment**  
of  
**7 North Franklin Street**  
and  
**502 & 506 East Washington Avenue**  
Madison, WI

November 2017

Re: Assessment of 502 and 506 East Washington Avenue & 7 North Franklin Street  
Madison, WI

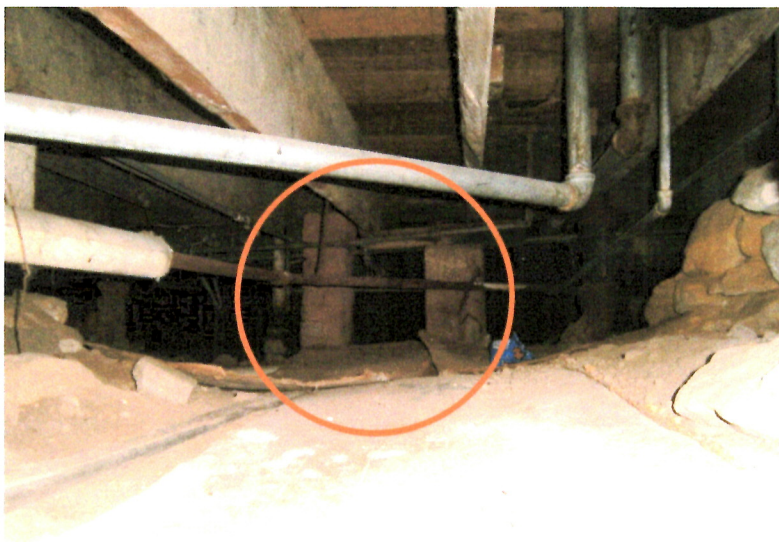
*View of the crawlspace. Note the isolated pier-like supports near the center of the building.*

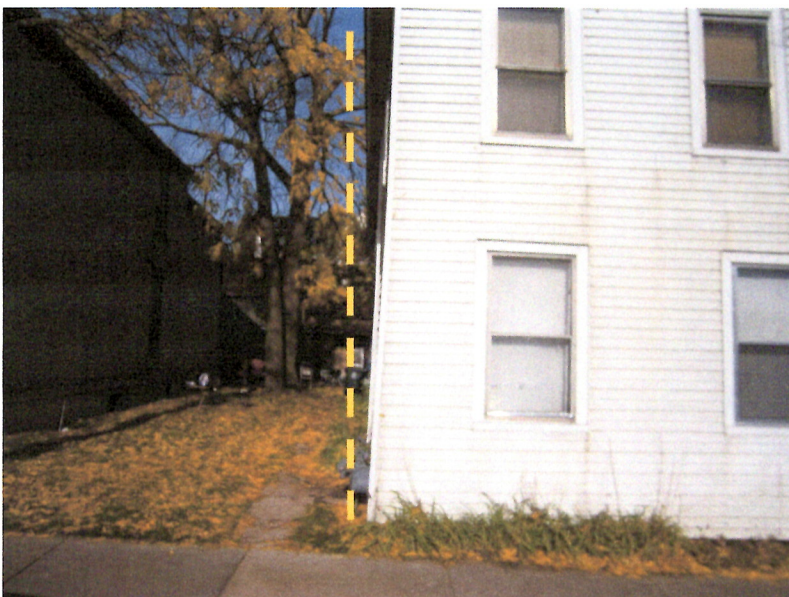
The entire house appears to be leaning to the northeast. Significant deviation from plumb was discovered at both corners the outside walls along the front of the home. The magnitude of the deviation was approximately 4 to 6" from top to bottom.

*Image showing the leaning of the home.*

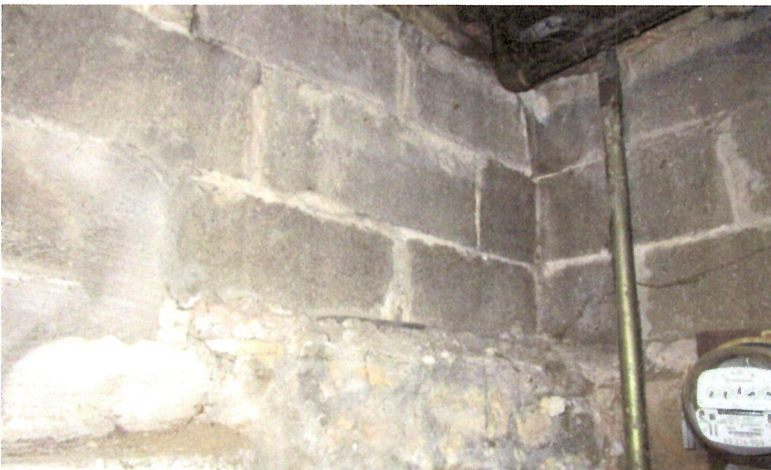
*View of the original stone foundation walls topped with concrete block walls.*

The exterior foundation walls were marked with significant signs of water infiltration and the parging coat was delaminating significantly in many areas. Mortar was missing in many cases from the concrete block portions of the walls. Cracks in the CMU in some cases had been filled with injected foam insulation.
