Historic Preservation Assessment
of
7 North Franklin Street
and
502 & 506 East Washington Avenue
Madison, WI

November 2017

Re: Assessment of 502 and 506 East Washington Avenue & 7 North Franklin Street
Madison, WI

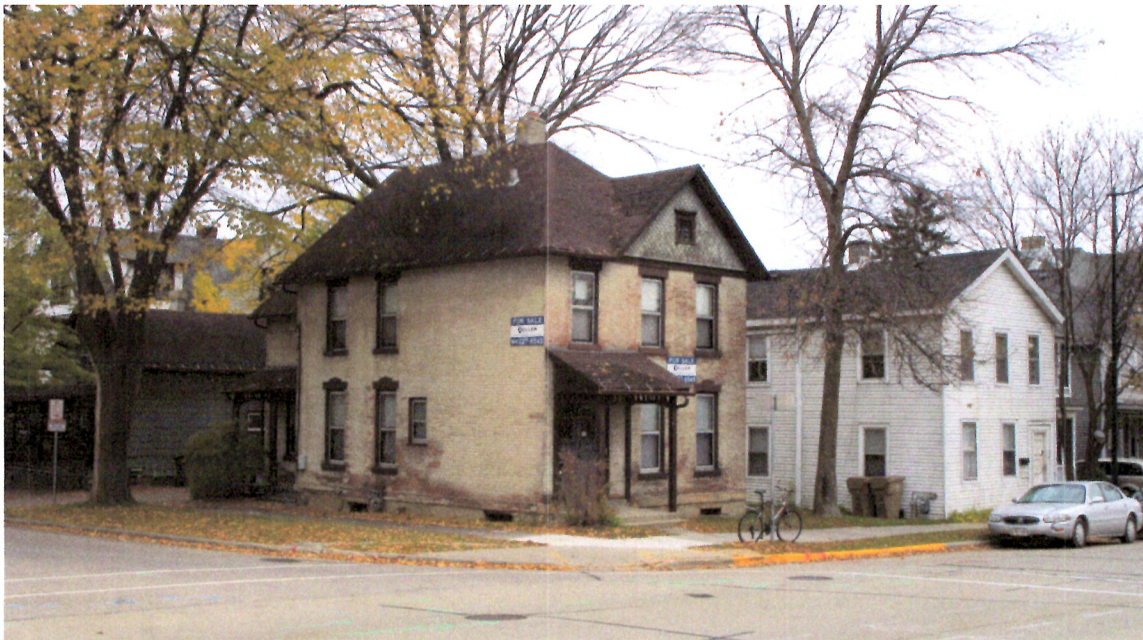
General view of 7 North Franklin Street, 502 and 506 East Washington Avenue

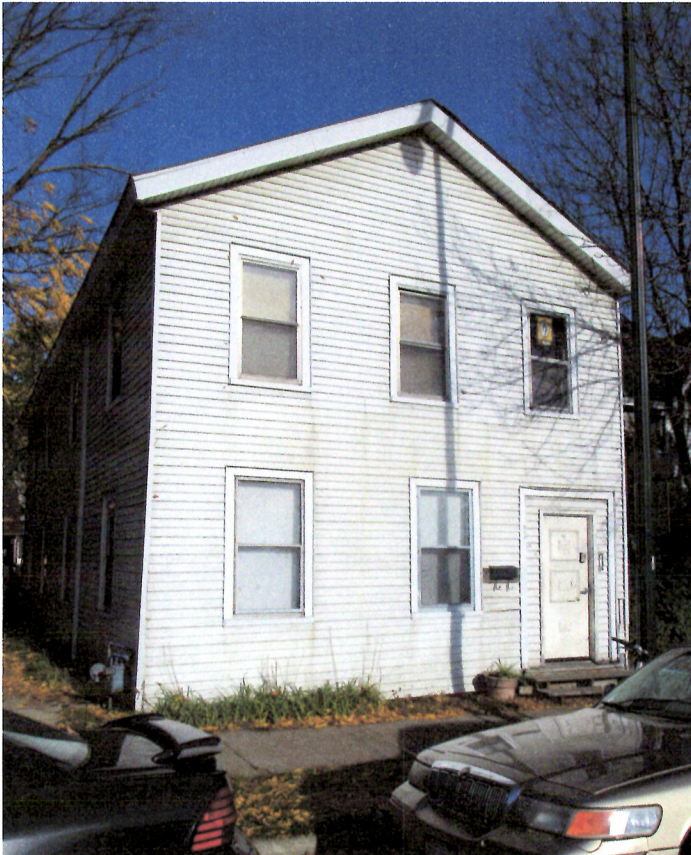
View of 506 East Washington Avenue from the street.

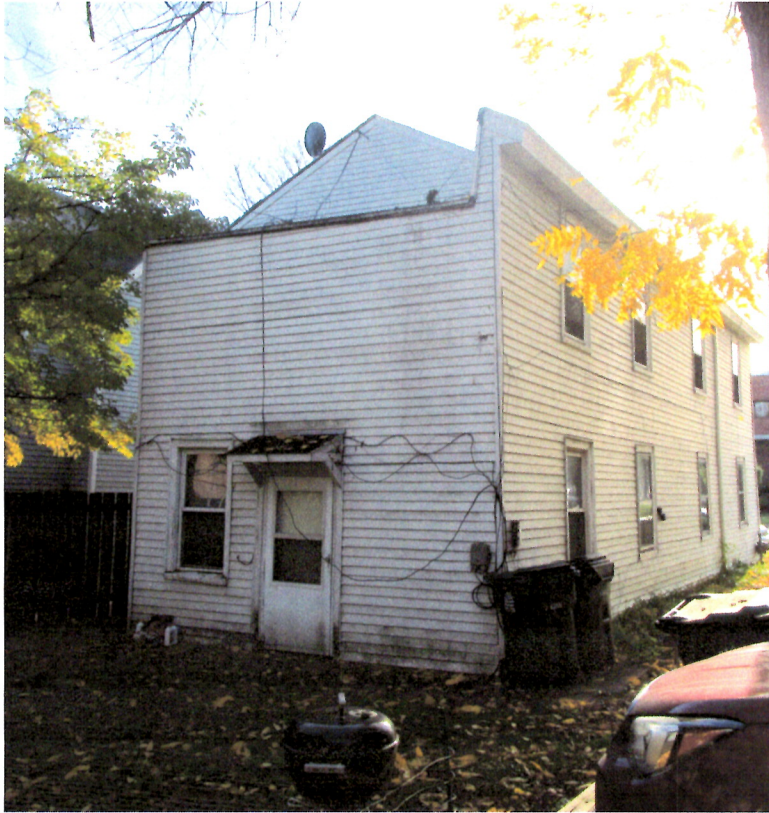
View of flat roof addition to rear of the house.

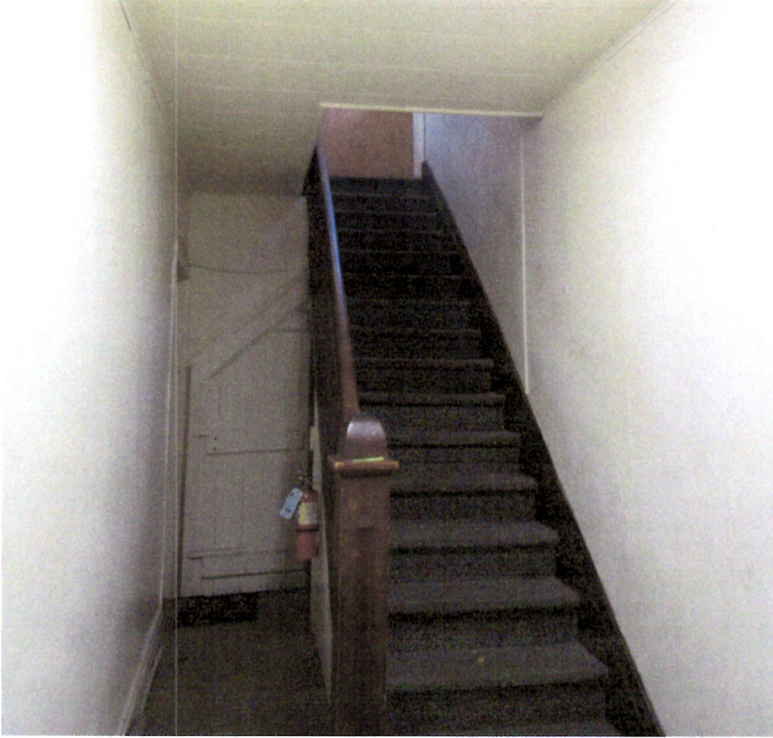
View of the interior of entry vestibule. The stair is likely original to the building. One of the few significant original elements remaining.

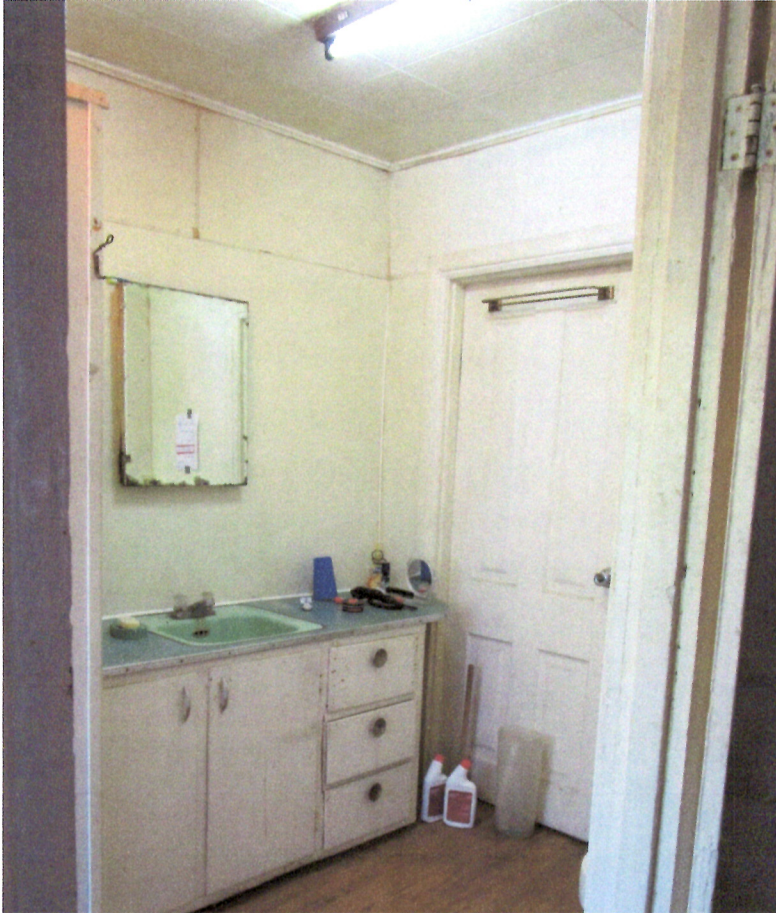
All the kitchens have some contemporary low budget cabinets, laminate counter tops and vinyl floors. The bathrooms of these units are typically in poor to fair condition with leaks present and the need for constant caulking and minor repairs evident. Water leakage was observed and is anticipated to be causing deterioration of adjacent windows, wall, floors and wood framing in some of the bathrooms observed.

View of one of the second floor bathroom areas.

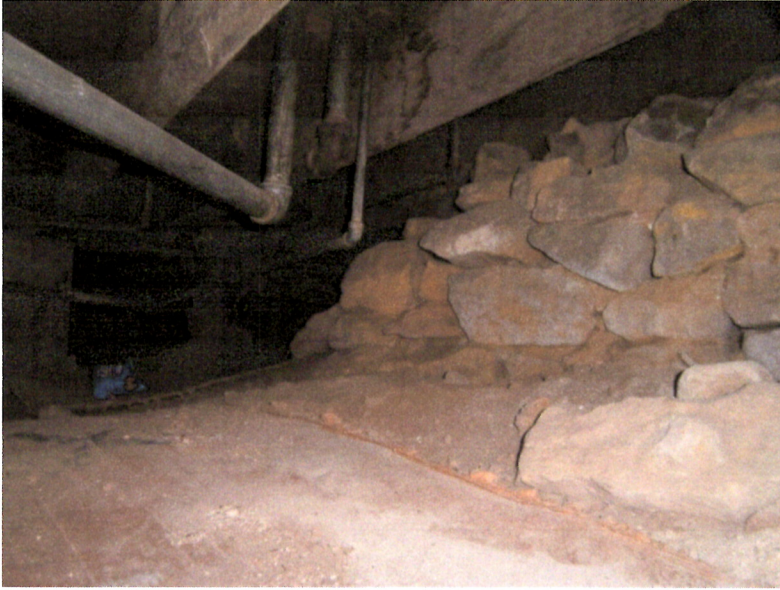
Image showing the foundation wall at the transition of the basement to the crawlspace. Most of the mortar appears to be deteriorated and eroded away.

The accessible foundation walls were in fair to poor condition. Significant mortar and stone deterioration is present as well as signs of moisture infiltration. Although no sign of inward movements or significant cracking was noted, there is concern over the general sloping of the floors above. Sloping floors usually means sloping foundations and settlements. We do not know the reason for the sloping/possible settlements.

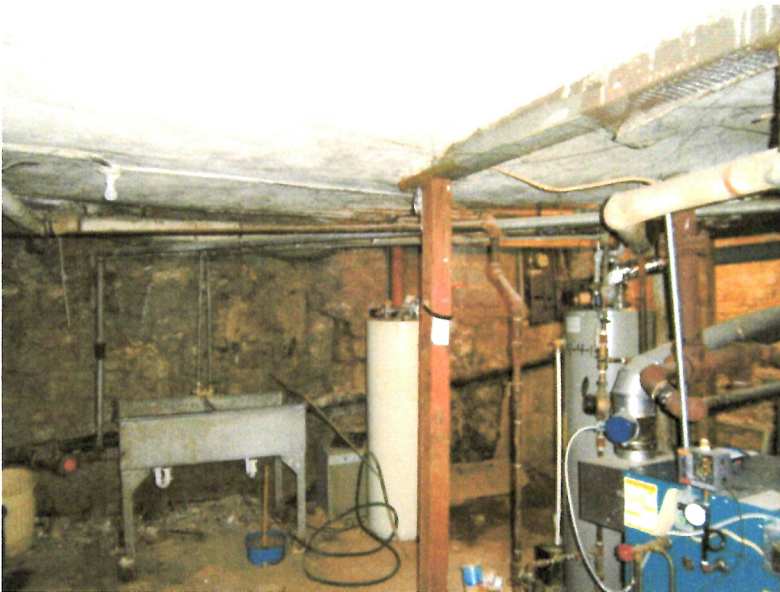
Image of the basement. Limestone walls are shown as well as wood beams and columns.

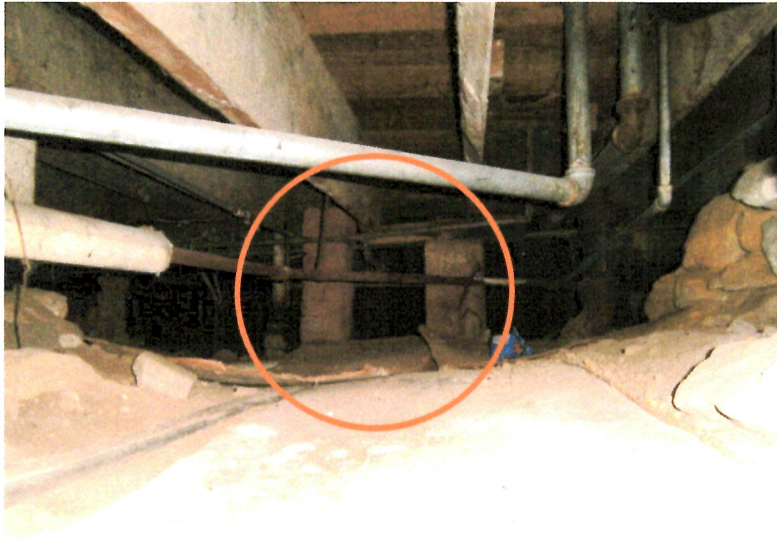
View of the crawlspace. Note the isolated pier-like supports near the center of the building.

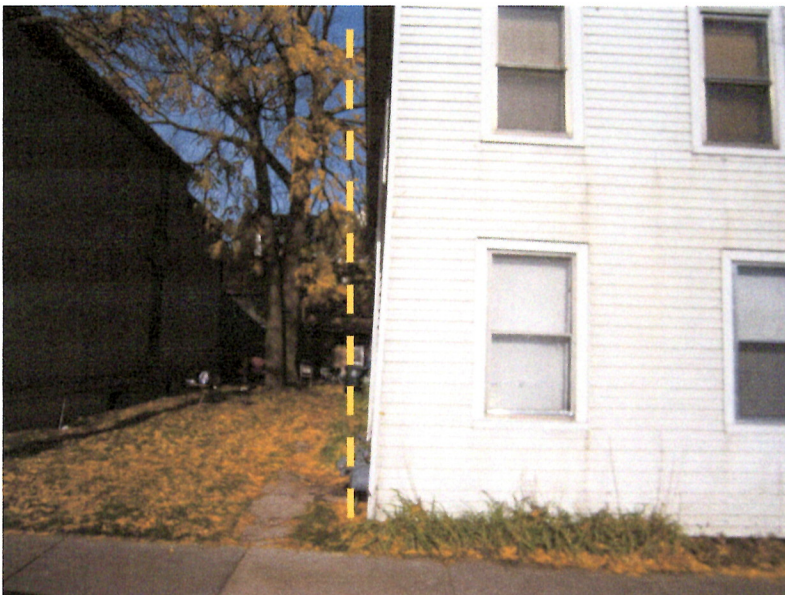
The entire house appears to be leaning to the northeast. Significant deviation from plumb was discovered at both corners the outside walls along the front of the home. The magnitude of the deviation was approximately 4 to 6" from top to bottom.

Image showing the leaning of the home.

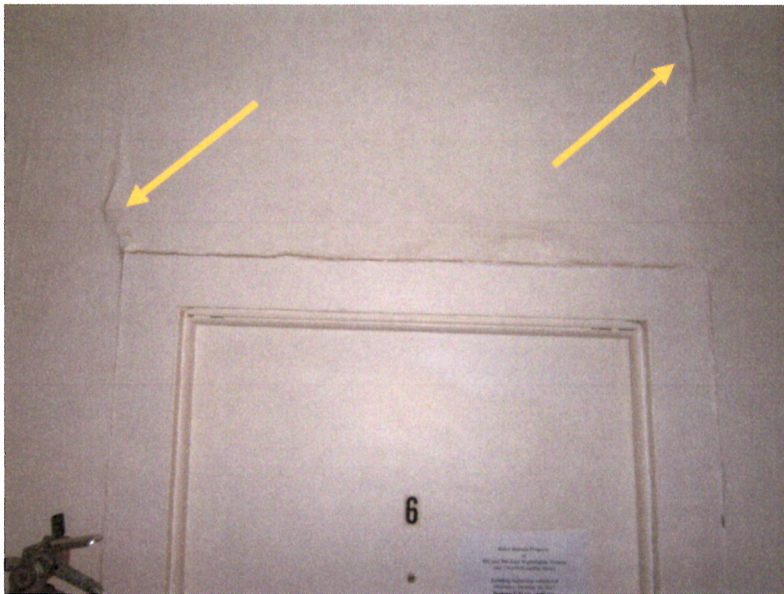
Image showing racking in walls of second floor.

The original plaster appears to have been covered in drywall to conceal cracking.

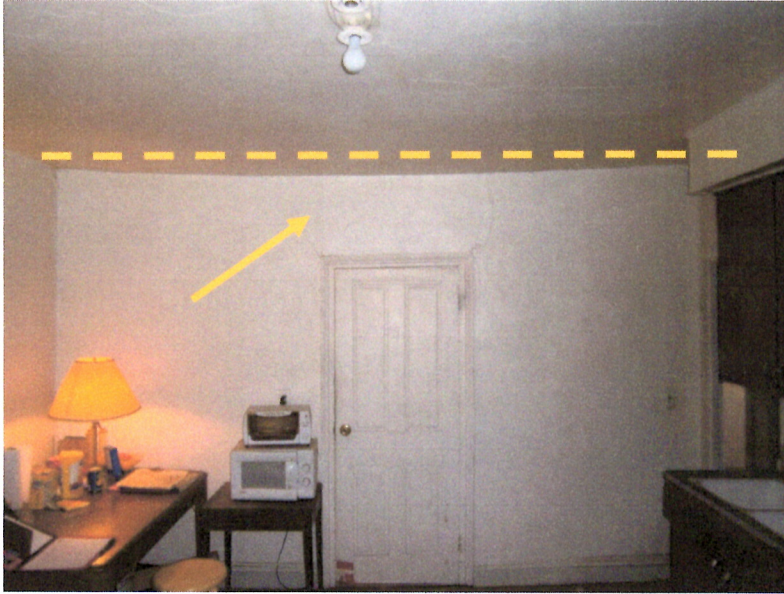
In addition to the general slope of the floors, there is some localized deformation and undulation in the floors. Similar deformations were noted on the second floor. The condition of the second-floor framing could not be determined. Sagging was noted in the roof framing. The magnitude of the sag appeared to be several inches in the center of the rafter spans.

Image taken on the second-floor kitchen. The wall in the image spans parallel with the joist span; the wall has sagged with the floor framing. The sag in the joist can be seen in the ceiling line. Note extensive cracking in wall.

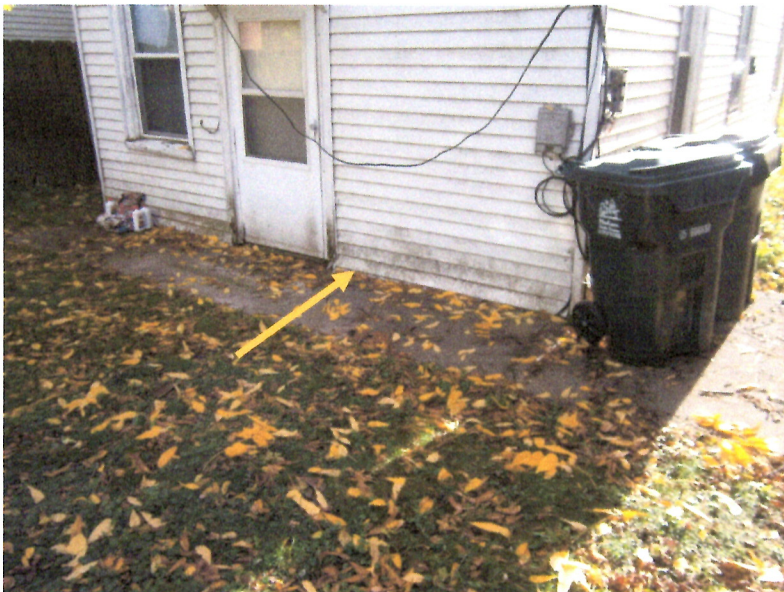
Some deterioration may be present in lower portions of the wall or floor framing along the back portion of the home within the crawl space area. The grade along these walls is quite high and algae and dirt is present on the siding along this wall. This is evidence of moisture intrusion into the structure.

Image showing the high grade along the back of the building allowing moisture penetration into the foundations

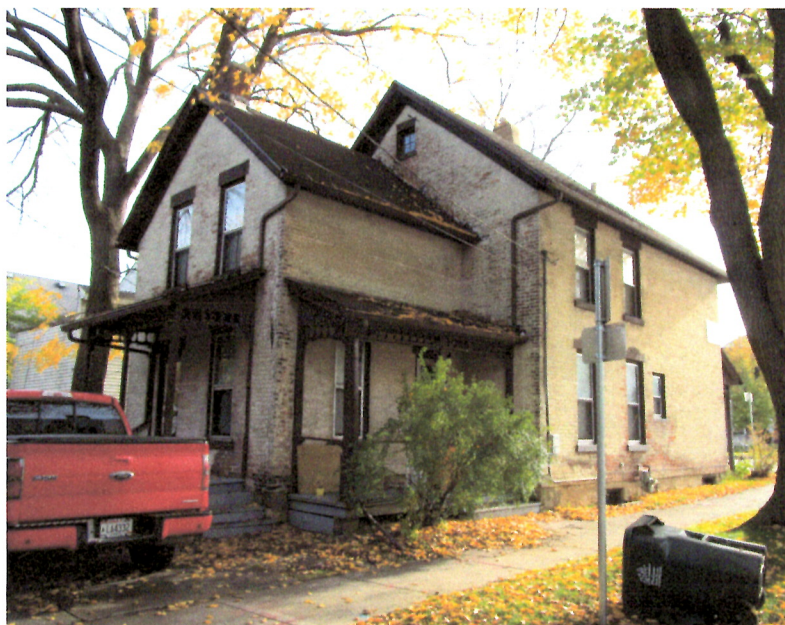
View of west side and rear areas of 502 East Washington Avenue

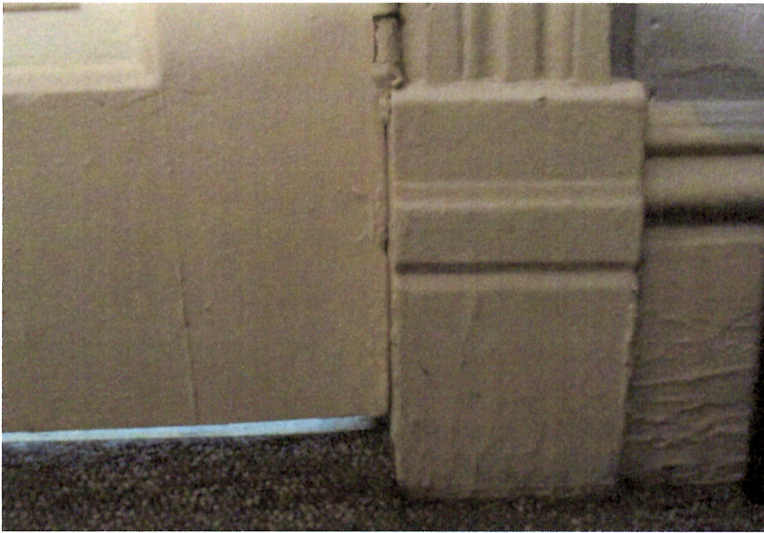
View of typical first floor door, base, plinth and casing detail

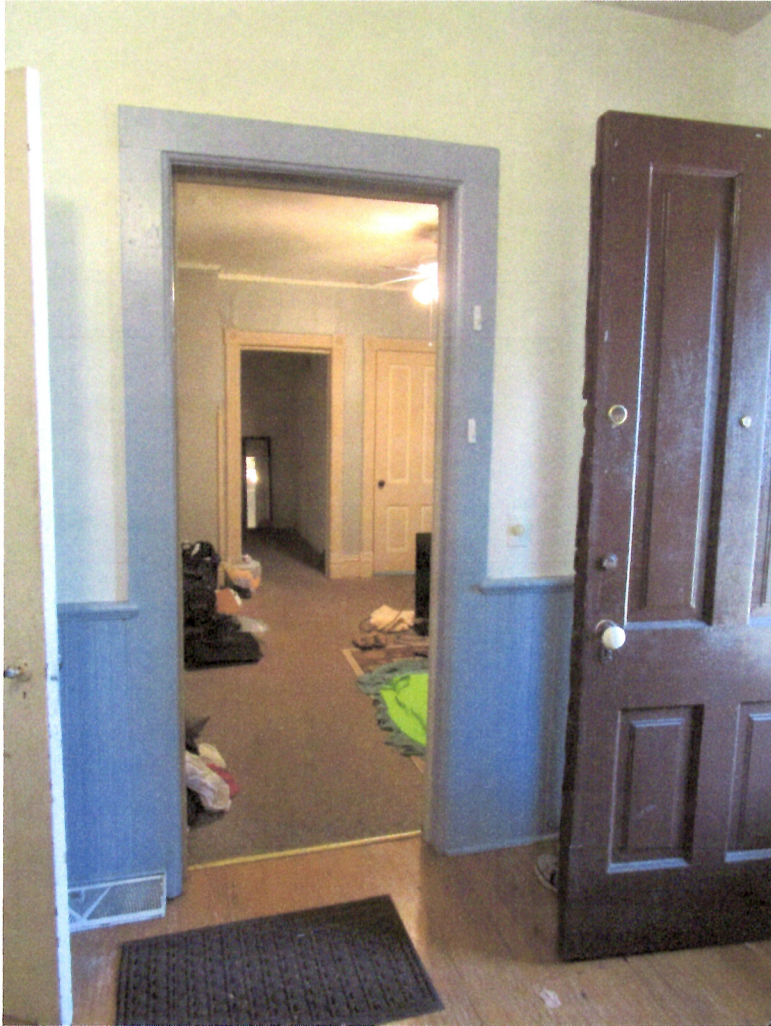
View looking from kitchen in to dining room

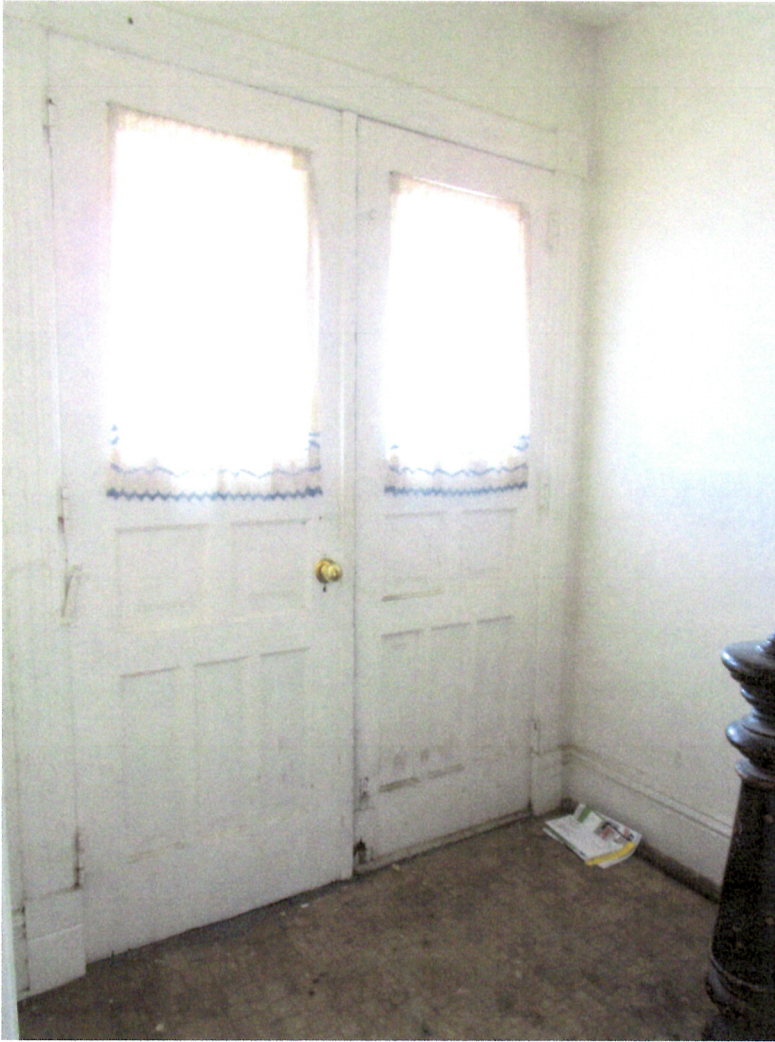
View of the front entry that features double entry doors and a stair to second floor.

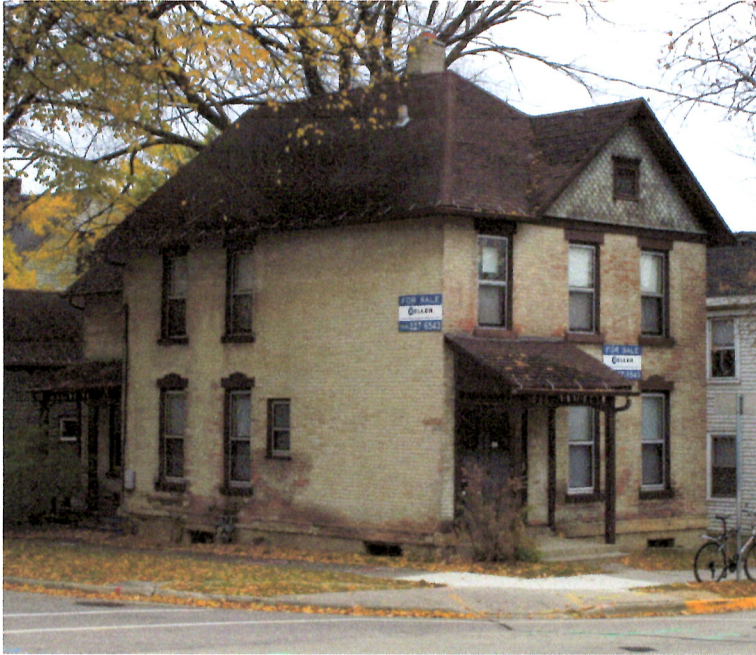
The exterior brick work is covered with a thin layer of paint. Possibly milk paint. The original red/orange brick is quite soft and vulnerable to water penetration and therefore deterioration. Several isolated areas of brick deterioration were observed.

View of the southwest corner of 502 East Washington Avenue

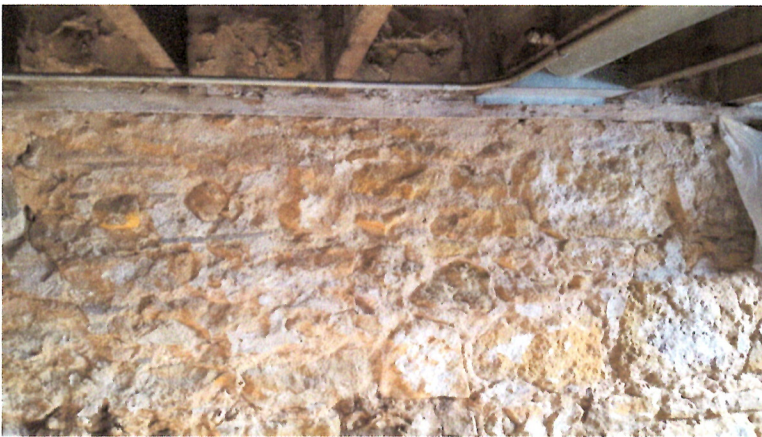
Image showing the rubble limestone foundation walls.

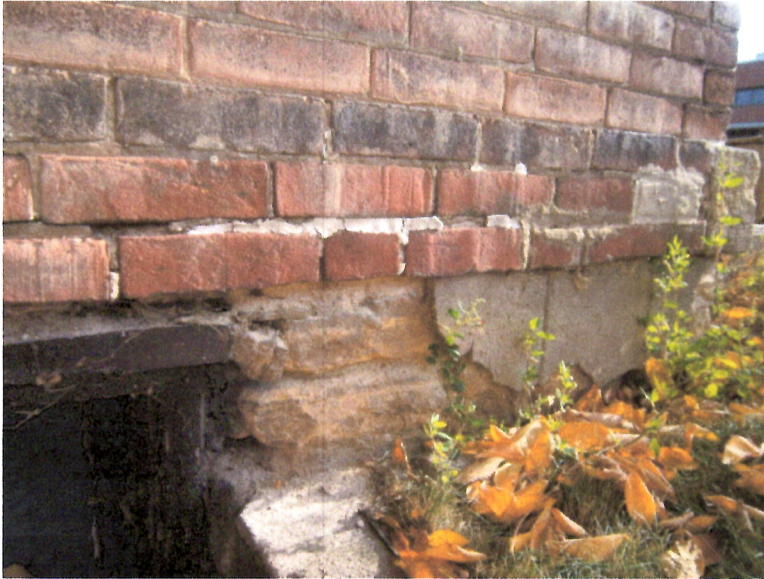
Image showing the brick water table and the top of the rubble limestone foundations.

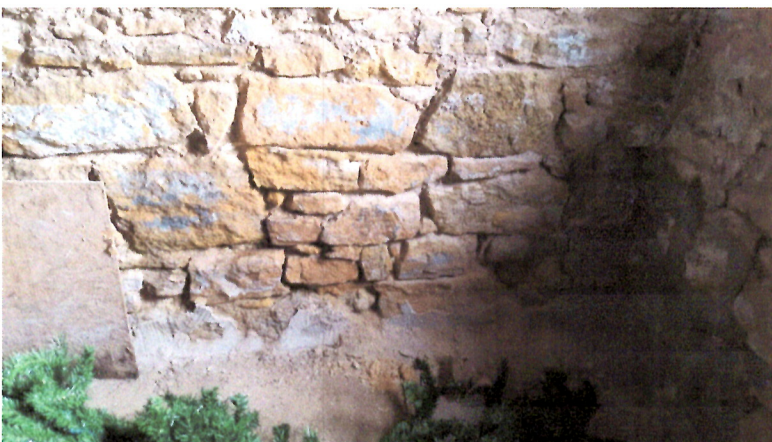
The stone foundation walls of the building are in good to fair condition. No cracking or bulging was noted. Some degradation of mortar and moisture infiltration was noted. A portion of the floor slab on the south half of the building had been excavated and was missing.

Image showing mortar deterioration at the base of the basement foundation walls.

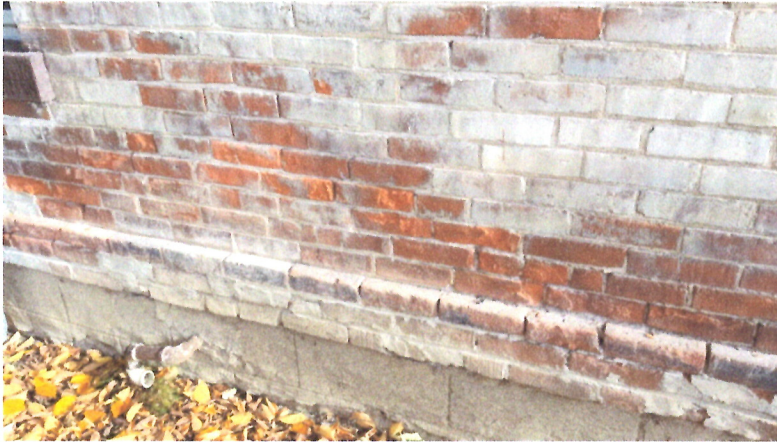
Some delamination was noted in the brick walls on the building exterior. The affected areas were low to the ground, and damage was likely caused by higher than normal absorption of water combined with freeze thaw.

Image showing the face delamination on the brick walls of the buildings west side.

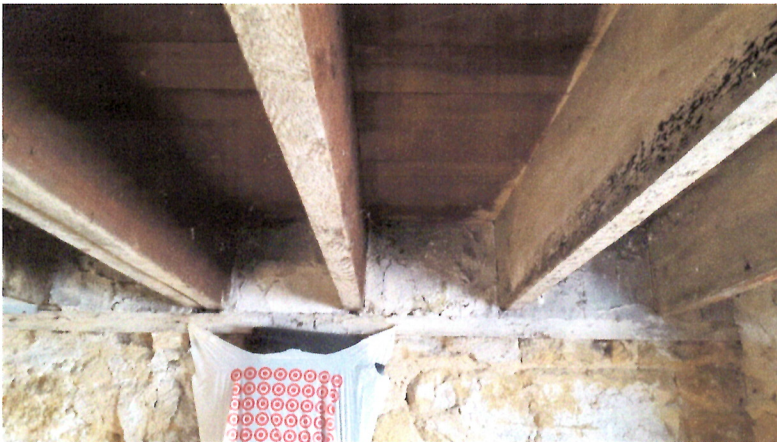
The first-floor framing was generally in good condition although some deterioration was present in joist framing. The framing ends encased in the exterior brick walls was not accessible to view.

Image showing the rotted joist bottom (at the right).

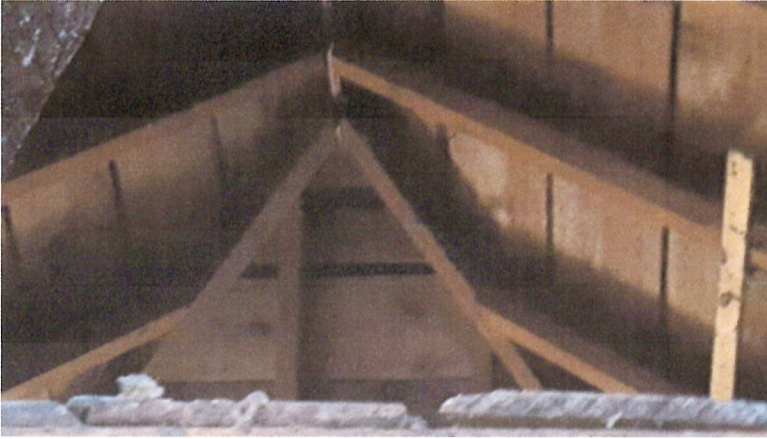
The roof was accessed from a hatch in the upstairs hallway. The framing was found to be 2x4 at 16 to 18" centers with 1x decking. The roof appeared to be quite square and planer with no significant issues.

Image showing the roof framing through the hatch.

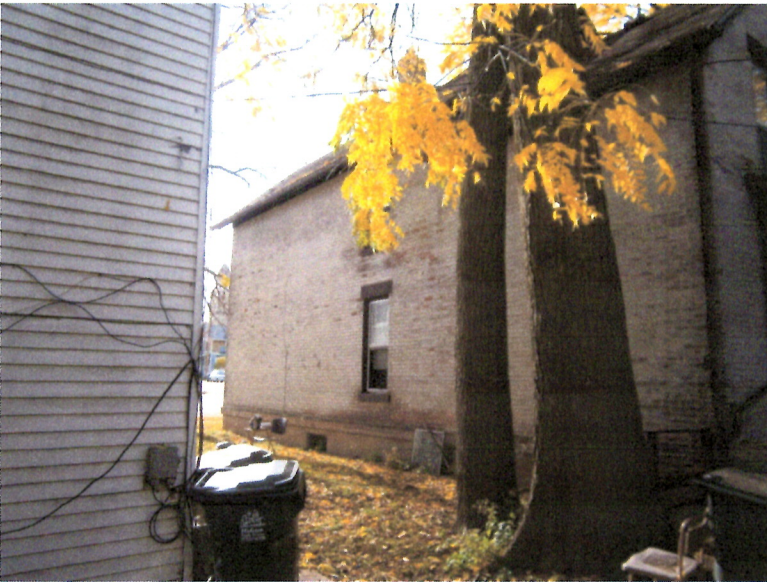
Image showing the northeast face of the building. No cracks were found in the masonry and the roof segments were generally planer without sags.

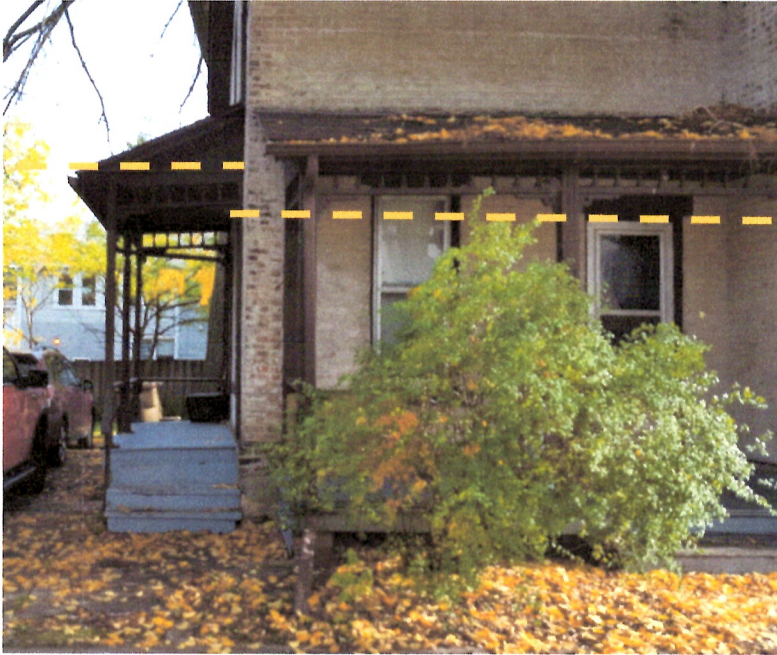
The side porch had a dip in the rear at the back column. The cause of the dip appeared to be related to deterioration in the floor framing but may also be related to settlement in the corner support pier. Some floor framing of the side and back porches appeared to be in poor condition.

Image showing the dip in the outer corner of the roof.

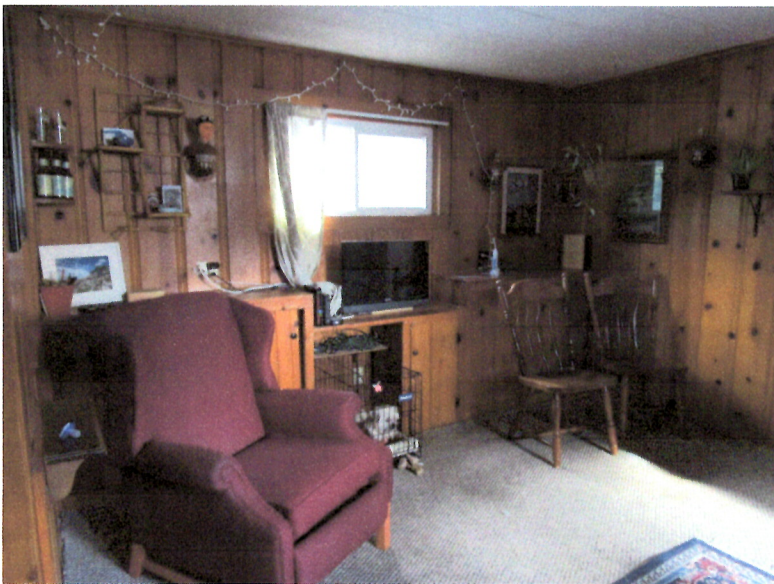
View of the interior of the first floor of 7 North Franklin Street

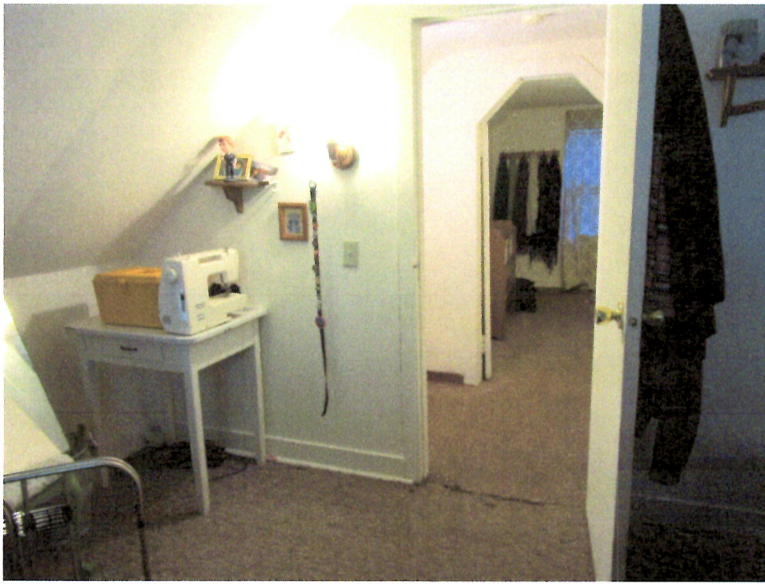
View of second floor level. Note the low ceilings and half height side walls.

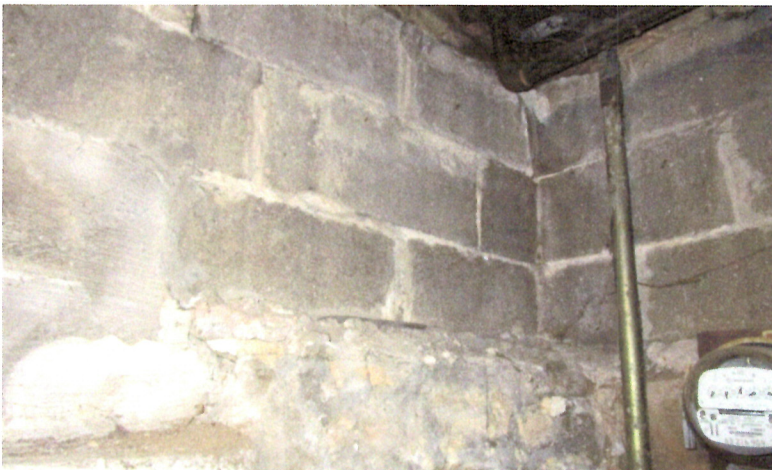
View of the original stone foundation walls topped with concrete block walls.

The exterior foundation walls were marked with significant signs of water infiltration and the parging coat was delaminating significantly in many areas. Mortar was missing in many cases from the concrete block portions of the walls. Cracks in the CMU in some cases had been filled with injected foam insulation.

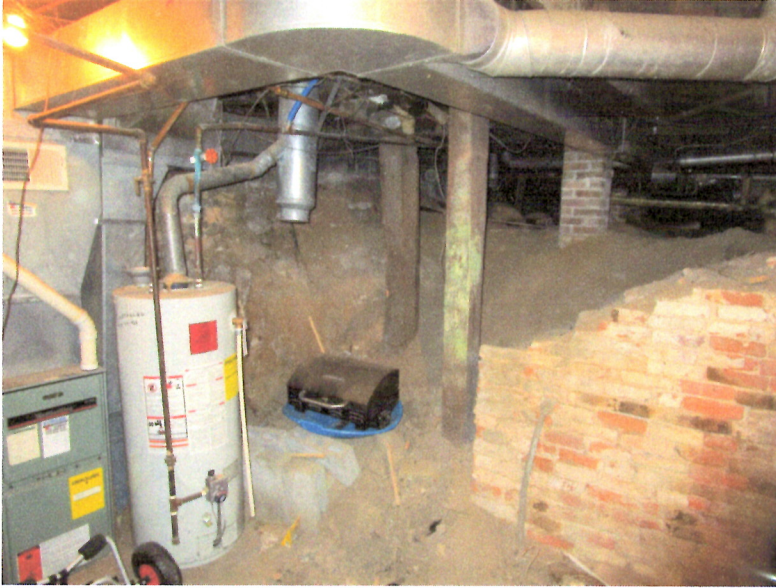
View of the partial brick wall separating the basement from the crawl space.

The foundation walls of the home were generally in poor condition. A separation wall in the basement constructed of brick (only 4" thick) was in a state of partial collapse. Soil from the crawl space was spilling into the basement space. Column foundations supporting the floors are likely being affected by the shifting soils in this area jeopardizing their support and stability.
