Written Letter of Intent

Conditions Report:

Names: Hubert and Margaret Schmitz House

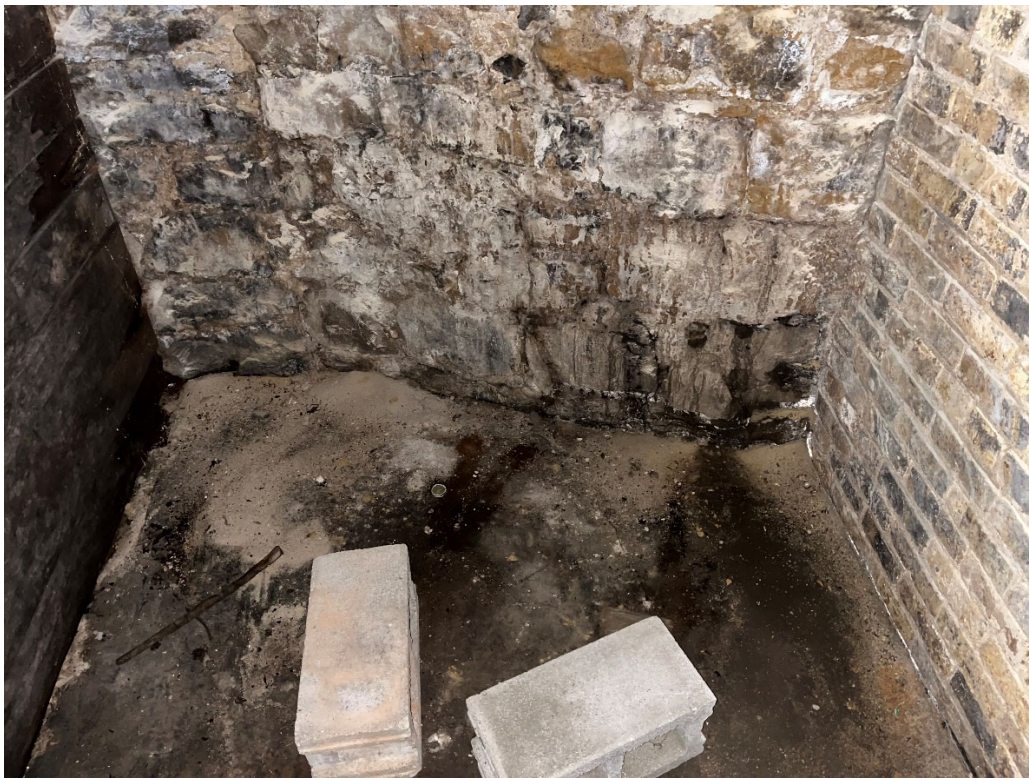
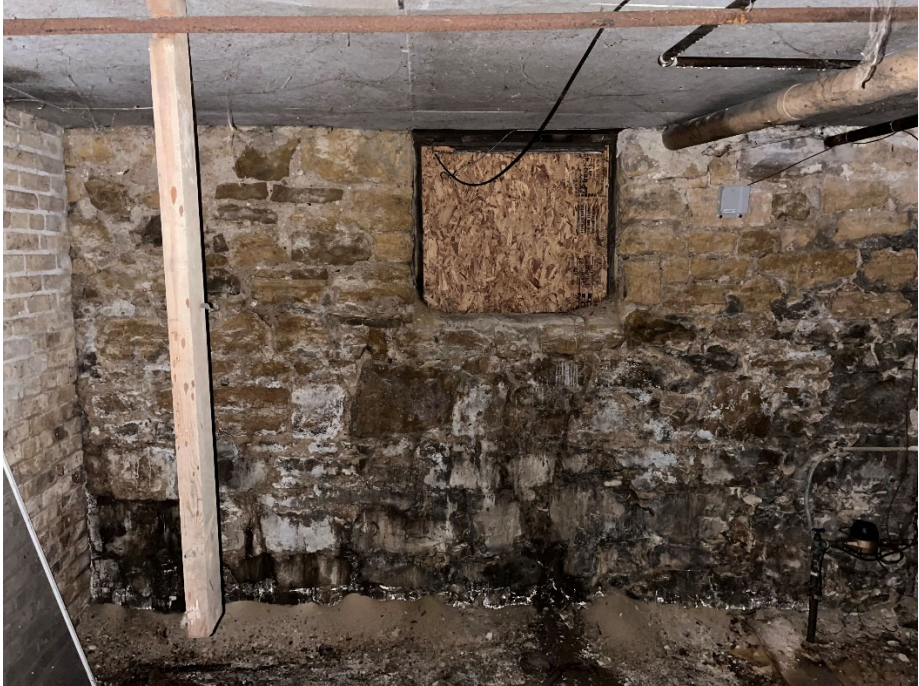
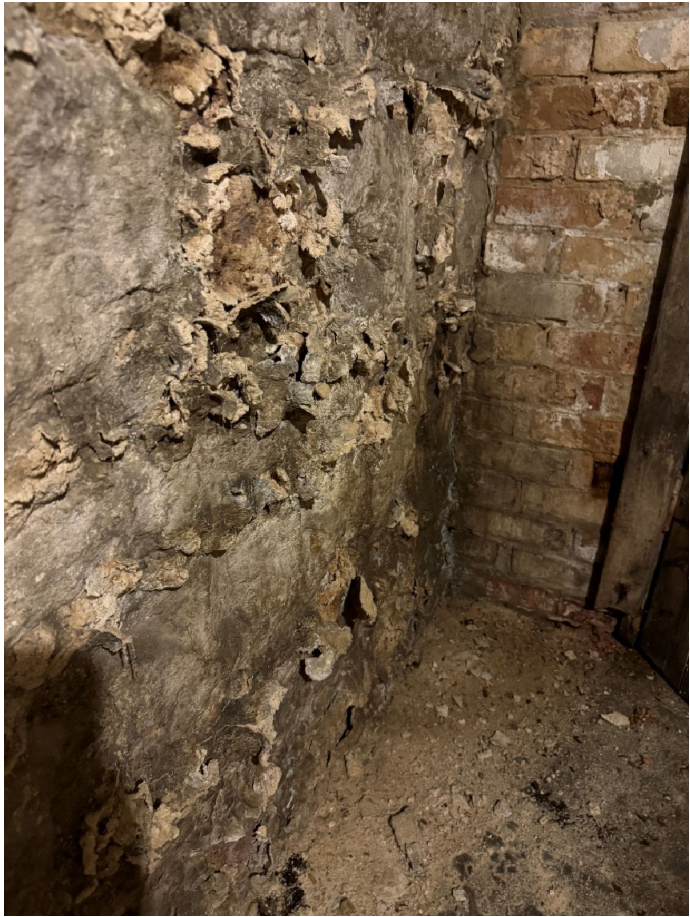
Foundation: Majority of foundation are constructed of rubble limestone and mortar. Shows significant water seepage through the limestone foundation wall and up through the basement floor. The basement floor concrete slab shows significant cracking. Foundation wall mortar appears to be significantly eroded. Water and sediment are collecting on the south side of foundation wall. High likelihood of mold growing throughout the basement. Foundation walls are settling in different locations at uneven rates. The limestone foundation wall architectural historic preservation state is deteriorated beyond repair.

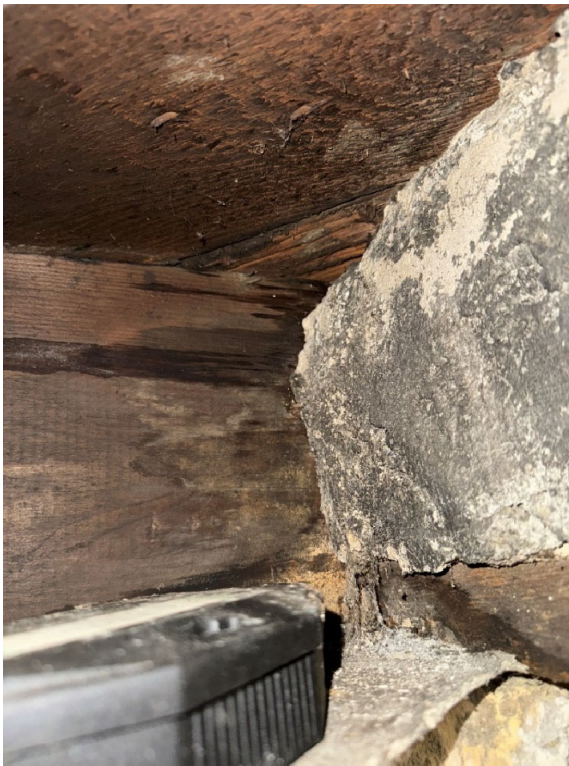
Bearing Floor Condition

First Floor: The first floor framing consists of 2x8 at 16" centers with 1x decking. The perimeter of the building is framed with a timber sill beam receiving the joists. First floor framing wood in certain locations appears to be deteriorating and rotting. Some joist supports appear to be undermined by deteriorated sections of stonework. Floor level appears to be sound with some sagging and undulation in floors over and away from supports. Ceiling damage from past water infiltration was noted.

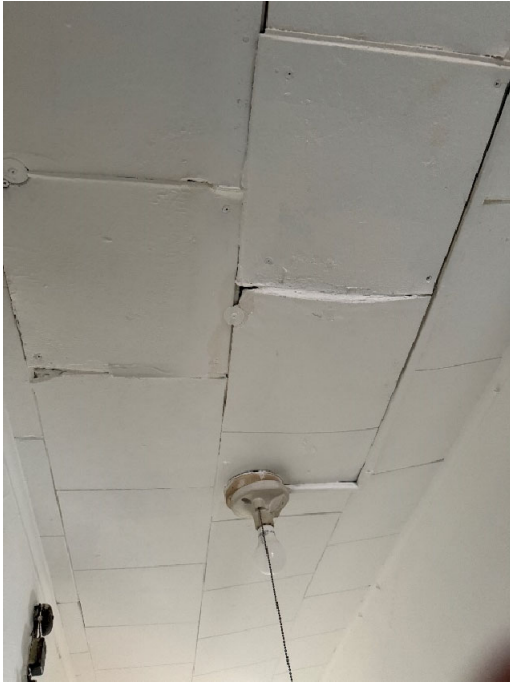
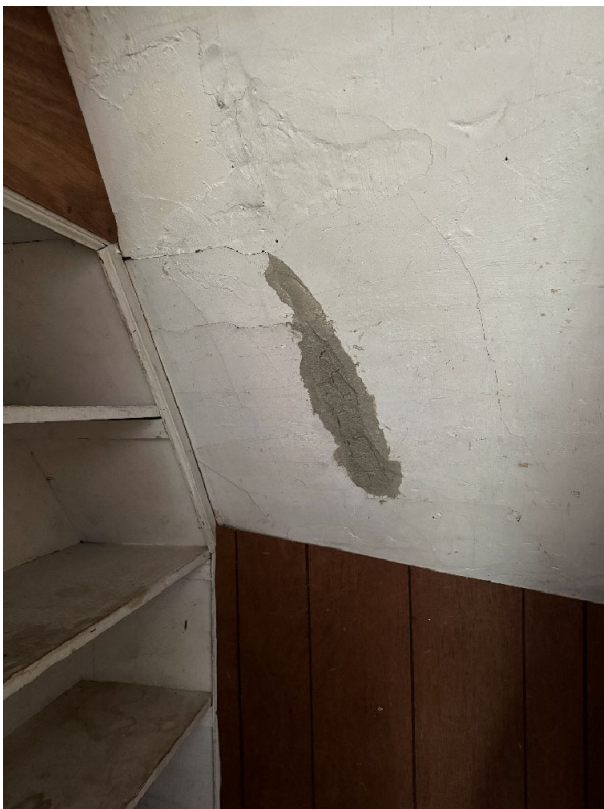
Second Floor and third floor framing and wall studs are completely concealed behind finishes. Ceiling damage from past roof leaks was noted.

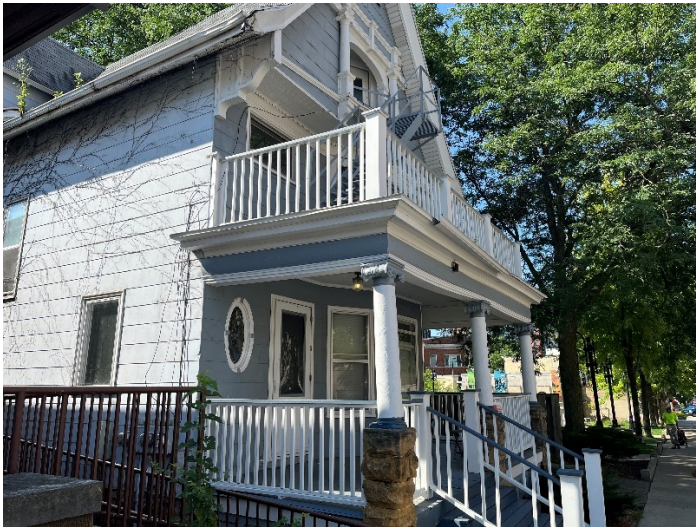
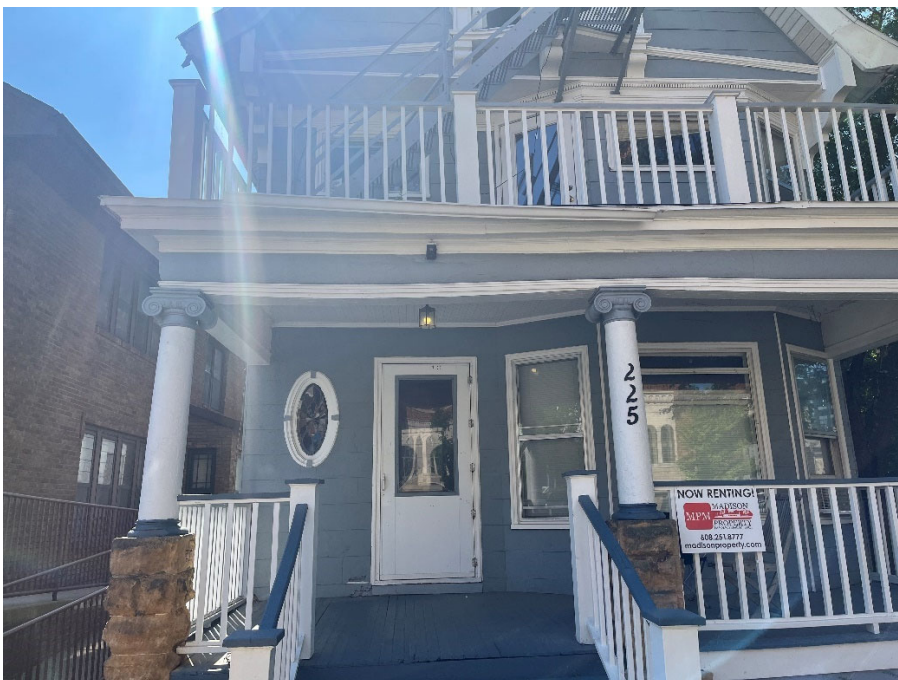
Exterior Porch: First floor patio appears to be settling in different locations. The limestone pier and column supporting roof appears to be protruding outwardly. Porch floor framing is spongy and sagging. The porch roof structure appears to be sagging. Fire escape added after the original construction has significantly damaged the original trim at connection points, shows signs of rotting.

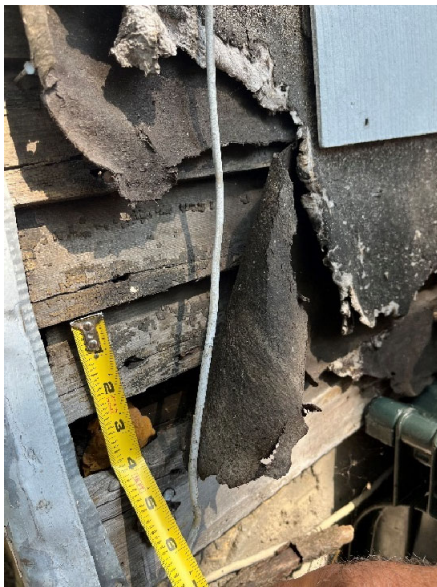
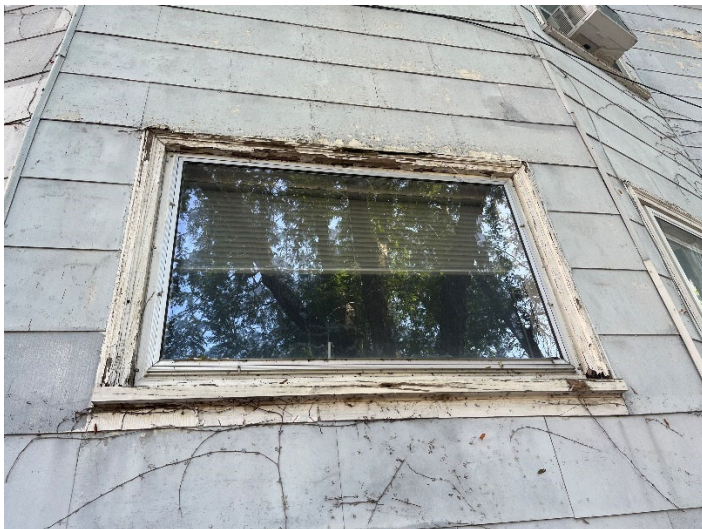
Exterior Envelope: Exterior siding, according to Wisconsin Historical Society, is made of asbestos with failing and cracking paint. Shows significant damage along the south side, facing Peace Park. Original 2.5" wood exterior siding supporting the 1950's additional siding shows major deterioration, significant rotting, and is damaged beyond repair. Many locations appear to be punched through showing the damaged sheathing beyond. Some of the original window trim along the south facing side deteriorated beyond repair. All windows lack any weather stripping and are very leaky to air infiltration.

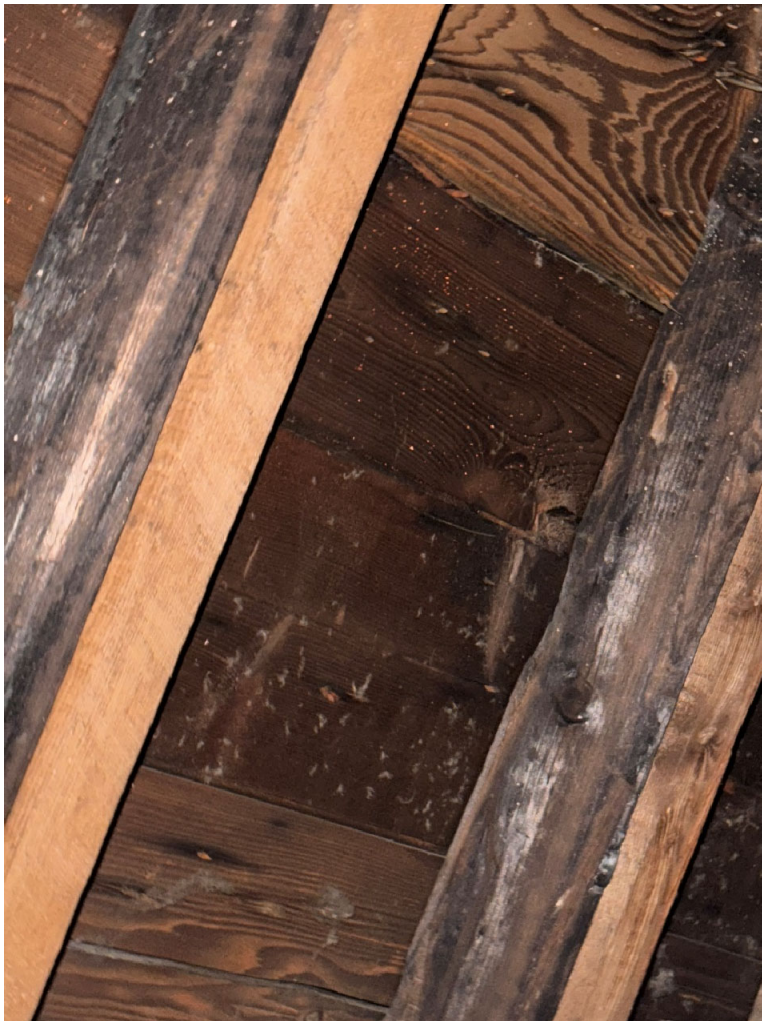
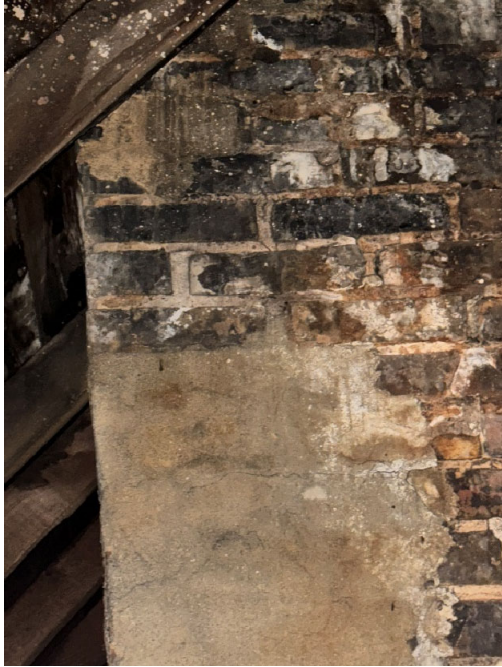
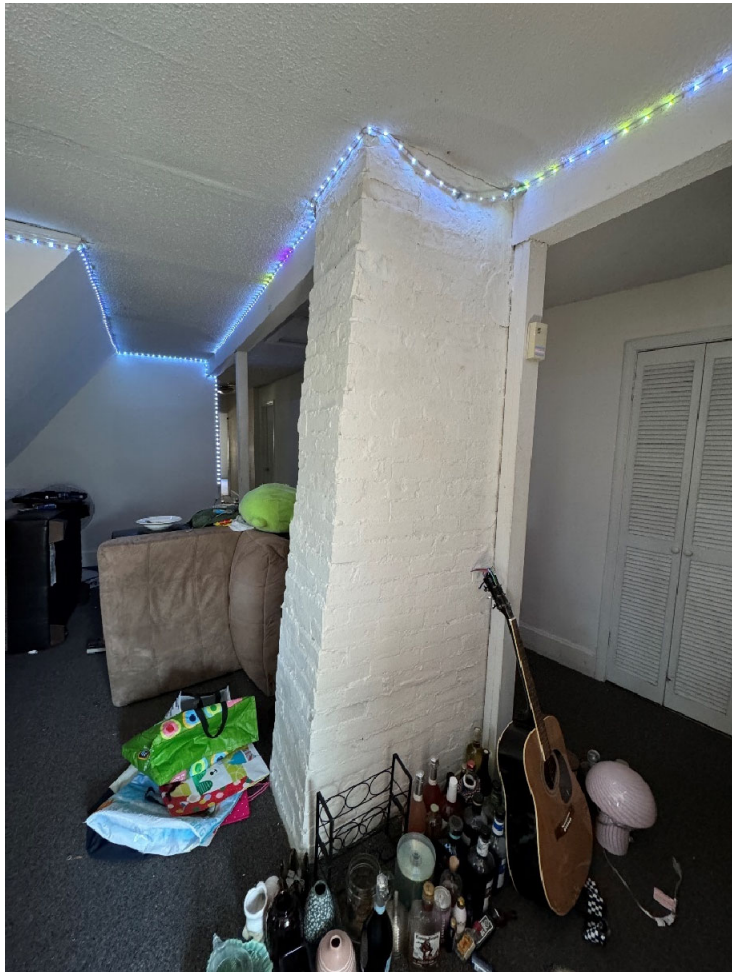
Roof: The roof framing is 2x4 rafters at 16" on center with 1x decking. The rafters are bearing on the exterior wall and extended to the ridges. The roof framing contains several areas of apparent damage. Holes in the shingled roof can be seen from the street. Some deterioration was noted in the soffits. It is probable that a significant amount of roof decking has been damaged since the shingle has been in poor condition for some time. The owner has repaired areas of roof due to water leaks. The existing chimney in the roof space appears to be dilapidated and looks to be sloping in one direction on lower floors.
