City of Madison

**Madison Municipal
Building
Conceptual
Schematic
Design Study**

November 2013

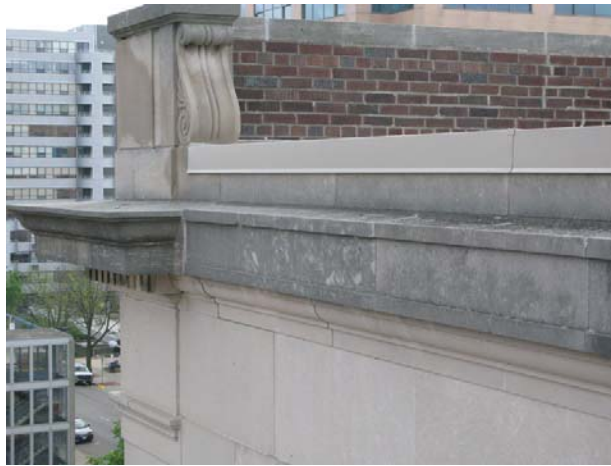
Brick is located on what is considered the rear of the building. Water infiltration at the parapet level within this “U” shape area is apparent. Moisture affecting the side walls is coming from deteriorated joints in the metal coping cap and/or flashing, not from the roof because these walls are on the high end of the roof slope located behind. The back wall parapet is showing signs of moisture infiltration that could be caused by deteriorated joints in the metal coping, flashing and from direct assault from the draining roof. The infiltration is at its worst where the metal coping meets the decorative stone scroll on both side walls.

Figure 21 – Darkening of the Stone below the Metal Coping indicates Water Saturation

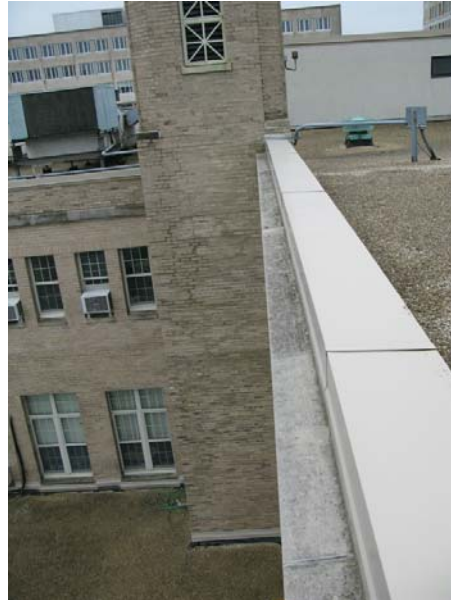
There are many movement cracks in the brick facades. Control, expansion and construction joints were not widely used in 1927 so when the building settled it found its own path for relief. The most serious cracking in the brick is located at the outside corner of the brick chimney where full height vertical cracks are occurring. It appears the chimney brick is linked with (rather than separated with a movement joint) the back and side walls so when the walls move independently and in different directions cracking is occurring at the weakest point; the chimney corner.

Figure 23 – Outside Corner of the Brick Chimney is Cracking Vertically on Both Sides

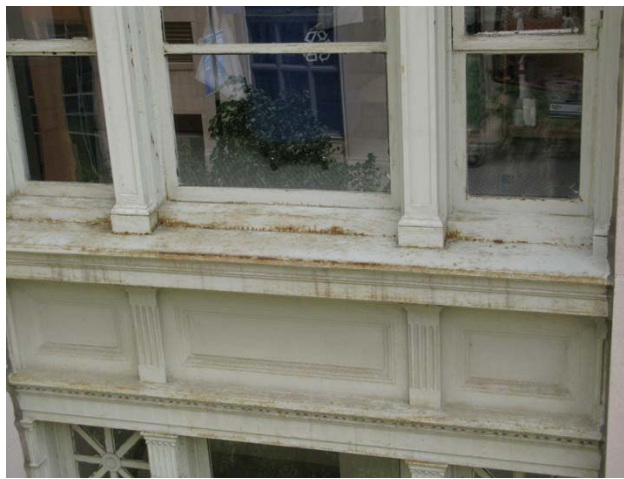
Unprotected cast iron and steel will rust when exposed to the elements. The coatings on the steel and cast iron frames and window units on the second and third floor have been compromised in several key locations. Typically we found rust occurring at the sills, at the bottom mullion of the operable casements and at the decorative ledge at the spring point of the circle top windows. The most severe of these occurrences is at the mullions. Over the years, as the original seals deteriorated, every type of caulk and sealant has been used to keep out the draft. Applied with care and good intent to aid the occupant, the sealant has aided in the accelerated deterioration of the coatings and obstructed moisture from exiting the system causing rusting. The excessive sealant has also rendered many of the operable sashes inoperable.

Figure 24 – Rust is Developing at Window Sills

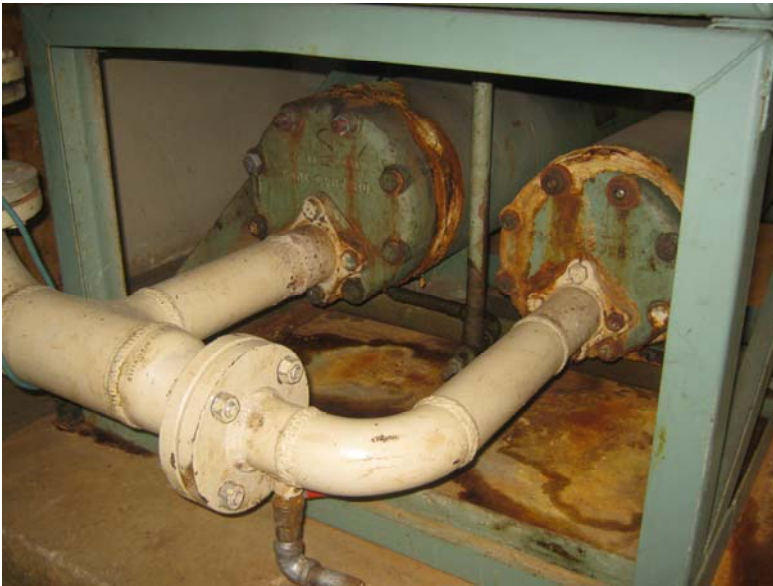
The chilled water system consist of one centrifugal water-cooled chiller (CH-1) located in the mechanical room. There is also a heat reclaim chiller (CH-2), which rejects heat from the chilled water system to a 10,000 gallon hot water storage tank located in the same lower level mechanical room. Both chillers were installed during the 1979 renovation, and are nearing the end of their usable life.

Figure 30 – Rust and Age Degradation on Heat Reclaim Chiller

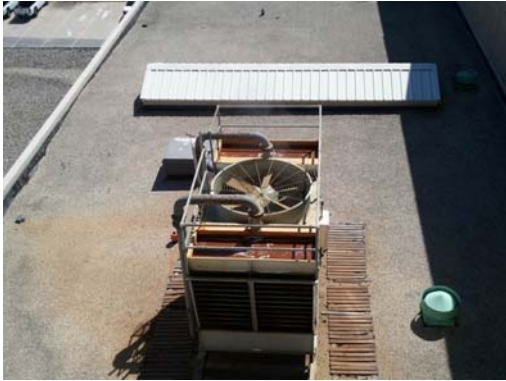
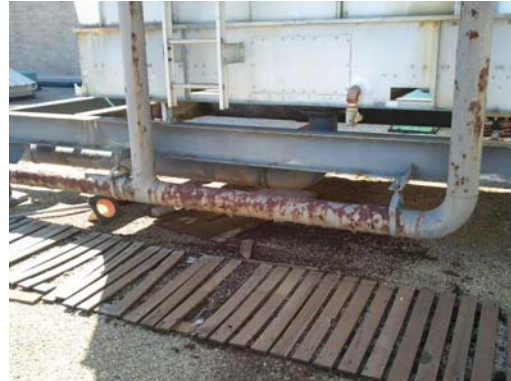
A draw through cooling tower is located on the single story roof and serves both chillers located in the lower level mechanical room. The cooling tower was installed during the 1979 renovation, and is nearing the end of its usable life. Both figures below show the current condition of the cooling tower and associated condenser water piping. In the last five years there have been multiple leaks in the condenser water piping that have been temporarily patched. The cooling tower does not operate the majority of the year, due to the heat reclaim chiller.

Figure 31 – Cooling Tower Condition

Figure 32 – Cooling Tower Condition

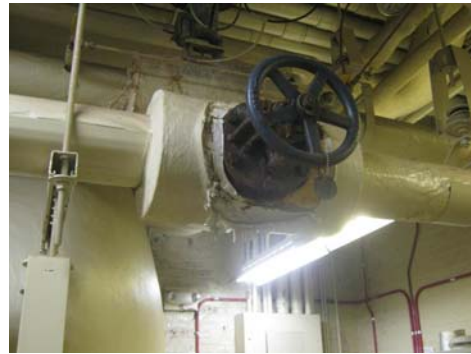
Many of the valves located in the lower level mechanical room are rusting and show signs of water damage to insulation.

Figure 34 – Leaking Valve and Damaged Insulation

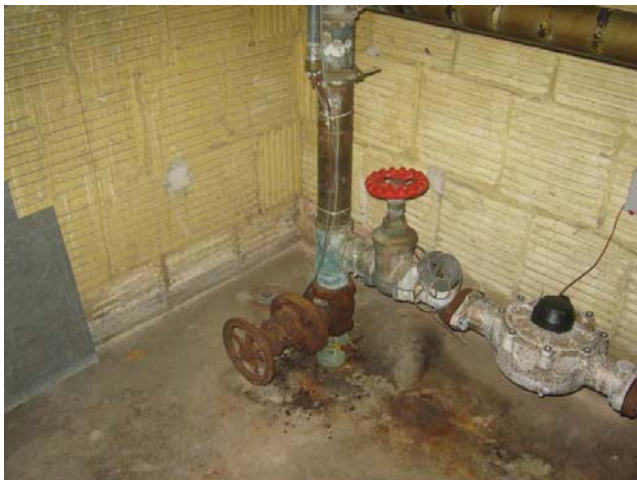
A 3” combination domestic water and fire protection service provides water to the building for the plumbing system. The 3” fire service splits off upstream of the water meter and feeds the remainder of the building; see fire protection system description below for details. Within the water entry room the domestic water system is metered and a building isolation valve is installed. The combined plumbing and fire protection service also shows significant rust and water damage within the water entry room.

Figure 39 – Incoming Combined Plumbing and Fire Protection Service

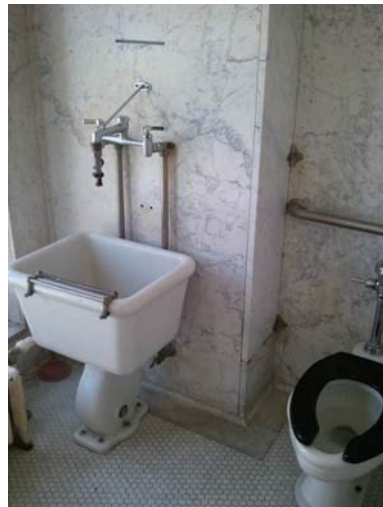
The existing plumbing distribution system consists of steel and copper piping for domestic water and cast iron and galvanized piping for sanitary and vent. Most of the piping is original to the building, and with the exception of some leaking shutoff valves, the system is reported to be in good working condition. There are various vintages of plumbing fixtures installed throughout the building. Many of the plumbing fixtures are antiquated, and some have been abandoned in place due to infrequent use. The current fixtures do not meet current EPA regulations for water flow requirements.

Figure 42 – Antiquated Plumbing Fixtures

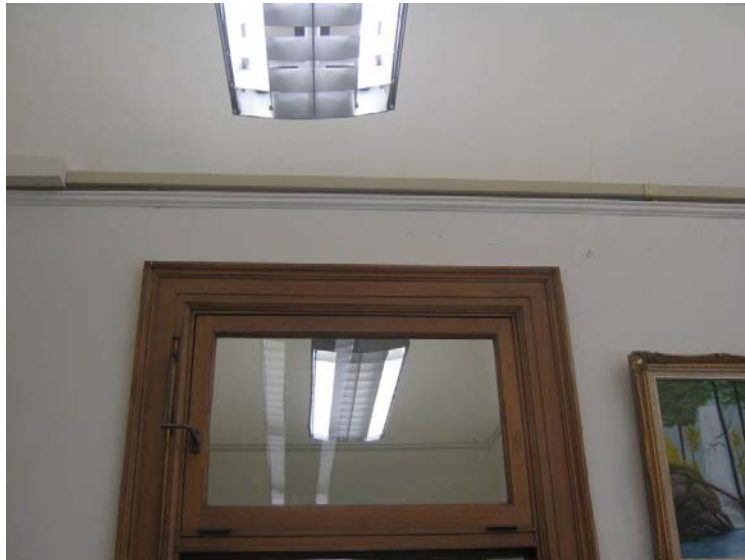
Figure 57 – Plaster Cracking at Corners of Third Floor Door

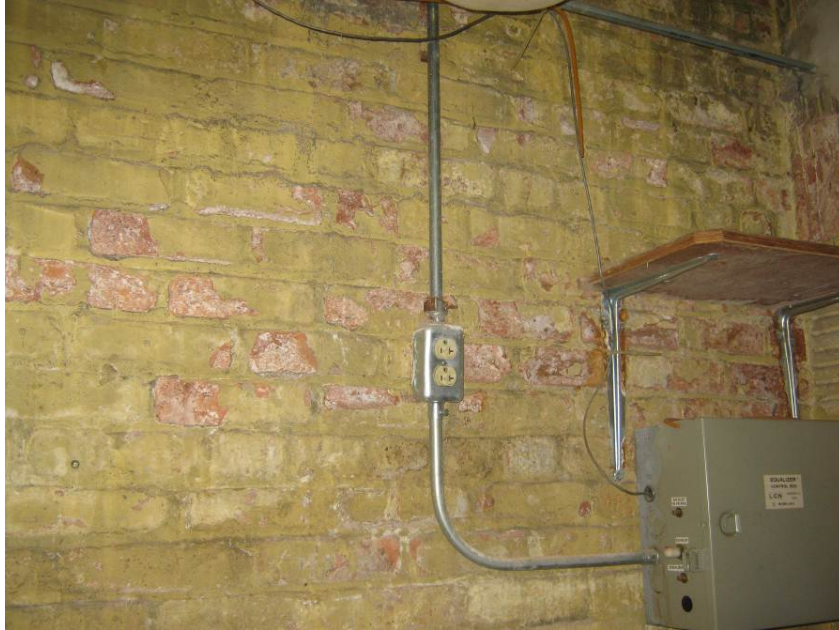
Figure 58 – Existing Brick Basement Wall Water Damage
