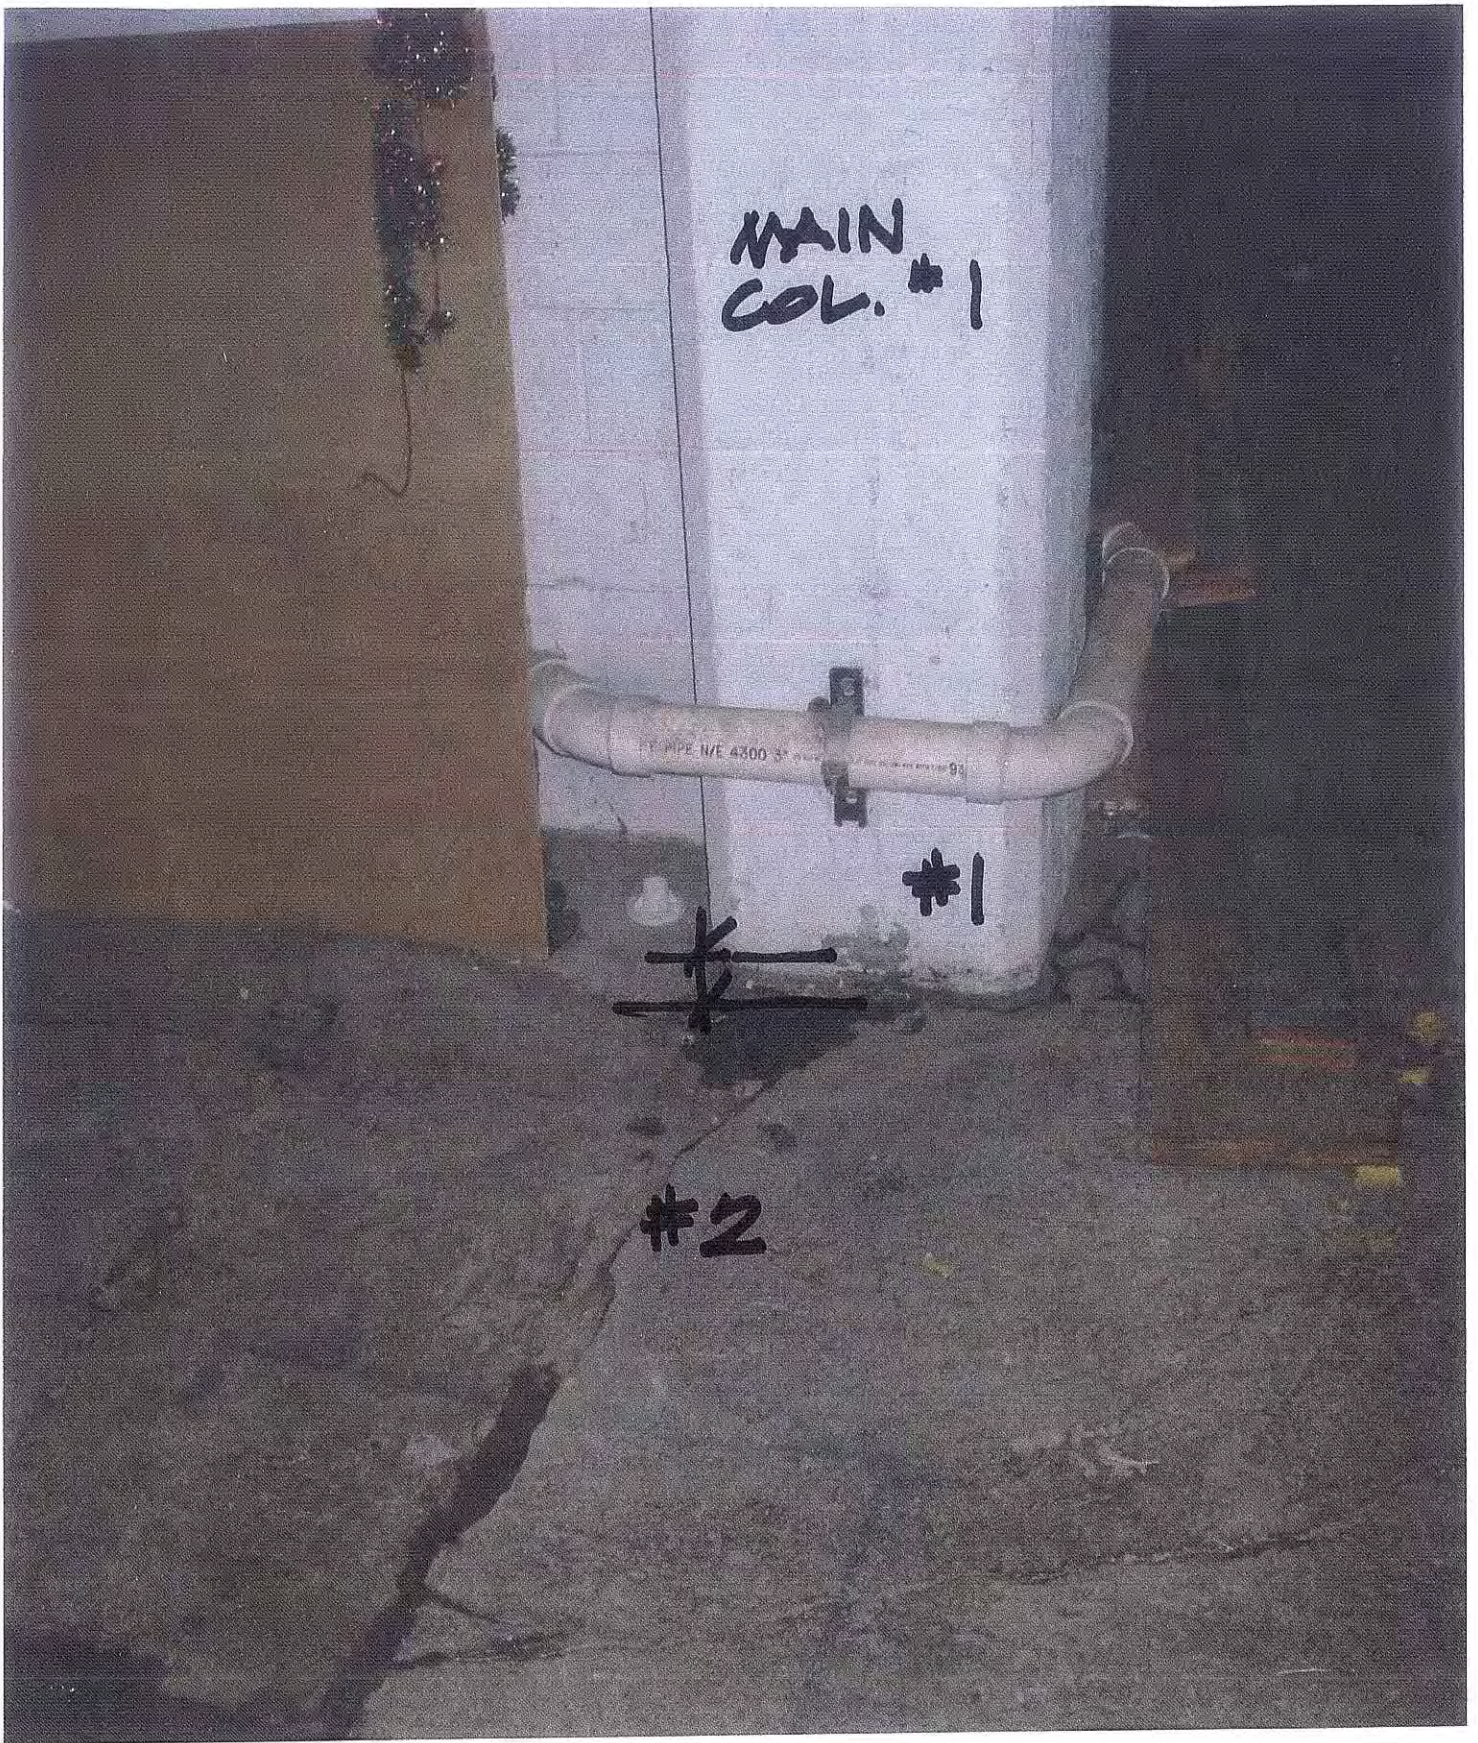
PHOTO #1 STRUCTURAL. BLDG SUPPORT

- #1** SETTLING IN FLOOR & STRUCTURAL COLUMN
- #2** FLOOR EXTENSIVE CRACKING

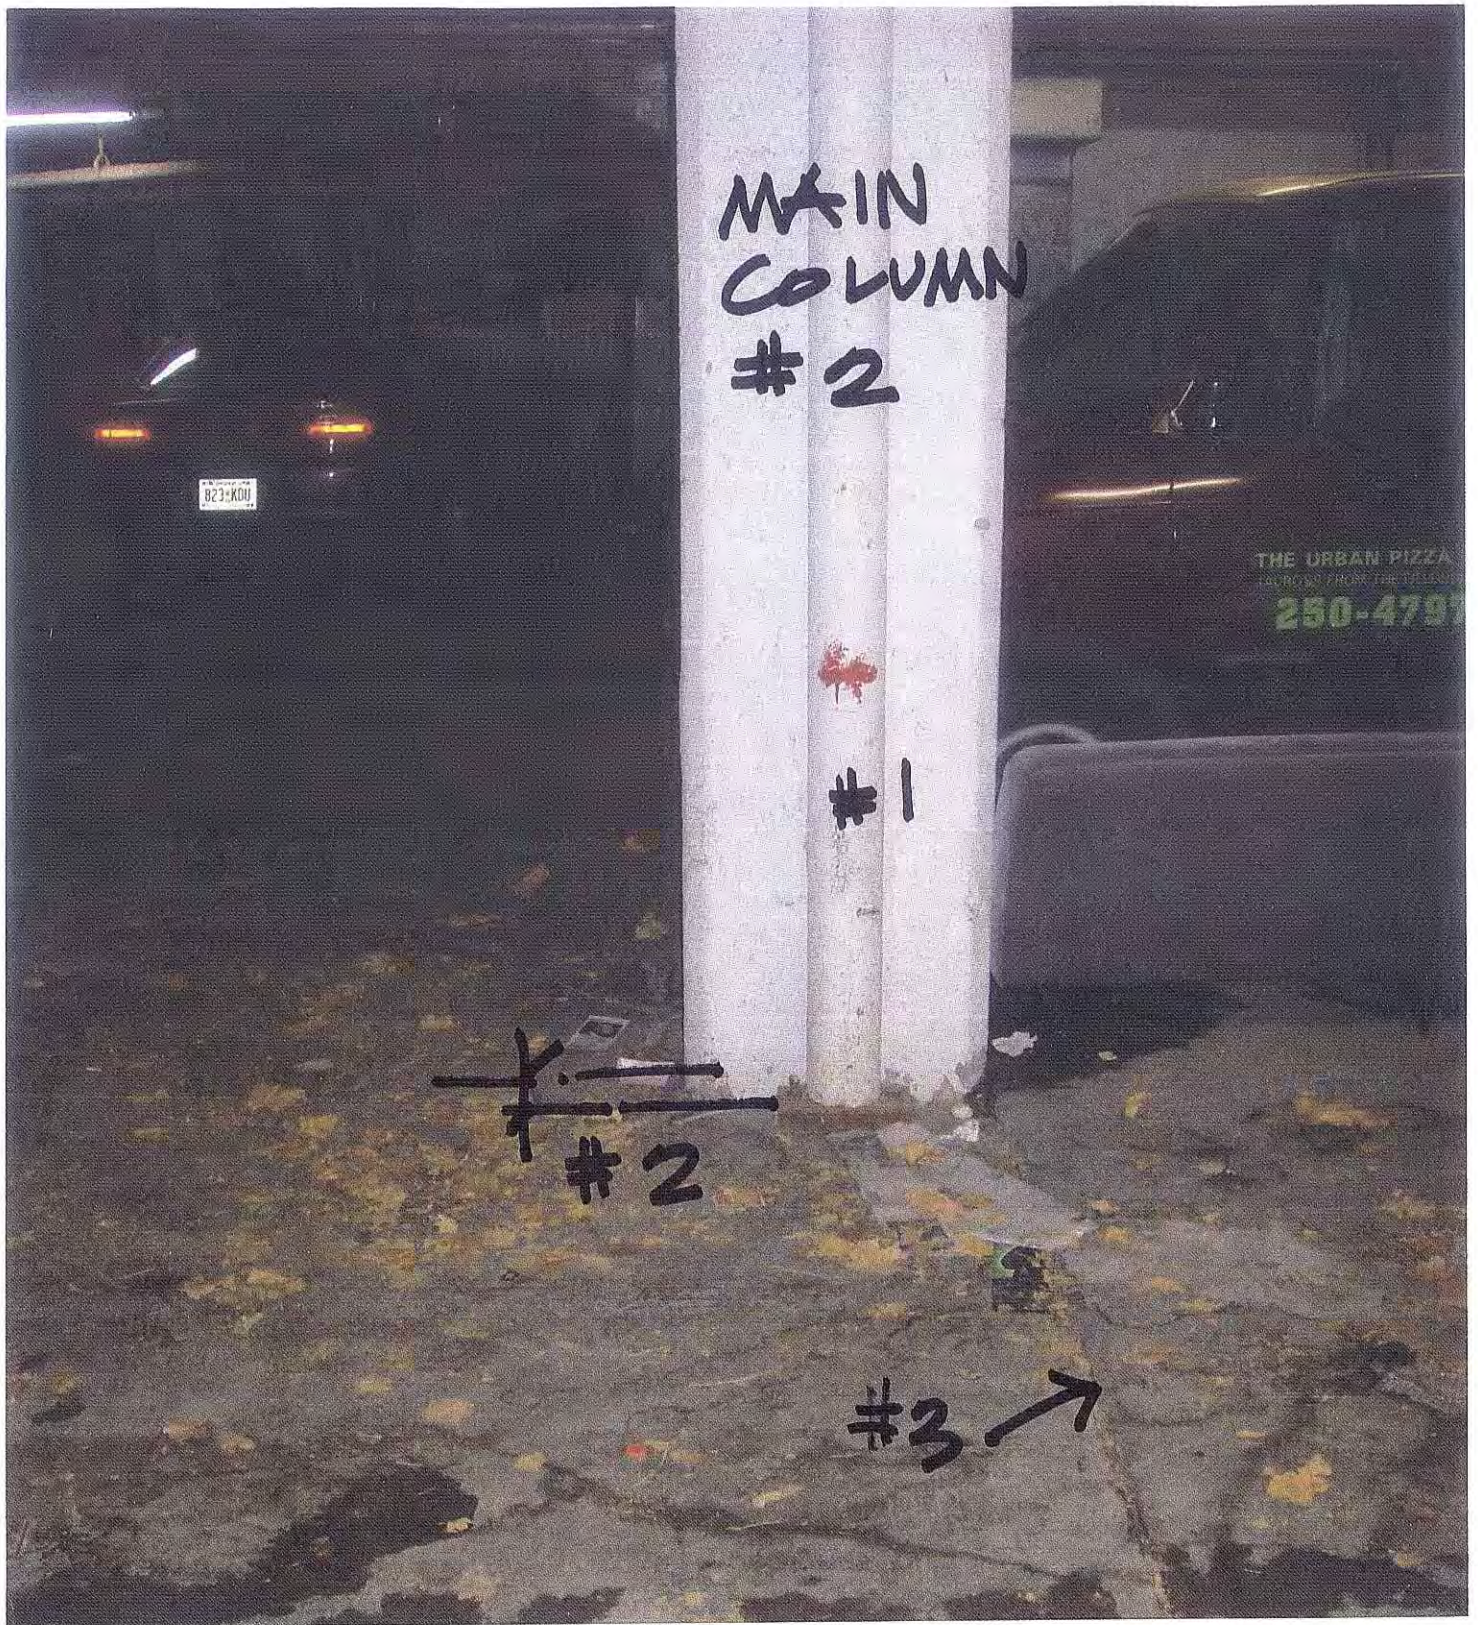
PHOTO #2 STRUCTURAL. BLDG SUPPORT

#1 ADDED STEEL COLUMN BECAUSE OF STRUCTURAL FAILURE @ MAIN CONC. COLUMN.

#2 SETTLING (SINKING) FLR & COLUMN.

#3 EXTENSIVE FLOOR CRACKS.

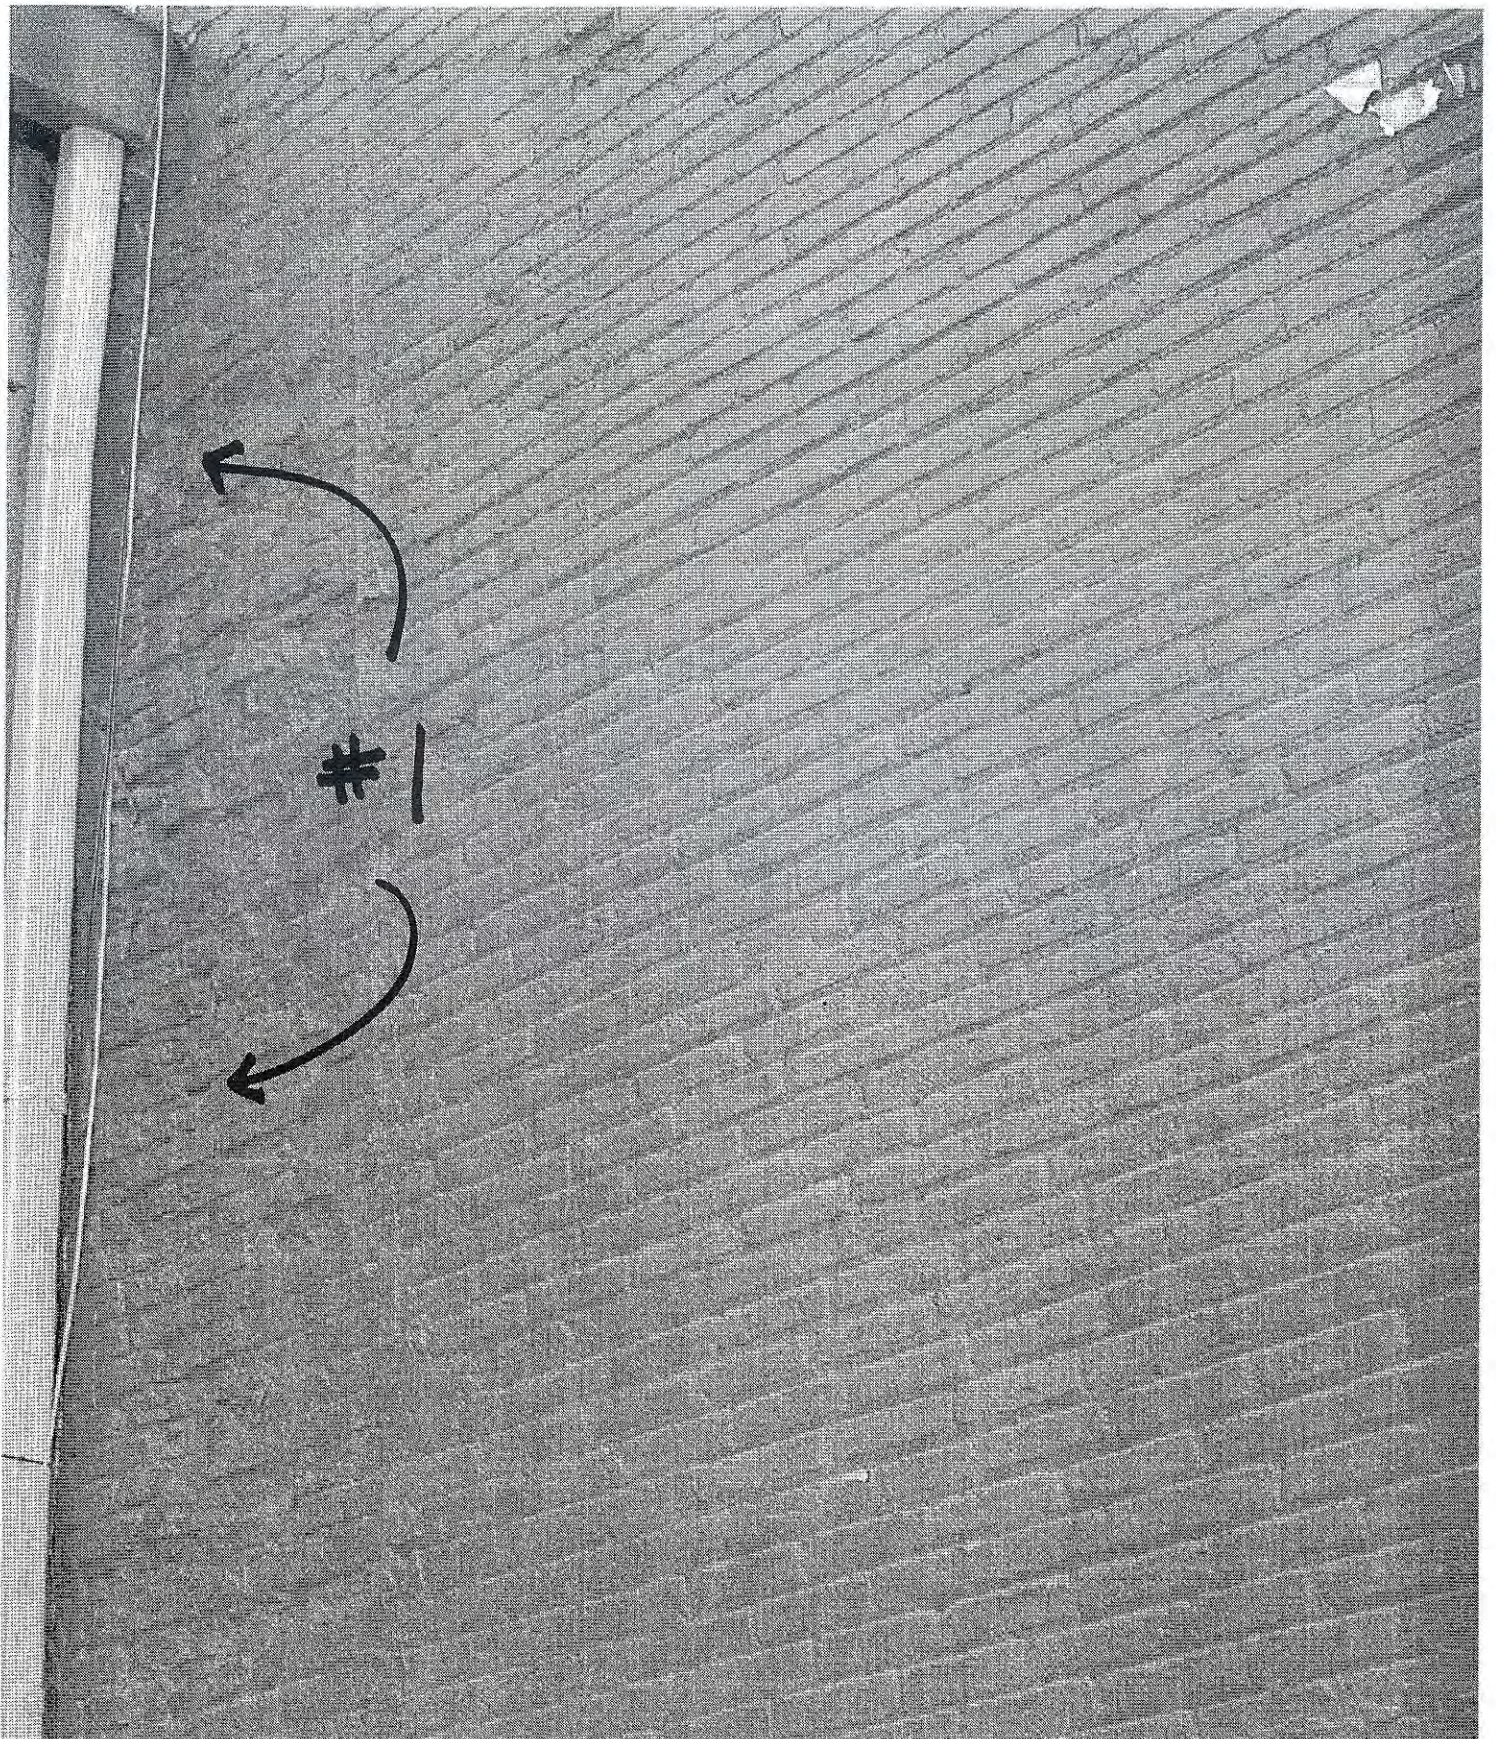
PHOTO # 3 STRUCTURAL WALL
#1 EXTENSIVE SPAULDING & DETERIORATION
OF STRUCTURAL EXTERIOR BRICK WALL

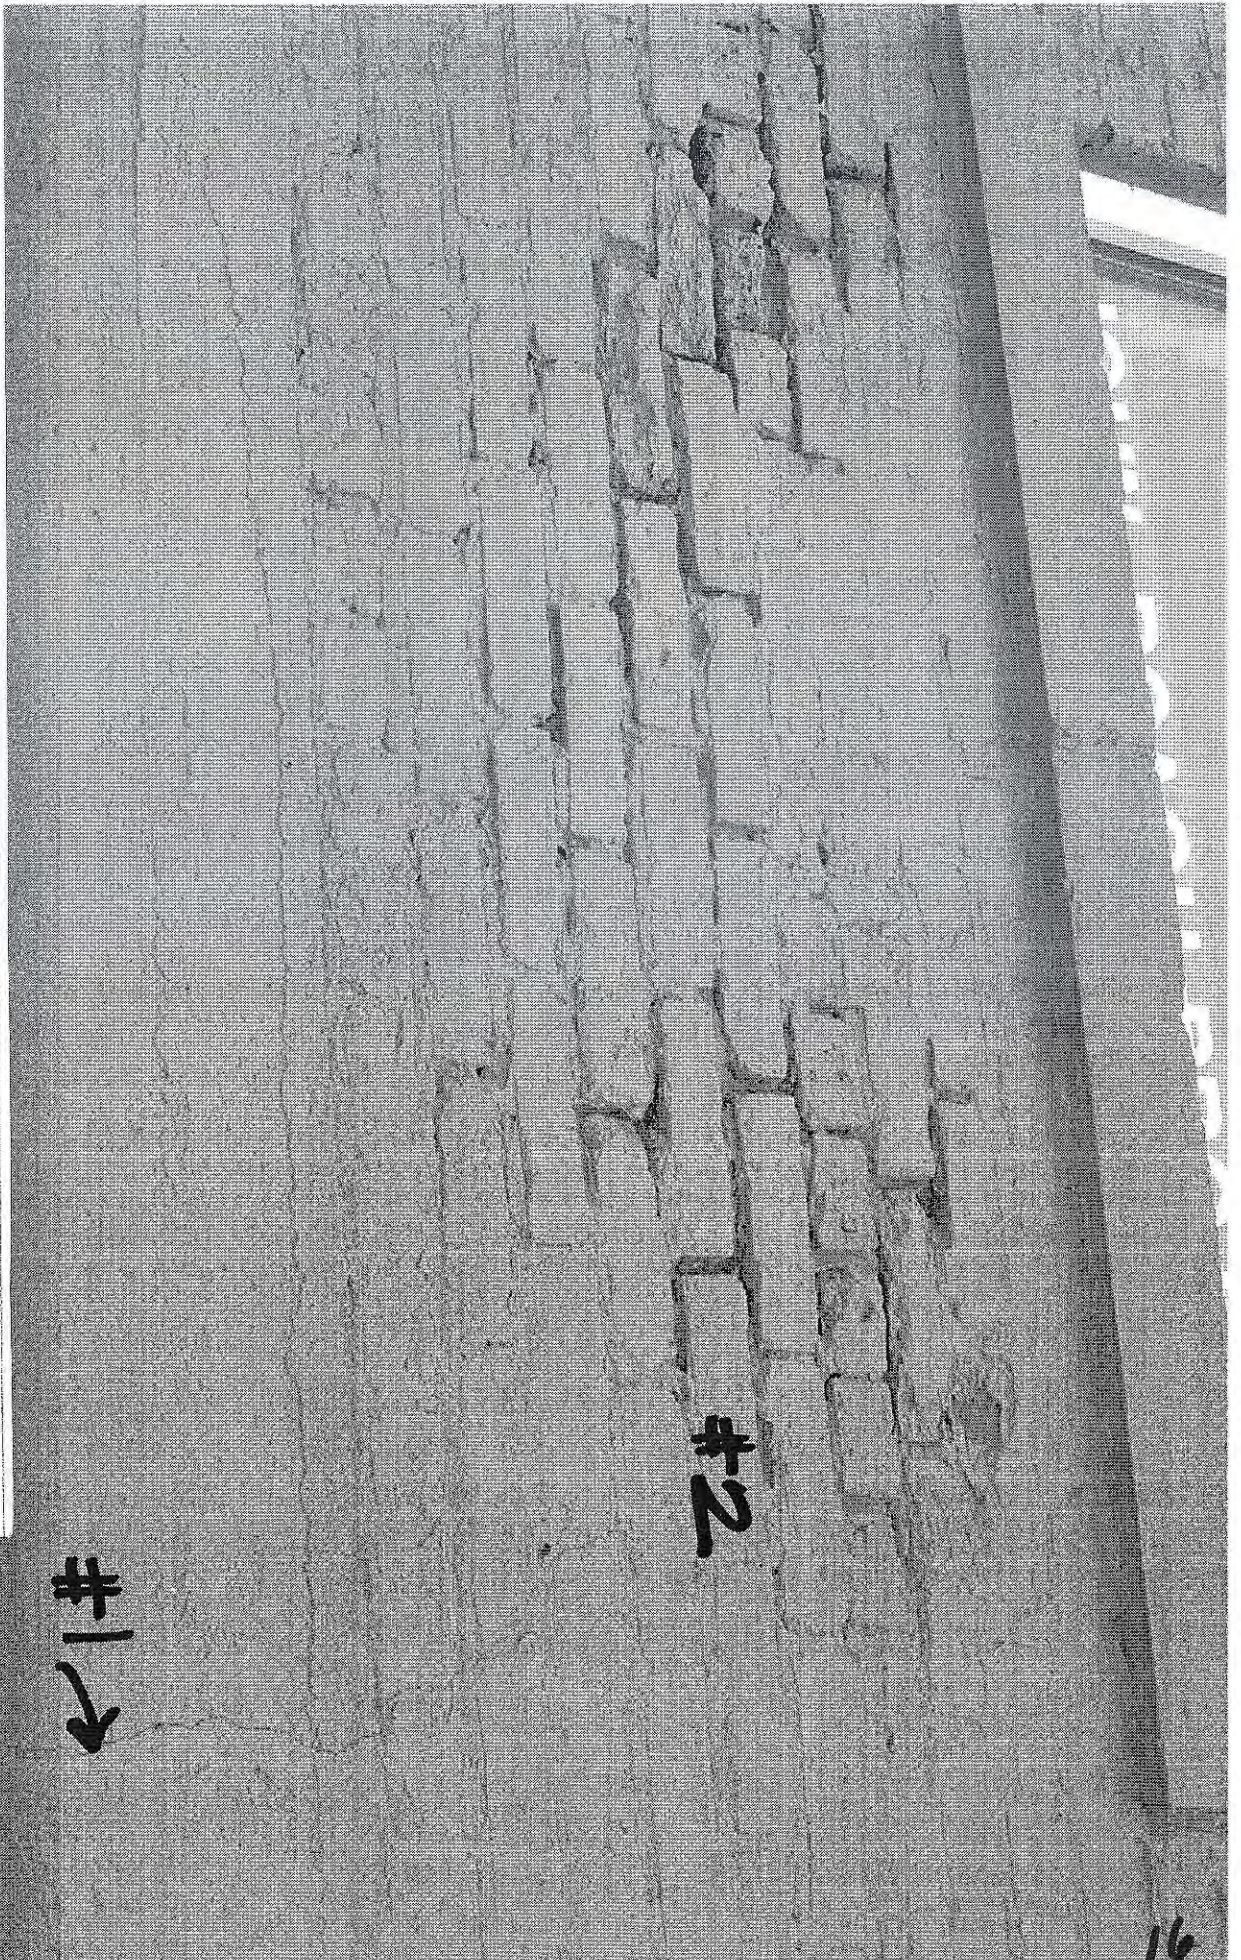
Photo # 5 STRUCTURAL WALL
#1 CRACKS IN STRUCTURAL BEARING WALLS.

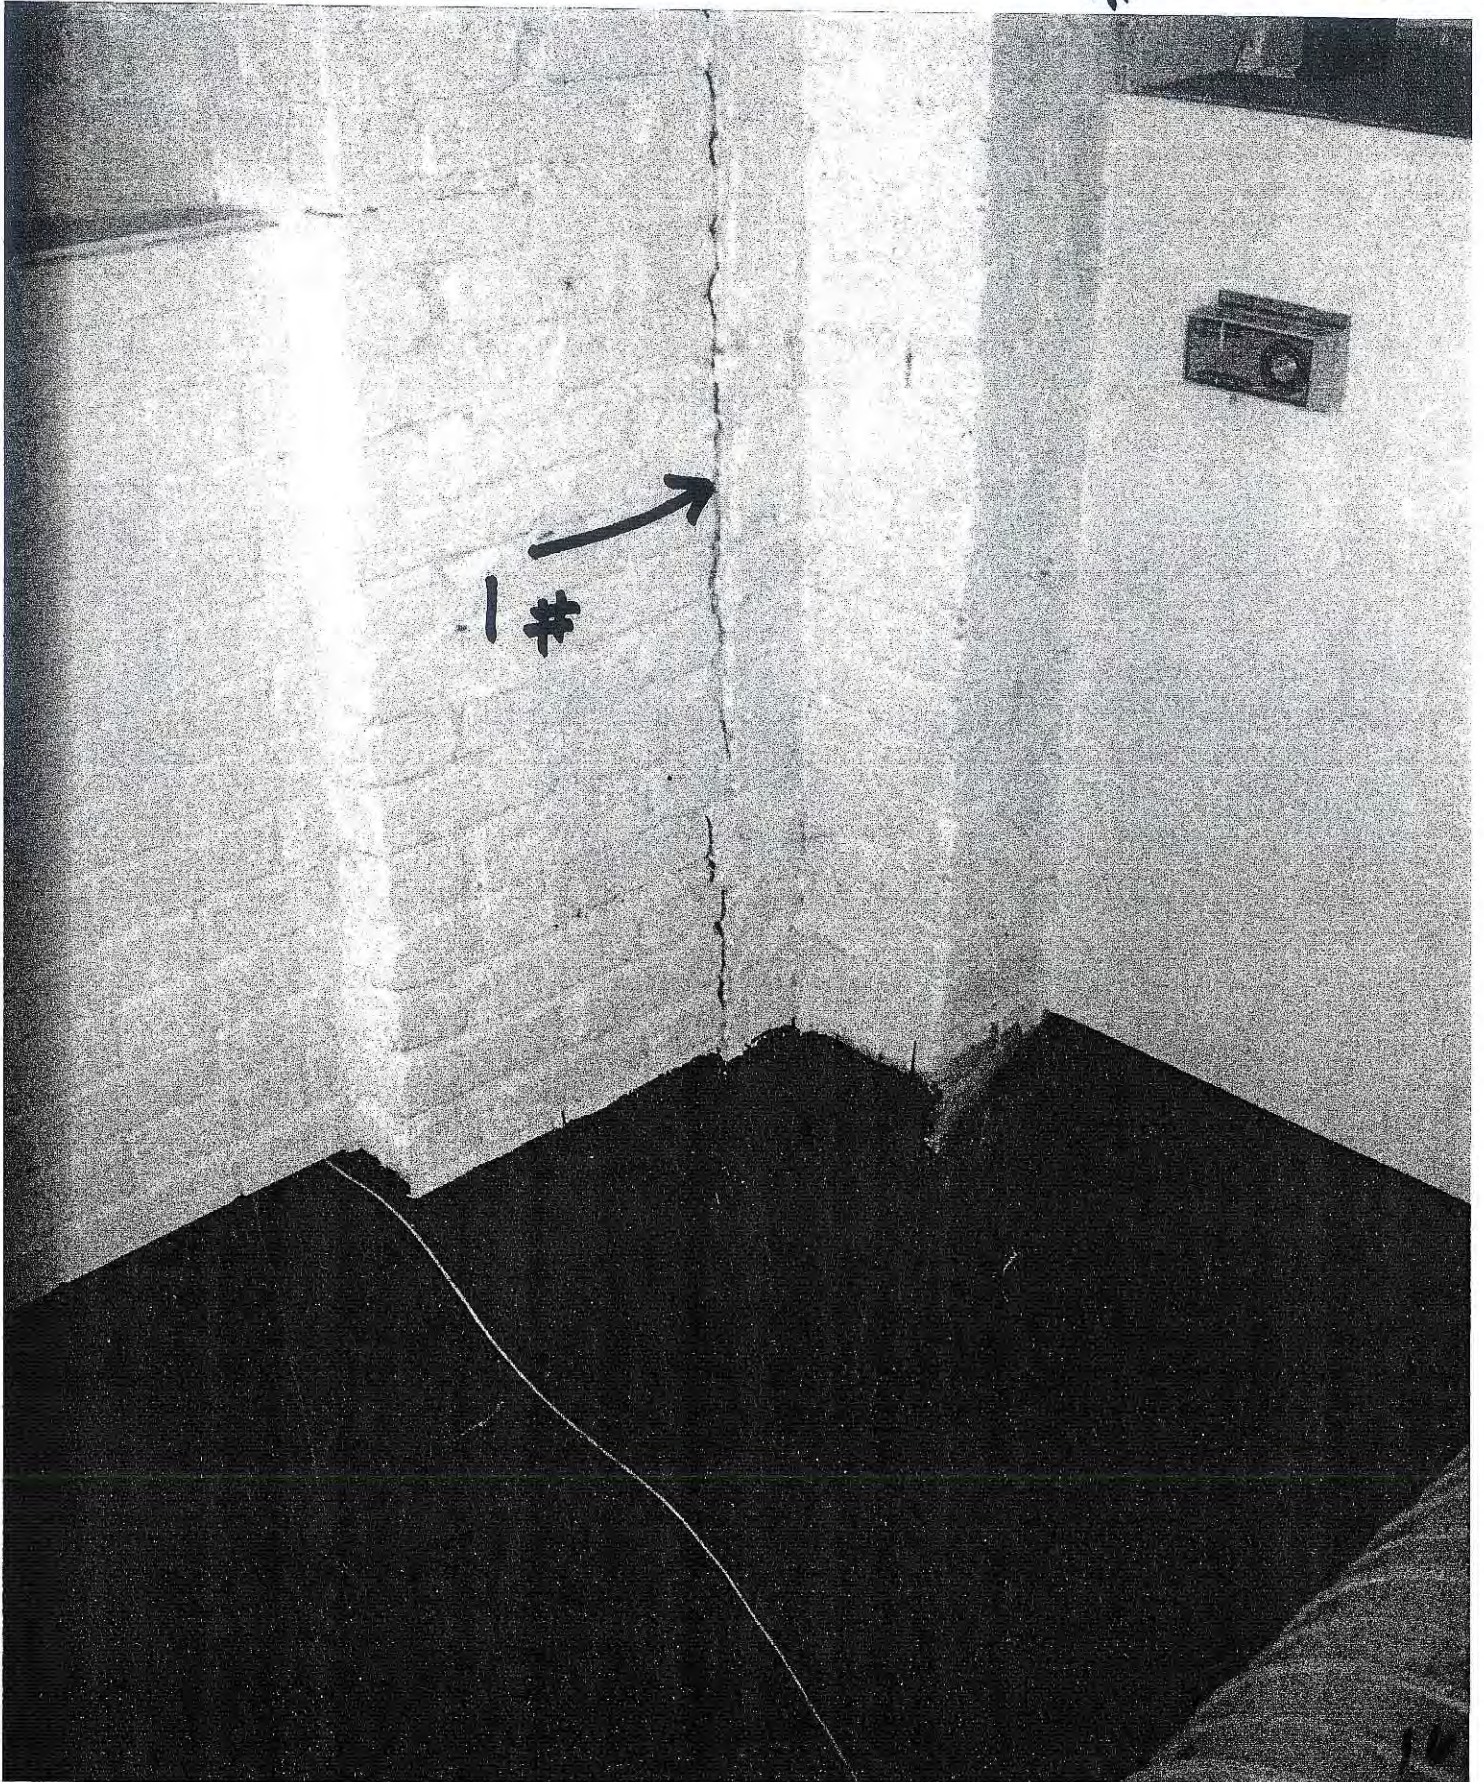
PHOTO # 6 STRUCTURAL: CEILING =
#1 CONCRETE STRUCTURE CRACKED & DEGENERATED
#2 CONCRETE STRUCTURE DAMAGED W/ STEEL
REINFORCING BARS EXPOSED.

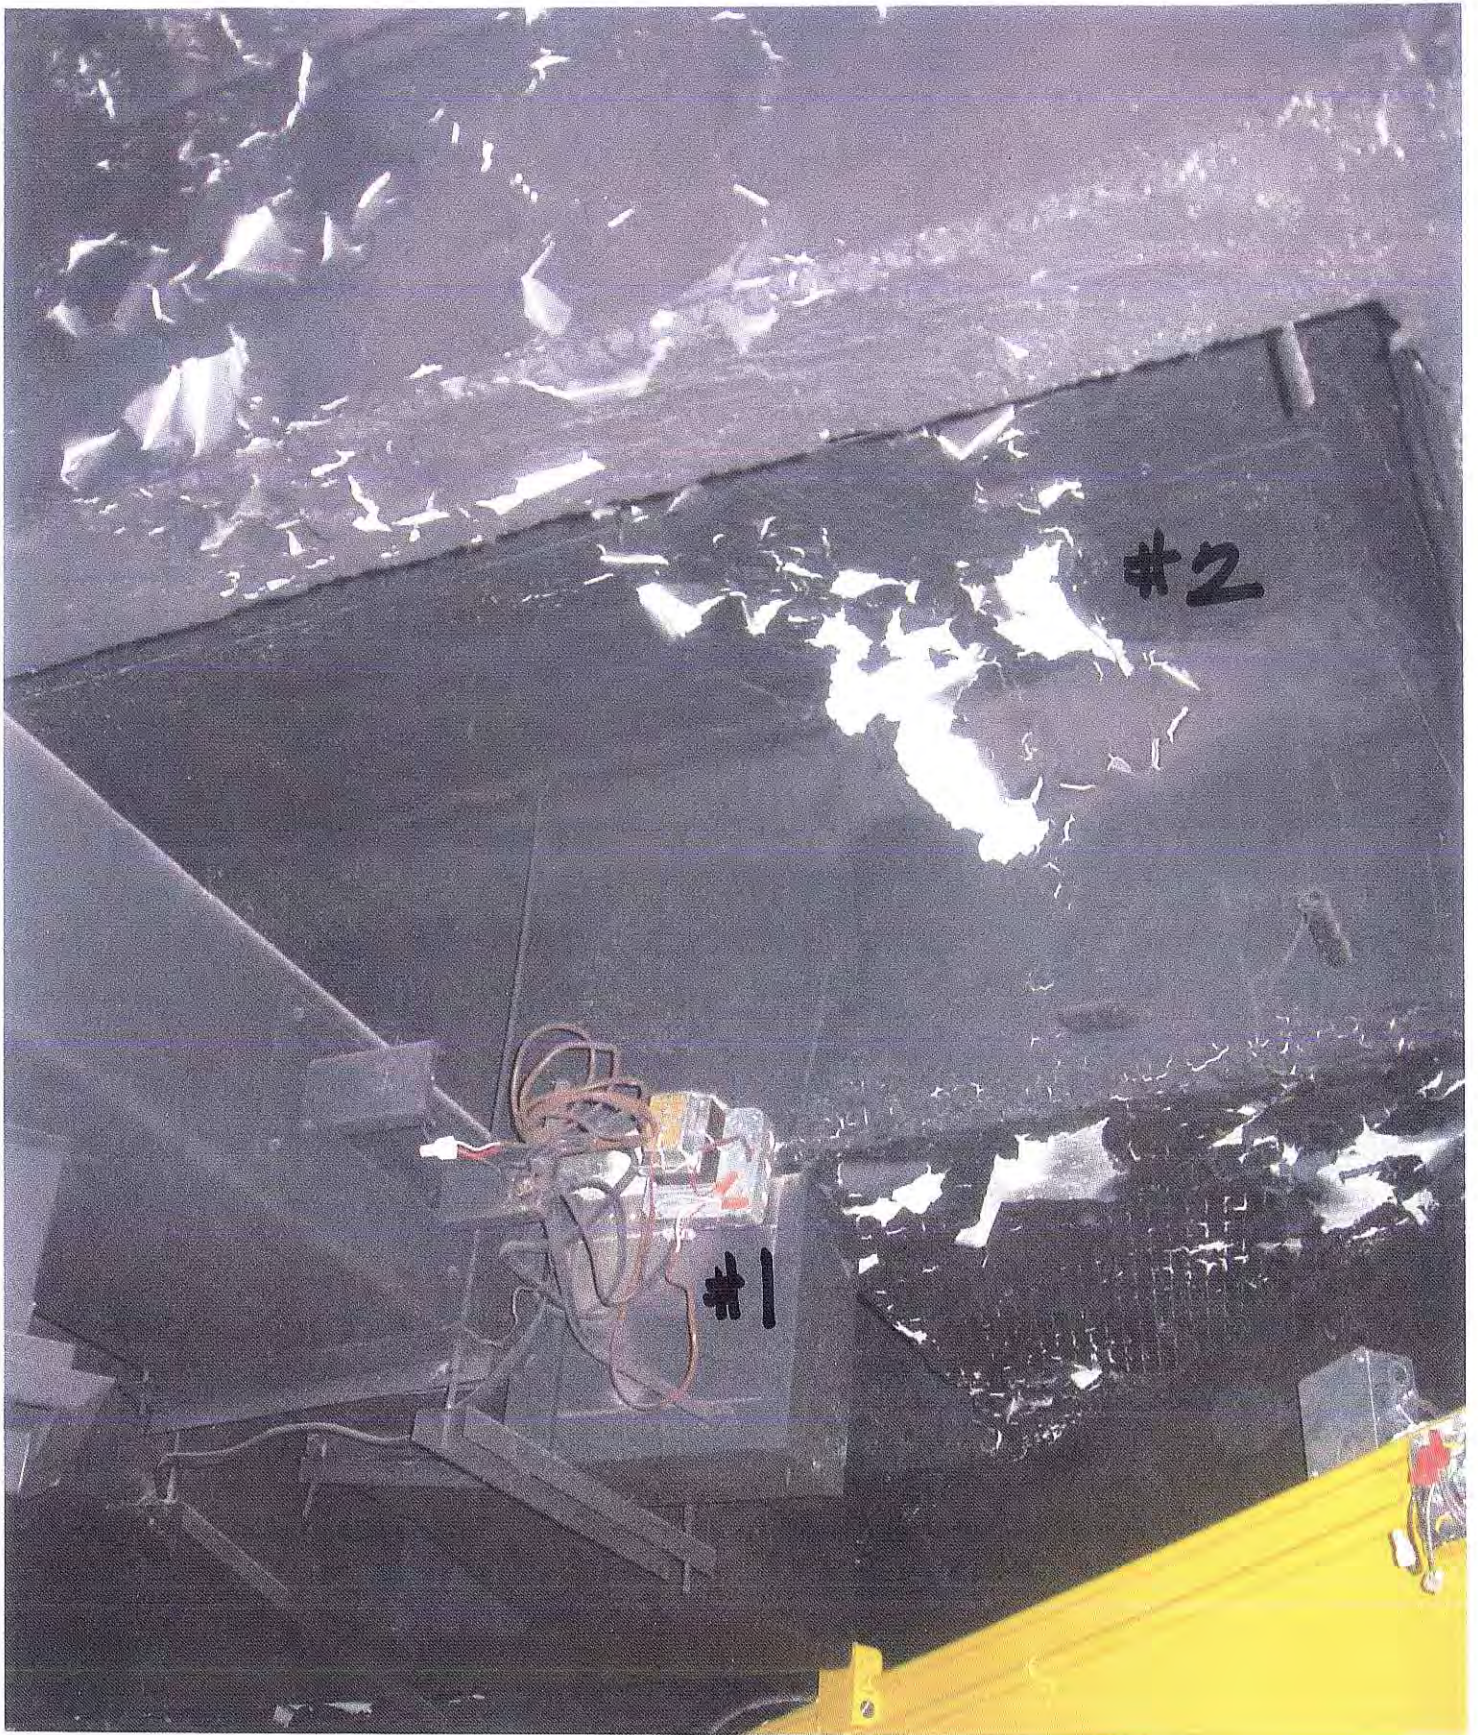
PHOTO # 7 MECHANICAL

- #1** DUCTING & HVAC CONTROL SYSTEMS OBSOLETE
- #2** WATER DAMAGE FROM LEAKING ROOF

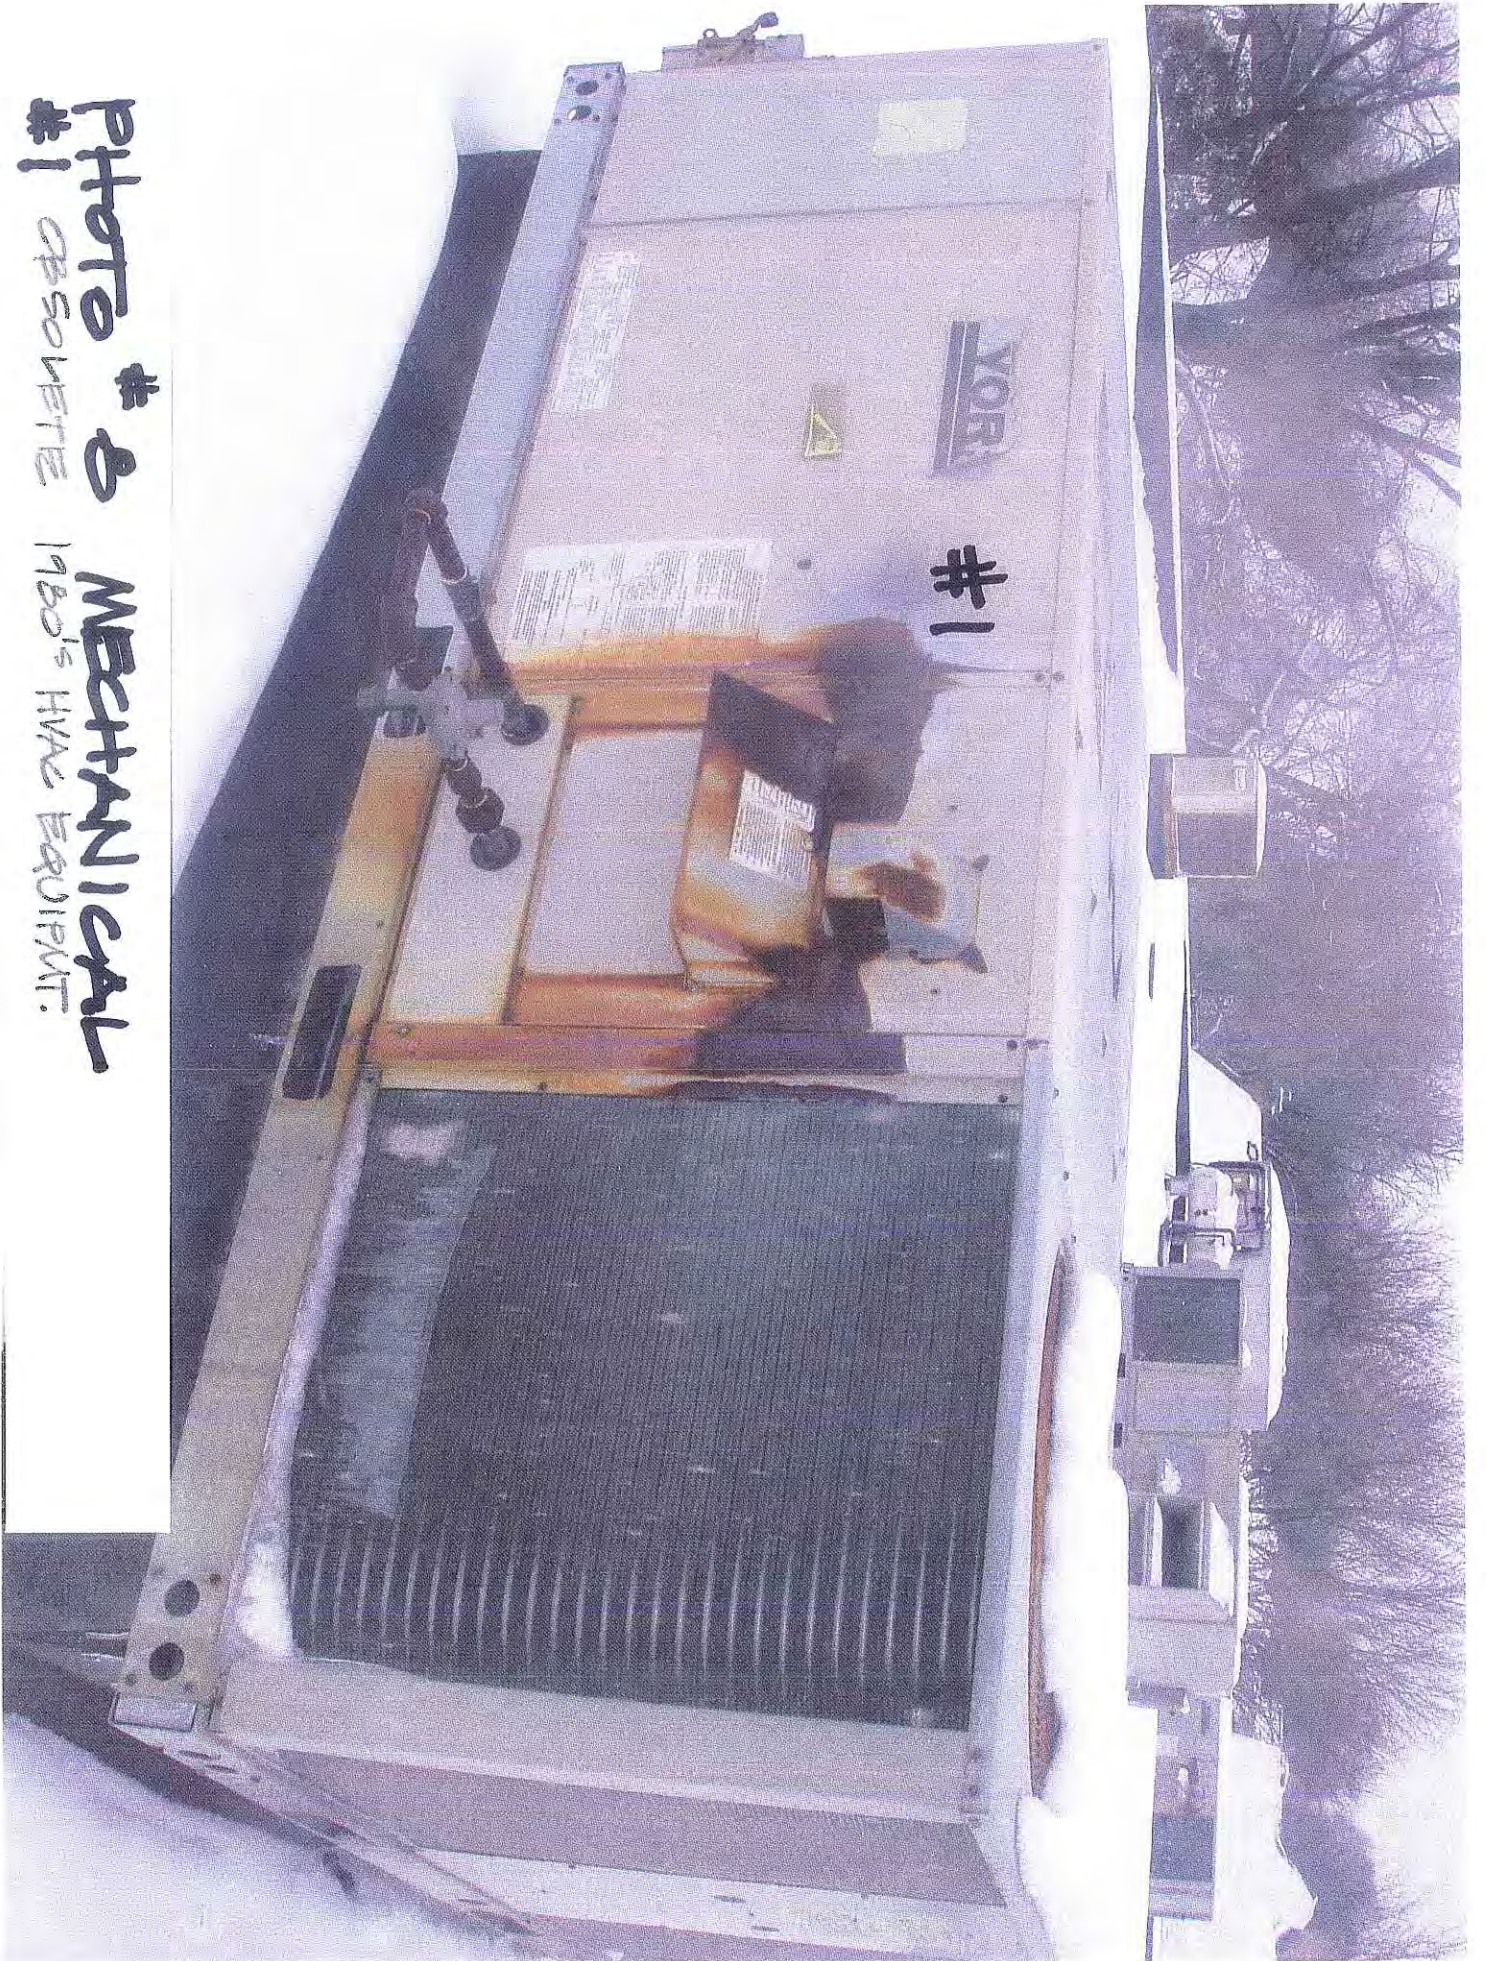
PHOTO # 2
#1 OBSOLETE
MECHANICAL
1980's HVAC EQUIPMENT.

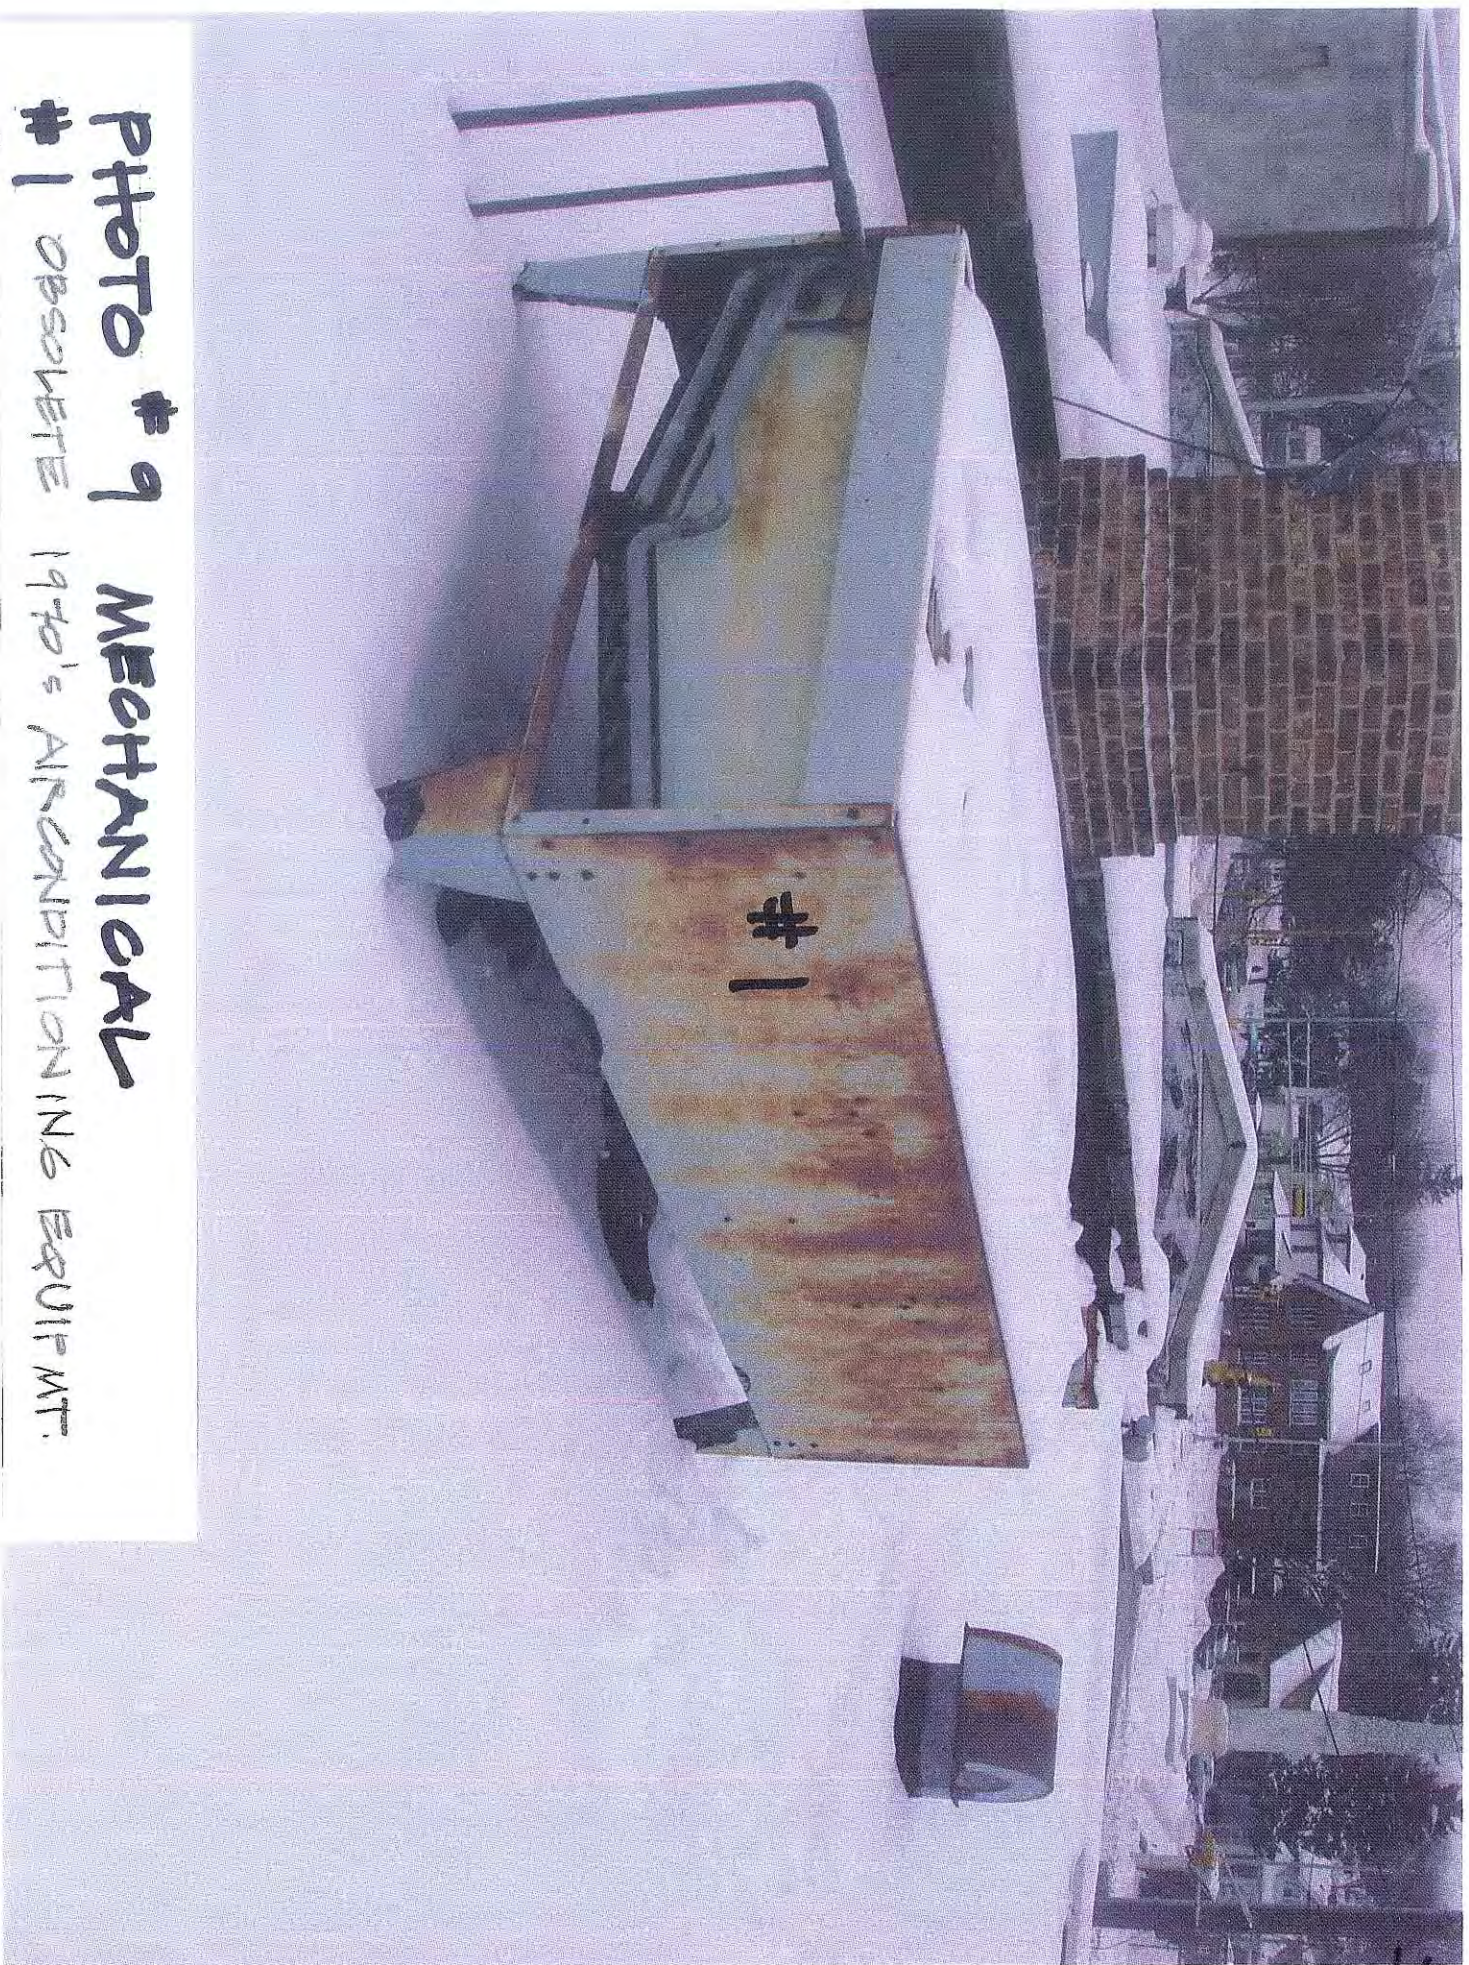
PHOTO #9 MECHANICAL

#1 OBSOLETE 1970's AIRCONDITIONING EQUIP.MT.
