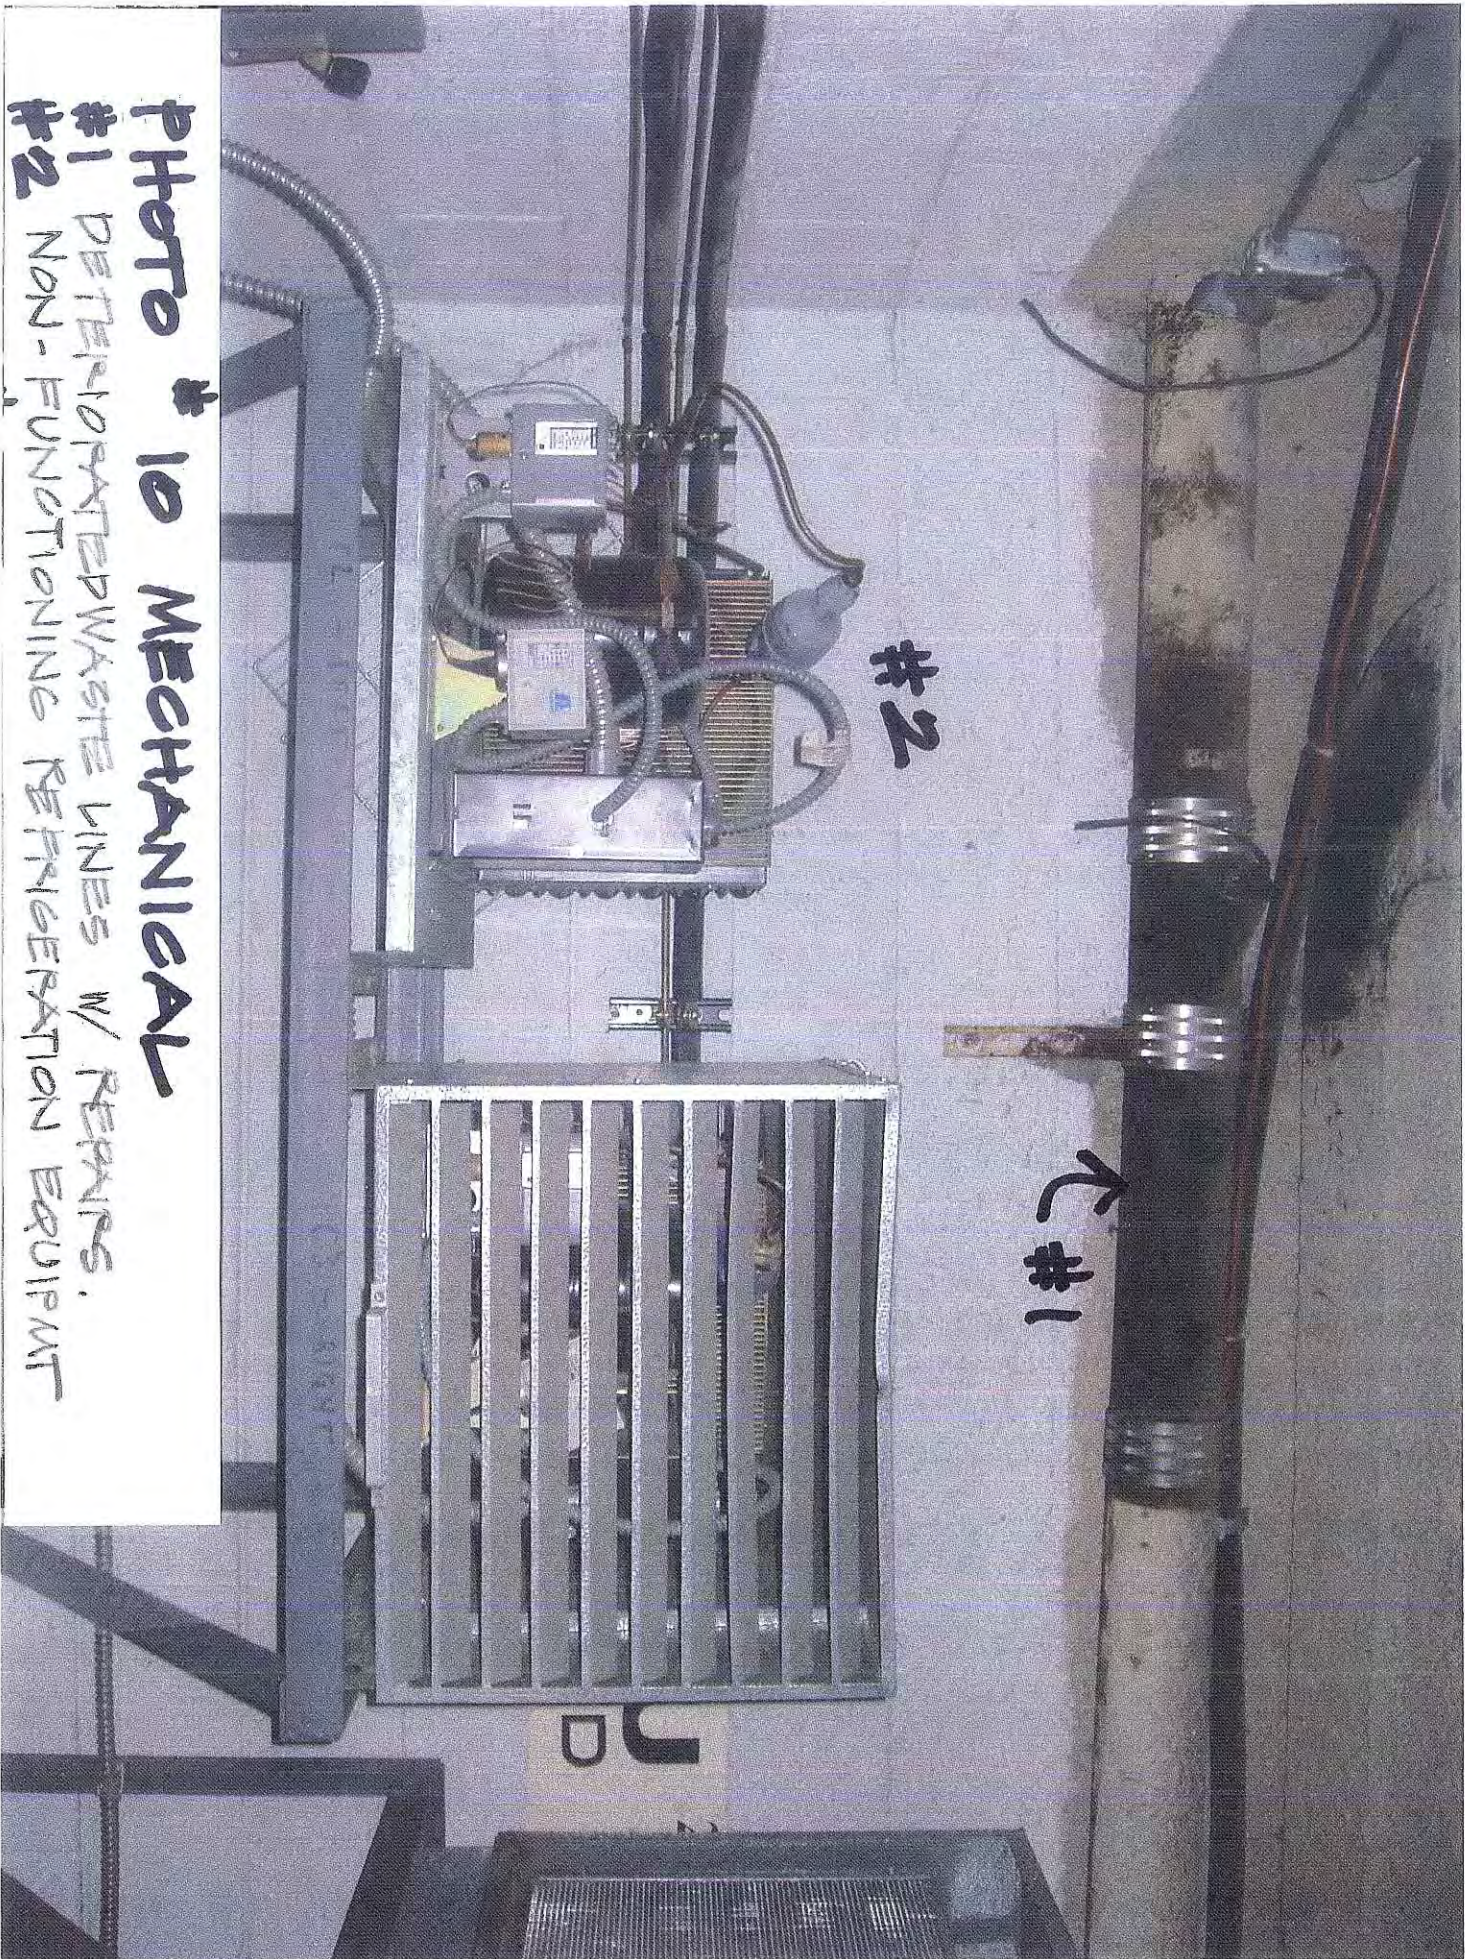
PHOTO # 10 MECHANICAL

- #1 DETERIORATED WASTE LINES W/ REPAIRS.
- #2 NON-FUNCTIONING REFRIGERATION EQUIPMENT

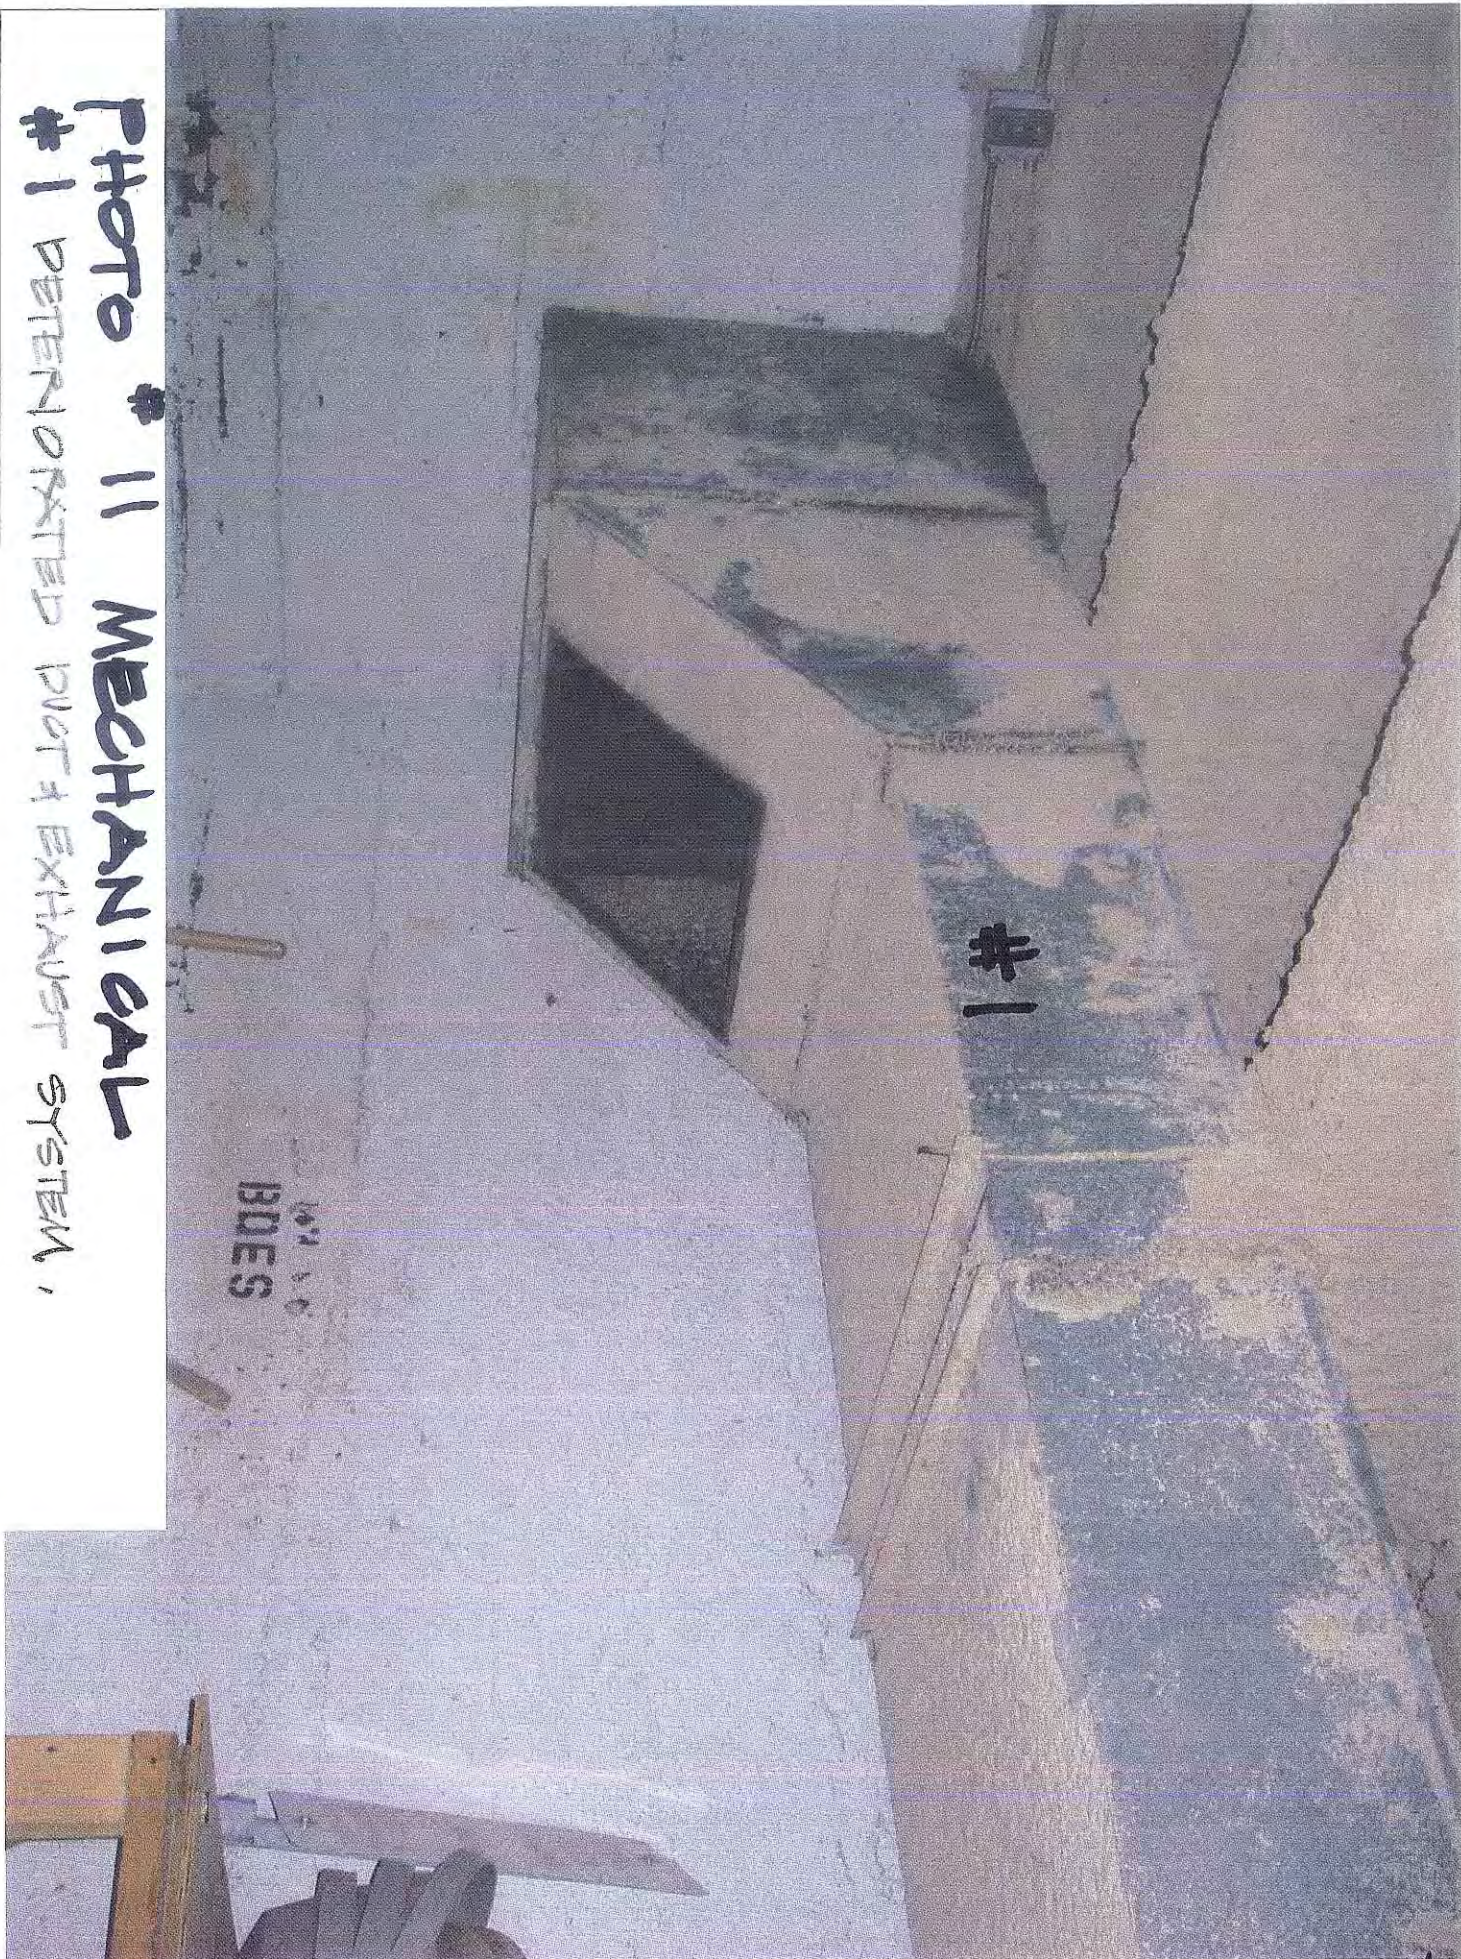
PHOTO # 11 MECHANICAL
#1 DETERIORATED PART OF EXHAUST SYSTEM.

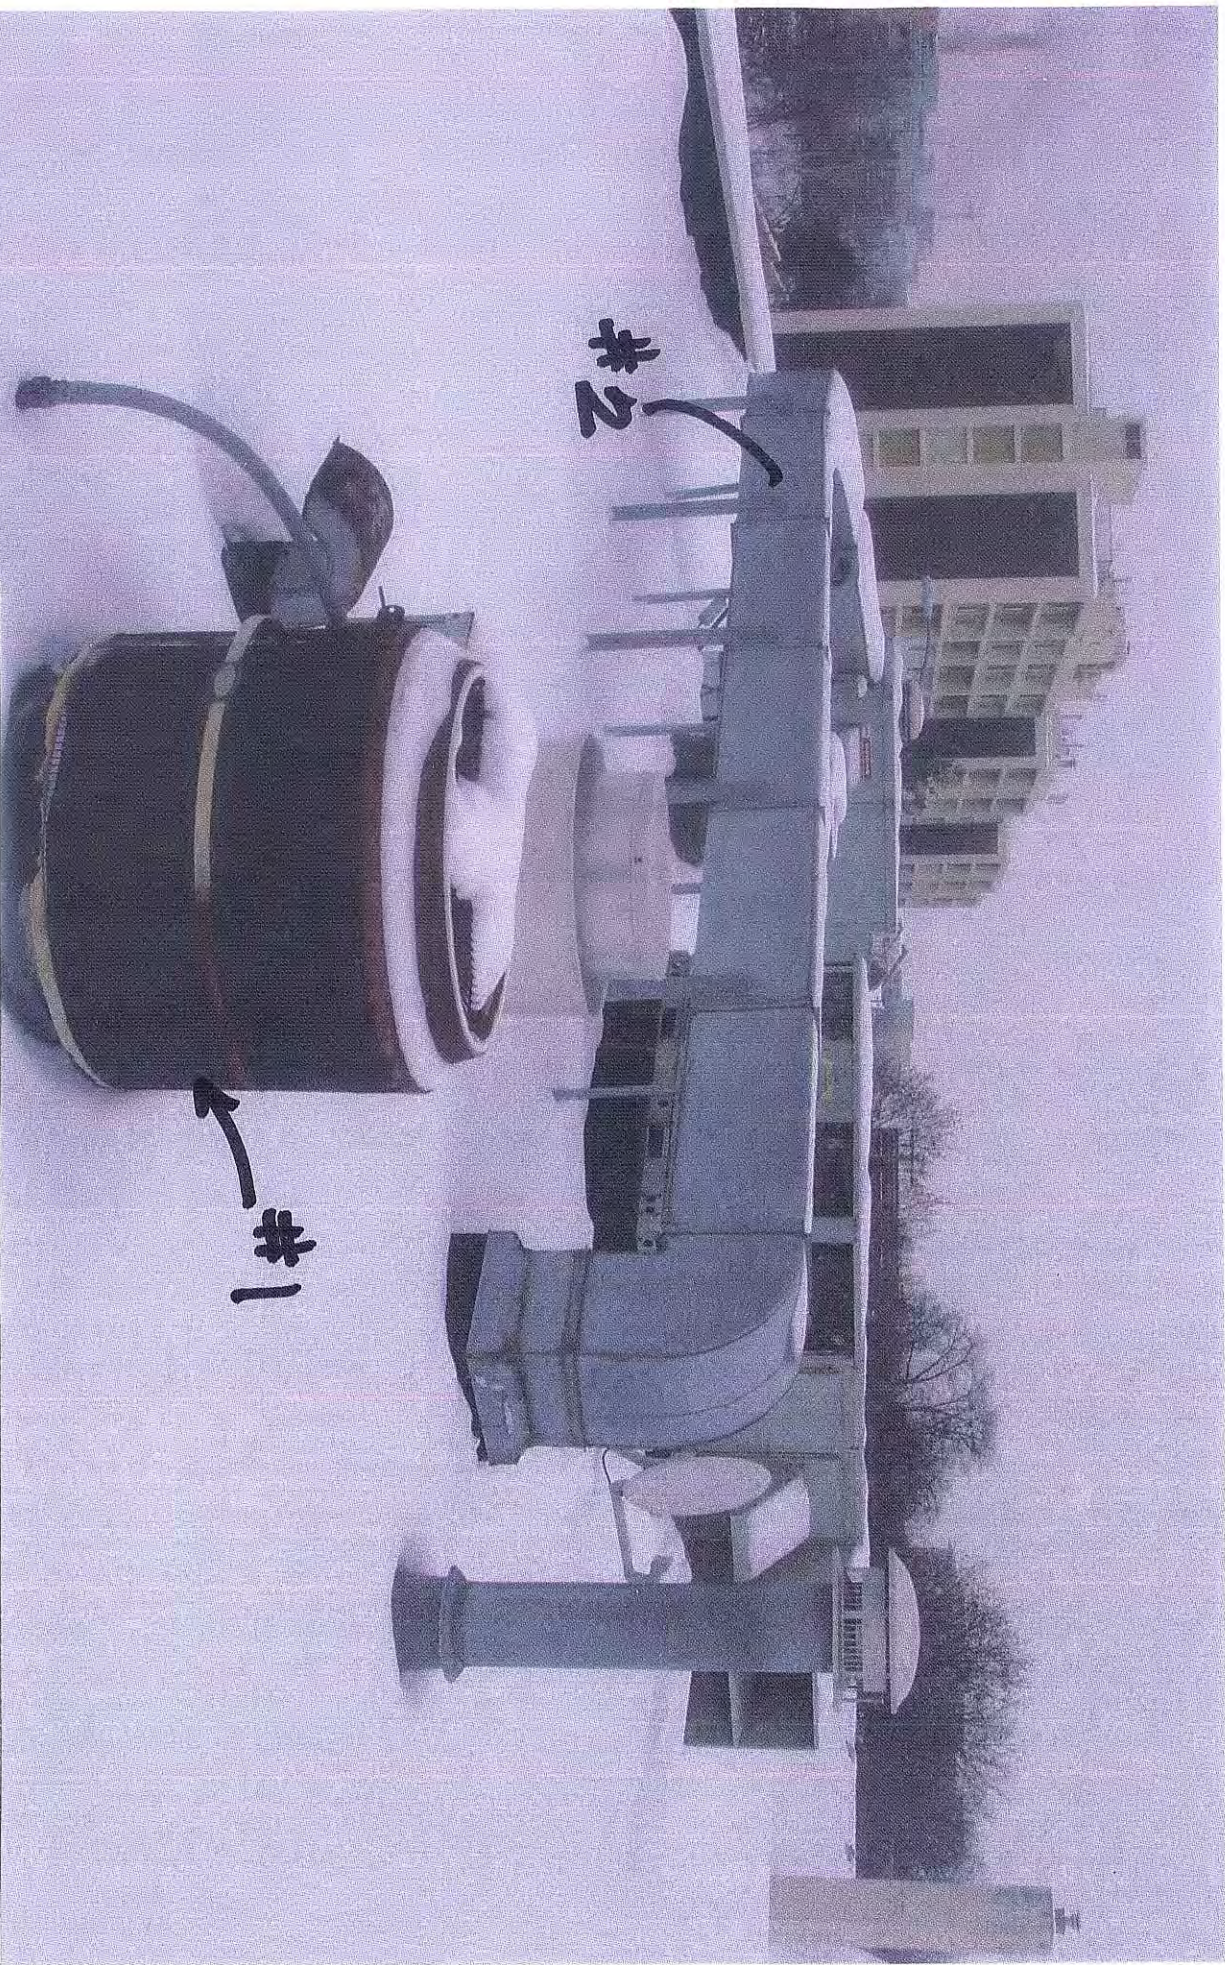
PHOTO #12 MECHANICAL

- #1 OBSOLETE 1970 AC EQUIPMENT
- #2 NON-FUNCTIONING KITCHEN AND EQUIPMENT

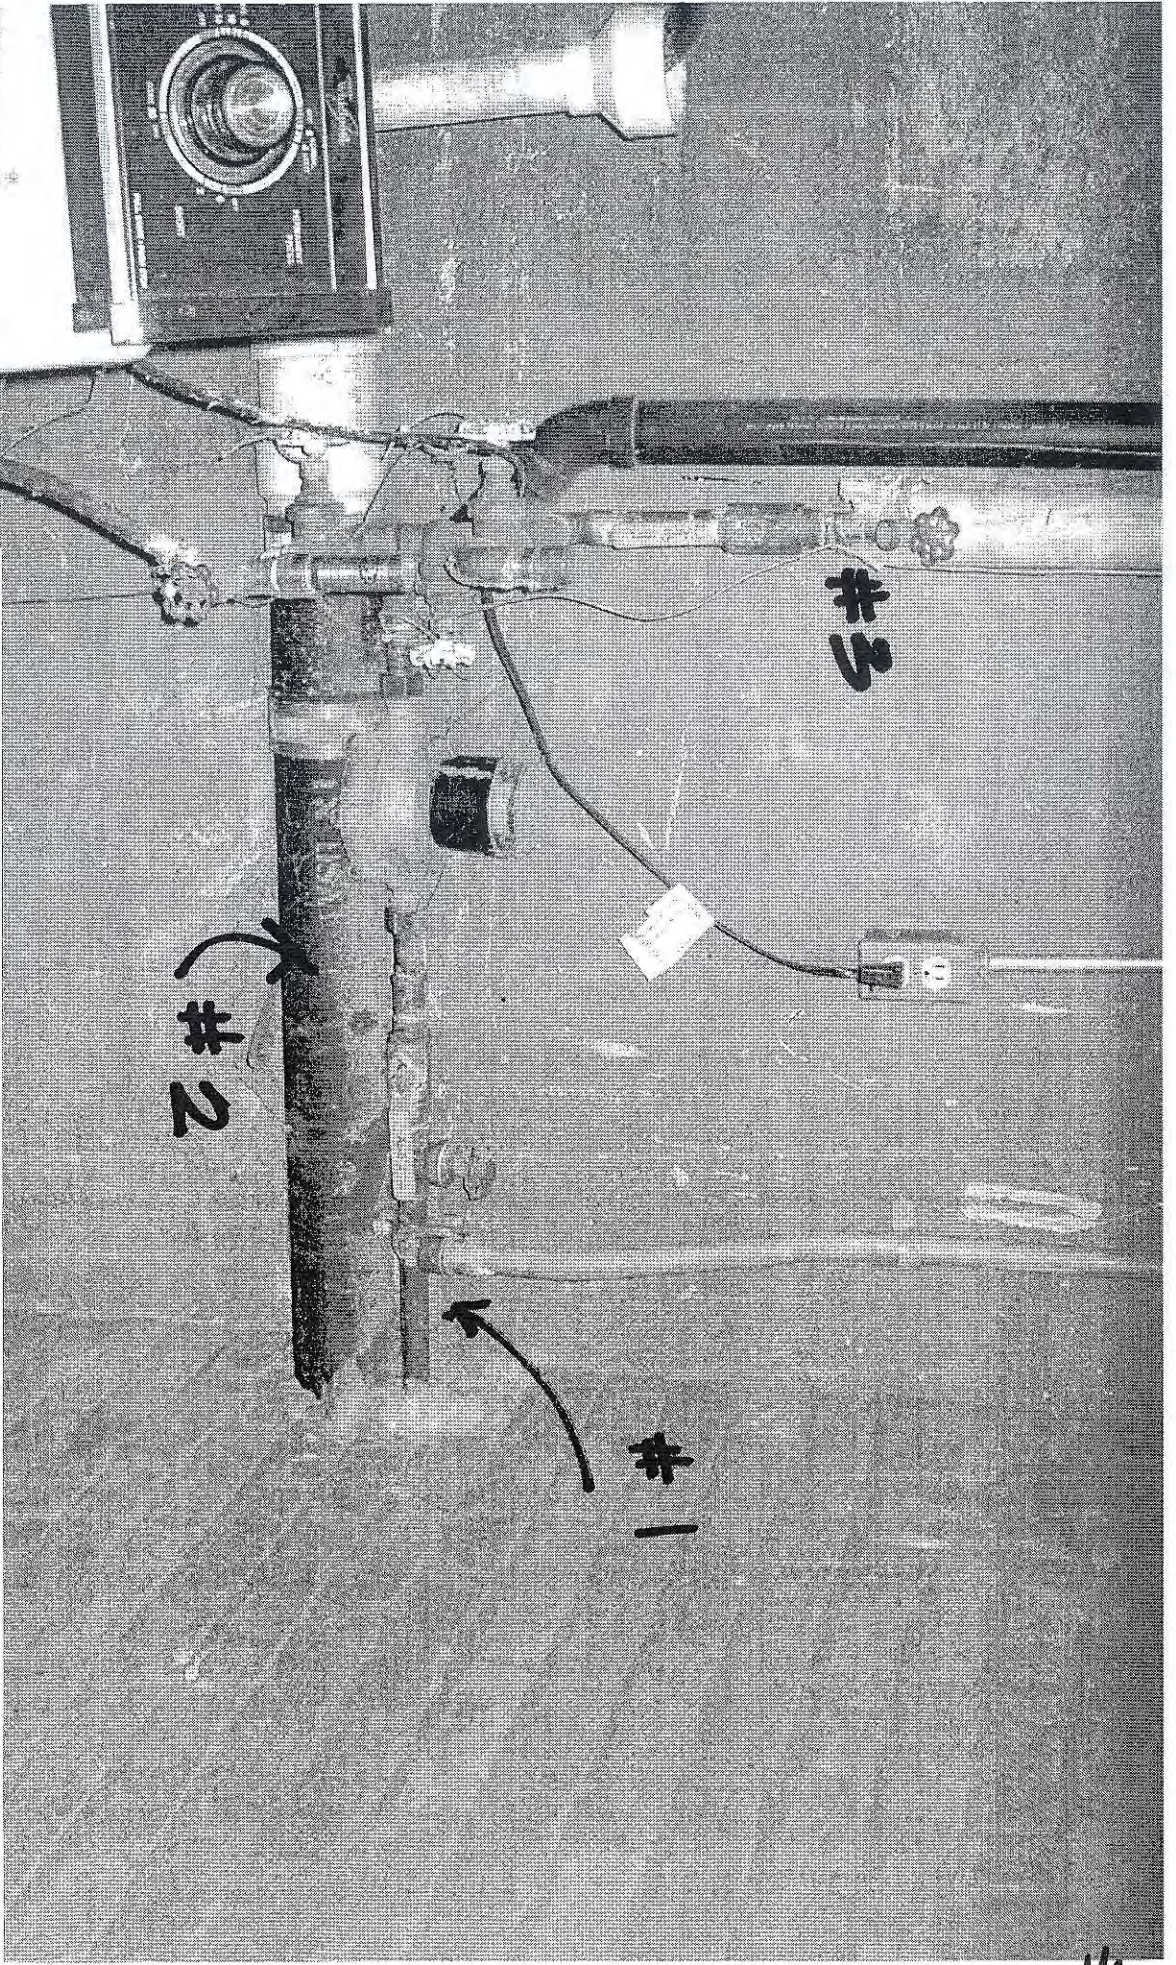
PHOTO # 15 MECHANICAL

- # 1 1970's 1" WATER SERVICE (NORMAL 15,000 SQ FT)
COMMERCIAL BIDS TODAY 3-6"
- # 2 1970's 4" SEWER (UNDERSIZED FOR 15,000 SQ FT.)
- # 3 PETER OPERATED CONDITION OF UTILITIES.

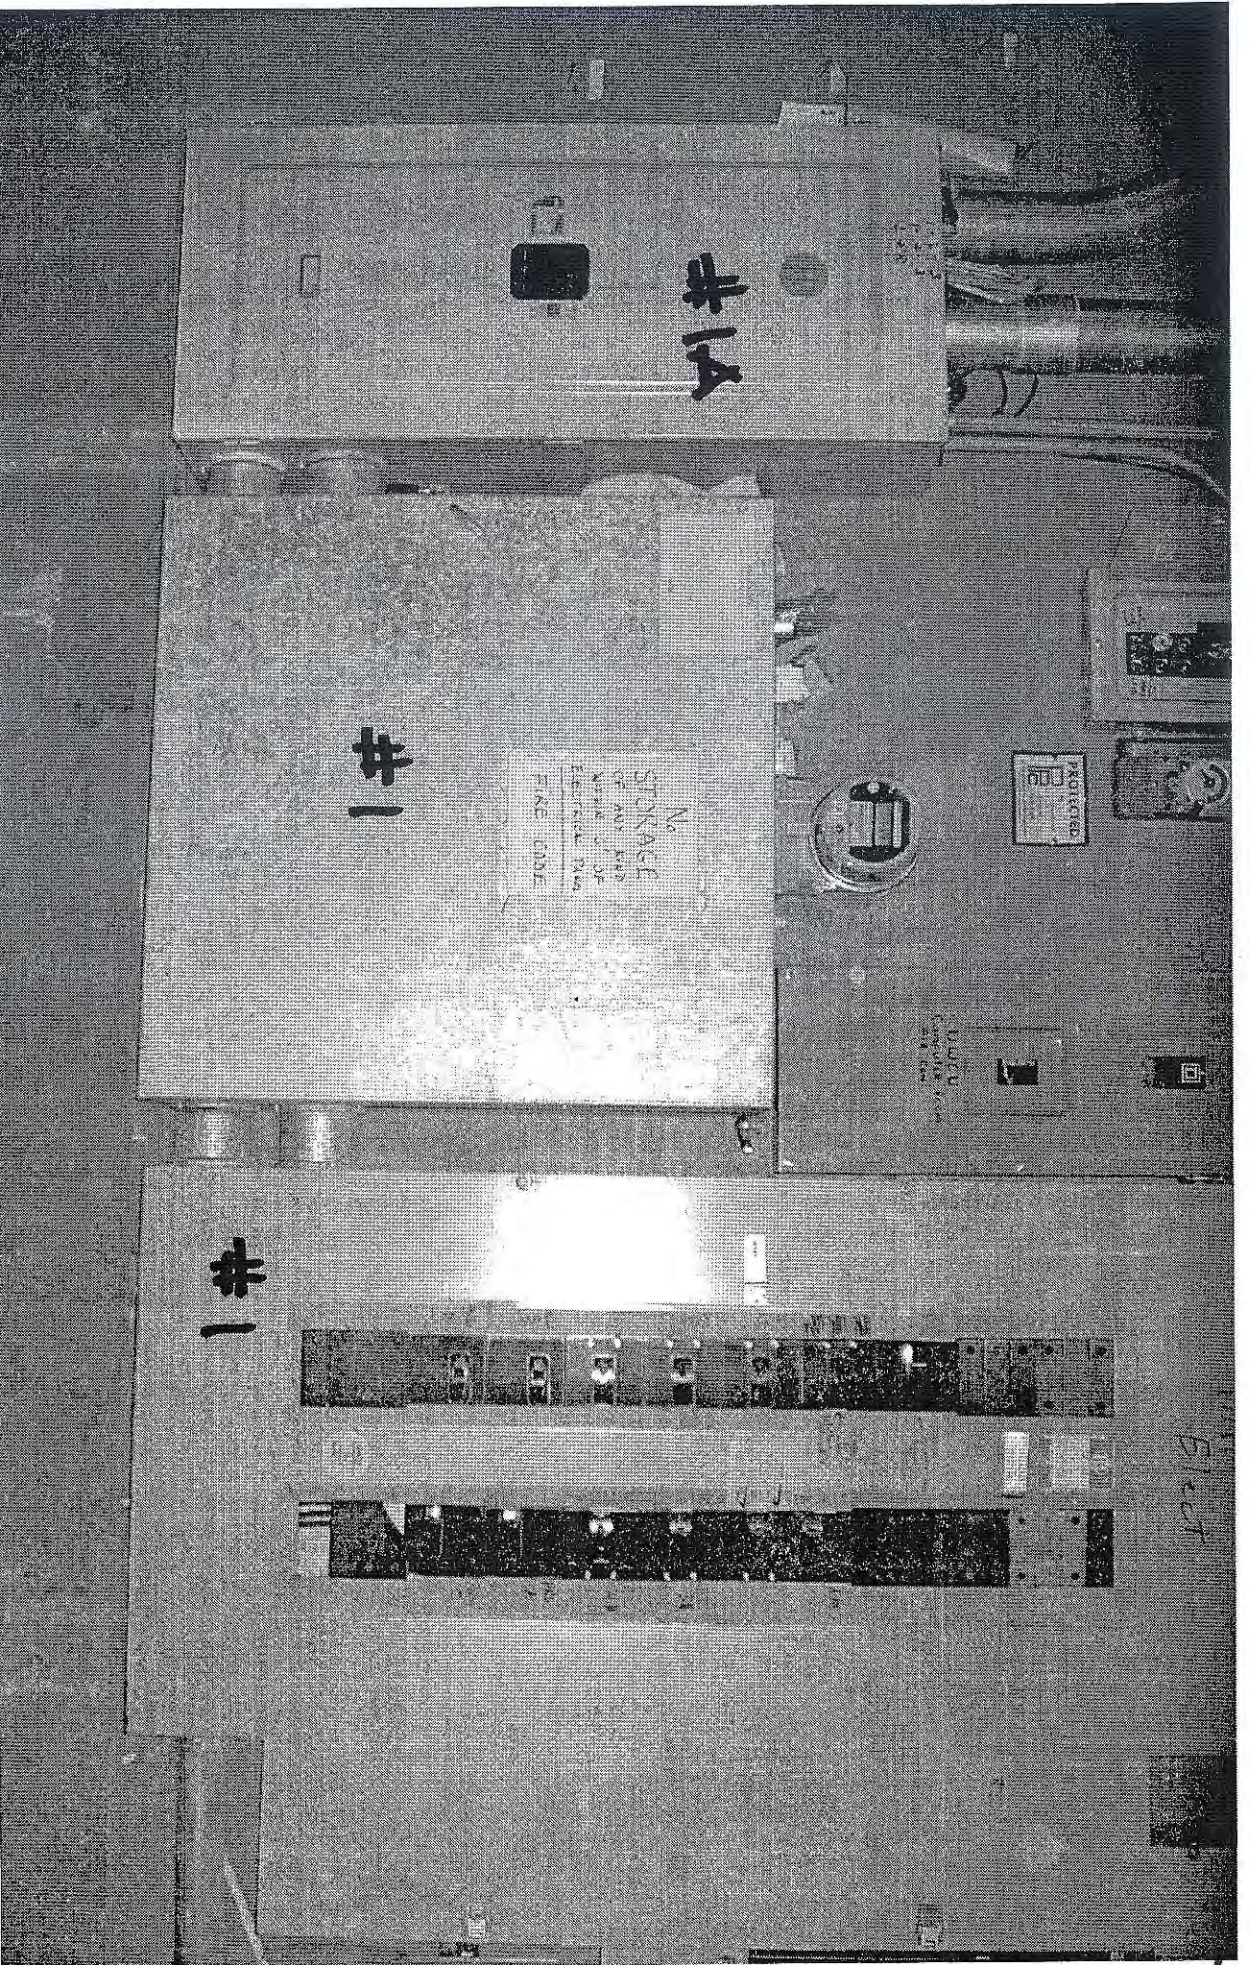
PHOTO # 14 ELECTRICAL MAIN
#1 400 AMP - 1970 ELECTRICAL SERVICE INSTALLED
AS USED EQUIPMENT - ALL OBSOLETE &
UNDER SIZED BY 1000 AMPS
