Re: 118 State Street Historic Evaluation
Madison, WI.

118 State Street
Selected Images (April 4, 2017)

Re: 122 State Street Façade Historic Fabric
Madison, WI.

122 State Street, Façade Historic Fabric
Selected Images (August 20, 2015 & October 1, 2015)

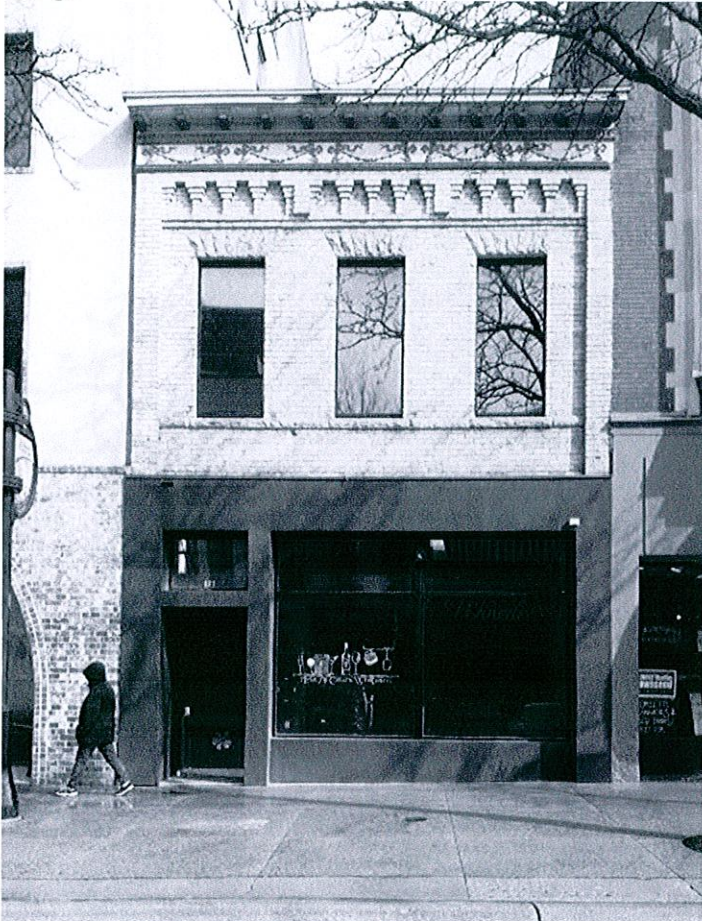
Image 1

Present view of the State Street façade. Compare to historic image below.
Note lack of engaged columns between the windows, contemporary aluminum windows of second floor and complete lack of original storefront at first floor.

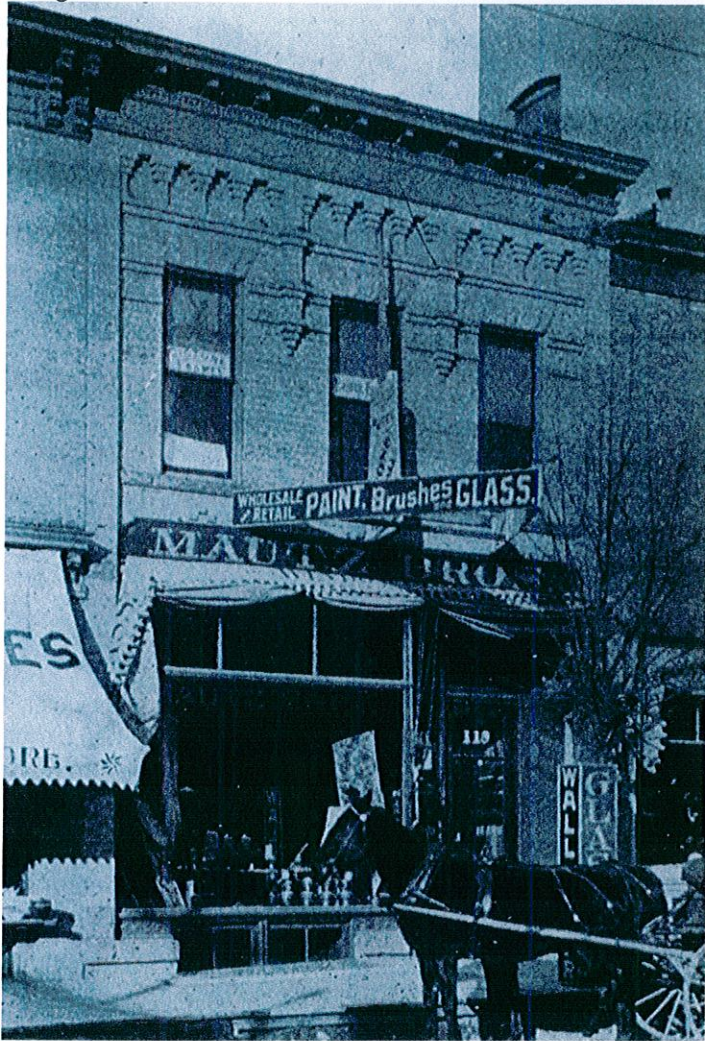
Image 2

Historic image circa 1900.
Madison Past and Present, Wisconsin State Journal, 1902.

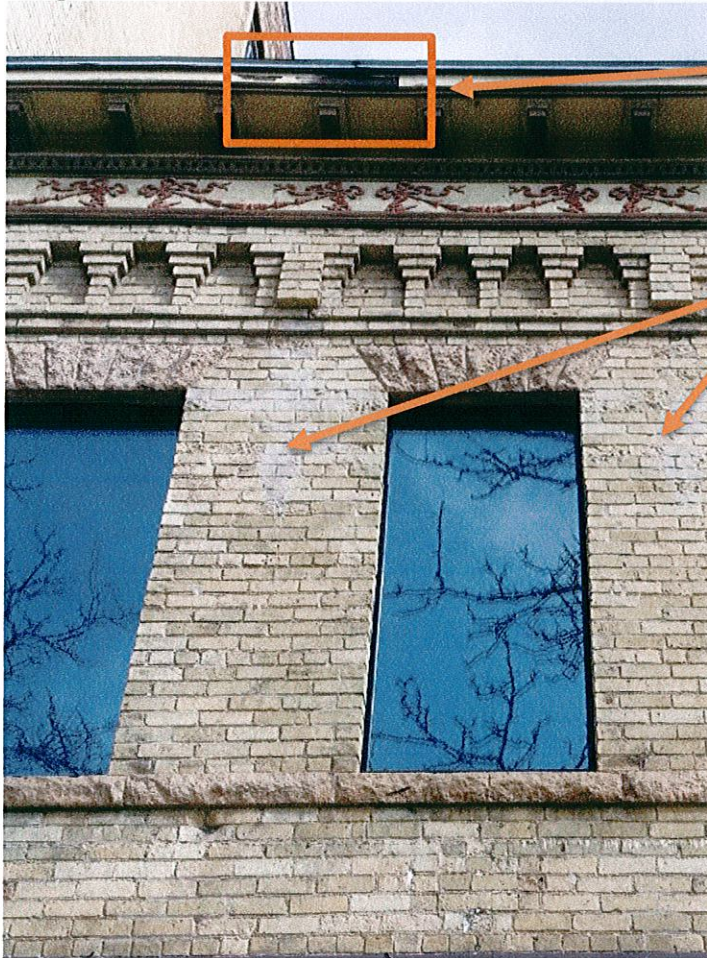
Image 3

In addition, the State Street façade was sandblasted. This detrimental abrasive cleaning remove the hard, outer protective surface of the brick, and therefore making the brick more permeable and susceptible to rapid weathering and deterioration. This cleaning also reduced the aesthetic character of the original smooth masonry face.

One of several areas of deterioration of the upper portion of the wood frame cornice.

Areas of brick infill where engaged columns and horizontal brick banding were removed.

Original double hung windows removed and contemporary aluminum windows inserted.

View of a portion the State Street façade.
Note the deterioration of the upper portion of the cornice and the poor infill where the engaged columns were removed between the windows. Also note the rough and porous surface of the “sandblasted” brick and stone.

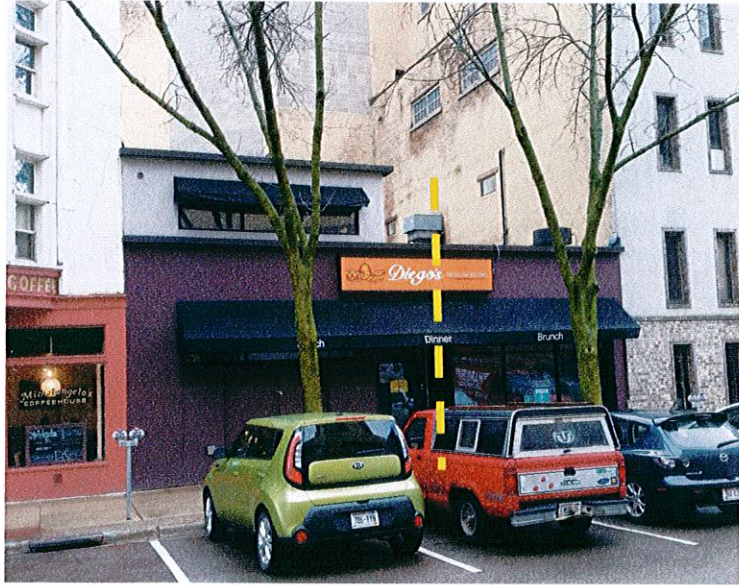
Image 4

View of the Carroll Street façade. As early as 1950, the two-story façade of the Carroll Street side of the building was combined with the one-story façade of the adjacent building at 120 Carroll Street to present a unified appearance. (Yellow line is the approximate division between the original separate facades.)

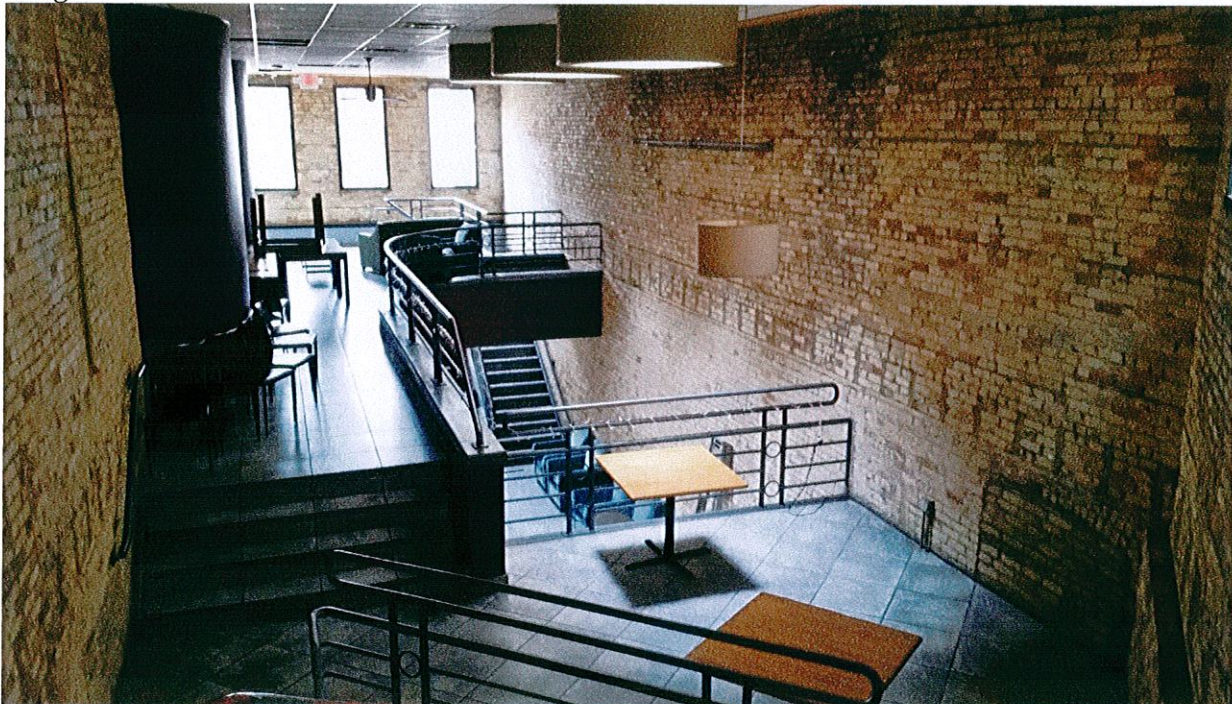
Image 5

Interior view at second floor looking towards State Street. Note exposed brick masonry party walls and complete lack of any interior historic fabric.

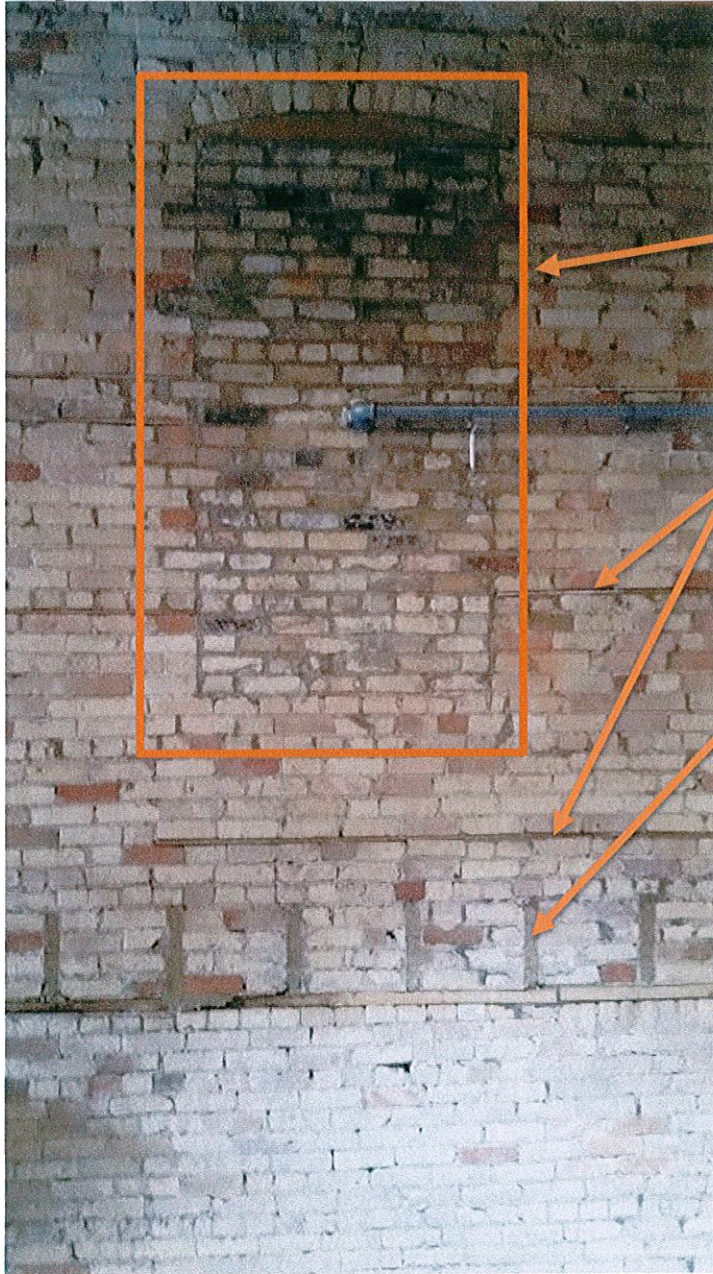
Image 6

Original window opening of west party wall. Filled in when adjacent building was built.

Original wood nailers that supported lath and plaster interior wall finish.

Original second level wood floor joists cut off when second floor was removed.

View of the west party wall at the second-floor level.
Note all original interior wall finishes have been removed.

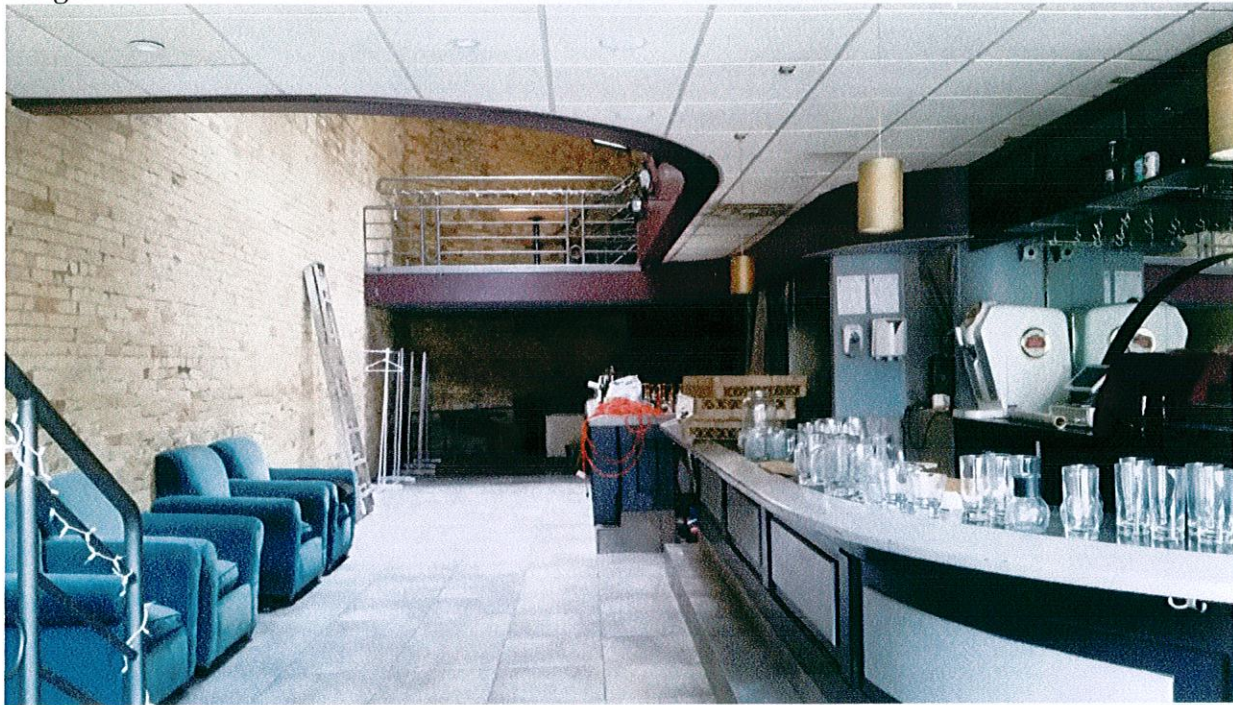
Image 7

View of the first floor interior looking towards Carroll Street. This is a similar view of the interior to the historic image *WHi image # 15613, December 12, 1935, McVicar*.

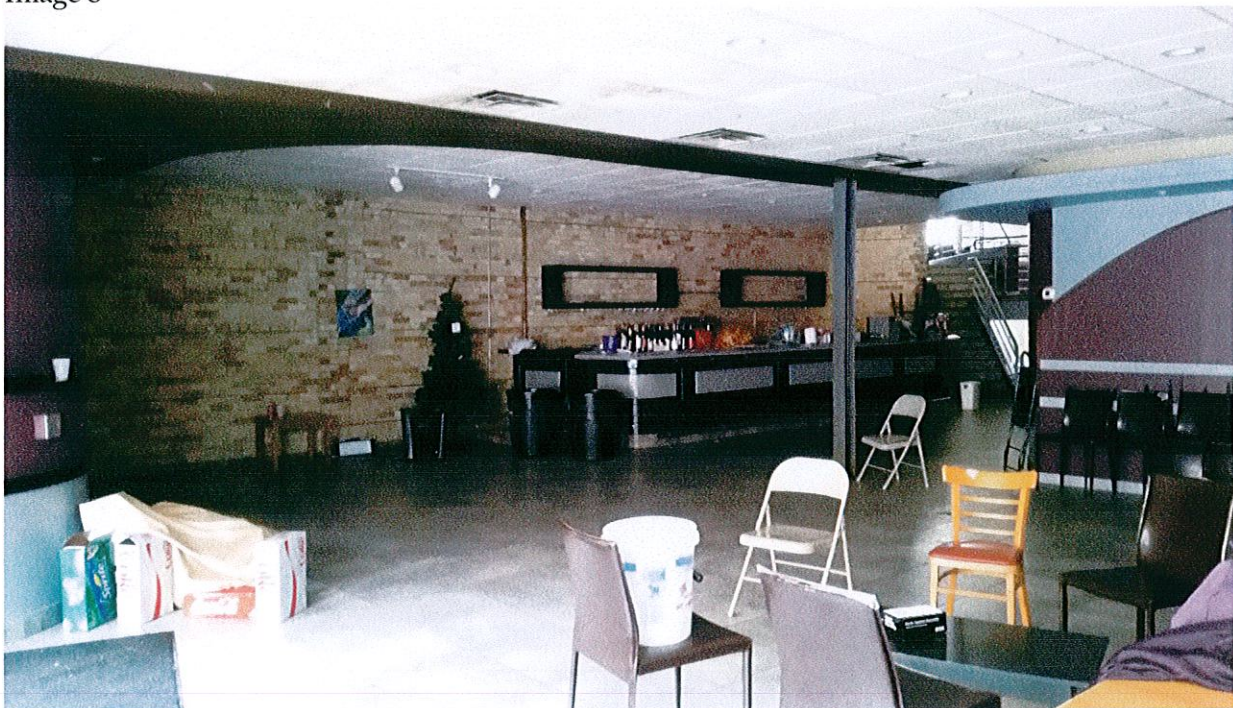
Image 8

View looking at the east interior wall of the original building, Carroll Street end of the building.

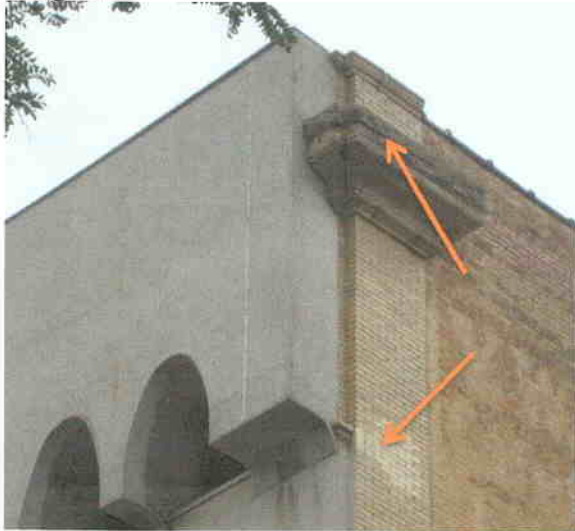
Image 4

View of the right side of the State Street façade at the cornice level. Note the damage to the terra cotta cornice and that the original stone belt course has been removed and infilled with brick. (orange arrows). August 20, 2015.

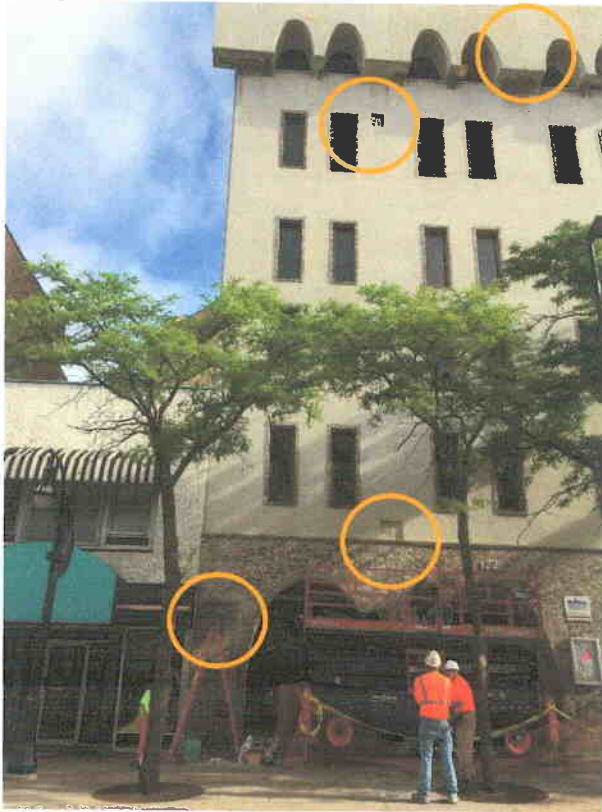
Image 7

Locations of some of the probes on the State Street Façade. August 20, 2015.
