## **EXISTING BUILDING REVIEW**

### **127-129 State Street**

## **127–129 State Street – Architectural Review**

Walk thru Evaluation of 127-129 State Street  
Madison, WI  
Date of Walk thru 11/18 and 12/3/2011. Date of report 12/7/2011  
PE Job #11272

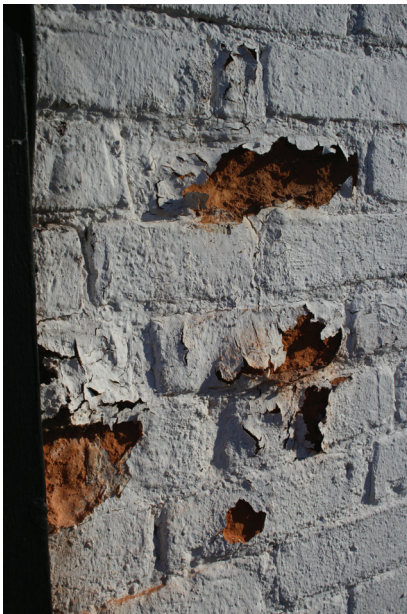
Exterior: View of damaged brick veneer

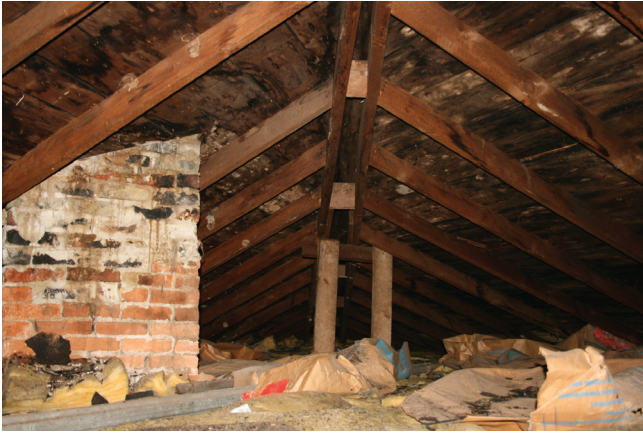
Attic: View toward flat iron corner showing damage to chimney

The roof framing is wood joists overlain with spaced wood 1 x decking overlain with modern day wood sheathing. The roof rafters measure full size 2x6 at 22" oc. Their calculated live load capacity is 21 psf. There is no noted snow drift to this roof. There are separate 2x4 ceiling joists. The shingles are in need of replacement. The chimney is in need of repair or rebuild.

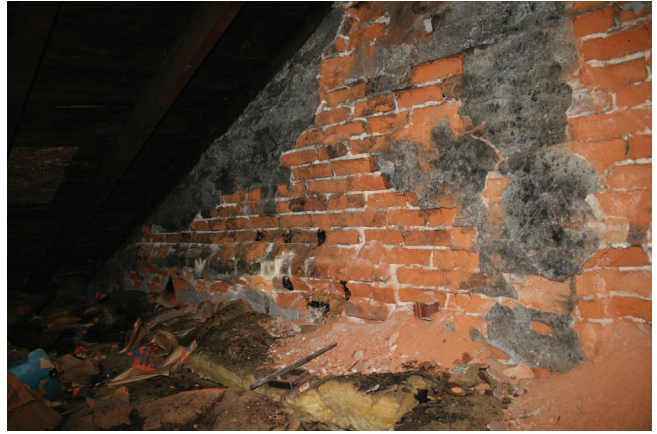
Attic: View toward wall between 127-129 state street and the castle and doyle building showing significant damage to existing brick

3. Areas of Compromised Structure
  - a. Water infiltration was noted in the basement. Brick damage due to moisture infiltration is noted at the attic at the east gable wall.

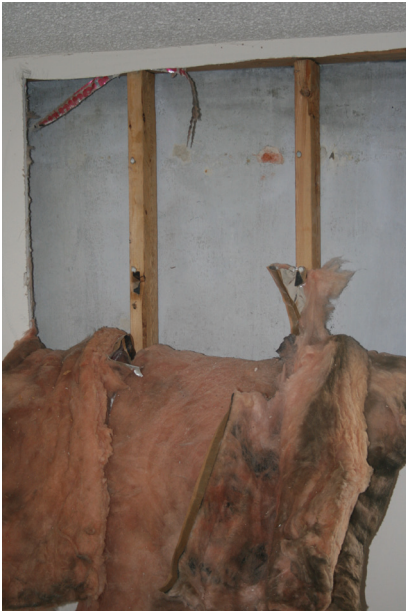
Third Floor: Section of exterior wall exposed showing back of brick and moisture within the insulation space

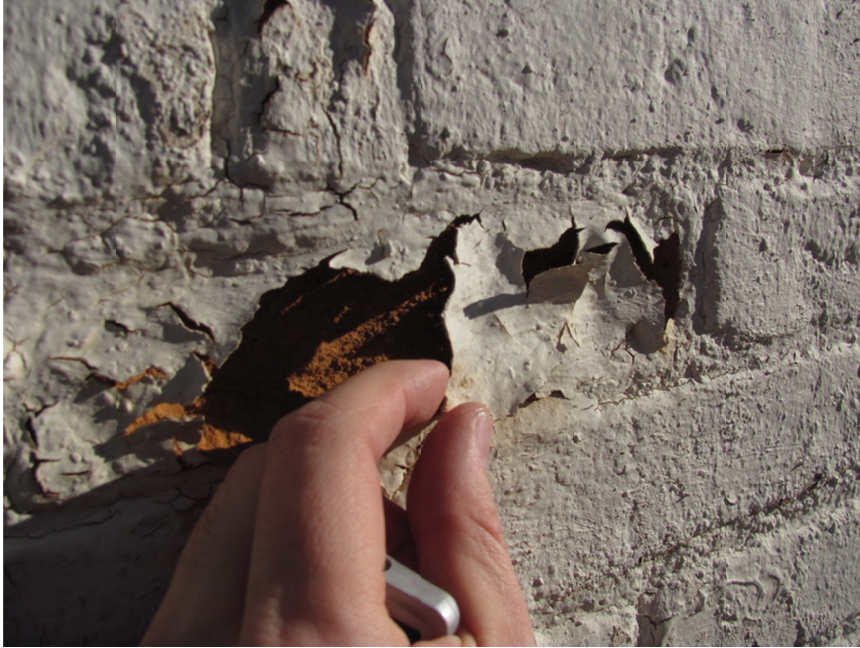
The brick masonry is generally in very poor condition, with extensive previous spalling and erosion of brick faces and open mortar joints. This masonry distress has been exacerbated by the application of multiple coating layers, some of which were applied over unrepaired deteriorated masonry. At many locations, loss of the coating has revealed severe deterioration and disintegration of the underlying brick and mortar (Figure 3 through Figure 6). Near the middle of the Fairchild Street elevation, interior finishes at the first floor had been previously removed, exposing the backup masonry to view. The brickwork at the lowest 30 inches of the wall in this area is severely deteriorated, with deep erosion and deterioration of the brick and mortar (Figure 7).

*Figure 3. Loss of the coating reveals severely deteriorated brick units.*

The brick masonry has deteriorated over time, and coatings and cementitious parging have been applied to the surface of the wall rather than addressing the underlying masonry distress. The build-up of coating layers has exacerbated and accelerated the deterioration of the brick masonry. Deterioration of the brick and mortar appears to be so widespread that extensive reconstruction of the exterior walls is now required. The quality and condition of the masonry materials appears to be relatively consistent across the facades; therefore, 100 percent replacement of the outer wythe of brick masonry of the facades should be assumed. Since the majority of the exterior walls are only 8 inches thick, reconstruction of the outer wythe only may not be feasible, especially considering the deterioration of the back-up wythe of brick in the portions near grade. Rather, reconstruction of the full thickness of substantial portions or all portions of the wall will likely be necessary. Development of an appropriate approach requires further investigation and coordination with the results of the structural survey recently undertaken by others. Inspection openings should be made to confirm the exact thickness of the wall in various locations and to review the condition of concealed portions of the wall.

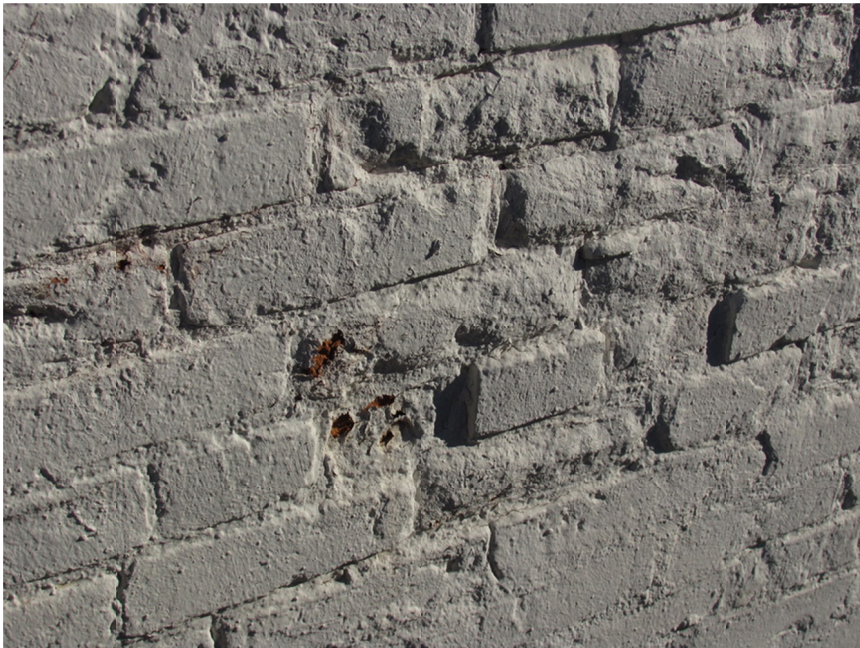
*Figure 4. The coating layers were applied over unrepaired deteriorated masonry.*

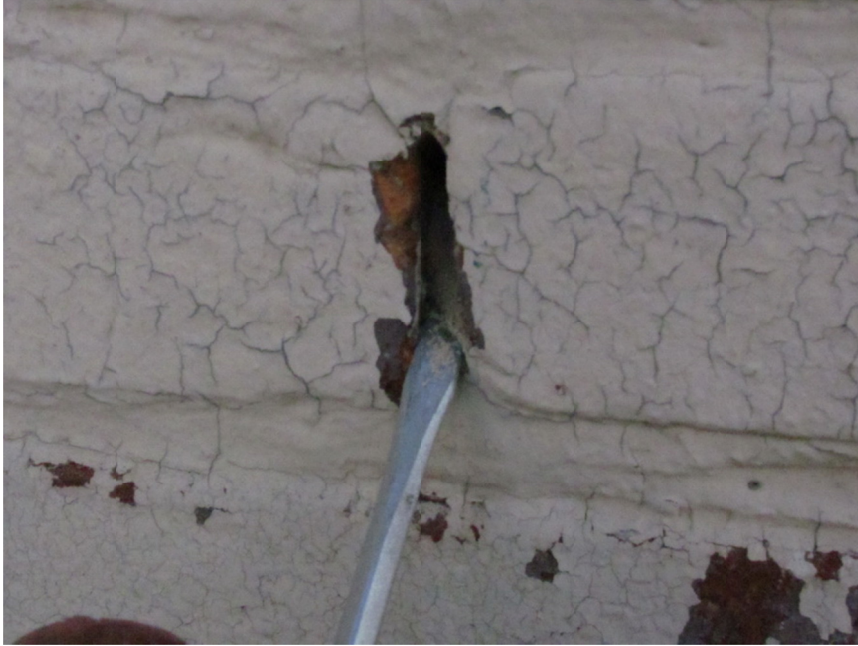
*Figure 5. Mortar behind the coating layers is friable and has disintegrated.*

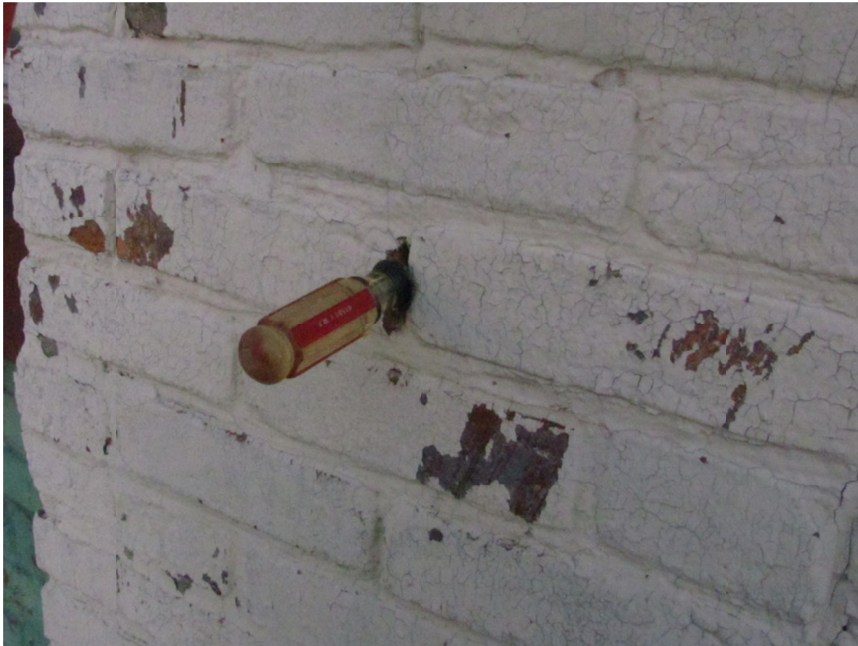
*Figure 6. Mortar behind the coating layers has disintegrated, resulting in voids within the masonry construction.*

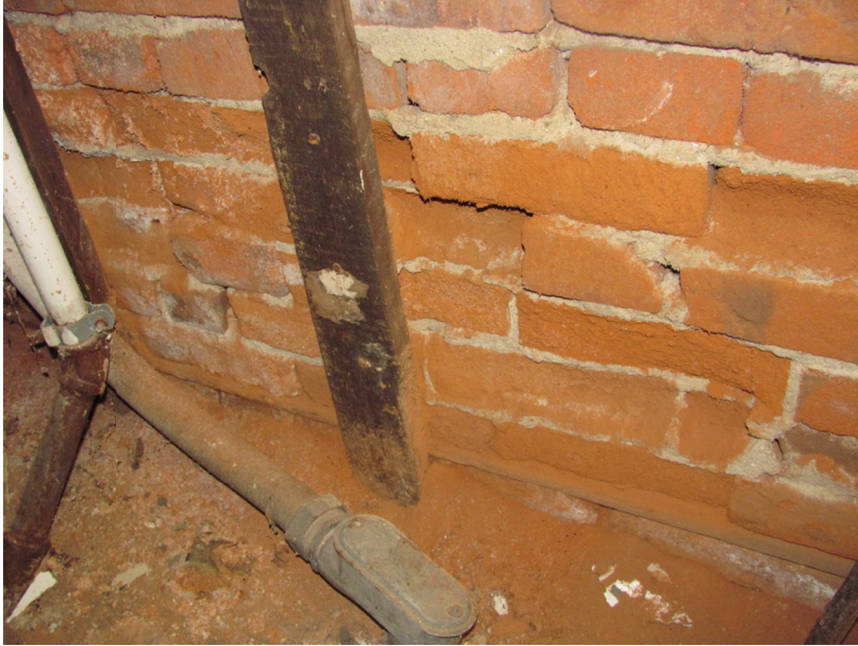
*Figure 7. Deterioration of the back-up masonry at the interior of the building.*

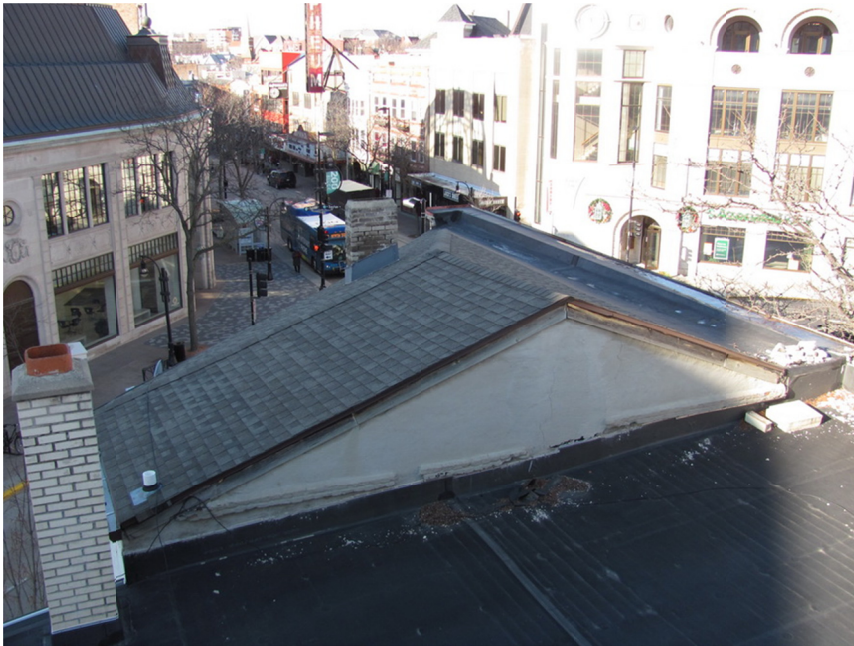
The building roof was not accessible for close-up inspection but was viewed from a nearby higher building (Figure 8). The existing roof covering is asphalt shingle that appears relatively new and intact. Along State Street, there is a low parapet wall and built-in gutter lined with EPDM rubber membrane. Along Fairchild Street, there is a hanging galvanized metal gutter. When viewed from below in the building attic, widespread water staining was apparent on the wood framing (Figure 9). Also, debris and remnants of roofing material were scattered over the insulation in the attic. It appears likely that much of the existing staining is from old water leakage that is not currently active, given the apparently good condition of the existing roofing.

*Figure 8. Overview of the roof.*

The existing roof system is likely relatively new and intact, based on its appearance as viewed from adjacent buildings, although the perimeter detailing and provisions for drainage should be reviewed in greater detail.

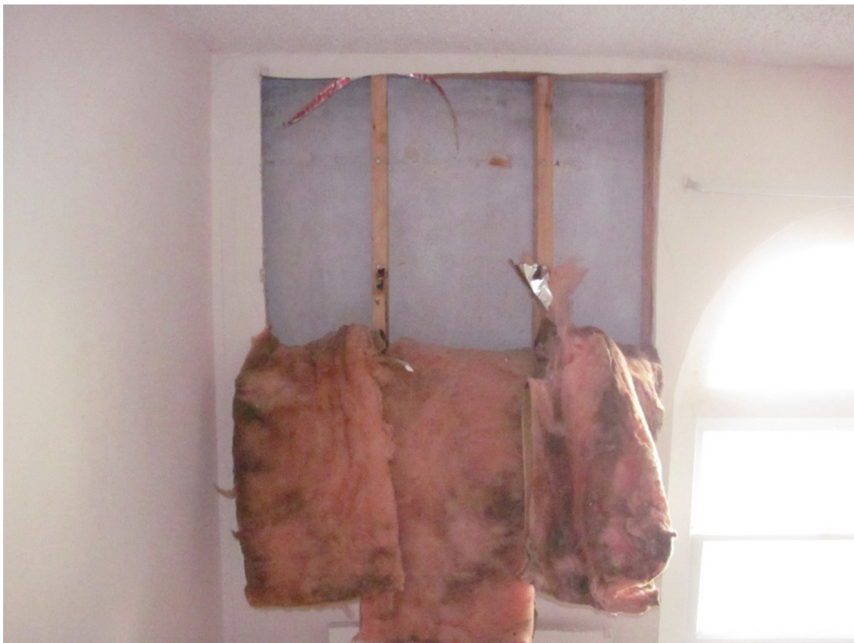
The second and third floors together constitute one three-bedroom rental apartment. The apartment is accessed via a separate entrance vestibule and stair from the south corner of the building on Fairchild Street. The apartment interior finishes include carpeting, sheet vinyl flooring, wood paneling, and gypsum board walls and ceilings (Figure 11). Several inspection openings were made during the site inspection at the exterior walls of the third floor. From interior to exterior, the exterior construction consists of gypsum board supported on 2x4 studs with batt insulation between the studs, installed inside the original brick masonry wall. Previous plaster finishes were observed directly applied to the inside face of the brick masonry. Staining and evidence of moisture penetration was observed on the batt insulation and plaster (Figure 12).

*Figure 12. Staining and evidence of moisture penetration was observed on the batt insulation and plaster at an inspection opening created at the third floor during the site visit.*

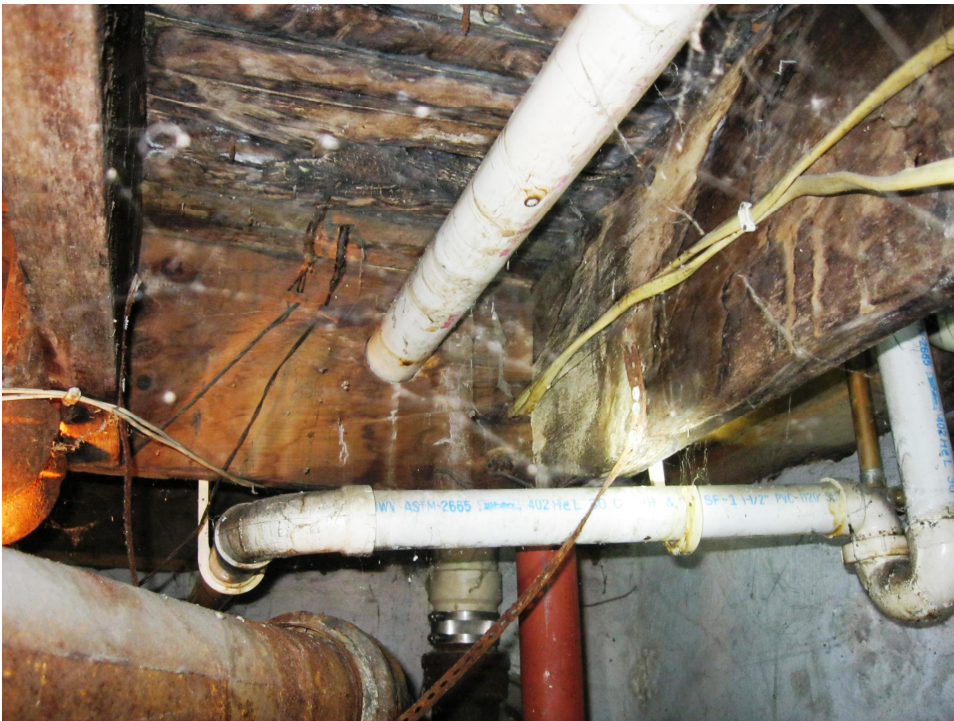
**Photo 7** – 1<sup>st</sup> floor framing with water damage

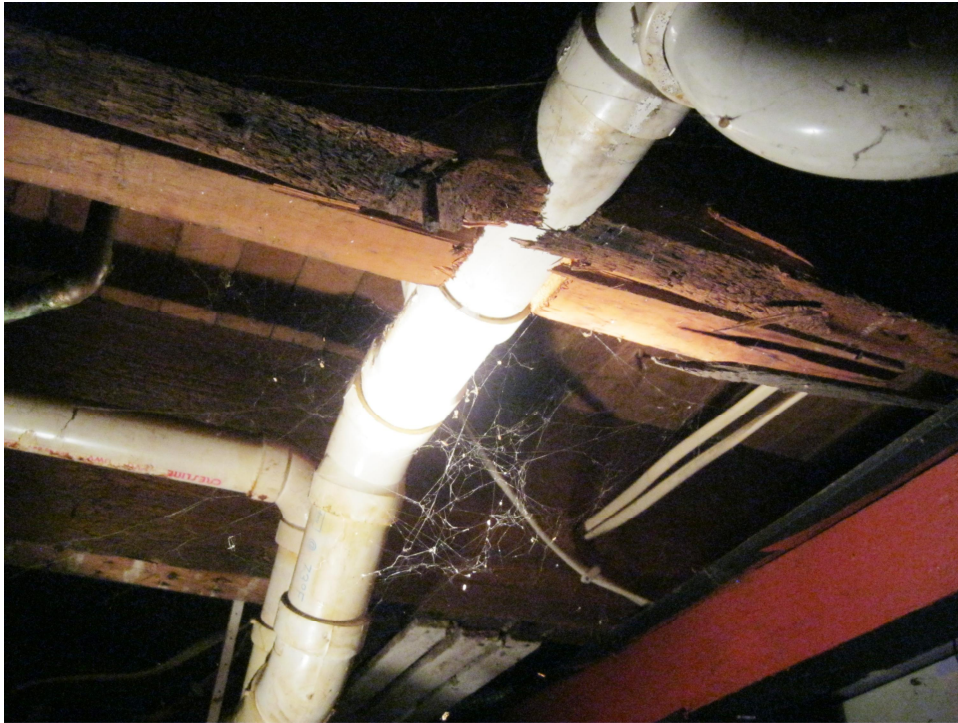
- b. Piping revisions over the years have damaged the first floor structure rendering the floor unusable.
4. Floor. Roof Loading
  - a. Existing Structure Capacity. First floor live load capacity-none specified, replacement needed. Second floor live load capacity 35 psf. Third floor live load capacity of 45 psf. Roof live load capacity 21 psf.

**Photo 8** – 1<sup>st</sup> floor framing notched for plumbing

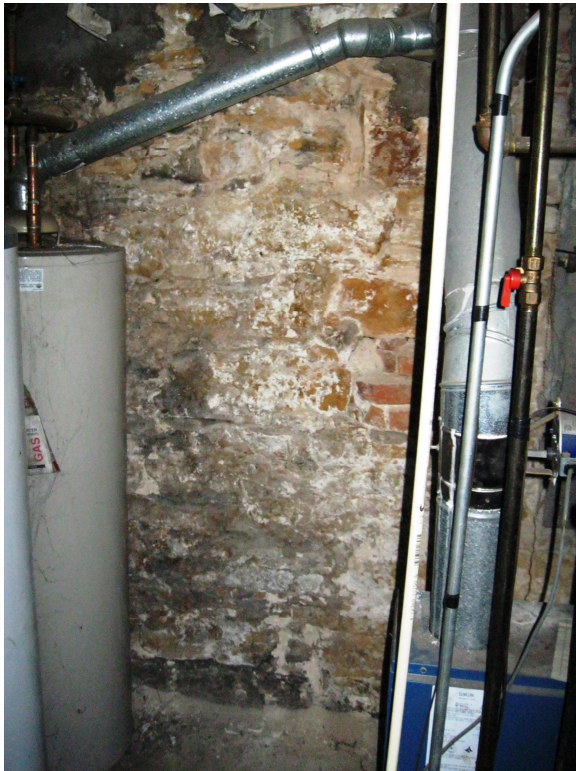
The exterior walls are thru the wall brick. In the basement, the exposed face shell of the brick basement wall have spalled and windrowed on the floor. This indicates significant water entry to this wall and makes one suspicious as the condition of the unobservable inner wythe of the wall. The inside surface of the gable end wall exposed in the attic was observed have been damaged by moisture entry. The wall is exposed above the adjacent roof. The wall has been parged presumably to resist water entry. The brick faces have been eroded away on the inner surface in the attic and are windrowed on the ceiling.

**Photo 9** – Basement wall along Fairchild Street

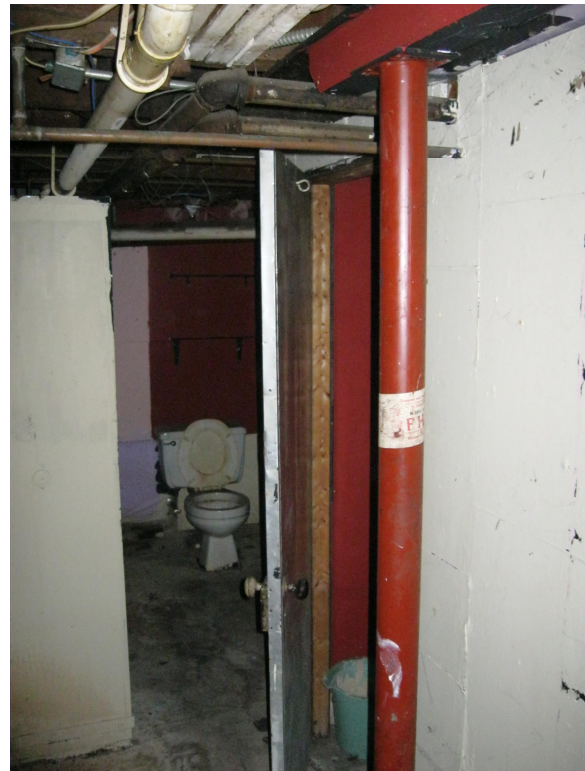
The floor is wood framed. There are two locations where shoring has been added to re-support the floor. The shores bear on wooden boards on the floor with no added footing present and as such should be considered temporary. The floor framing has been modified over the years to accommodate revised plumbing runs. The 2x framing has been cut as needed to allow the piping to pass. There are rotted 2x 's noted near the piping indicating unresolved leaks. No load capacity is assigned to this floor as it has excessive defects and needs to be replaced.

**Photo 10** – 1<sup>st</sup> floor shoring beam and post

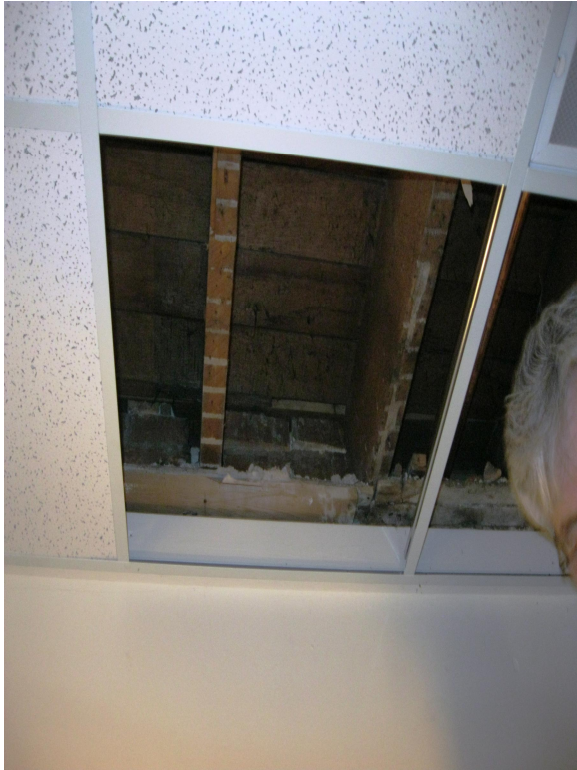
The framing for the second floor was observed from the 129 space. The second floor framing is full size 2x8 @16" oc spanning 17' and paralleling State Street. The calculated live load capacity of the second floor for the noted joists would be 35 psf. Present day code would require 40 psf for apartment occupancy.

**Photo 12** – 2<sup>nd</sup> floor joist framing observed from 1<sup>st</sup> floor retail space

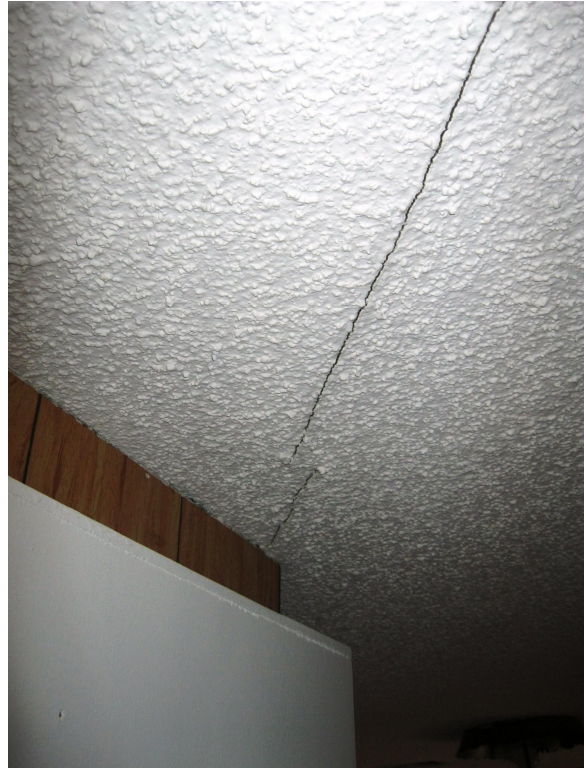
**Photo 13** – Ceiling finish distress beneath roof

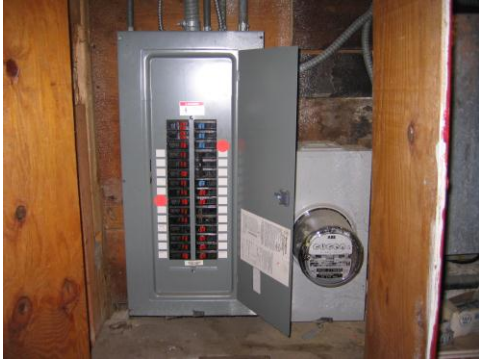
Part of the electrical service in a constructed cabinet.

The cabinet around the service equipment would need to be removed to make the equipment accessible.

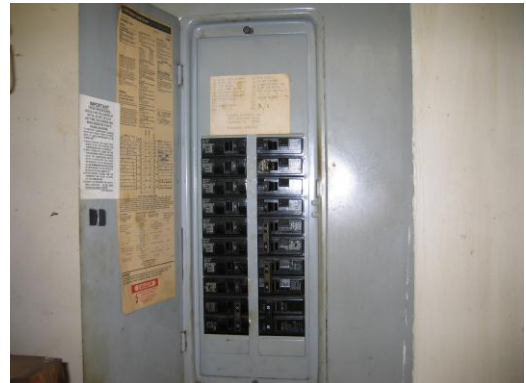
Electrical equipment age varies from about the 1970's to 1980's. The electrical panels are either at or are nearing the end of their useful life. There were no noted obvious failures of electrical equipment, such as evidenced by heat or smoke discoloration. The MG&E electrical service equipment appeared to be in good condition.

Electrical panel in 127 State Street (First Floor).
