Facility Name	Unit Well 11	Facility Description
Well ID	BF511	Drilled in 1956, Unit Well 11 has a pumping capacity of 2,300 gallons per minute. It operates year-round and serves Madison's East side including the Emerson East, Eken Park, Marquette, Schenk-Atwood, Hawthorne, and Worthington Park neighborhoods as well as homes in Burke Heights, Hiestand, Rolling Meadows, and Eastmorland. In 2017, the well pumped 625 million gallons of water compared to its 5-year average of 526 million gallons annually.
Service Zone	6E	
Capacity	2.88 MGD	
Reservoir Capacity	0.150 MG	
Number of Assets	31	
Current Replacement Cost	\$3.2M

Asset Condition Profile

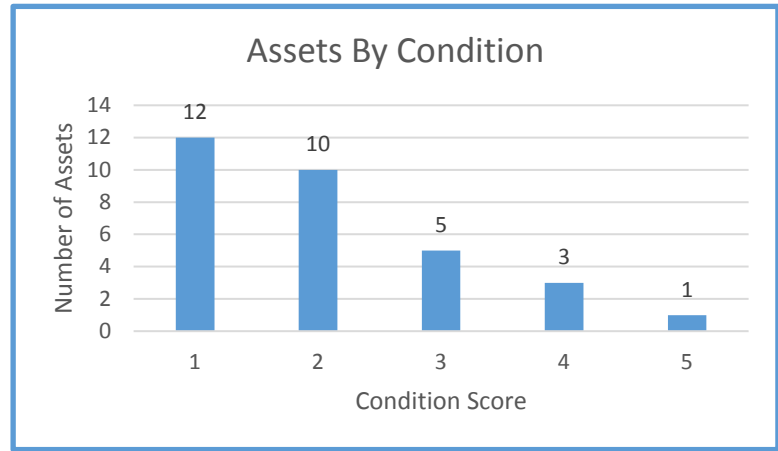
Figure 2. Asset Condition

Overall Condition Assessment: The assets at Unit Well 11 are in good to excellent condition with over 90% scoring 3 or better.

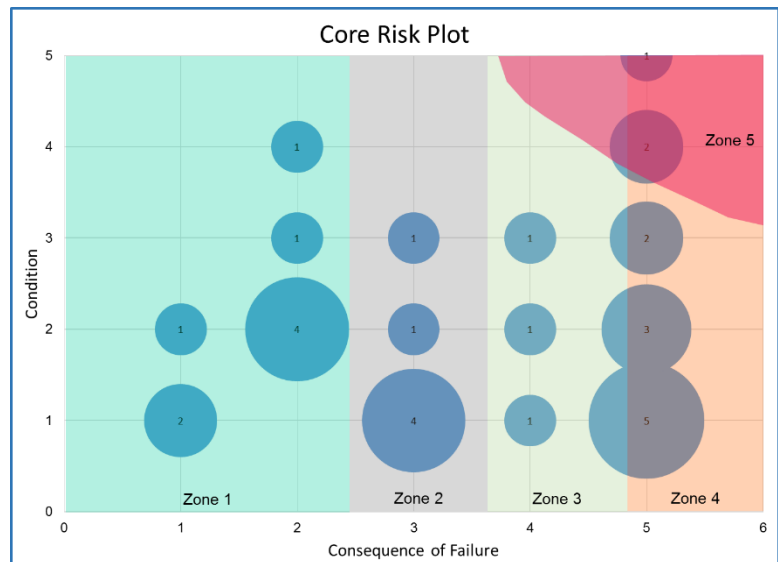
Figure 3. Risk Zone Plot

Based on the analysis, there are 3 assets falling in zone 5 (significant risk zone) that require immediate attention, including: Chlorine System, Fluoride System, and PUMP-71 Starter. The MCC and Level/Pressure Instruments fall just outside zone 5 and should also be addressed in the short term.

Asset Name	Intervention Type	Driver	Cost
Chlorine System	Rehabilitation	Risk	\$2,398
Fluoride System	Rehabilitation	Risk	\$2,398
MCC	Replacement	Risk	\$14,452
PUMP-71 Starter	Replacement	Risk	\$1,530
Level/Pressure Instruments	Replacement	Risk	\$3,910
		Total	\$24,688
