## Table of Contents

Introduction	2 - 3
Observations	
150 Langdon Street	4 - 17
621 Henry Street	17 - 30
625 Henry Street	31 - 42
145 Iota Court	42 - 54
Glossary	55
Condition Definitions	56

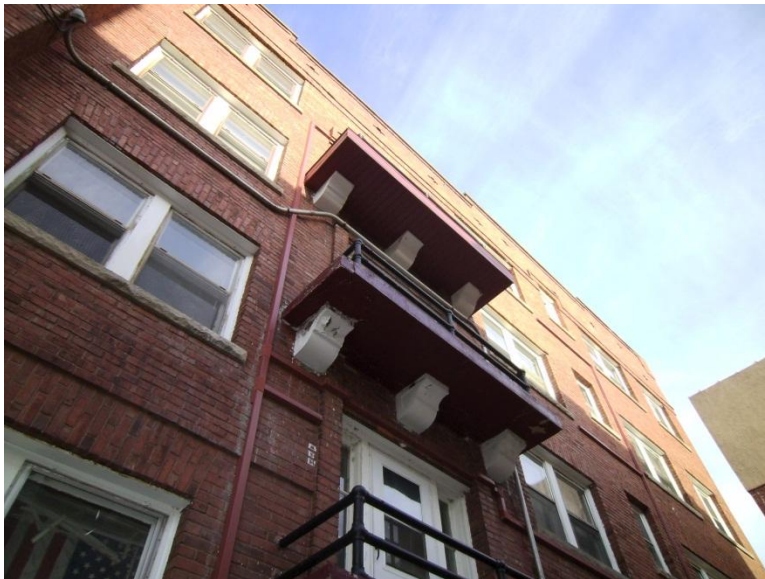
*Image 1.0* View of the west balconies of 145 Iota Court

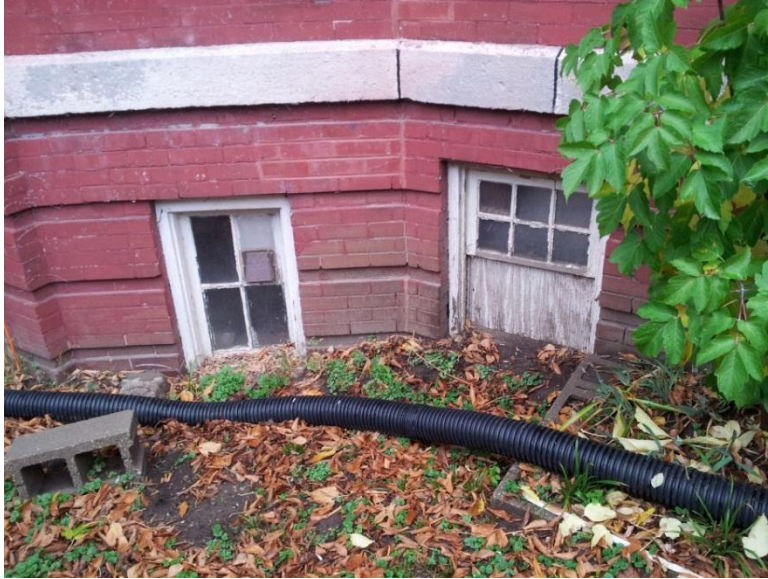
*Image 1.2* View of the west side at grade. Moisture is penetrating the perimeter walls below-grade at this and other locations

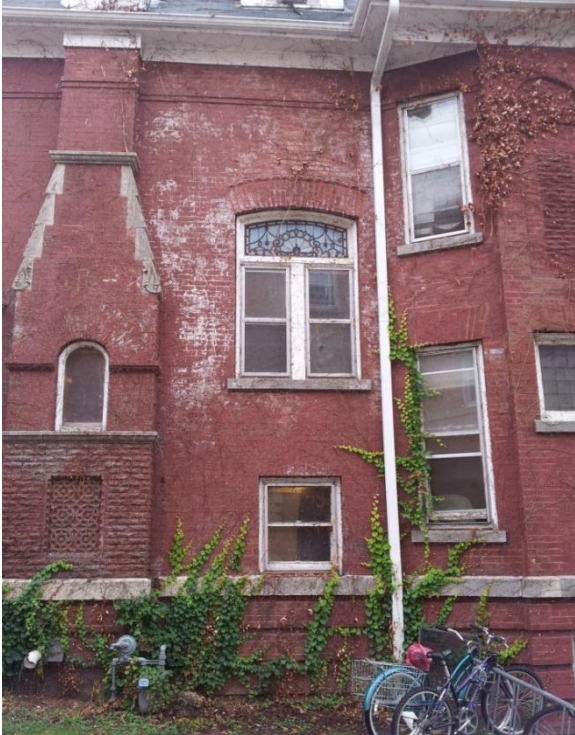
*Image 1.3* The brick masonry observed is largely in good condition, but it contains evidence of minor instability in the form of step-cracking. There is also efflorescence at several locations indicating moisture penetration of the masonry.

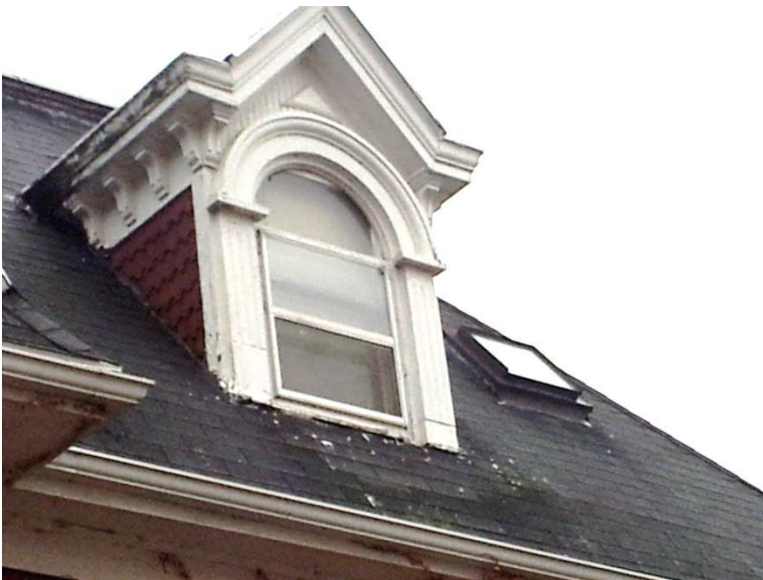
*Image 1.4* The gables and dormer walls originally featured beaded board and shingle siding and major portions of these areas are presently exposed and functioning. Areas exposed to view appear to be rotting and otherwise deteriorating

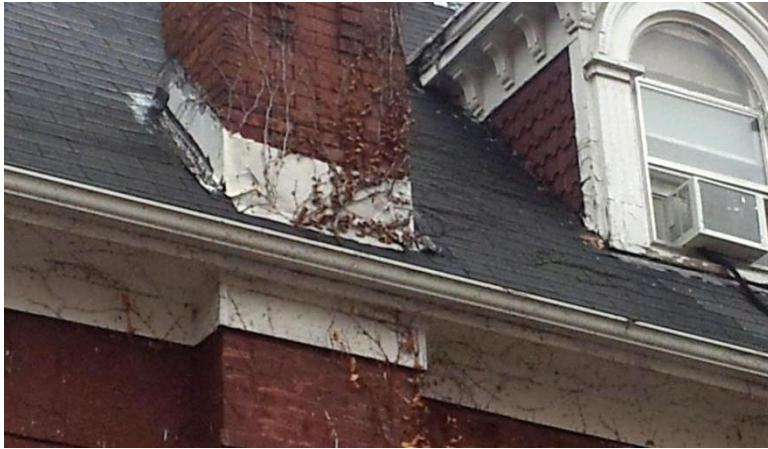
*Image 1.6* The eave system consists of original painted (finished) wood members, including eave and rake boards (fascia), crown, and soffit. The condition is largely sound.

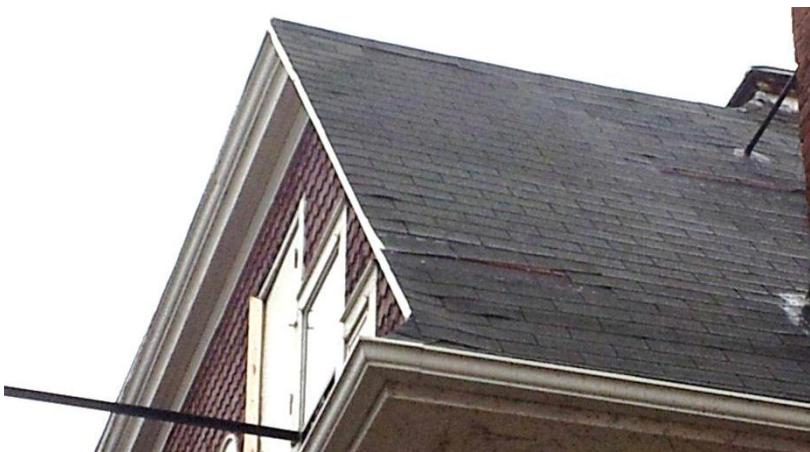
*Image 1.7* The roof is a gable design with complementary gabled dormers. The roofing systems include roll membrane (asphaltic), (asphaltic) shingle, and metal.

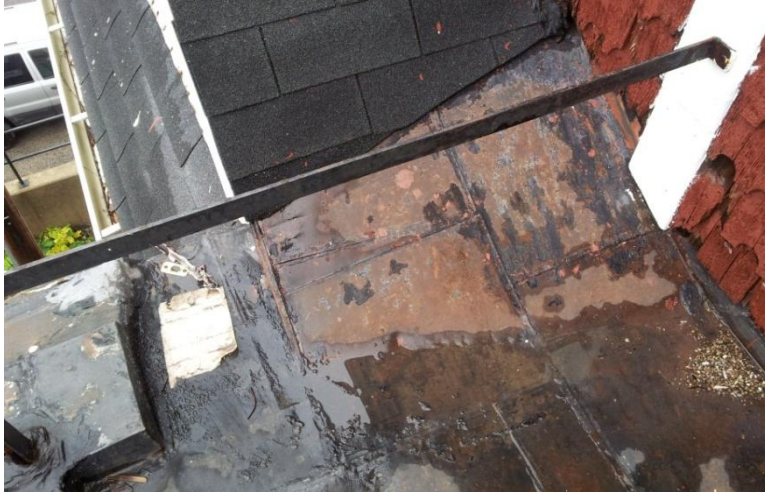
*Image 1.8 A combination of roofing systems and wall cladding intersect here. The condition is unsound and moisture penetration is occurring*

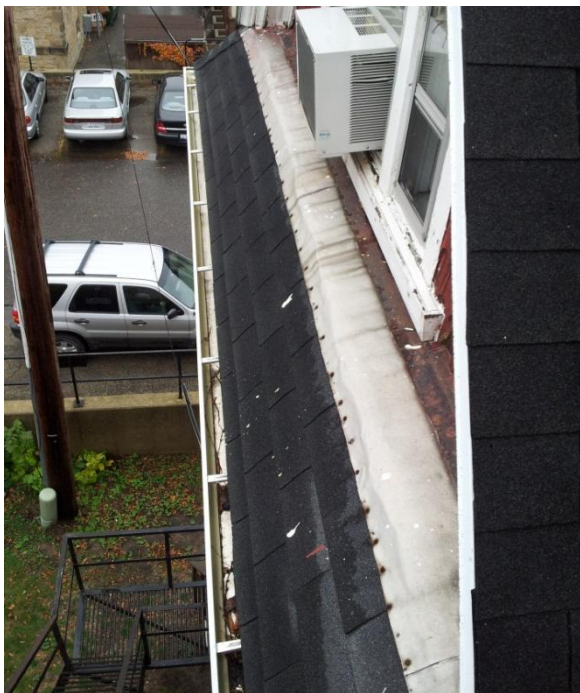
*Image 1.9 Gutters and downspouts consist of prefinished sheet metal; they are sound. They appear newer and could possibly be reclaimed*

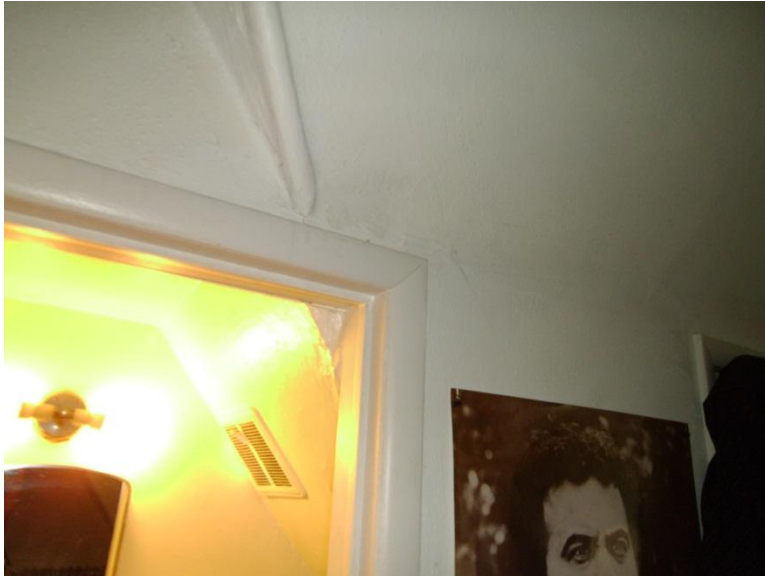
**Image 1.10** View showing a valley rafter crossing an interior wall at a doorway. Note the doorway appears to cut through the bottom of the rafter.

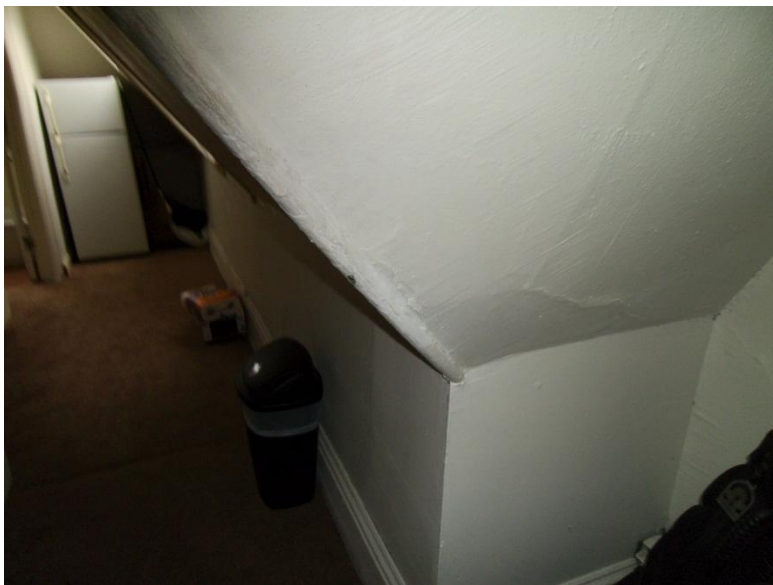
**Image 1.11** View showing a valley rafter bearing on the exterior wall. Note the deflection in the rafter and cracking in the plaster.

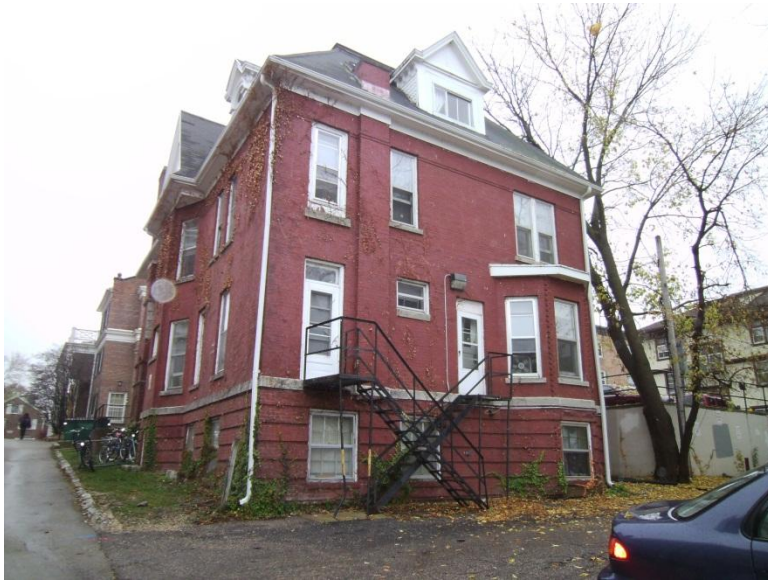
**Image 1.12** View showing the north end of the building. Note the damaged columns of the fire escape.

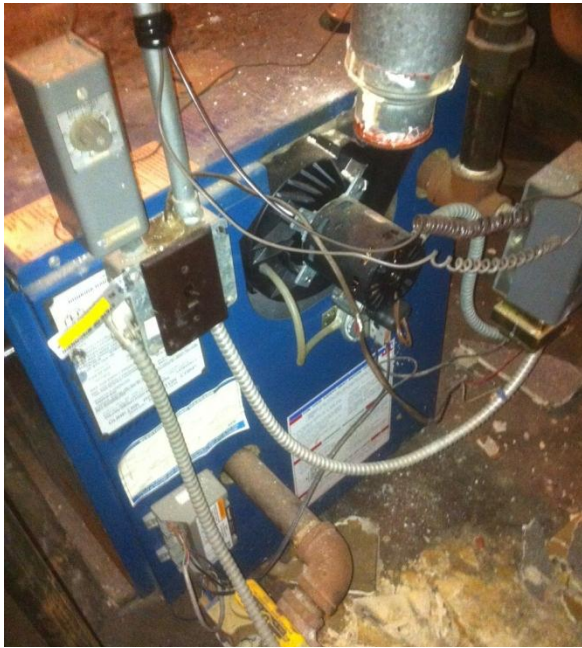
**Image 1.17** *Dunkirk boiler in the basement mechanical room.*

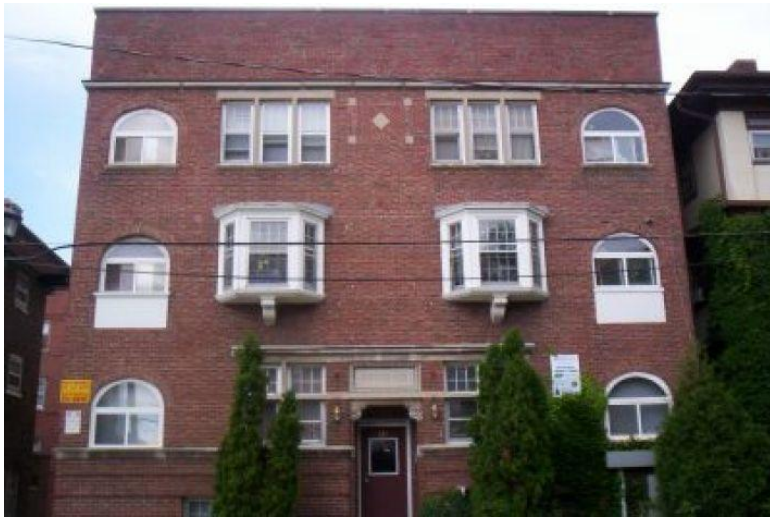
*Image 1.18* View of the front (west) façade of 621 Henry Street.

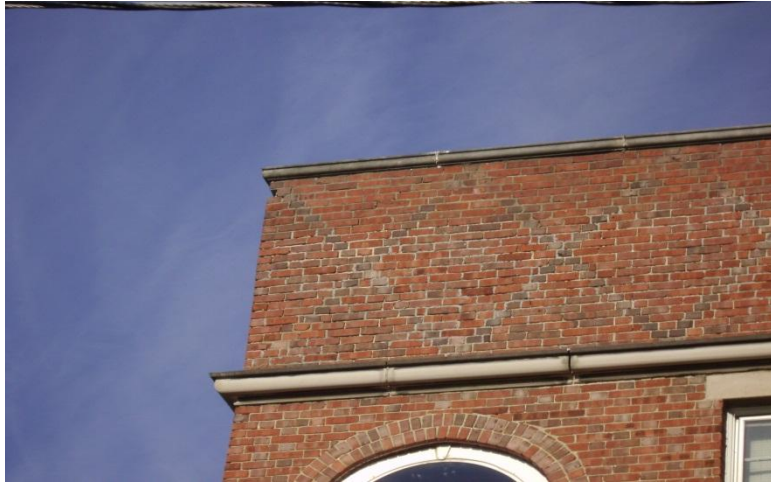
*Image 1.20* View of the front parapet. The parapet was rebuilt yet still has deterioration occurring. Moisture is penetrating the perimeter walls at open joints in the parapet coping and in the limestone band trim.

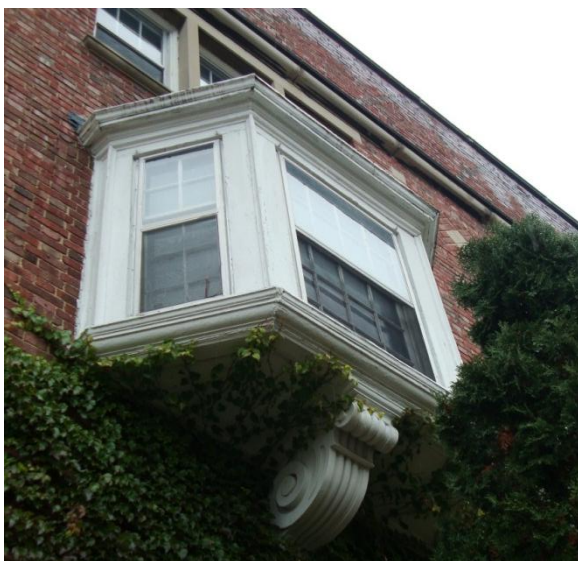
*Image 1.21* View of one of the west facing bays.

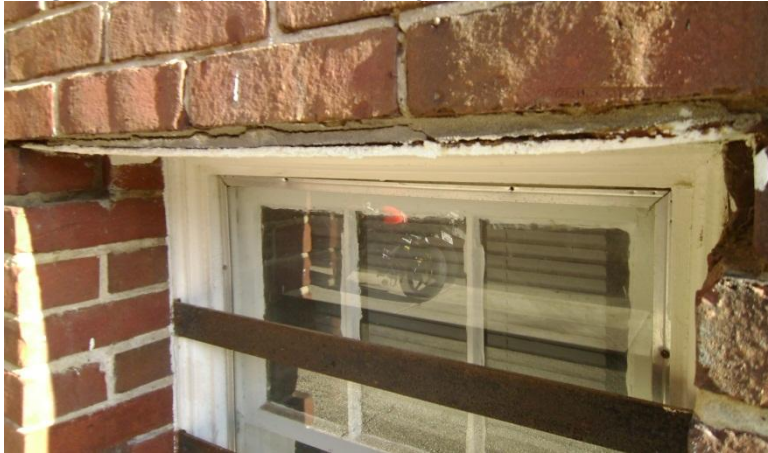
*Image 1.22* View of one of the window lintels illustrating rust jacking.

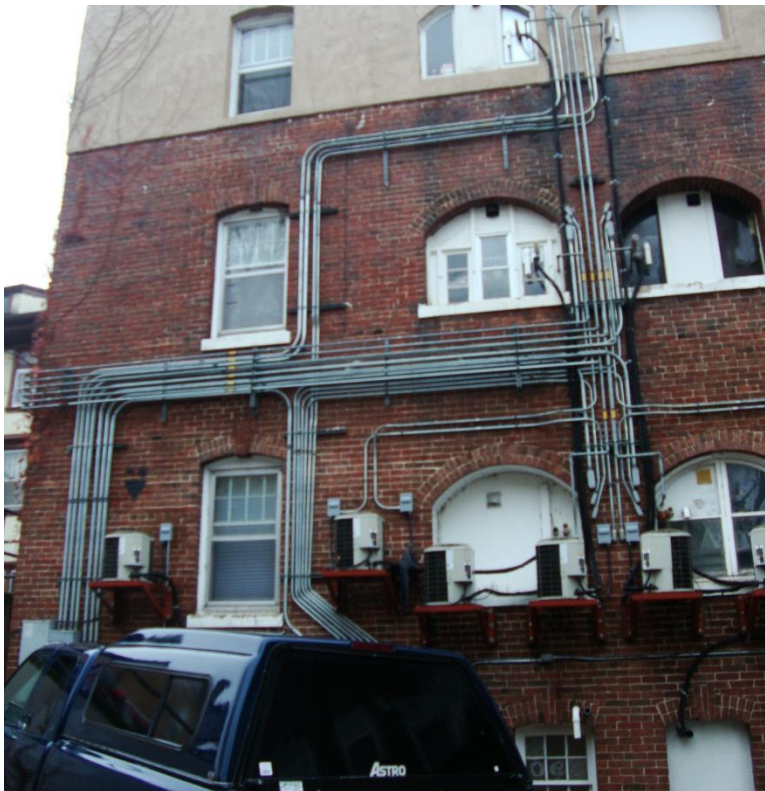
*Image 1.23* View of the east elevation of the building. Note the third floor masonry has been covered with synthetic stucco.  
Exterior Doors and Windows

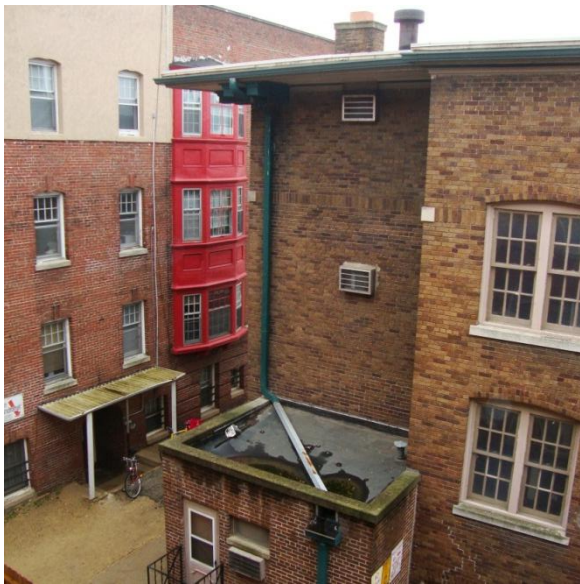
*Image 1.24* View of the east side of 625 Henry Street (right) and the north side of 621 Henry Street (left).

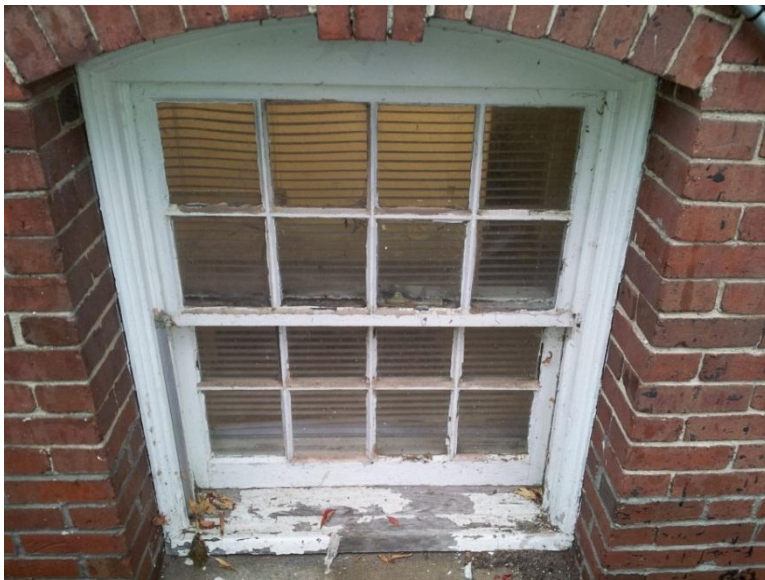
*Image 1.26* Rapidly deteriorating wood windows without aluminum combination storms that have protected other windows from the elements.

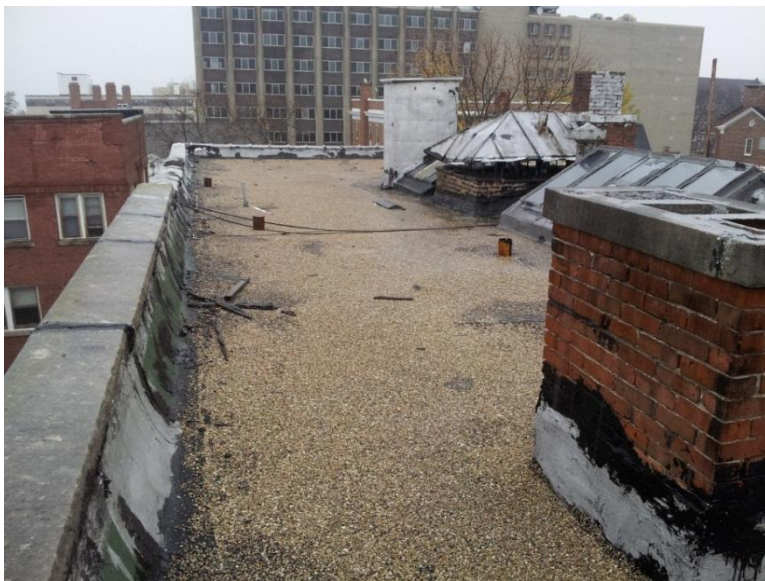
*Image 1.27 General view of the roof looking west towards campus.*

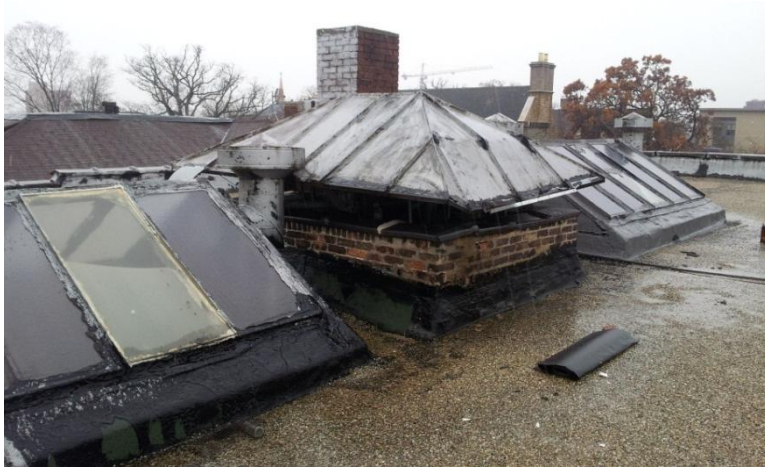
*Image 1.28* Roof appurtenances and conditions. Glazing of the skylights is largely intact but fractured. Leaks to the interior were observed.

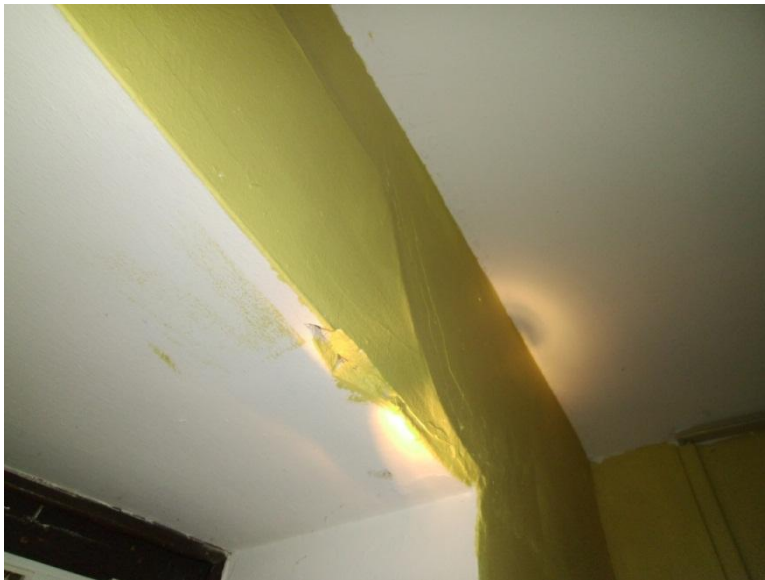
**Image 1.29** View showing possible shear failure in a support lintel below the larger openings of the bay within an apartment. The side bay windows align and occur on each of levels 2 – 4.

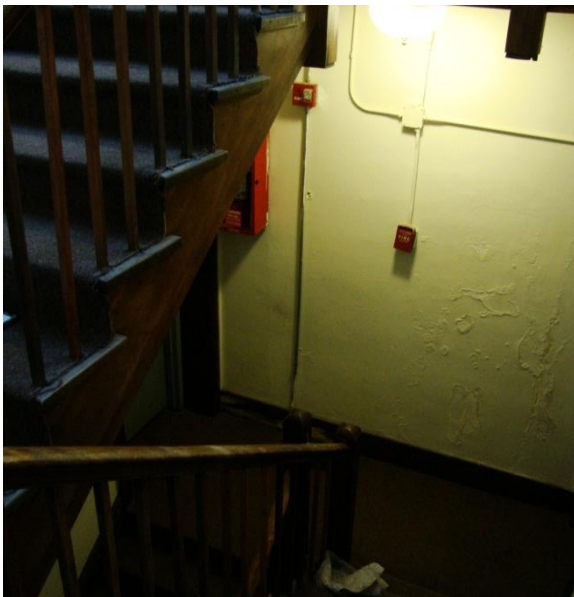
*Image 1.32* View of the east central stair at the third floor landing. Note the deterioration of the plaster walls from skylight leaks above.

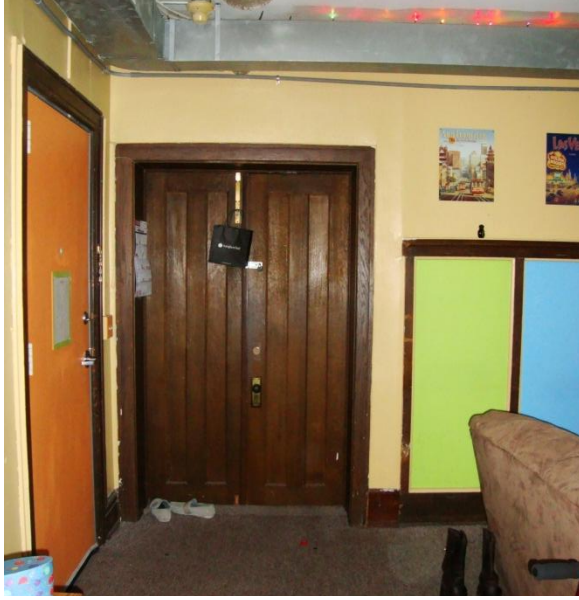
*Image 1.33* View of a typical apartment living room.

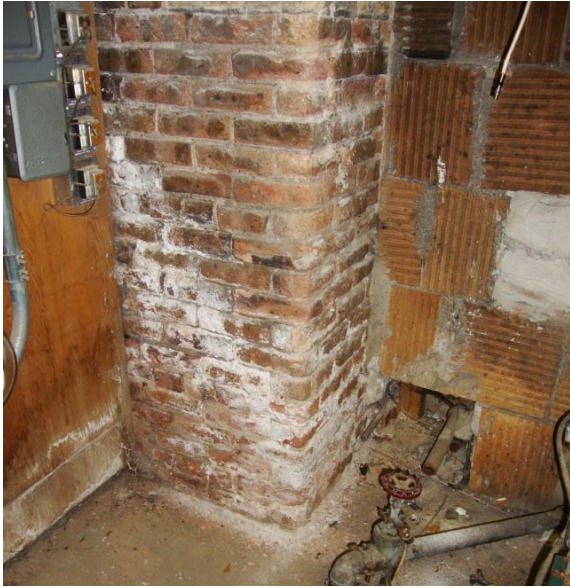
*Image 1.38* View of efflorescence in the mechanical room along the exterior wall evidence of water penetration.

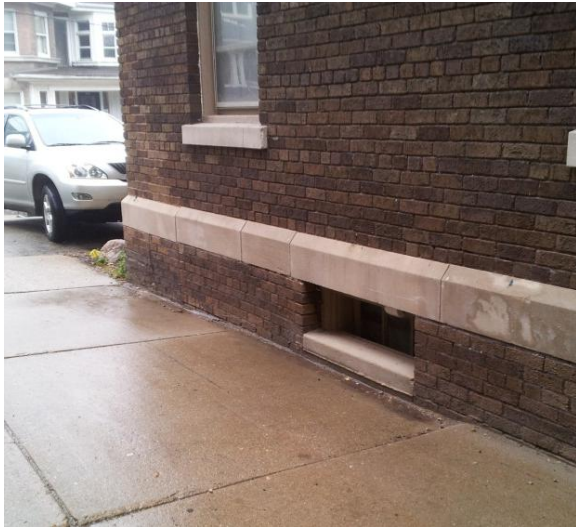
*Image 1.39* View of concrete driveway pitched towards foundation wall allowing rain and snow melt water to enter basement area.

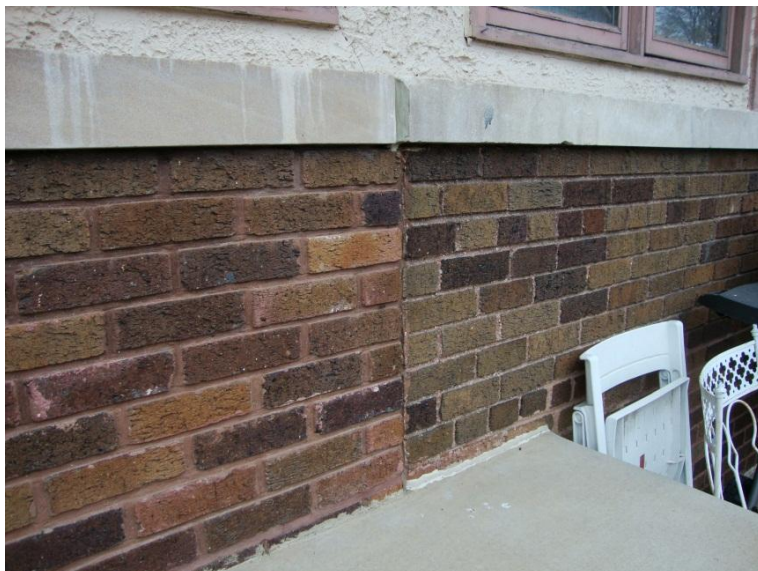
*Image 1.41* View of infill brick at front porch. Enough evidence of original conditions remains to restore this porch if desired.

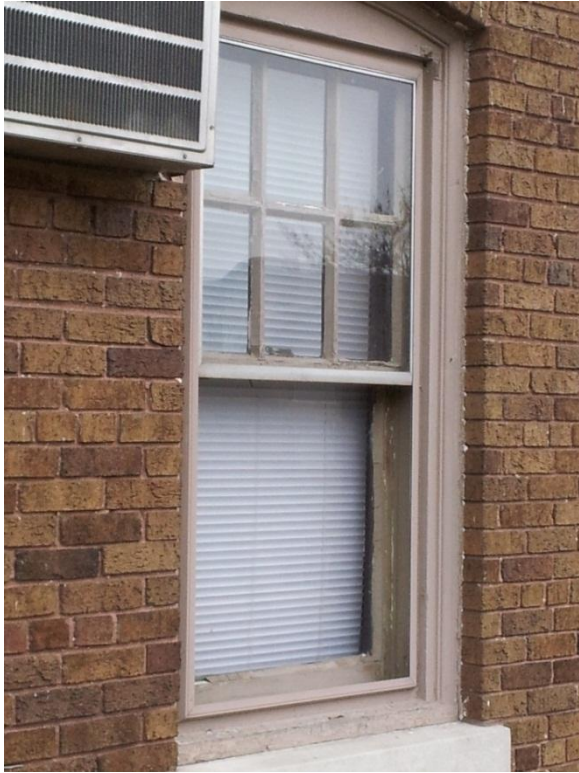
*Image 1.42* View original wood windows are in place with modern-generation combination storms at their exterior exposure. The style of the original windows is single-hung.

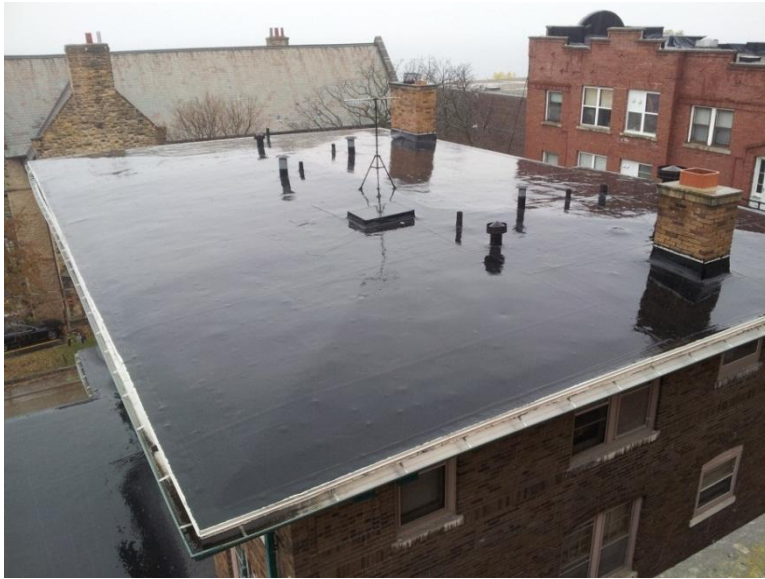
*Image 1.43* The roof is a flat (low-slope), deep-eave design consisting of an exposed layer of EPDM (rubber) material, and it likely contains tapered rigid insulation beneath it, forming a hipped-roof surface for drainage.

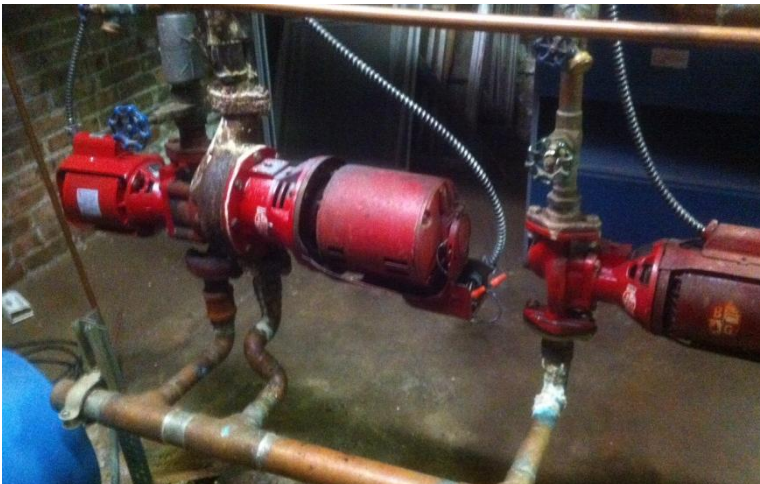
*Image 1.50* View of boiler hot water circulating pumps in the mechanical room.

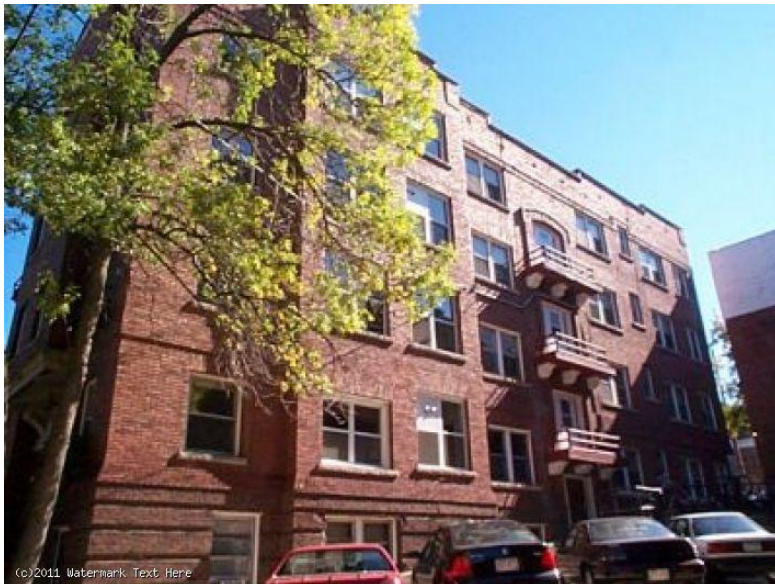
*Image 1.51* View of the west elevation of 145 Iota Court.

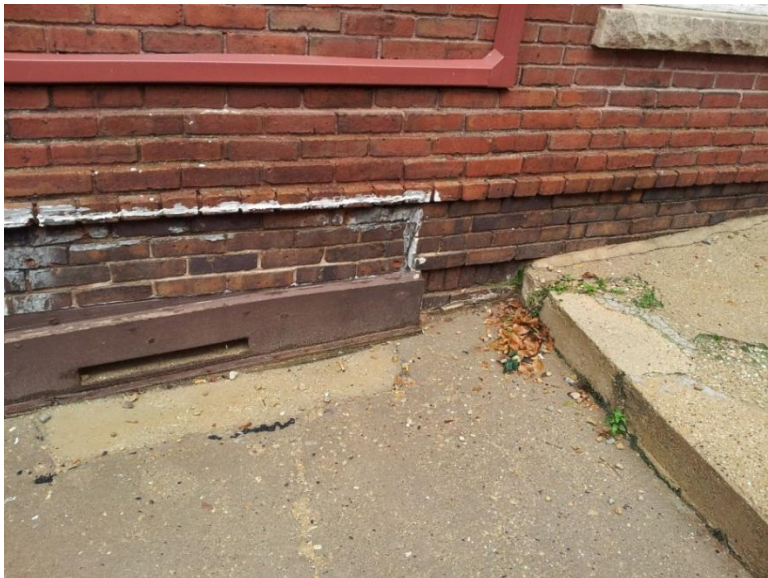
*Image 1.52* Moisture is penetrating the perimeter walls below-grade. This is most noticeable at the southwest elevation walkway slab contour.  
Exterior Walls

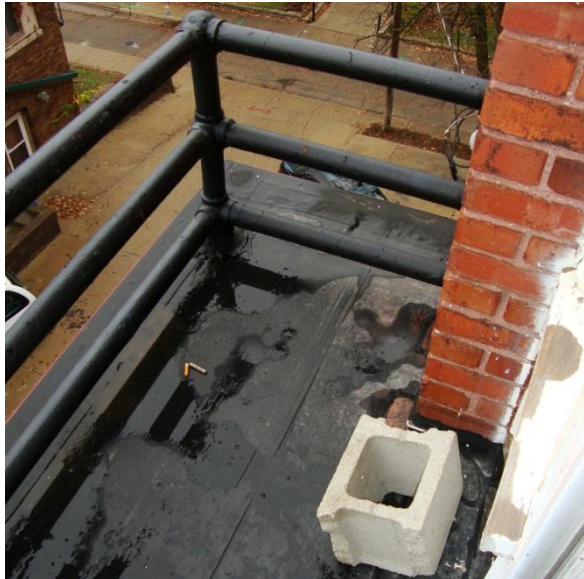
*Image 1.56* West facing balcony deck.

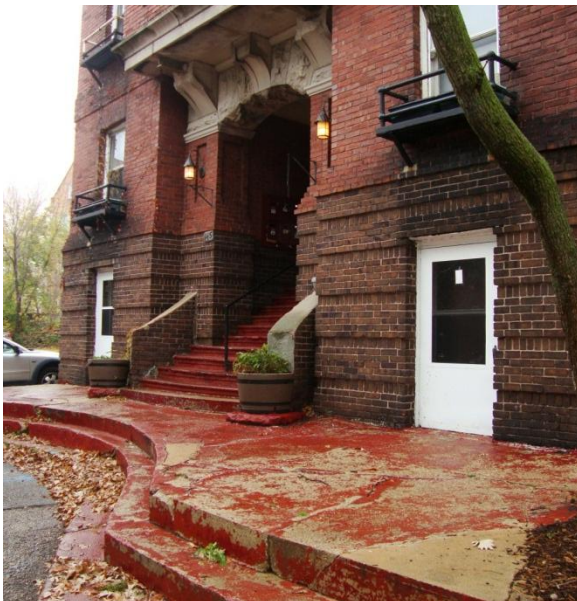
*Image 1.57 North facing main entry.*

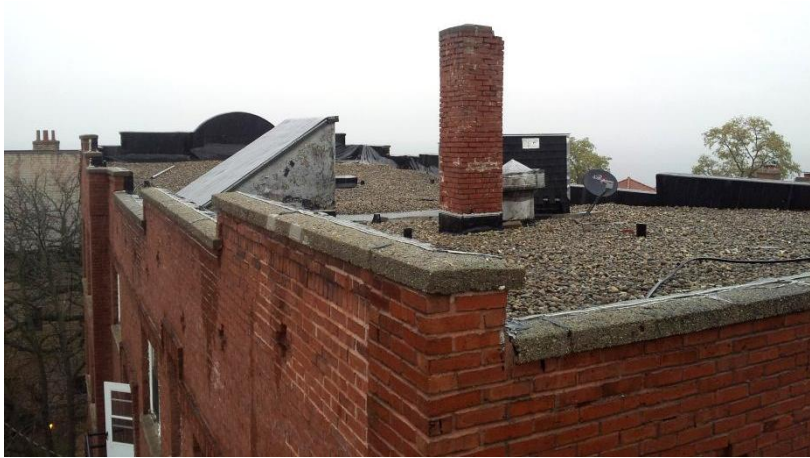
*Image 1.59* The roof is a low-slope design consisting of a stone-ballasted EPDM (rubber) membrane bordered with continuous brick masonry parapets with precast concrete caps.

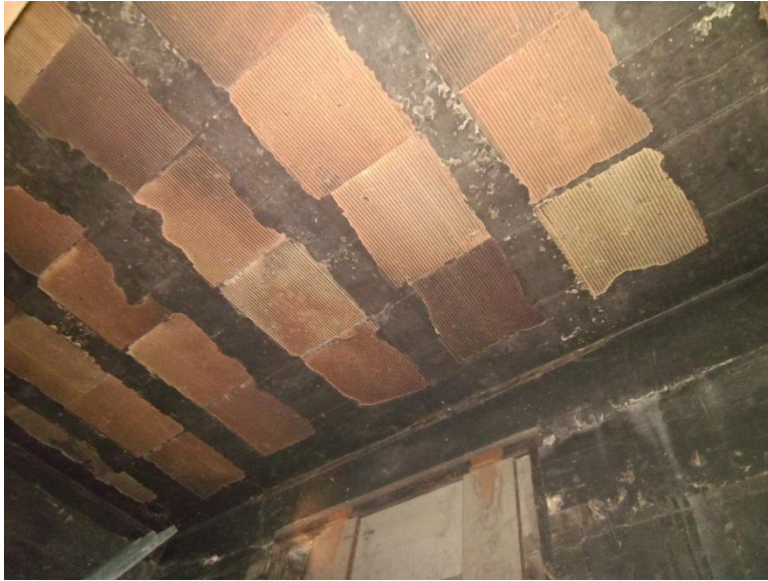
*Image 1.61* View of the concrete one way joist and tile infill floor system.

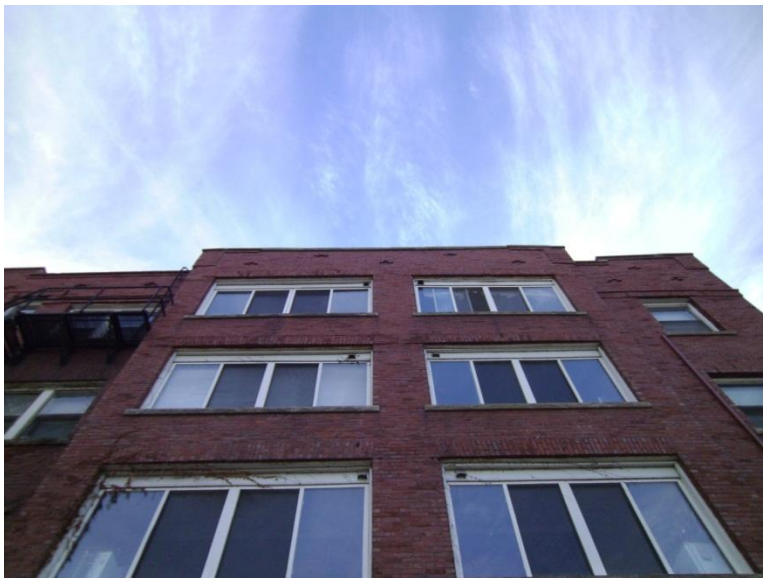
*Image 1.67* View of the east façade of 145 Iota Court
