APPLICATION FOR  
URBAN DESIGN COMMISSION  
REVIEW AND APPROVAL

AGENDA ITEM # \_\_\_\_\_  
Project # \_\_\_\_\_  
Legistar # \_\_\_\_\_

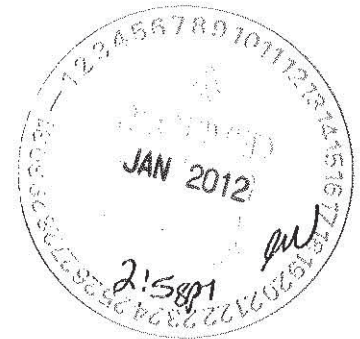
TYPE OF PROJECT:  
(See Section A for:)

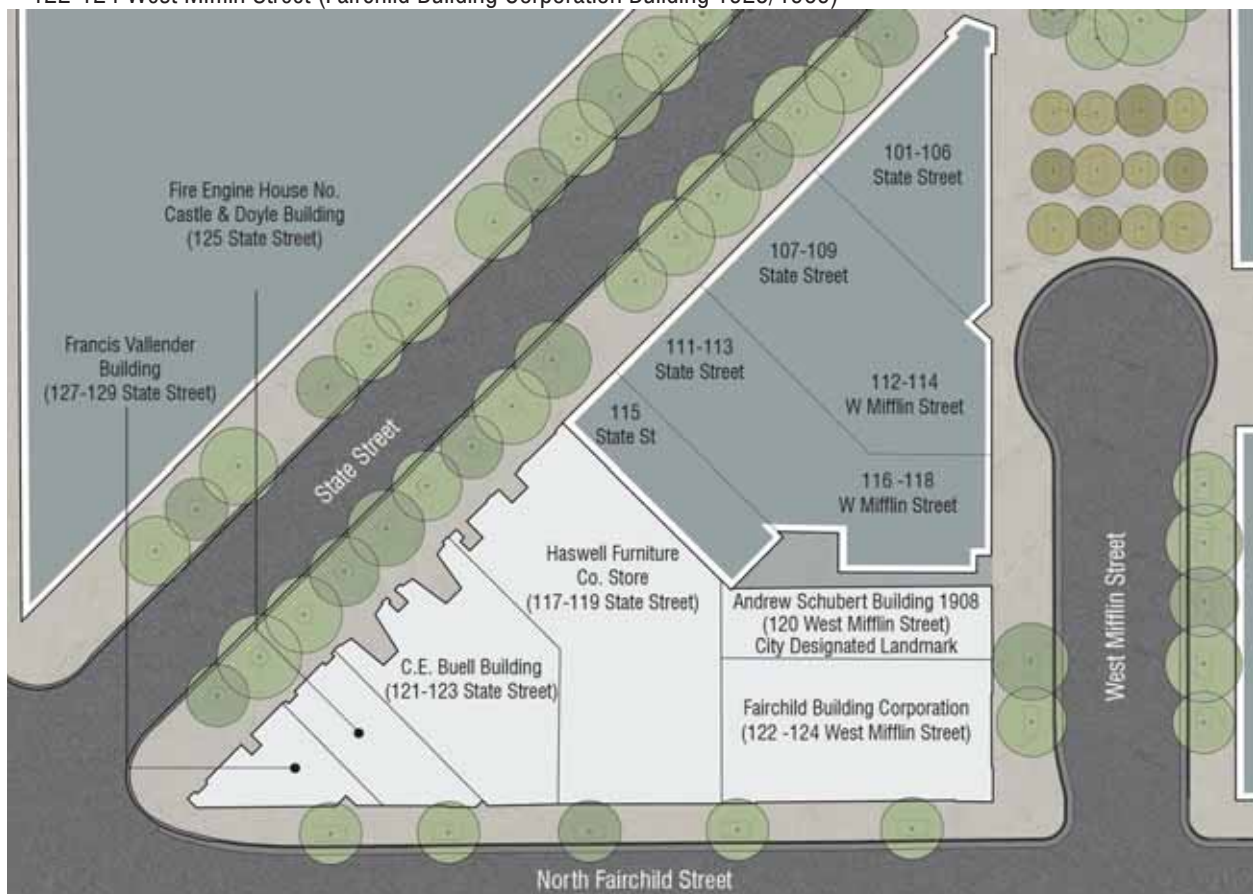
The Project will preserve the scale and architectural context of State Street while energizing North Fairchild Street with vibrant new retail, restaurant and office spaces. Title to the properties will be placed in a new foundation, Block 100 Foundation, Inc. Net income from property rentals will be permanently gifted to Overture Center for the Arts.

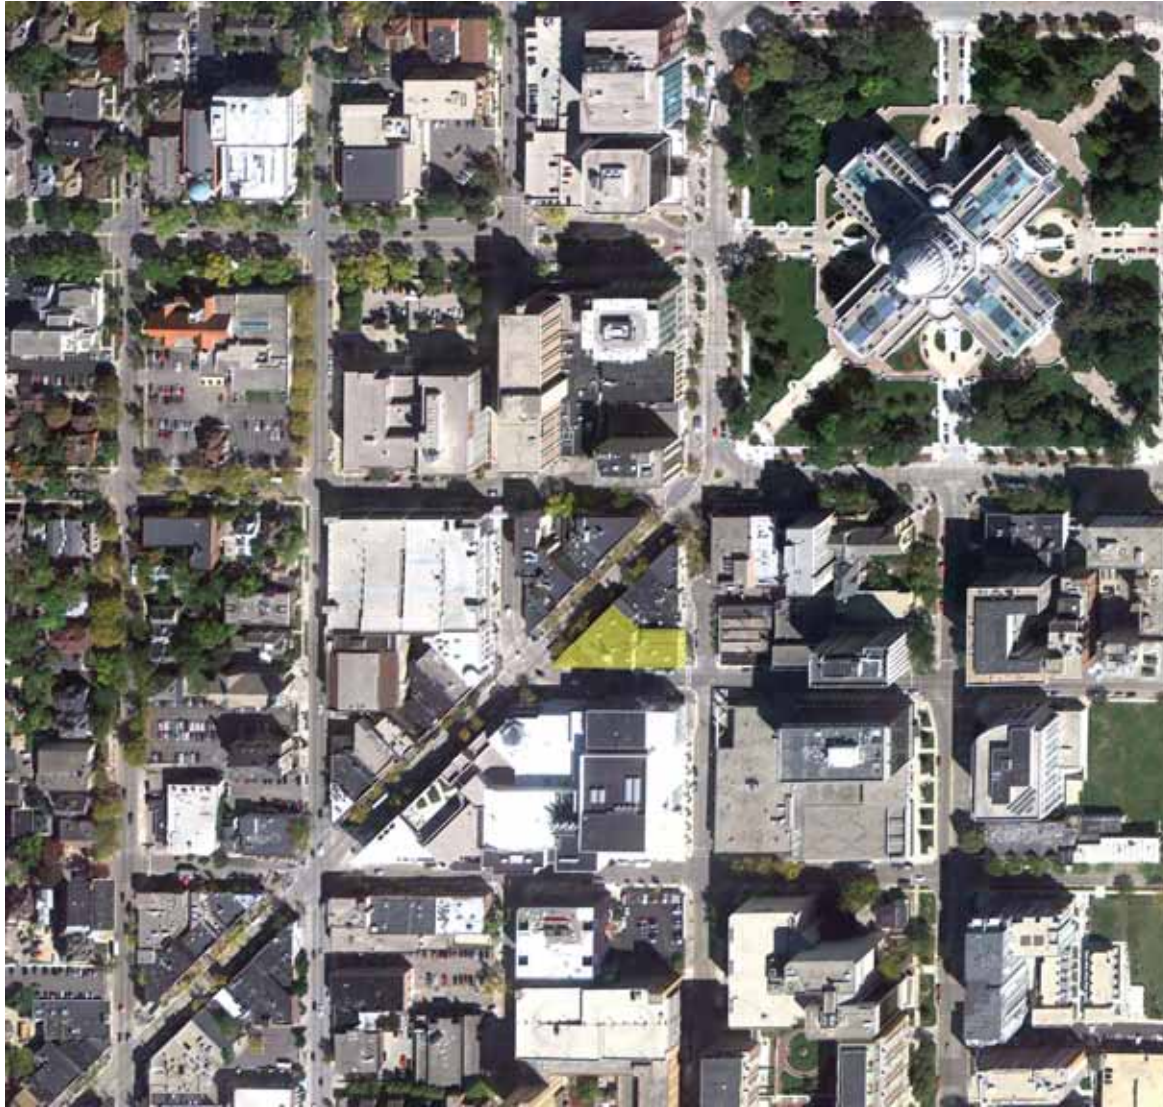
Block 100 Foundation Project

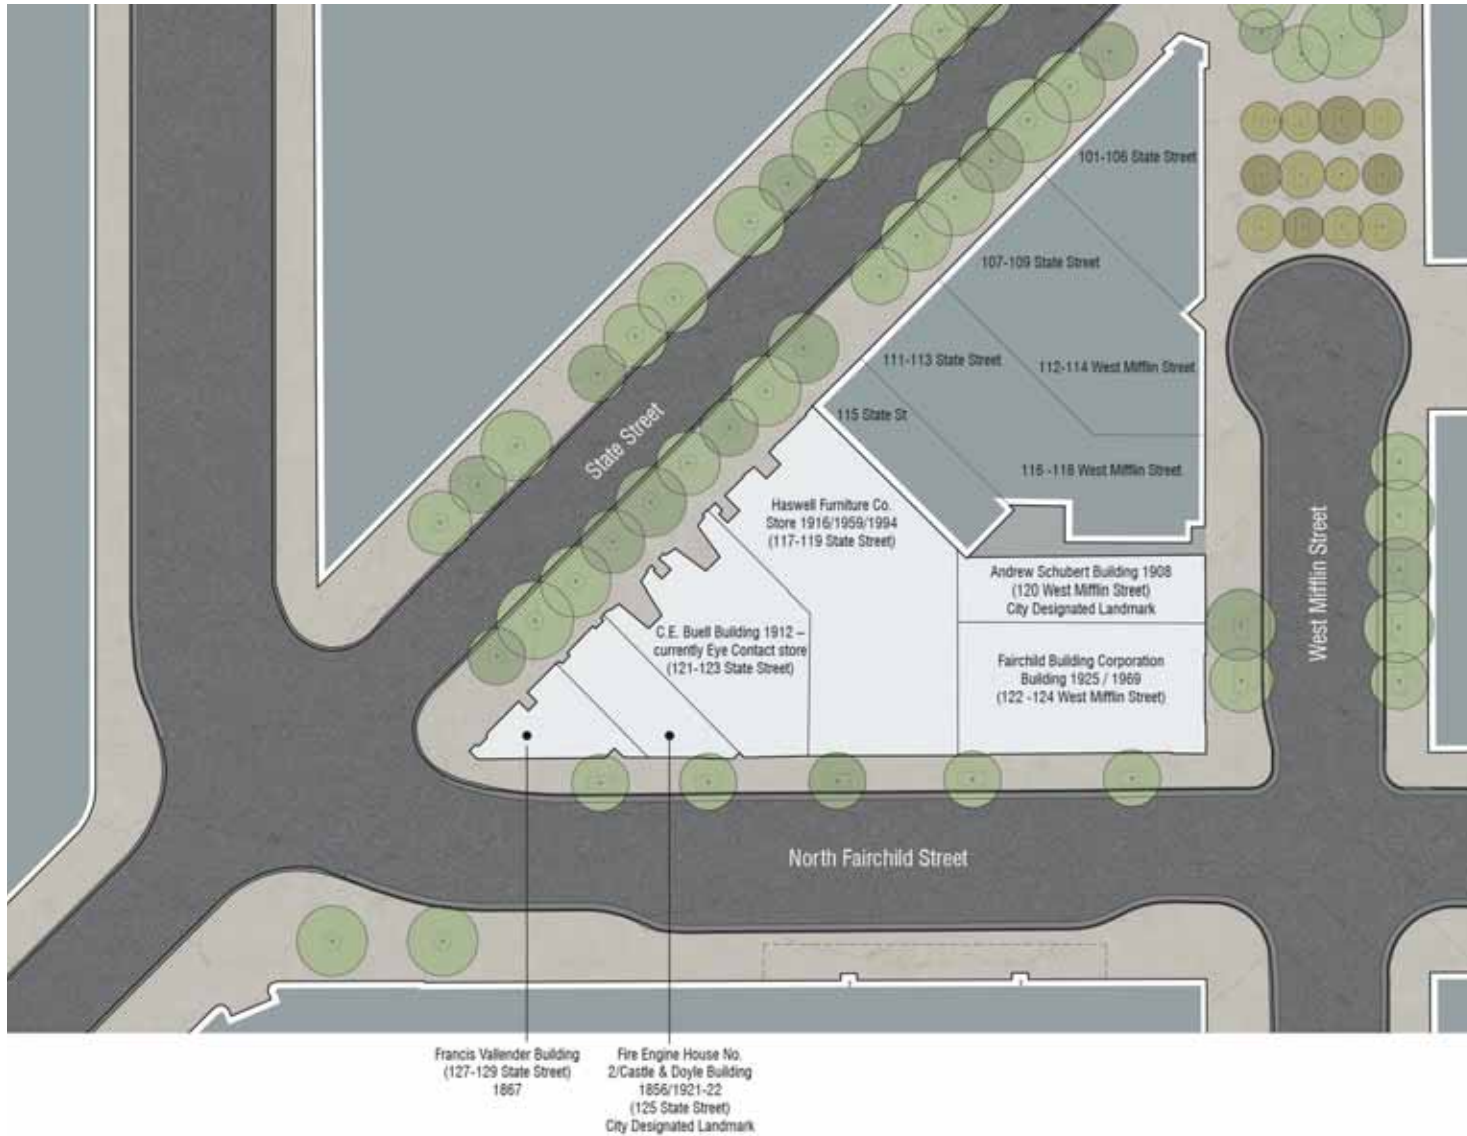
Block 100 Foundation Project

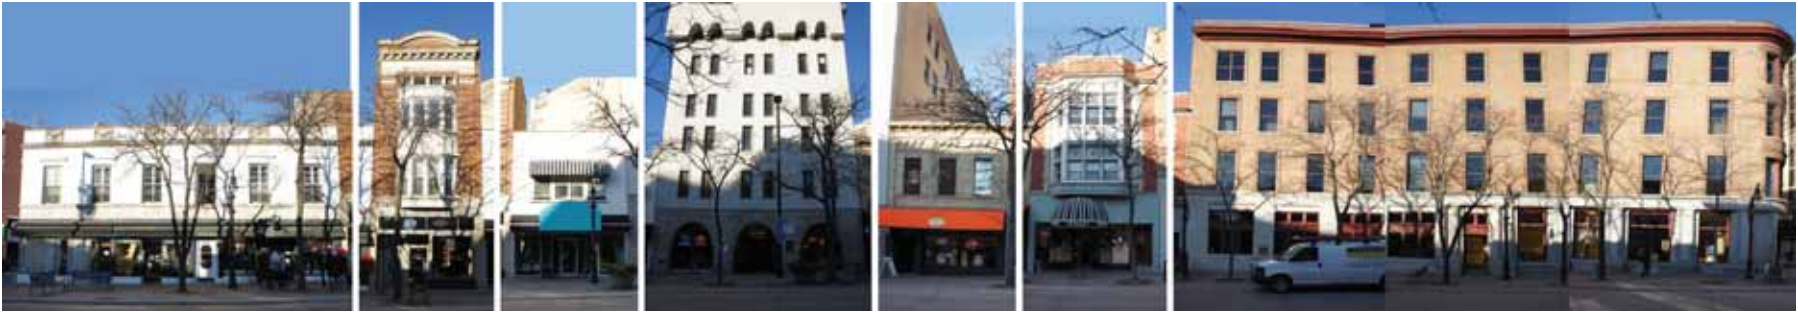
100 Block of State Street (North)

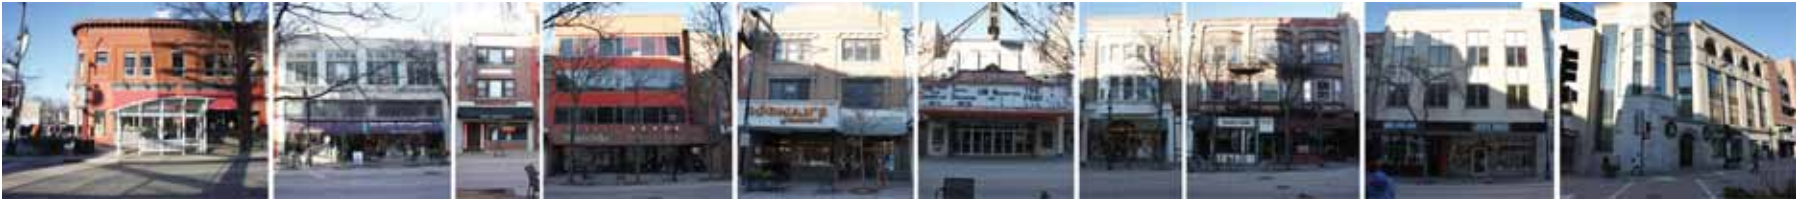
200 Block of State Street (North)

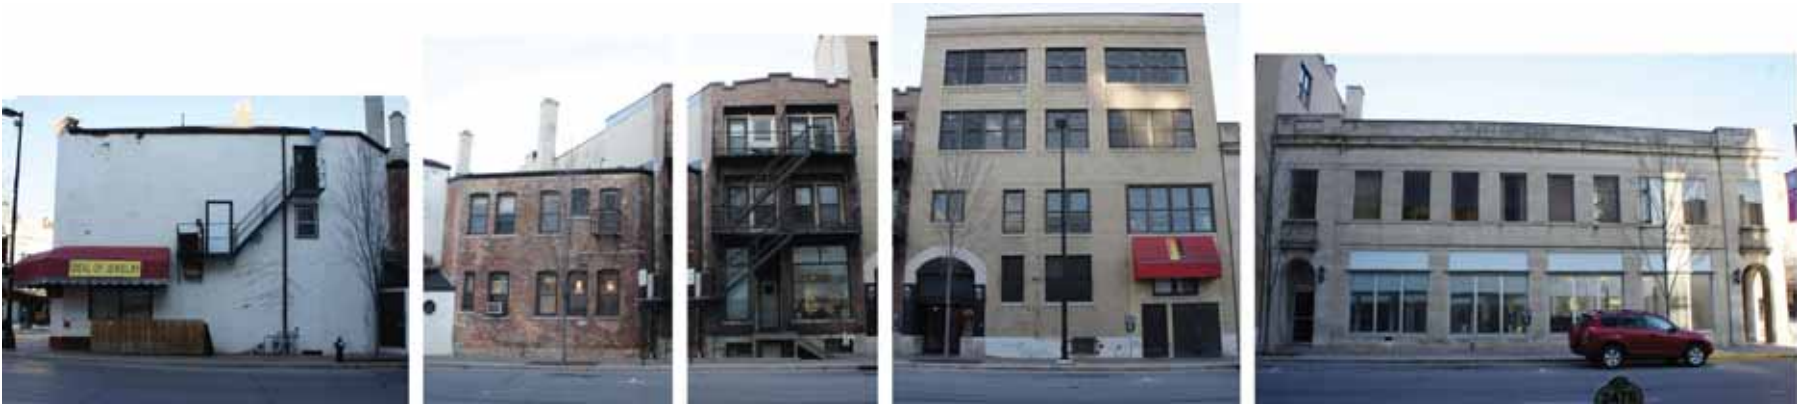
200 Block of State Street (South)

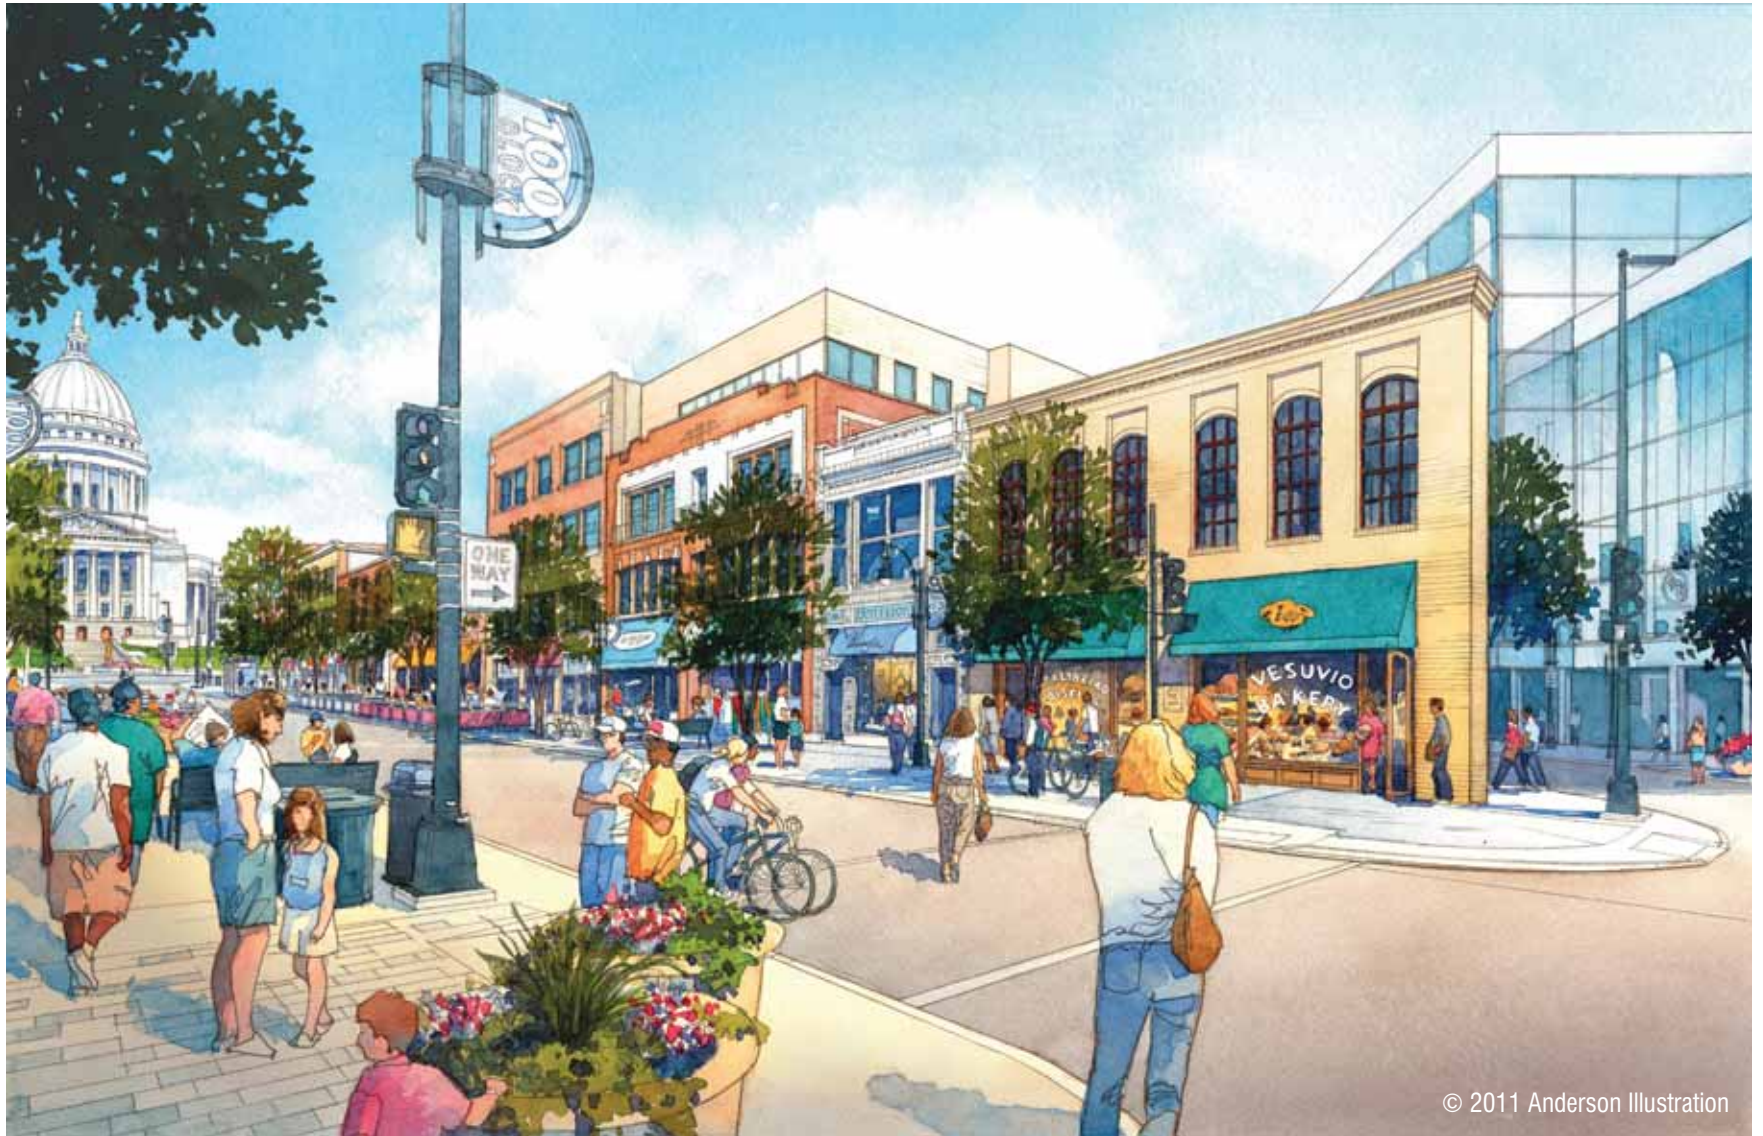
© 2011 Anderson Illustration

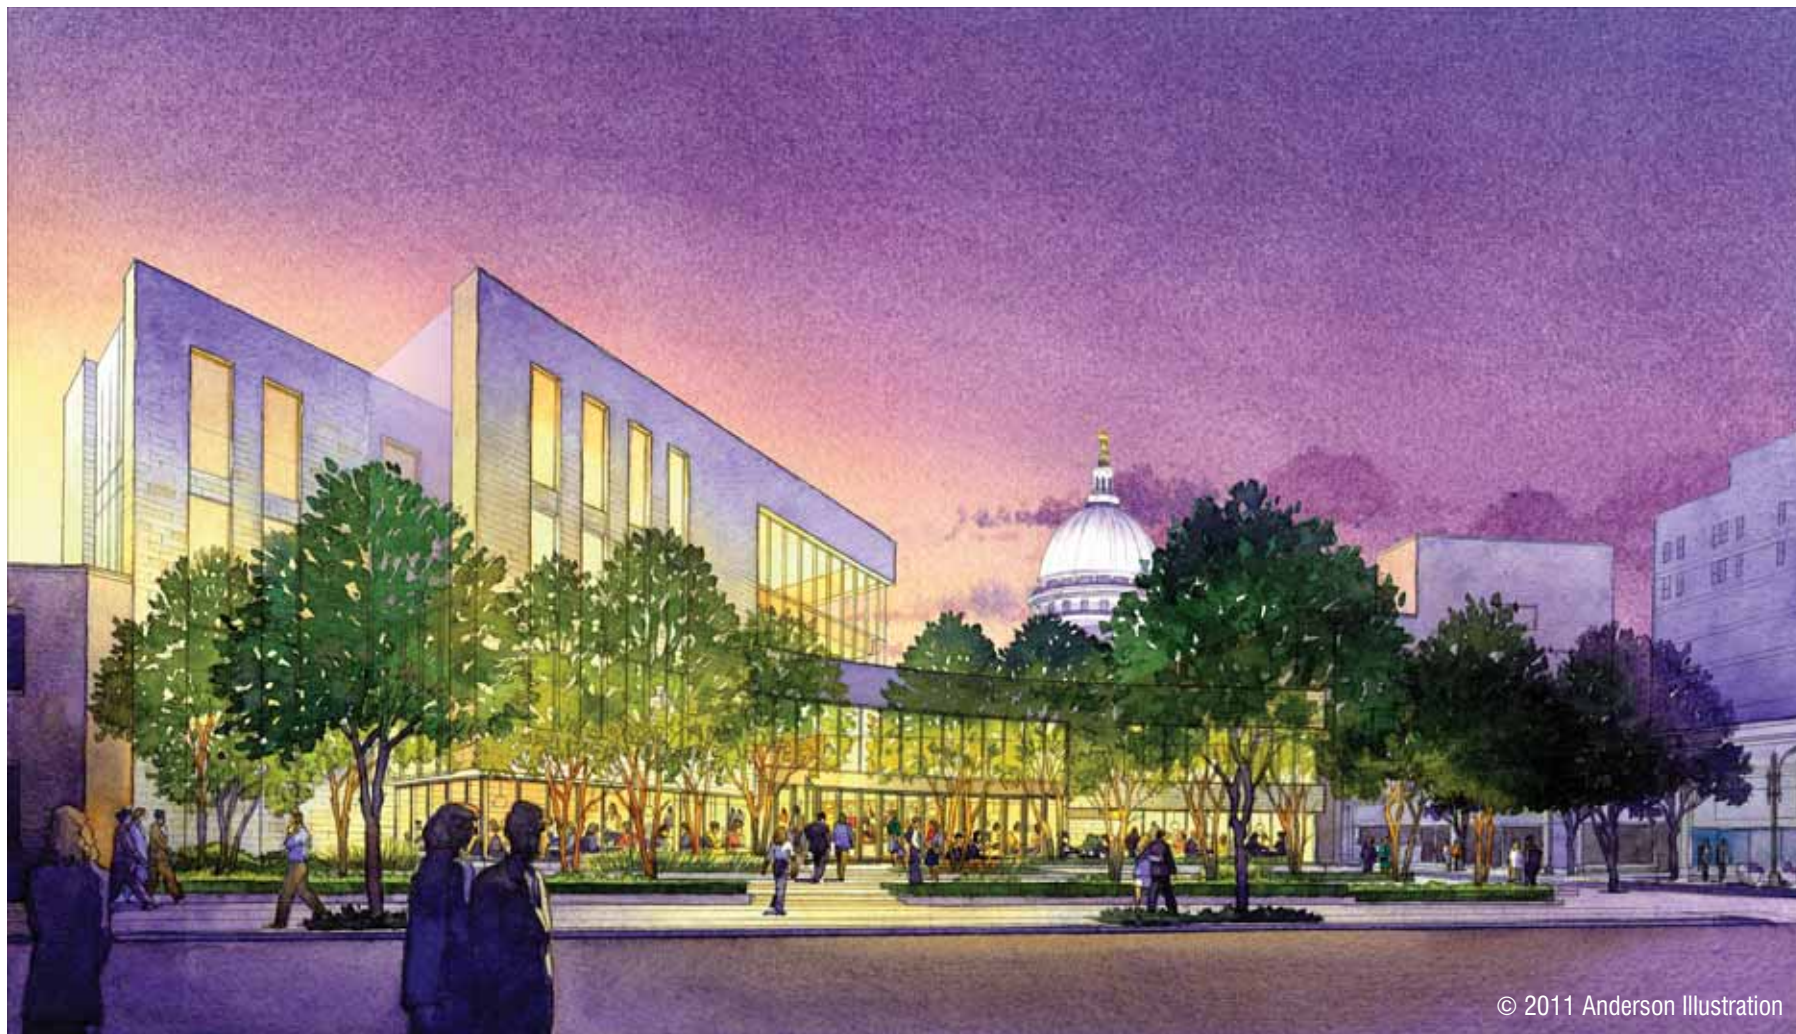
© 2011 Anderson Illustration

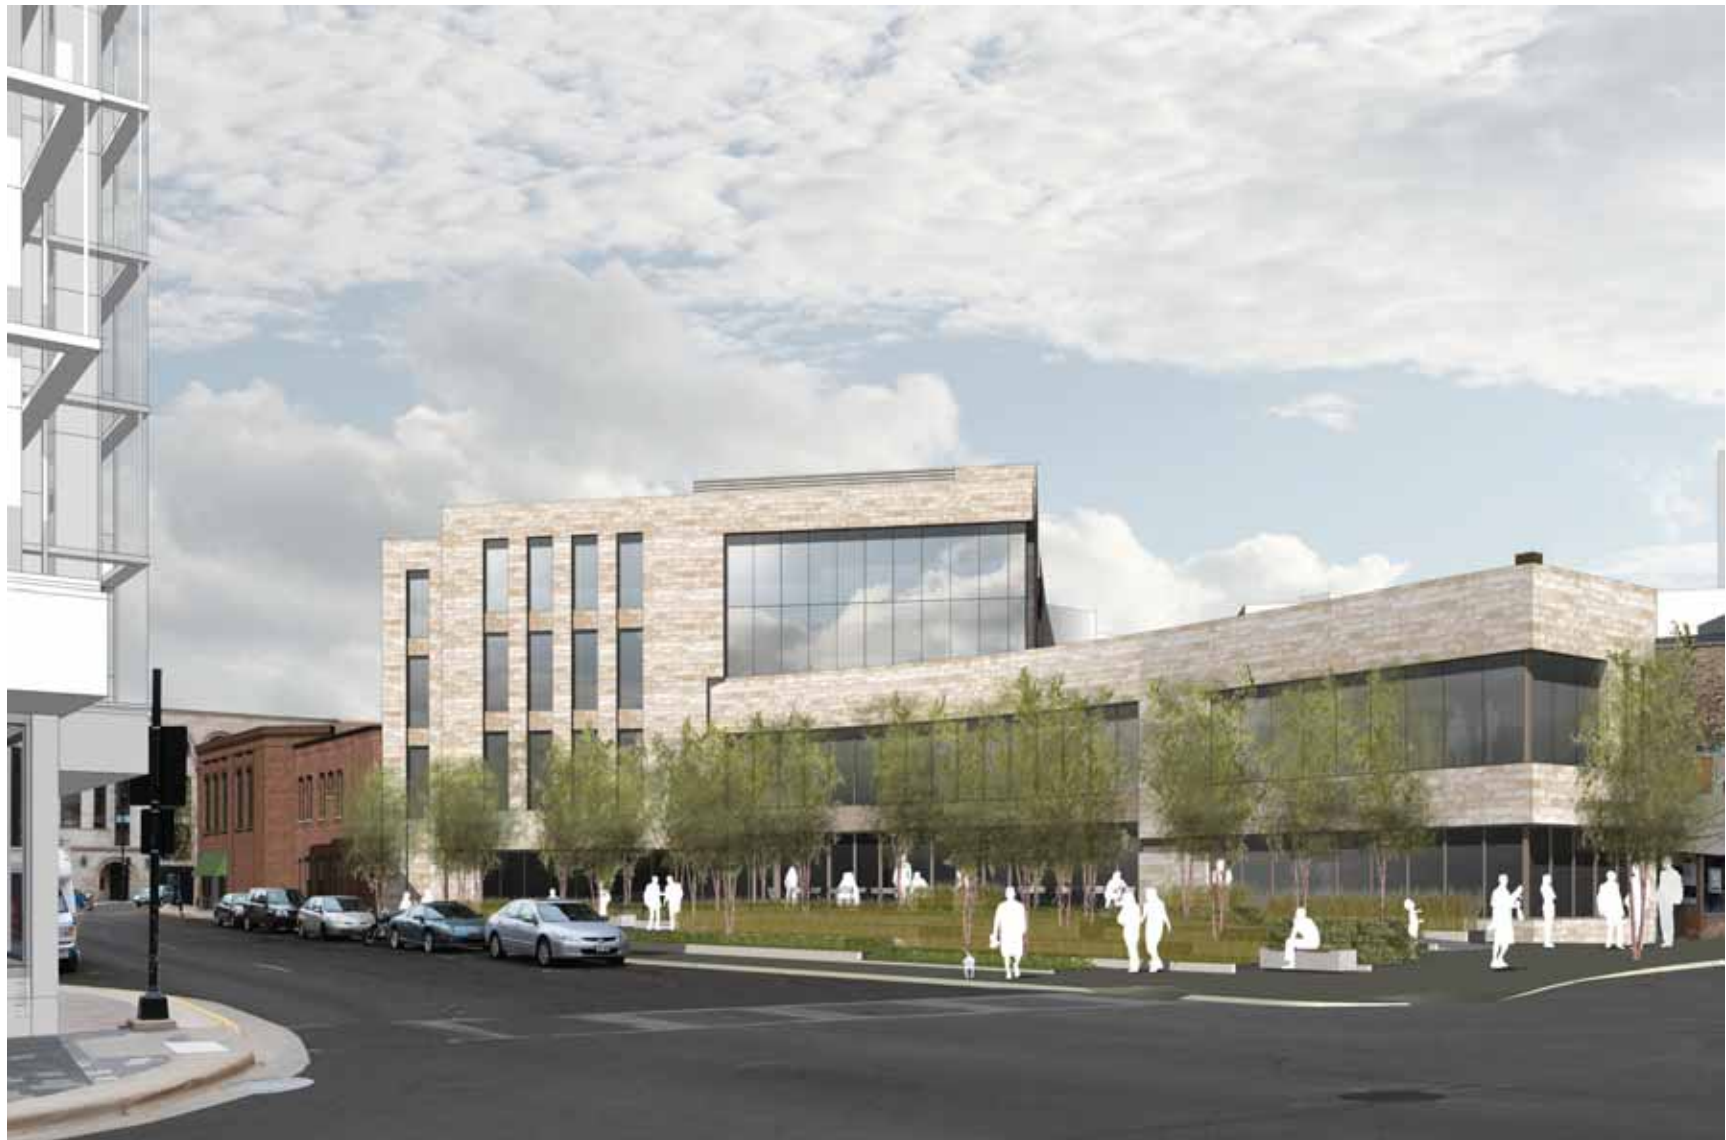
Block 100 Foundation Project

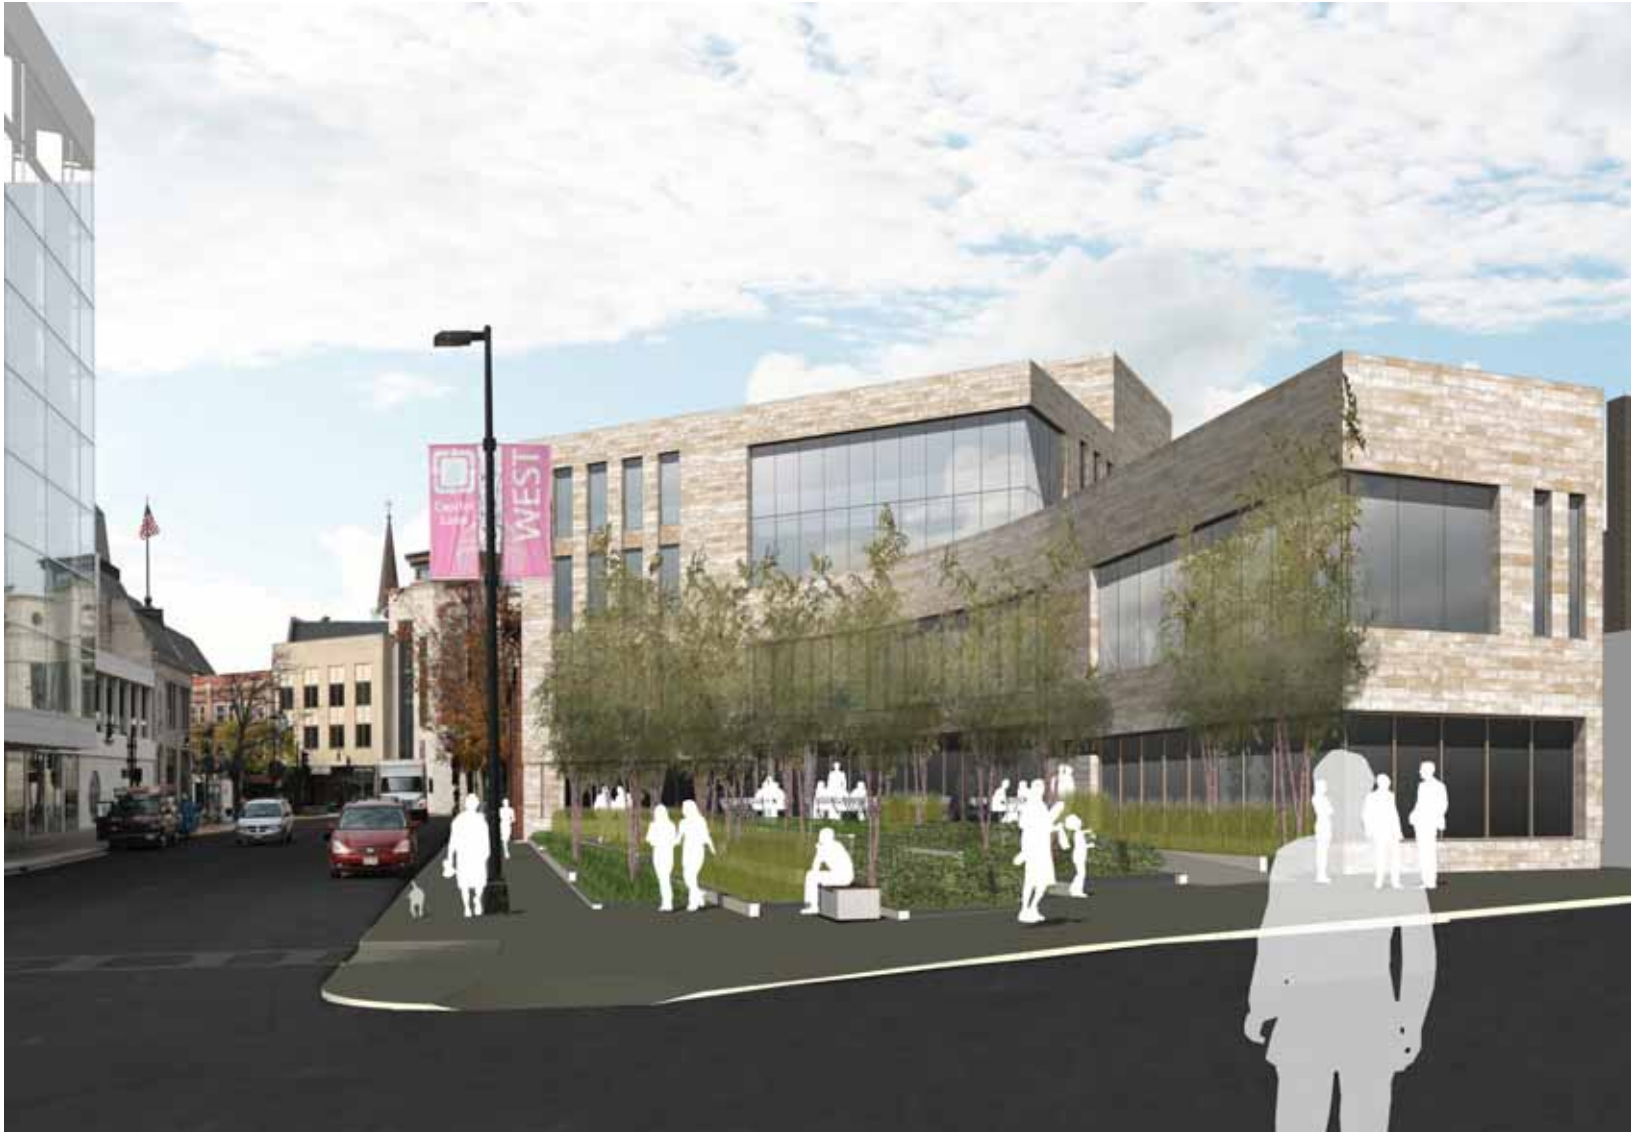
Block 100 Foundation Project

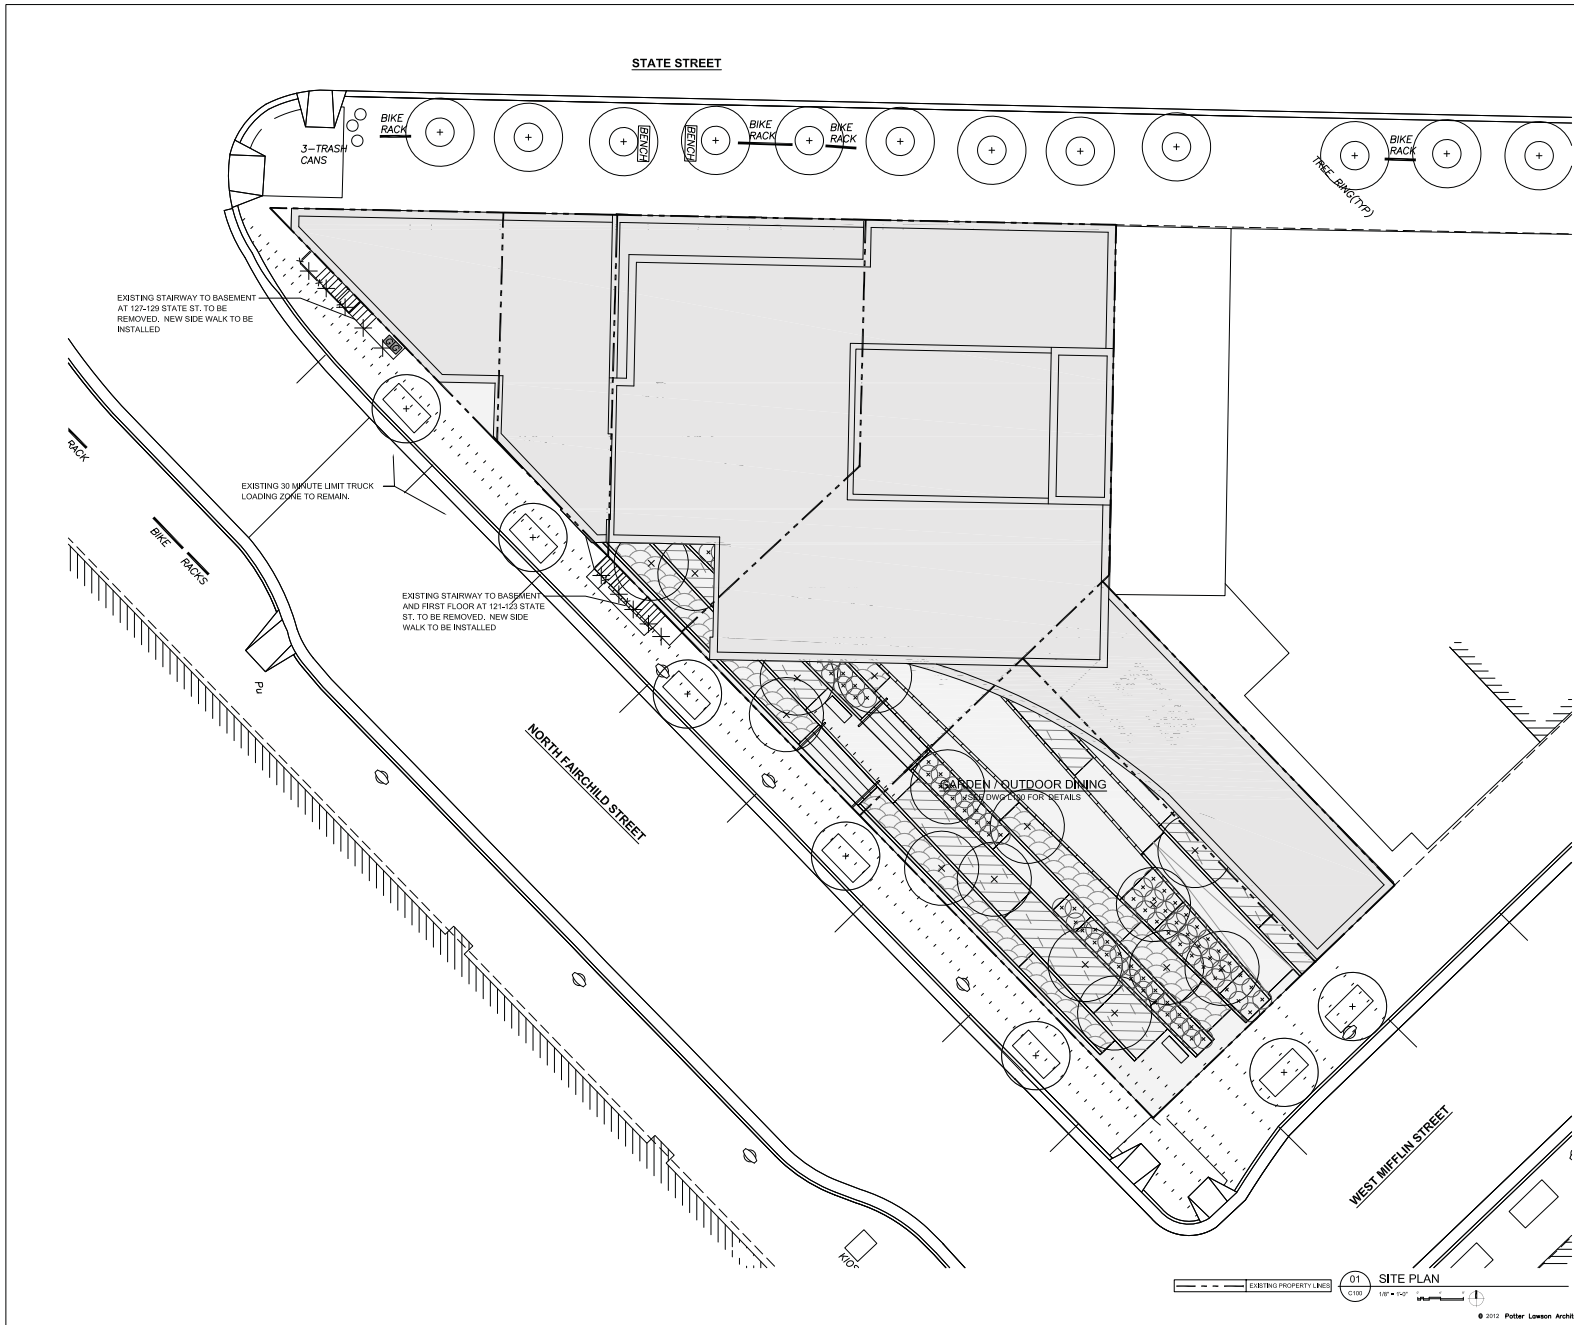
7/9/2015	PLAN COMMISSION/IBC/LANDMARKS SUBMITTAL	
Date	Issuance/Revisions	Symbol

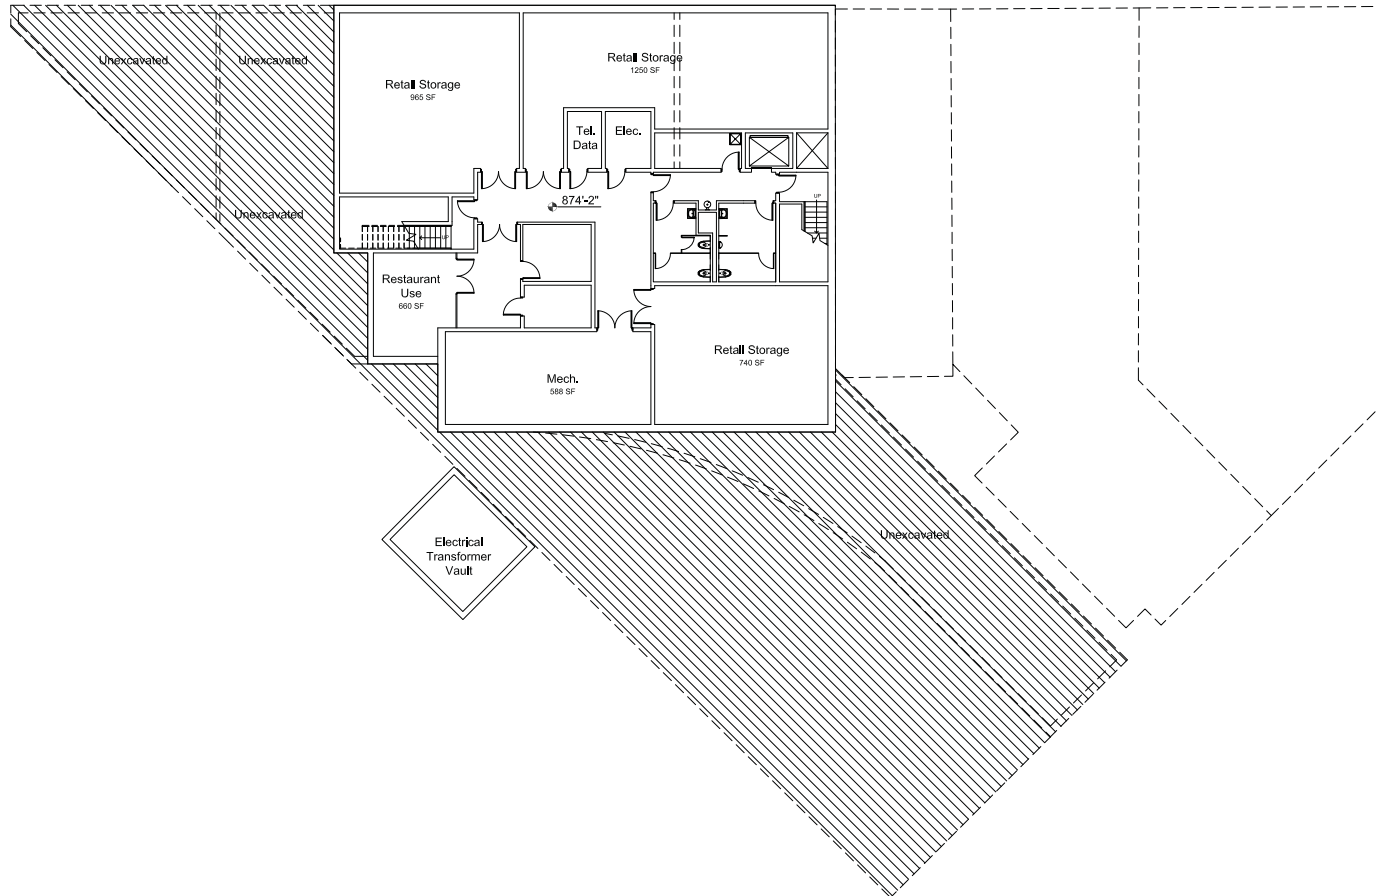
--	--	
--	--	
--	--	
--	--	
--	--	
--	--	
--	--	
--	--	
7/9/2012	PLAN COMMISSION/ABC/LANDMARKS SUBMITTAL	
Date	Issuance/Revisions	Symbol

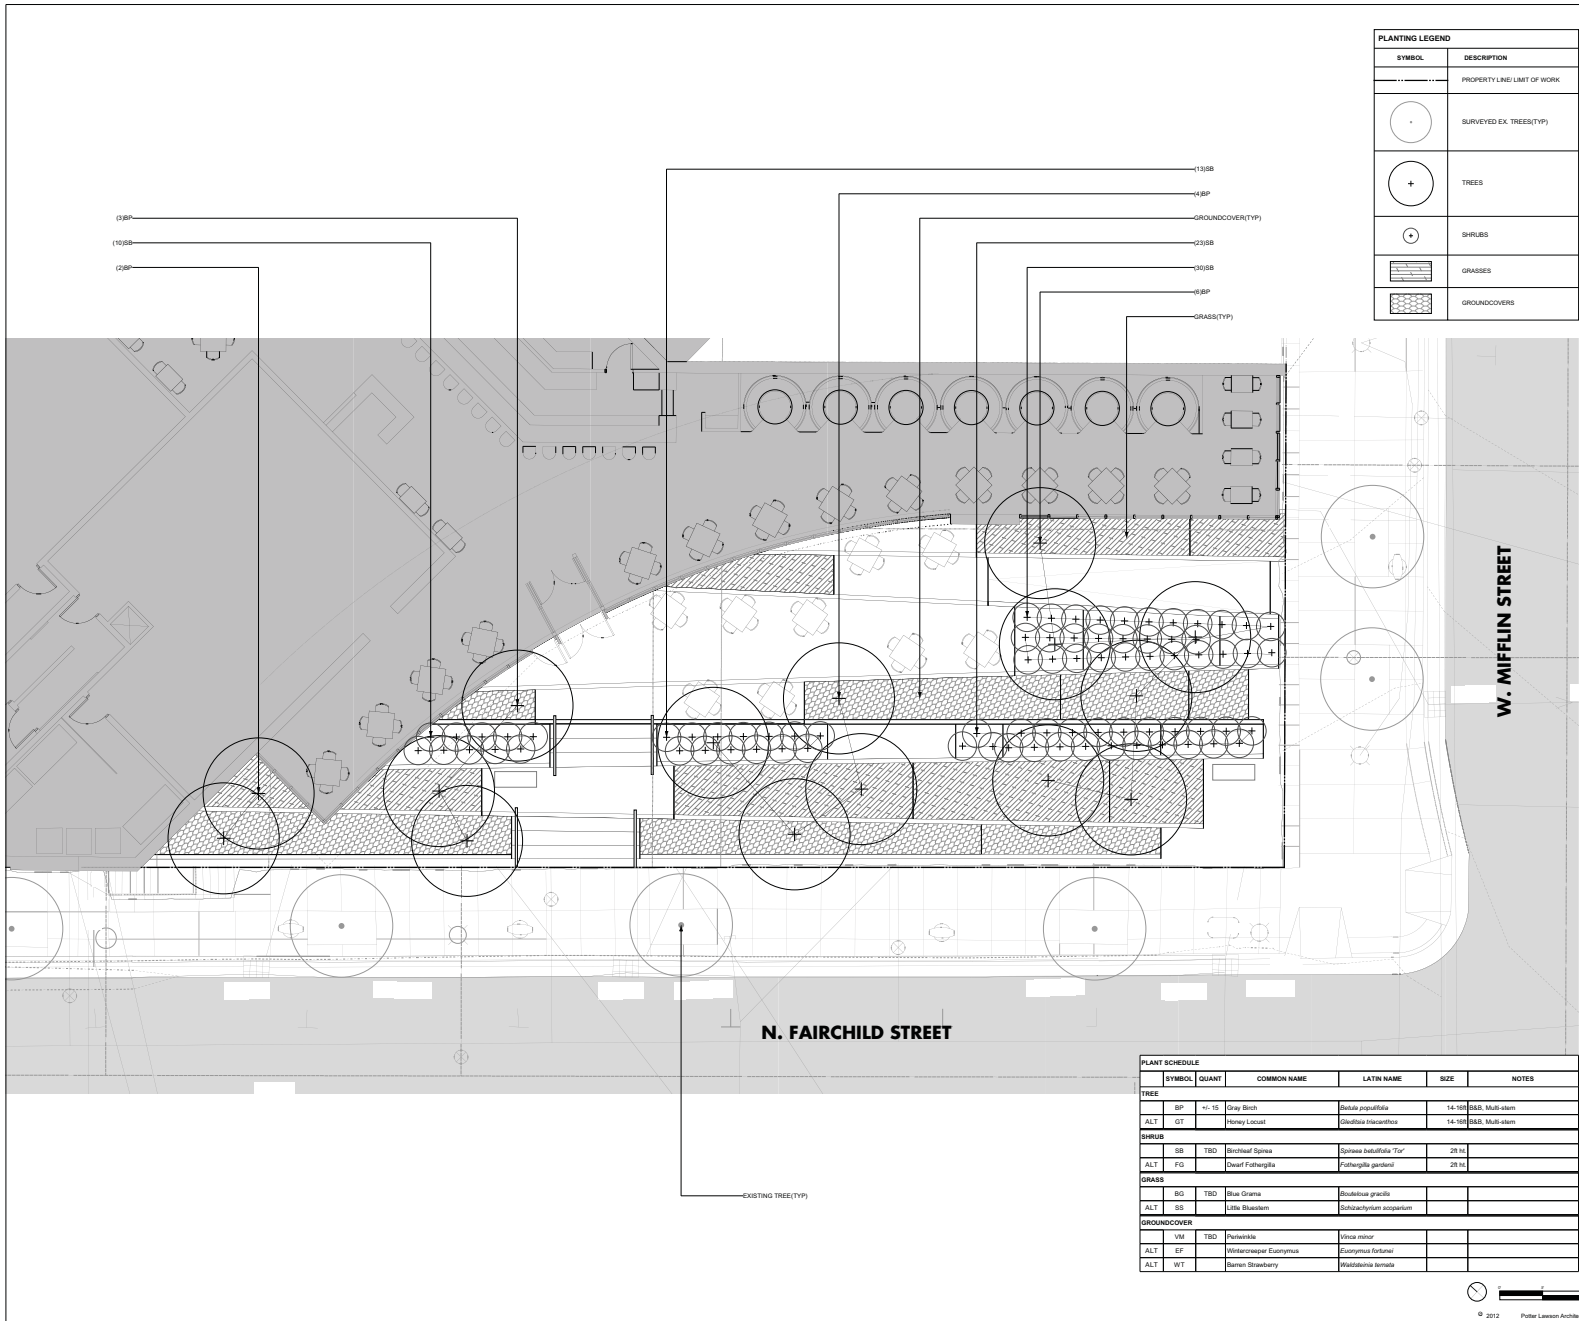
PLANT SCHEDULE						
SYMBOL	QUANT	COMMON NAME	LATIN NAME	SIZE	NOTES	
<b>TREE</b>						
BP	~1-15	Gray Birch	<i>Betula populifolia</i>	14-16'	BBB, Multi-stem	
ALT	QT	Honey Locust	<i>Gleditsia inaequalis</i>	14-16'	BBB, Multi-stem	
<b>SHRUB</b>						
SB	TBD	Bronzed Spirea	<i>Spiraea betulifolia 'Ice'</i>	28 in		
ALT	FG	Dwarf Fothergilla	<i>Fothergilla gardenii</i>	28 in		
<b>GRASS</b>						
BS	TBD	Blue Grama	<i>Bouteloua gracilis</i>			
ALT	SS	Little Bluestem	<i>Schizachyrium scoparium</i>			
<b>GROUNDCOVER</b>						
VM	TBD	Parakele	<i>Vincetoxicum</i>			
ALT	EF	Wintercreeper Euonymus	<i>Euonymus fortunei</i>			
ALT	WT	Burns Strawberry	<i>Waldsteinia ternata</i>

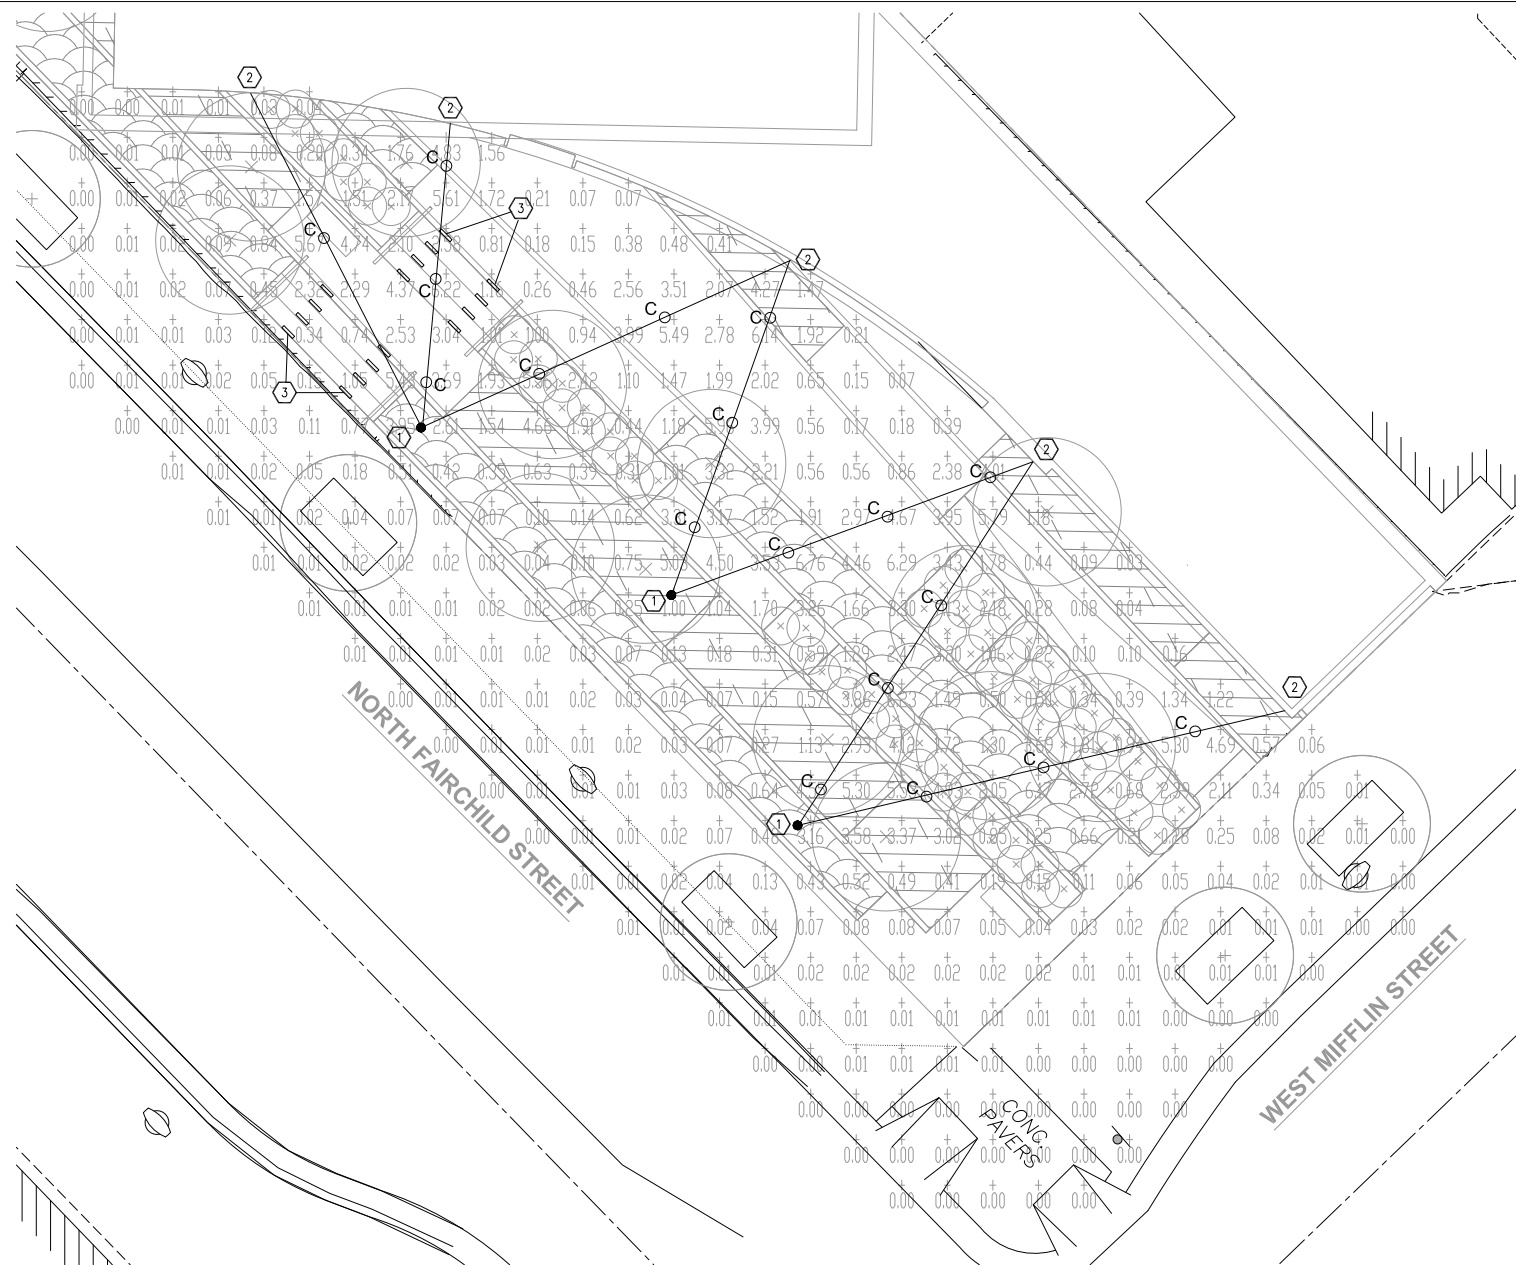
-	-	
-	-	
-	-	
-	-	
-	-	
-	-	
-	-	
-	-	
-	-	
-	-	
-	-	
-	-	
7/2/2013	PLAN COMMISSION/ARC/LANDMARKS SUBMITTAL	
Date	Issuance/Revisions	Symbol

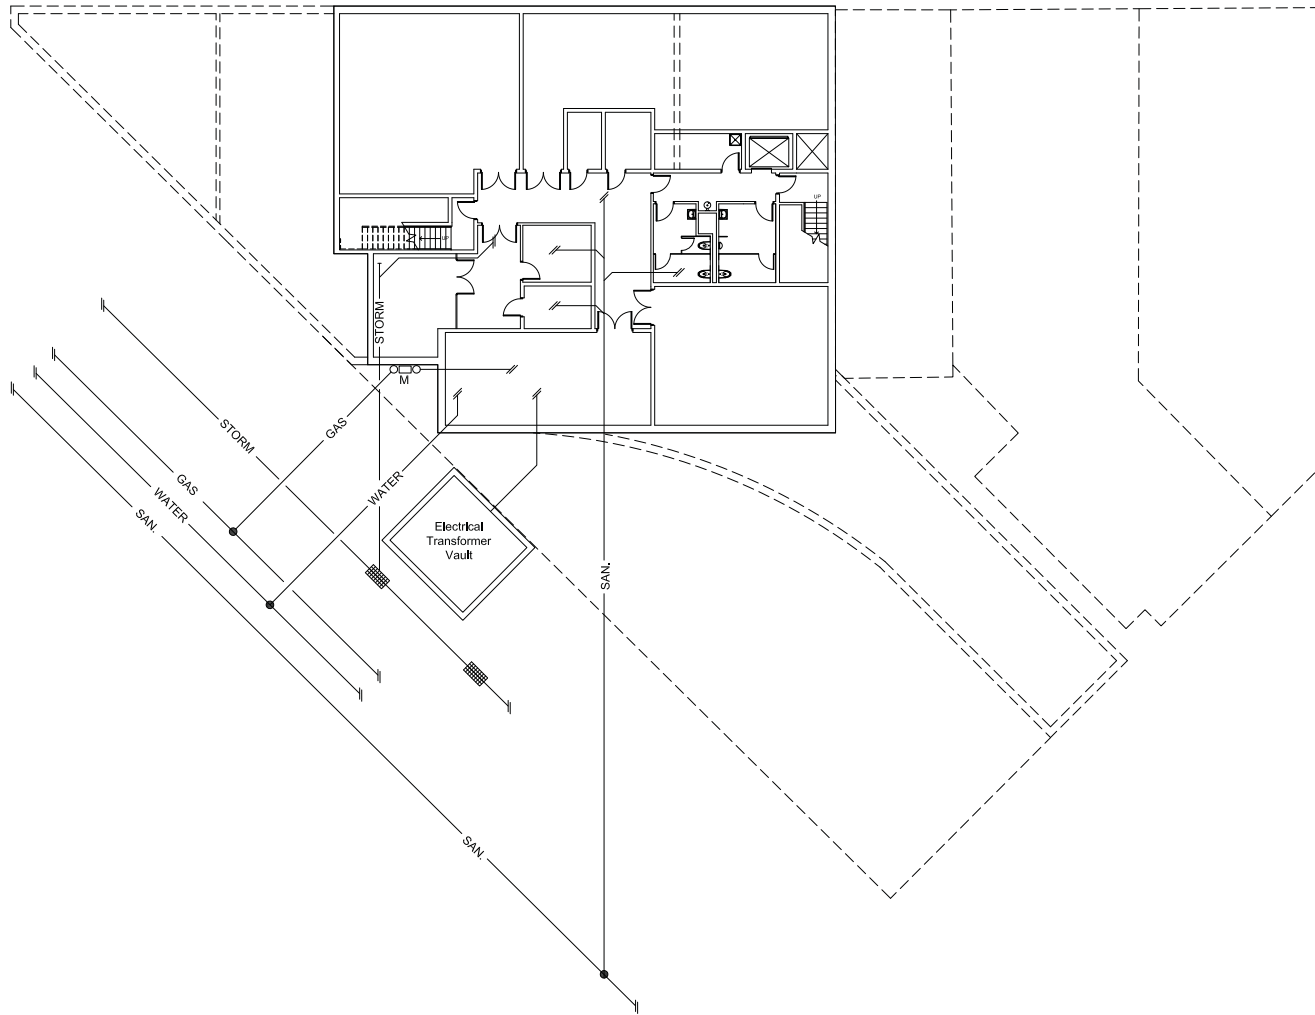
-	-	
-	-	
-	-	
-	-	
-	-	
-	-	
-	-	
-	-	
-	-	
7/9/2013	PLAN COMMISSION/ABC/LANDMARKS SUBMITTAL	
Date	Issuance/Revisions	Symbol

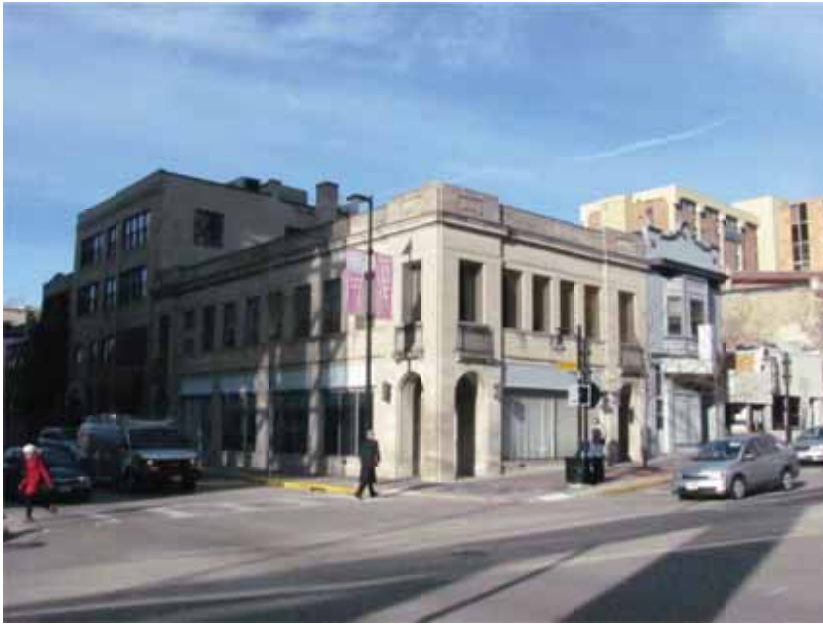
*Figure 1. Overall view of 124 West Mifflin. The Mifflin Street facade is at right, while the Fairchild Street facade is at left.*
