APPLICATION FOR  
URBAN DESIGN COMMISSION  
REVIEW AND APPROVAL

AGENDA ITEM # \_\_\_\_\_  
Project # \_\_\_\_\_  
Legistar # \_\_\_\_\_

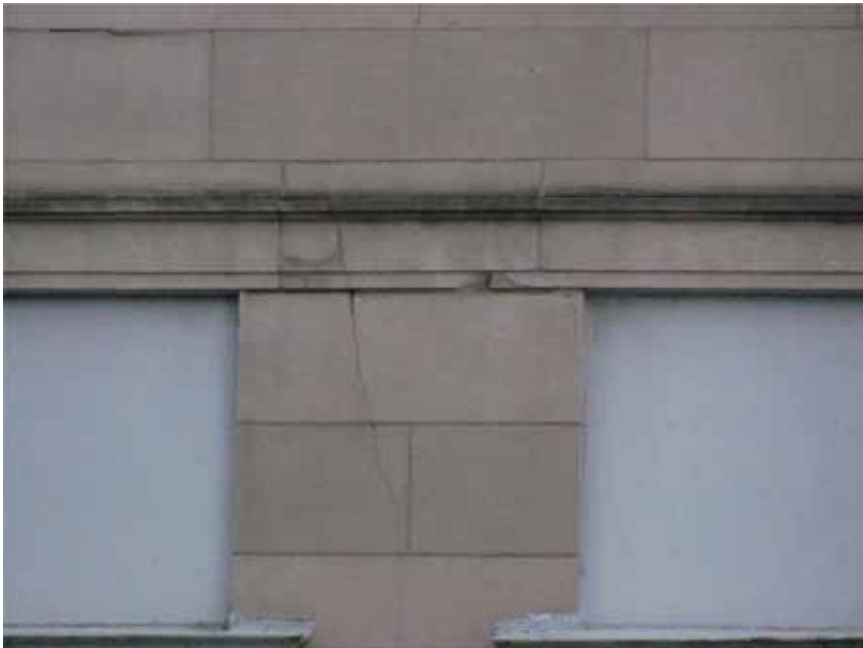
*Figure 5. Cracking and spalling of limestone masonry at the head of a first floor window opening.*

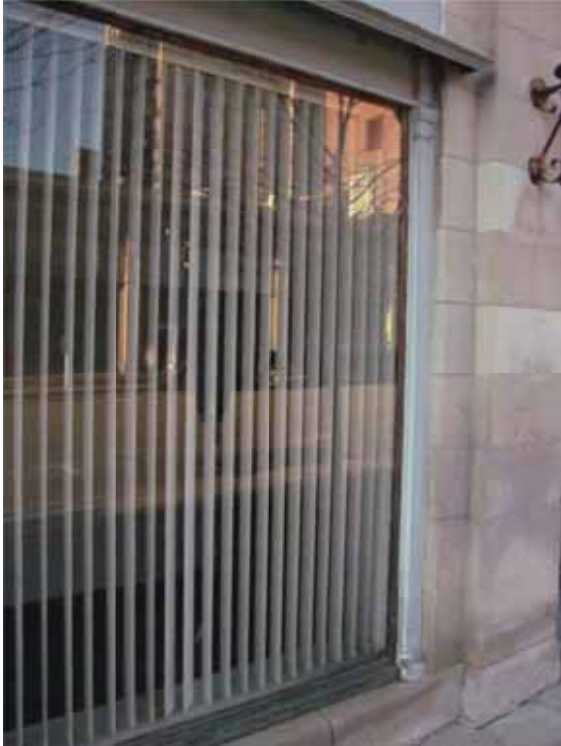
*Figure 6. The storefront facing Mifflin Street has a bronze frame and fluted bronze pilasters as window jambs.*

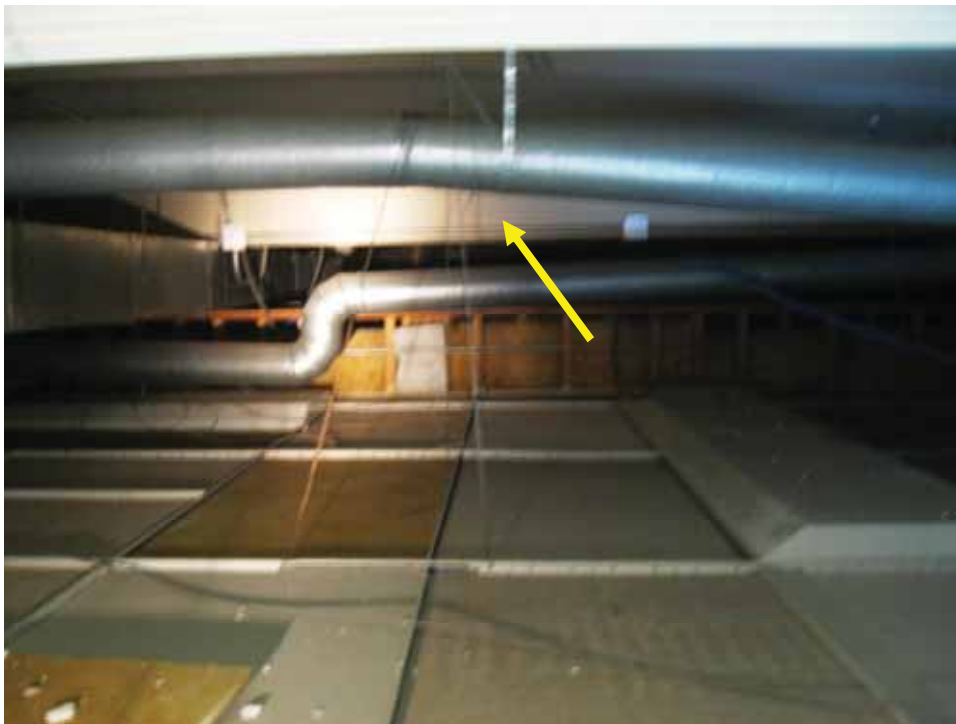
**Photo 2** – Typical steel girder (encased) supporting 2<sup>nd</sup> floor wood joists

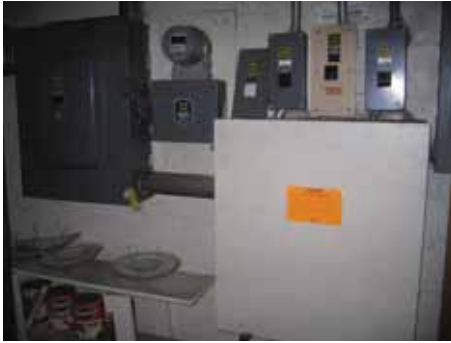
Electrical service in the basement.

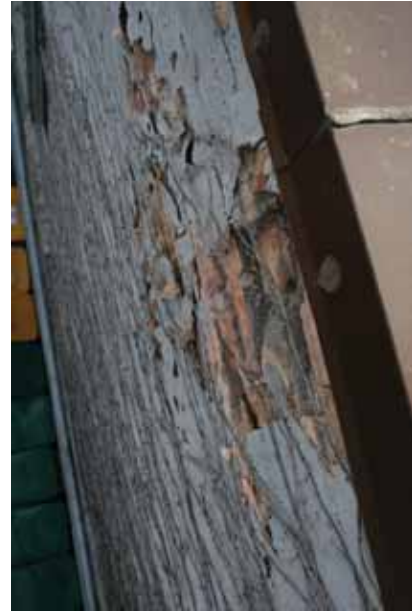
View from roof looking at condition of brick and parged wall

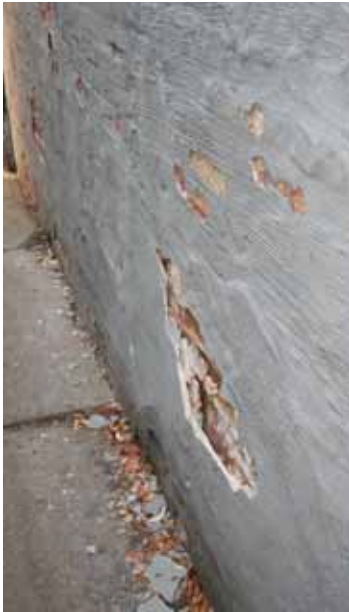
Exterior: View in the alley showing a section of delaminated parging

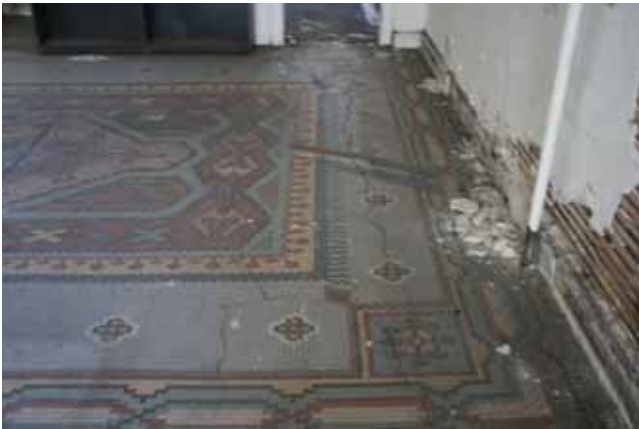
First Floor: View toward back exit showing multiple cracks in floor tile

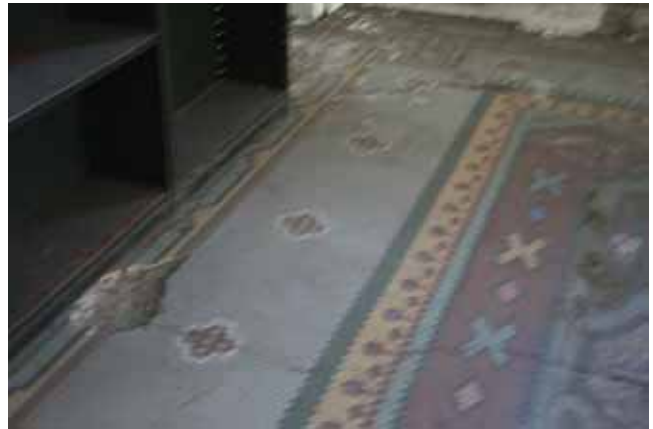
First Floor: View at back of room showing areas where tile floor has been removed

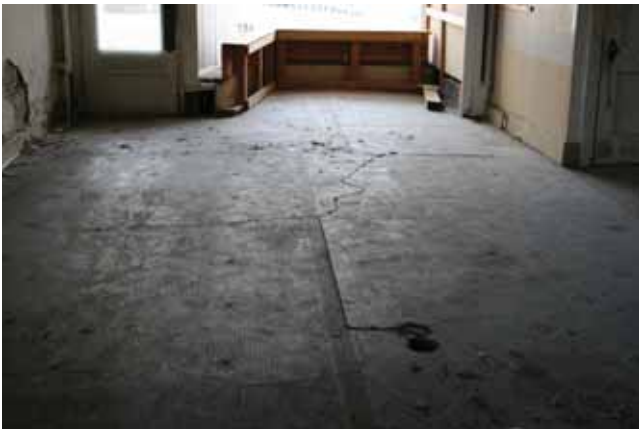
First Floor: View toward Mifflin Street entry showing multiple cracks in floor tiles

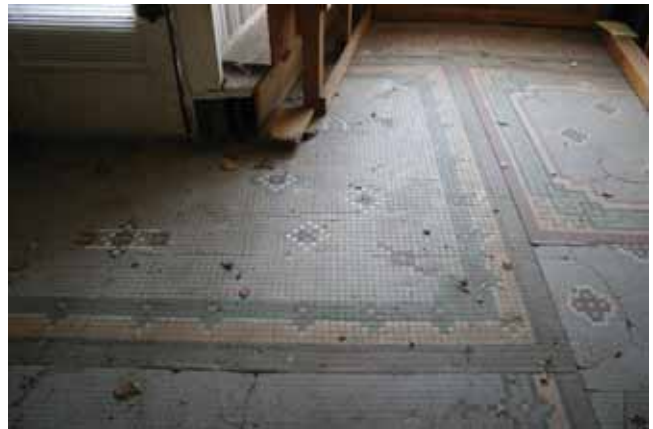
First Floor: View at entry off Mifflin Street showing three flooring surfaces. 1) Original 3/4" square tiles 2) 1" square tiles at entry 3) composite flooring at window

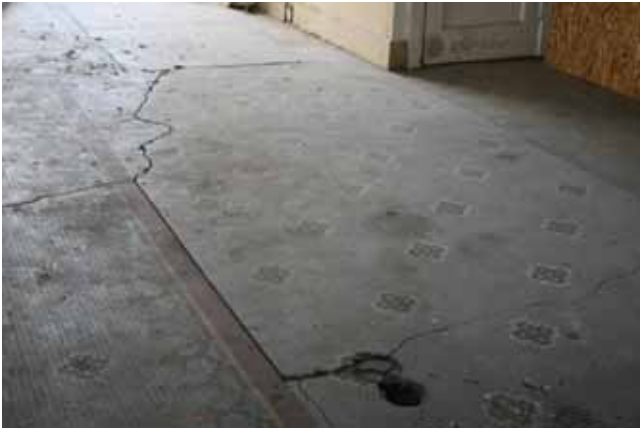
First Floor: View toward basement stair showing multiple cracks in tile floor

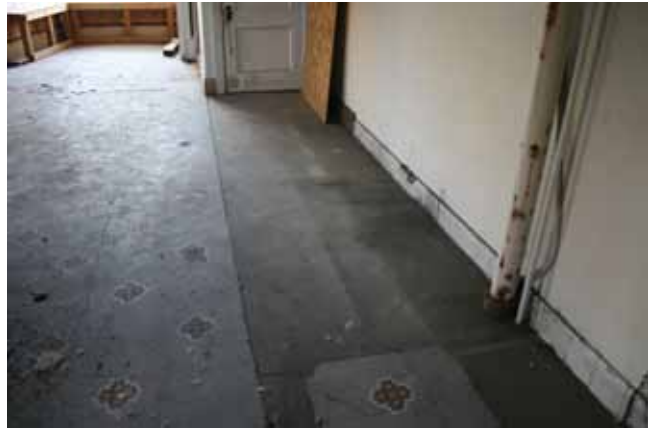
First floor: View of area where exposed concrete is installed

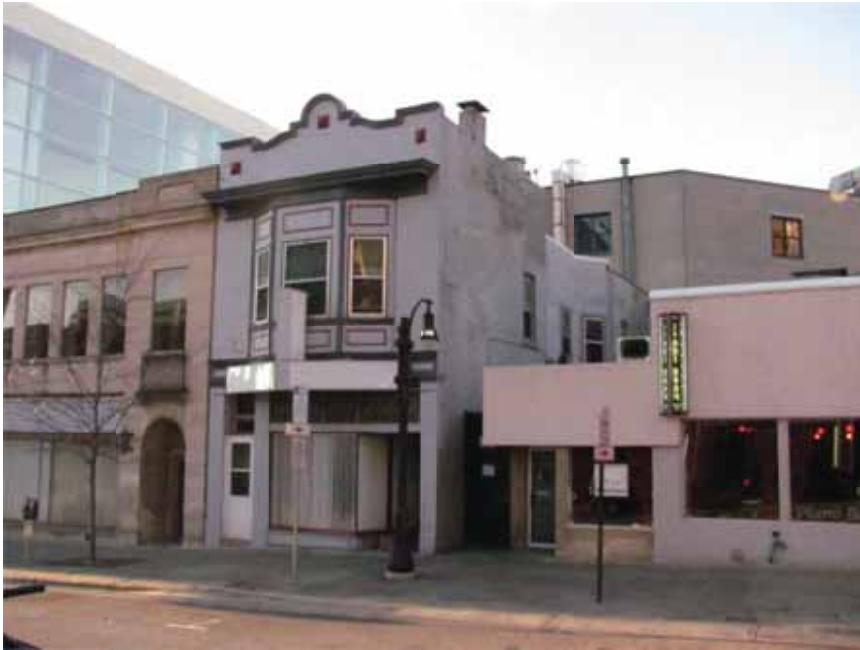
*Figure 1. Overview of the building from the south. The Mifflin Street facade is at left.*

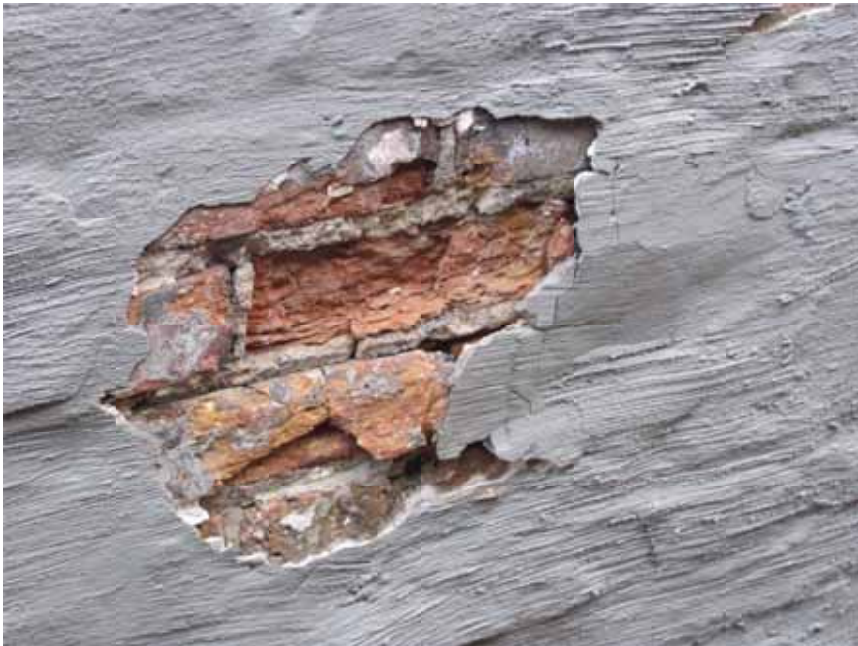
*Figure 5. Failure of cementitious parge coat, revealing deteriorated brick masonry.*

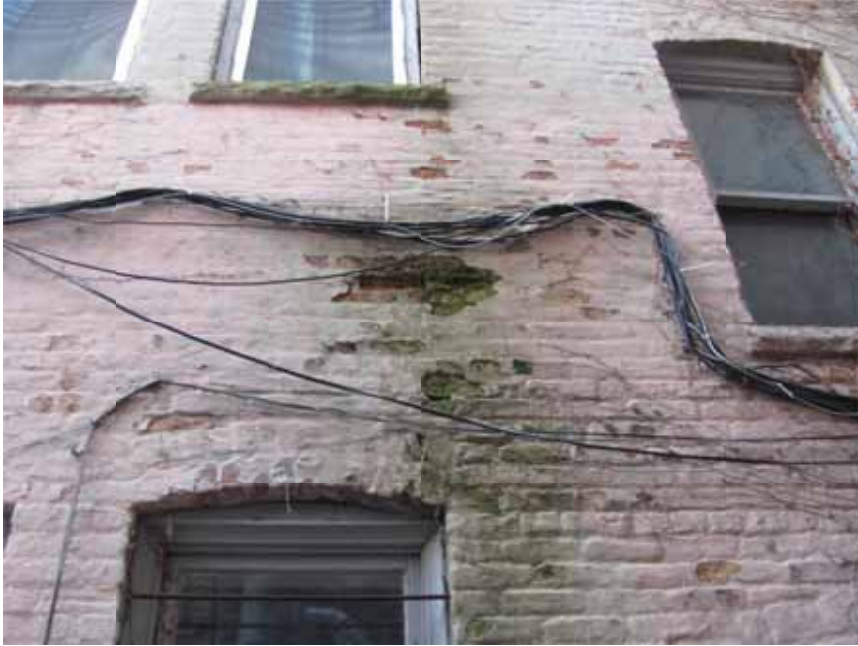
*Figure 6. Deterioration of brick masonry at the rear facade.*

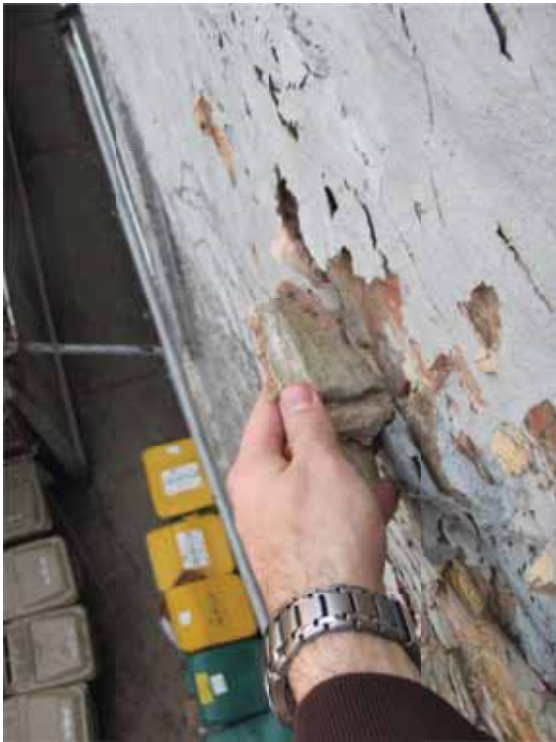
*Figure 7. Left. Loose fragments of brick/mortar/parging were removed by hand from the side wall.*

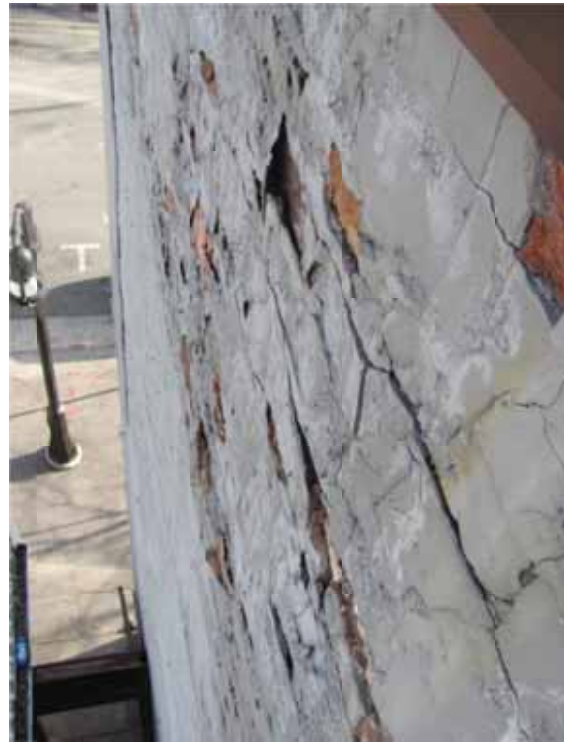
*Figure 8. Right. Deterioration of brick and parging near the top of the side wall.*

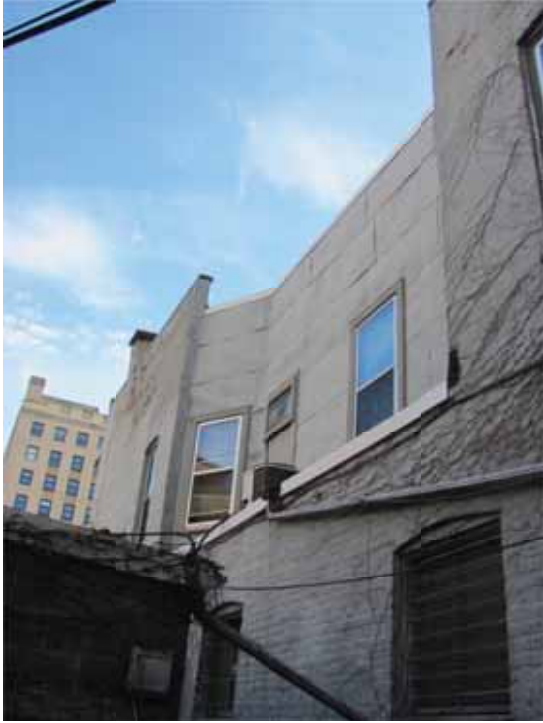
*Figure 9. A portion of the side wall is recessed at the second floor and is clad with painted sheet metal.*

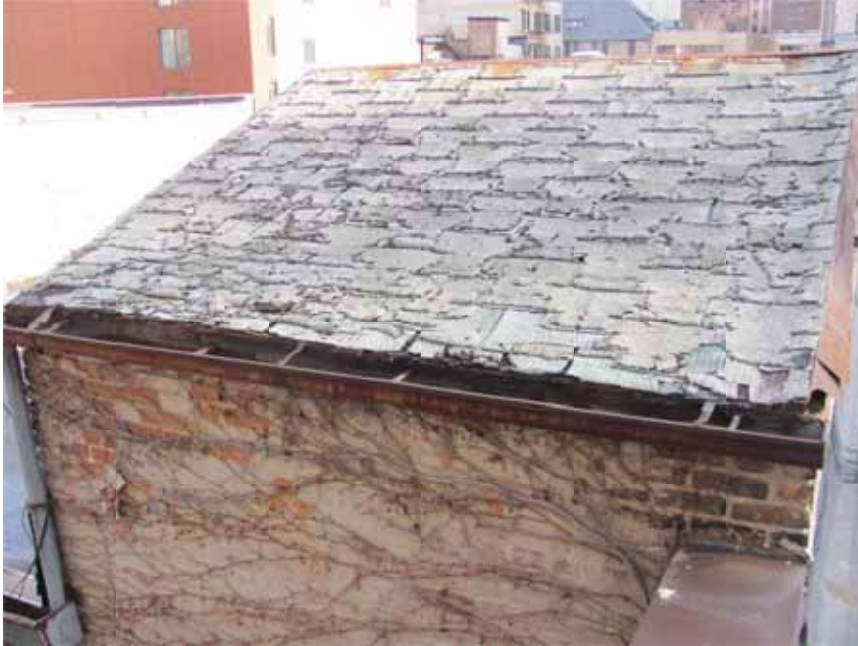
*Figure 13. The penthouse roof is covered with asphalt shingles in deteriorated condition.*

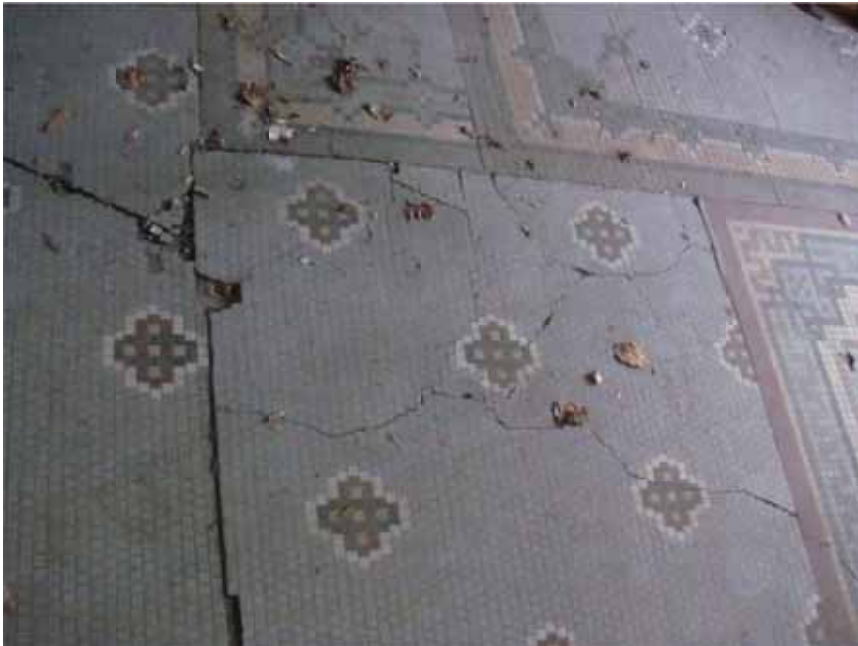
*Figure 14. There is elaborate mosaic tile flooring at the first floor; the flooring has suffered extensive cracking and displacement.*

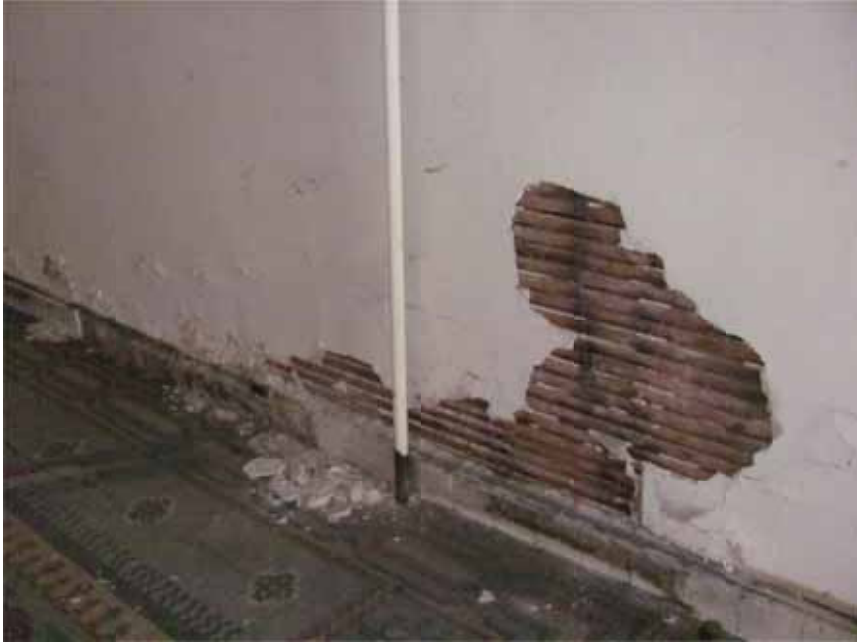
*Figure 15. Damage to interior plaster wall finish.*

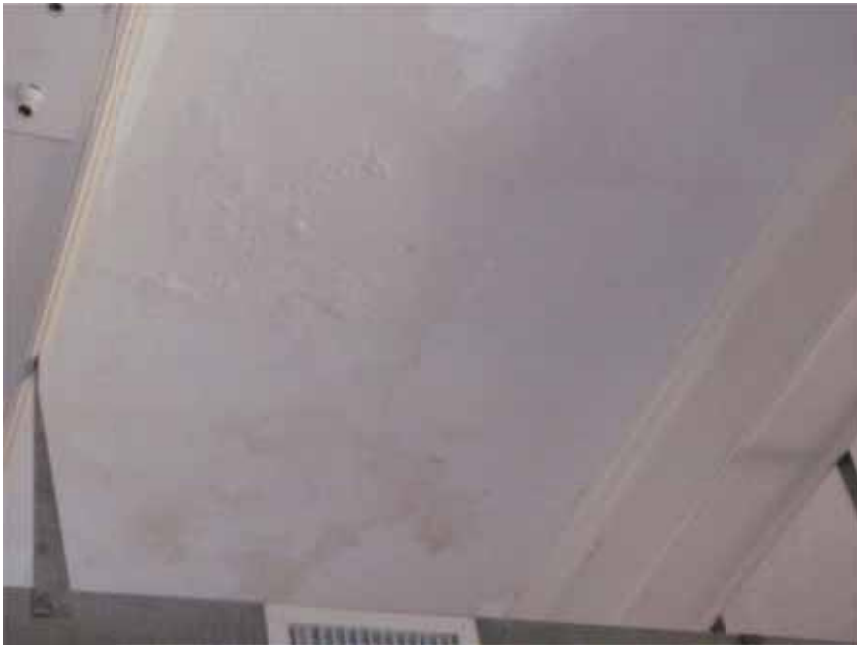
*Figure 16. Water staining and bubbling of interior plaster ceiling.*

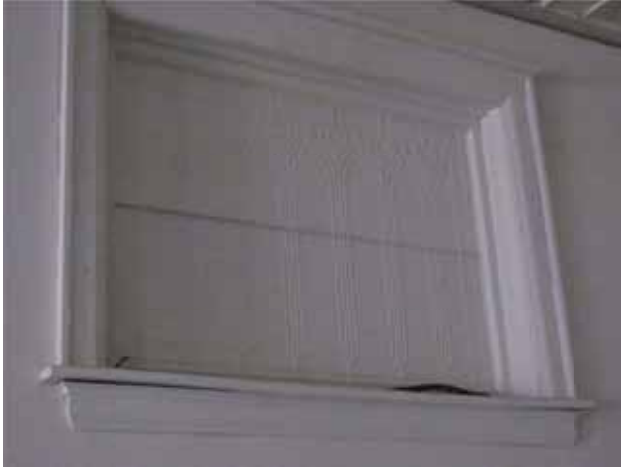
*Figure 17. Leaded glass window, which has been painted over, at the southwest party wall.*

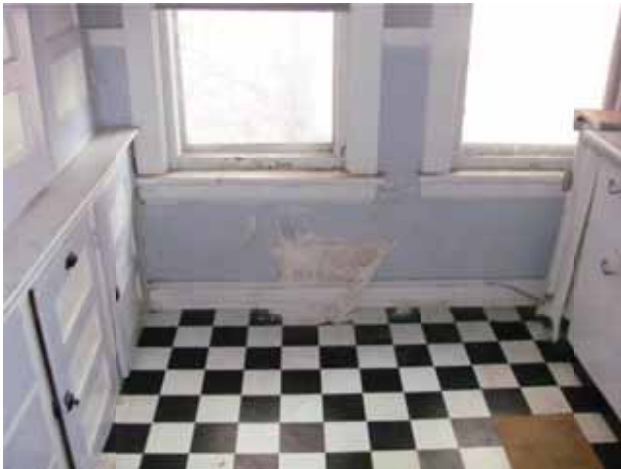
*Figure 18. Plaster damage at the rear wall at the second floor of the building.*

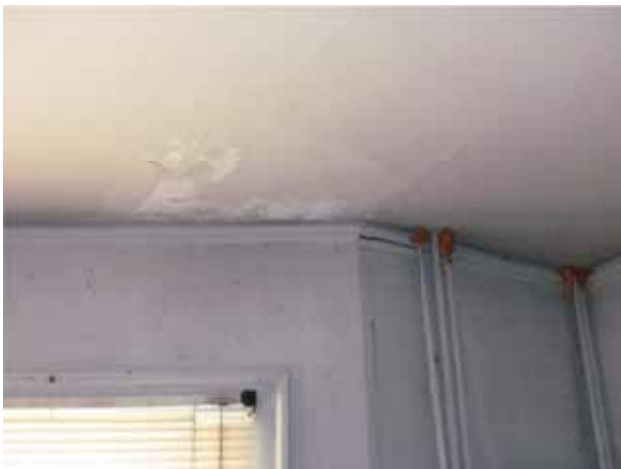
*Figure 19. Moisture damage to plaster finishes at the second floor.*

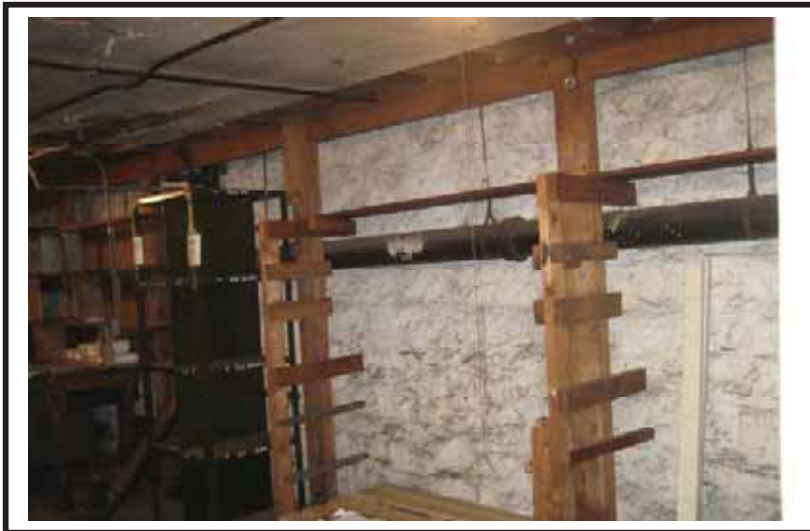
Figure 1 – Shoring along basement wall –also used as shelving.

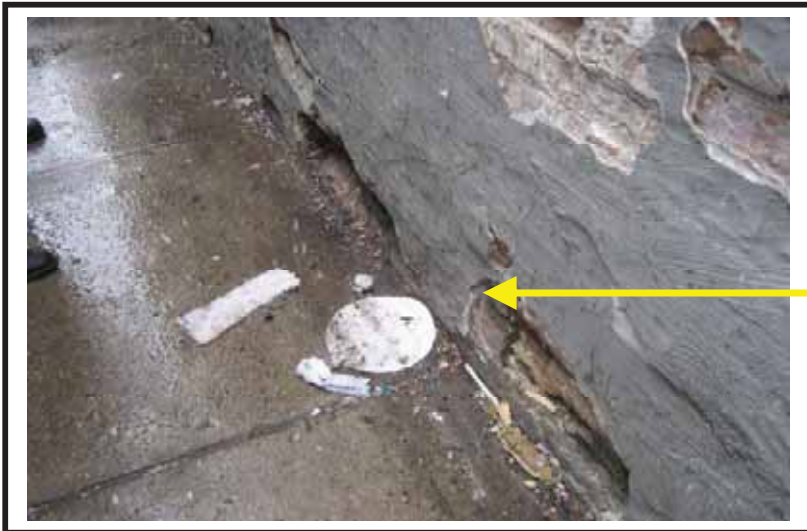
Figure 4 – Spalling brick face-east exterior wall.

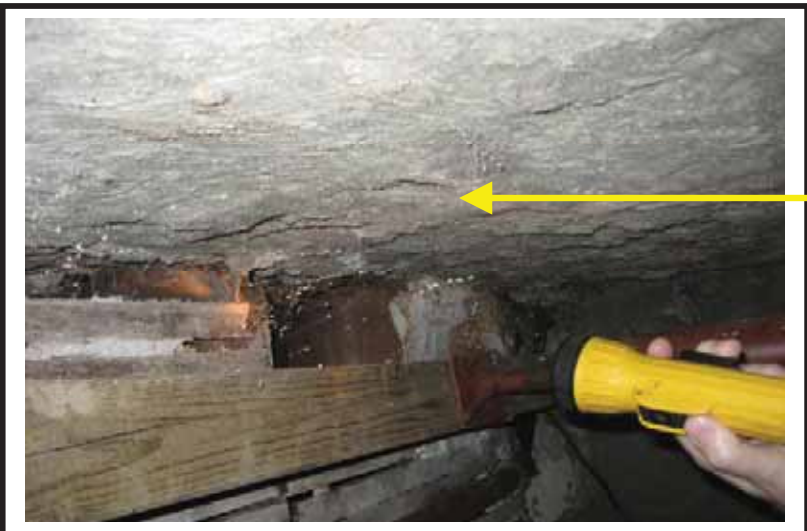
Figure 5 – Picture of rotted end of wood floor joist at first floor.

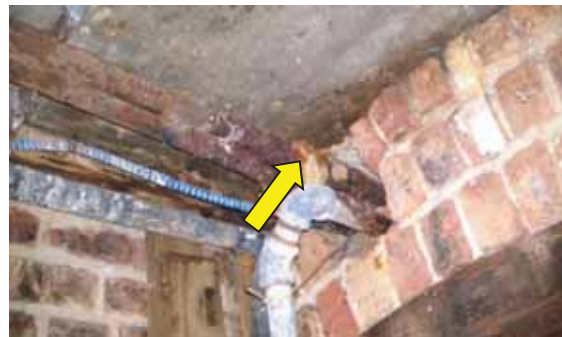
Deteriorated gas pipe

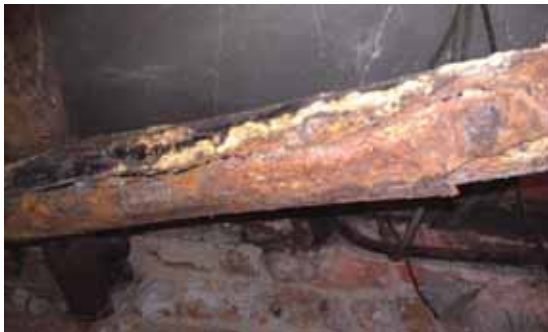
Deteriorated sanitary pipe

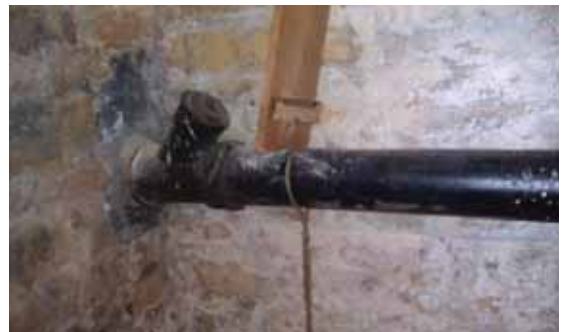
Storm main support/pitch

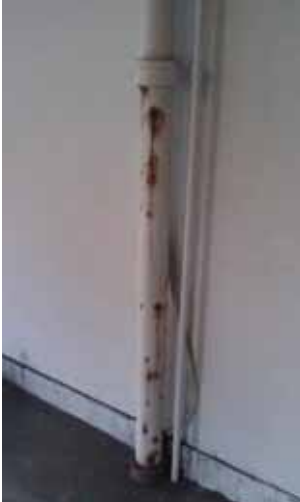
Leaking sanitary pipe

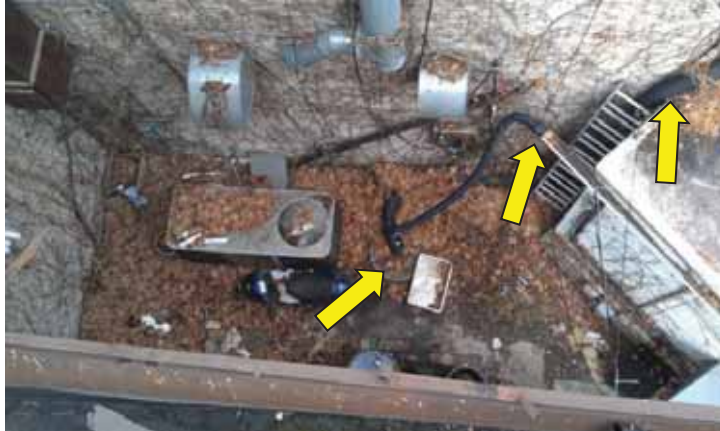
Roof drains into cistern that discharges through basement

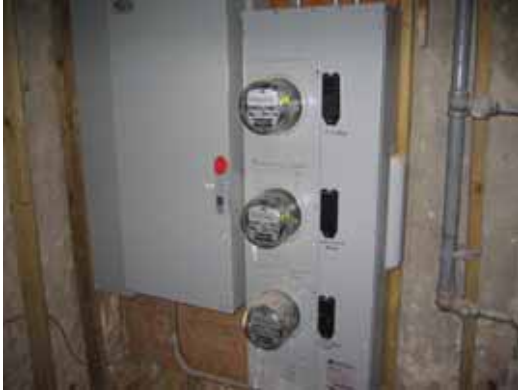
Electrical service in the basement.

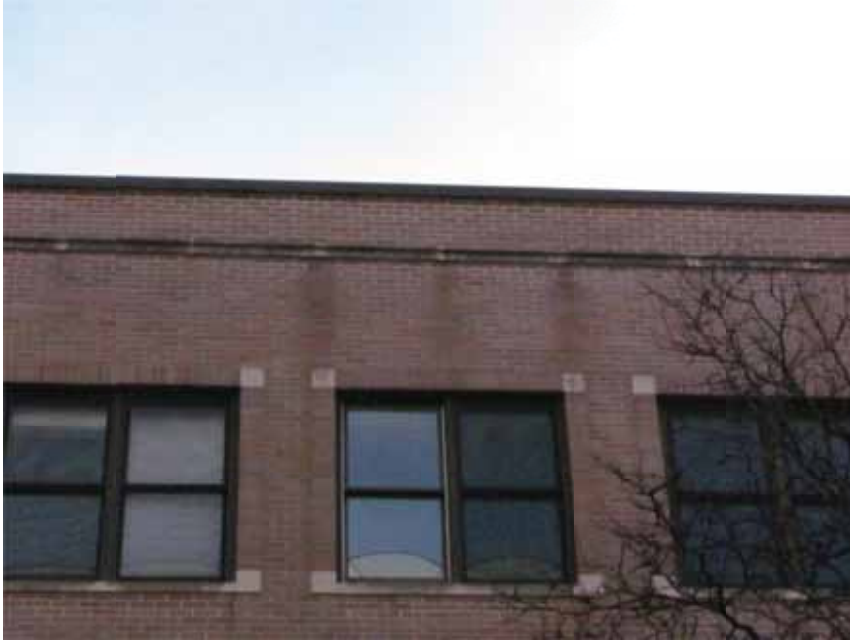
*Figure 3. Water runoff staining below the stringcourse at the parapet wall.*

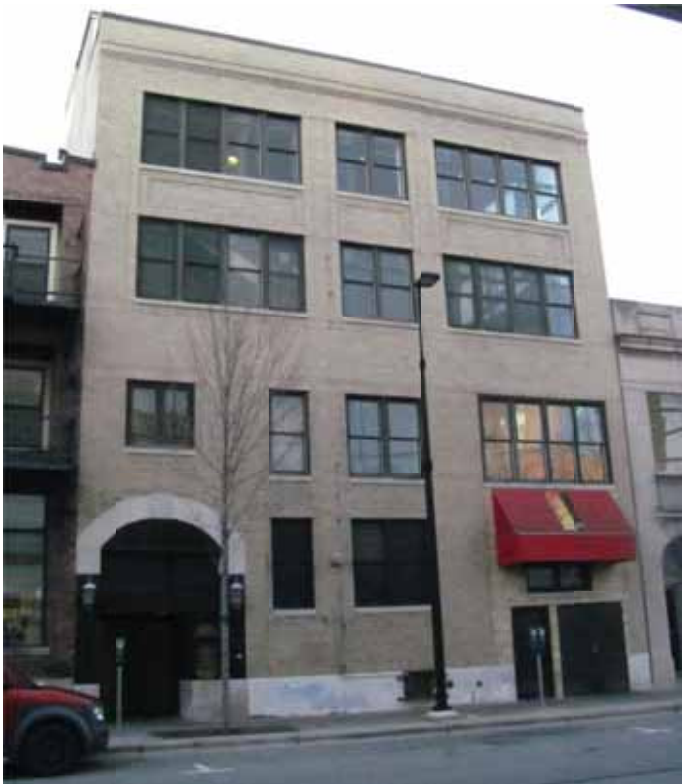
*Figure 4. The Fairchild Street facade.*

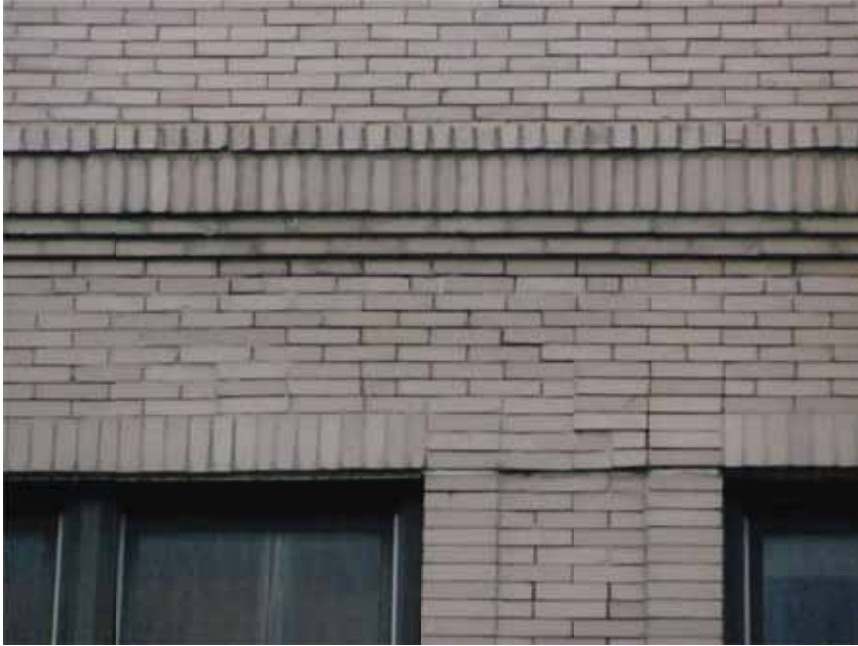
*Figure 5. Cracking and displacement of brick masonry above window heads.*

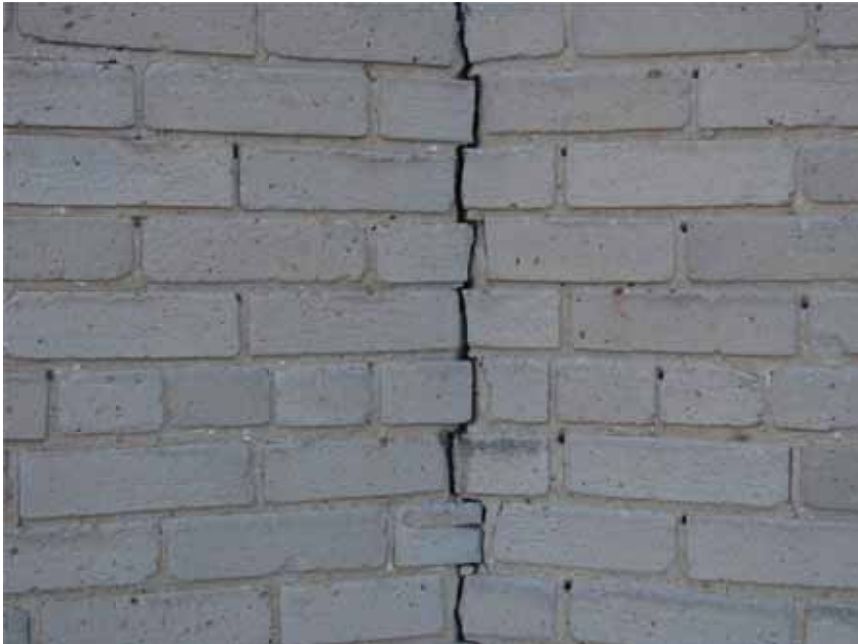
*Figure 6. Vertical cracking at an obtuse corner in the brick party wall.*

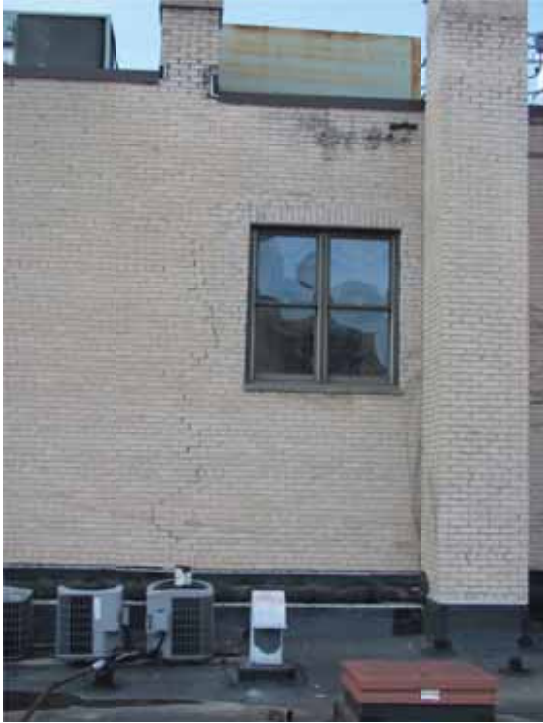
*Figure 7. Left. Vertical cracking and localized damage in the brick masonry party wall, which is visible where it extends above the roofs of the adjacent buildings.*

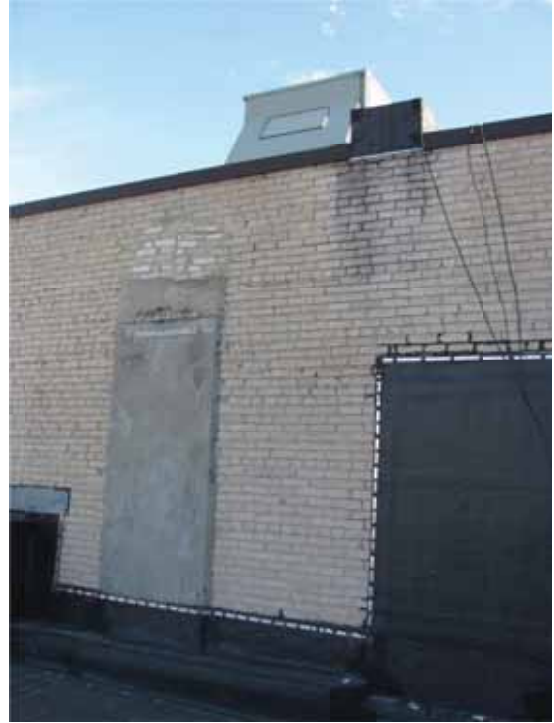
*Figure 8. Right. Some areas of poorly matched repairs and areas overlaid with an EPDM rubber roof membrane were observed at the party walls. Also note rundown staining and open mortar joints.*

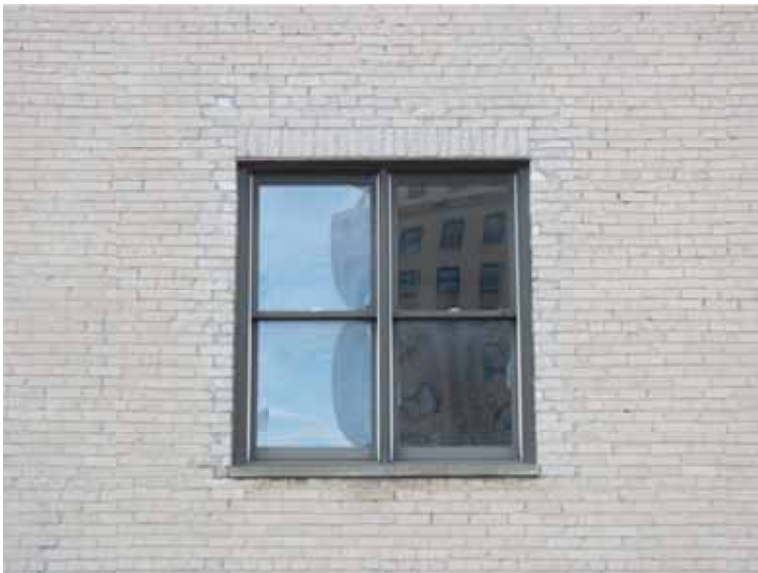
*Figure 9. Typical aluminum-clad wood windows.*

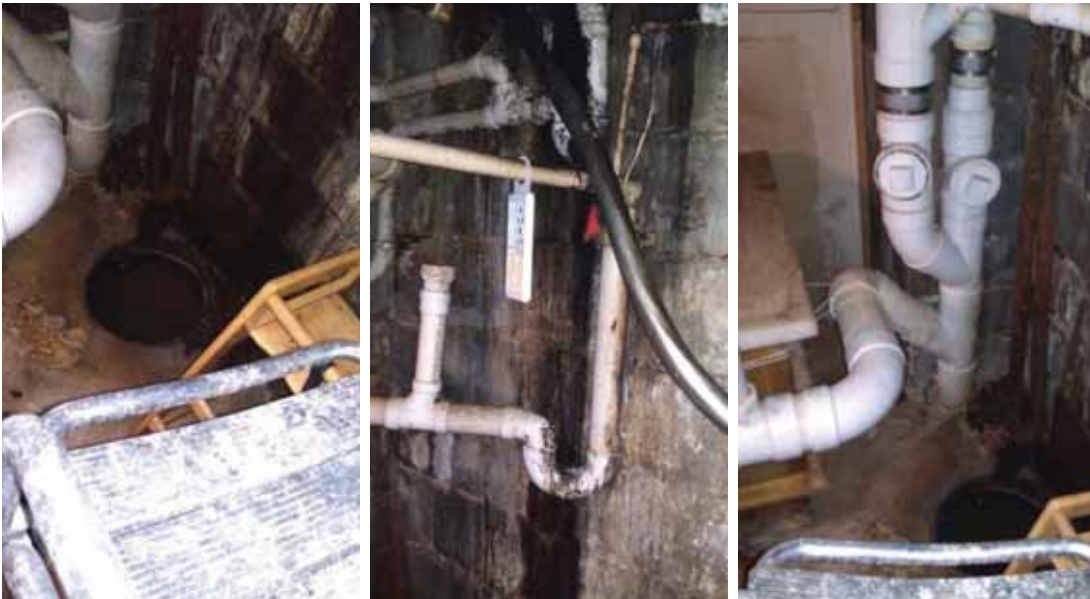
Poor condition of sanitary piping

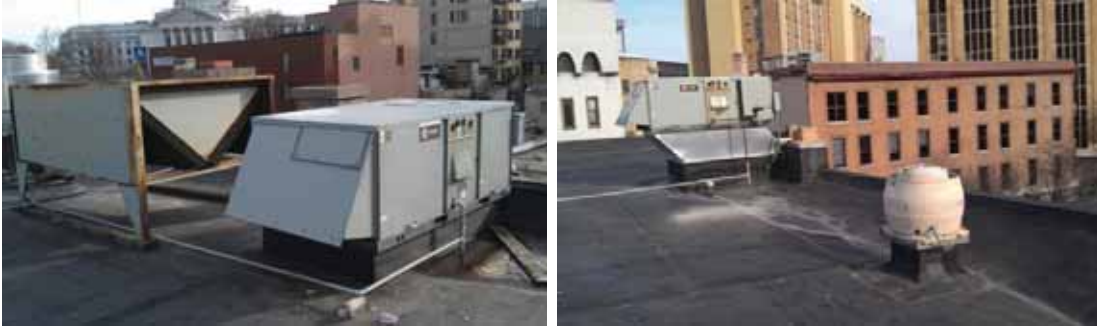
Existing rooftop equipment

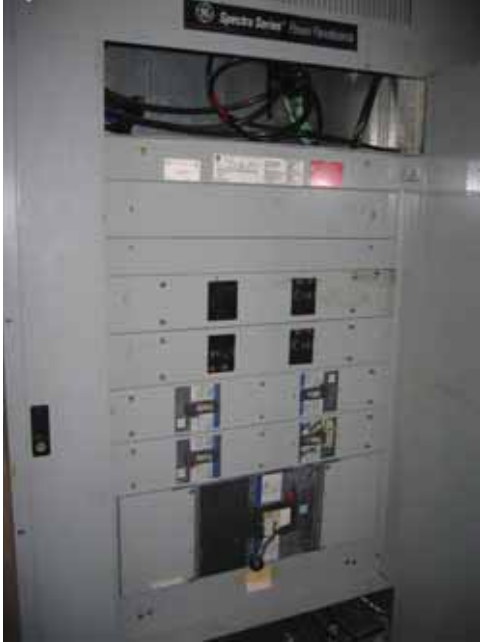
Distribution panel in the basement.

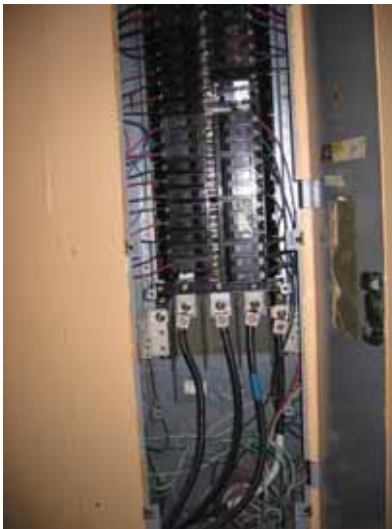
Electrical panel on 2<sup>nd</sup> floor restaurant missing interior trim cover.

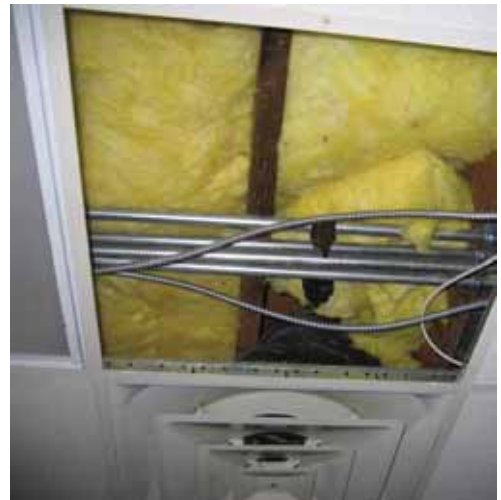
Conduits above ceiling on 3<sup>rd</sup> floor.

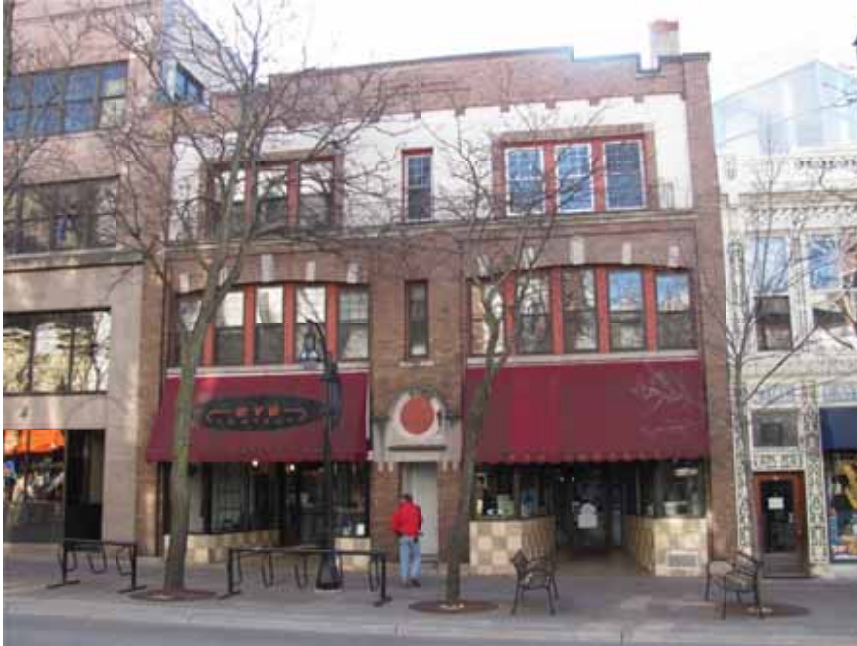
*Figure 1. Overall view of the State Street facade.*

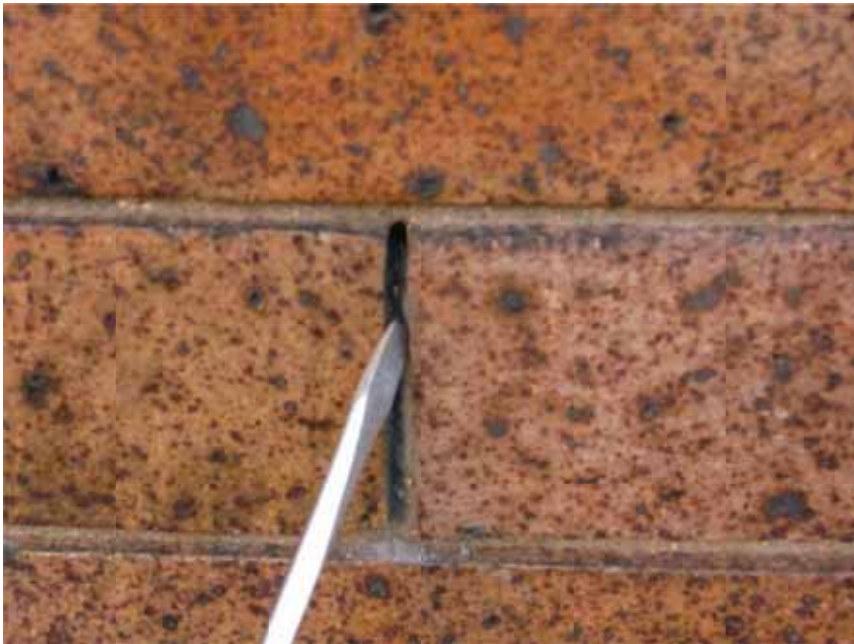
*Figure 4. Occasional open mortar joints were observed.*

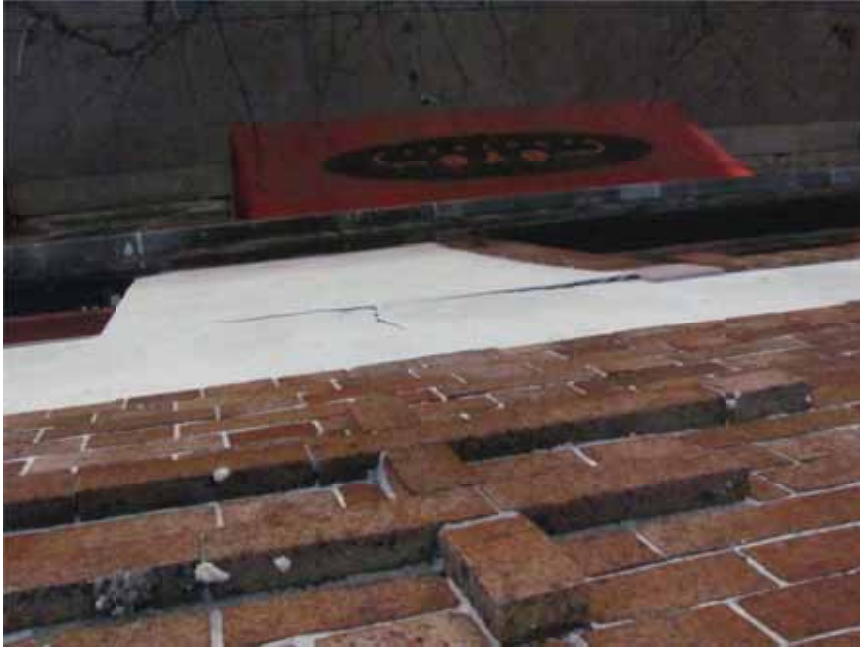
*Figure 5. View from the roof of one especially large delaminated area of stucco observed near the middle of the facade.*

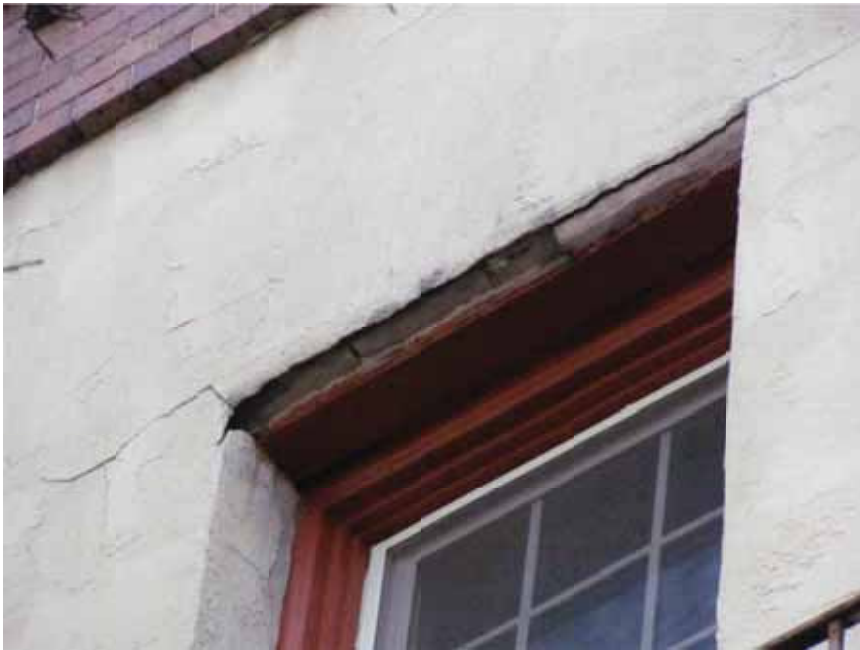
*Figure 6. A portion of stucco has previously spalled at the head of the center third floor window.*

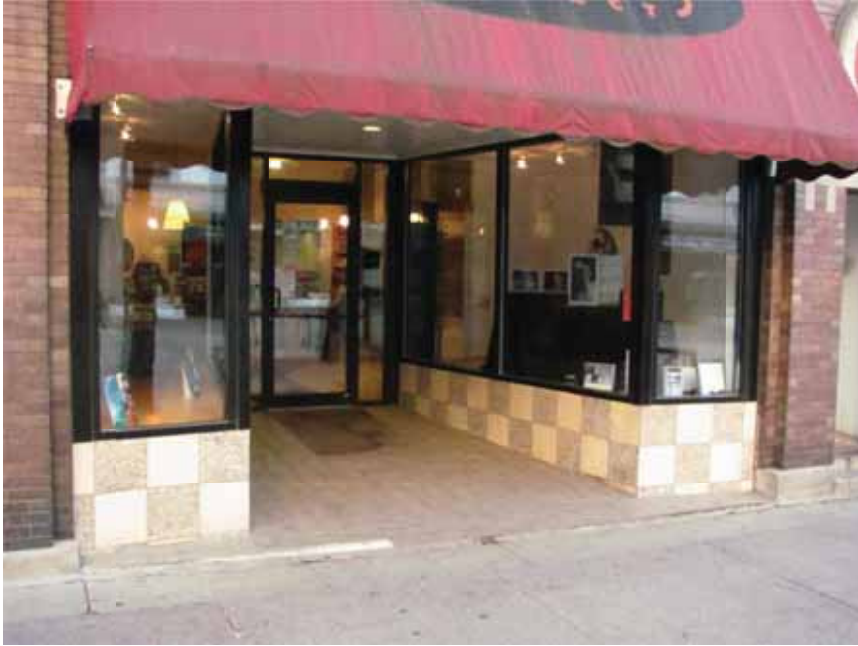
*Figure 7. The first floor storefronts are relatively new aluminum-framed windows above a tile-clad knee wall.*

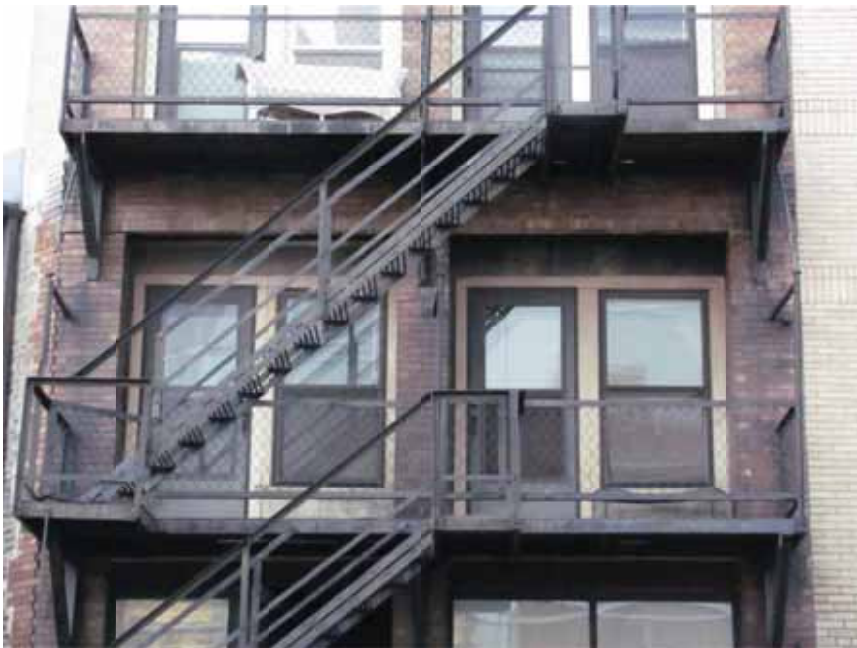
*Figure 12. The balconies and fire escapes appeared intact, with areas of paint loss and surface corrosion.*

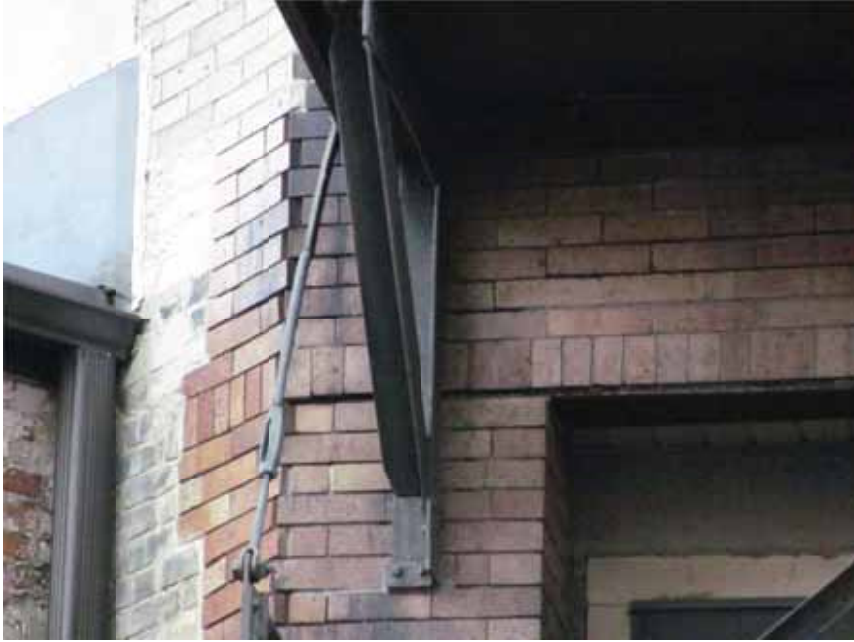
*Figure 13. Surface corrosion and minor displacement of masonry associated with the bearing points of the lintels was observed.*

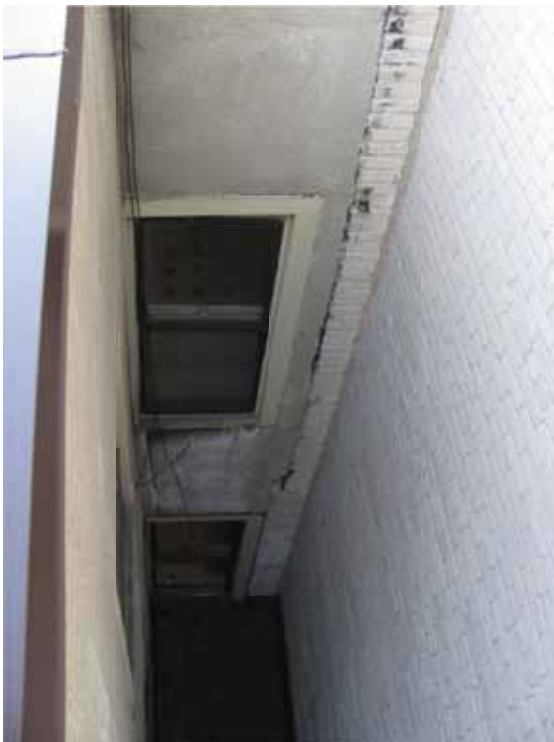
*Figure 14. Two-story light well along the east wall of the building.*
