APPLICATION FOR  
URBAN DESIGN COMMISSION  
REVIEW AND APPROVAL

AGENDA ITEM # \_\_\_\_\_  
Project # \_\_\_\_\_  
Legistar # \_\_\_\_\_

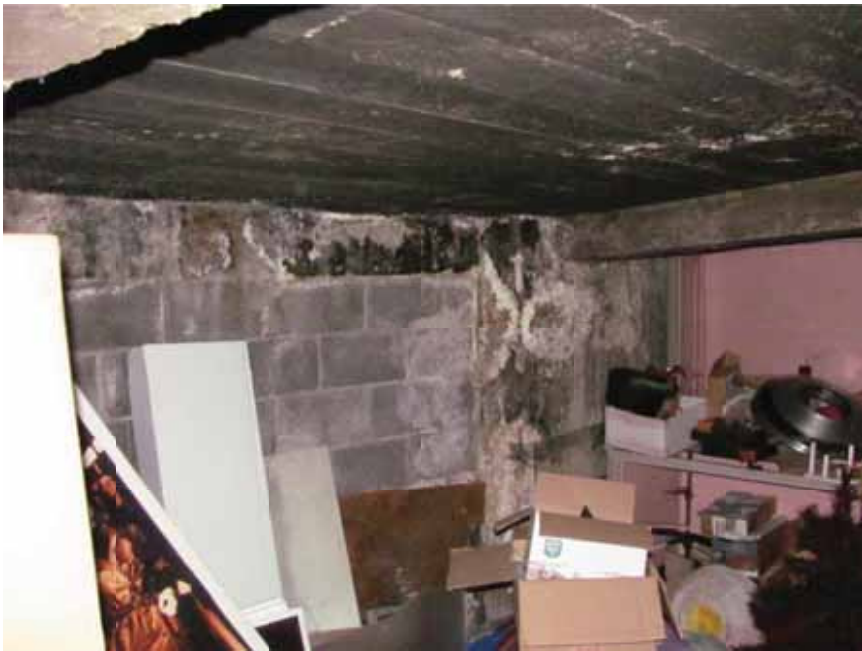
*Figure 22. Efflorescence and water staining at the basement level below the entrance storefront.*

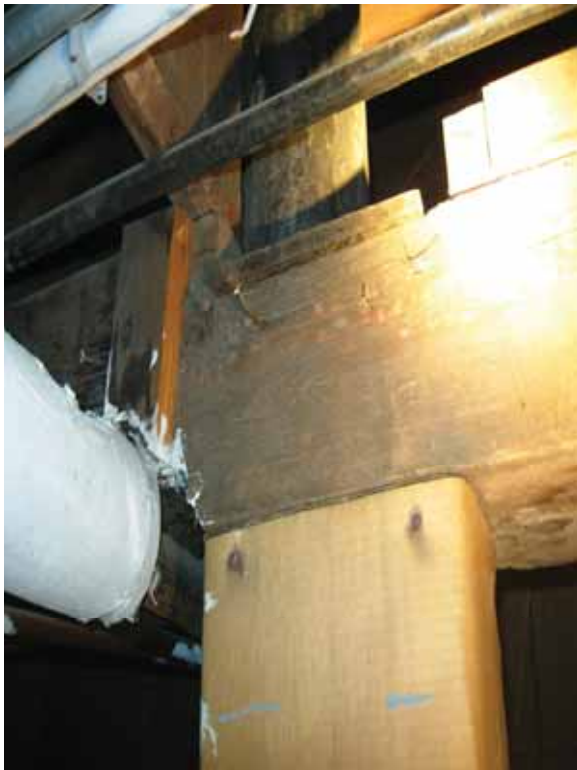
**Photo 1** – Notched 1<sup>st</sup> floor beam requiring replacement

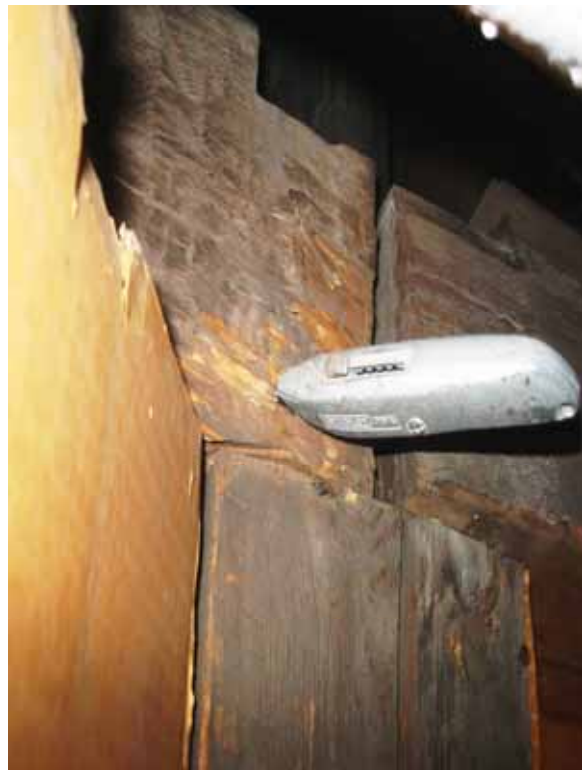
**Photo 2** – Poor fit up and wood density at 1<sup>st</sup> floor beams and column

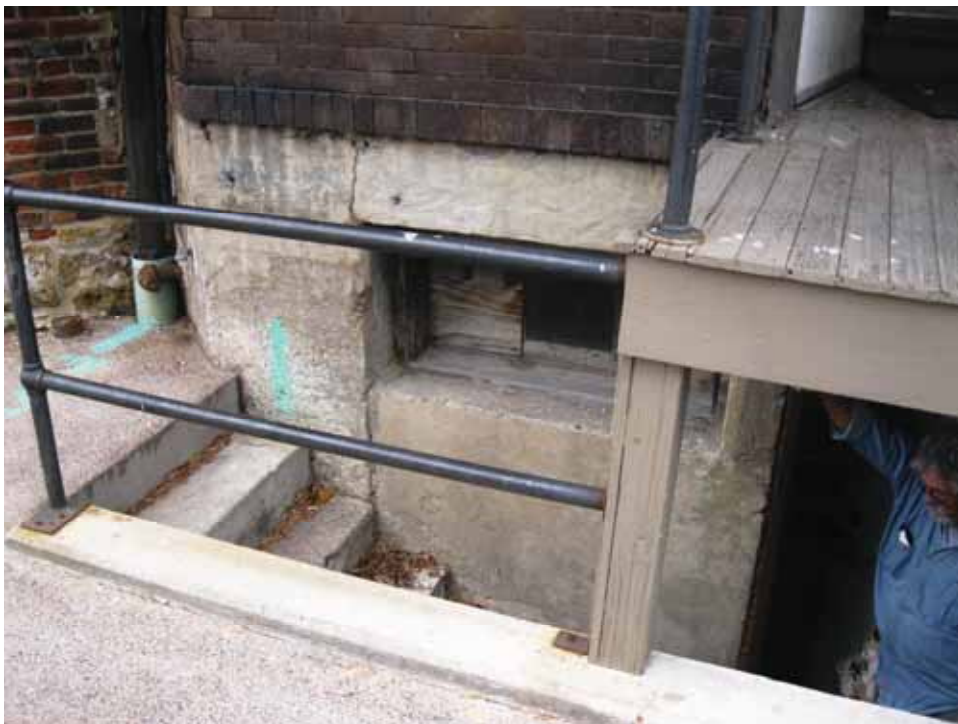
**Photo 4** – Stair to basement from Fairchild Street

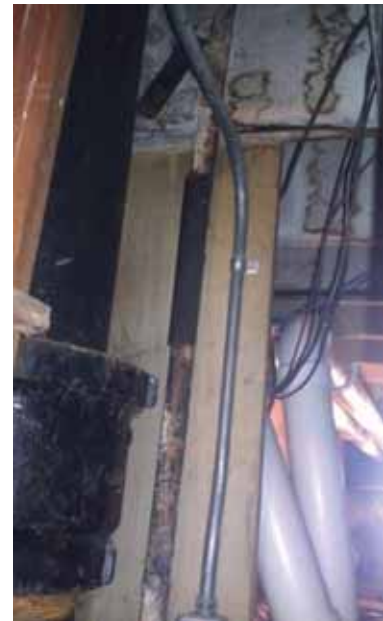
Failing storm main support

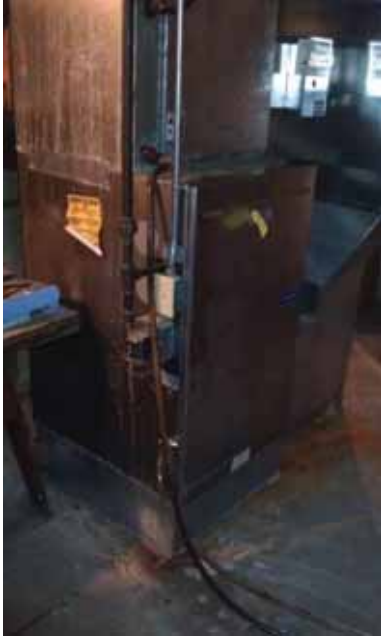
The building does not have a fire protection system.

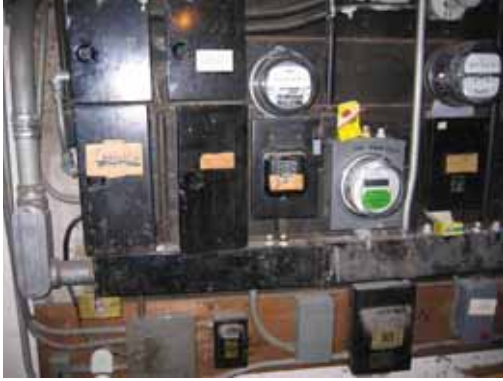
A portion of the older electrical service equipment in the Basement.

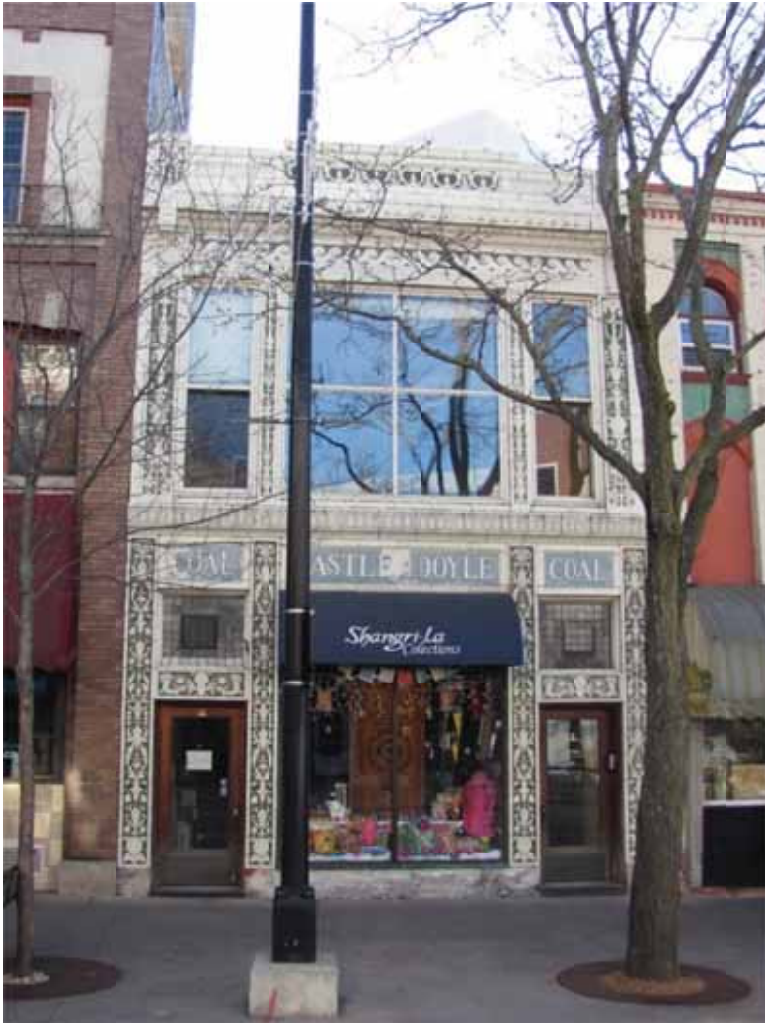
*Figure 1. Overall view of the State Street facade.*

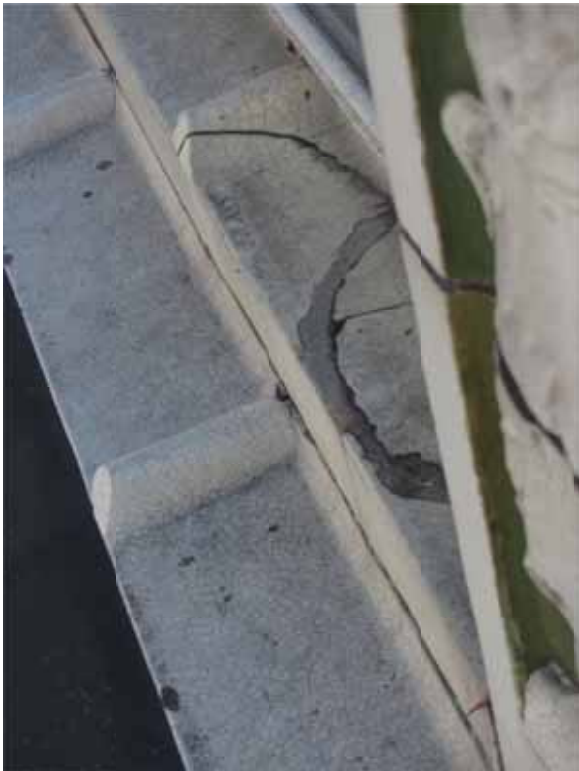
*Figure 3. One cracked terra cotta window sill.*

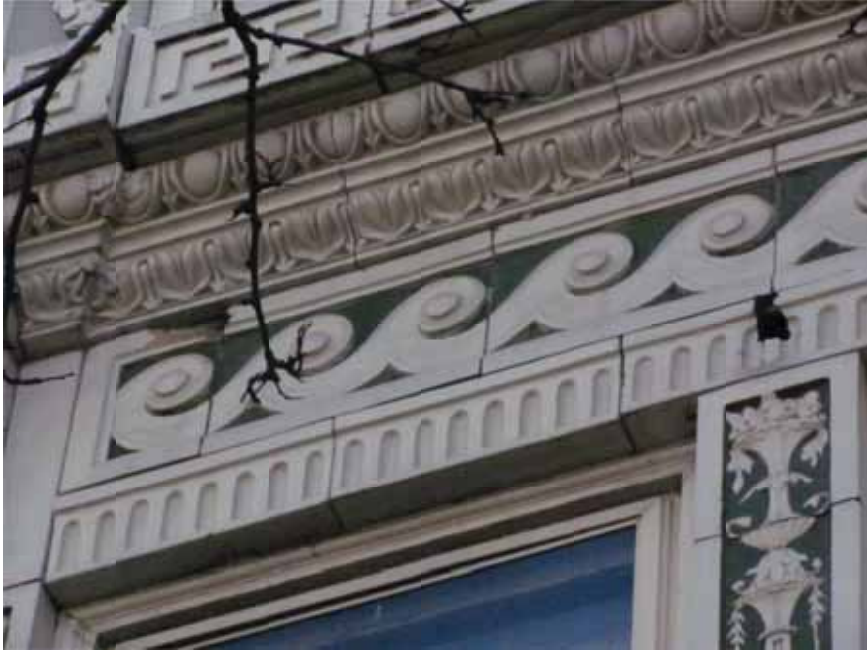
*Figure 4. One unit with a hole and one spalled unit.*

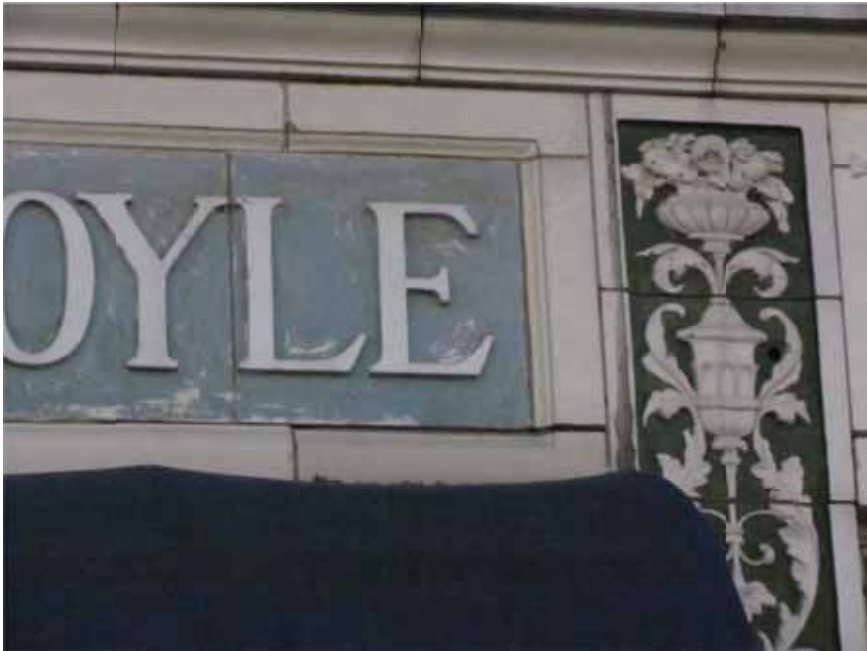
*Figure 5. One displaced unit above the first floor storefront.*

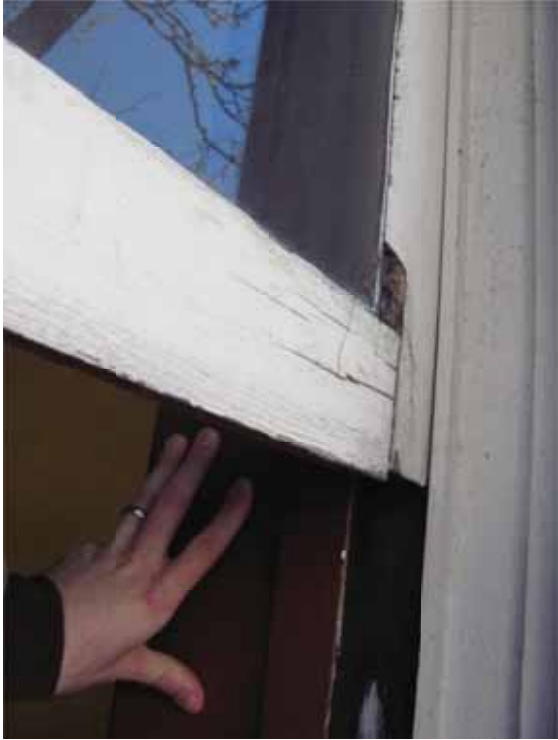
*Figure 8. The wood windows are in fair condition, with some wood decay and displacement of window sash joinery.*

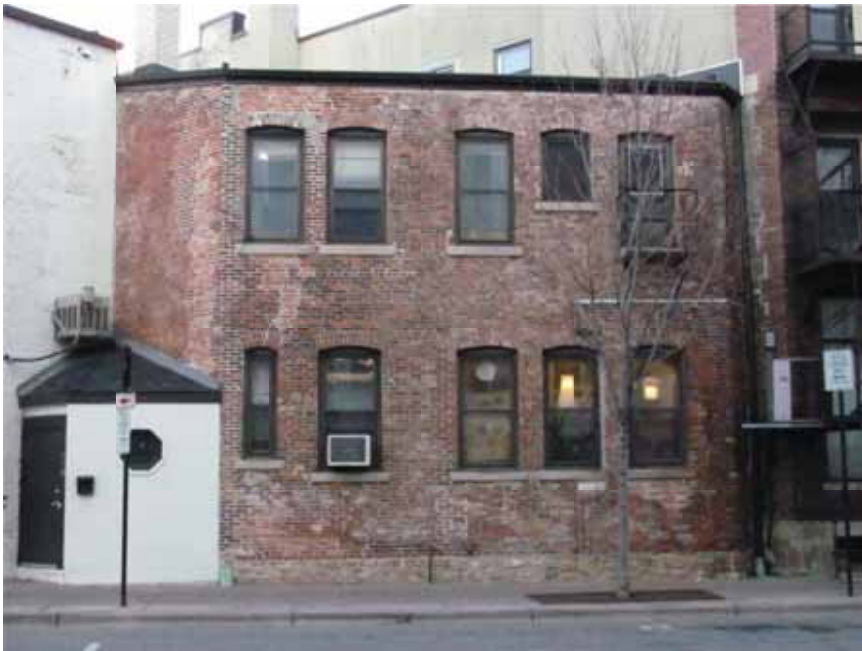
*Figure 9. The Fairchild Street facade.*

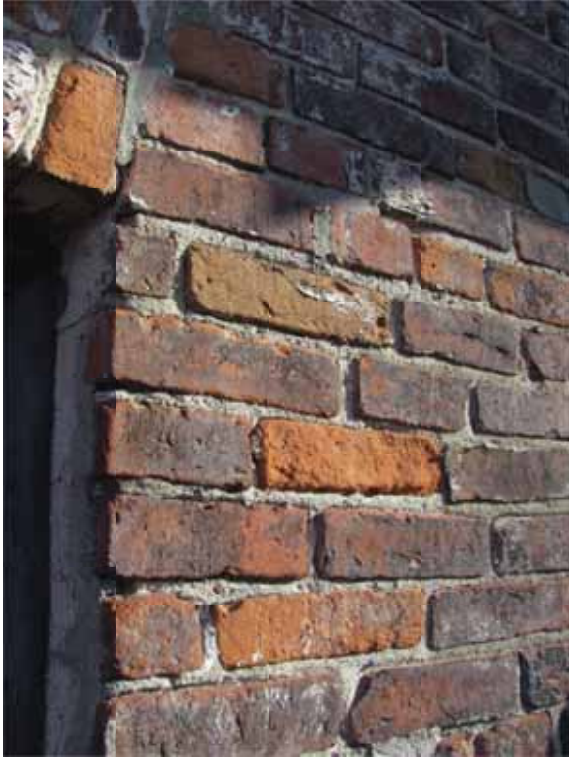
*Figure 10. Left: Individual brick units were observed to have erosion or spalling of the face.*

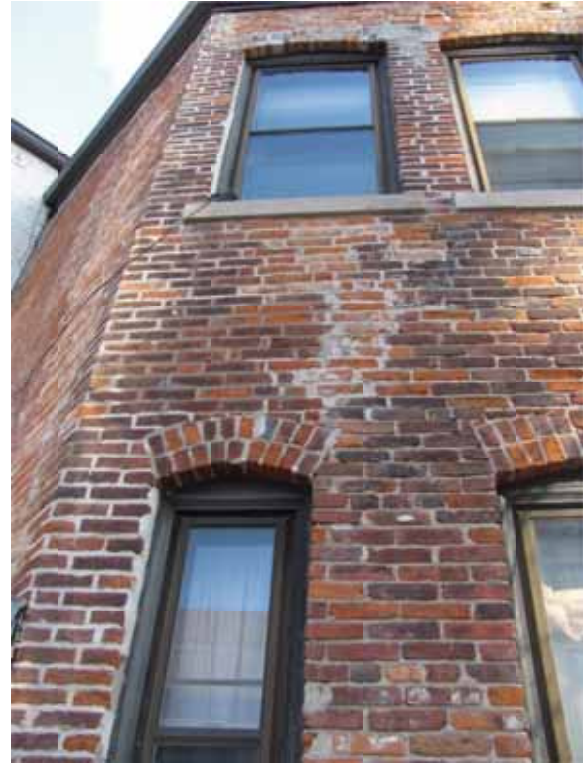
*Figure 11. Right: Cracks and spalls that have been previously filled with mortar were observed.*

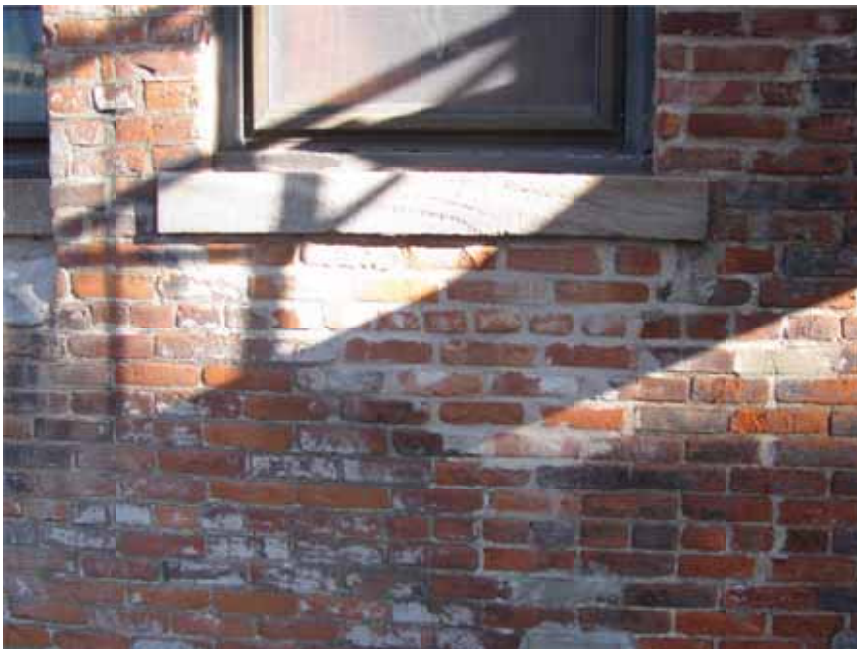
*Figure 12. Localized areas of brick masonry appear to have been rebuilt previously.*

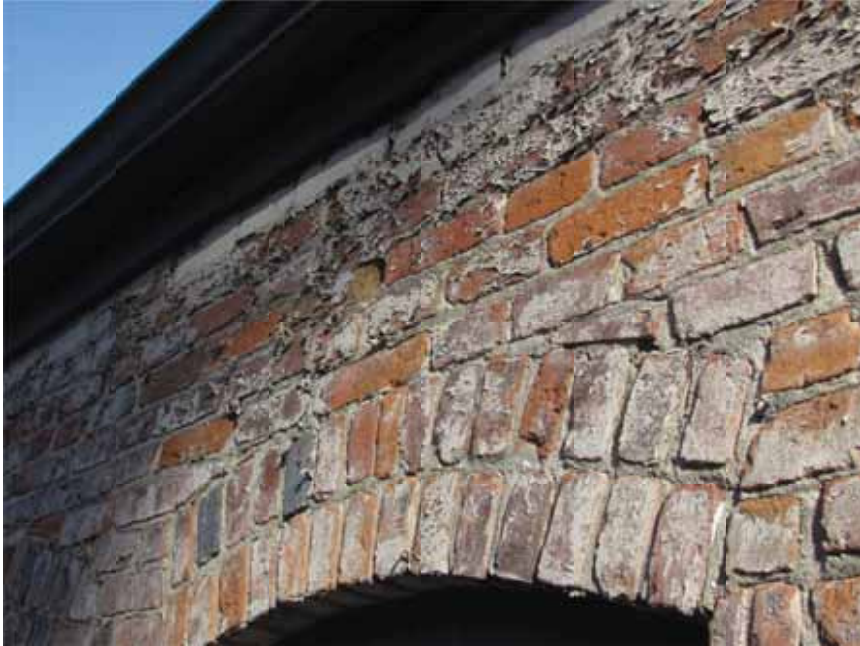
*Figure 13. Remnants of a previous coating on the masonry were observed.*

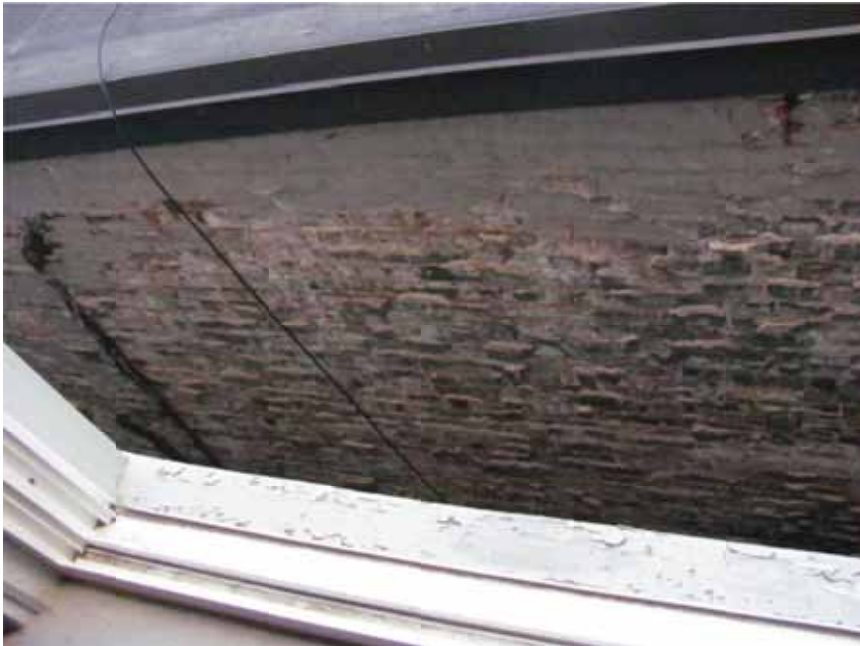
*Figure 14. The masonry party wall as viewed from the adjacent building appeared to be in fair condition.*

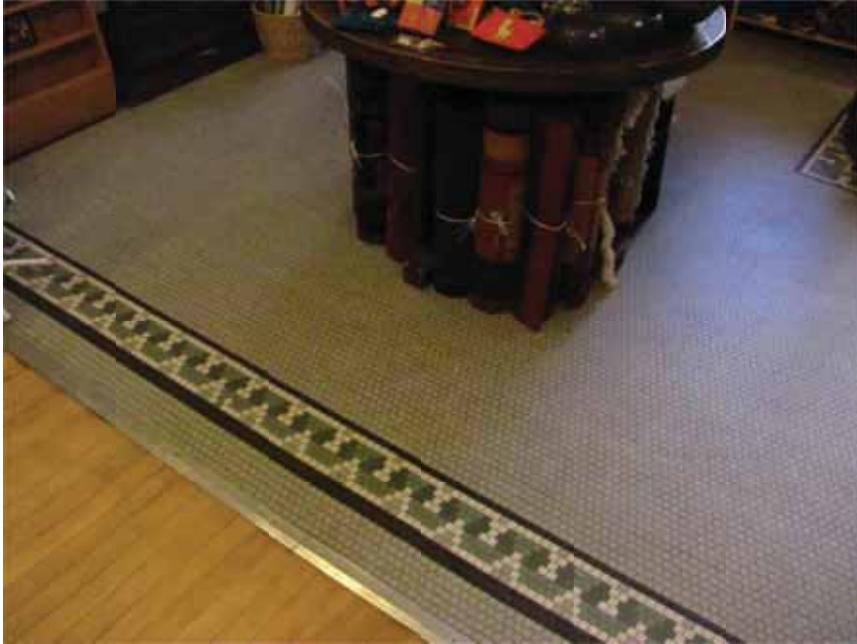
*Figure 15. Hardwood and mosaic ceramic tile flooring in the first floor retail space.*

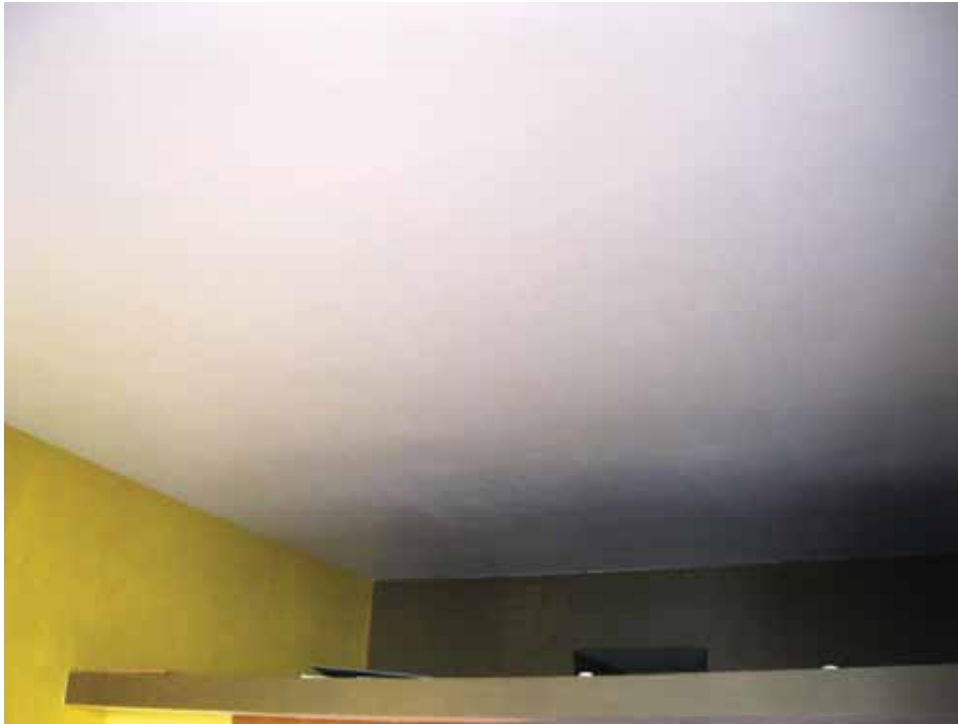
**Photo 8** – 2<sup>nd</sup> floor apartment ceiling

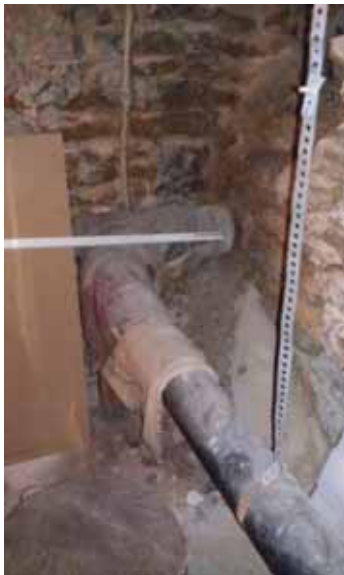
The heating system consists of a gas-fired atmospheric hot water boiler located in the basement. A gas-fired domestic water heater is next to the boiler. The retail space has an air conditioning unit but the apartments not air conditioned. There is a single gas meter and single water meter for this building, which serves only this building. The roof drains into a gutter along N. Fairchild St. and into an exterior downspout .

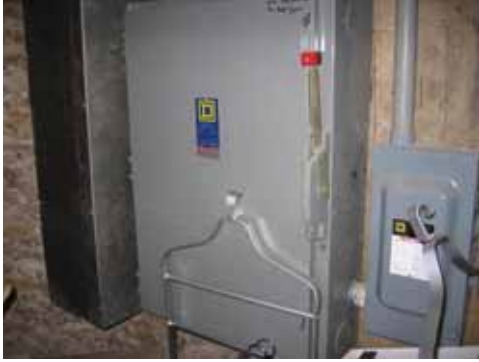
Building main disconnect.

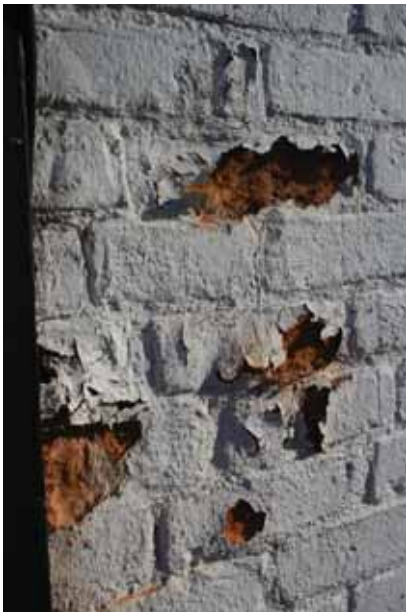
Exterior: View of damaged brick veneer

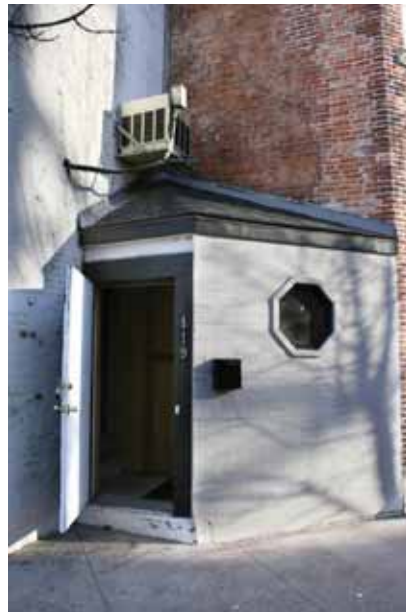
Exterior: Entry to apartment on N Fairchild Street

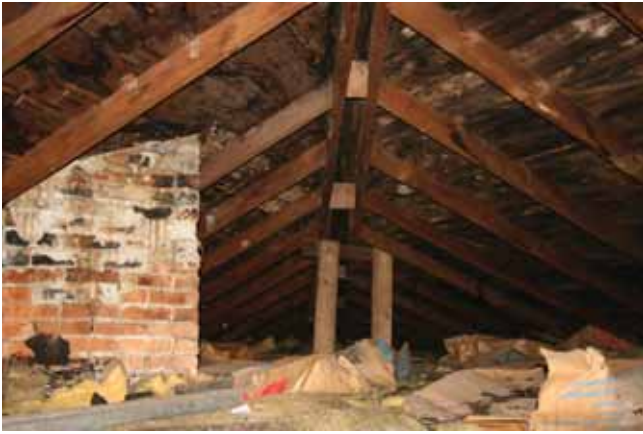
Attic: View toward flat iron corner showing damage to chimney

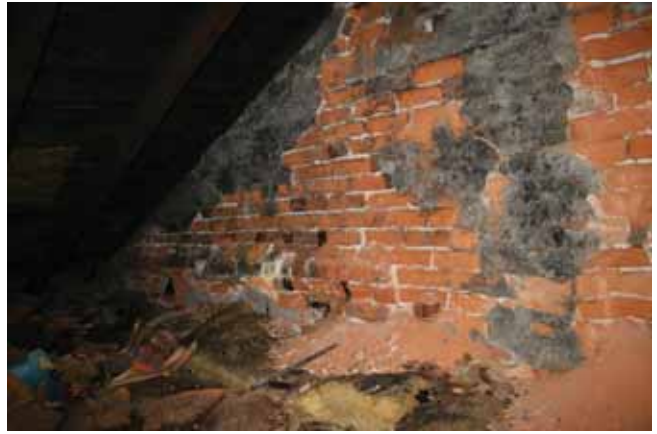
Attic: View toward wall between 127-129 state street and the castle and doyle building showing significant damage to existing brick

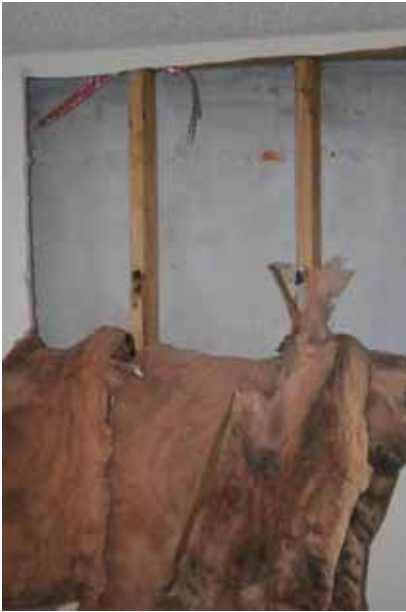
Third Floor: Section of exterior wall exposed showing back of brick and moisture within the insulation space

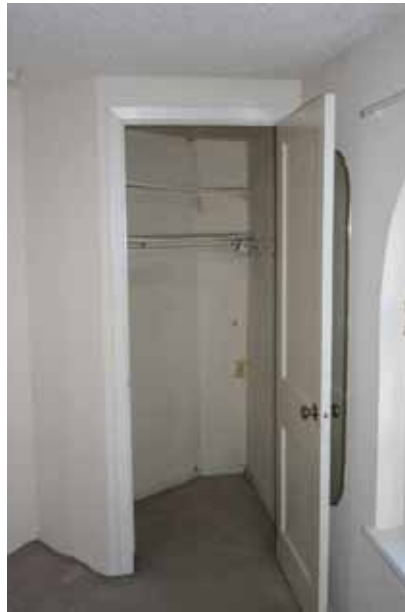
Third Floor: View of bedroom closet at Flat-Iron building corner

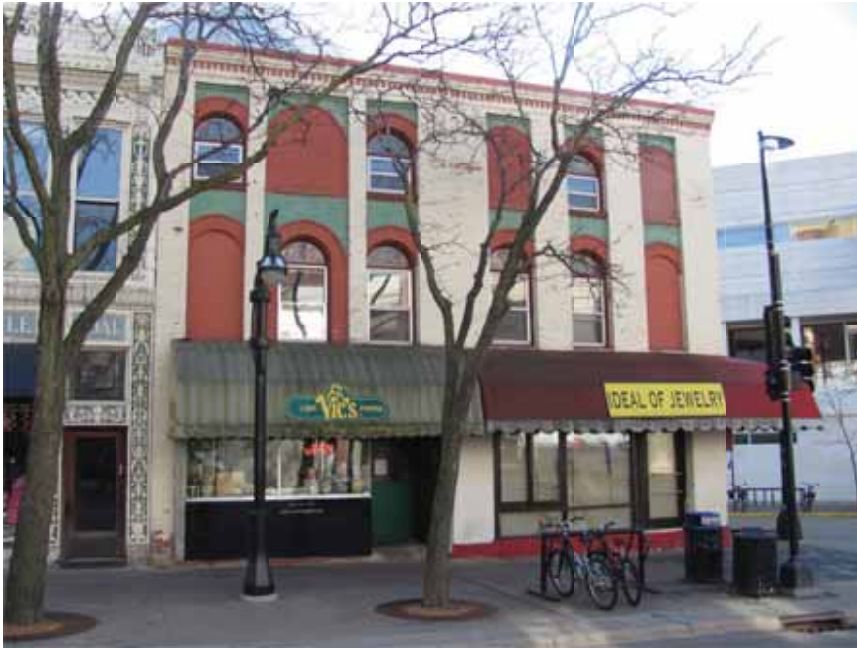
*Figure 1. Overall view of the State Street facade.*

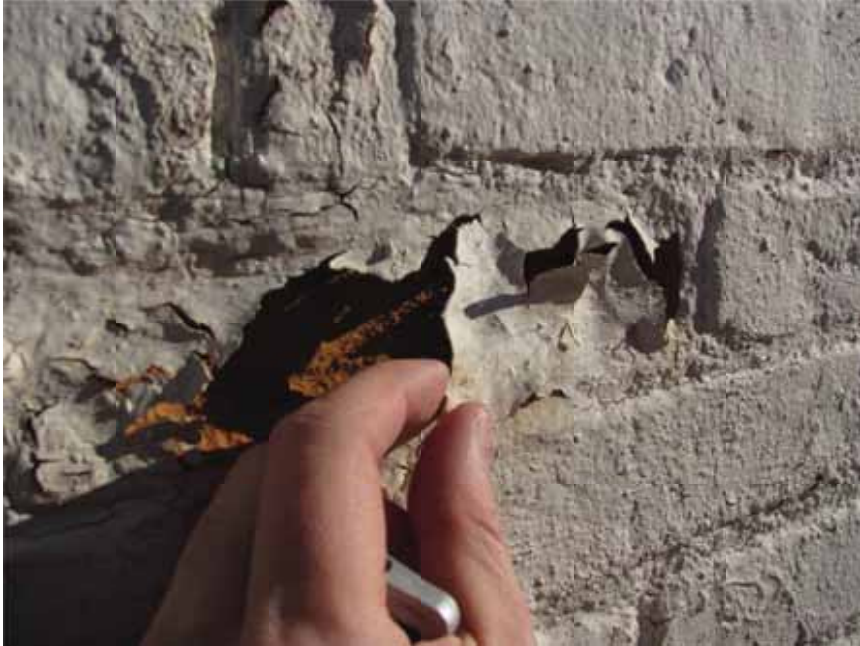
*Figure 3. Loss of the coating reveals severely deteriorated brick units.*

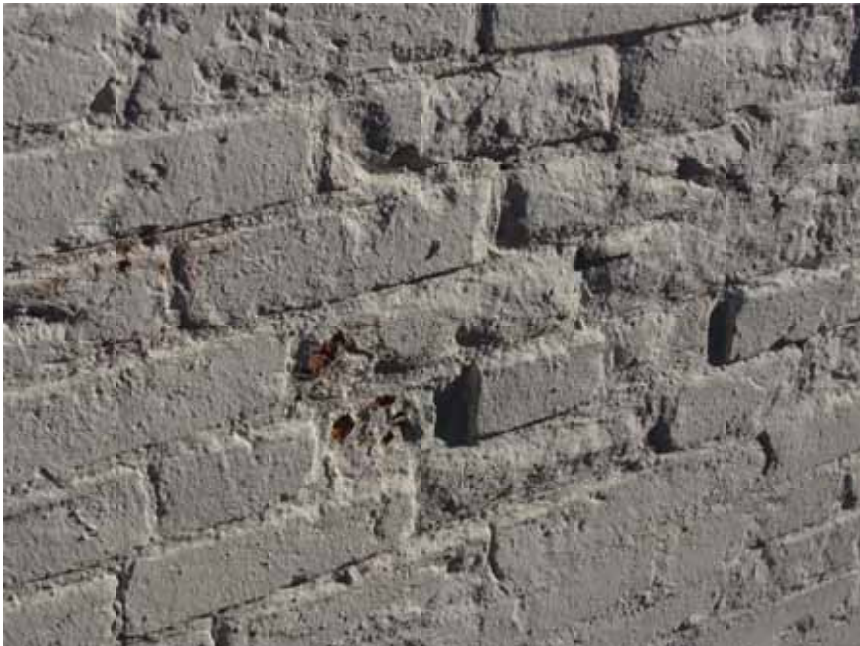
*Figure 4. The coating layers were applied over unrepaired deteriorated masonry.*

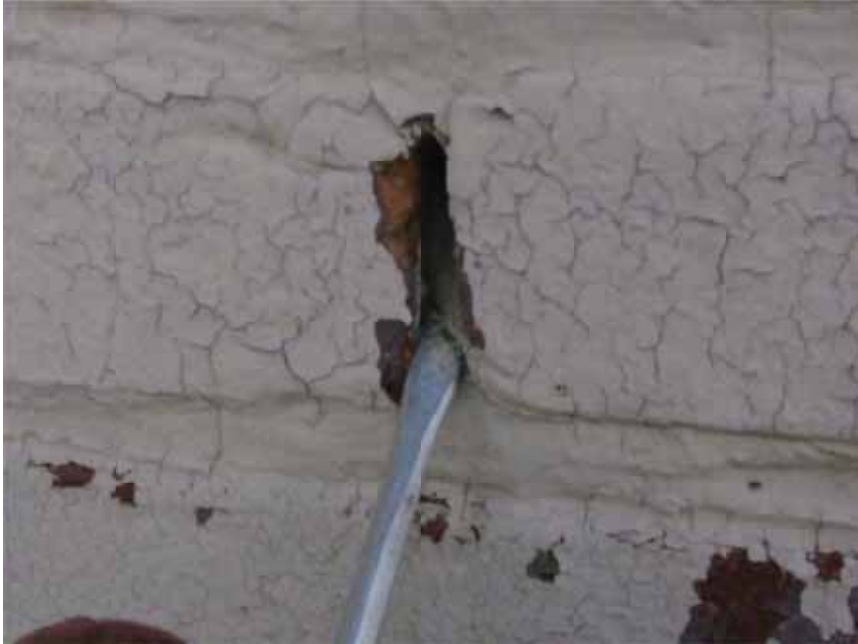
*Figure 5. Mortar behind the coating layers is friable and has disintegrated.*

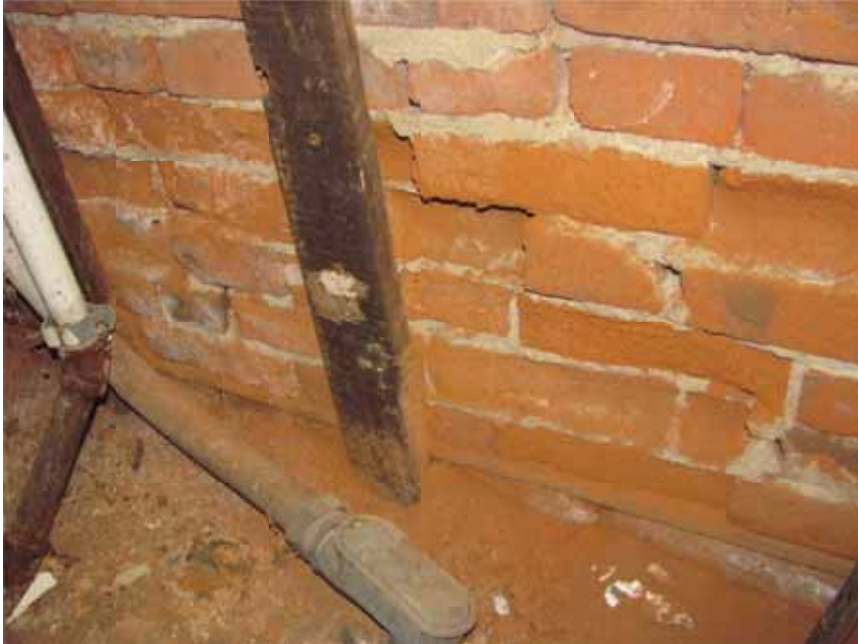
*Figure 7. Deterioration of the back-up masonry at the interior of the building.*

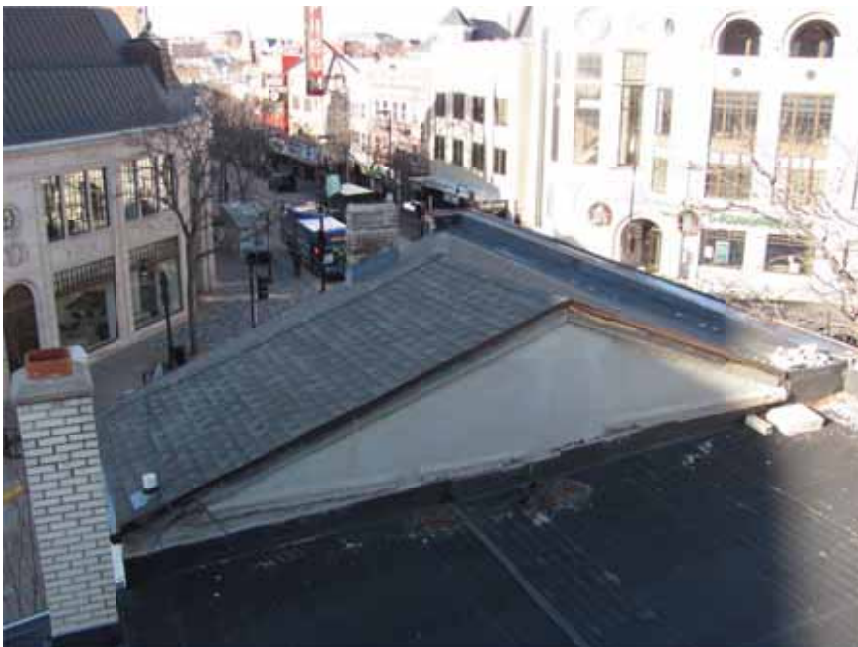
*Figure 8. Overview of the roof.*

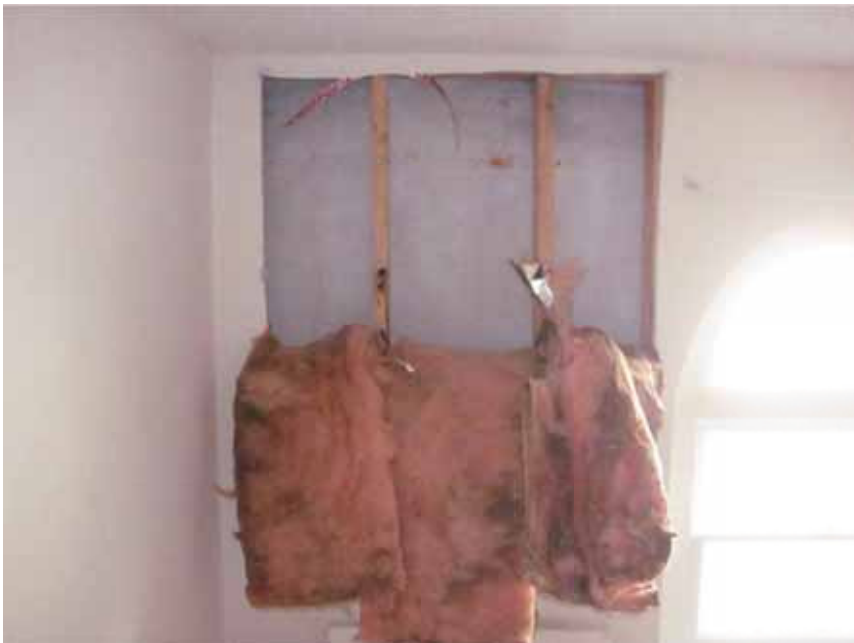
*Figure 12. Staining and evidence of moisture penetration was observed on the batt insulation and plaster at an inspection opening created at the third floor during the site visit.*

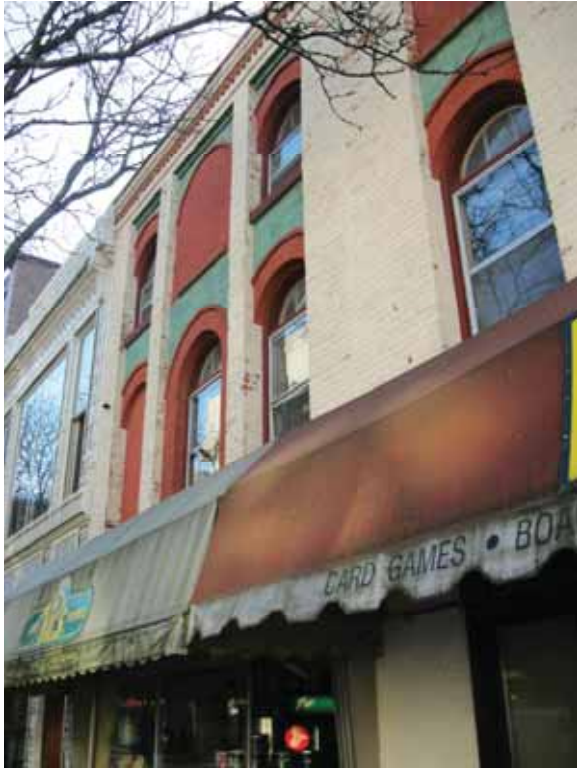
Photo 1 – State Street elevation

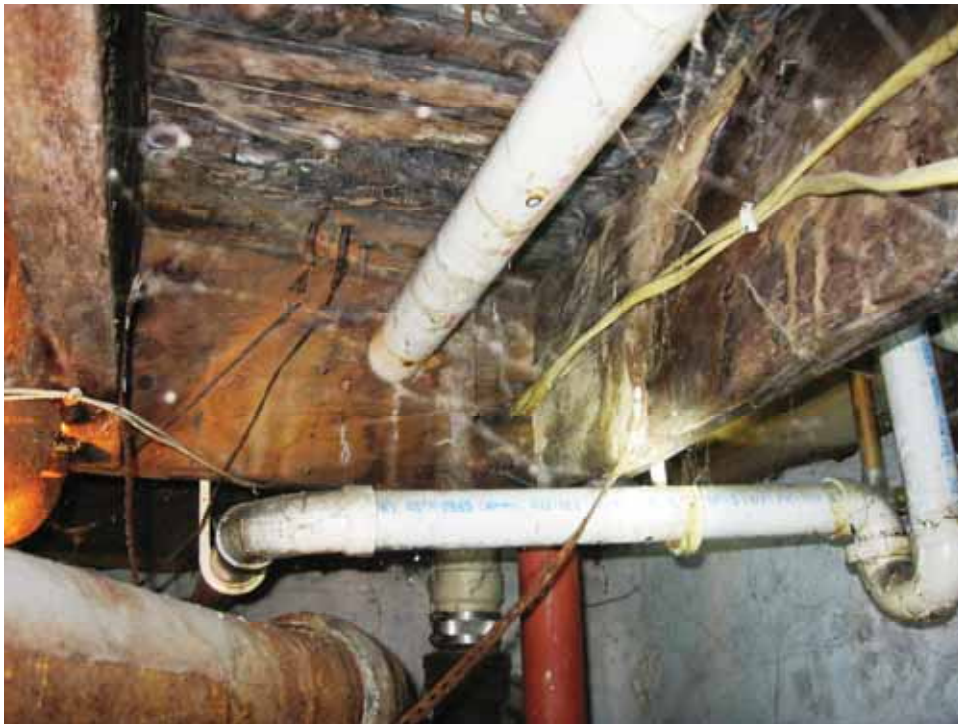
**Photo 7** – 1<sup>st</sup> floor framing with water damage

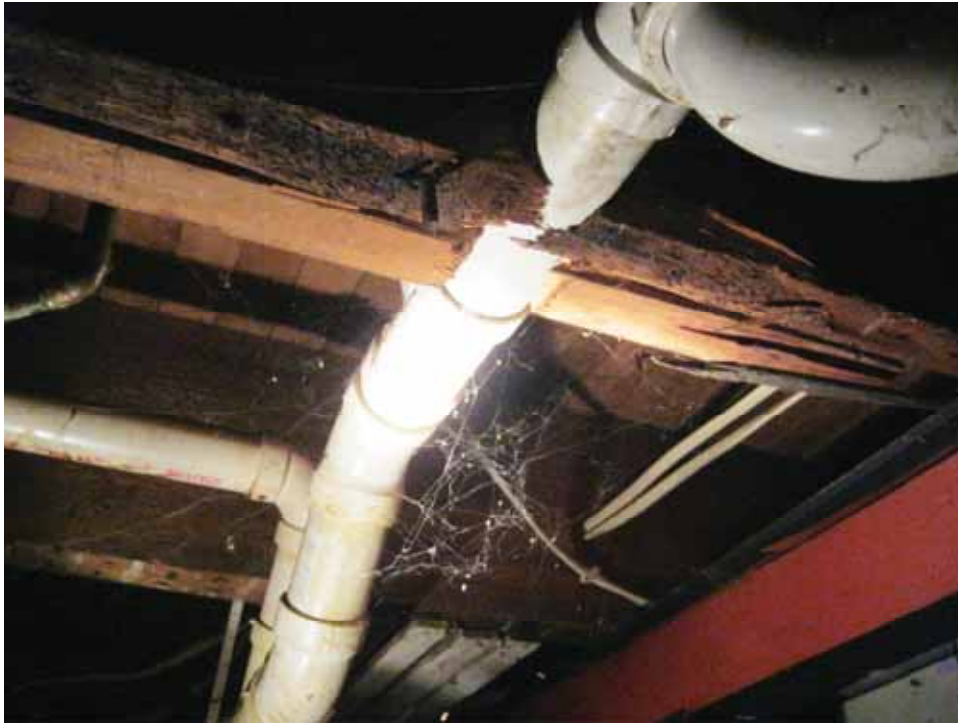
**Photo 8** – 1<sup>st</sup> floor framing notched for plumbing

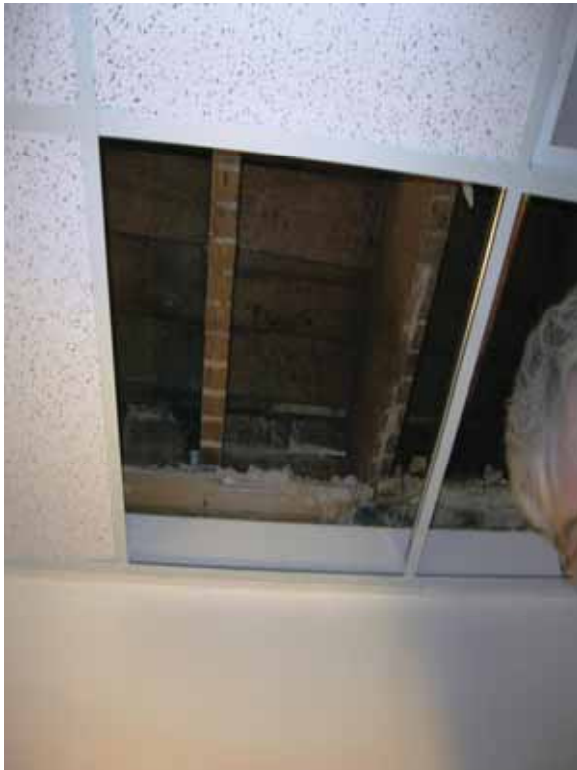
**Photo 12** – 2<sup>nd</sup> floor joist framing observed from 1<sup>st</sup> floor retail space

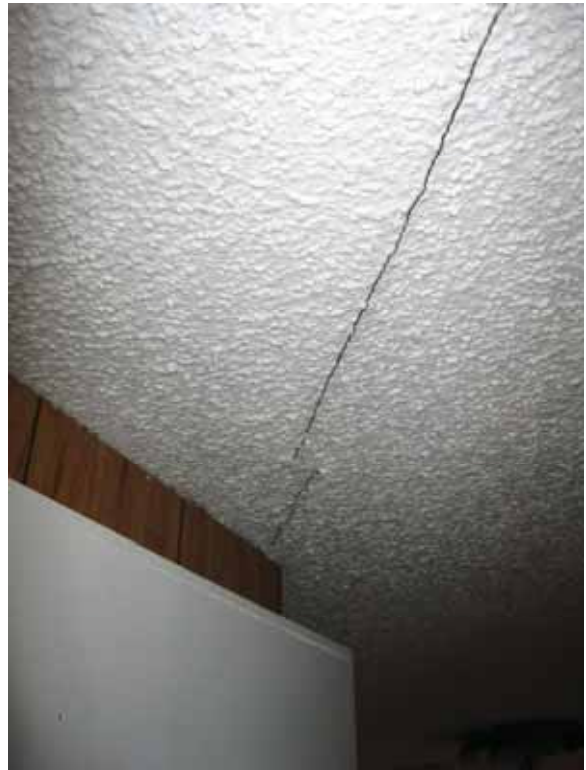
**Photo 13** – Ceiling finish distress beneath roof

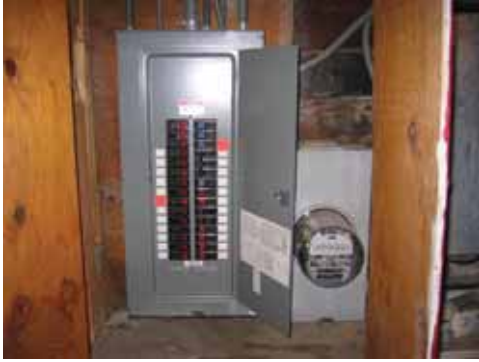
Part of the electrical service in a constructed cabinet.
