**SURVEY OF CONDITIONS FOR PROPOSED
BADGER ROAD/ANN STREET/PARK STREET
REDEVELOPMENT PROJECT**

Report on Blight Determination

**Prepared by:
Mid-America Planning Services, Inc.
621 N. Sherman Ave.
Madison, WI 53704
608-249-2514**

July 12, 2005

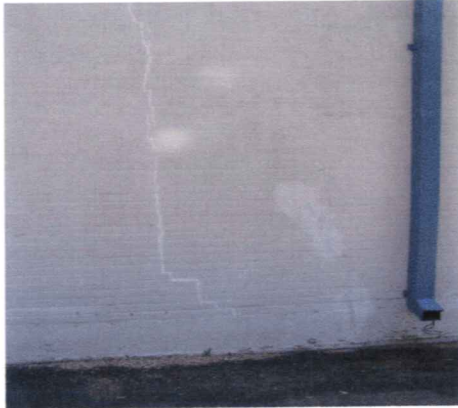
1818 South Park St
Cracked Wall
October 25, 2003

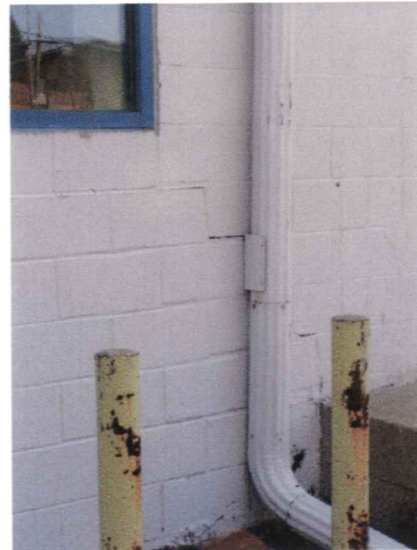
2216 South Park St
Cracked Wall
May 25, 2003

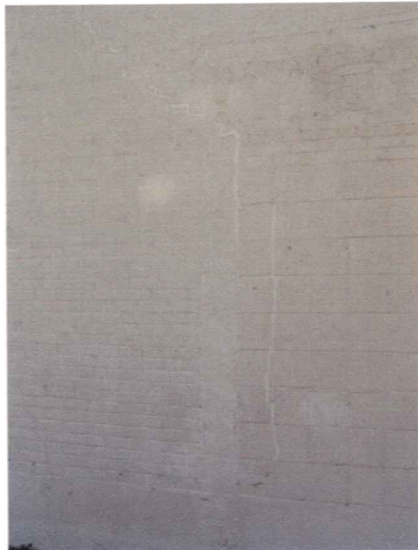
1818 South Park St
Cracked Wall
October 25, 2003

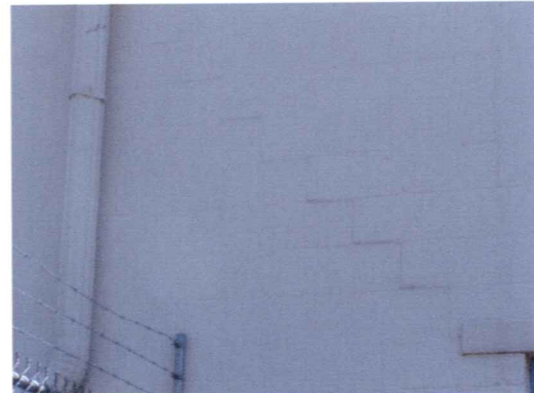
1818 South Park Street
Cracked Wall
October 25, 2003

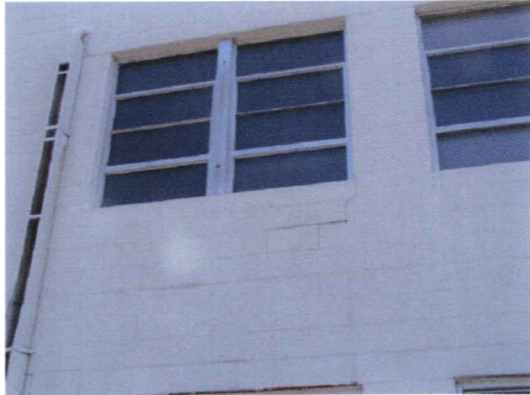
2216 South Park Street
Cracked Wall
May 25, 2003

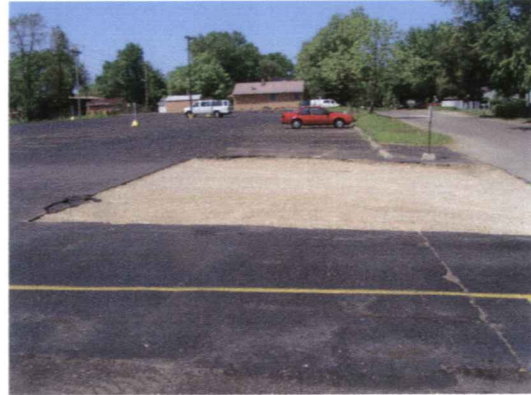
1202 Ann Street
Blighted Parking Lot
October 25, 2003

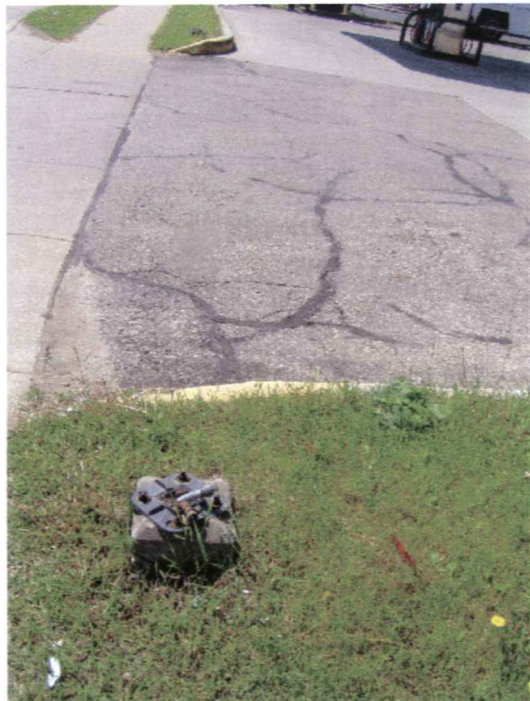
2200 South Park Street
Obsolete sign base and cracked
driveway
May 25, 2003

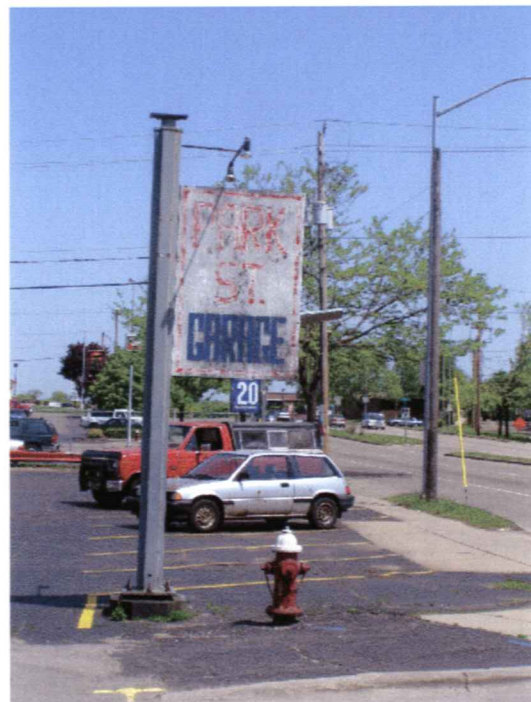
2116 South Park Street
Blighted sign and blighted parking lot
May 25, 2003

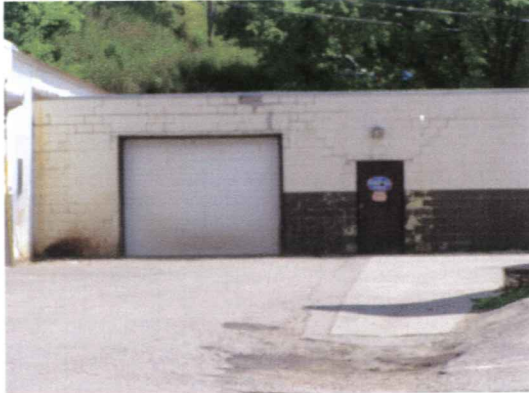
2431 South Park Street
Cracked wall, blighted parking lot
May 25, 2003

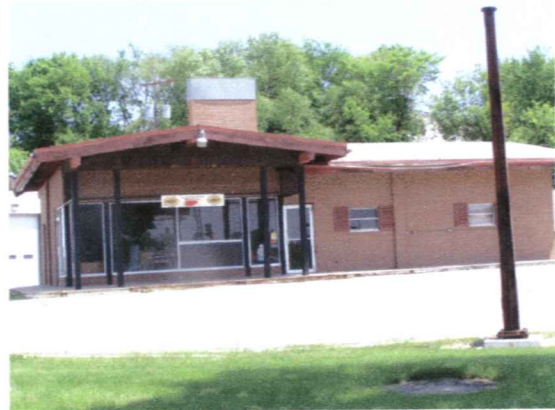
2421 South Park Street
Vacant building, sagging eave trough
May 25, 2003

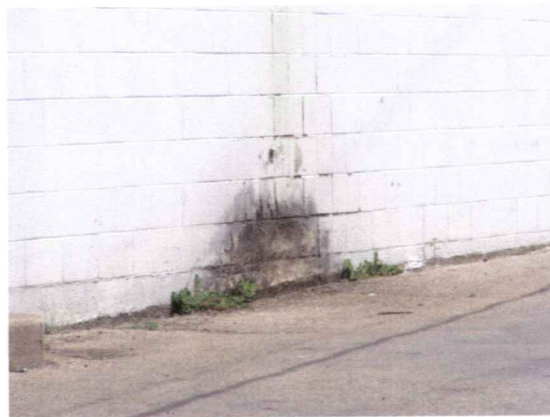
2431 South Park Street
Cracked and water damaged wall,
May 25, 2003

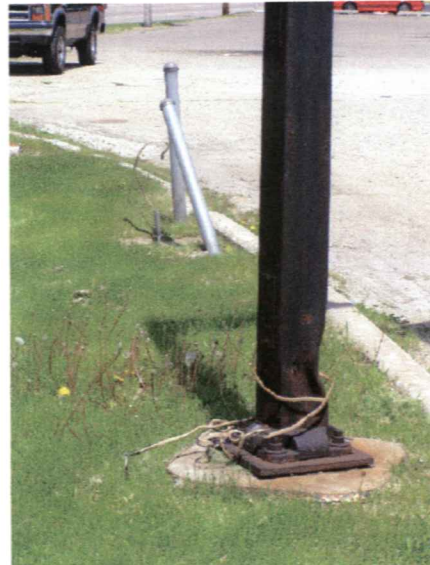
2421 South Park Street
Exposed wiring, bent and dented
posts
May 25, 2003

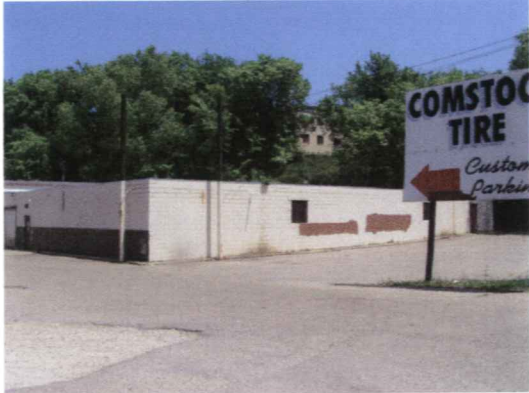
2421 South Park Street
Blighted driveway and parking lot,
water damaged wall
May 25, 2003

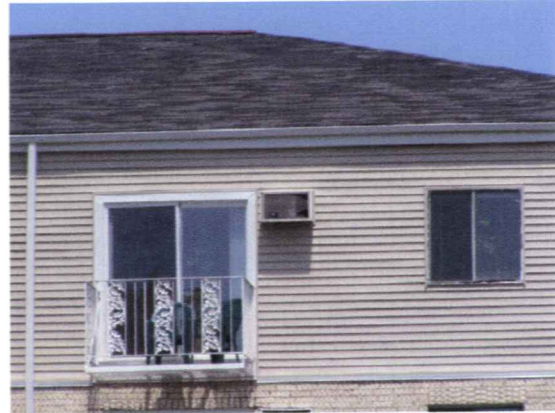
700 West Badger Road
Deteriorated roof and window frame
May 25, 2003

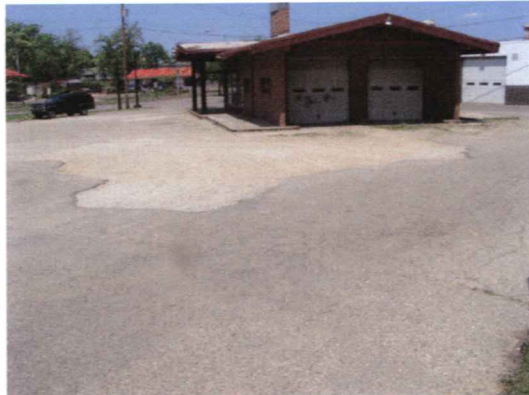
2421 South Park Street
Blighted driveway and parking lot
May 25, 2003

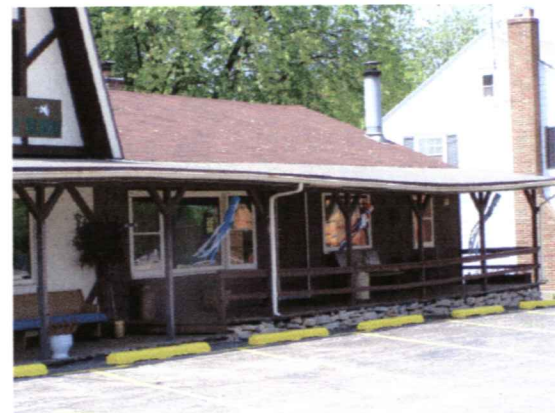
2465 South Perry Street
Sagging Roof
May 25, 2003

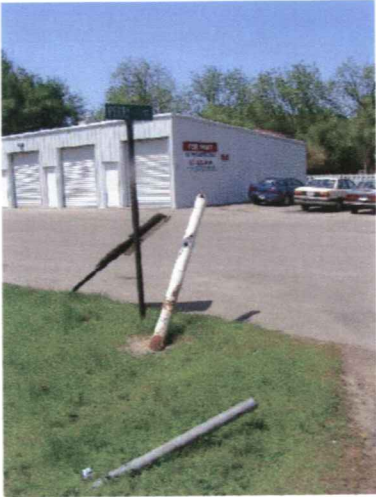
2505 South Perry St
Bent Posts
May 25, 2003

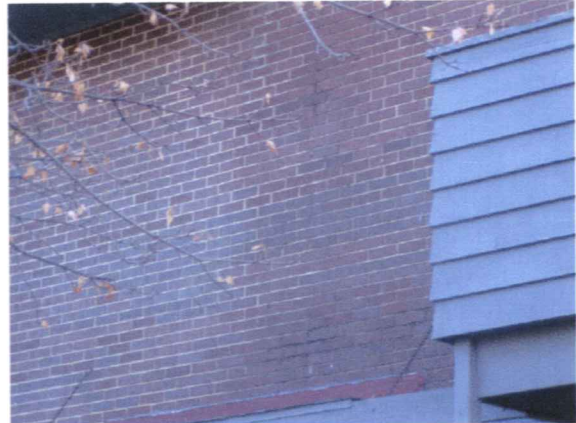
1850 Beld Street
Cracked wall with water damage
October 25, 2003

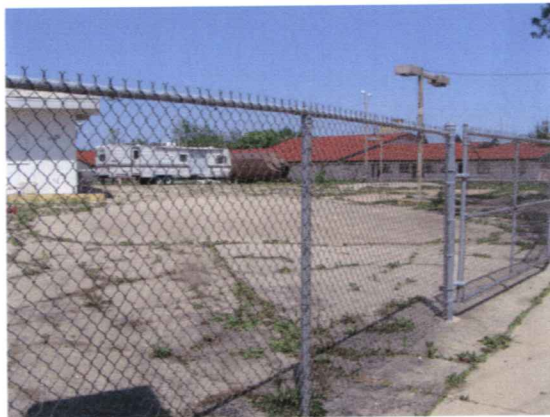
1010 Ann Street
Blighted Parking Area
October 25, 2003

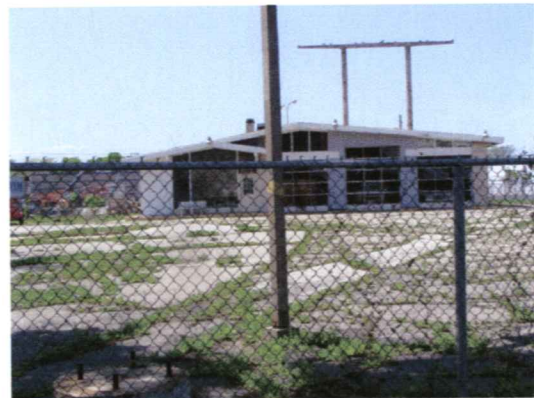
1010 Ann Street
Abandoned sign posts, blighted
parking areas
October 25, 2003

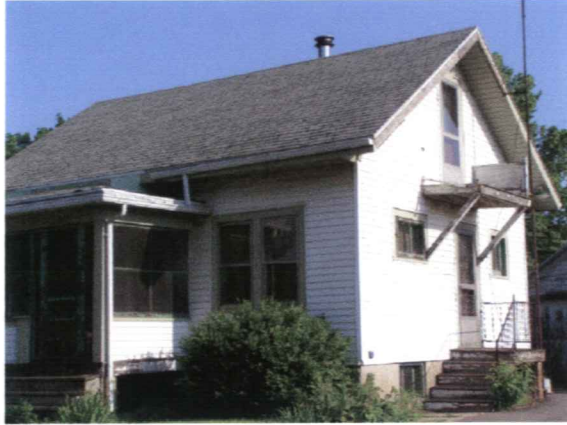
836 Hughes Place
Deteriorated porches and roof at
May 25, 2003

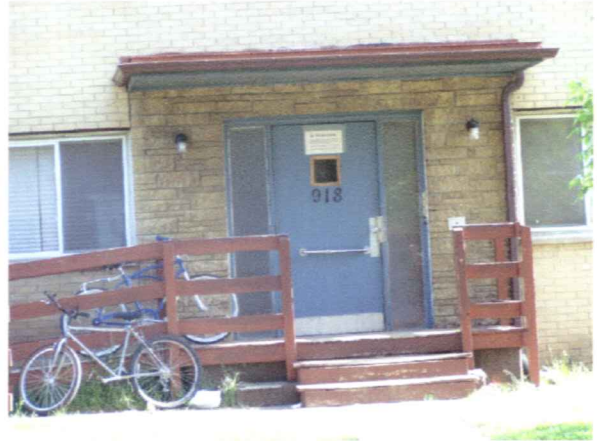
918 Magnolia Lane
Deteriorated porch, steps and unsafe
steps
May 25, 2003

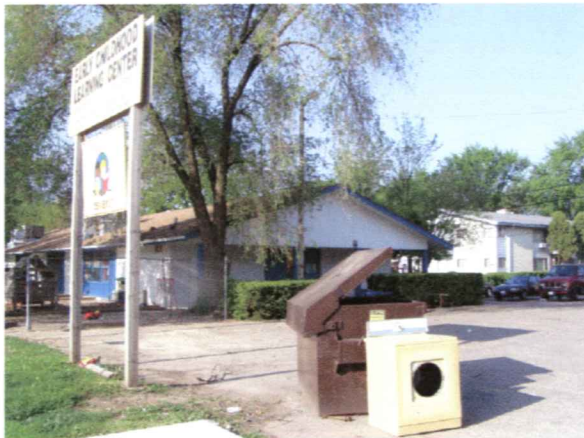
833 Hughes Place
Lack of trash container screening
May 25, 2003

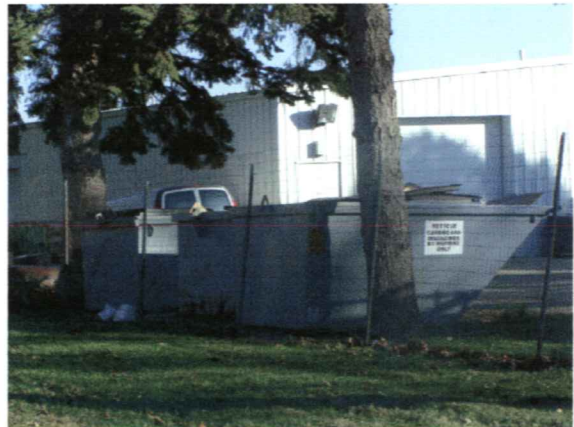
1114 Ann Street
Unscreened trash container
October 25, 2003

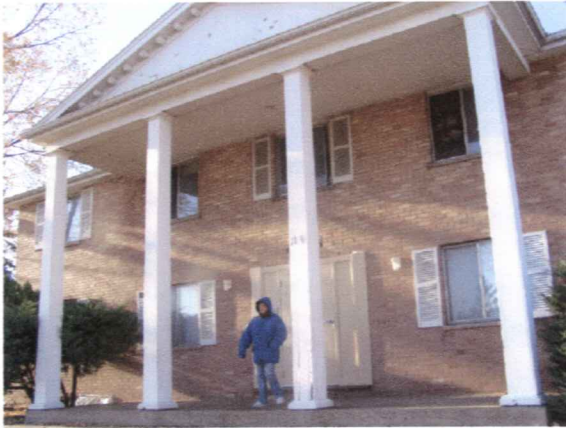
1114 Ann Street
Deteriorated porch posts
October 25, 2003

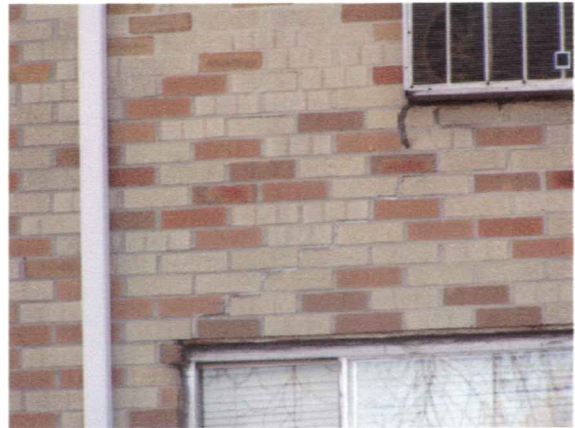
1114 Ann Street
Cracked Wall
October 25, 2003

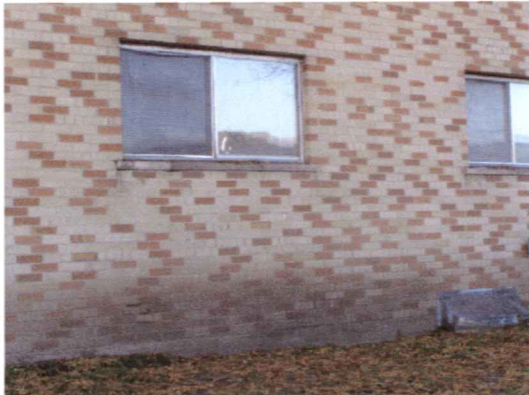
1114 Ann Street
Water damaged wall
October 25, 2003

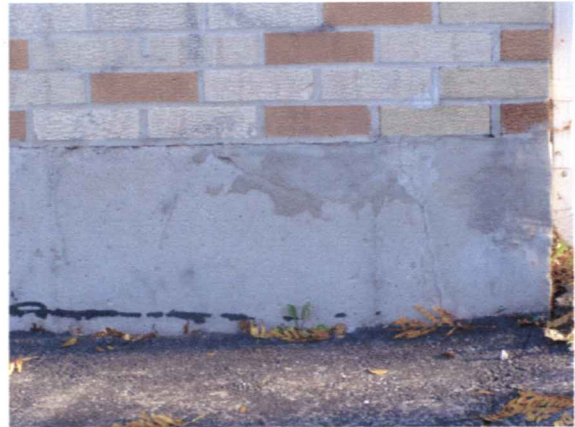
1114 Ann Street
Cracked foundation
October 25, 2003

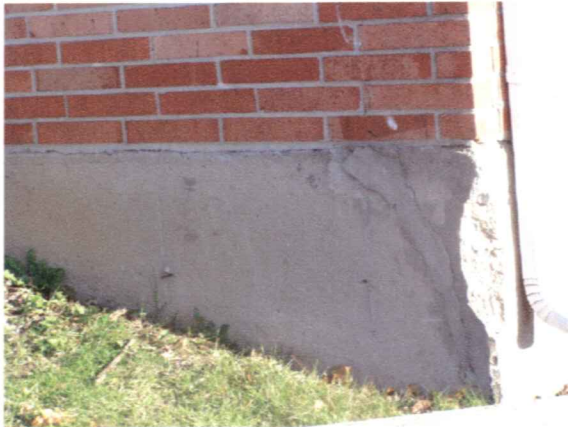
1114 Ann Street
Cracked foundation
October 25, 2003

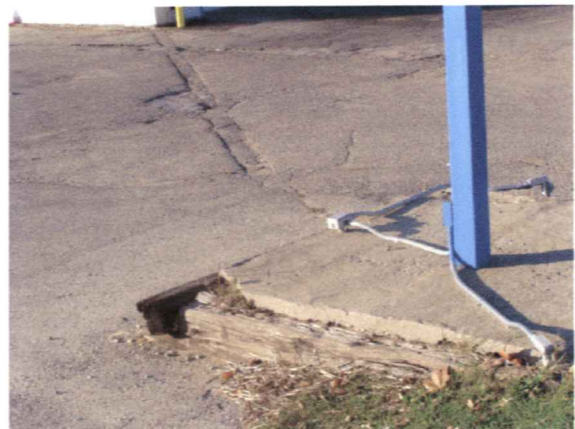
1824 South Park Street
Deteriorated sign base
October 25, 2003

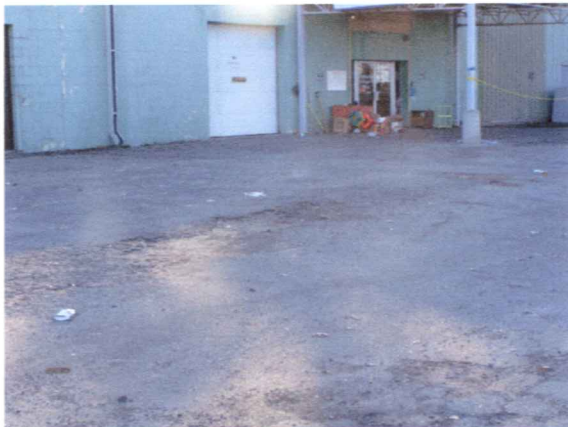
1500 South Park Street
Deteriorated drive
October 25, 2003

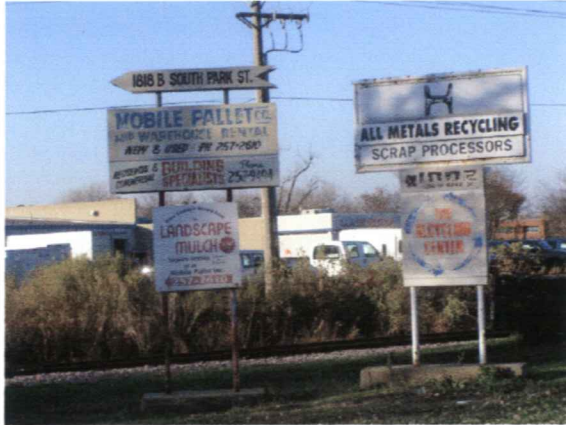
1800 South Park Street
Signs in disrepair
October 25, 2003

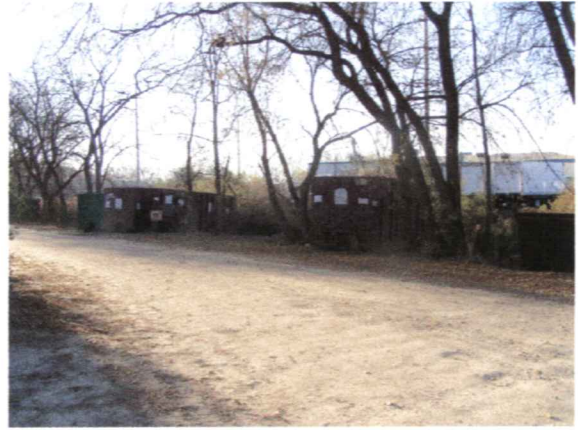
1800 South Park Street
Non-functional trash containers
October 25, 2003

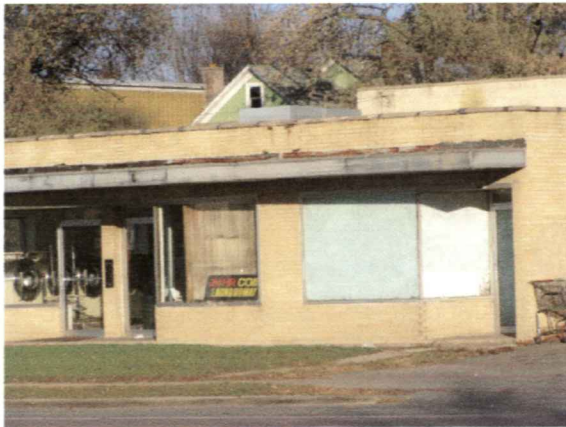
1817 South Park Street
Deteriorated roof
October 25, 2003

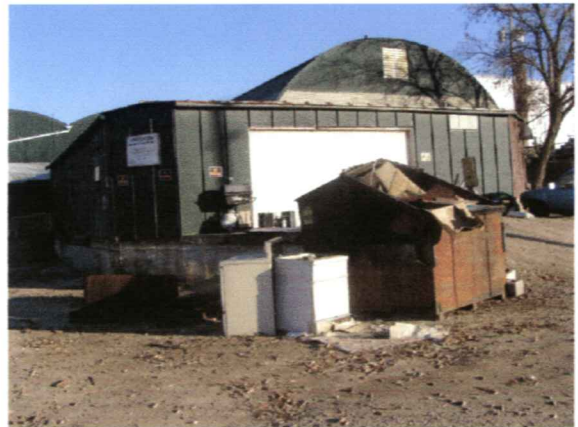
1818 South Park Street
Trash/unscreened trash containers
October 25, 2003

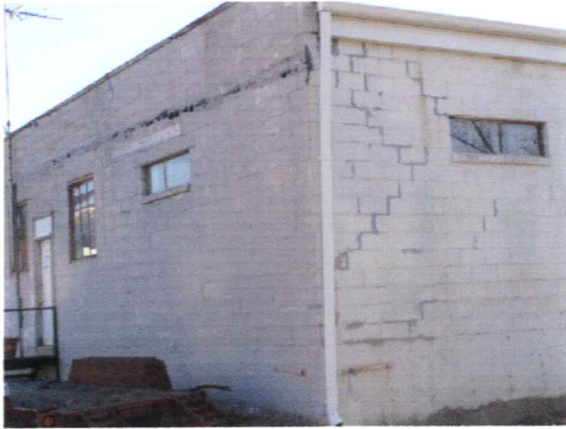
1818 South Park Street
Cracked wall and foundation
October 25, 2003

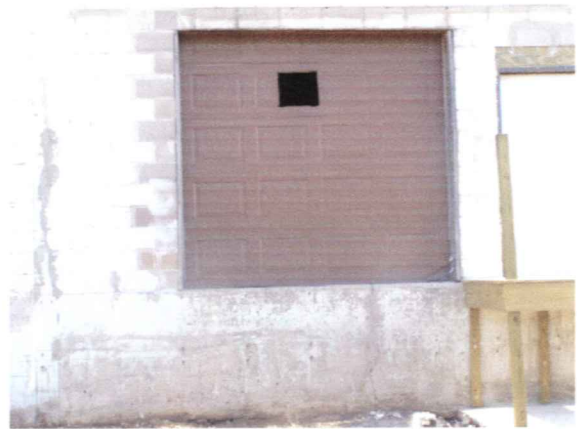
1818 South Park Street
Cracked wall and foundation
October 25, 2003

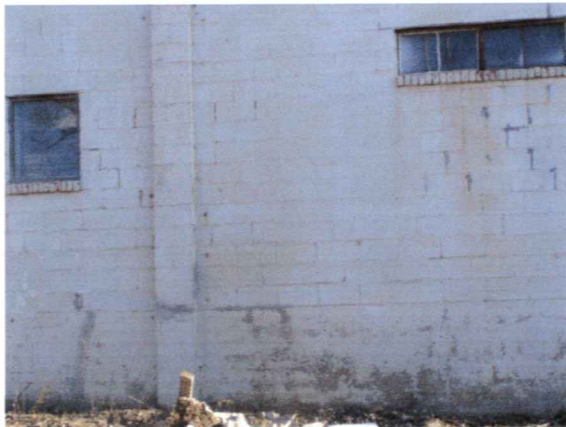
1818 South Park Street
Cracked wall and foundation
October 25, 2003

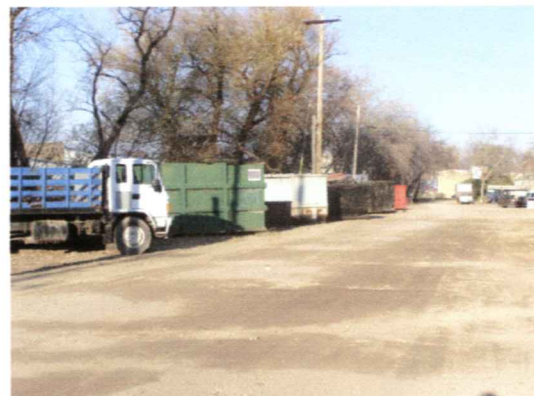
1800 South Park Street
Deteriorated Containers
October 25, 2003

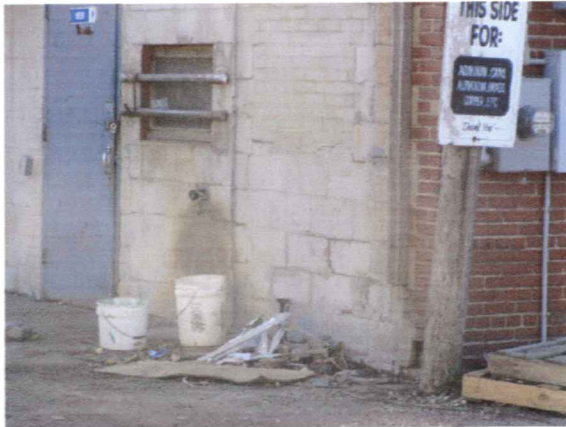
1818 South Park Street
Trash and cracked wall, deteriorated
door and window
October 25, 2003

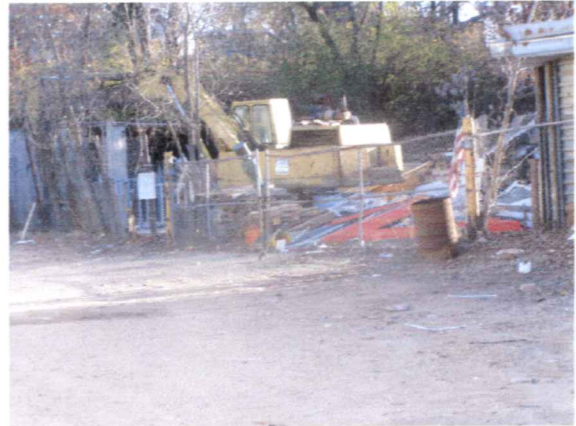
1818 South Park Street
Deteriorated fence/trash
October 25, 2003

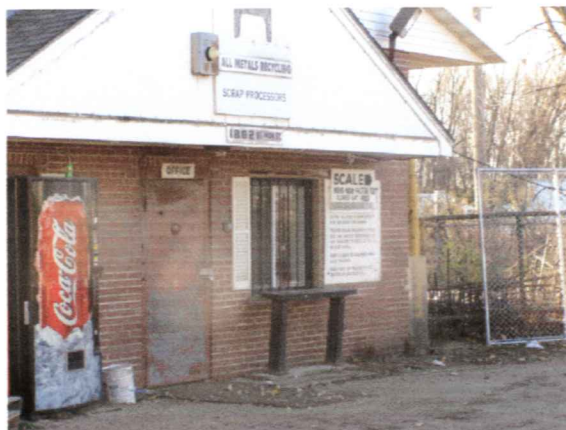
1818 South Park Street
Deteriorated door
October 25, 2003

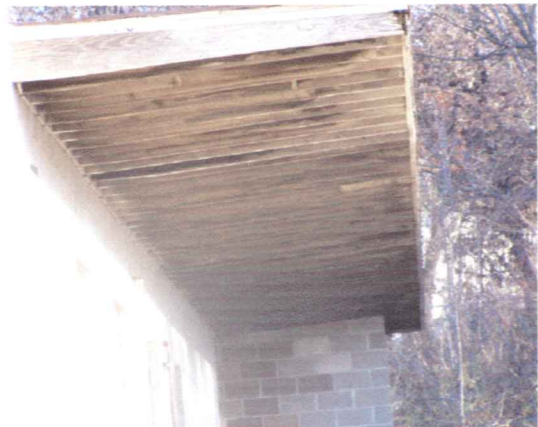
1818 South Park Street
Rotten fascia and roof joists
October 25, 2003

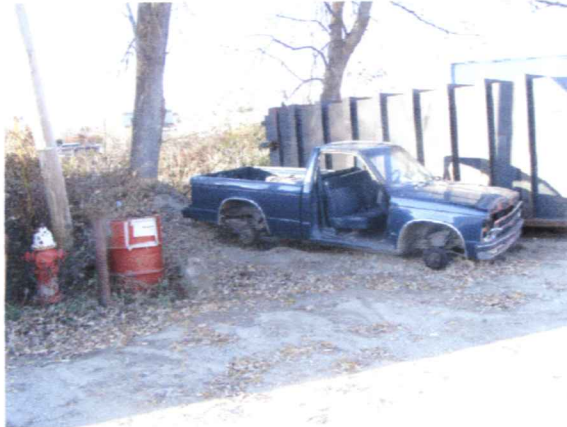
1800 South Park Street
Junked, abandoned truck
October 25, 2003

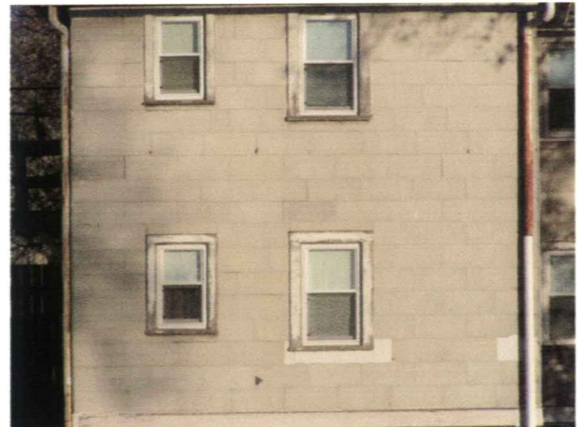
1810 Beld Street
Deteriorated wall and window frames
October 25, 2003

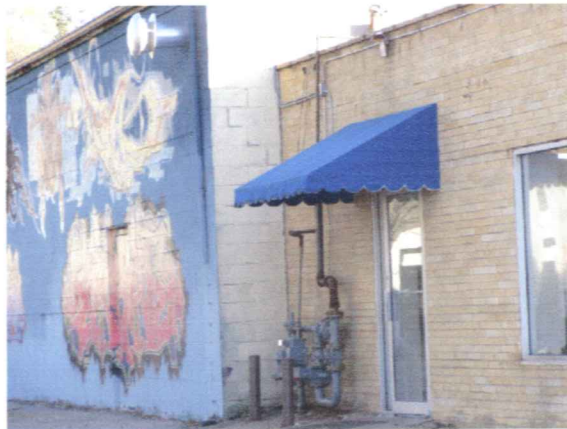
1817 South Park Street
Cracked wall
October 25, 2003

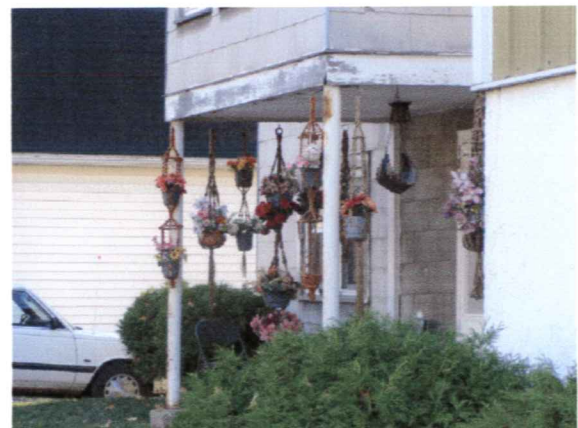
1810 Beld Street
Rotted porch
October 25, 2003

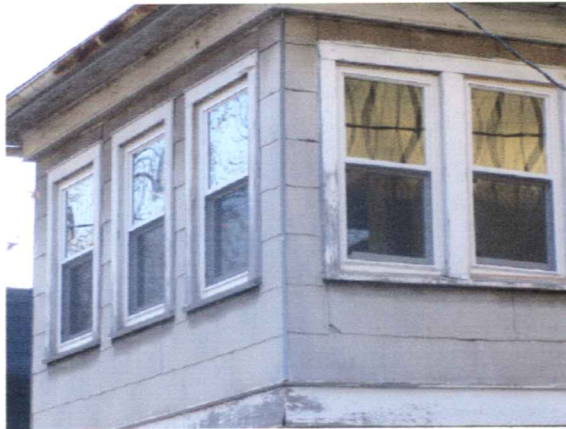
1810 Beld Street
Deteriorated windows
October 25, 2003

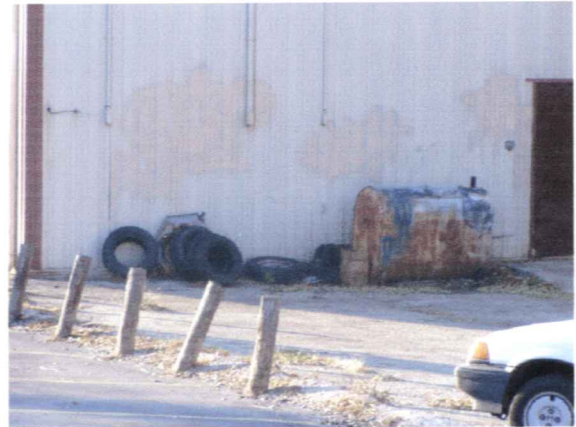
1817 South Park Street
Trash, bent posts
October 25, 2003

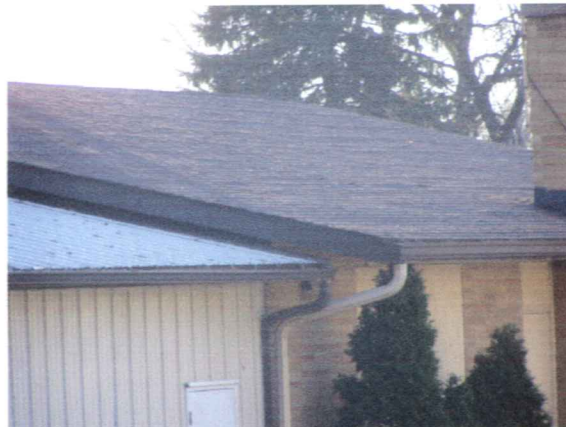
1823 South Park Street
Deteriorated shingles and boarded
windows
October 25, 2003

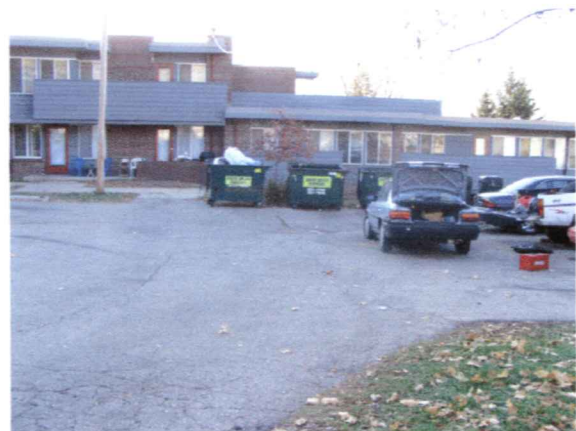
1850 Beld Street
Cracked drive, unscreened trash
containers
October 25, 2003

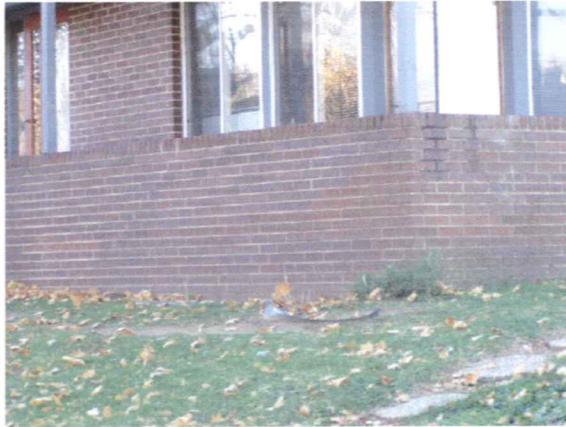
1850 Beld Street
Cracked wall
October 25, 2003

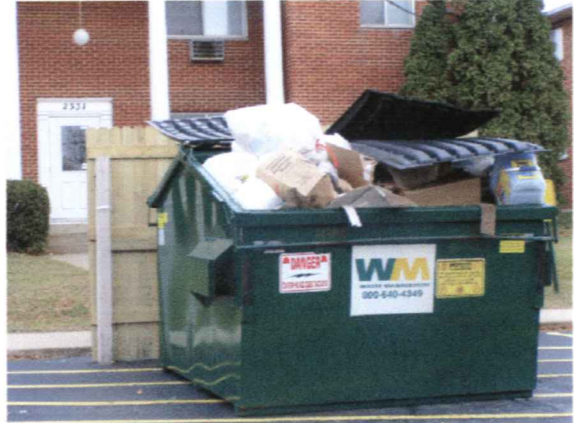
2331 Badger Parkway
Unscreened trash containers
October 25, 2003

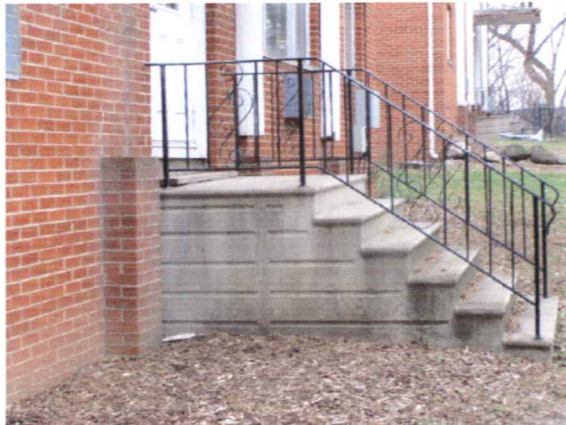
2306 Badger Parkway
Uneven porch
October 25, 2003

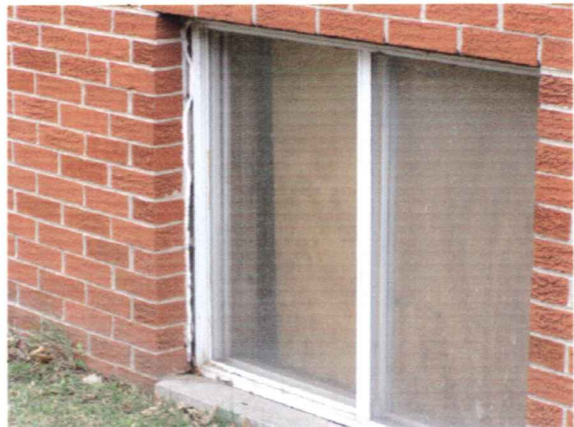
2306 Badger Parkway
Deteriorated window frame
October 25, 2003

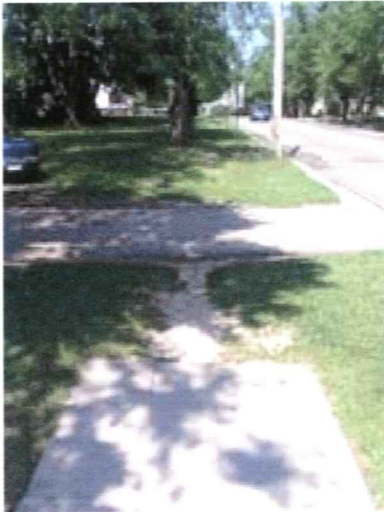
Badger road
Missing Sidewalk
July 7, 2005

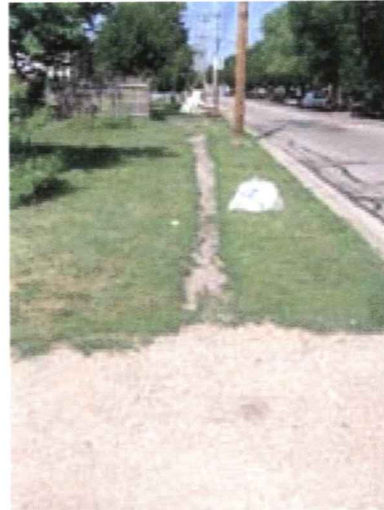
Badger Road
Missing Sidewalk
July 7, 2005

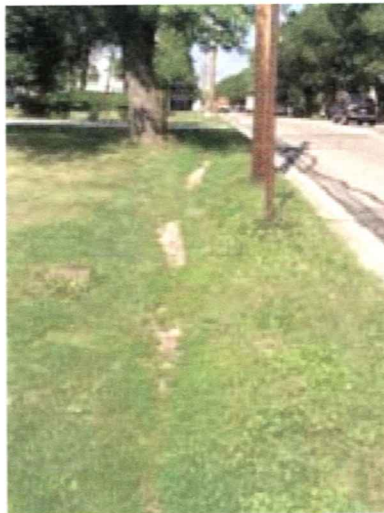
Badger Road
Missing Sidewalk
July 7, 2005

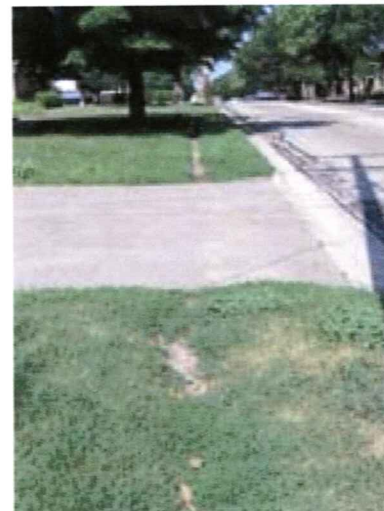
Badger Road
Missing Sidewalk
July 7, 2005

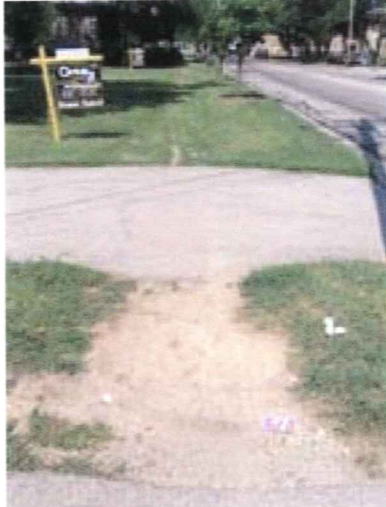
Badger Road
Missing Sidewalk
July 7, 2005

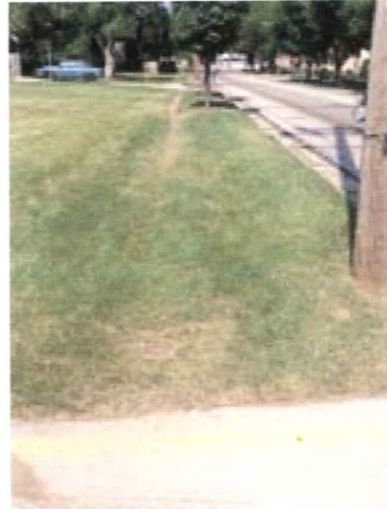
Badger Road
Missing Sidewalk
July 7, 2005

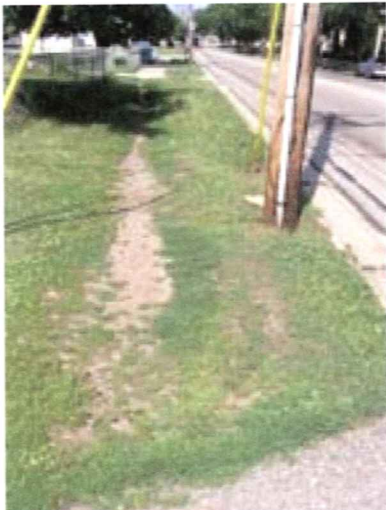
Missing Sidewalk
Badger Road
July 7, 2005

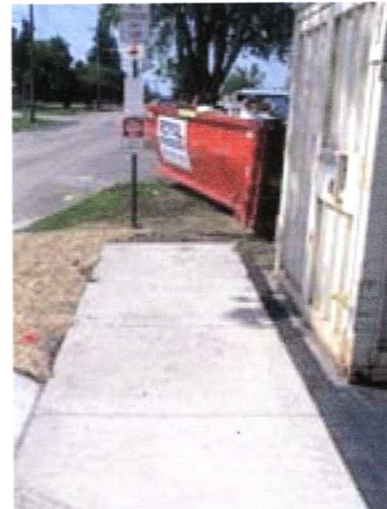
Missing Sidewalk
Perry Street
July 7, 2005

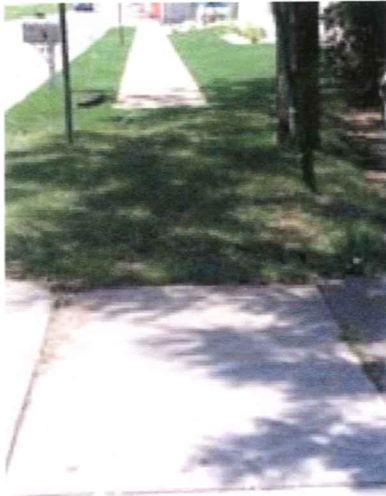
Perry Street
Missing Sidewalk
July 7, 2005

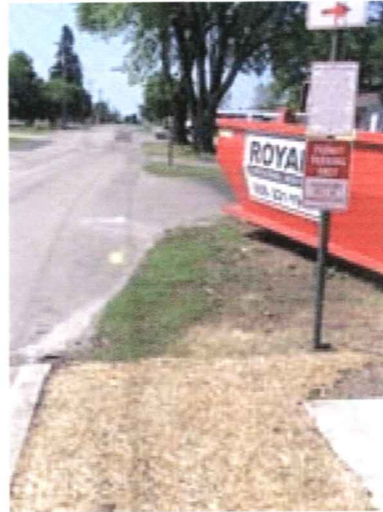
Perry Street
Missing Sidewalk
July 7, 2005

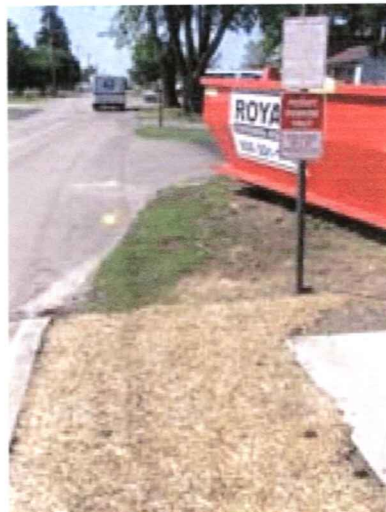
Perry Street
Missing Sidewalk
July 7, 2005

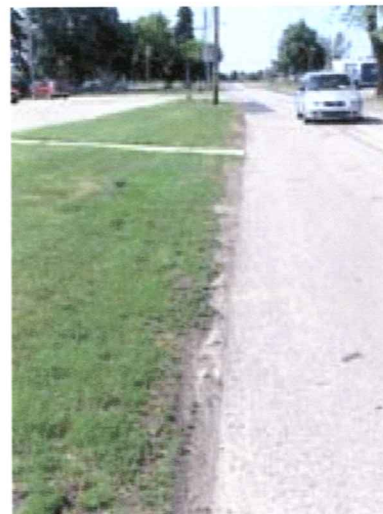
Perry Street
Missing Sidewalk
July 7, 2005
