Tree Evaluation Report

Old Sauk Managing Member LLC
1010 East Washington Ave
Madison, WI 53703

April 3, 2024

RE: 6706 Old Sauk Rd. Tree Survey (Heartland Project #20231124)

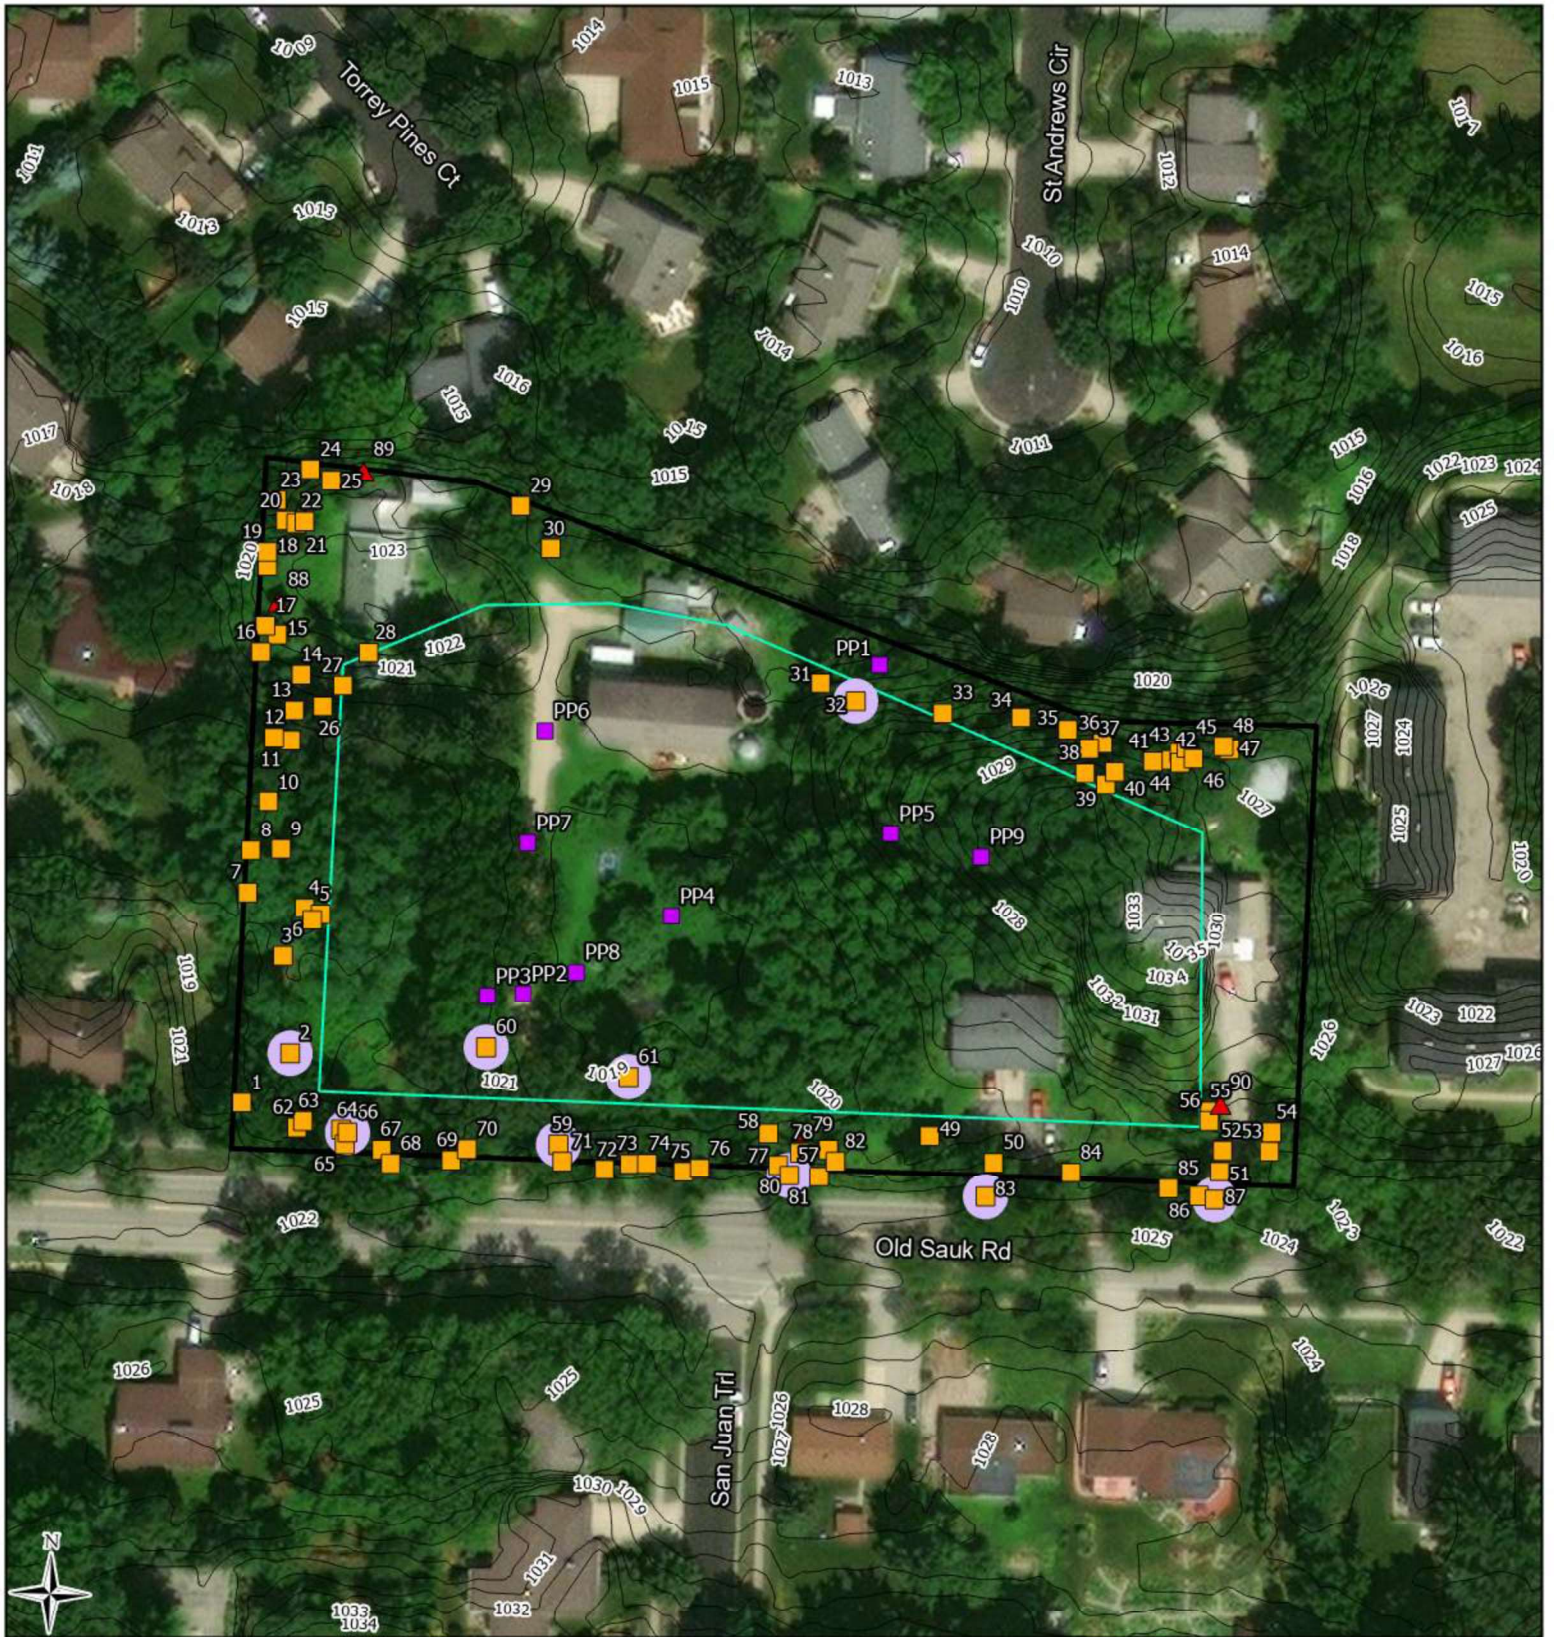
Figure 2. Tree Survey Map

A total of four (4) potentially hazardous trees were encountered during the tree survey field work. Based on professional opinion, these trees were observed to be dead or possessing extensive internal rot which could pose a risk to the public due to structural failure. Further consultation with an International Society of Arborists (ISA) certified arborist, capable of performing a more detailed Tree Risk Assessment, may be warranted for these trees. It should also be noted that numerous trees encountered during the survey were "topped". These topped trees at one point had their central leaders and upper main branches removed which is now causing irregular growth habits due to a proliferation of water sprouts. Topped trees are noted in Attachment 4.

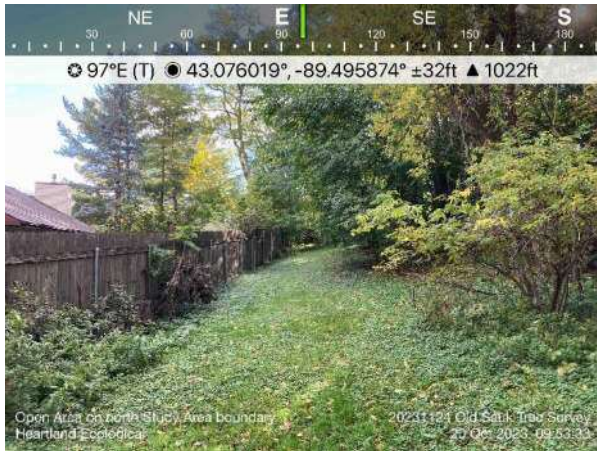
Photo #1 Photo point PP1: Open area on north Study Area boundary

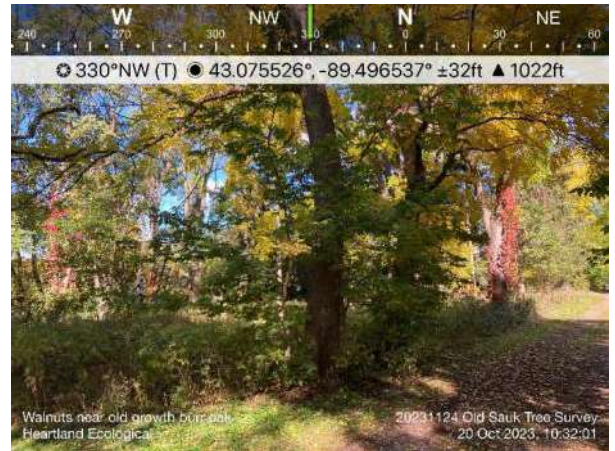
Photo #2 Photo point PP2: Two (2) walnuts growing near open grown oak

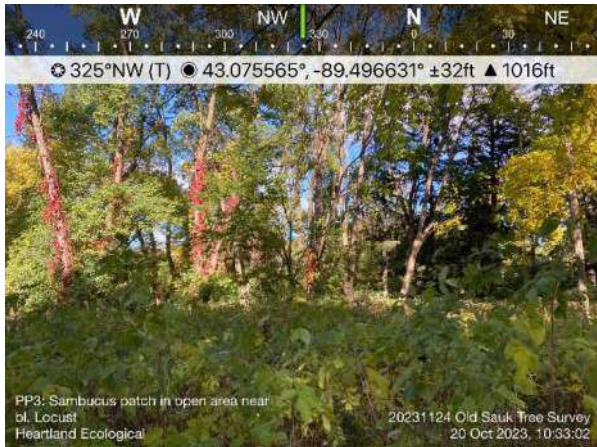
Photo #3 Photo point PP3: Patch of elderberry (*Sambucus nigra*) in open woodland area west of access road

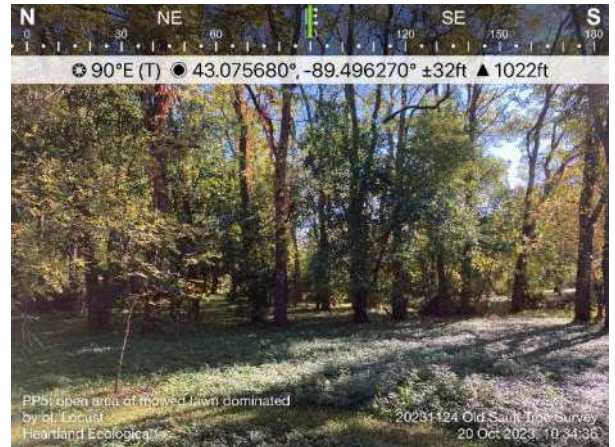
Photo #4 Photo point PP4: Open woodland area with mowed lawn and black locust east of access road

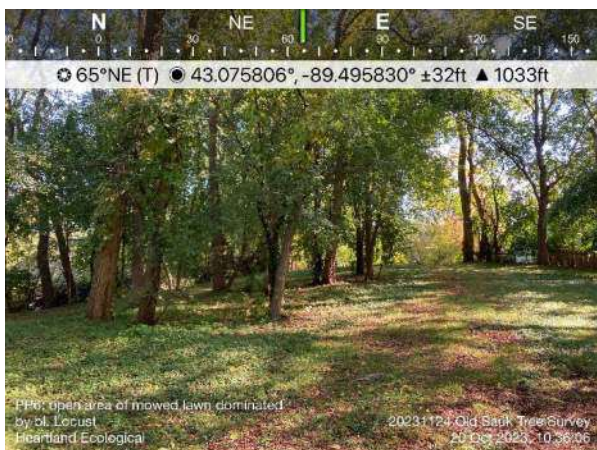
Photo #5 Photo point PP5: Open woodland area with mowed lawn and black locust east of access road

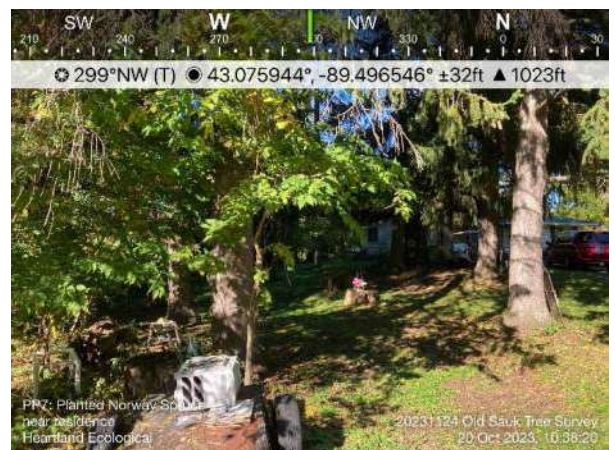
Photo #6 Photo point PP6: Planted cluster of Norway spruce providing screening for house

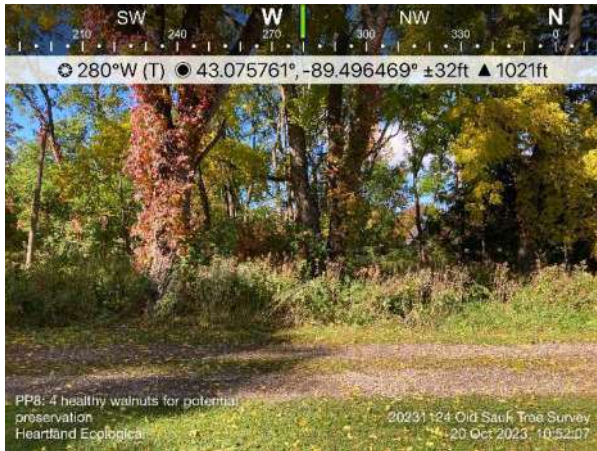
Photo #7 Photo point PP7: Four (4) healthy walnuts for potential preservation

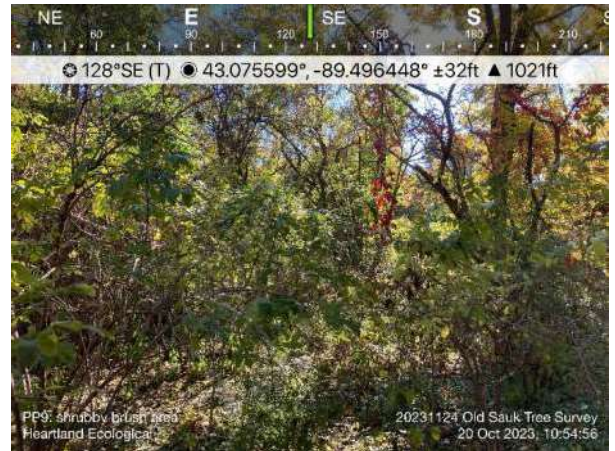
Photo #8 Photo point PP8: Photo of shrub/scrub dominated by elderberry and hybrid honeysuckle

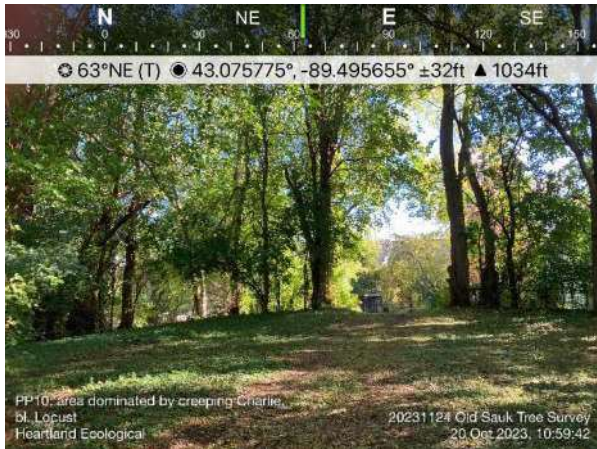
Photo #9 Photo point PP9: Open area dominated by mowed lawn and black locust

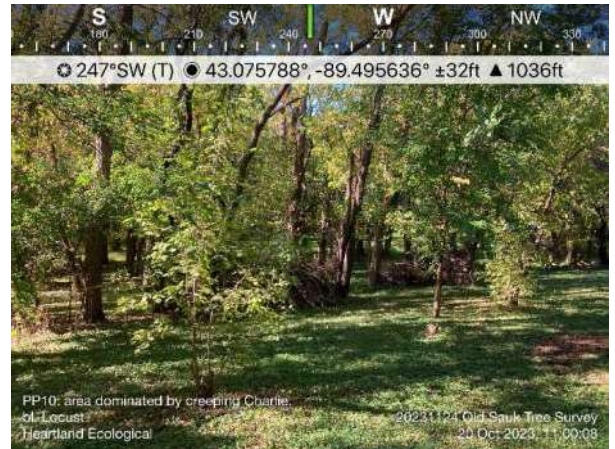
Photo #10 Photo point PP9: Open area dominated by mowed lawn and black locust

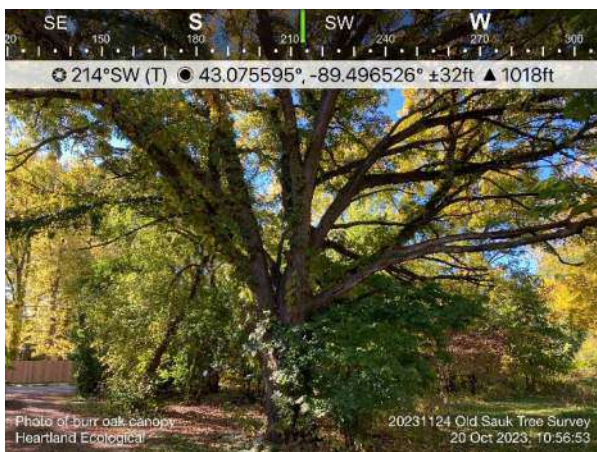
Photo #11 Photo of Tree 60- open grown burr oak for potential preservation
