**Tree Evaluation Report**

Old Sauk Managing Member LLC  
1010 East Washington Ave  
Madison, WI 53703

April 3. 2024

## **RE: 6706 Old Sauk Rd. Tree Survey (Heartland Project #20231124)**

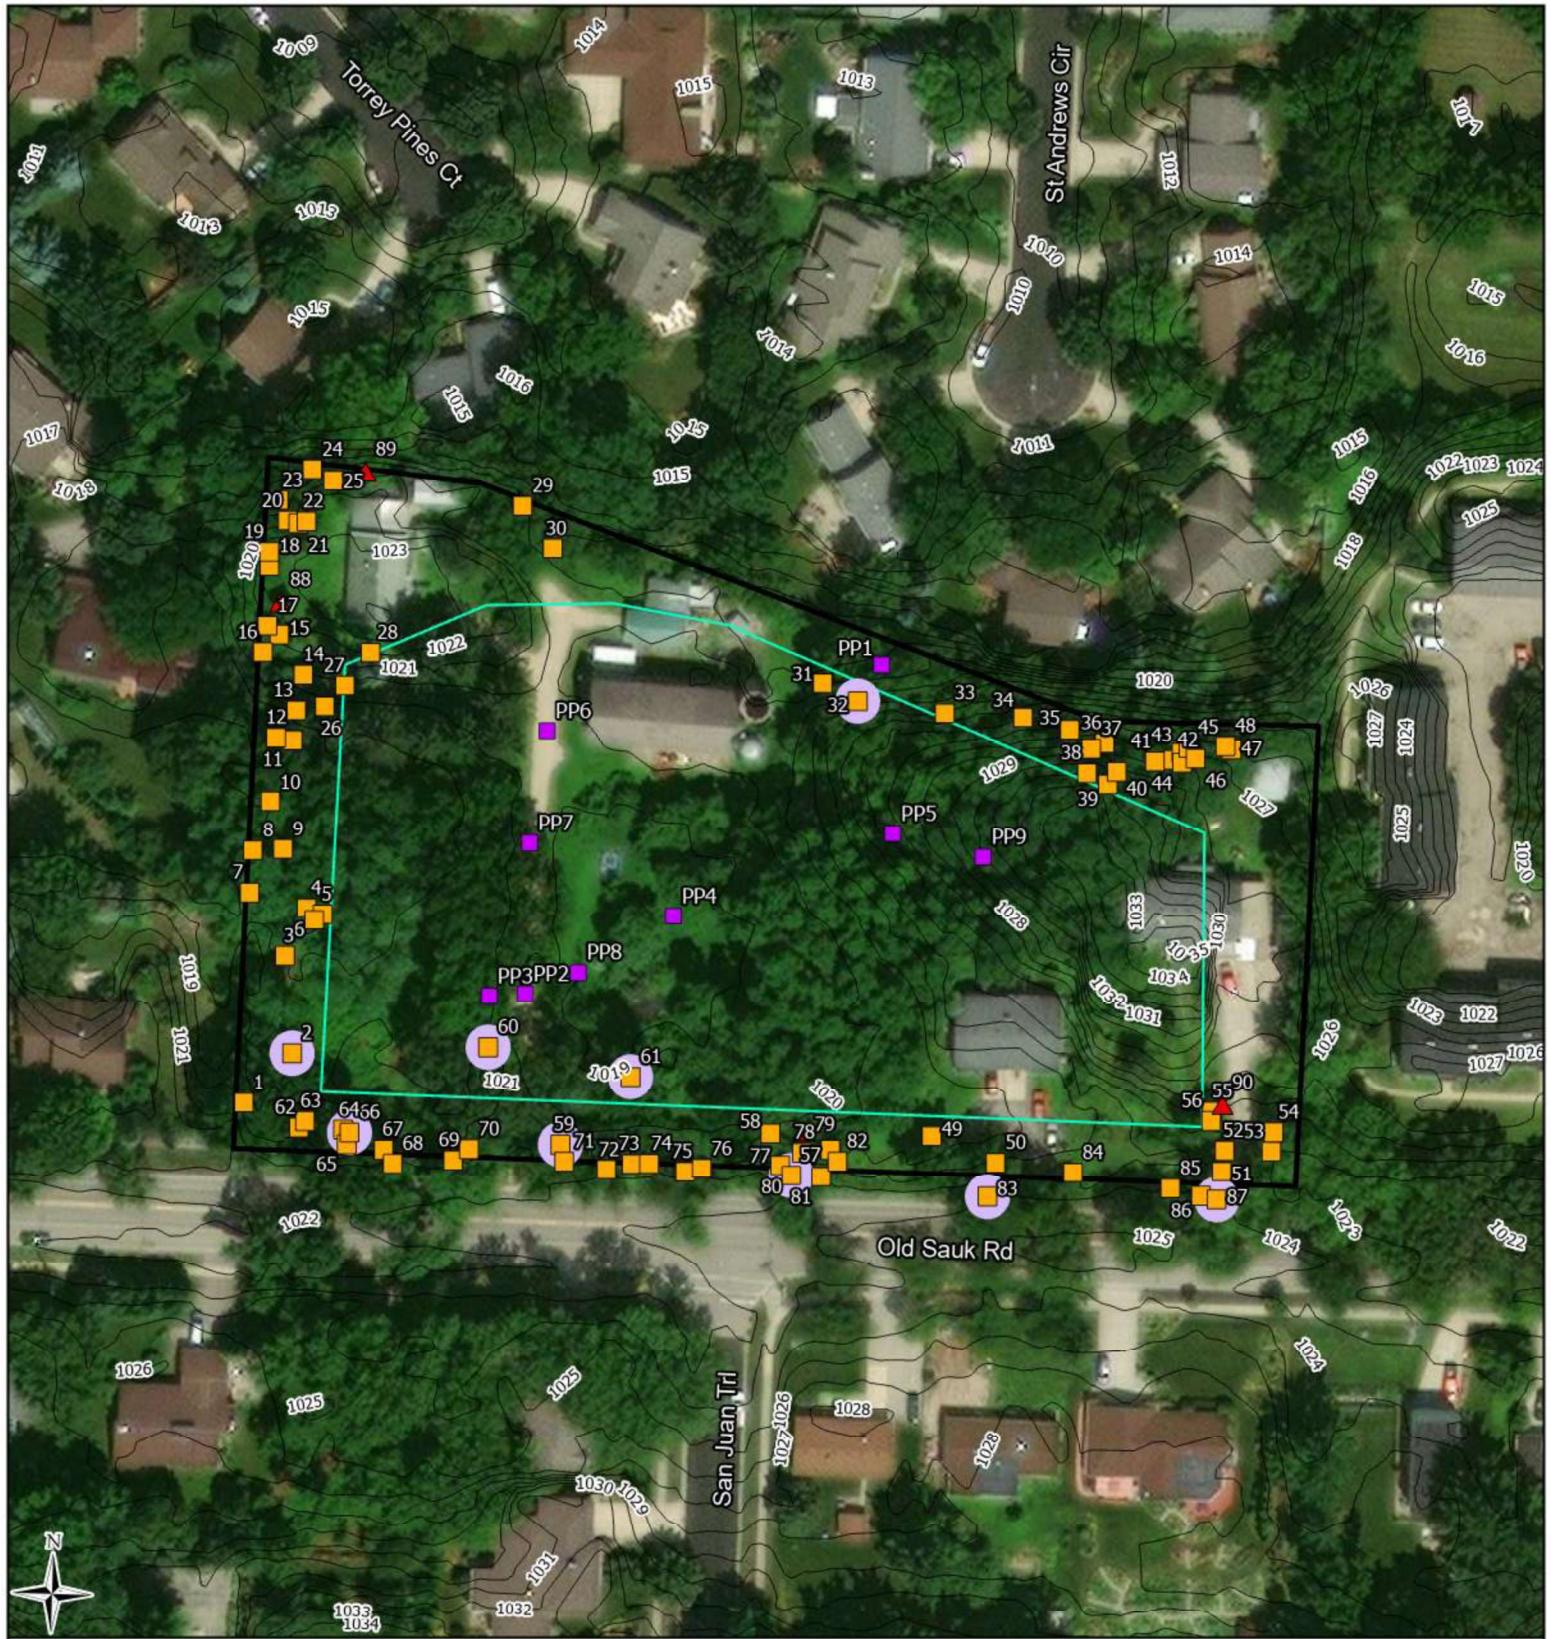
Figure 2. Tree Survey Map

A total of four (4) potentially hazardous trees were encountered during the tree survey field work. Based on professional opinion, these trees were observed to be dead or possessing extensive internal rot which could pose a risk to the public due to structural failure. Further consultation with an International Society of Arborists (ISA) certified arborist, capable of performing a more detailed Tree Risk Assessment, may be warranted for these trees. It should also be noted that numerous trees encountered during the survey were "topped". These topped trees at one point had their central leaders and upper main branches removed which is now causing irregular growth habits due to a proliferation of water sprouts. Topped trees are noted in Attachment 4.

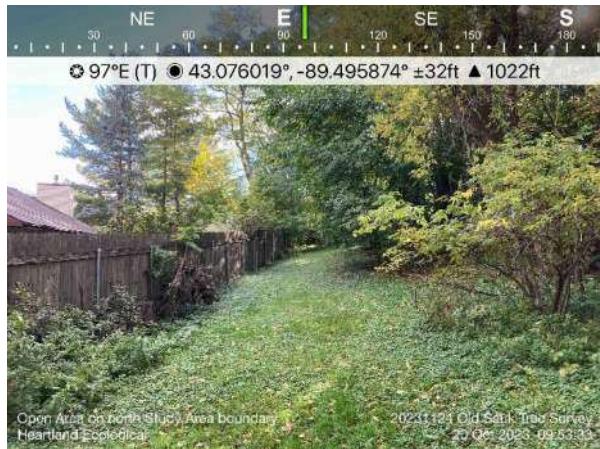
**Photo #1** Photo point PP1: Open area on north Study Area boundary

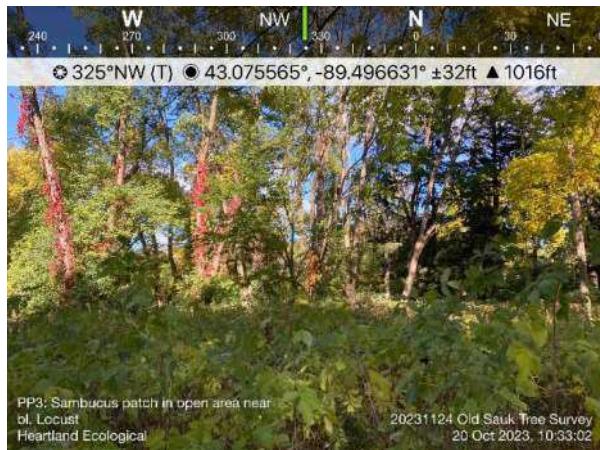
**Photo #3** Photo point PP3: Patch of elderberry (*Sambucus nigra*) in open woodland area west of access road

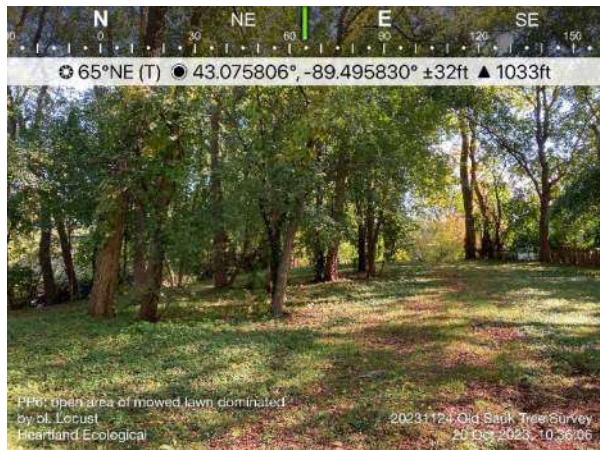
**Photo #5** Photo point PP5: Open woodland area with mowed lawn and black locust east of access road

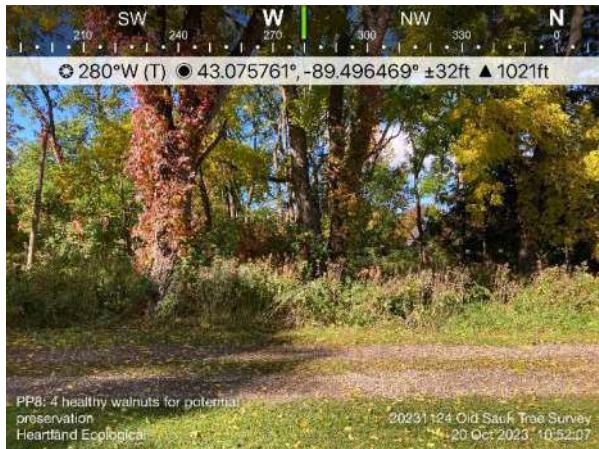
**Photo #7** Photo point PP7: Four (4) healthy walnuts for potential preservation

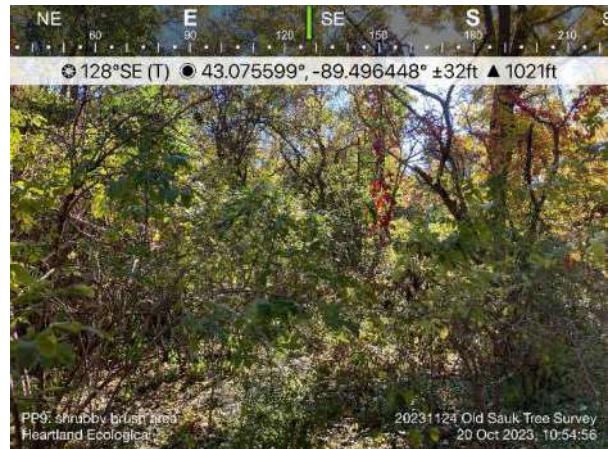
**Photo #8** Photo point PP8: Photo of shrub/scrub dominated by elderberry and hybrid honeysuckle

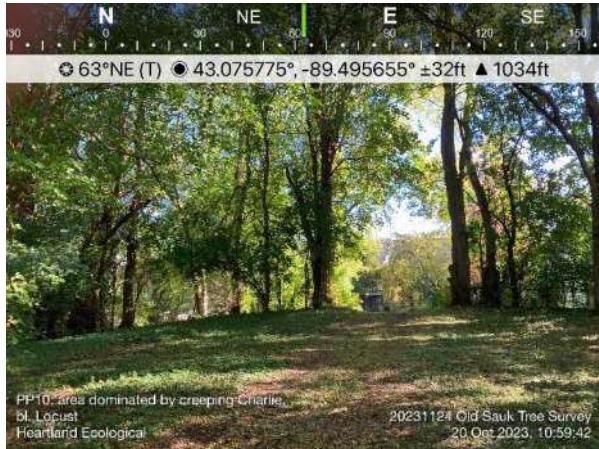
**Photo #9** Photo point PP9: Open area dominated by mowed lawn and black locust

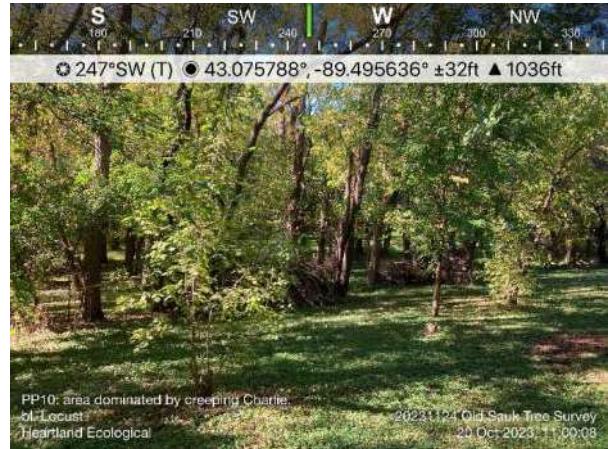
**Photo #10** Photo point PP9: Open area dominated by mowed lawn and black locust

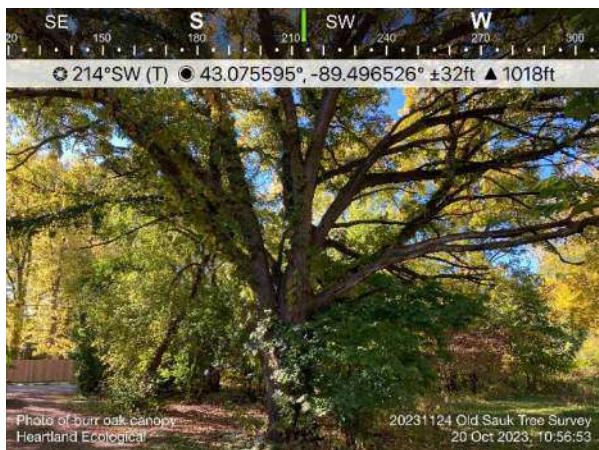
**Photo #11** Photo of Tree 60- open grown burr oak for potential preservation

58	Boxelder	<i>Acer negundo</i>	12	Fair	No	Dramatic leaning tree, 6 ft off ground in most cases
59	Black Walnut	<i>Juglans nigra</i>	27	Good	No	84 circ, Tree good canopy structure, strong Union, no decline
60	Burr Oak	<i>Quercus macrocarpa</i>	40	Fair	No	Tree for preservation, some dead limbs evident, open grown growth form, some decline present but still healthy
61	Black Walnut	<i>Juglans nigra</i>	21	Good	No	Tree for potential preservation. Good Unions, open canopy, slight lean
62	Common Hackberry	<i>Celtis occidentalis</i>	6	Good	No	
63	Basswood	<i>Tilia americana</i>	6	Good	No	
64	Common Hackberry	<i>Celtis occidentalis</i>	11	Good	No	
65	White Mulberry	<i>Morus alba</i>	8	Poor	Yes	Poor, Internal rot, leaning in road.
66	Black Walnut	<i>Juglans nigra</i>	26	Good	No	Healthy form, leaning slightly, good candidate to preserve
67	White Mulberry	<i>Morus alba</i>	6	Good	Yes	Healthy
68	Common Hackberry	<i>Celtis occidentalis</i>	21	Good	No	Healthy
