**INSPECTION REPORT
FOR
SARA INVESTMENT REAL ESTATE
FLOOR INSPECTION – 6409 ODANA ROAD**

GEC No. 2-0519-243

INSPECTION REPORT
For
SARA INVESTMENT REAL ESTATE
MAY 2019

**INSPECTION REPORT
FOR
SARA INVESTMENT REAL ESTATE
FLOOR INSPECTION – CLOCK TOWER OFFICE
PARK**

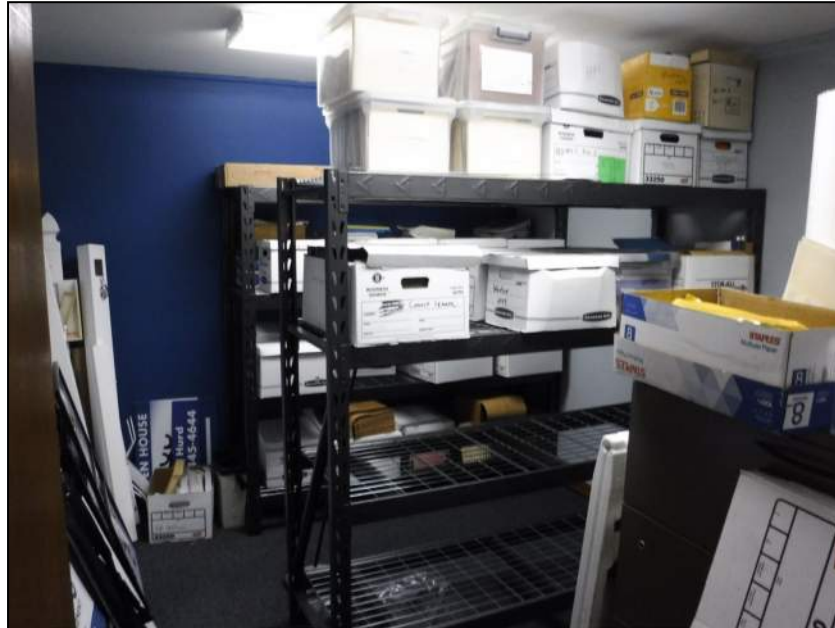
A second floor tenant informed Sara Investment that there was deflection in their floor system. This deflection was mostly in the file room in the second floor of this building. When I entered this room, I found extremely large file cabinets and a shelving system which had paper storage which ran from the second floor almost to the ceiling. The current tenant had already removed some of the storage that was in this room.

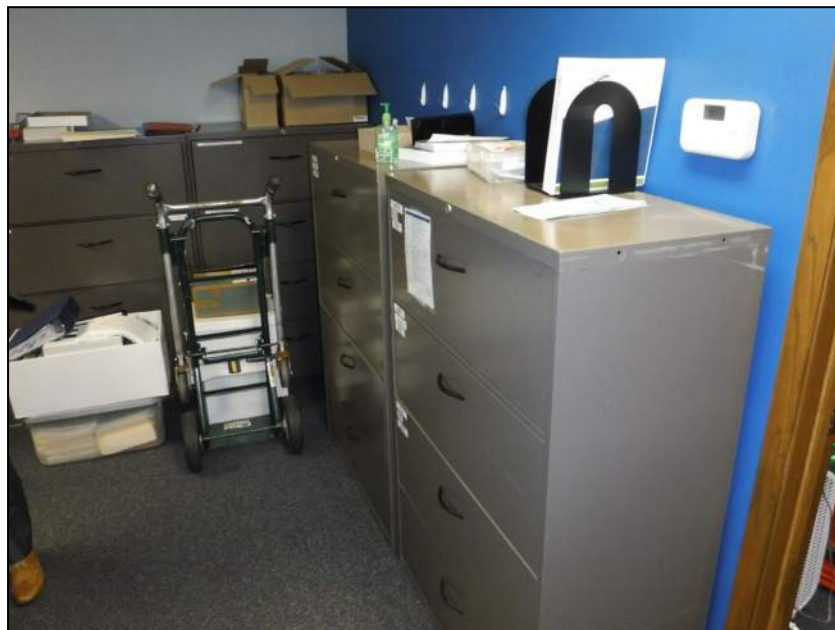
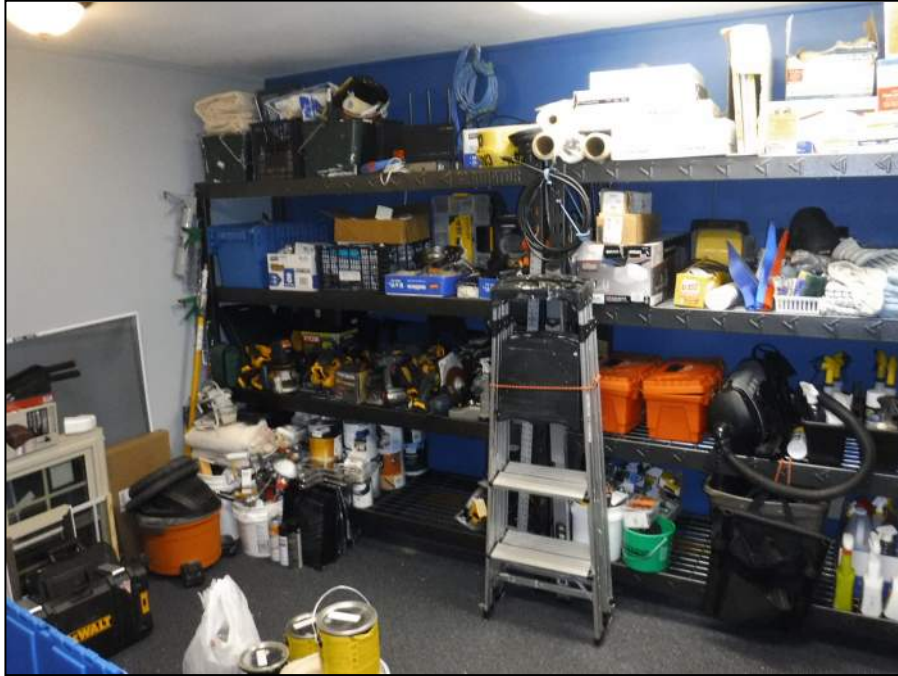
The adjacent room has a tool rack that extends from the second floor to the ceiling. This tool rack is loaded on every shelf. Just outside of this room are more banks of very heavy file storage. In an effort to correct the situation, the tenants moved some of the heavy file storage over to the entryway of this facility that already has 3 additional heavy file cabinets.

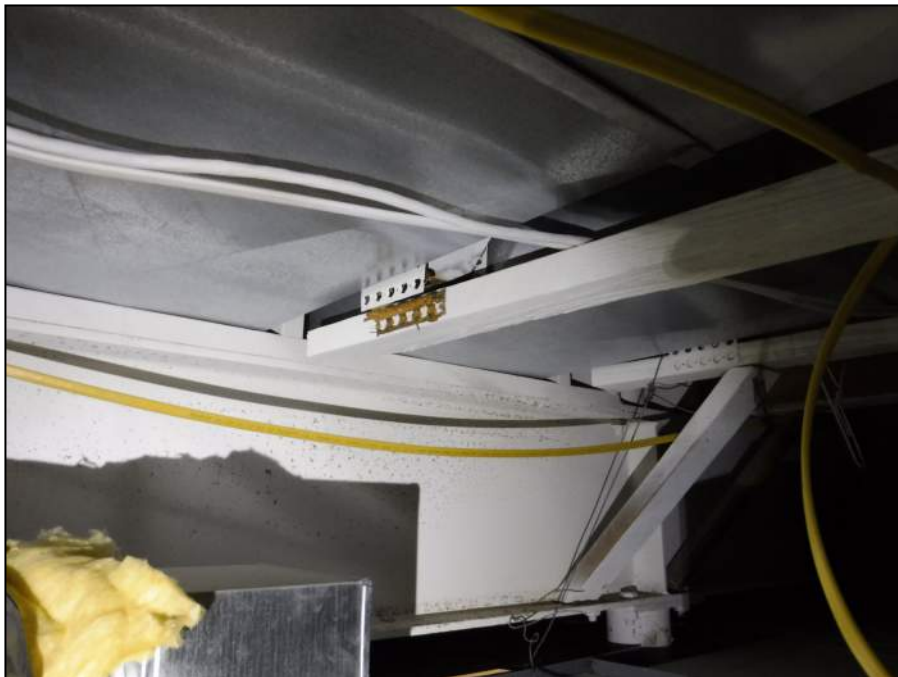
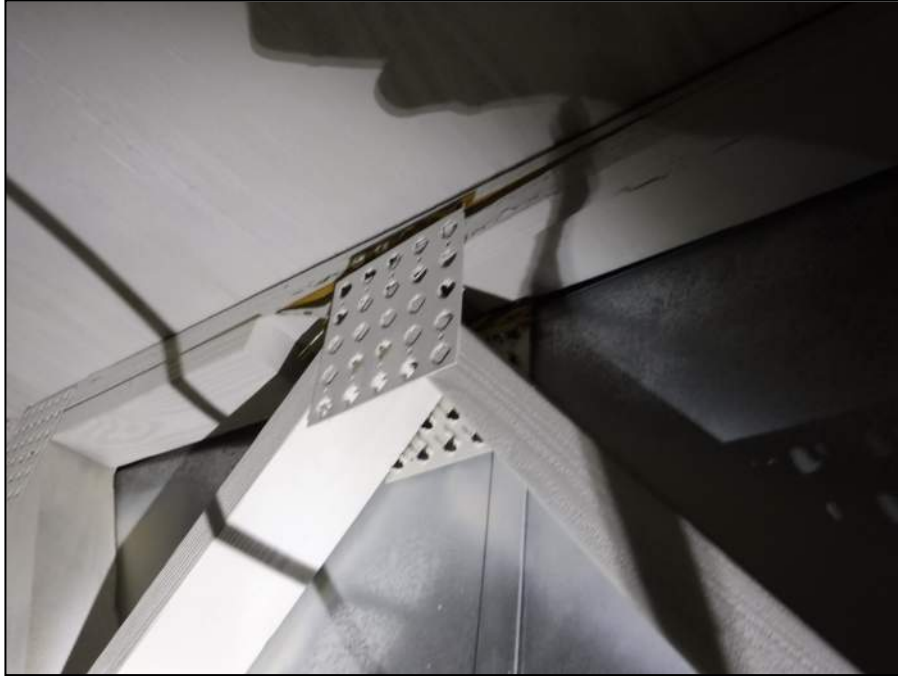
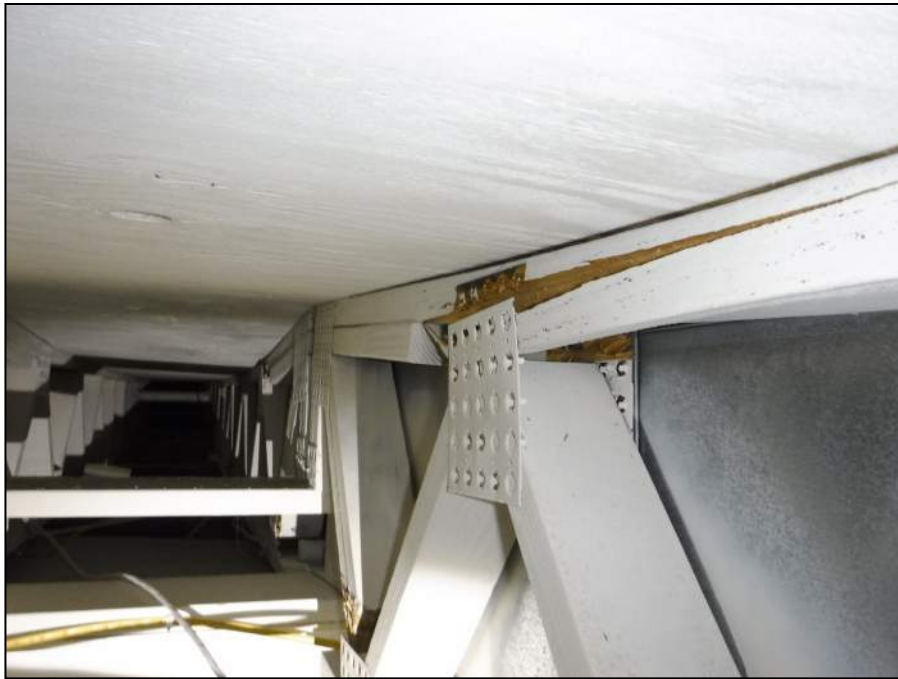
All of the areas that have the heavy storage have failed the trusses below. The way that these trusses failed is they pulled the web members at the two outer ends through the gang nail plates and displaced the gang nail plates from the bottom chord of the truss. This has dramatically reduced the strength of these trusses.

Short term, I recommend having any tenants above or below this failed floor system removed immediately. Next, I recommend installing temporary supports beneath each end of each of the failed trusses at a panel point. This could be done with a single 2 x 6 stud beneath each panel point or a beam could be installed and larger columns could be installed along the way. Installation of these temporary supports will be necessary to remove the heavy contents from the floor above. Once the contents have been removed, then the trusses can be repaired.

Fortunately the trusses failed in the outer edges which means they will be easier to repair. The repair involves installing plywood gusset plates on each side of each truss with a specified nailing pattern. Please note that it is very important that the contractor nailing the trusses make sure that he hits the web members when completing the repair.

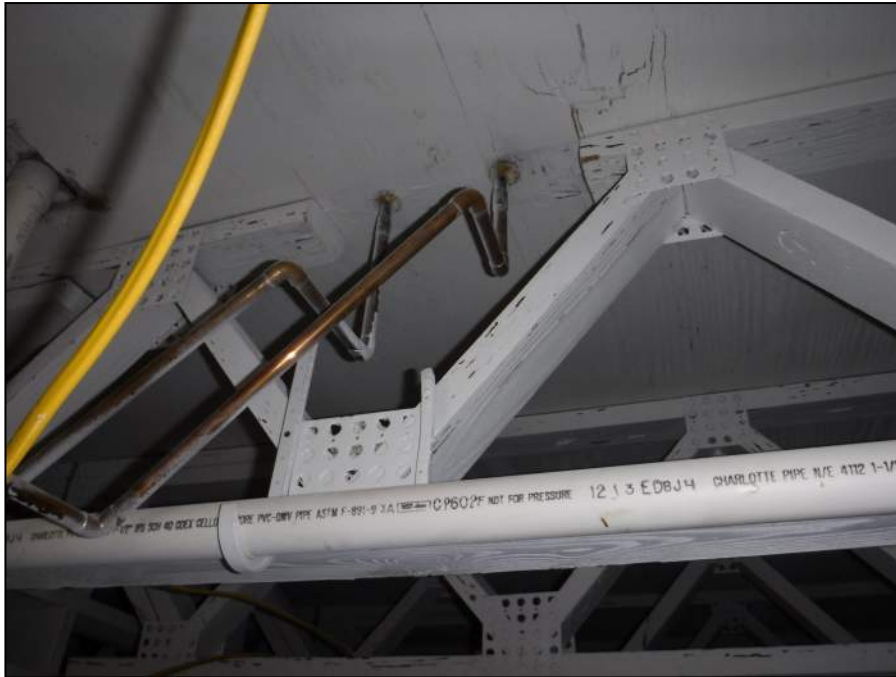
There was one other area where the truss was cut and this truss should be repaired. The truss was cut to install plumbing components.

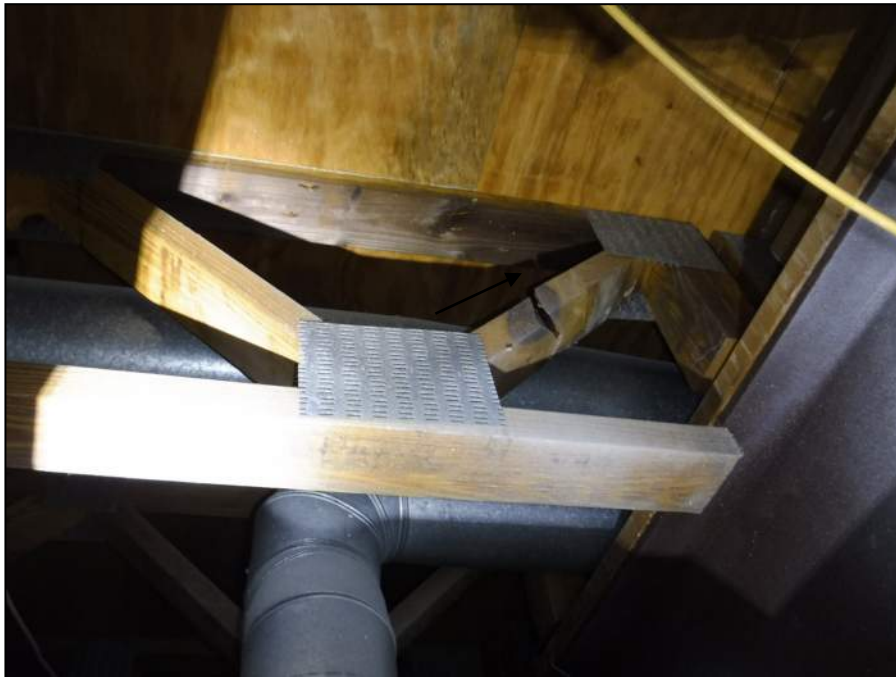
•**Building 6325.** This building was built with good truss gang nail plates and only one truss was found in this entire building that had an issue. This truss was constructed with the use of one bad wood member. Unfortunately this bad web member was the highest loaded member on the truss near the bearing point and therefore this wood member failed in tension. A repair was designed for the failed trusses in building 6409. The repair for this truss member is the same as it was for all of the other failed trusses.

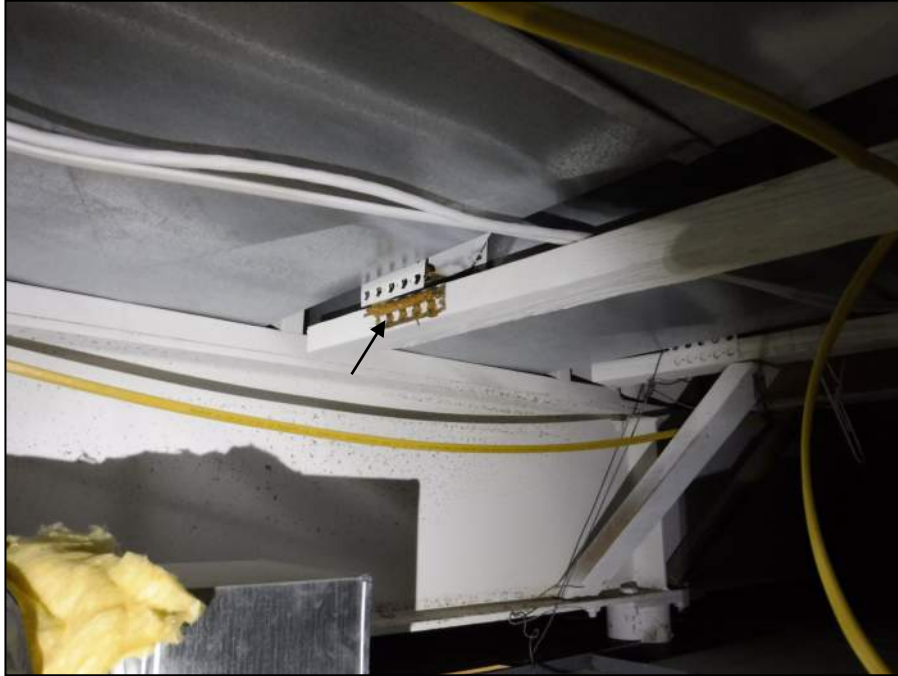
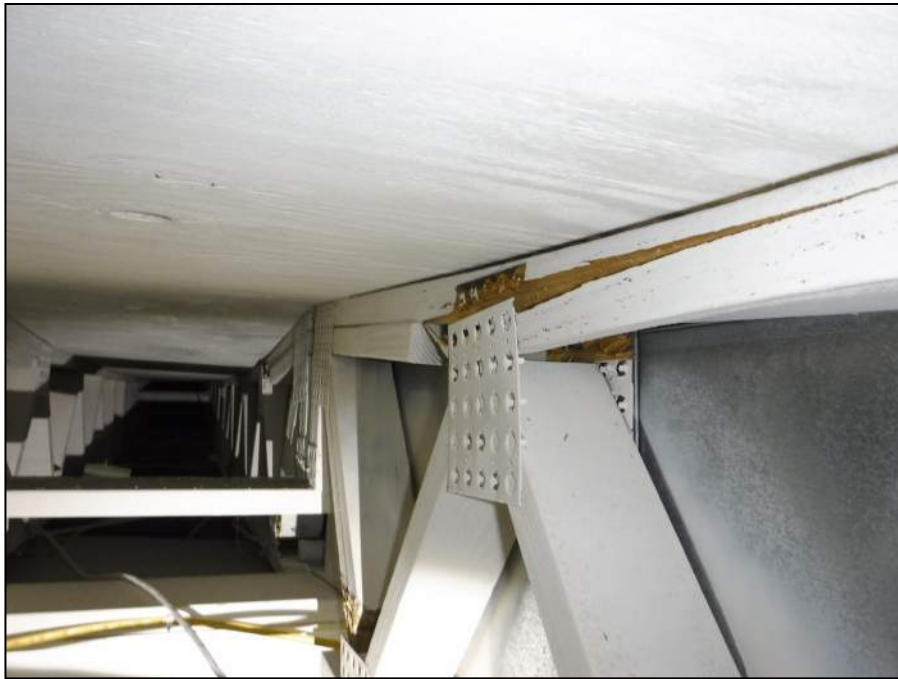
•**Building 6409.** Building 6409 is one of the two buildings that are framed with the older style truss plates. There are truss failures that have occurred in many locations in this building. Some had already been repaired prior to the purchase by Sara Investments. The majority of the truss failures however have not been repaired.

The most heavily loaded web member in a top chord bearing truss is always the first diagonal from the bearing point. This is the member that has failed in almost every case. Fortunately this also makes it such that the repair is typically easier because you don't have to try to splice the plywood gusset plates that will need to be installed. I have included a detail that shows the best way to complete these repairs on these floor trusses. Truss failures were found on both the first floor system and the second floor system.

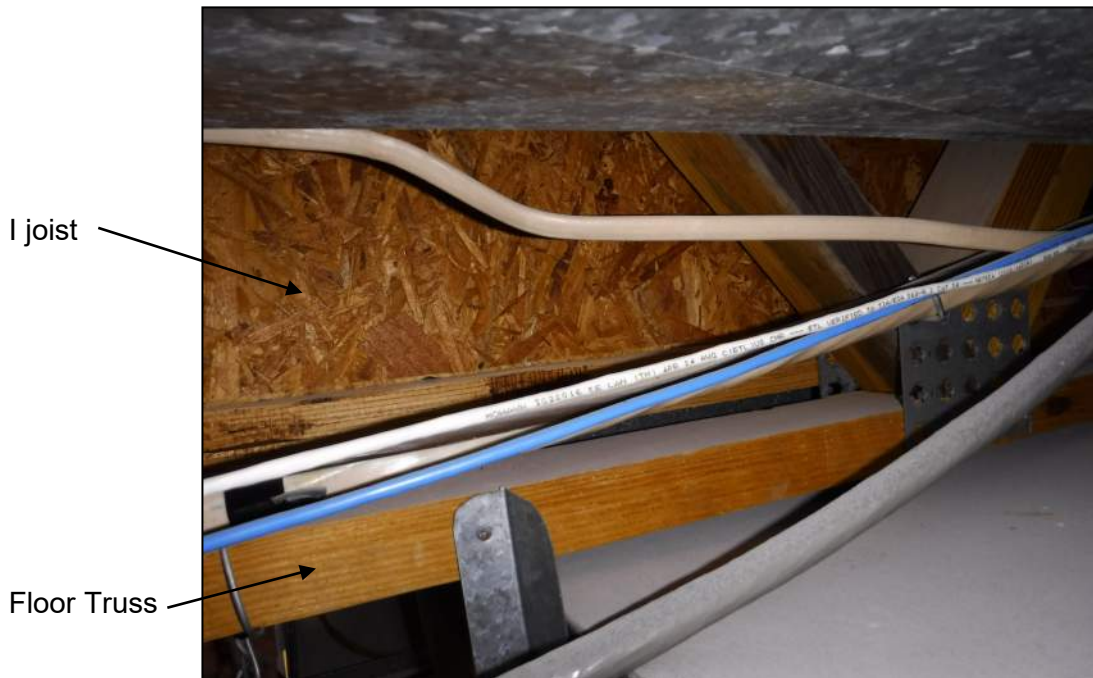
Some of the second floor trusses have been cut. Cutting a floor truss is a very bad idea and heavily compromises the load carrying capacity of the truss. This only happens in one area on this building but it affects approximately 8 – 10 trusses. The repair for these trusses in the same repair as what was prescribed for the previous repair. Plywood gusset plates will need to be installed on both sides of the existing truss.

Some of the failed trusses in this building have been sistered with an I-joist adjacent to the floor truss. Also note that there was one second floor truss that had been cut for plumbing installation.

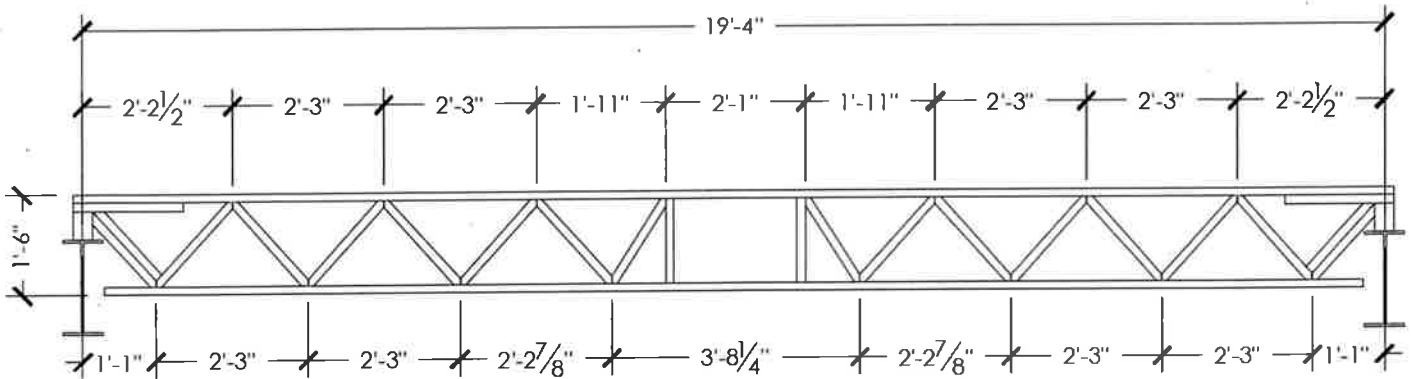
THE ANALYSIS PROVES THAT THE DESIGN LIVE LOAD OF THE TRUSS WAS SET AT 50psf FOR OFFICE SPACES, AND NOT THE 150psf FOR FILE ROOM.
