Assessor-Garrett Hughes
Company-Heartwood Tree Company
Date-April 22nd

On April 22nd Garrett Hughes performed a Level 3 tree risk assessment on a 44" ash tree located south of 5118 Spring Ct. The targets for the area include customer's house and garage, neighbor's house, shared driveway to the west of tree, and power lines running to the west of tree.

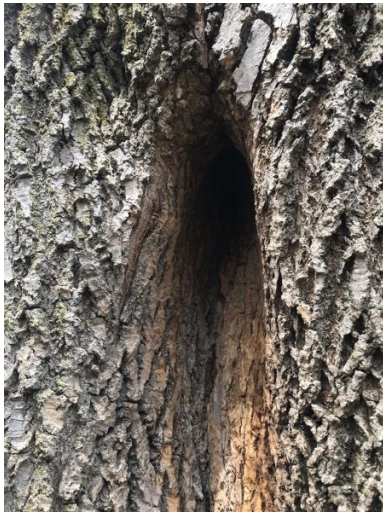
Picture of area on south side of scaffold A.

Recommendation: Due to amount of decay in scaffold A and open crack between scaffold A and B, removal of tree is warranted. Since it is an ash tree, continued treatment to protect against EAB would be needed. Effectiveness of treatment would be lessened due to decay issues.

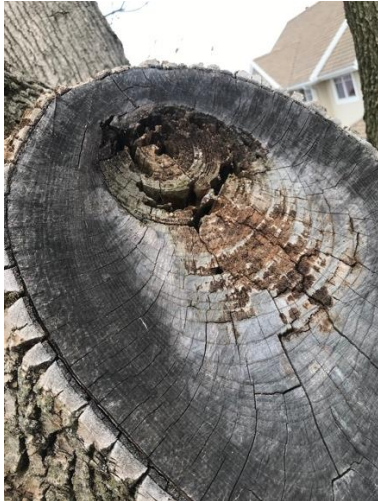
Picture of 14" pruning cut with decay on east side of scaffold A.

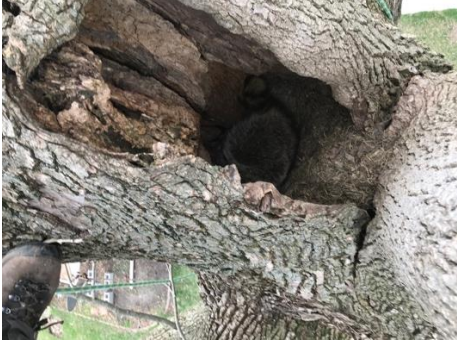
Picture of the top of scaffold A, at main union.

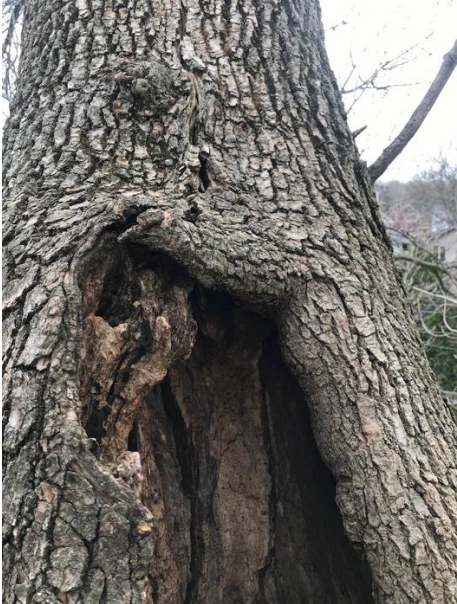
Picture of scaffold A above main decay pocket. Vertical crack is apparent at top of decay pocket.

Analysis: Failure of either scaffold A, or scaffold B is deemed to be imminent due to open crack and extent of decay. The likelihood of impact for customer's house, garage, and power lines would be high, as they are within the drop zone for both of these scaffolds. Consequences of failure would be significant for structures, and severe for people if they were located within drop zones. This is considered a high risk situation and mitigation should be performed as soon as possible.

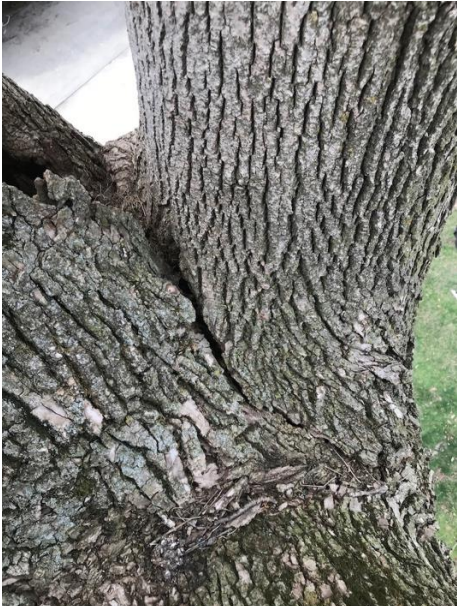
Picture of union between scaffold A and B with open crack.
