SRI design

May 23, 2012

Subject: Structural Observation at the Ideal Body Shop
500 S. Park St., Madison

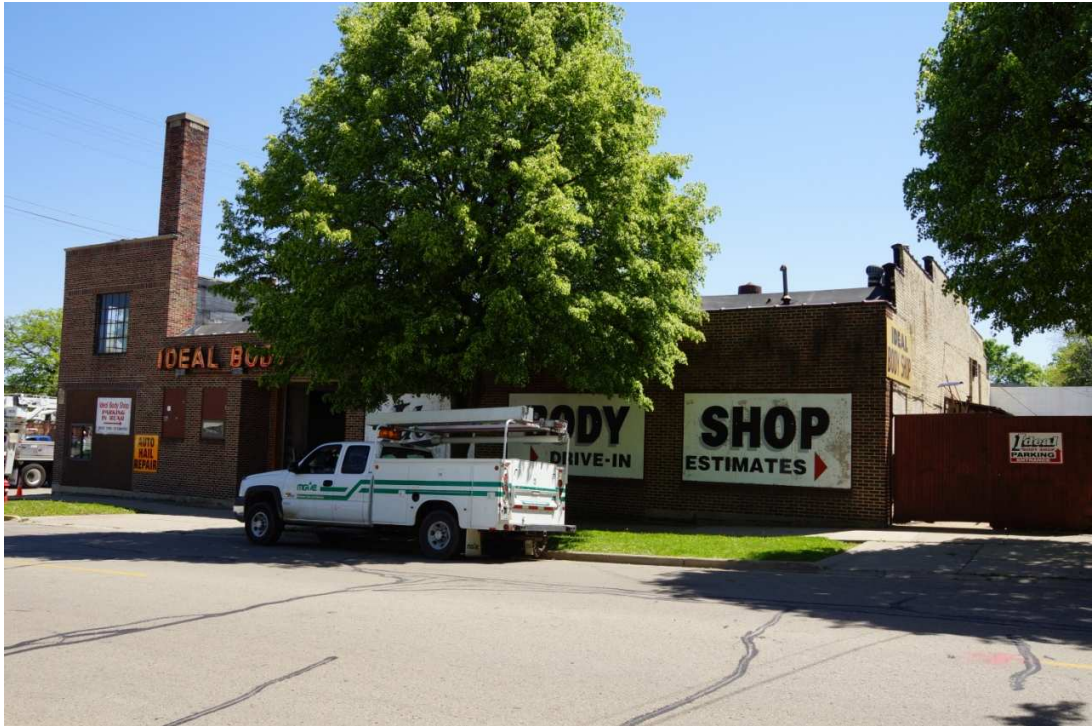
Fig.1. Side view – Ideal Body Shop

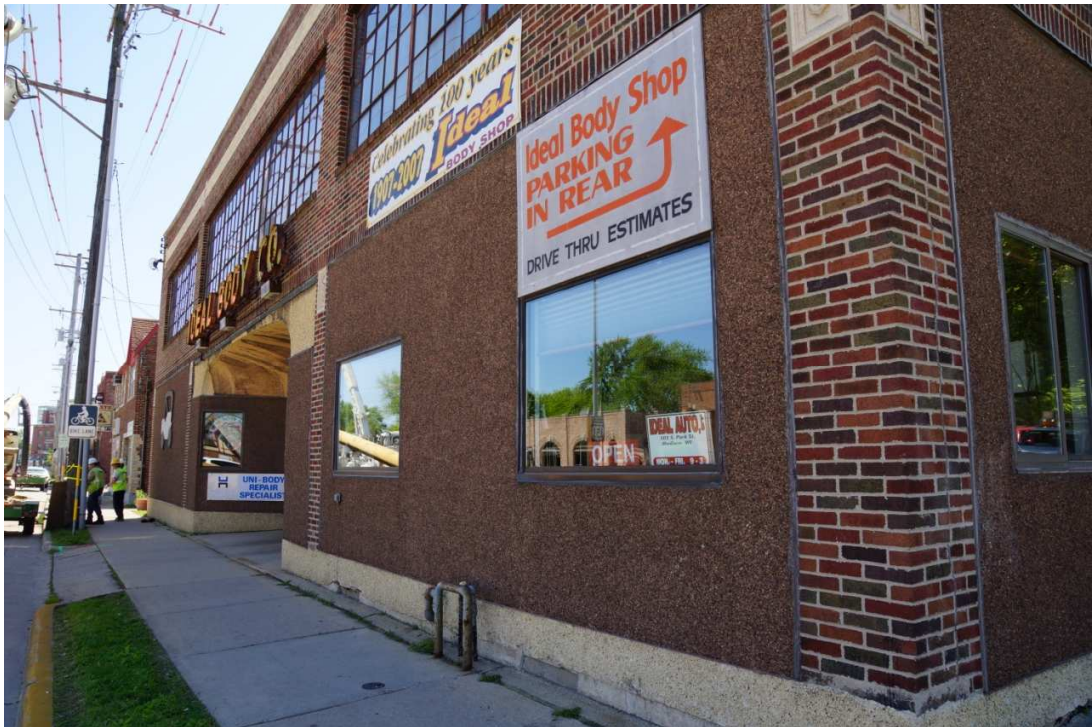
Fig. 2. Front view – Ideal Body Shop

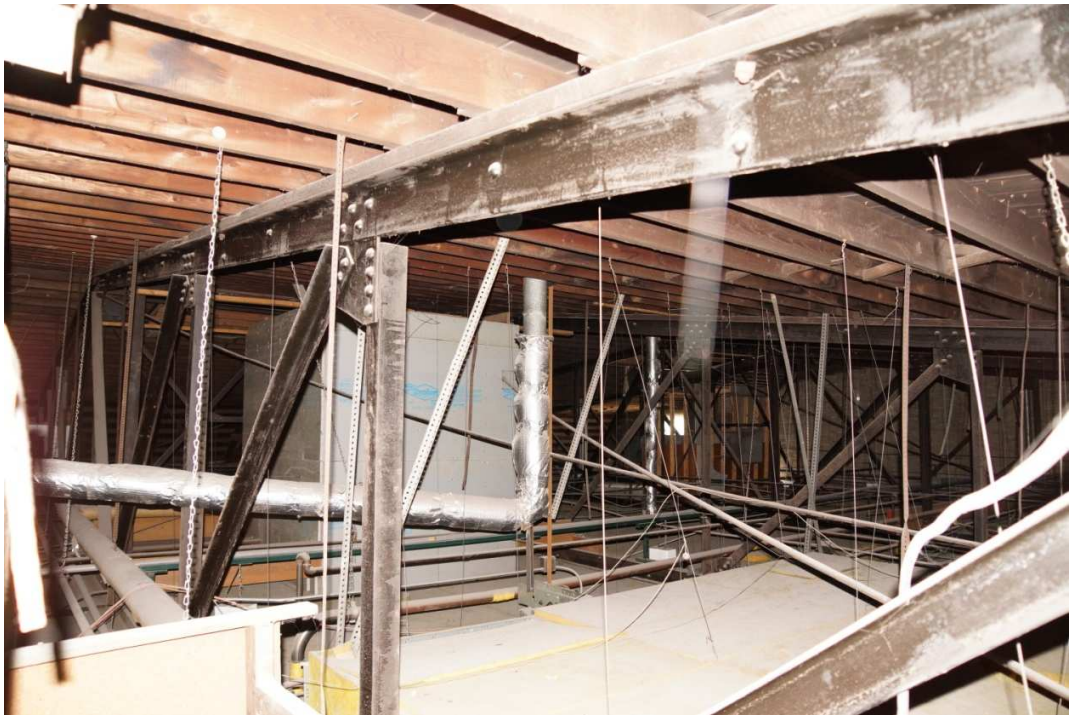
Fig. 3. Steel Roof Trusses

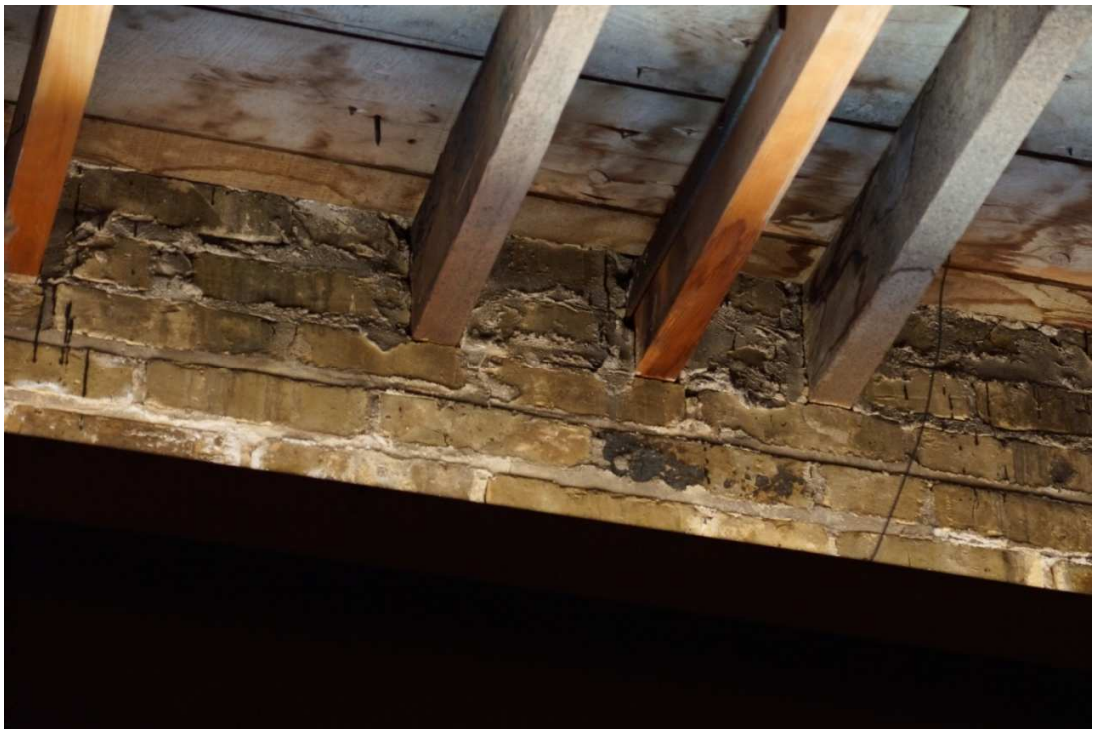
Fig.4. Front roof rafters

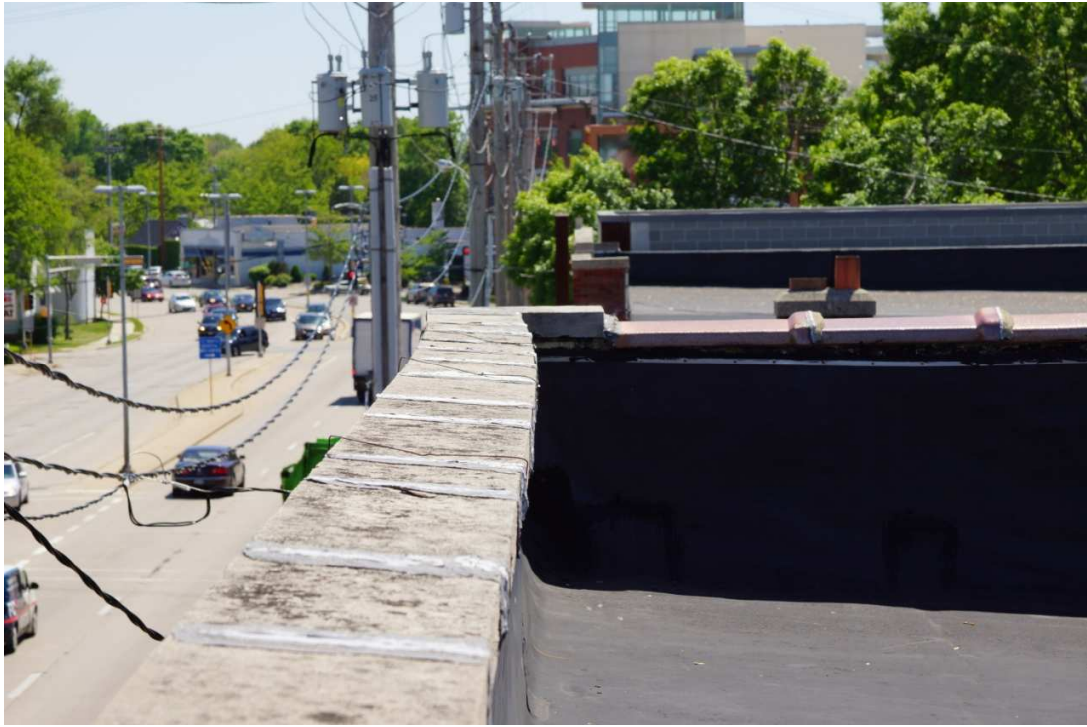
3. The front masonry is in very poor shape. The front wall has out-of-vertical-plane displacements as well as relative displacements between some adjacent elements. There are cracks through the brick as well as in the mortar joints. Flashings are cracked and ineffective, and caulking shrunk and cracked.

Fig. 5. Front wall displacement

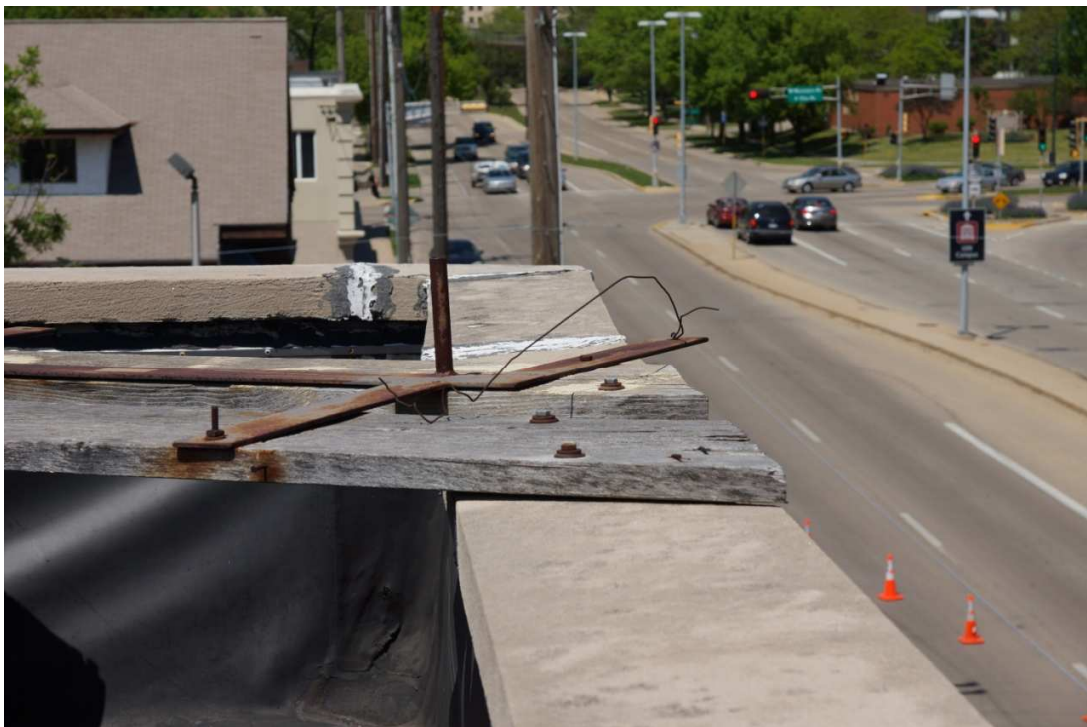
Fig.6. Front wall Displacement

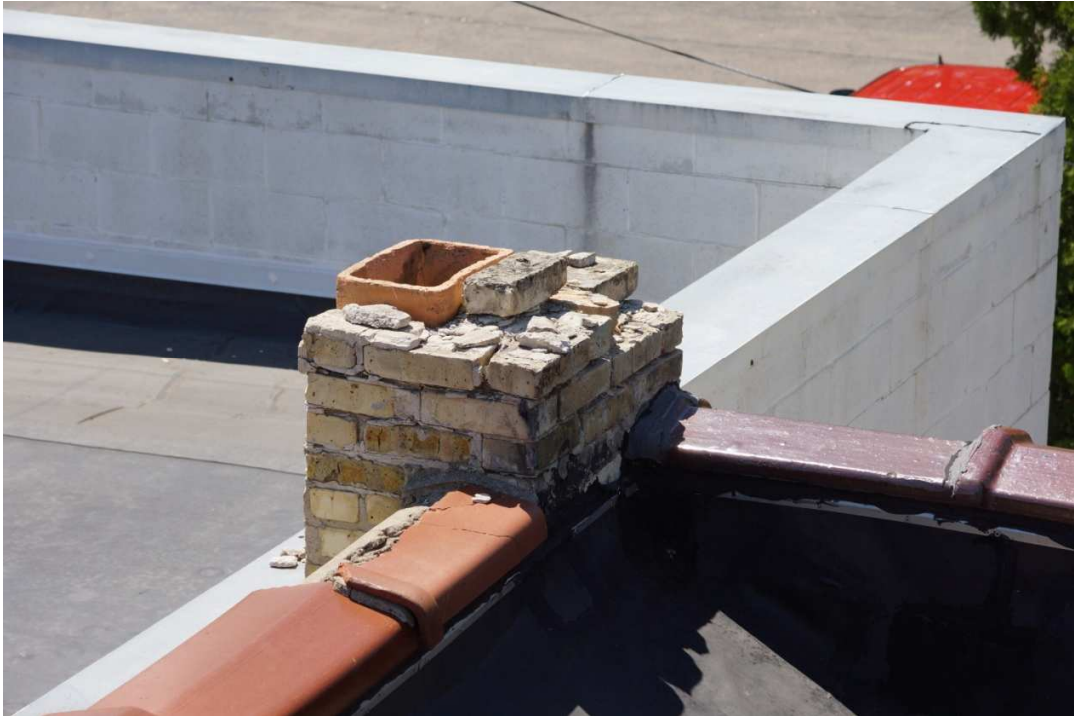
Fig. 7. Deteriorated Chimney Brick

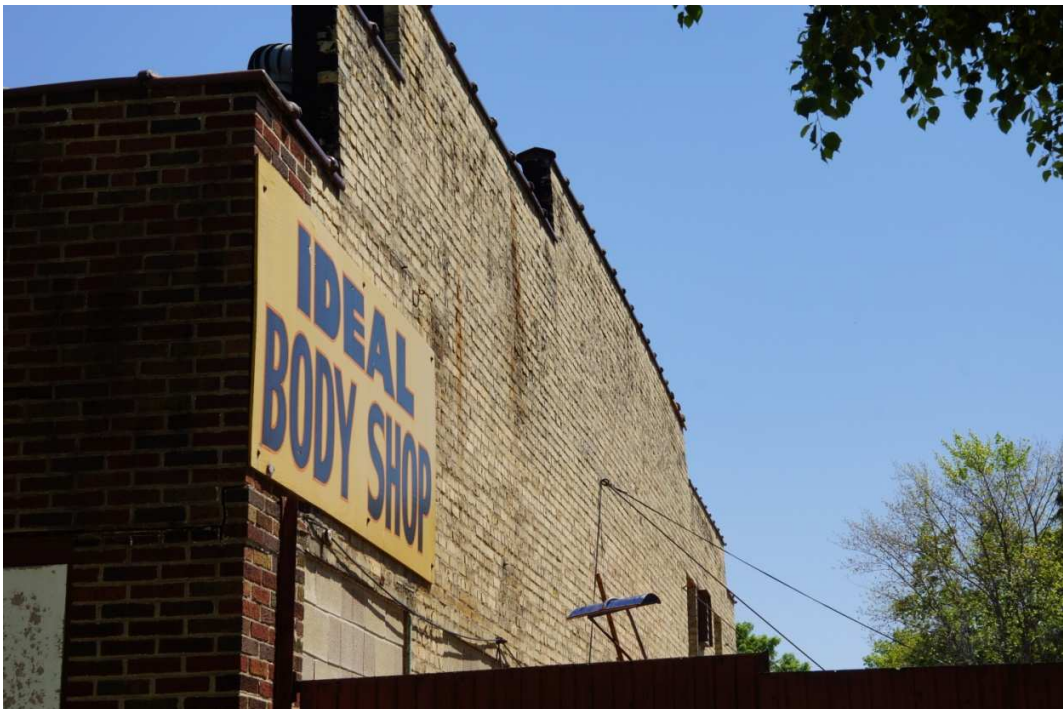
5. The rear masonry wall has the same cracking problem as the others. In addition, the rear masonry is also deteriorated, and the mortar, weathered and loosen as well.

Fig. 8. Wall at the Back

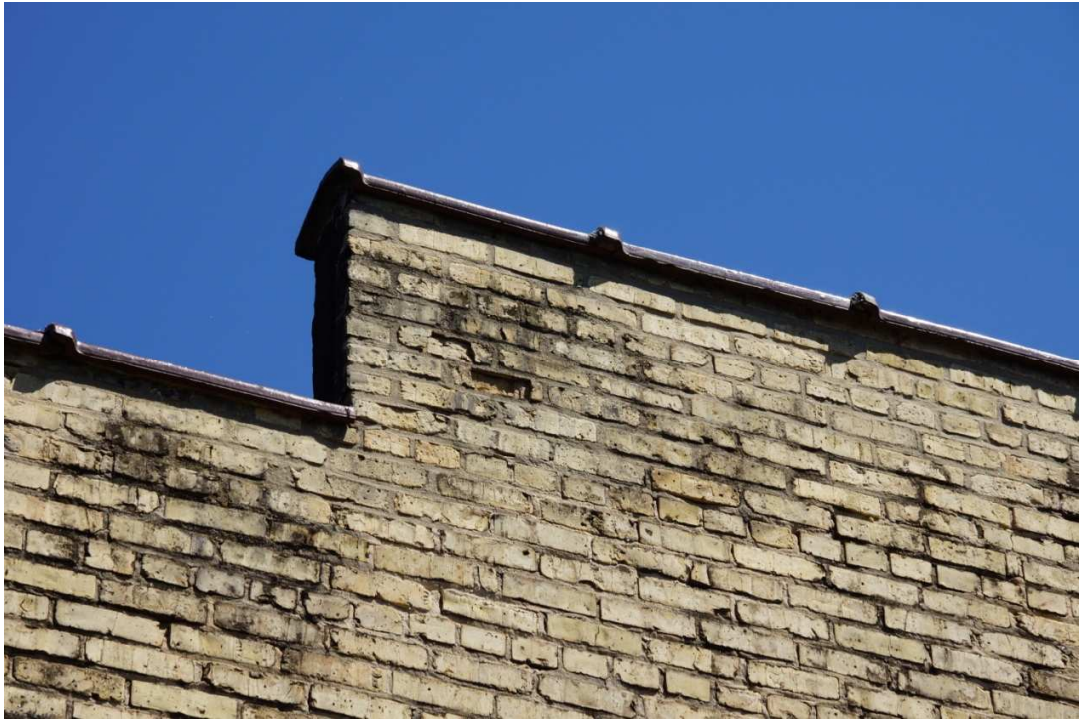
Fig. 9. Deteriorated brick at the back wall

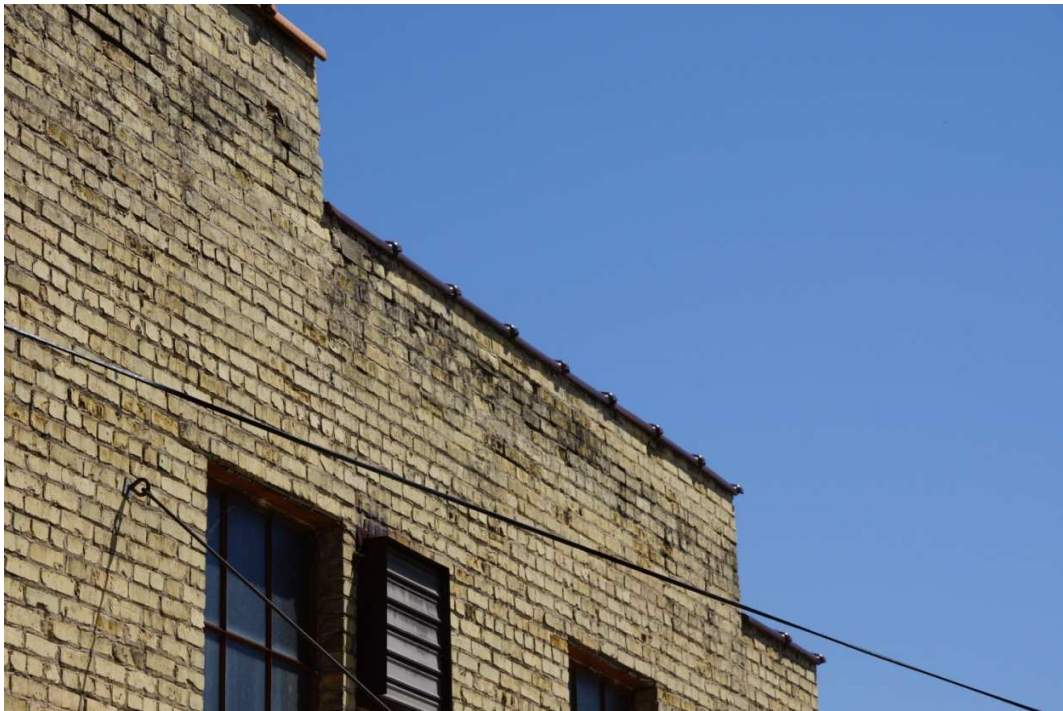
Fig. 10. Deteriorated brick at the back wall

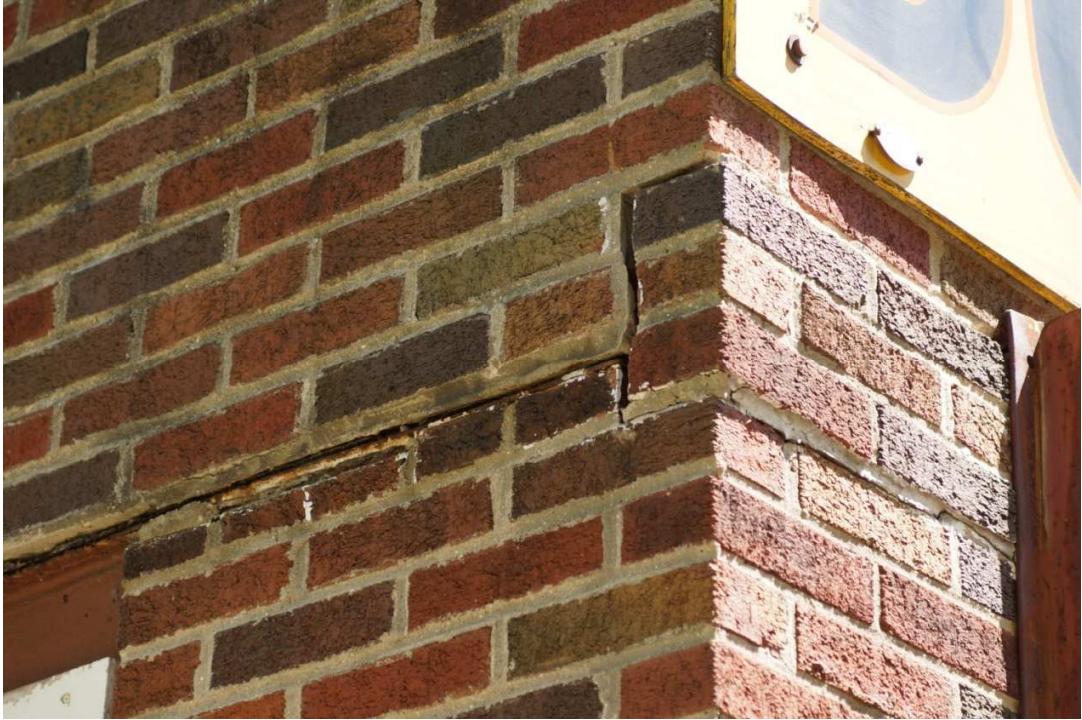
Fig. 11. Displaced brick at the side facade

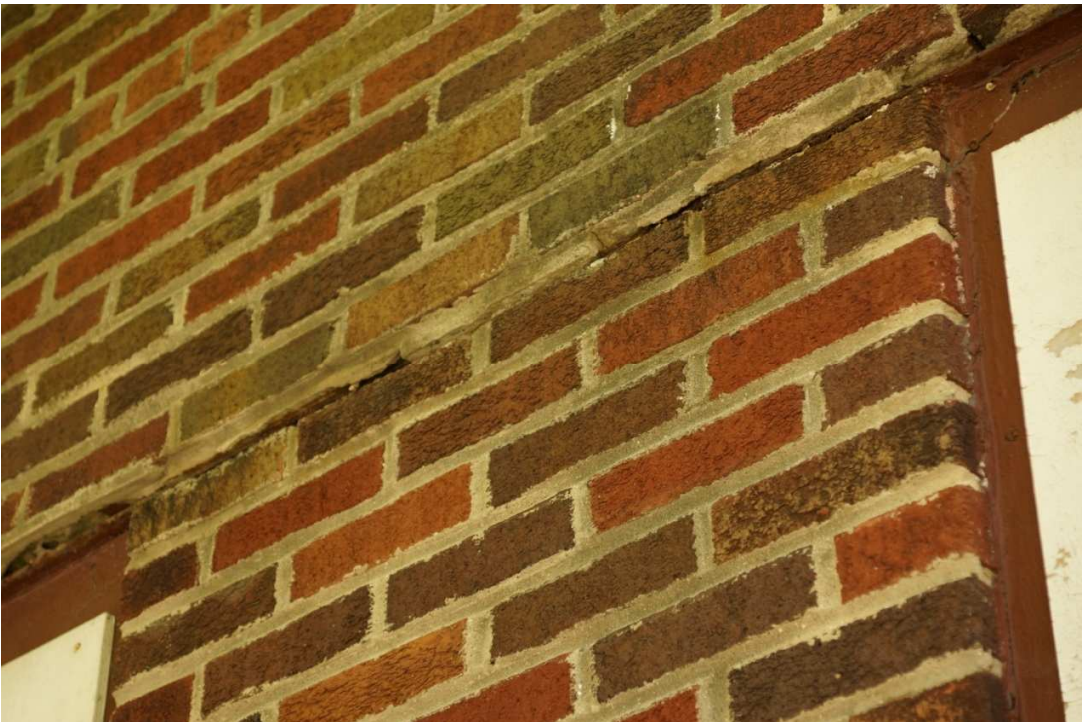
Fig. 12. Cracked mortar joint at the side façade

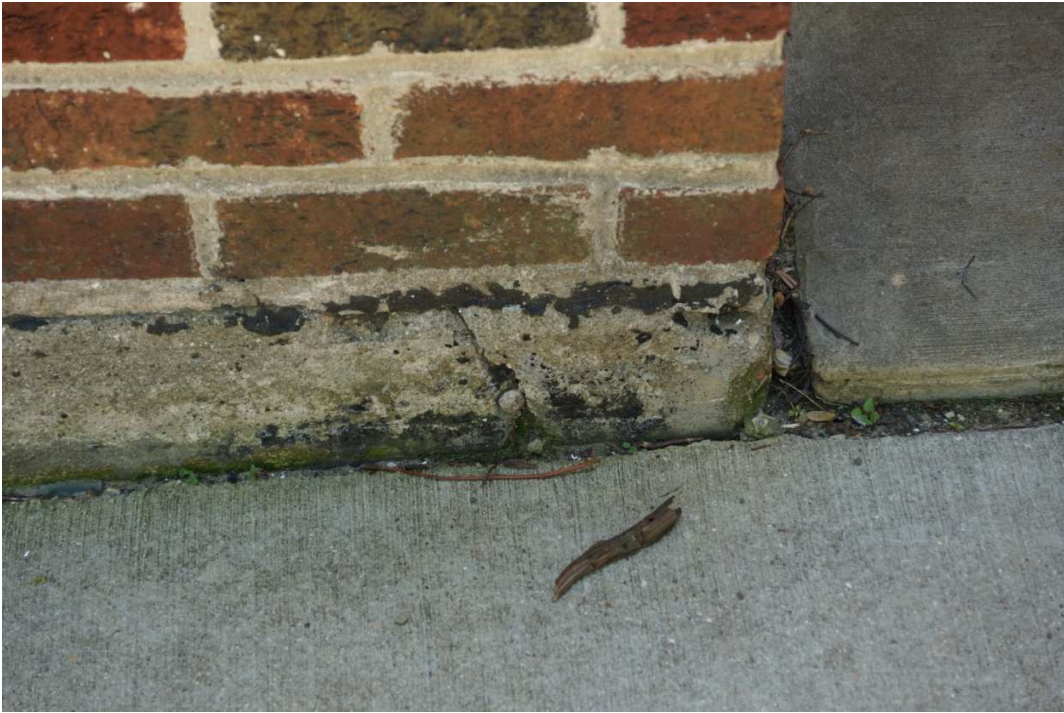
Fig. 13. Cracked foundation wall

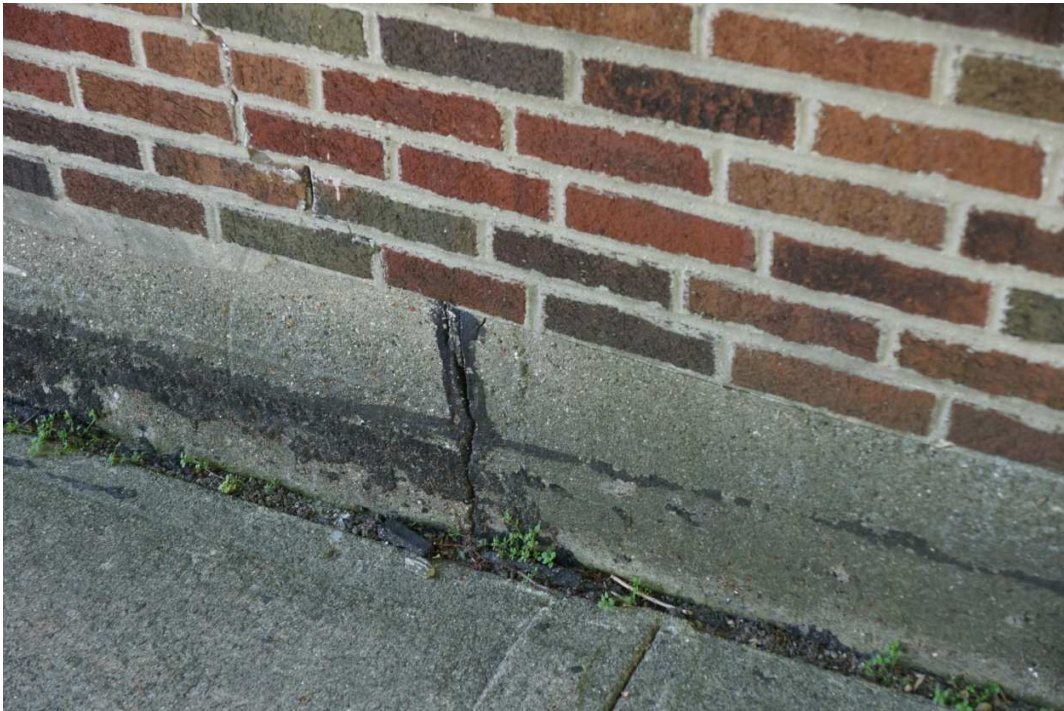
Fig. 14. Cracked foundation wall

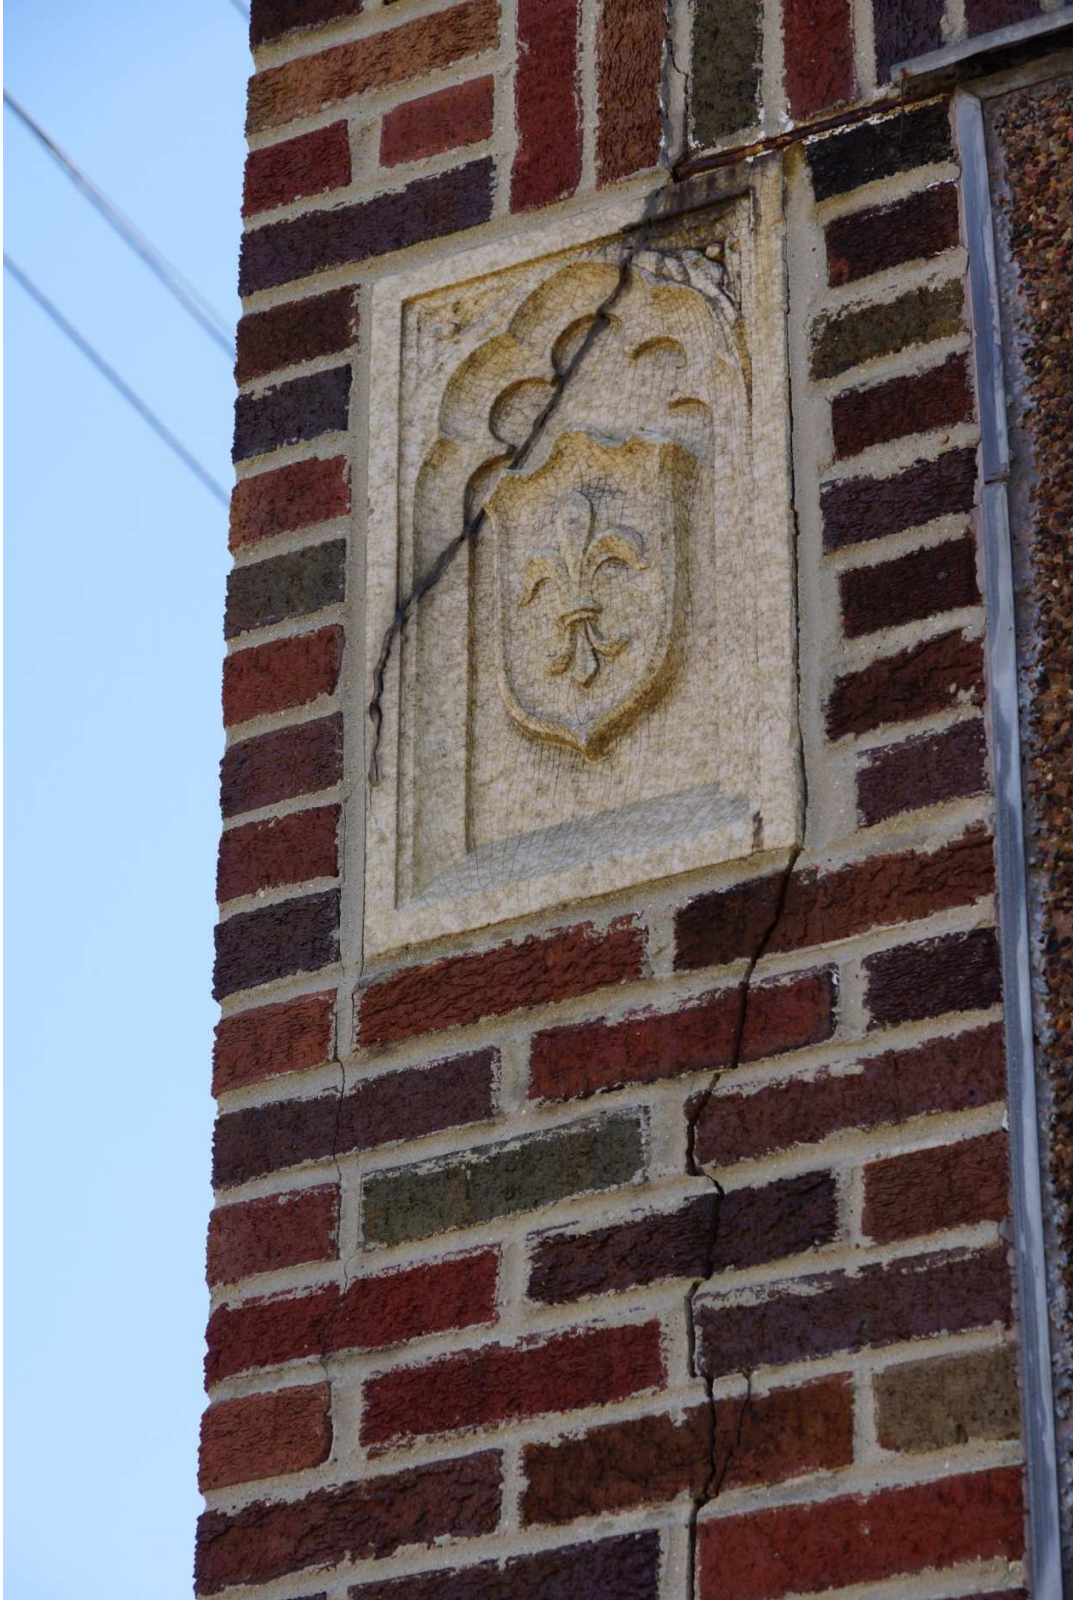
Fig. 15. Cracked corner stone.

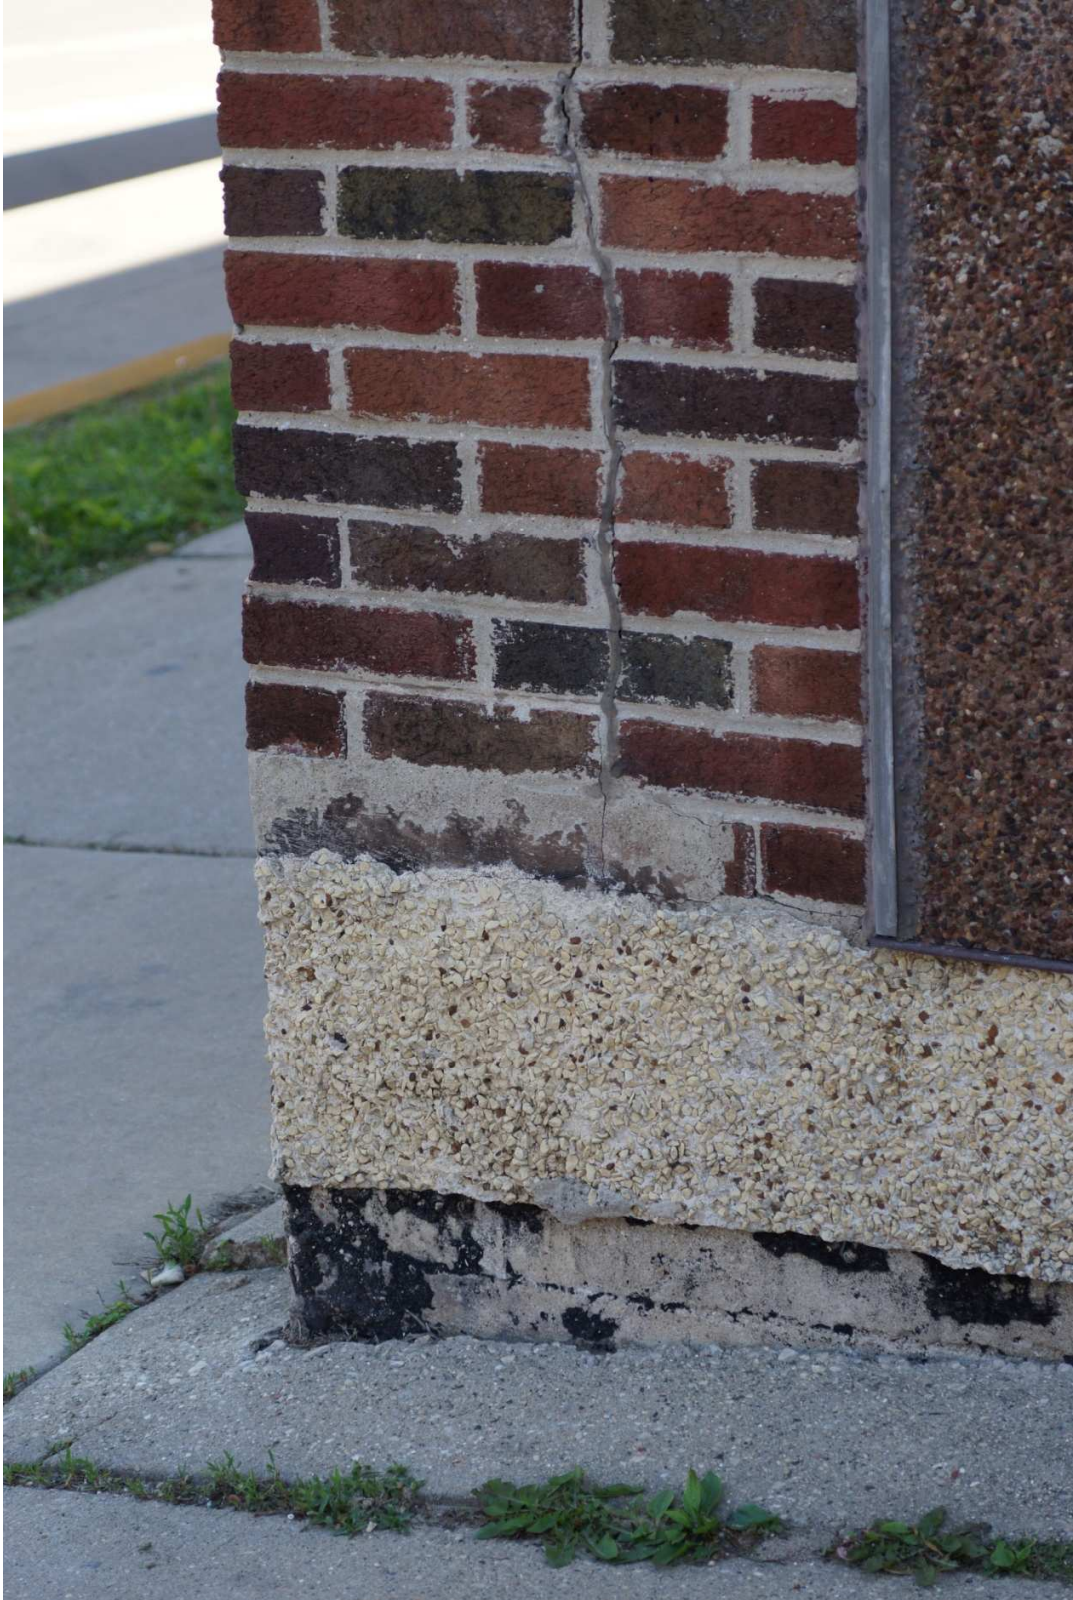
Fig. 16. Vertical wall crack

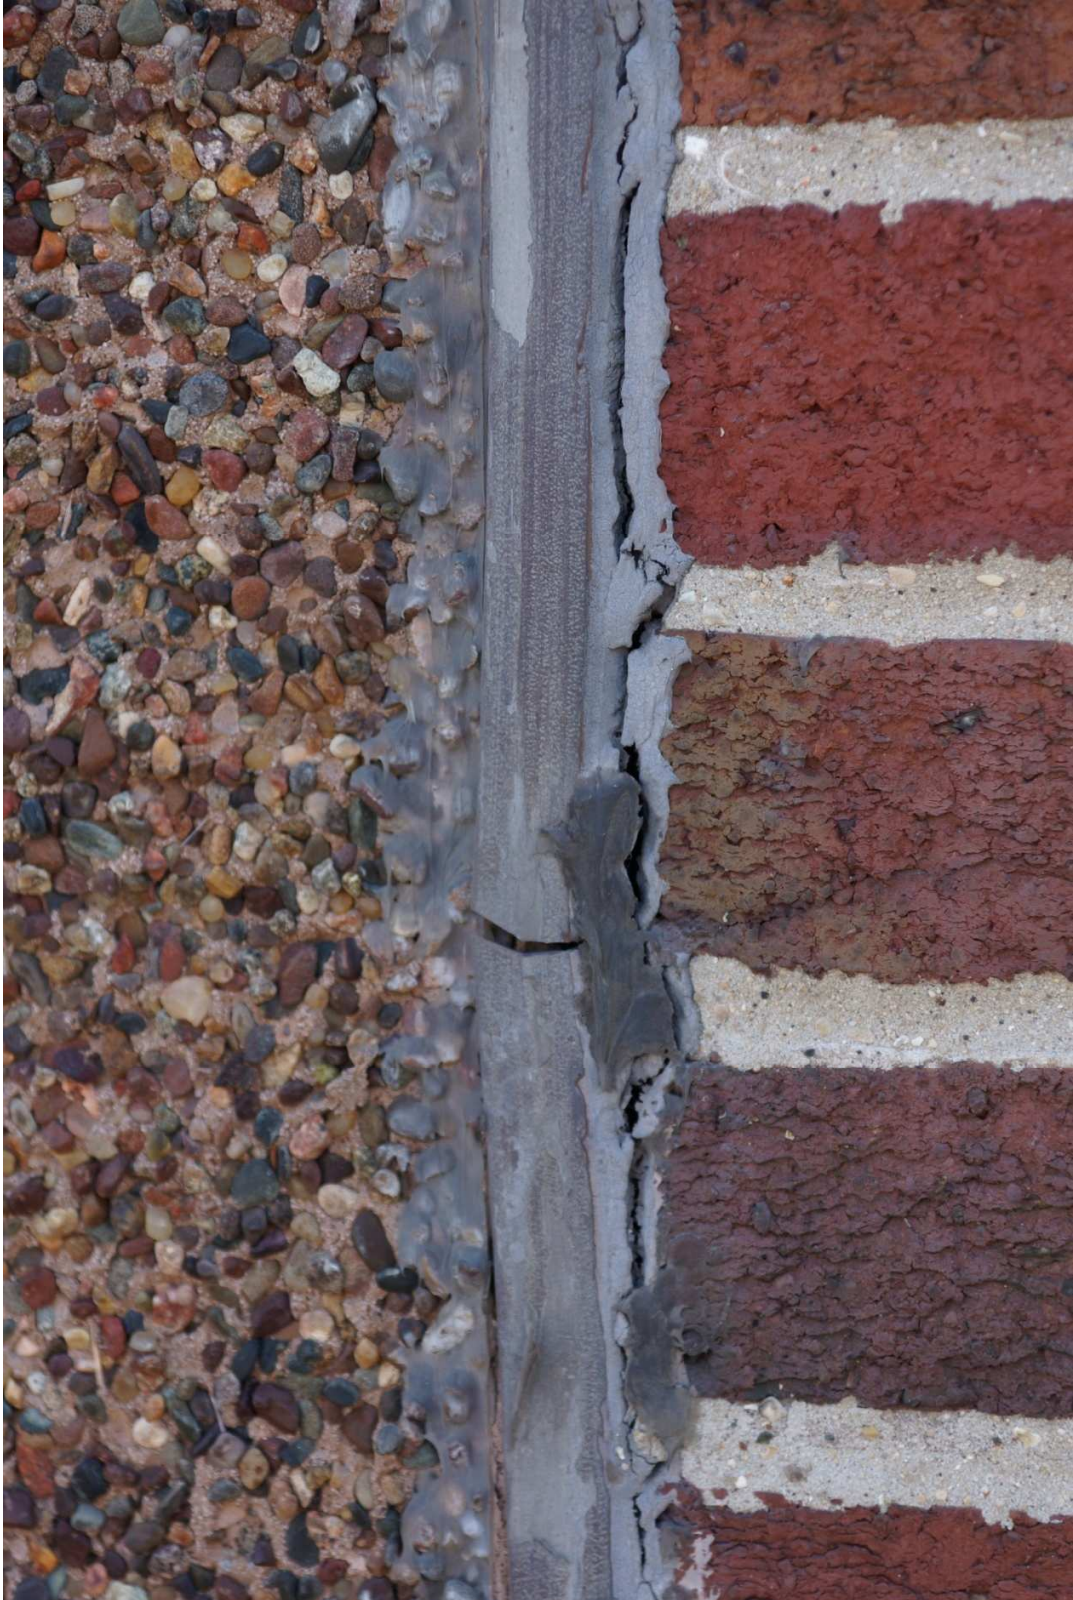
Fig. 17. Crack at flashing and caulk

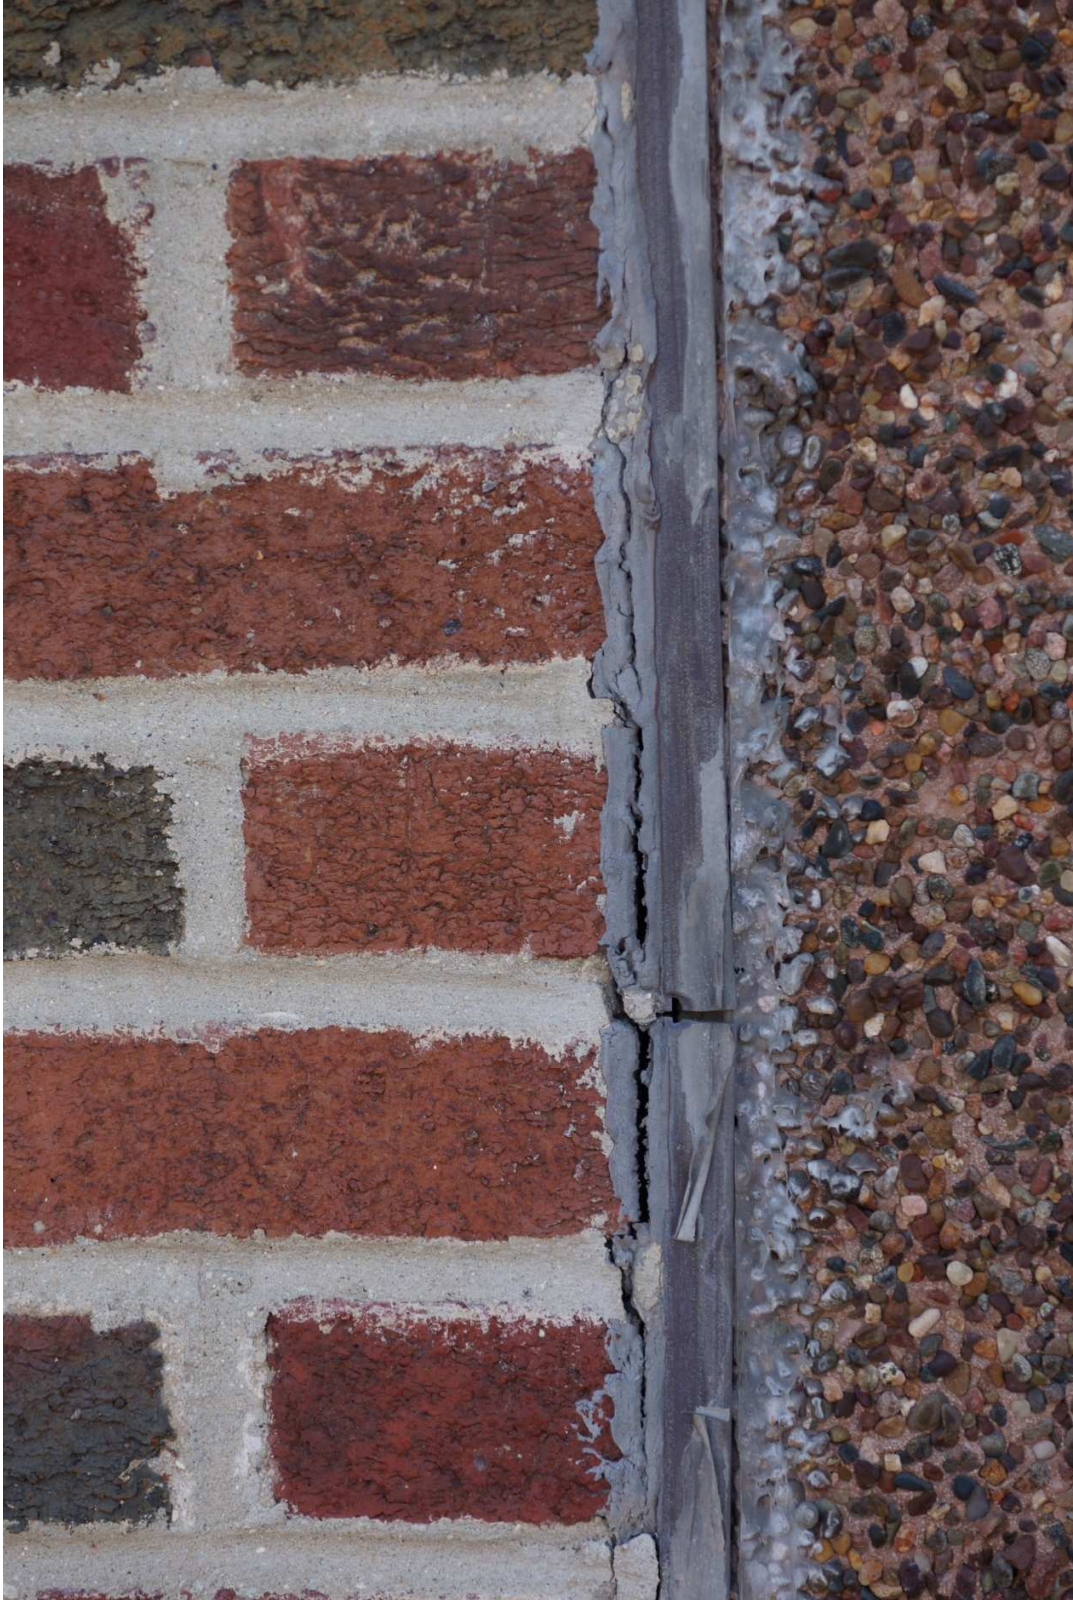
Fig. 18. Crack at flashing and caulk

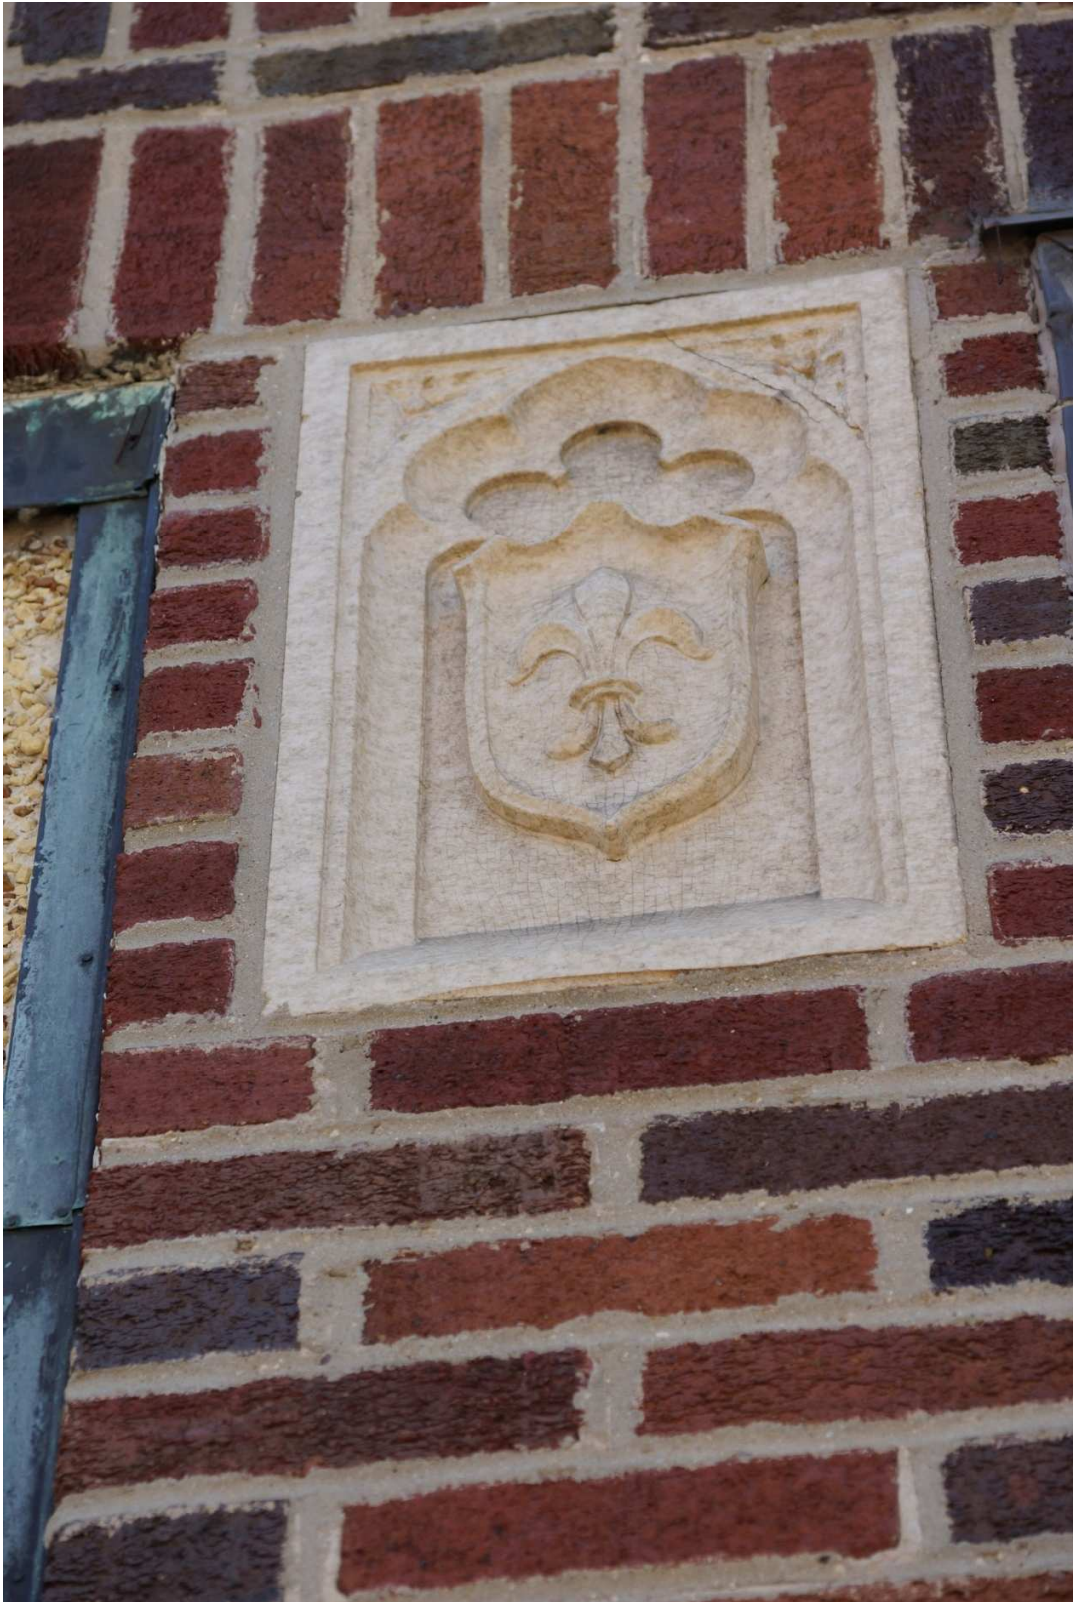
Fig. 19. Cracked corner Stone

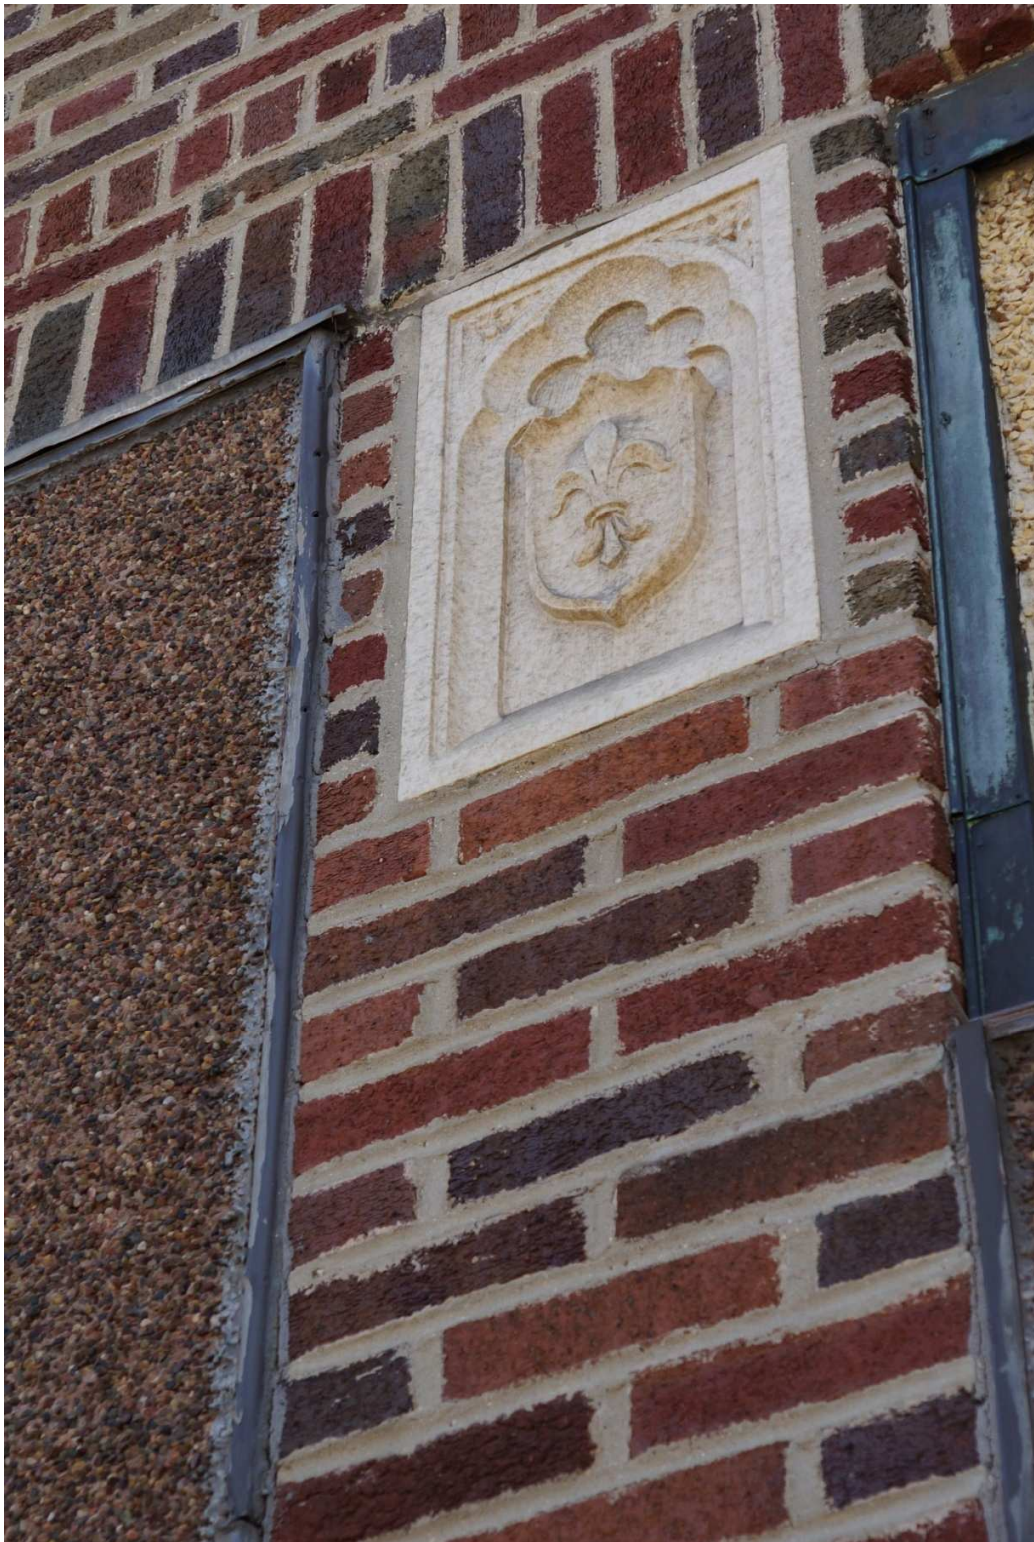
Fig. 20. Intact corner stone

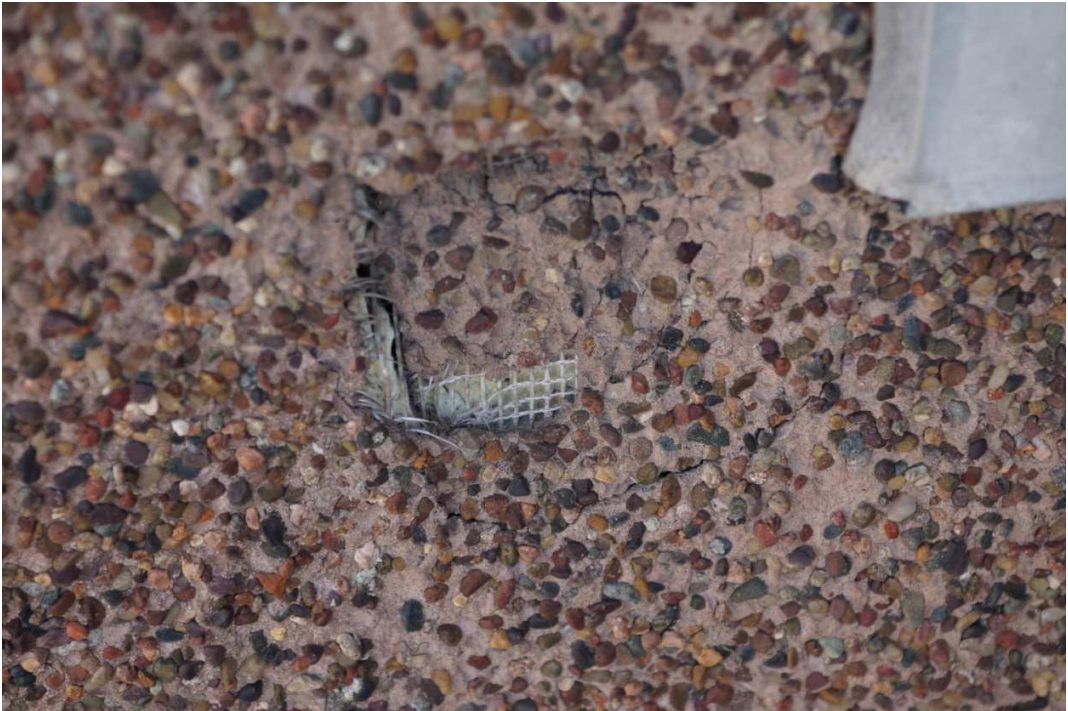
Fig. 21. Stucco damage

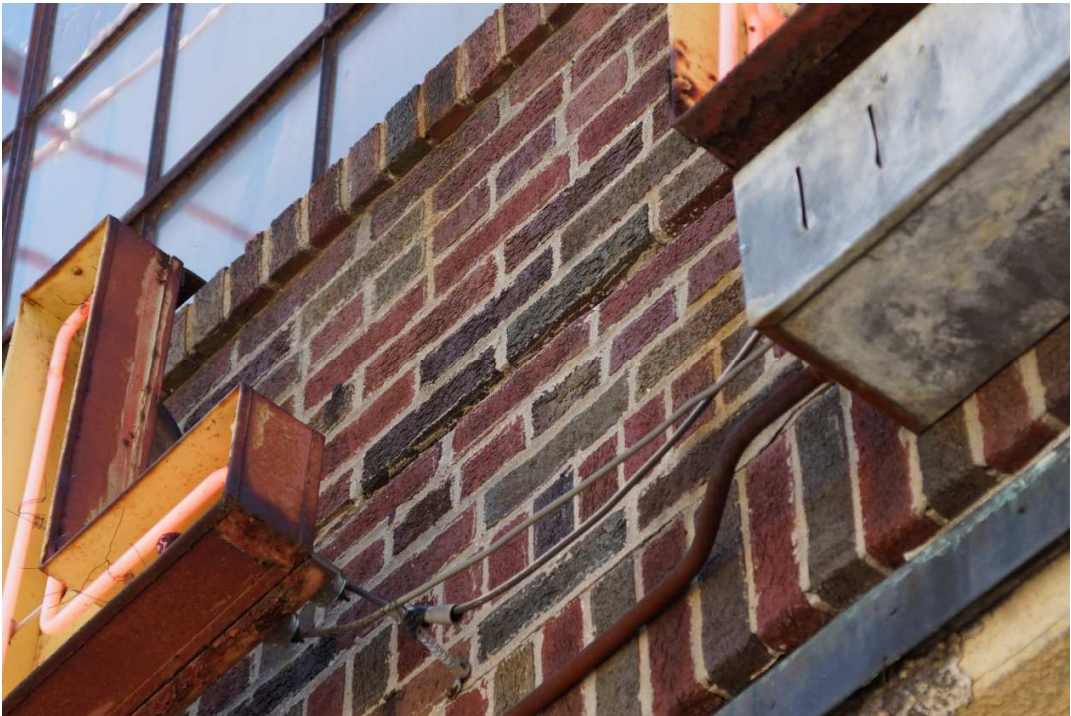
Fig. 22. Mortar deterioration at front wall
