SRI design

May 23, 2012

Subject: Structural Observation at the Ideal Body Shop
500 S. Park St., Madison

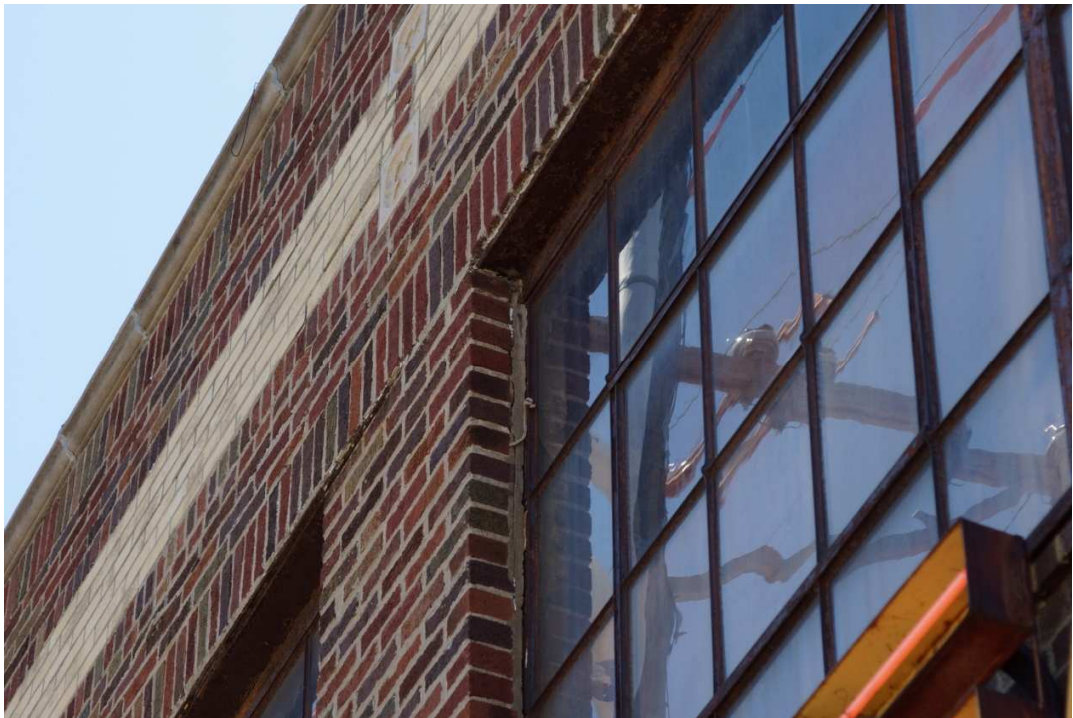
Fig. 23. Relative wall displacement between wall elements

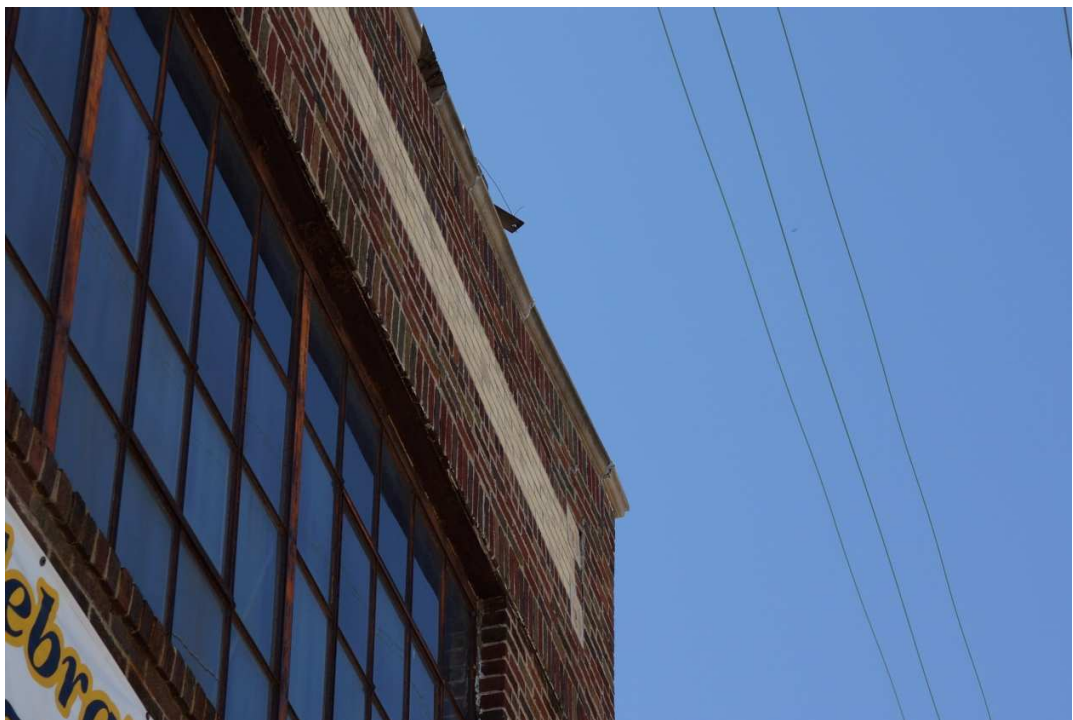
Fig. 24. Front wall displacement

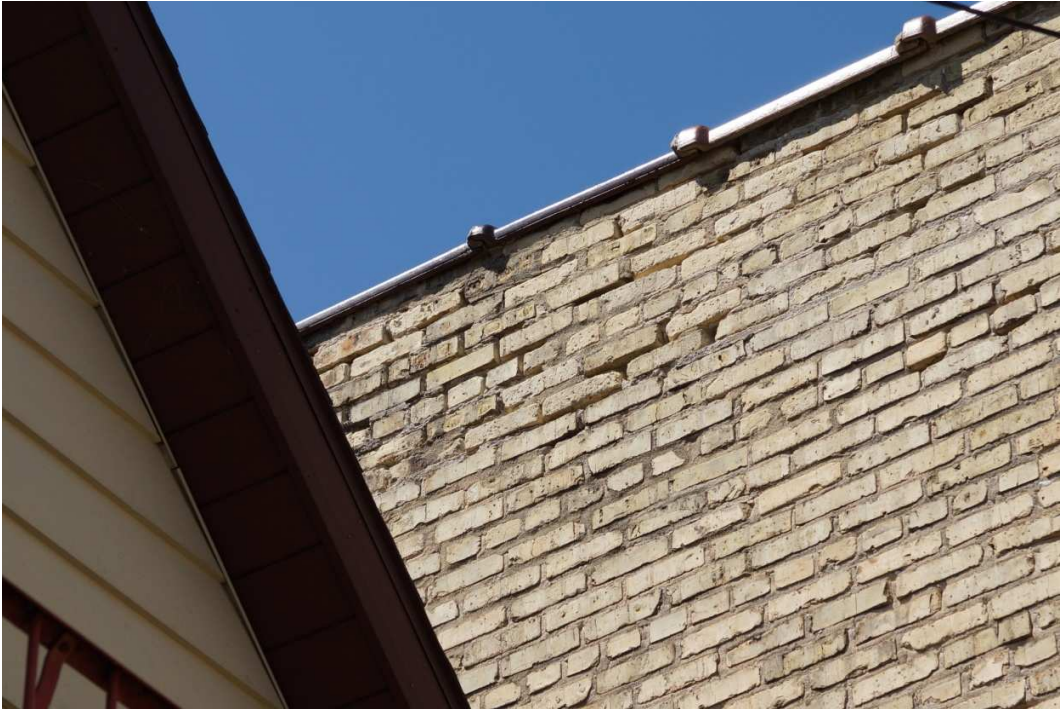
Fig. 25. Side wall condition
