PREPARED FOR THE LANDMARKS COMMISSION

Project Name/Address: Additional demolition review for 609 E Dayton
Legistar File ID # [68860](#)
Prepared By: Heather Bailey, Preservation Planner, Planning Division
Date Prepared: July 21, 2022

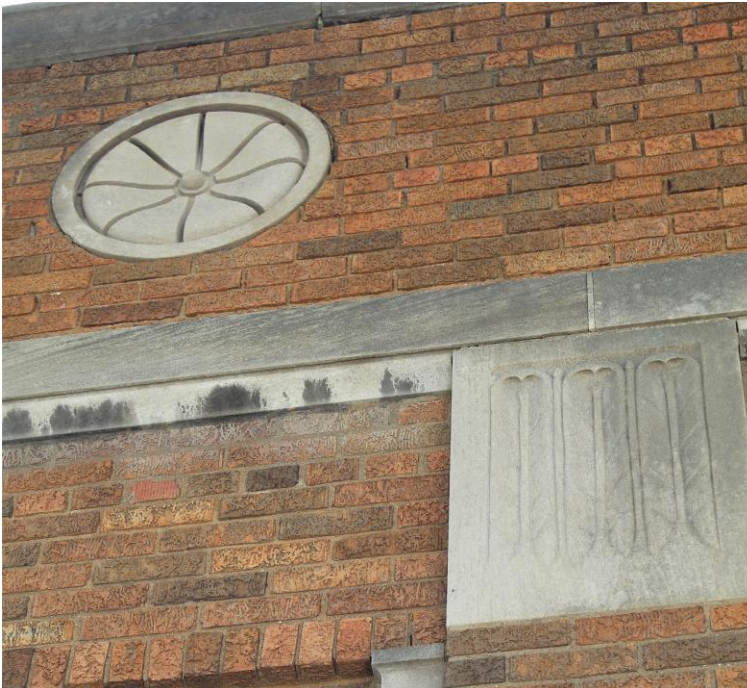
Details of front facade with stylized limestone rosette, banding and stylized acanthus leaf panel.

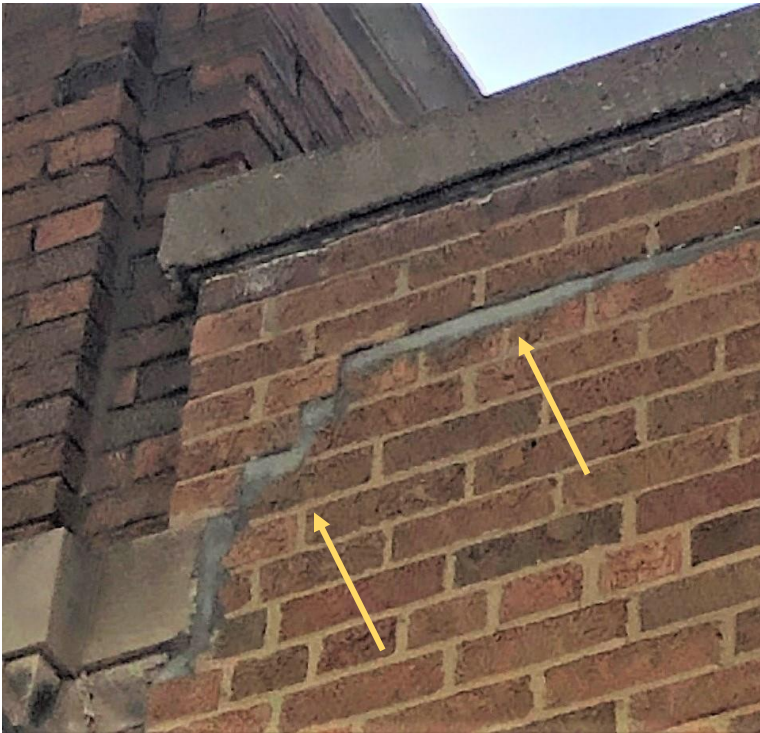
*Juncture of original building and west addition along Dayton Street.
Note structural crack and previous repairs.*

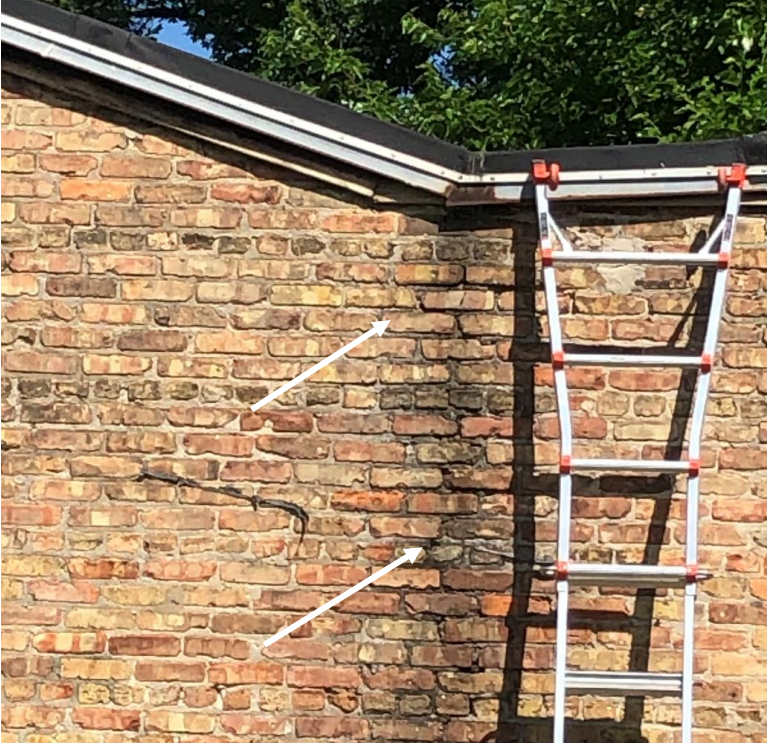
Mortar erosion along south wall of the original building.

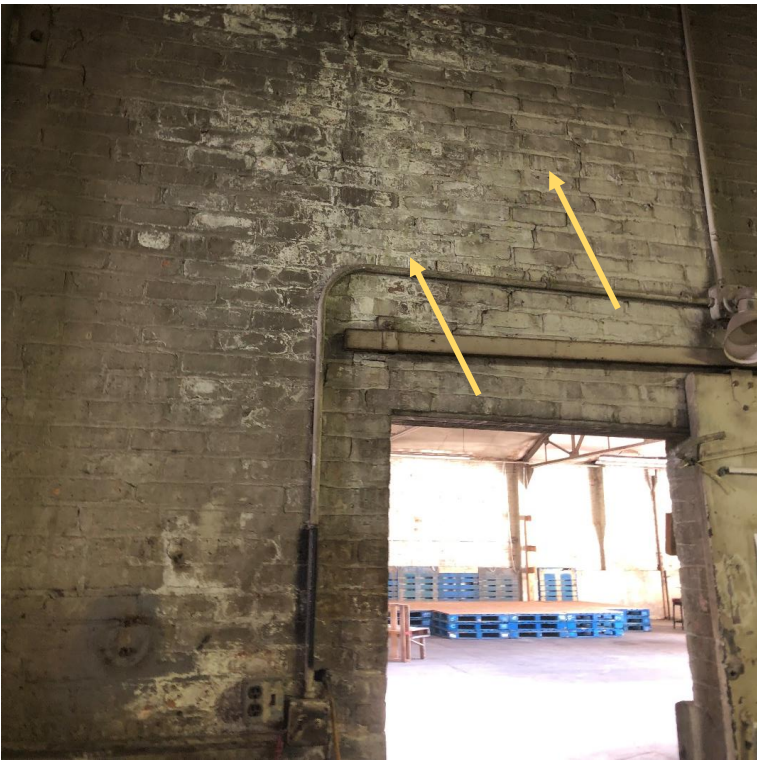
Image showing possible water infiltration from the roof in the form of calcium salt efflorescence.

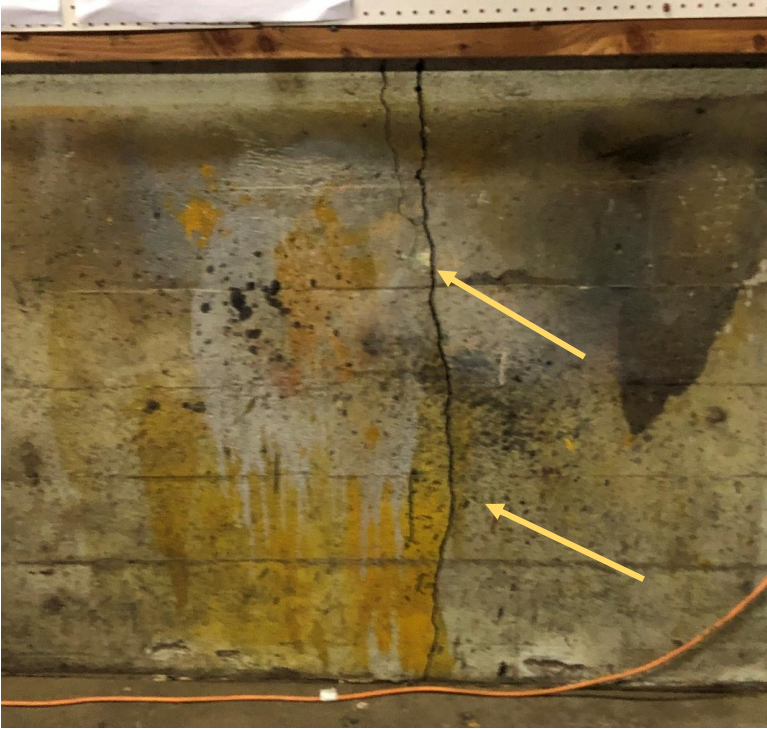
Image showing an unrepaired crack in the foundation wall separating the original building from the first addition along East Dayton Street

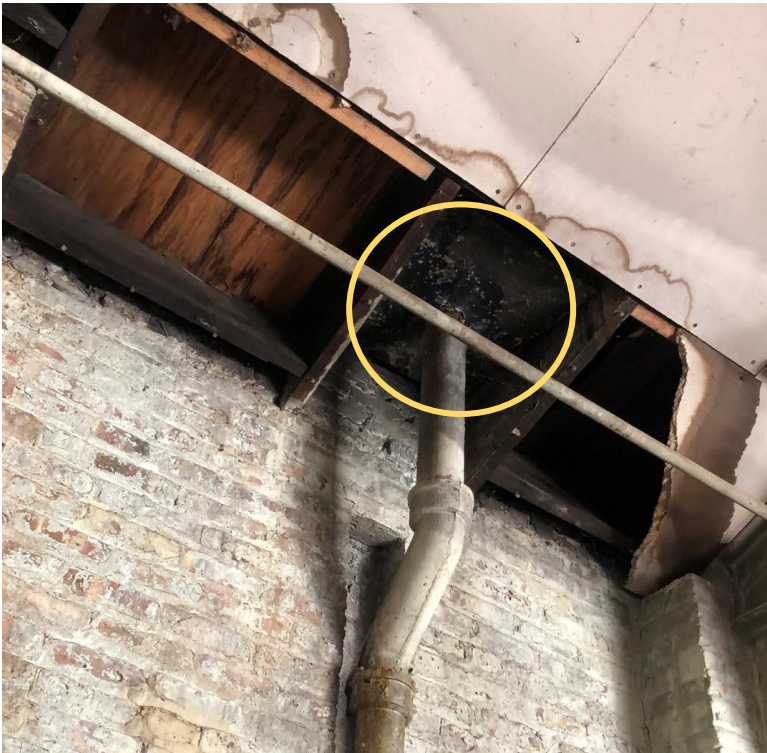
Image showing minor damage below roof pitch pocket drain pan.

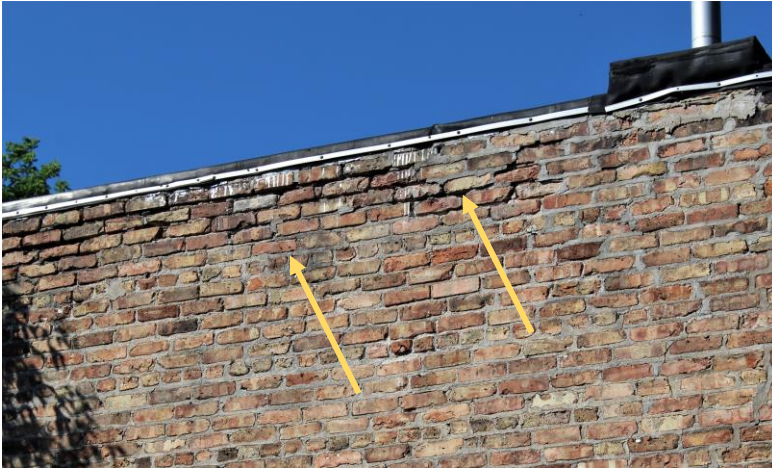
Deterioration of the east parapet. Common bond brick pattern.

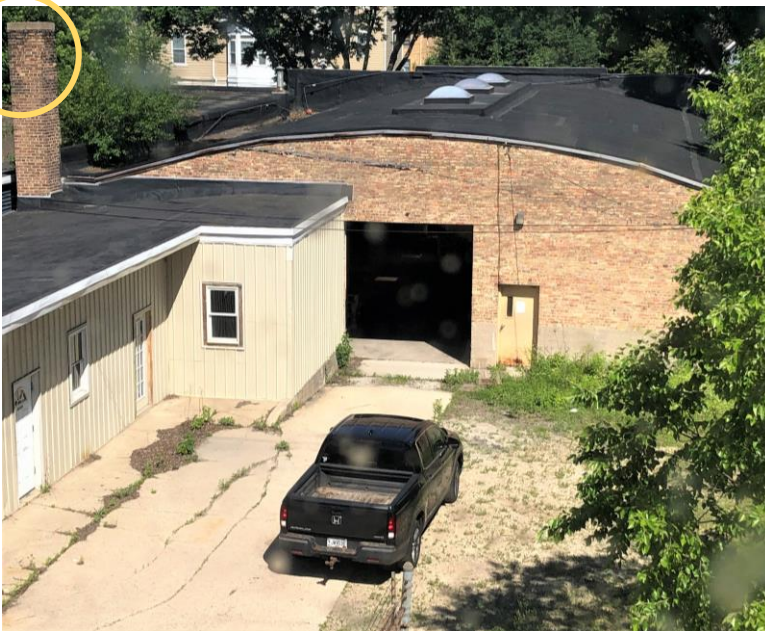
View of the EPDM roof on the original building (with new skylights) and south addition. Poor masonry condition at top of chimney.

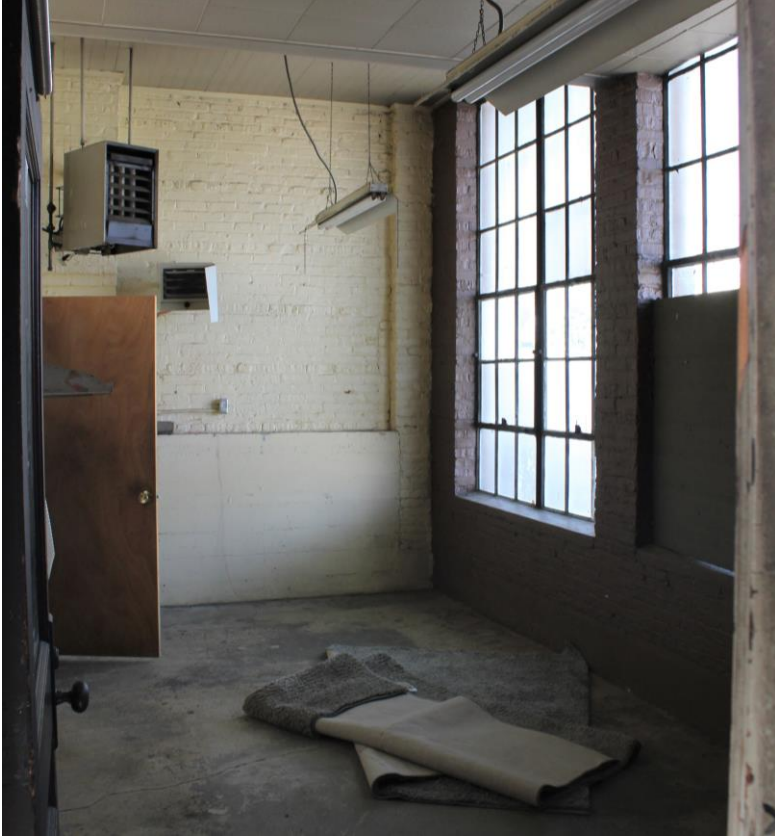
View of the office area within the original building. Note brick masonry walls and industrial steel windows.

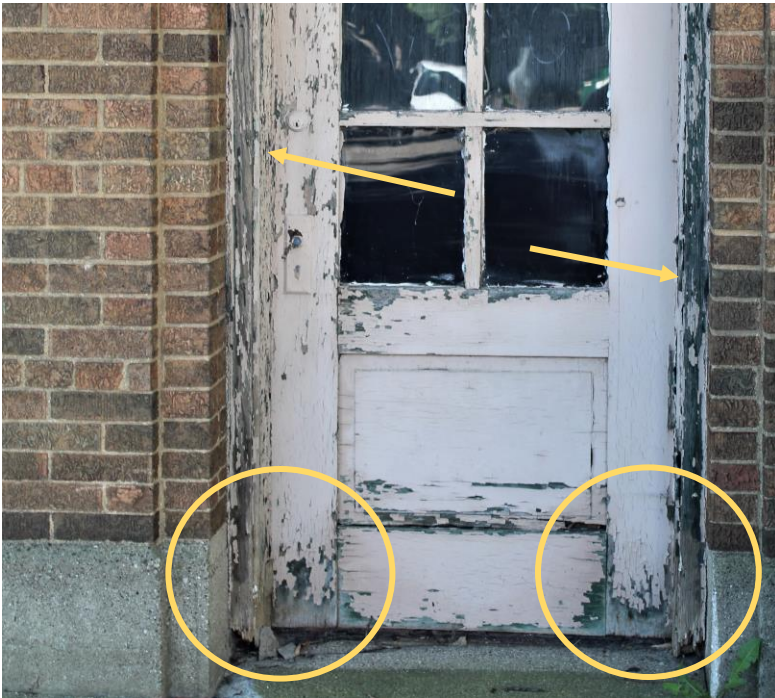
Deterioration of the right-side front door

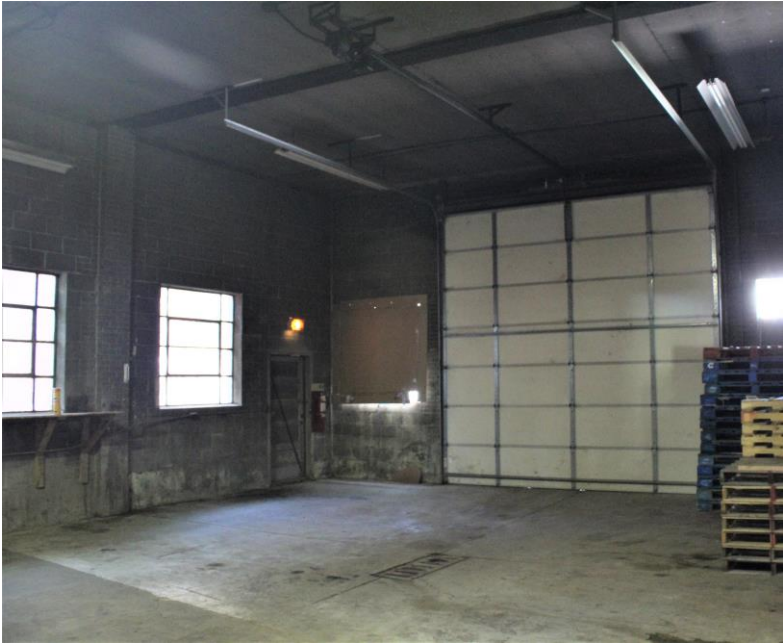
View of the interior of the west addition.

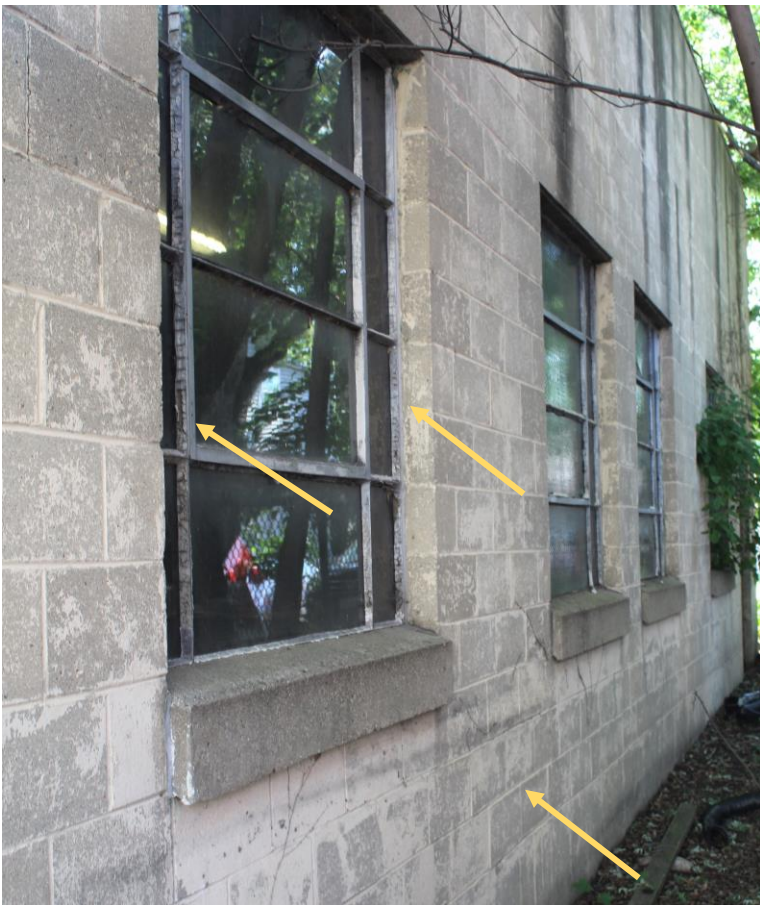
View of the west side of the west addition. Note the deteriorated steel window glazing and paint finish and the paint finish on the concrete block.

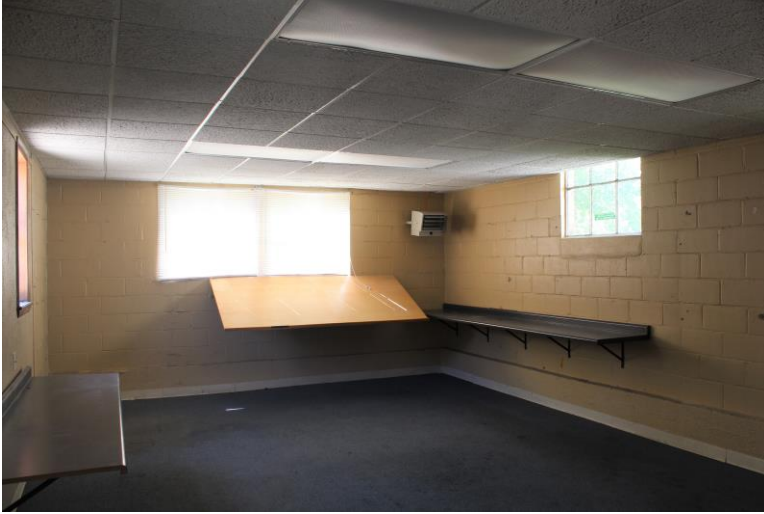
View of one of the work area/offices in the south addition.

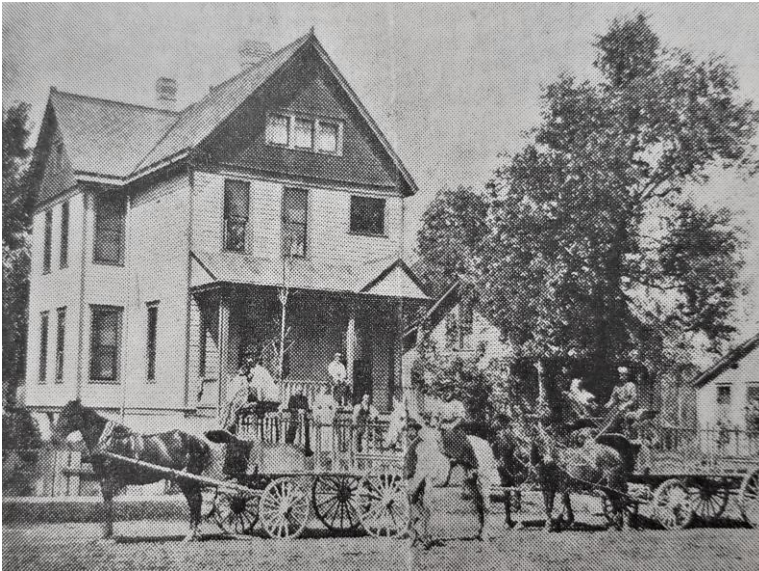
*The Reynolds Dray line in 1900.
Wisconsin State Journal 3/3/1961*

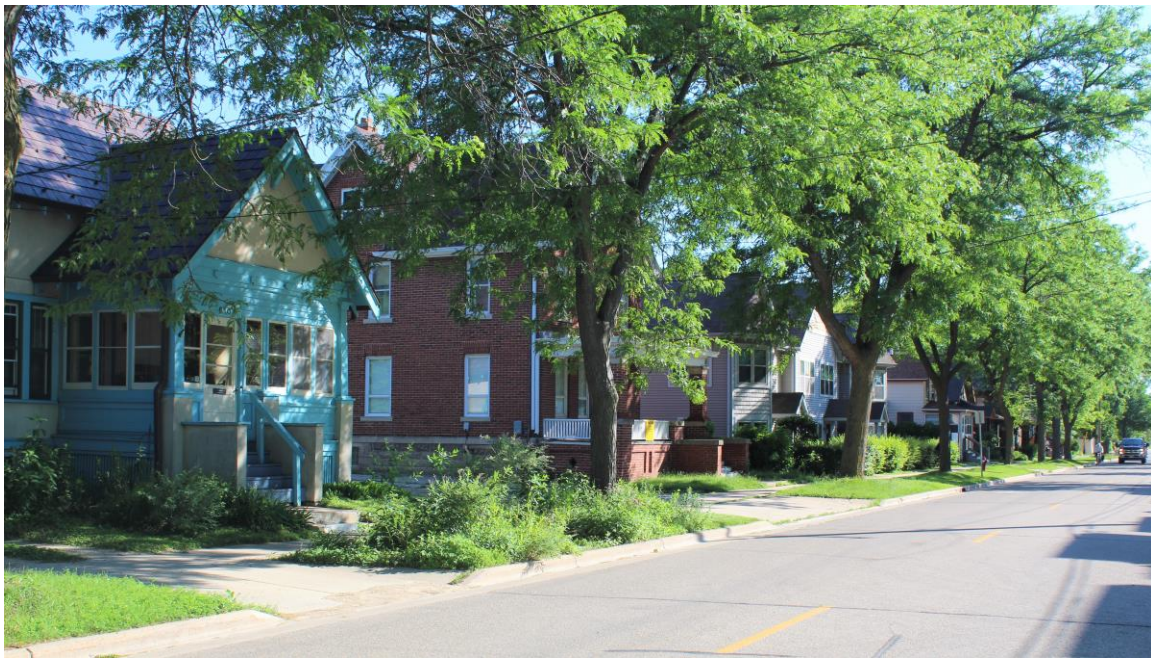
616 East Mifflin and adjacent houses, June 20, 2022

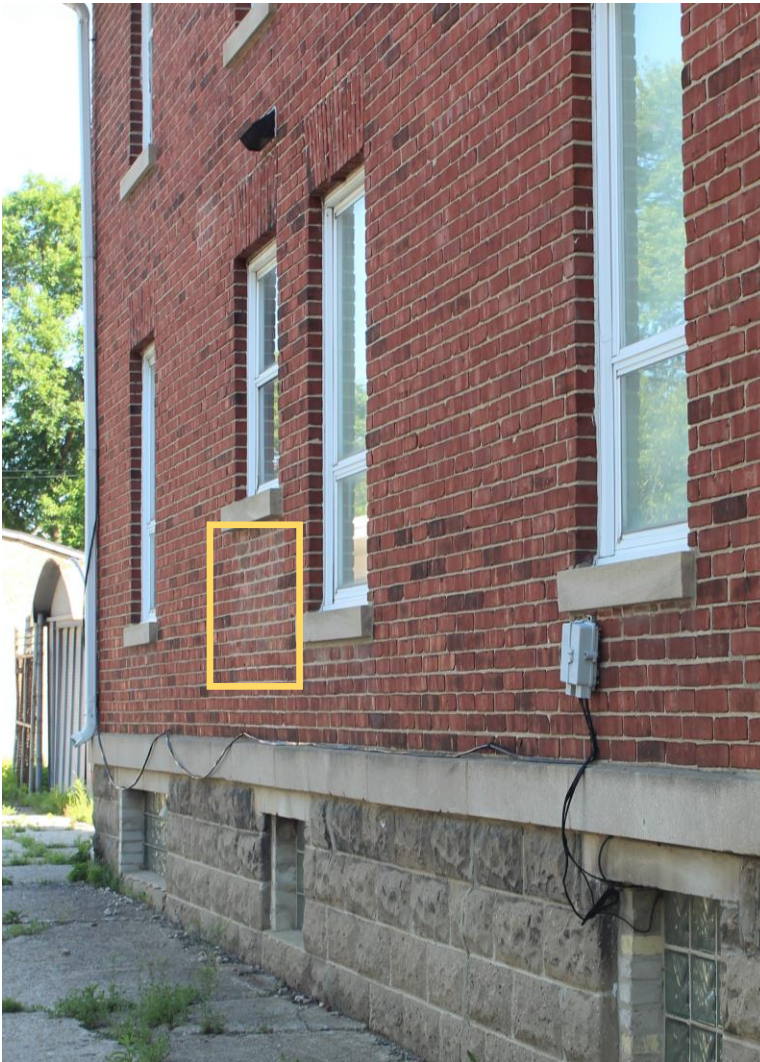
View of the west façade, note the rusticated concrete block foundation, limestone belt course and running brick masonry with limestone sills. Area of window infill illustrated.

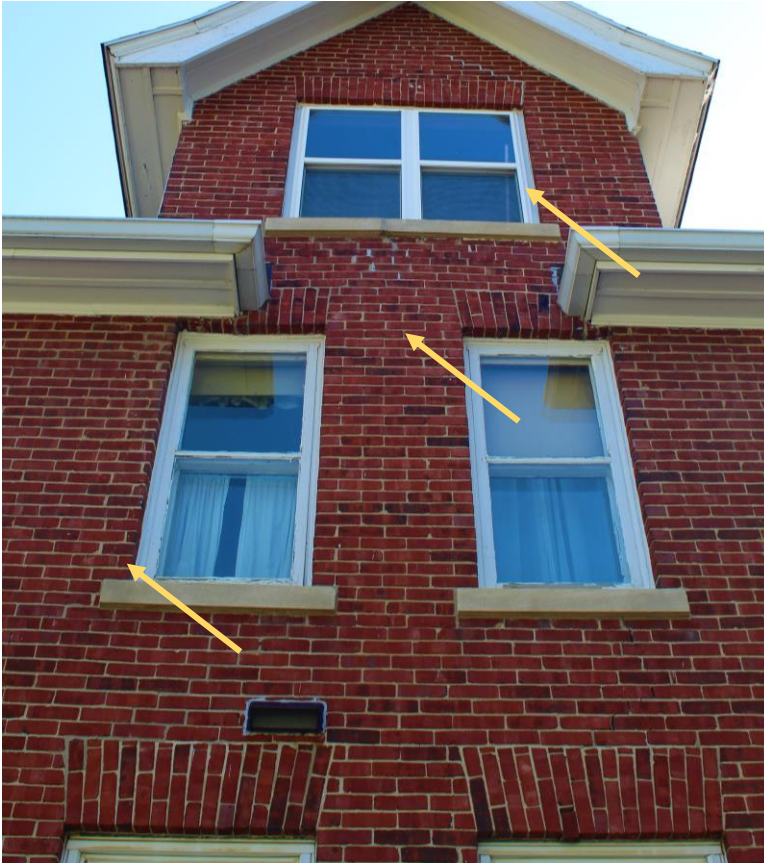
View of the east façade. Note flat brick arches over windows, decorative soffit treatment and original second floor windows. Areas of inappropriate repointing illustrated.

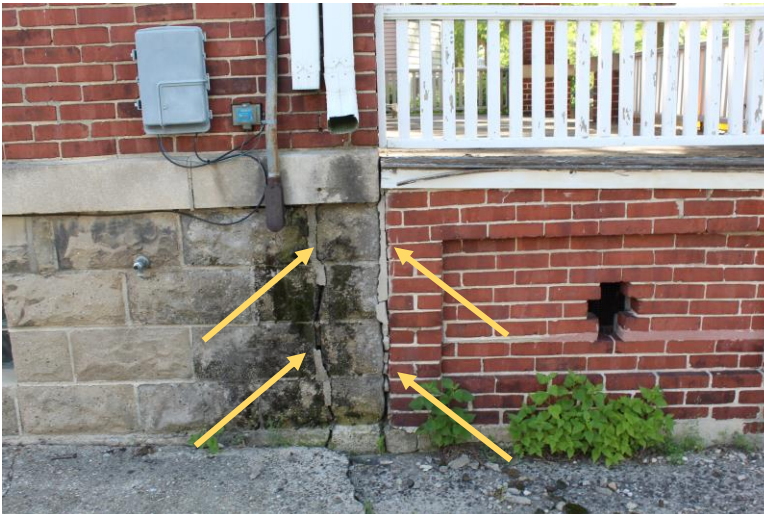
Area of settlement at southwest corner of house at junction with porch. Significant foundation cracking. Rain and snow melt water ponding here.

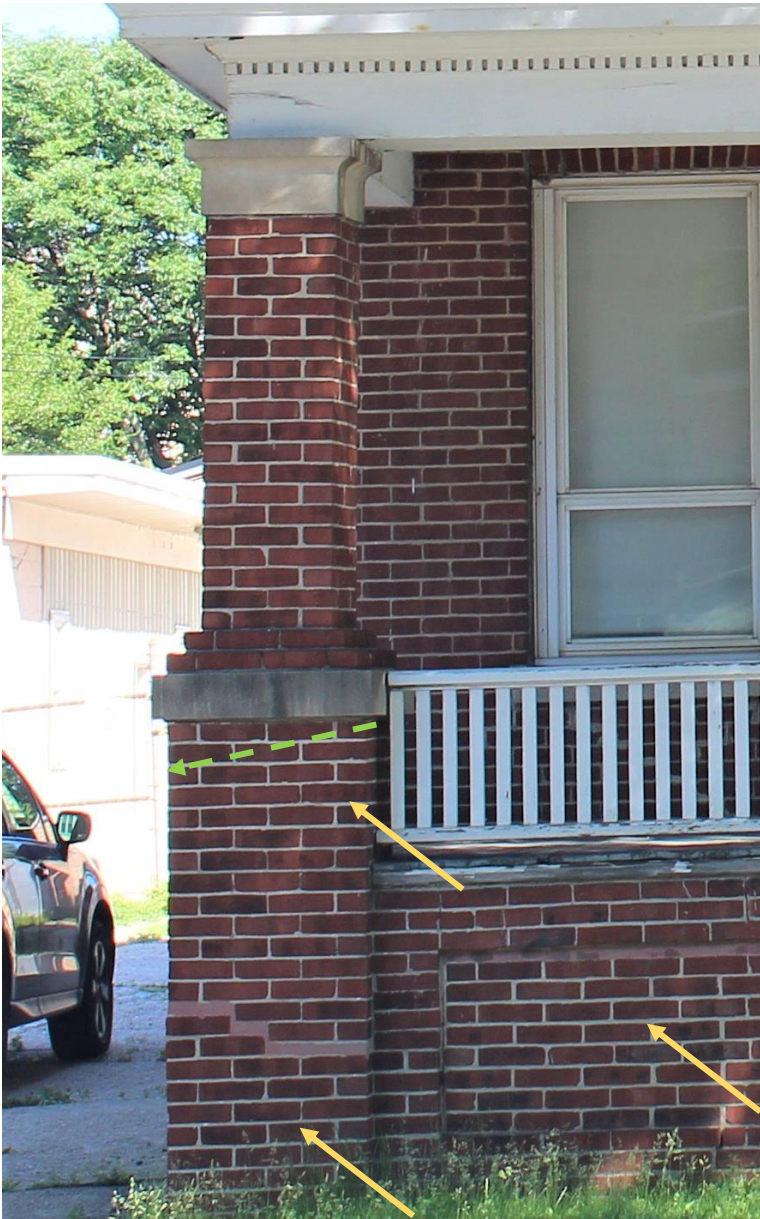
View of southeast corner of front porch. The limestone pier cap has rotated. Evidence of previous repairs of full mortar replacing brick.

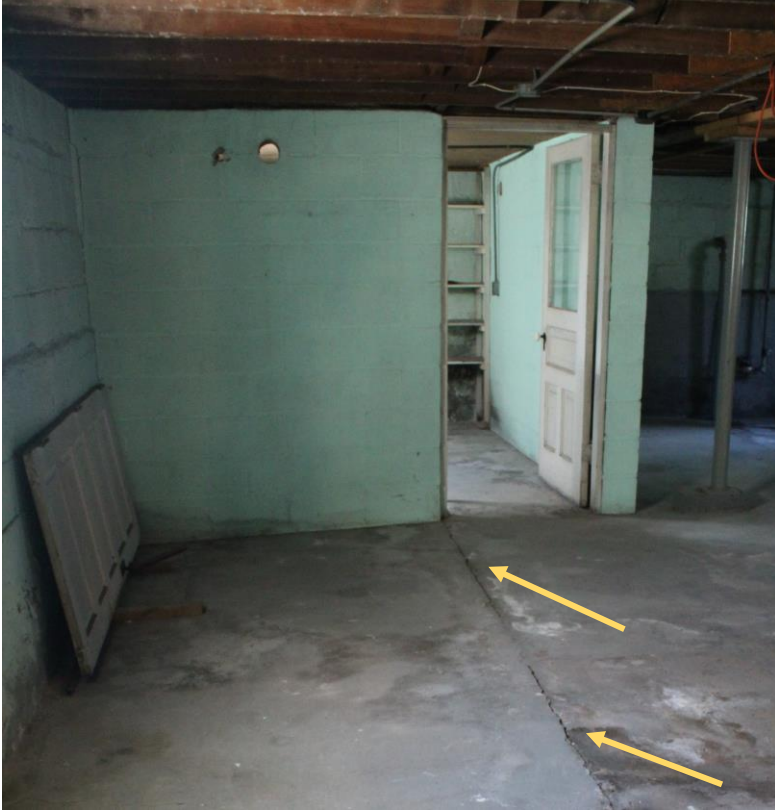
Unfinished basement area. Line of heaved floor slab shown.

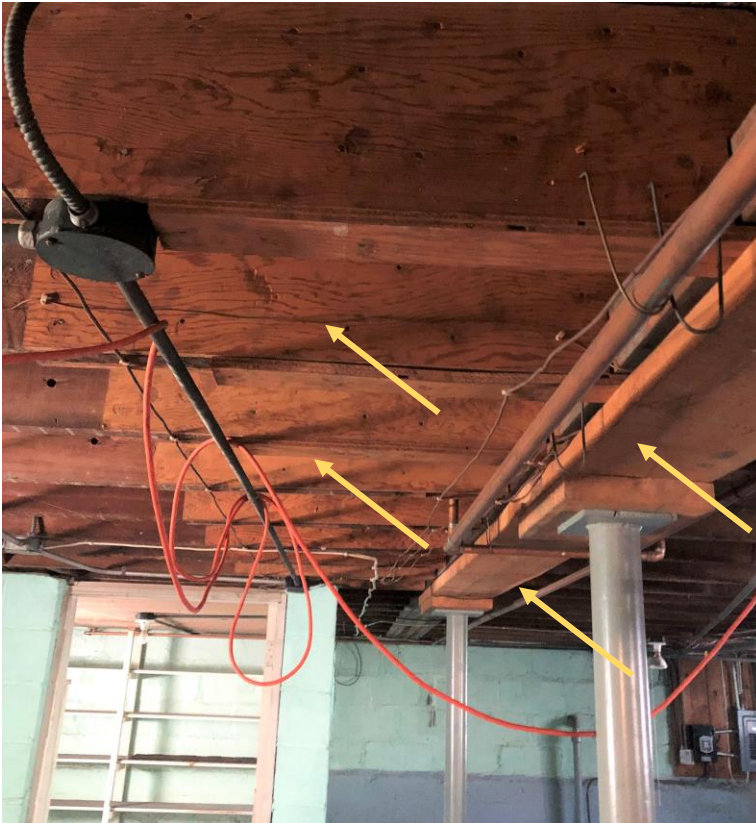
Modifications to floor joists and main beam in basement.

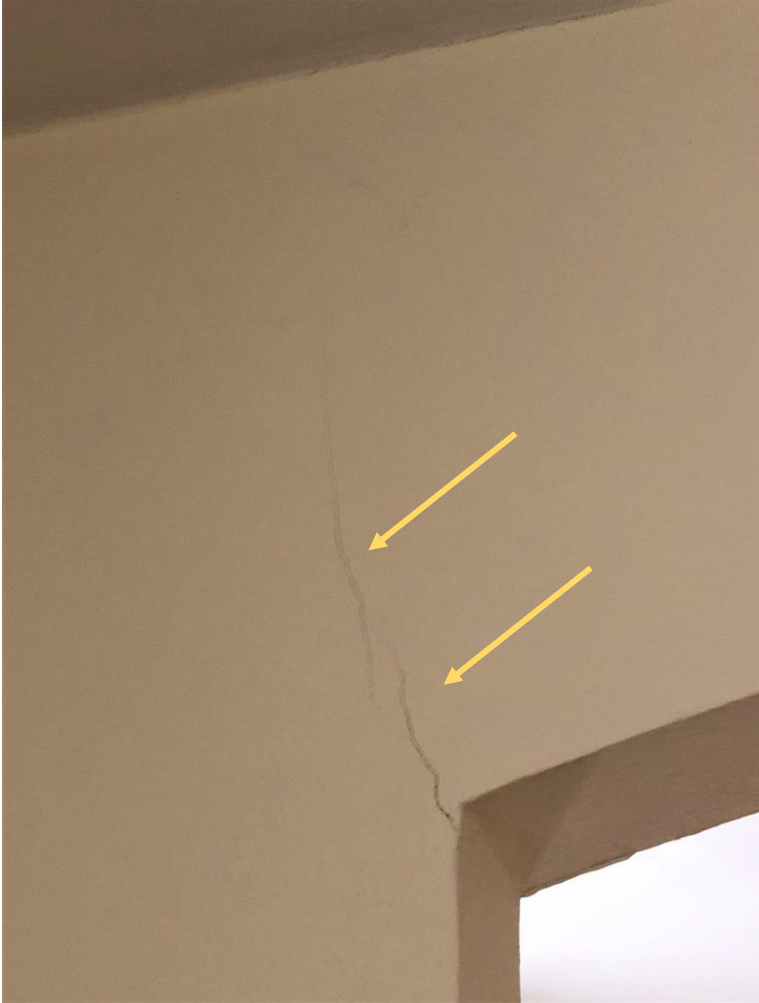
Image of crack in first floor plaster wall of living room.

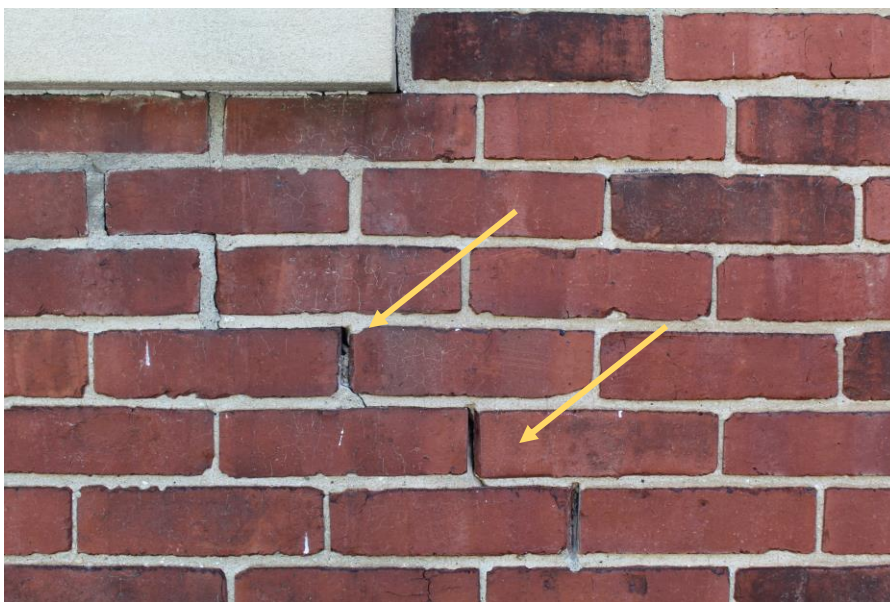
West masonry wall. Typical area for mortar repointing.

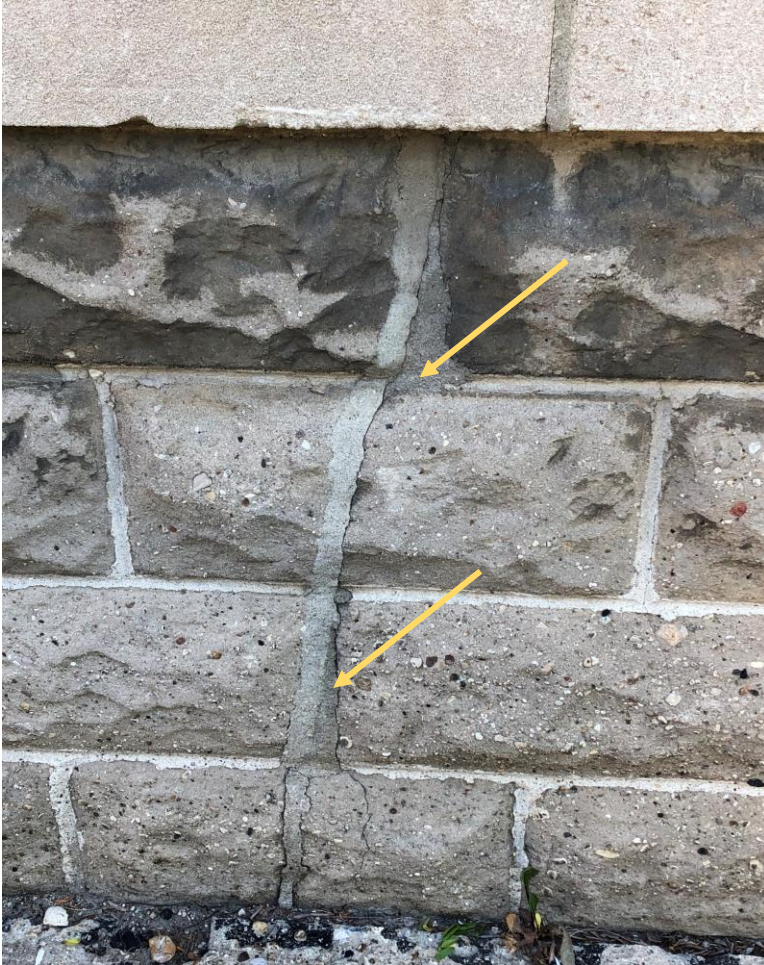
Crack through foundation wall, repaired with hard Portland mortar.

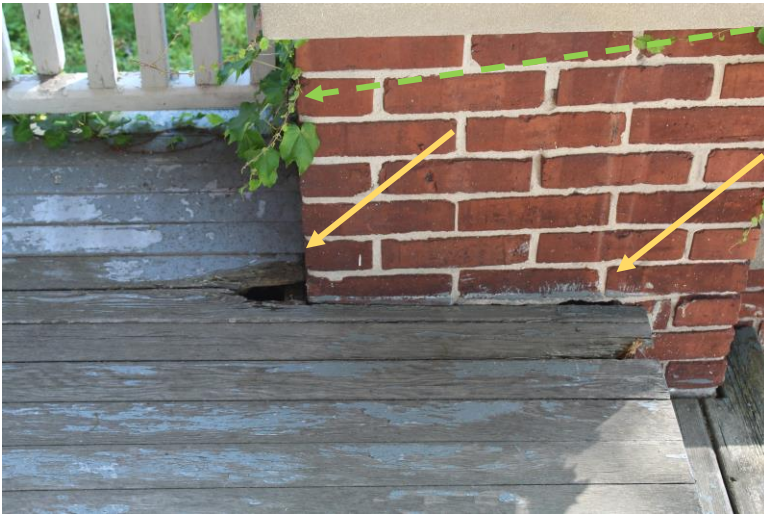
Deteriorate front porch floor and tilting brick column.

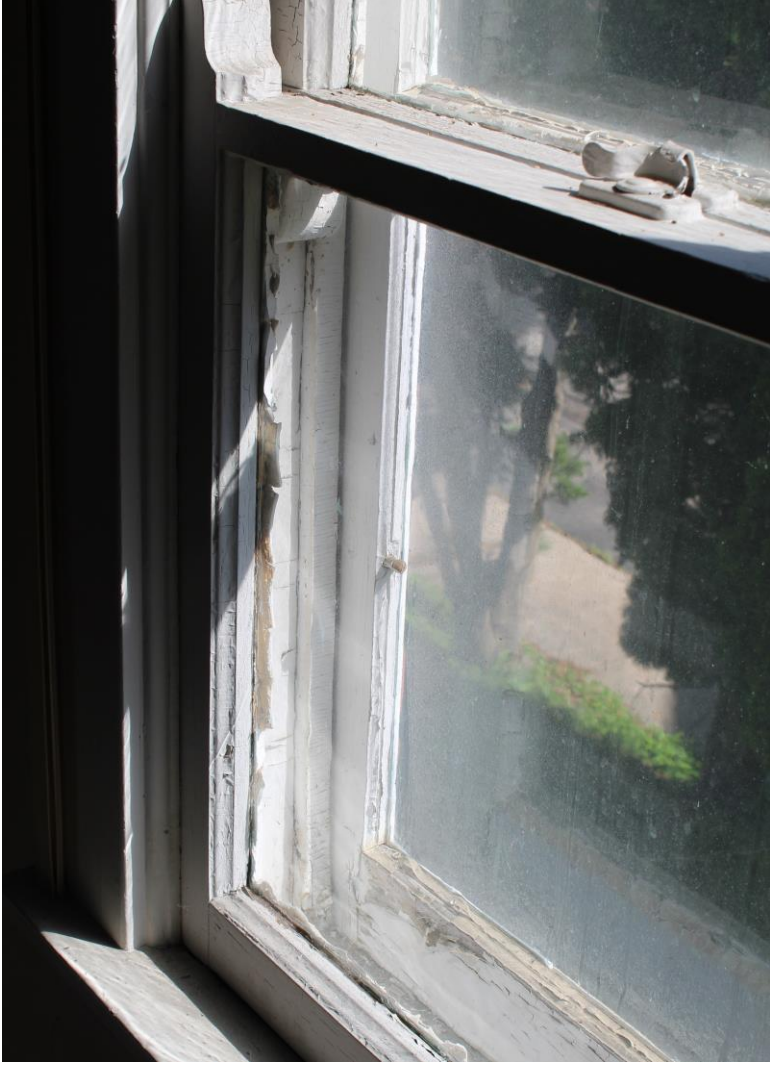
Second floor original wood window and storm

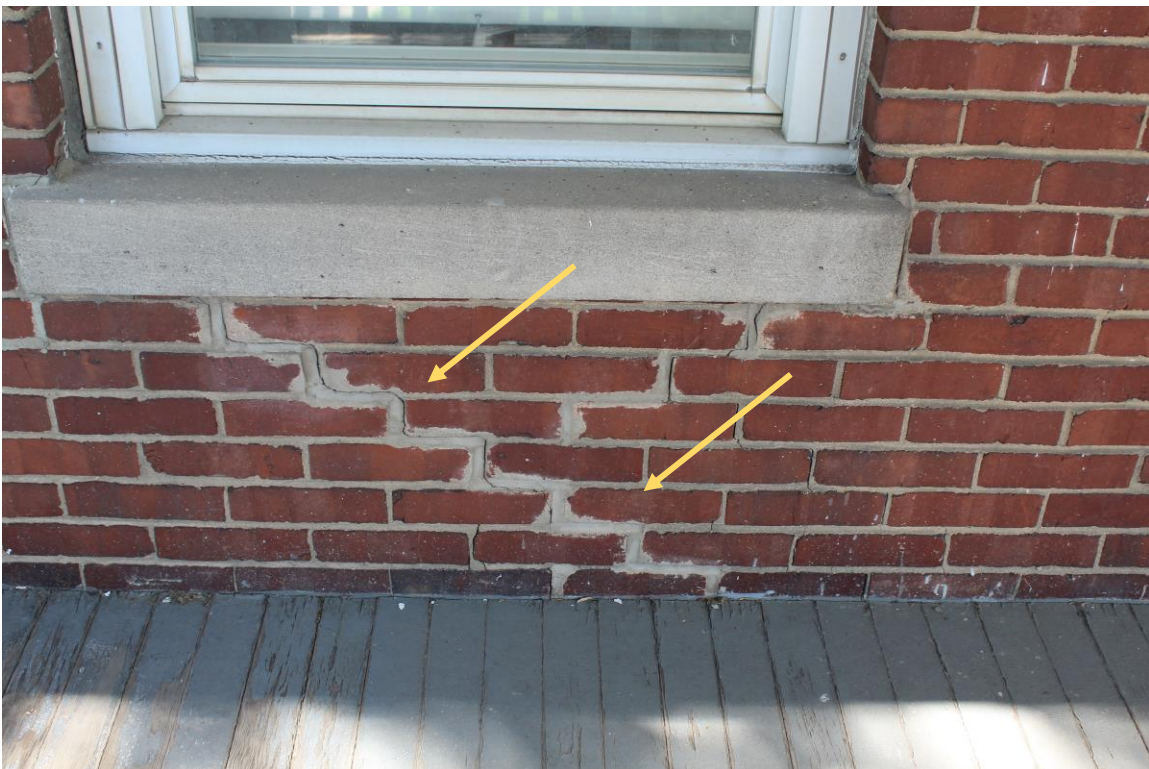
Step crack in brick masonry at corner of front porch. Inappropriate Portland mortar.
