Home Inspection Report

4022 Manitou Way, Madison , WI 53711

Sunday January 4, 2015

Sean Shannahan

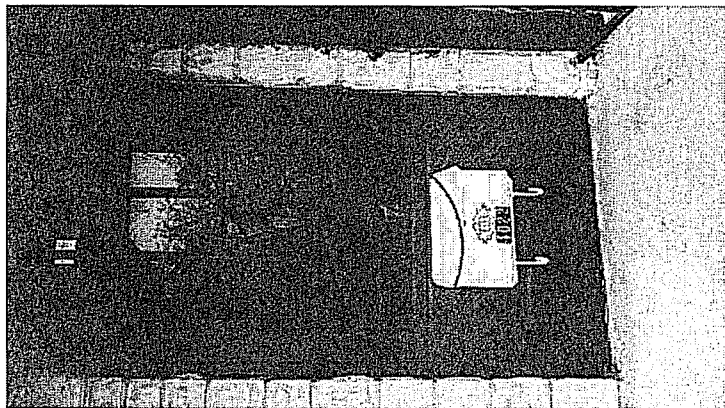
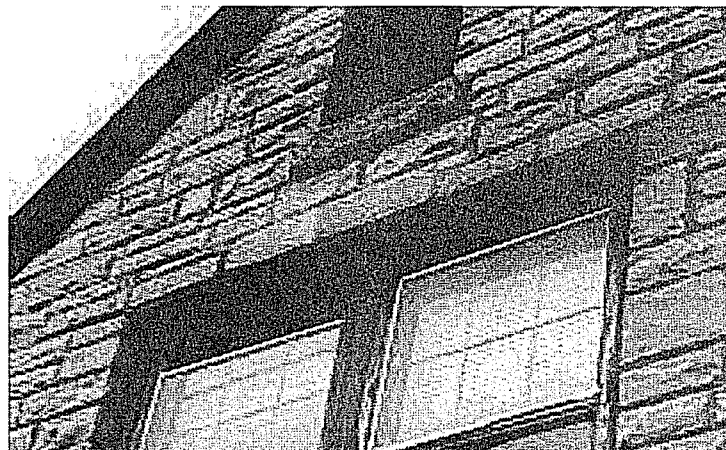
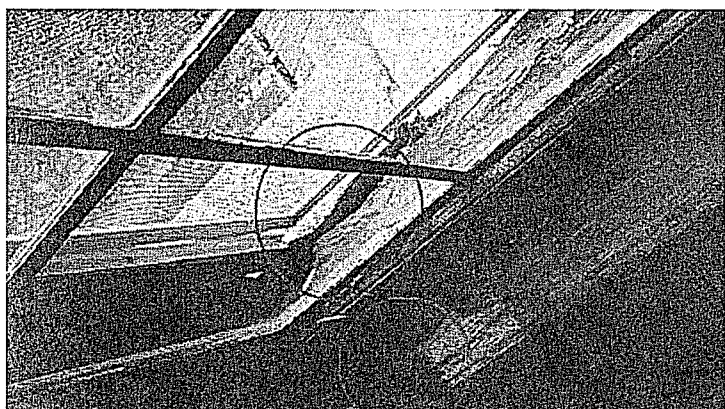
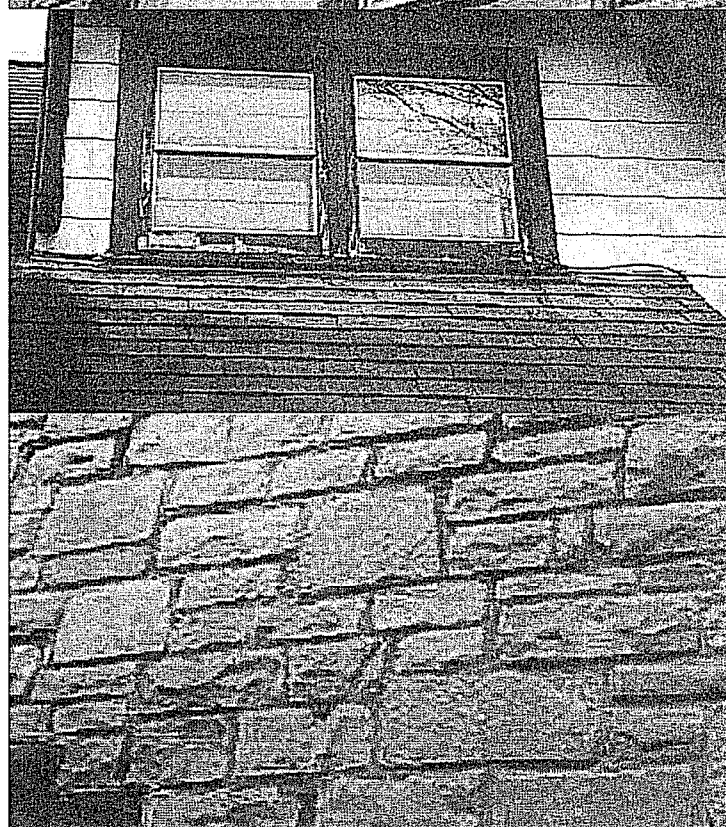
visible leaking on still and cracked and wood rot to storm window.

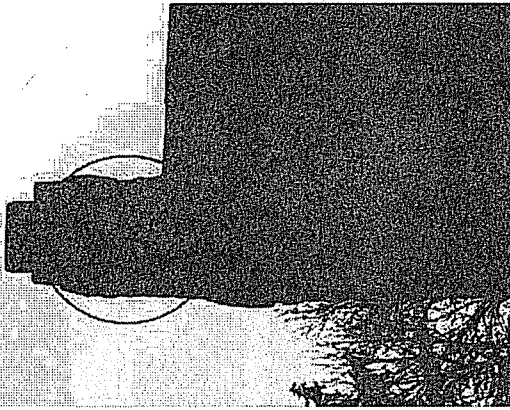
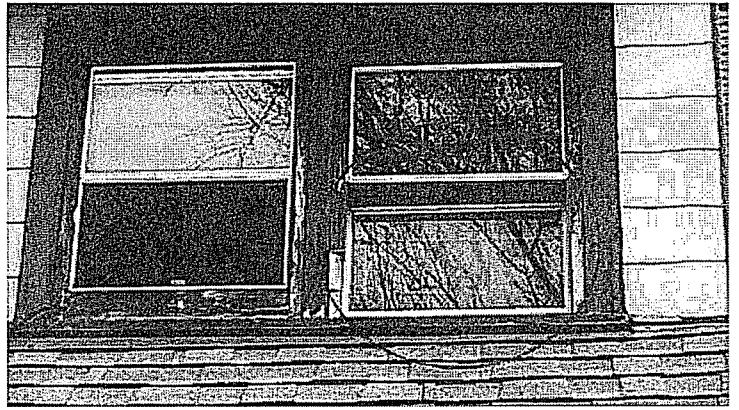
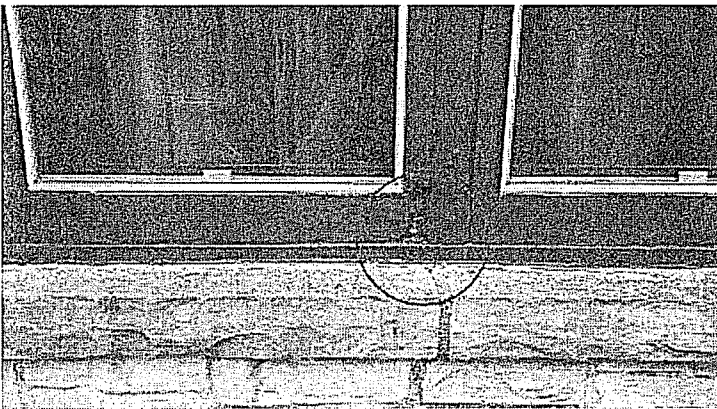
Wood rot

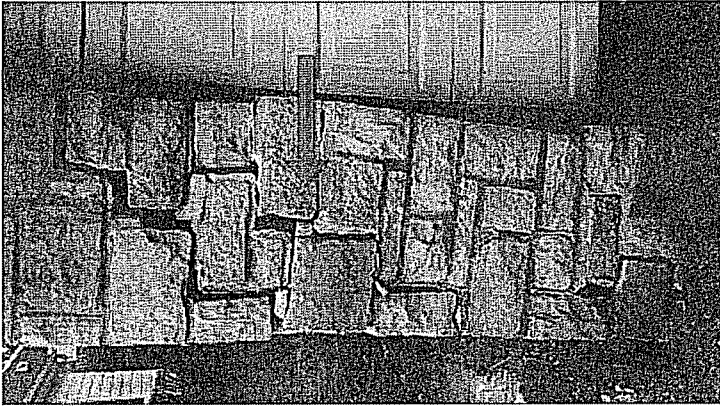
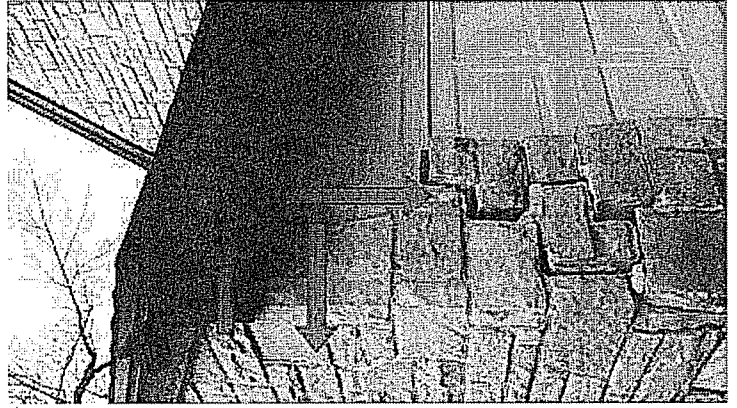
Missing downspout left rain water to saturate the ground causing some siding to crack due to settling.

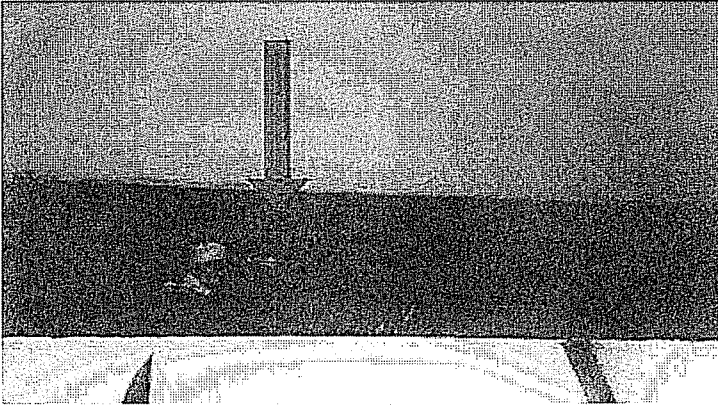
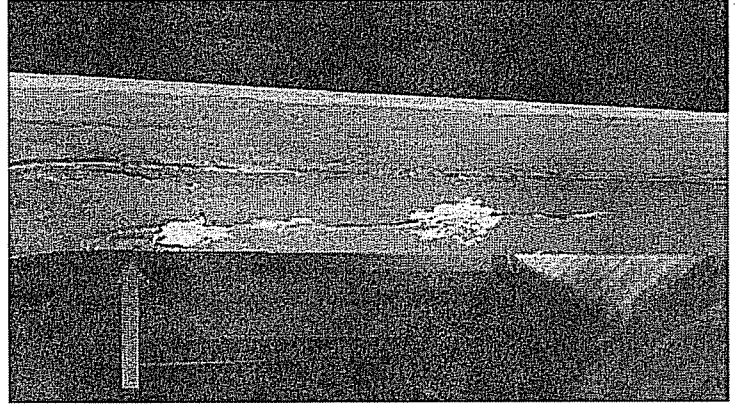
Comments Moisture stains and plaster damage from leaking plumbing on second floor.

water damage to plaster

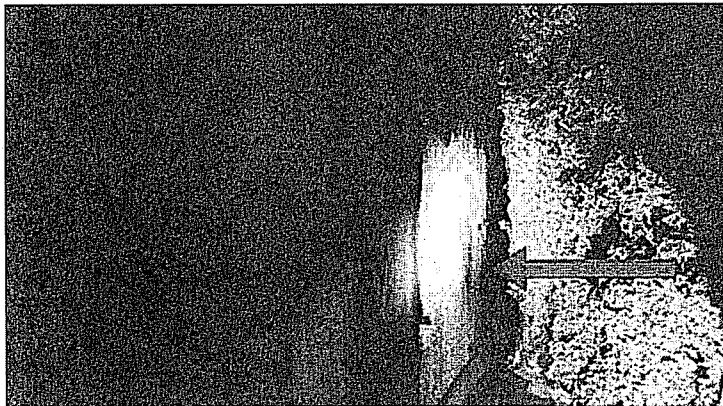
ice built up on roof decking

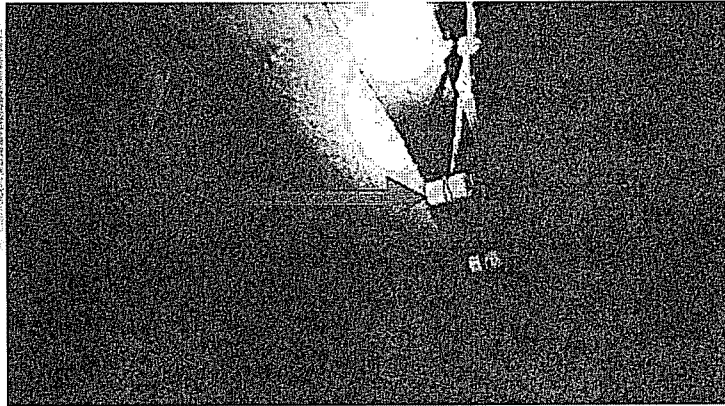
Visible Knob-and - tube

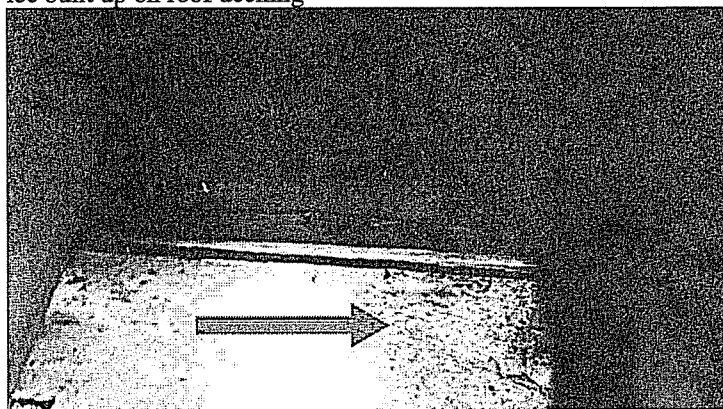
Mold on roof decking

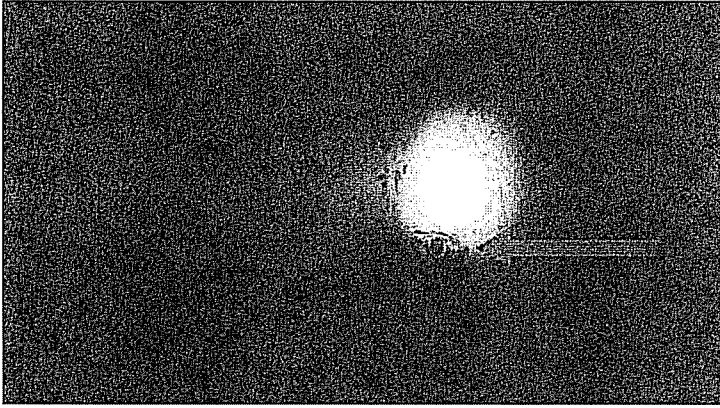
Oil full pipe from exterior.

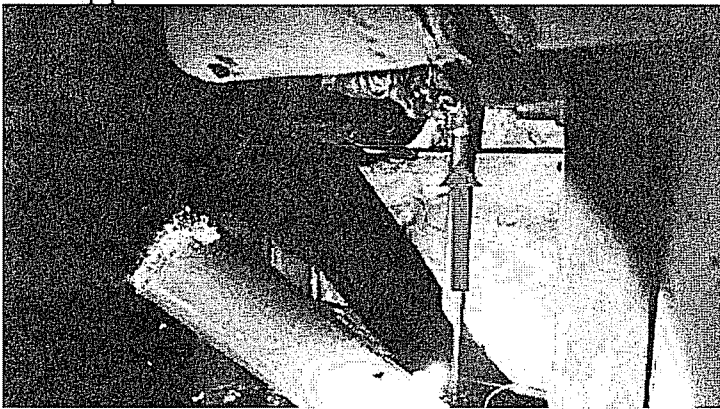
Not Visible Indication of moisture stains/rotting
Comments Wood rot around plumbing distribution pipes.

subfloor wood rot

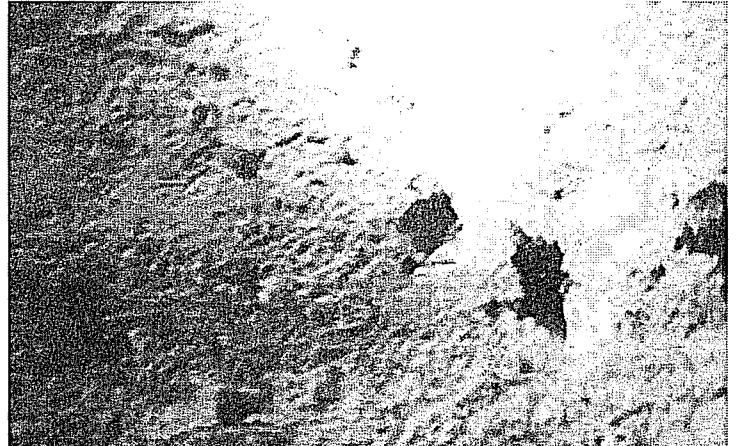
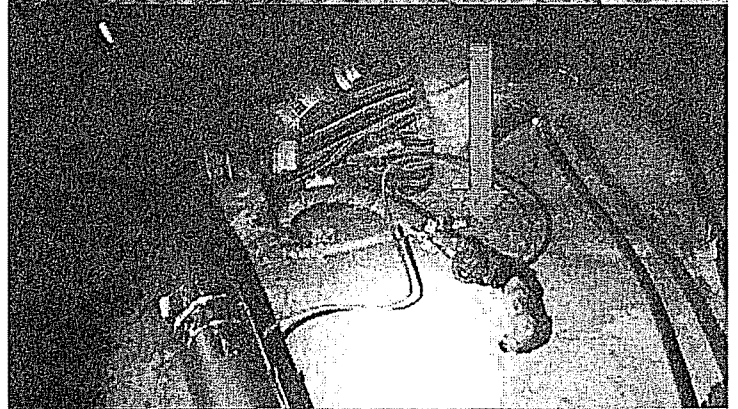
lead water service pipe.

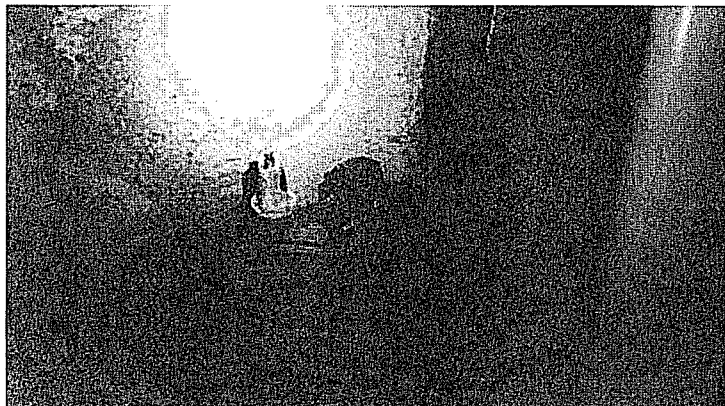
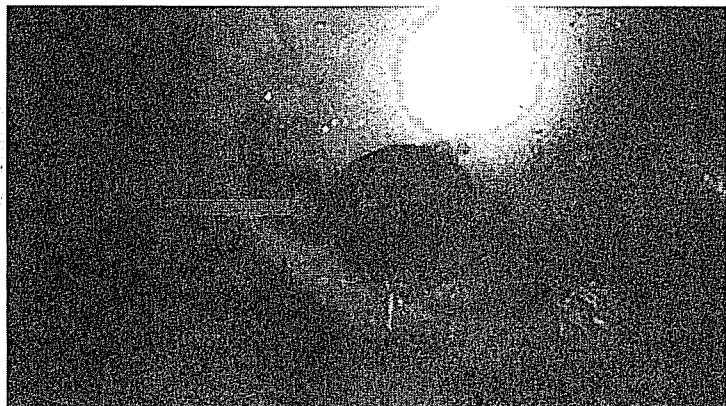
old floor drain not tested for oil contamination
