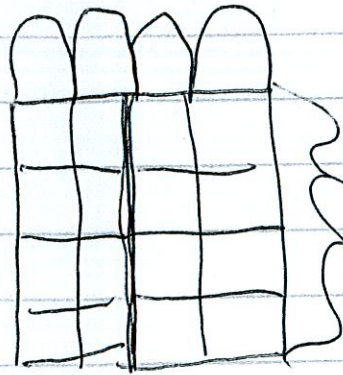
23

door
needs
safety glass
