## **EXISTING BUILDING REVIEW**

### **121-123 State Street**

Name: C.E. Buell Building

Walk-Through Observations: December 16, 2011  
Reported by: Kenneth M. Itle  
WJE No. 2011.5656

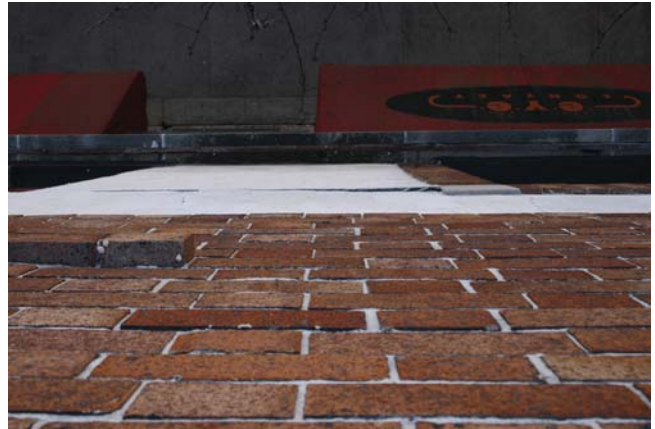
Exterior: View from roof of plaster-coated wall surface showing delamination of the plaster coating

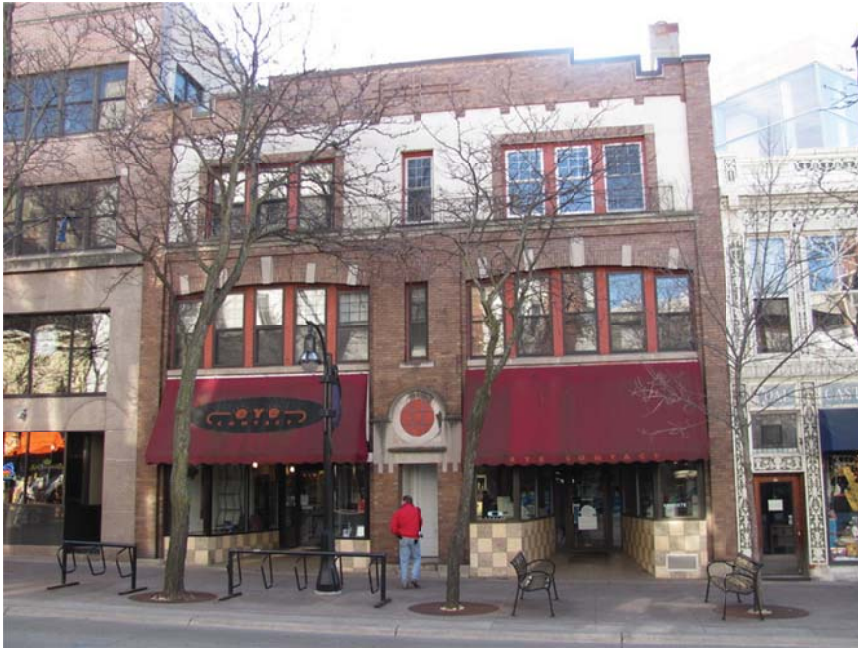
The State Street facade is built of iron-spot face brick masonry with limestone trim (Figure 1). The third floor is largely clad with cementitious stucco framed by masonry and features decorative iron railings. A circular opening above the entrance door to the apartments has been infilled with painted plywood (Figure 2). It is not clear if this opening was originally a window or some other facade material. The window openings at the second floor of this facade are formed by true masonry arches, whereas the third floor window openings have steel lintels embedded in the masonry.

*Figure 1. Overall view of the State Street facade.*

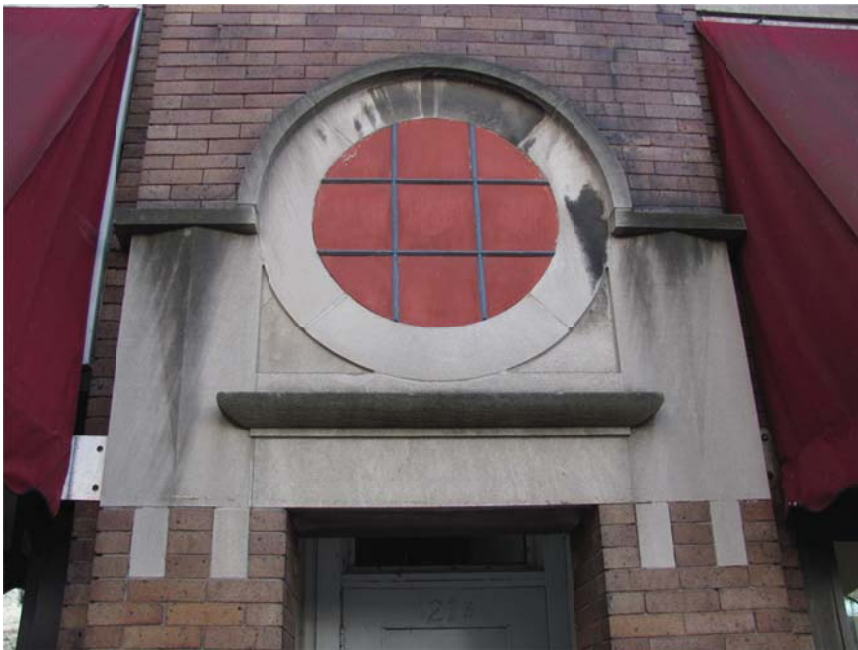
*Figure 2. A circular opening above the entrance door to the apartments has been infilled with painted plywood.*

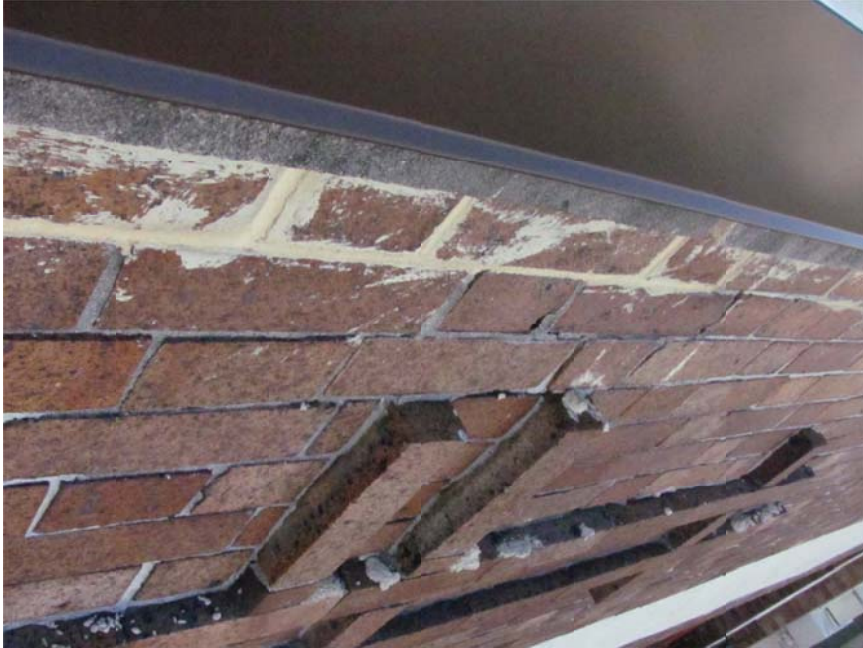
Overall, the masonry of the State Street facade generally appears to be in good condition. Portions of the top of the parapet wall were previously repointed; this work was poorly done, with numerous mortar smears and mortar droppings left on the facade (Figure 3). At other areas, occasional open mortar joints were observed (Figure 4). Portions of the stucco cladding at the third floor have cracked and delaminated. One especially large delaminated area was observed in line with the window heads near the middle of the facade (Figure 5). A portion of stucco has previously spalled at the head of the center third floor window, revealing the common brick masonry that underlies the stucco cladding (Figure 6).

*Figure 3. Portions of the top of the parapet wall were previously repointed.*

Localized repointing of brick masonry is necessary at locations of open mortar joints. Also, mortar joints with poorly installed previous repointing should be repointed. The condition of steel lintels bearing in the brick masonry should be investigated in more detail to develop appropriate repairs. The stucco clad portions of the State Street facade require more extensive repair. The entire stucco surface should be sounded, cracked and delaminated portions should be removed, and new cementitious stucco should be installed at these locations.

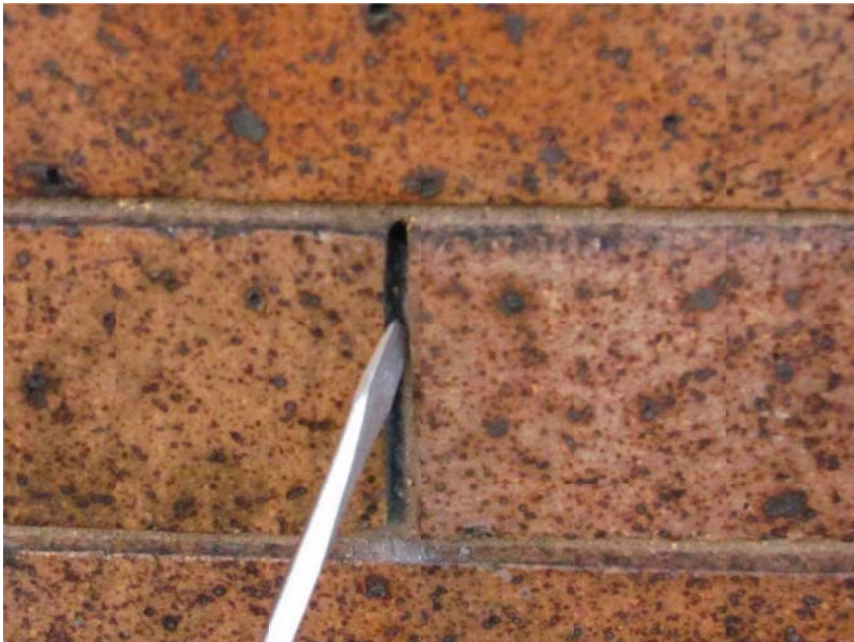
*Figure 4. Occasional open mortar joints were observed.*

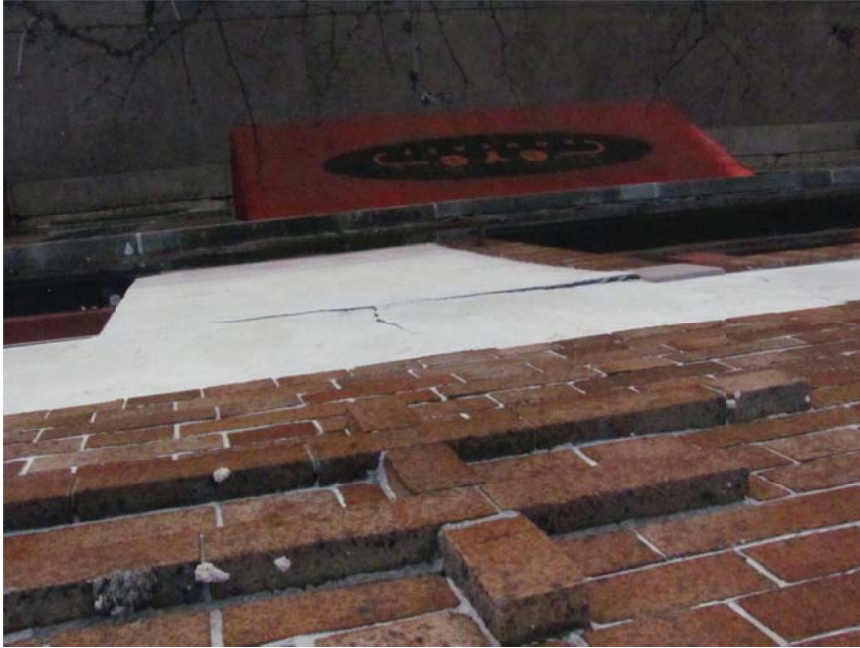
*Figure 5. View from the roof of one especially large delaminated area of stucco observed near the middle of the facade.*

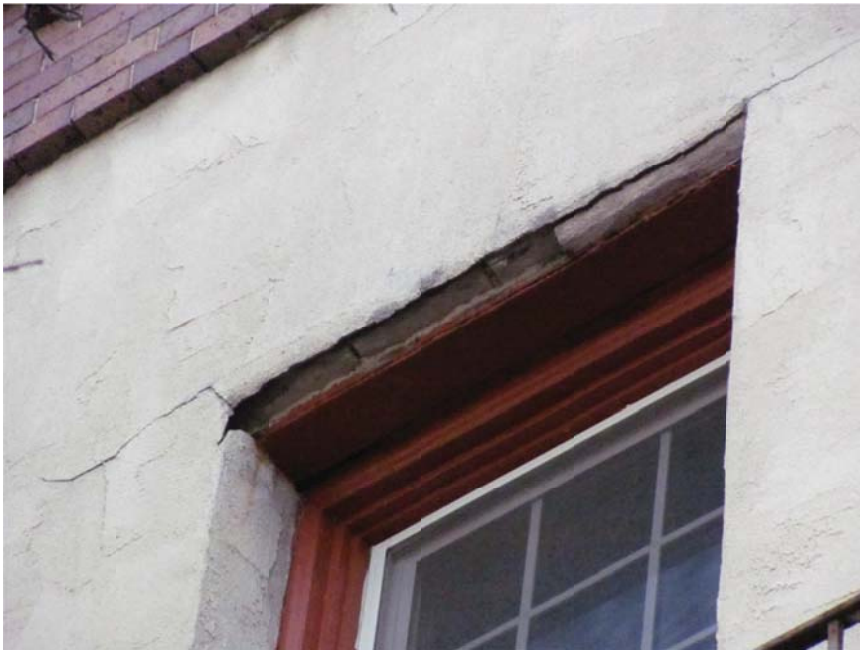
*Figure 6. A portion of stucco has previously spalled at the head of the center third floor window.*

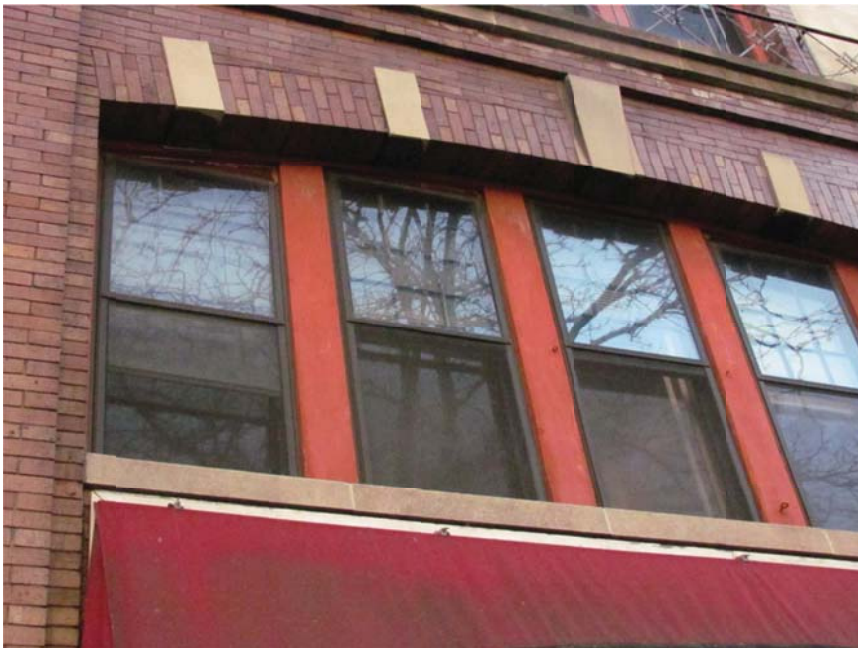
The upper floors of the building typically have original double-hung nine-over-one wood windows, covered by aluminum triple-track exterior storm windows (Figure 8). At one third floor apartment, the original window sash and storm windows have been removed and replaced with white vinyl double-hung windows with insulating glazing and false muntins between the glass, imitating the original design. Where inspected, the original wood windows appear intact, with minor paint loss and some localized loss of glazing putty. The window sash have been routed to receive galvanized metal weatherstripping (Figure 9).

*Figure 8. The upper floors of the building typically have original double-hung nine-over-one wood windows, covered by aluminum triple-track exterior storm windows.*

The double hung wood windows throughout the building should be restored, including stripping and repainting, repairing the wood frame and sash as needed, reglazing, and repairing the pulley and counterweight balance system. If desired, new interior or exterior storm windows can be provided to improve the thermal efficiency of the windows. As part of this work, the newer vinyl double hung windows may be replaced with windows of more appropriate and durable materials that more closely match the historic configuration.

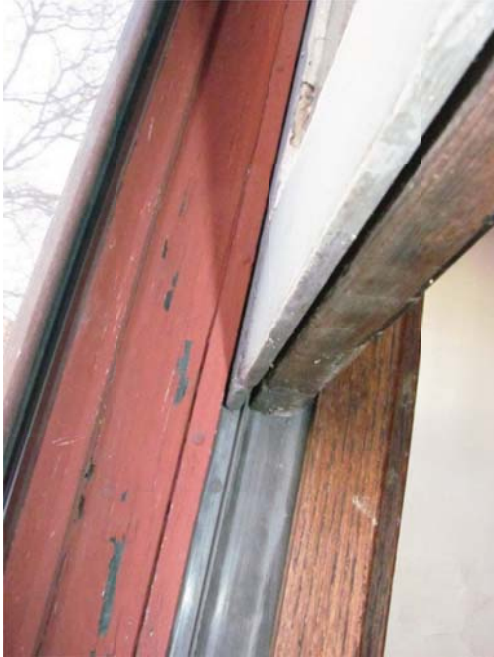
*Figure 9. The original wood windows appeared intact and have been routed to receive galvanized metal weatherstripping.*

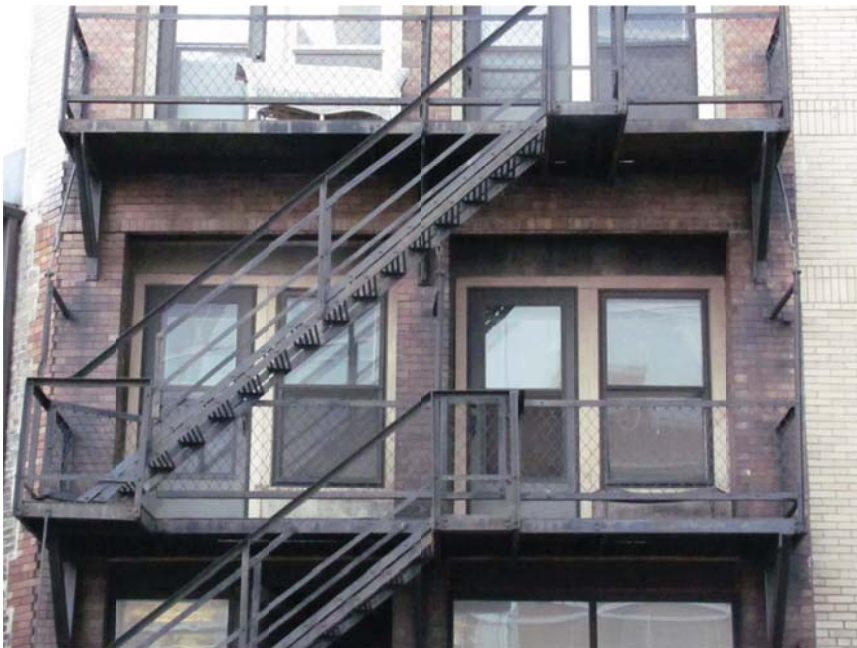
*Figure 12. The balconies and fire escapes appeared intact, with areas of paint loss and surface corrosion.*

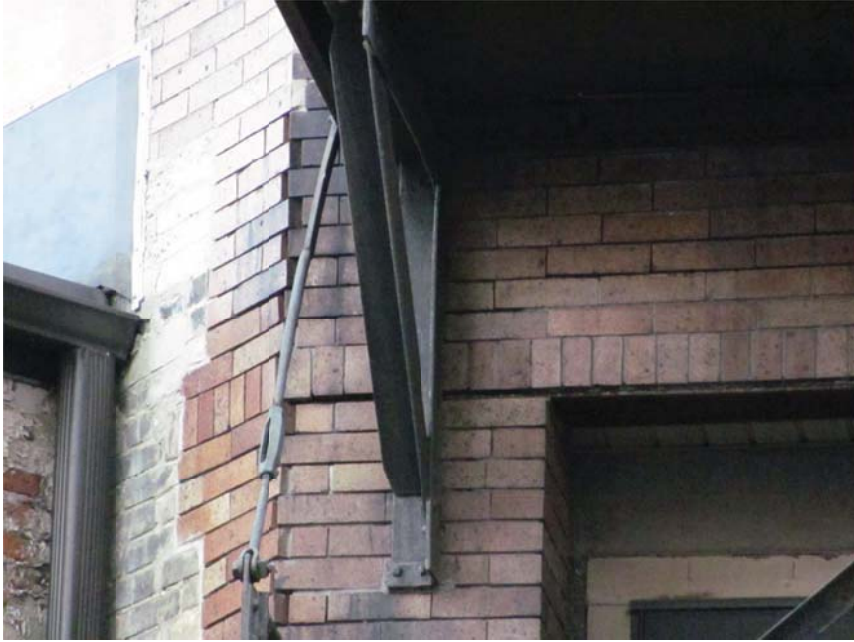
The first floor windows of this facade are relatively new aluminum-framed storefronts with insulating glazing. At the upper two floors of the Fairchild Street facade, each apartment has a door and window overlooking a partially recessed balcony. The iron balconies are connected by fire escape stairs. The balconies and fire escapes appear intact, with areas of paint loss and surface corrosion (Figure 12). The balcony and window openings are constructed with embedded steel lintels; surface corrosion and minor displacement of masonry associated with the bearing points of these lintels was observed (Figure 13).

*Figure 13. Surface corrosion and minor displacement of masonry associated with the bearing points of the lintels was observed.*

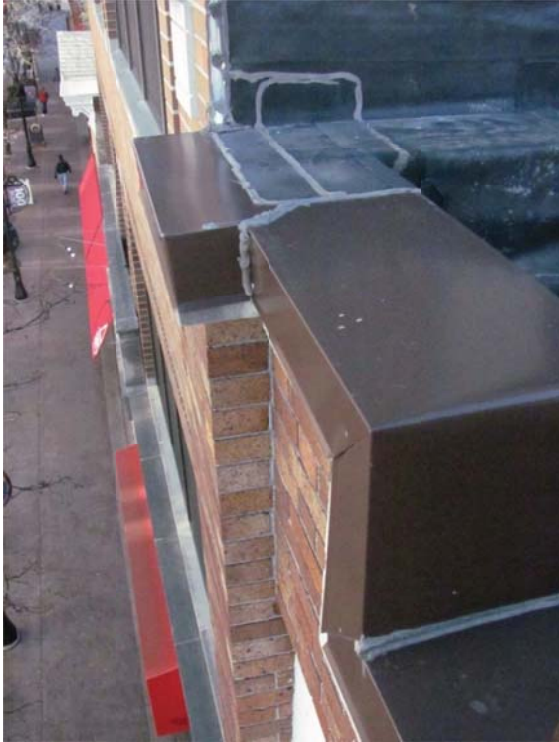
*Figure 15. The sheet metal coping covers the original limestone coping.*

The roof membrane termination details should be reviewed. In particular, the perimeter sheet metal coping is not well detailed and does not appear to be installed in a manner that will ensure long term performance. Also, an alternate detail that does not overlaid the original limestone masonry coping with sheet metal could improve the appearance of the street facades. If required by code, provision for overflow drainage should be provided. The roof membrane, flashings, and drainage for the low roofs at the bottom of the light wells should be inspected.

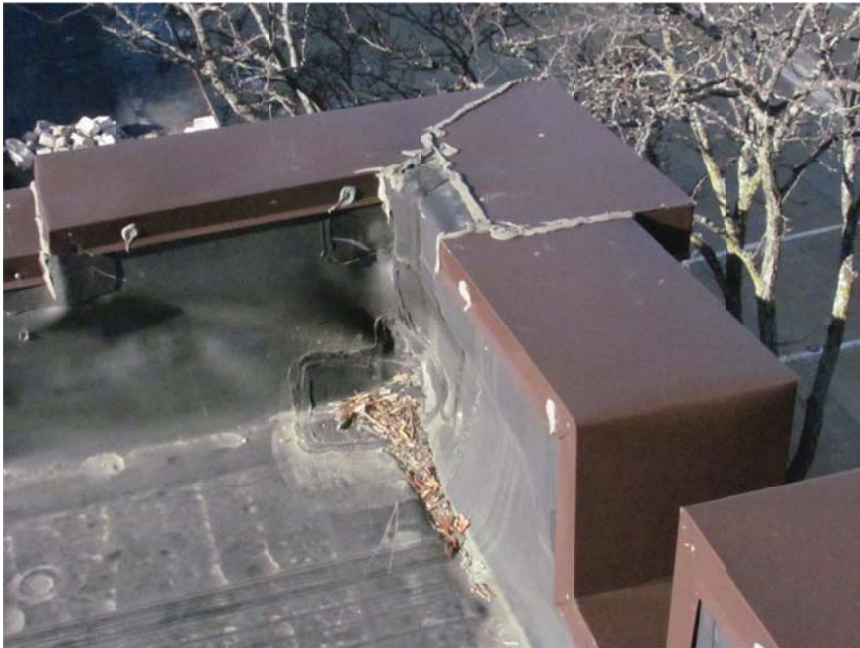
*Figure 16. The sheet metal coping has numerous laps and splices that are surface-sealed with untooled sealant.*

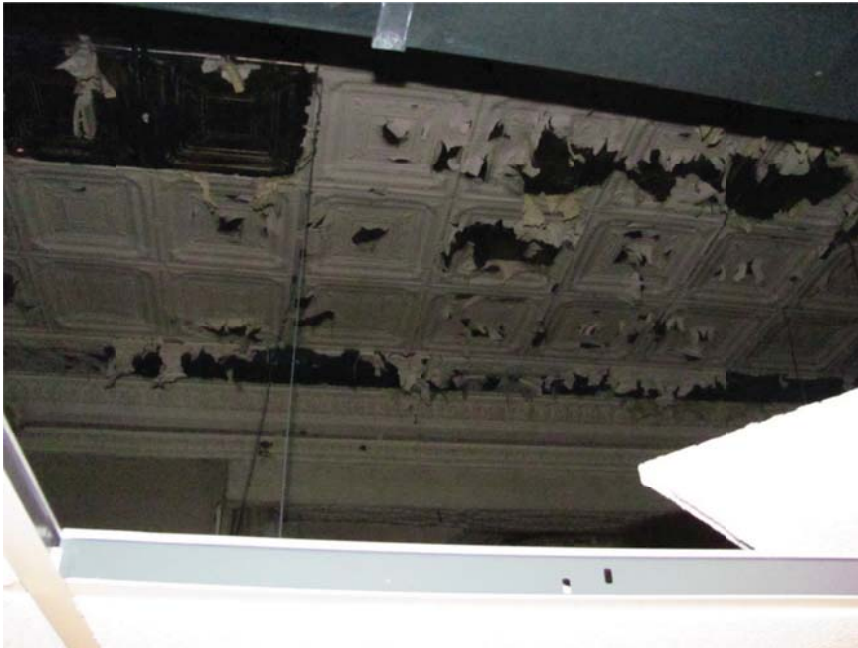
*Figure 18. A suspended acoustic tile ceiling conceals other similar original pressed metal ceilings. The full extent of the pressed metal ceiling finish is not known.*

The first floor retail interiors are generally in good condition. In the future, consideration could be given to removing additional portions of the suspended acoustic tile ceiling and restoring the original pressed metal ceiling.

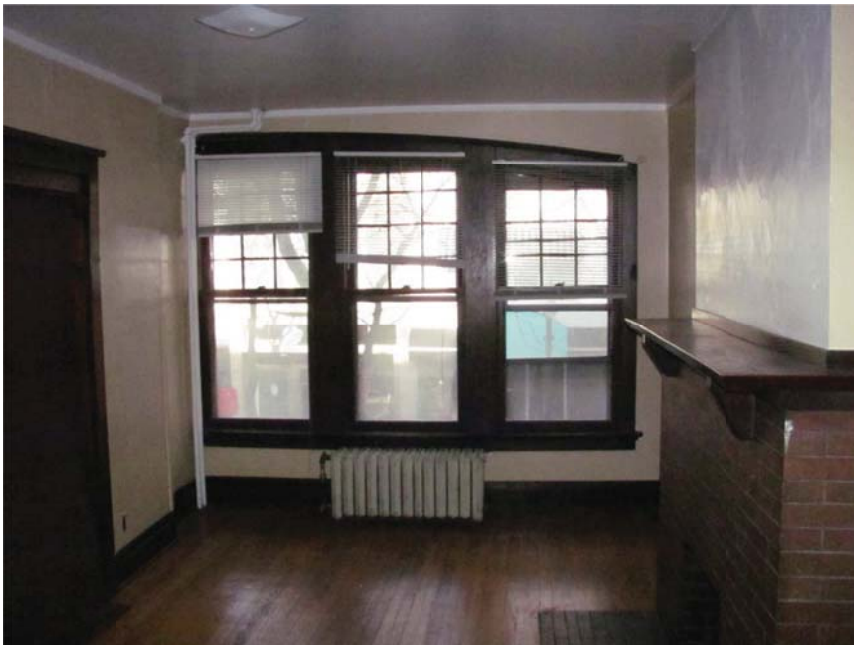
The second and third floors each have two apartments, now vacant. The four individual apartments have some intact original interior elements, including oak and maple hardwood flooring, stained and varnished window and door trim and baseboards; decorative brick fireplaces; and original three-panel doors (some with transoms) with mortised hardware (Figure 20). Other portions of the apartments, typically kitchens and bathrooms and the south bedroom, have been modernized within the last several decades with low-quality finishes such as wood veneer paneling, sheet vinyl flooring, plastic laminate casework, flat panel doors, and carpeting. Generally, the interior materials are in fair to poor condition, with heavy wear, mismatched repairs, and localized damage.

*Figure 20. Typical apartment interior showing intact original finishes.*

The second and third floor apartment interiors would require repair of worn and damaged finishes to allow for continued rental housing use.

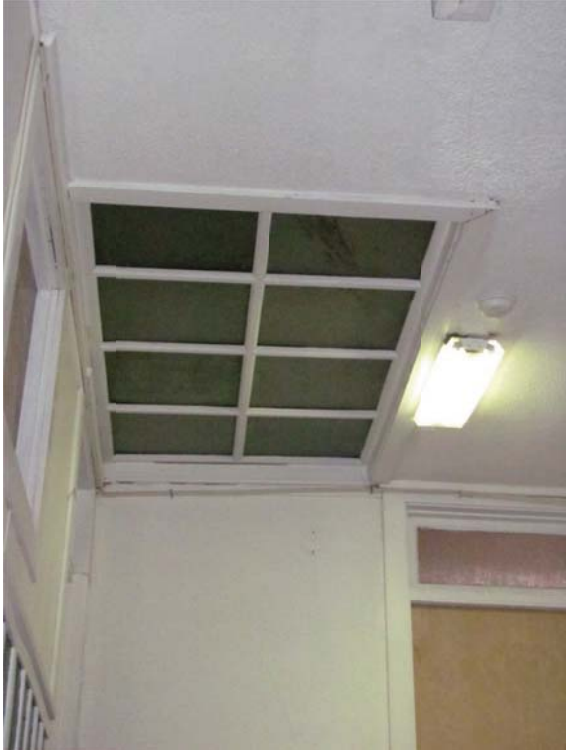
Interior glass laylights are present in the stairwell and one third floor apartment, corresponding to former skylights at the roof (Figure 21). The skylights have been covered by the EPDM rubber roof membrane.

*Figure 21. Interior laylight at the third floor corridor.*

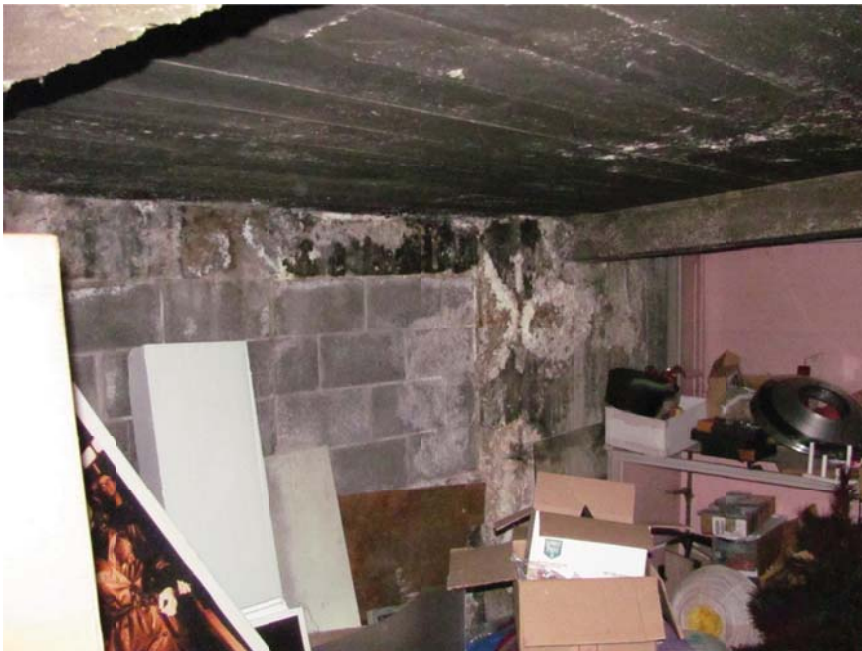
During a brief walk-through of the basement level, severe efflorescence and water staining was observed along the north wall, at a location corresponding to the left-hand State Street storefront entrance (Figure 22).

*Figure 22. Efflorescence and water staining at the basement level below the entrance storefront.*

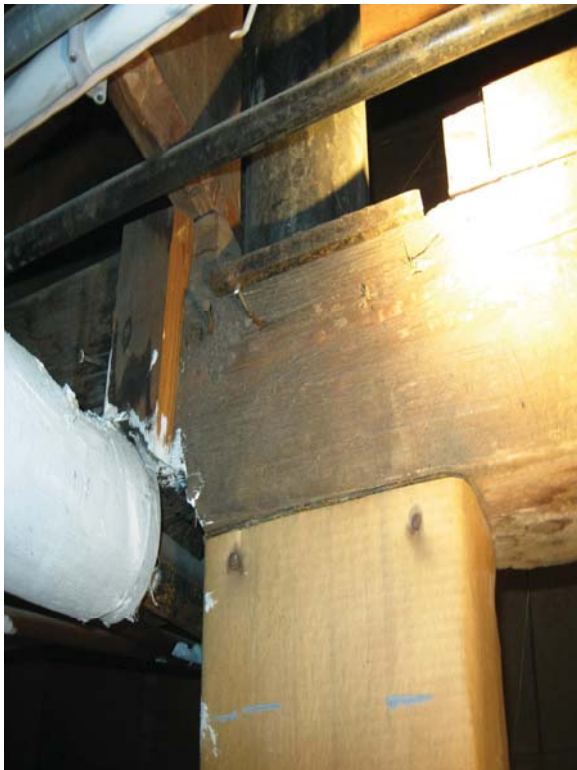
Defects in the floor system are noted on the west side of the stair. The 8x8 wood beam near the base of the stair is notched for a plumbing pipe. The beam capacity is adversely affected by this notch and will require replacement. The beams/columns look almost as if they are railroad ties. The fit up of the beam/ column joints is poor as if done with rudimentary equipment. The poor fit up may have resulted in pressure concentrations and corresponding deformation in the building frame. The wood beams/columns appear quite dry and the surface brittle. There is little resistance to the penetration of a utility knife. We would tend to recommend the replacement of the beam/ column system due to their condition but understand it would require shoring of the entire building height to accomplish.

**Photo 1** – Notched 1<sup>st</sup> floor beam requiring replacement

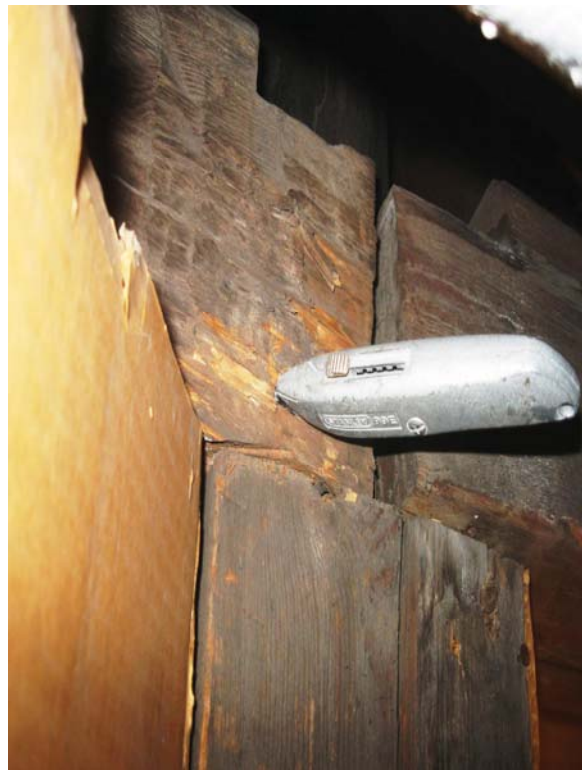
**Photo 2** – Poor fit up and wood density at 1<sup>st</sup> floor beams and column

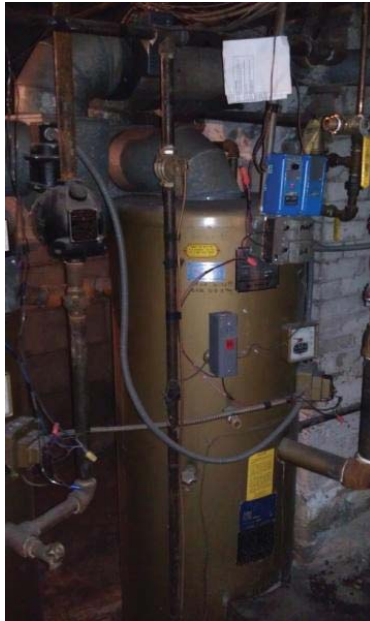
Hot water boiler

The two hot water boilers were installed around 1963 which makes them nearly 50 years old but look to be in fair condition for their age. The energy efficiency is expected to be poor and the remaining life expectancy is expected to be short. The furnace appears to be 15-20 years old and in fair condition but that age is considered to at the end of its life.

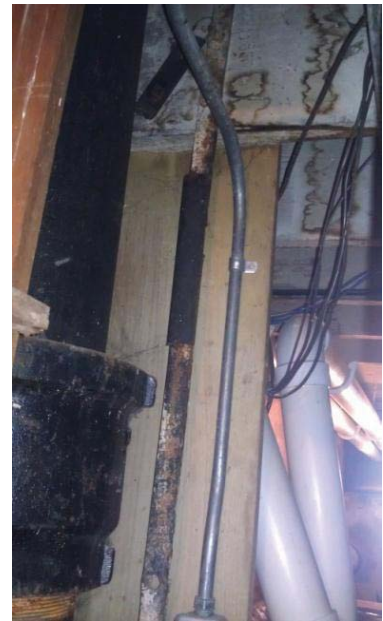
Failing storm main support

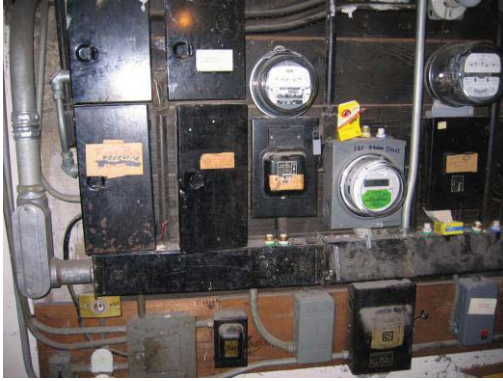
Electrical equipment age varies from the 1940's to 1980's, while the 3 meter center is from the 1980's. The majority of the electrical service equipment in the basement is at the end of its useful life. There are several fuse panels in the basement. The fuse panels on the 2<sup>nd</sup> and 3<sup>rd</sup> floors serving the apartments were converted to use circuit breakers and are recommended to not be used. There were no noted obvious failures of electrical equipment, such as evidenced by heat or smoke discoloration. The MG&E electrical service equipment appeared to be in good condition.

A portion of the older electrical service equipment in the Basement.

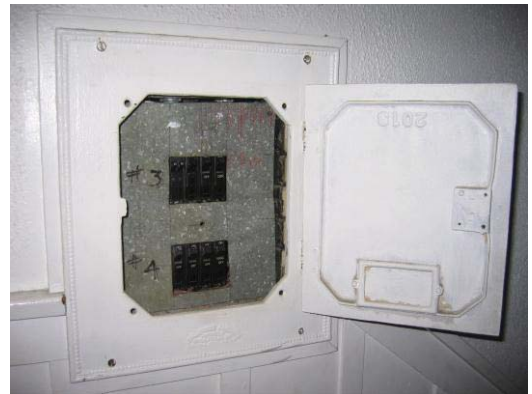
Third floor fuse panel converted to circuit breakers.
