Table of Contents

Introduction	2 - 3
Observations	
150 Langdon Street	4 - 17
621 Henry Street	17 - 30
625 Henry Street	31 - 42
145 Iota Court	42 - 54
Glossary	55
Condition Definitions	56

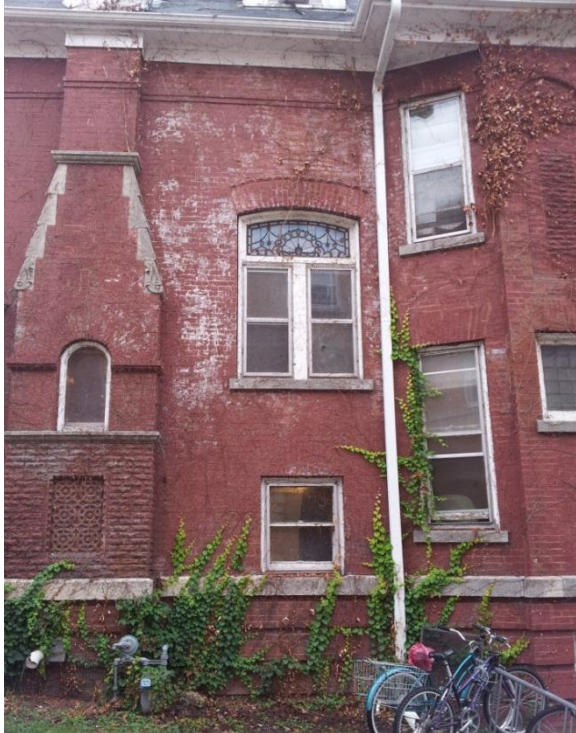
Image 1.3 The brick masonry observed is largely in good condition, but it contains evidence of minor instability in the form of step-cracking. There is also efflorescence at several locations indicating moisture penetration of the masonry.

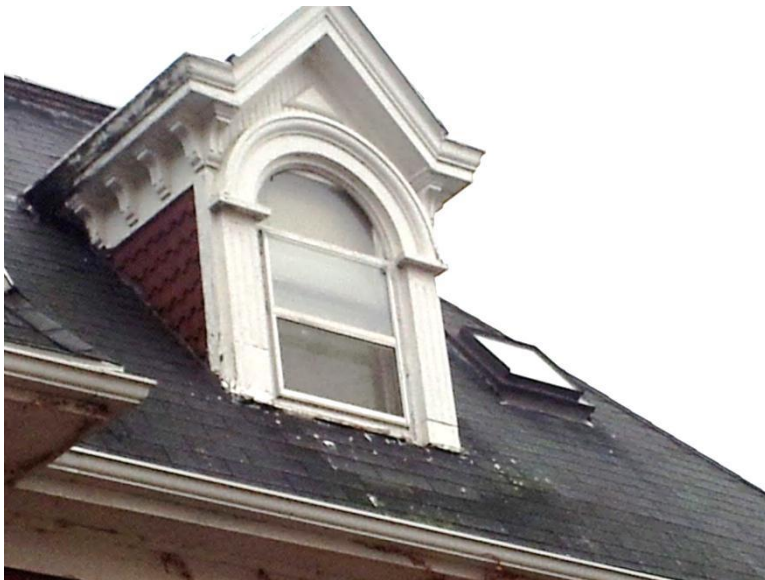
Image 1.4 The gables and dormer walls originally featured beaded board and shingle siding and major portions of these areas are presently exposed and functioning. Areas exposed to view appear to be rotting and otherwise deteriorating

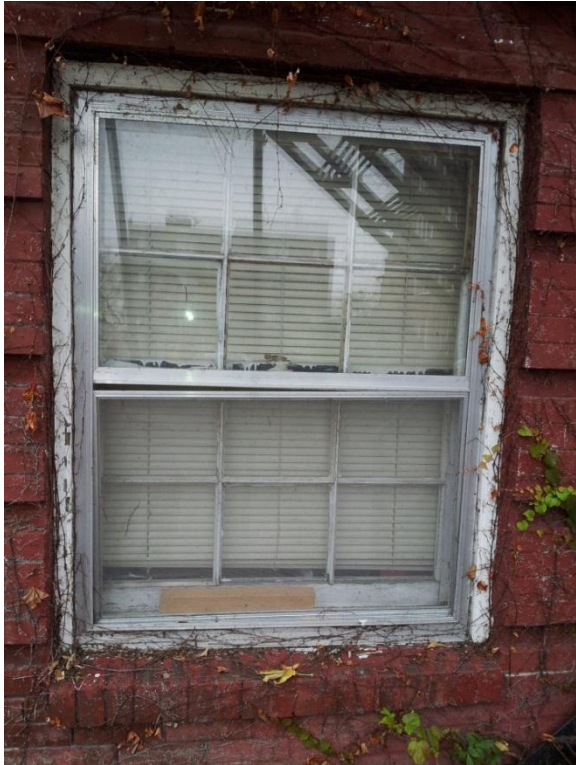
Image 1.5 Original wood windows are in place with modern-generation combination storms at their exterior exposure. The style of the original windows is single-hung.

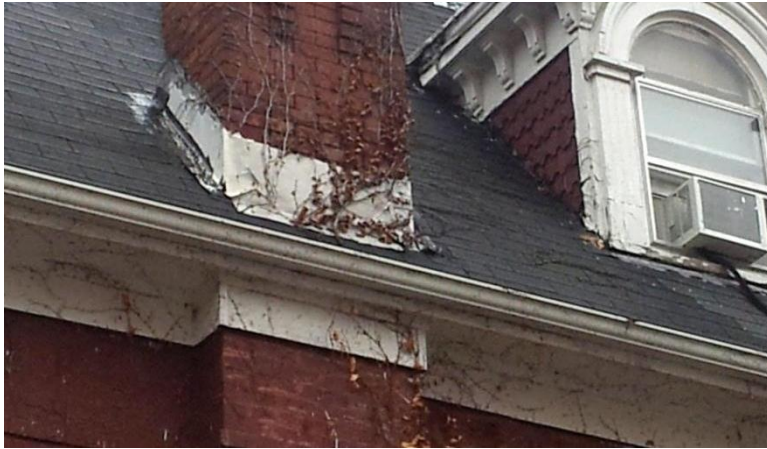
Image 1.6 The eave system consists of original painted (finished) wood members, including eave and rake boards (fascia), crown, and soffit. The condition is largely sound.

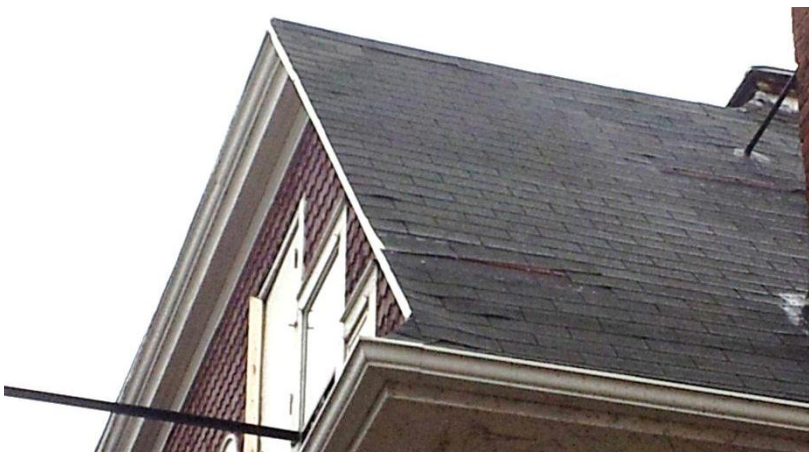
Image 1.7 The roof is a gable design with complementary gabled dormers. The roofing systems include roll membrane (asphaltic), (asphaltic) shingle, and metal.

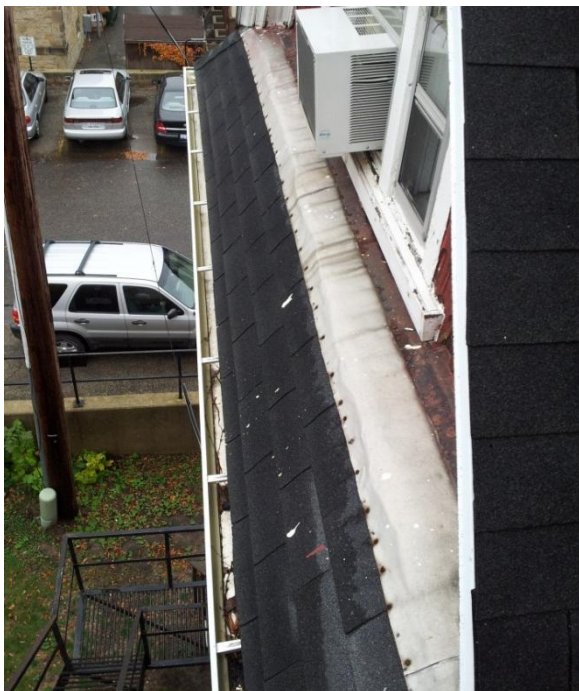
Image 1.9 Gutters and downspouts consist of prefinished sheet metal; they are sound. They appear newer and could possibly be reclaimed

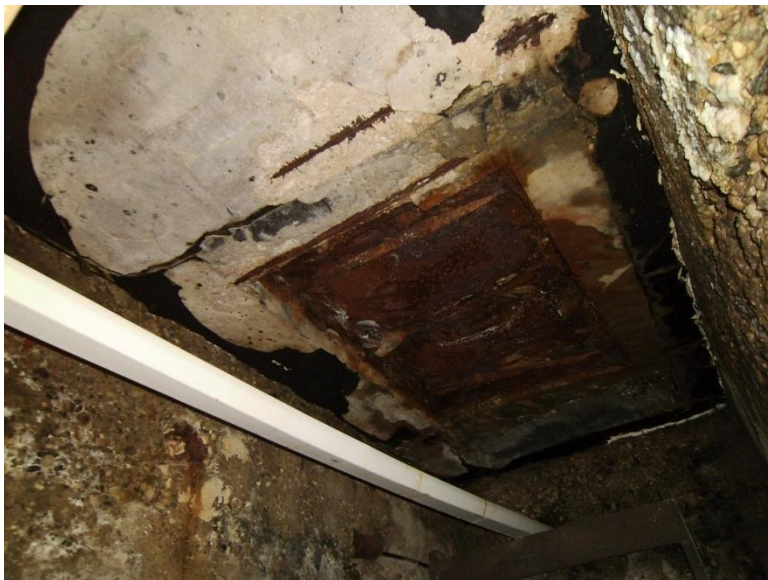
Image 1.13 View showing the exterior vault and steel cover connected to the basement. The steel framing embedded in the concrete foundations are corroded and damaged.

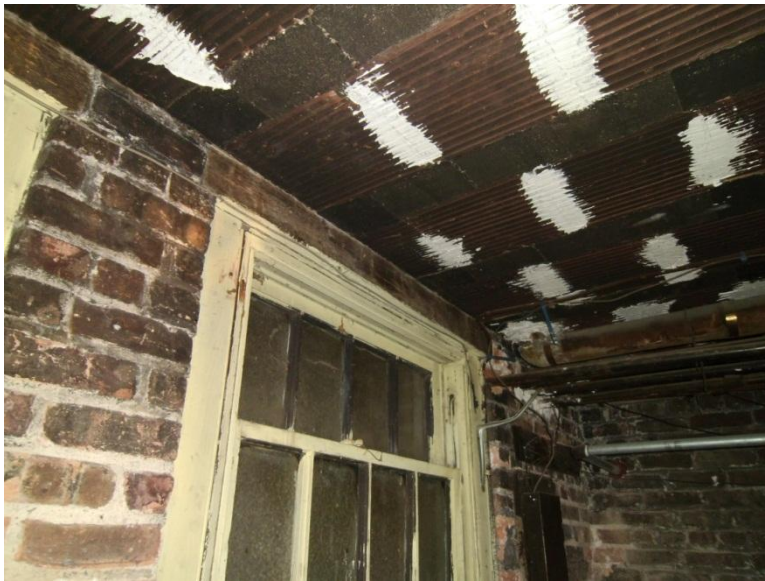
Image 1.19 View showing the exterior bearing wall from the interior. Note the concrete lintel construction over the opening and one way concrete joist with clay tile infill construction of the first floor.

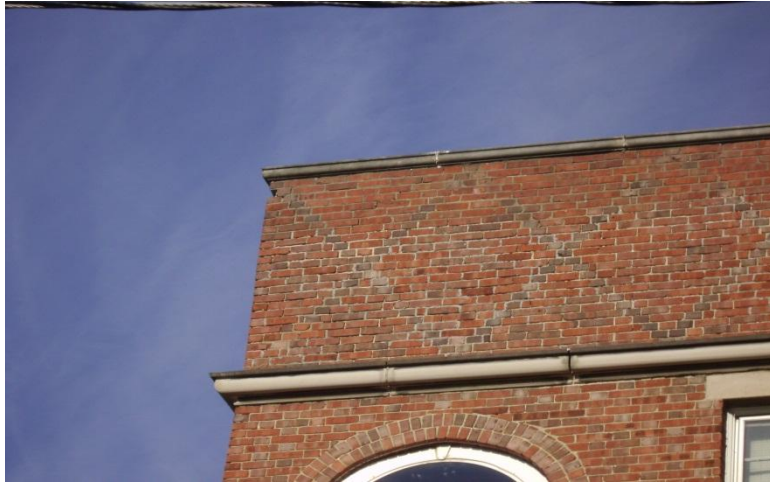
Image 1.20 View of the front parapet. The parapet was rebuilt yet still has deterioration occurring. Moisture is penetrating the perimeter walls at open joints in the parapet coping and in the limestone band trim.

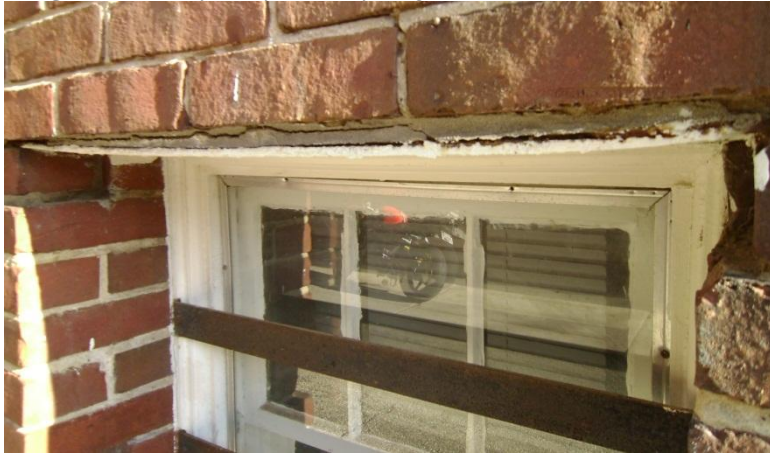
Image 1.22 View of one of the window lintels illustrating rust jacking.

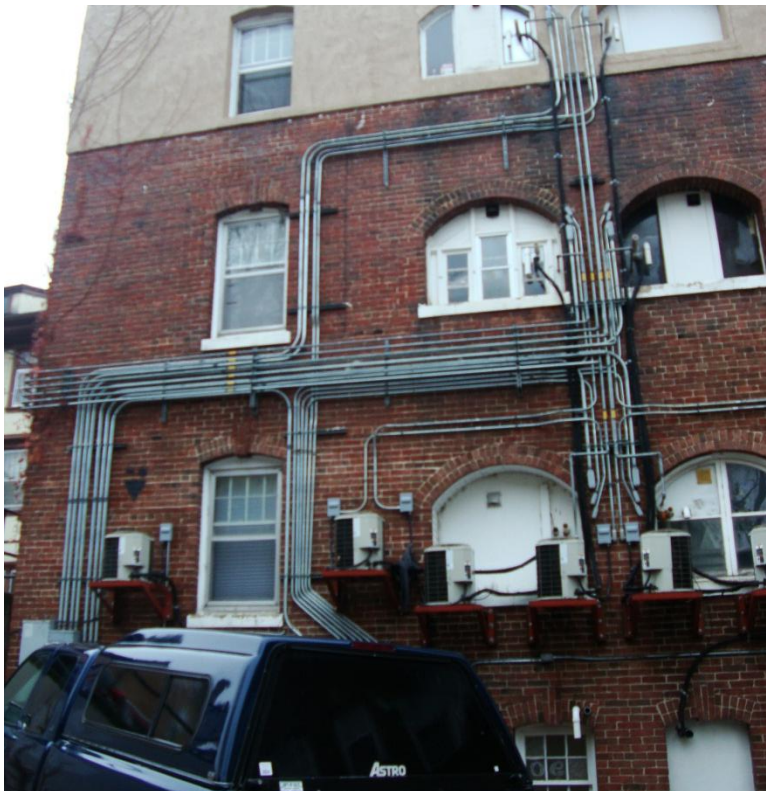
Image 1.23 View of the east elevation of the building. Note the third floor masonry has been covered with synthetic stucco.
Exterior Doors and Windows

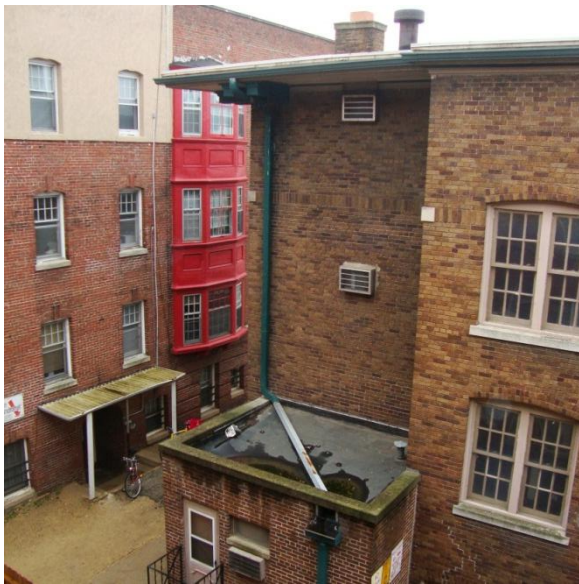
Image 1.24 View of the east side of 625 Henry Street (right) and the north side of 621 Henry Street (left).

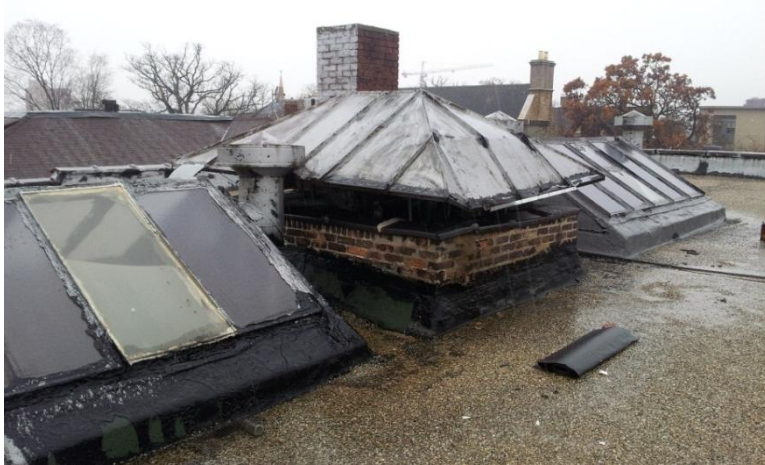
Image 1.28 Roof appurtenances and conditions. Glazing of the skylights is largely intact but fractured. Leaks to the interior were observed.

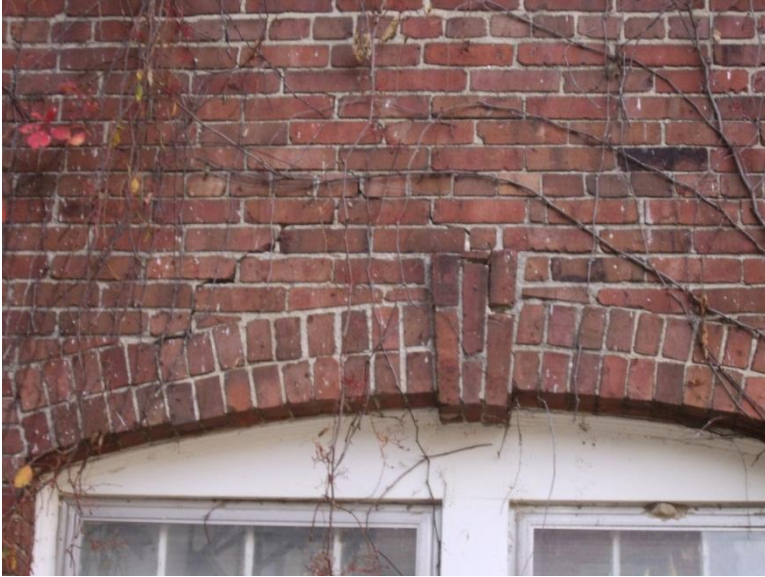
Image 1.30 View showing a failing masonry arch at an opening.

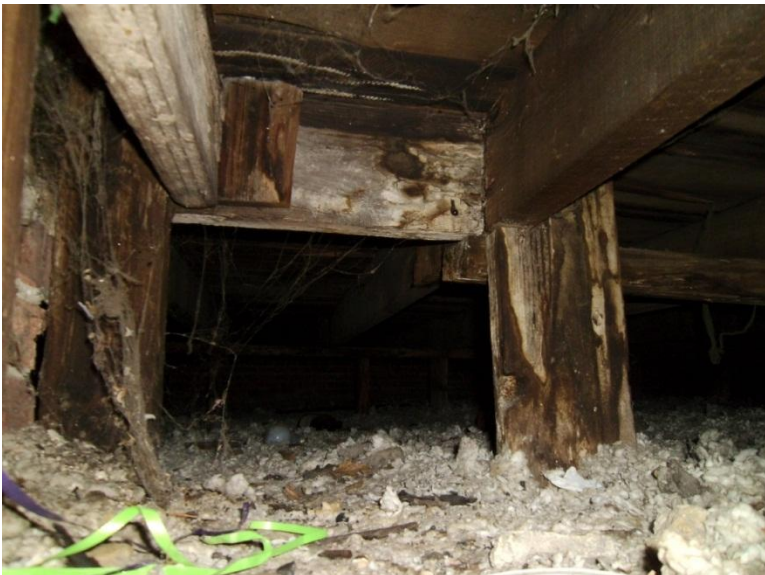
Image 1.31 showing heavily stained wood framing of the sloped roof. Portions of the framing are likely deteriorated.

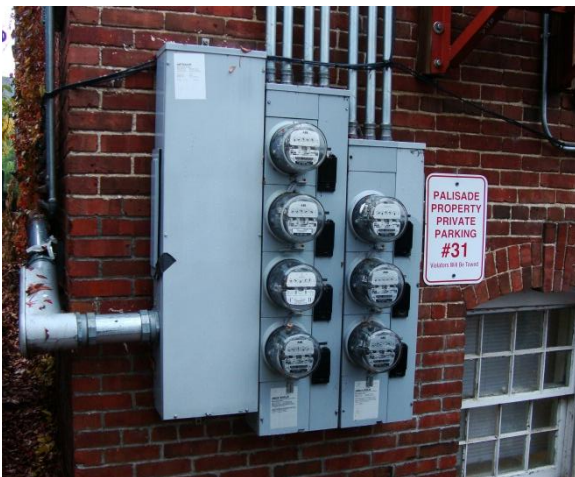
Image 1.36 Electrical entrance and meters.

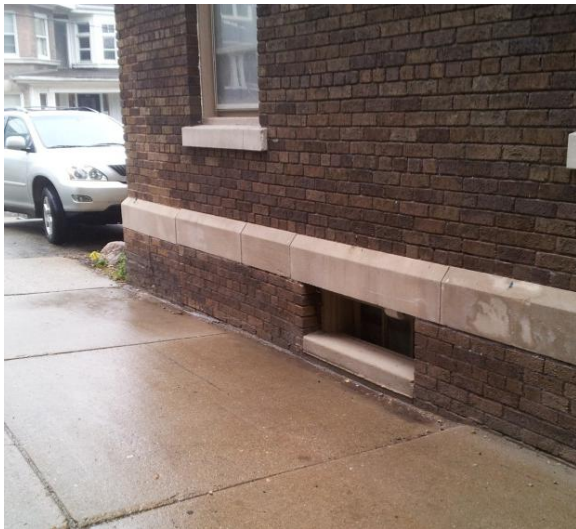
Image 1.39 View of concrete driveway pitched towards foundation wall allowing rain and snow melt water to enter basement area.

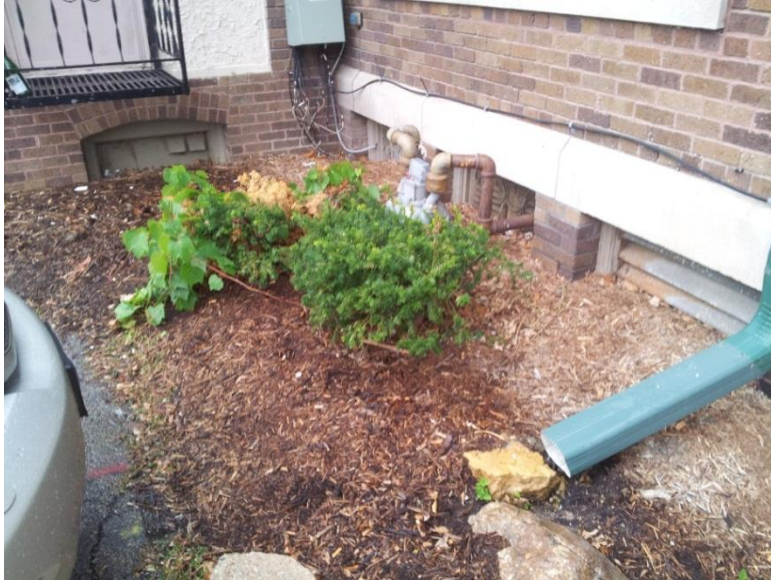
Image 1.40 View of small softscape area at the southwest corner of the building. Water is trapped here and percolates into the soil penetrating the perimeter walls below-grade.

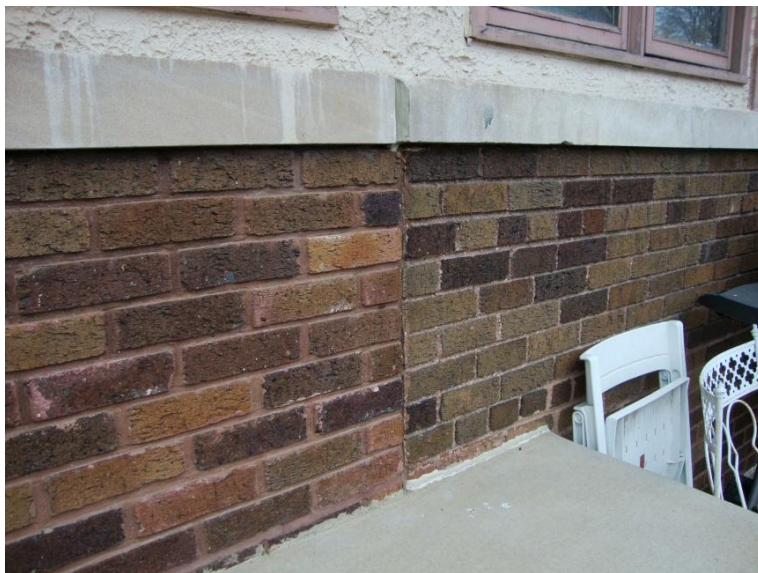
Image 1.41 View of infill brick at front porch. Enough evidence of original conditions remains to restore this porch if desired.

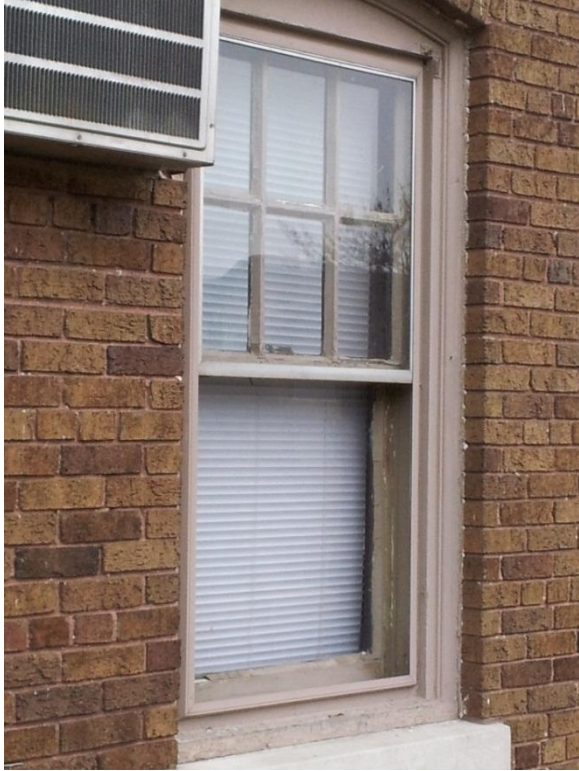
Image 1.42 View original wood windows are in place with modern-generation combination storms at their exterior exposure. The style of the original windows is single-hung.

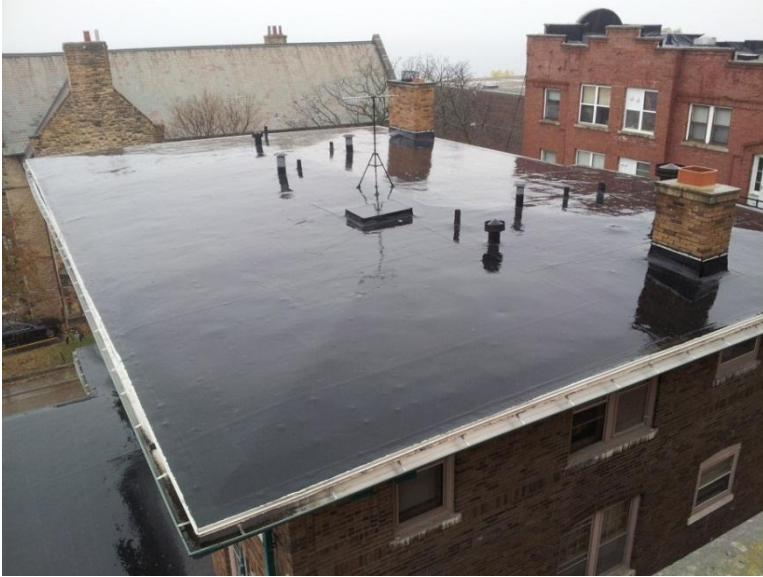
Image 1.43 The roof is a flat (low-slope), deep-eave design consisting of an exposed layer of EPDM (rubber) material, and it likely contains tapered rigid insulation beneath it, forming a hipped-roof surface for drainage.

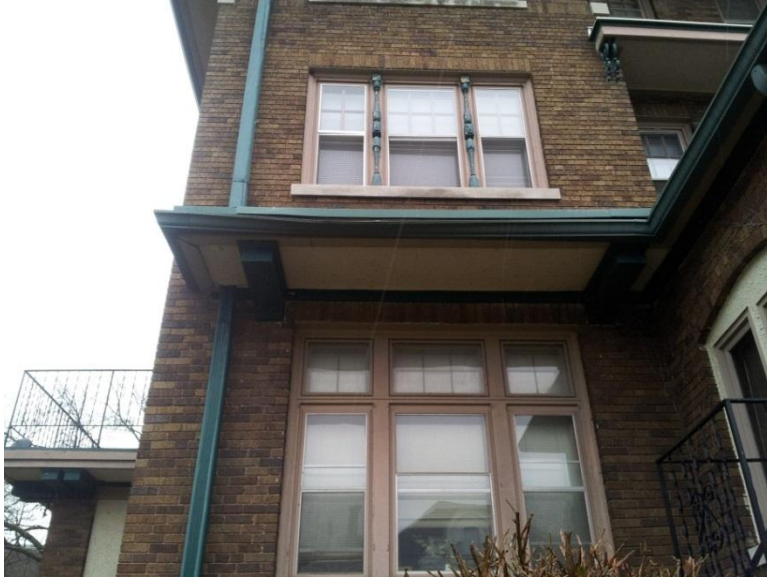
Image 1.44 Portions of the gutters and downspouts are deformed and/or detached from the substrate.

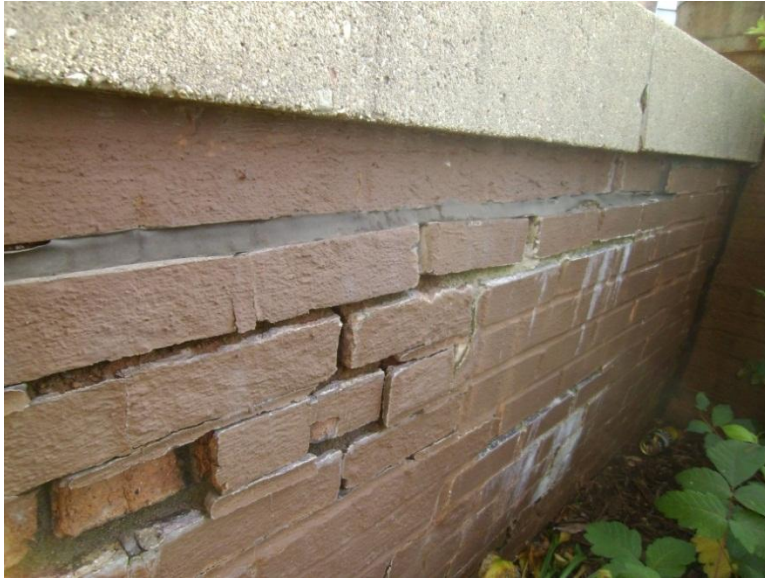
Image 1.45 Image showing the damaged and collapsing north side retaining wall of the front entry stoop.

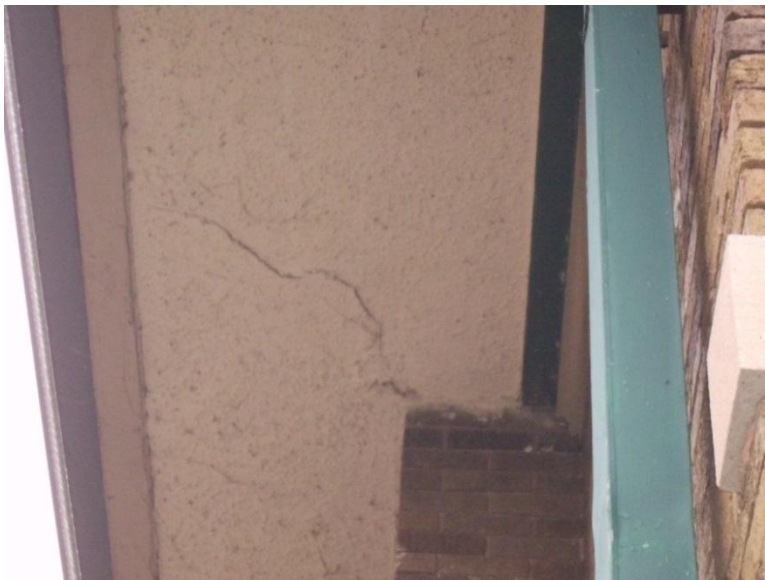
Image 1.46 View showing the cracking at the plaster on the soffit at the roof cantilever.

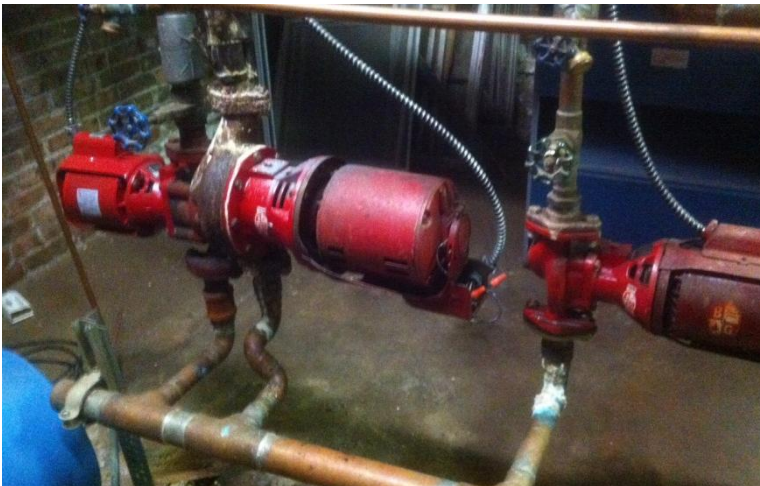
Image 1.50 View of boiler hot water circulating pumps in the mechanical room.

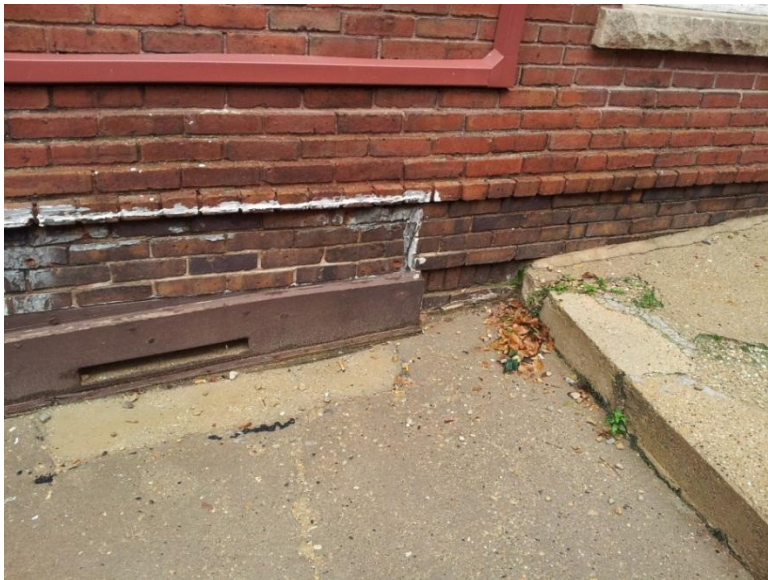
Image 1.52 Moisture is penetrating the perimeter walls below-grade. This is most noticeable at the southwest elevation walkway slab contour.
Exterior Walls

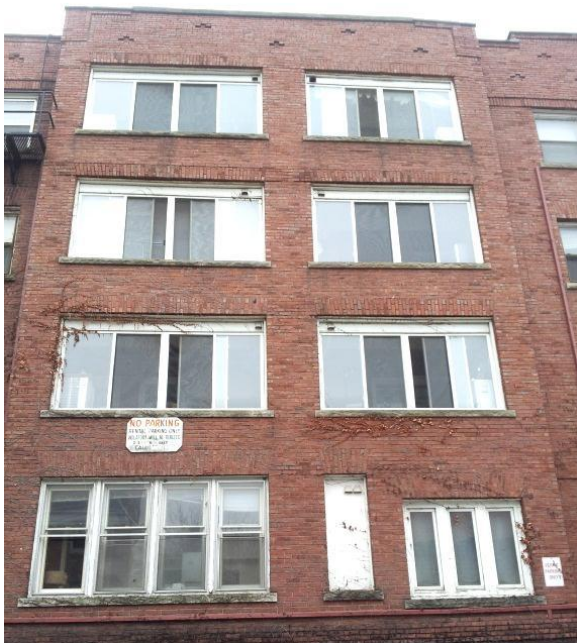
Image 1.53 The brick masonry is largely in good condition, but it contains evidence of instability including wall length expansion with associated vertical and horizontal cracking, deviating vertical wall plane, and protruding brick units.

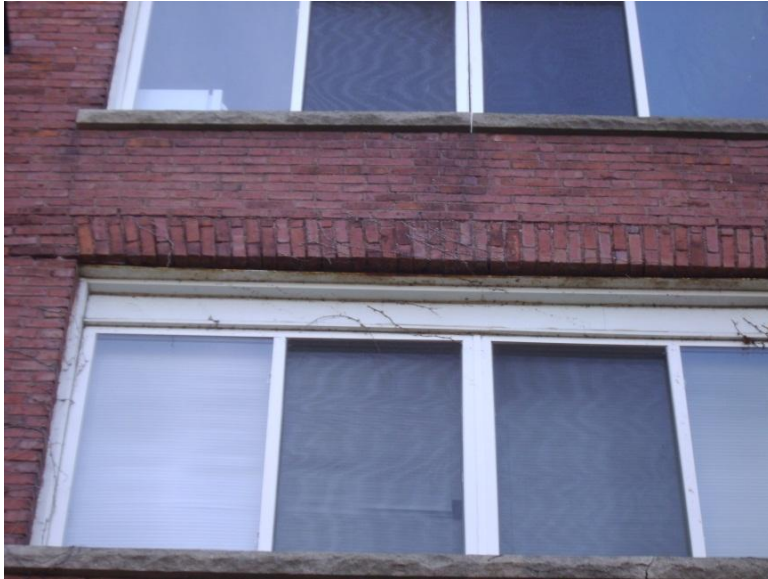
Image 1.54 Severe rust-jacking between the steel angle lintel and the brick flat arch above the window.

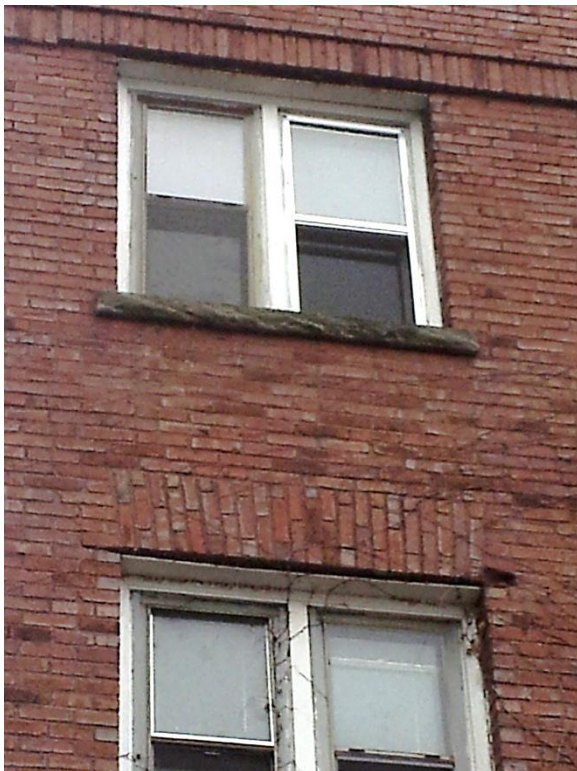
Image 1.55 Steel lintels (for windows) are in various forms of disrepair. The lintels are experiencing expansion from moisture-related corrosion, and in-turn, the surrounding brick unit masonry is damaged by its forces.

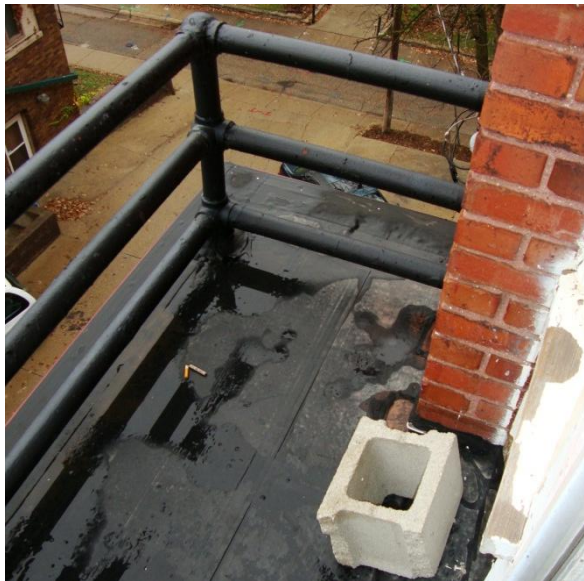
Image 1.56 West facing balcony deck.

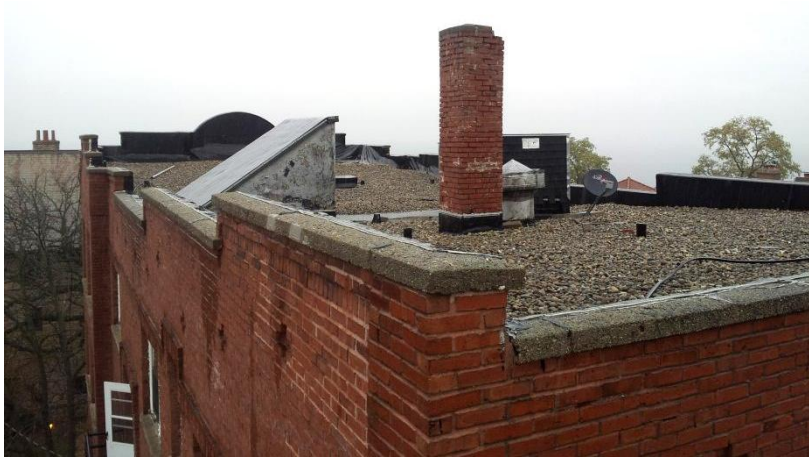
Image 1.59 The roof is a low-slope design consisting of a stone-ballasted EPDM (rubber) membrane bordered with continuous brick masonry parapets with precast concrete caps.

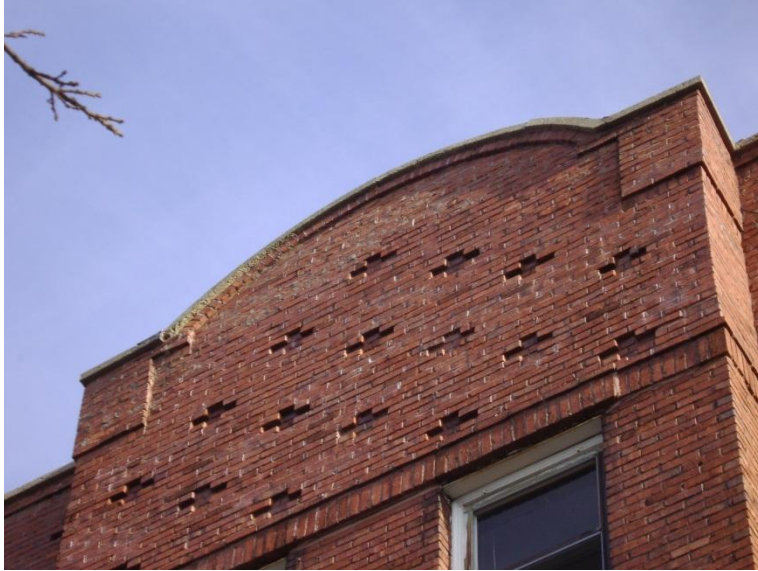
Image 1.60 View showing the top of the front of the building. Note the entire curved upper section is leaning backward.

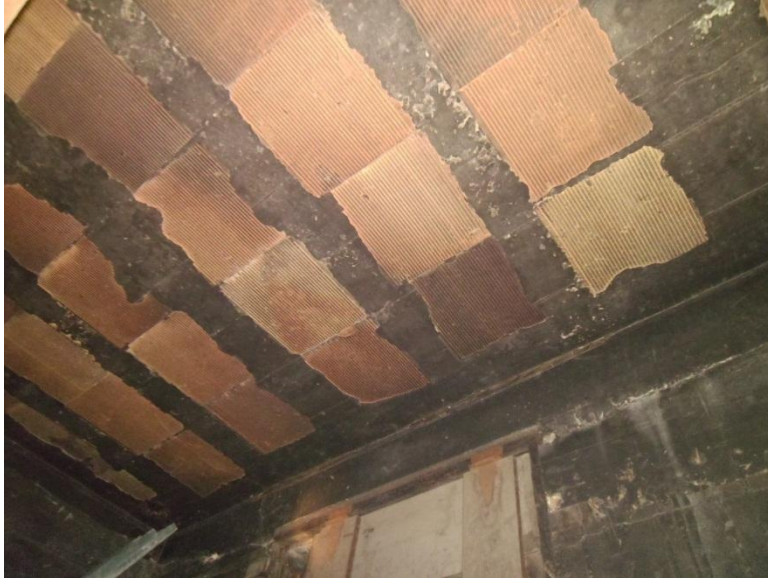
Image 1.61 View of the concrete one way joist and tile infill floor system.
