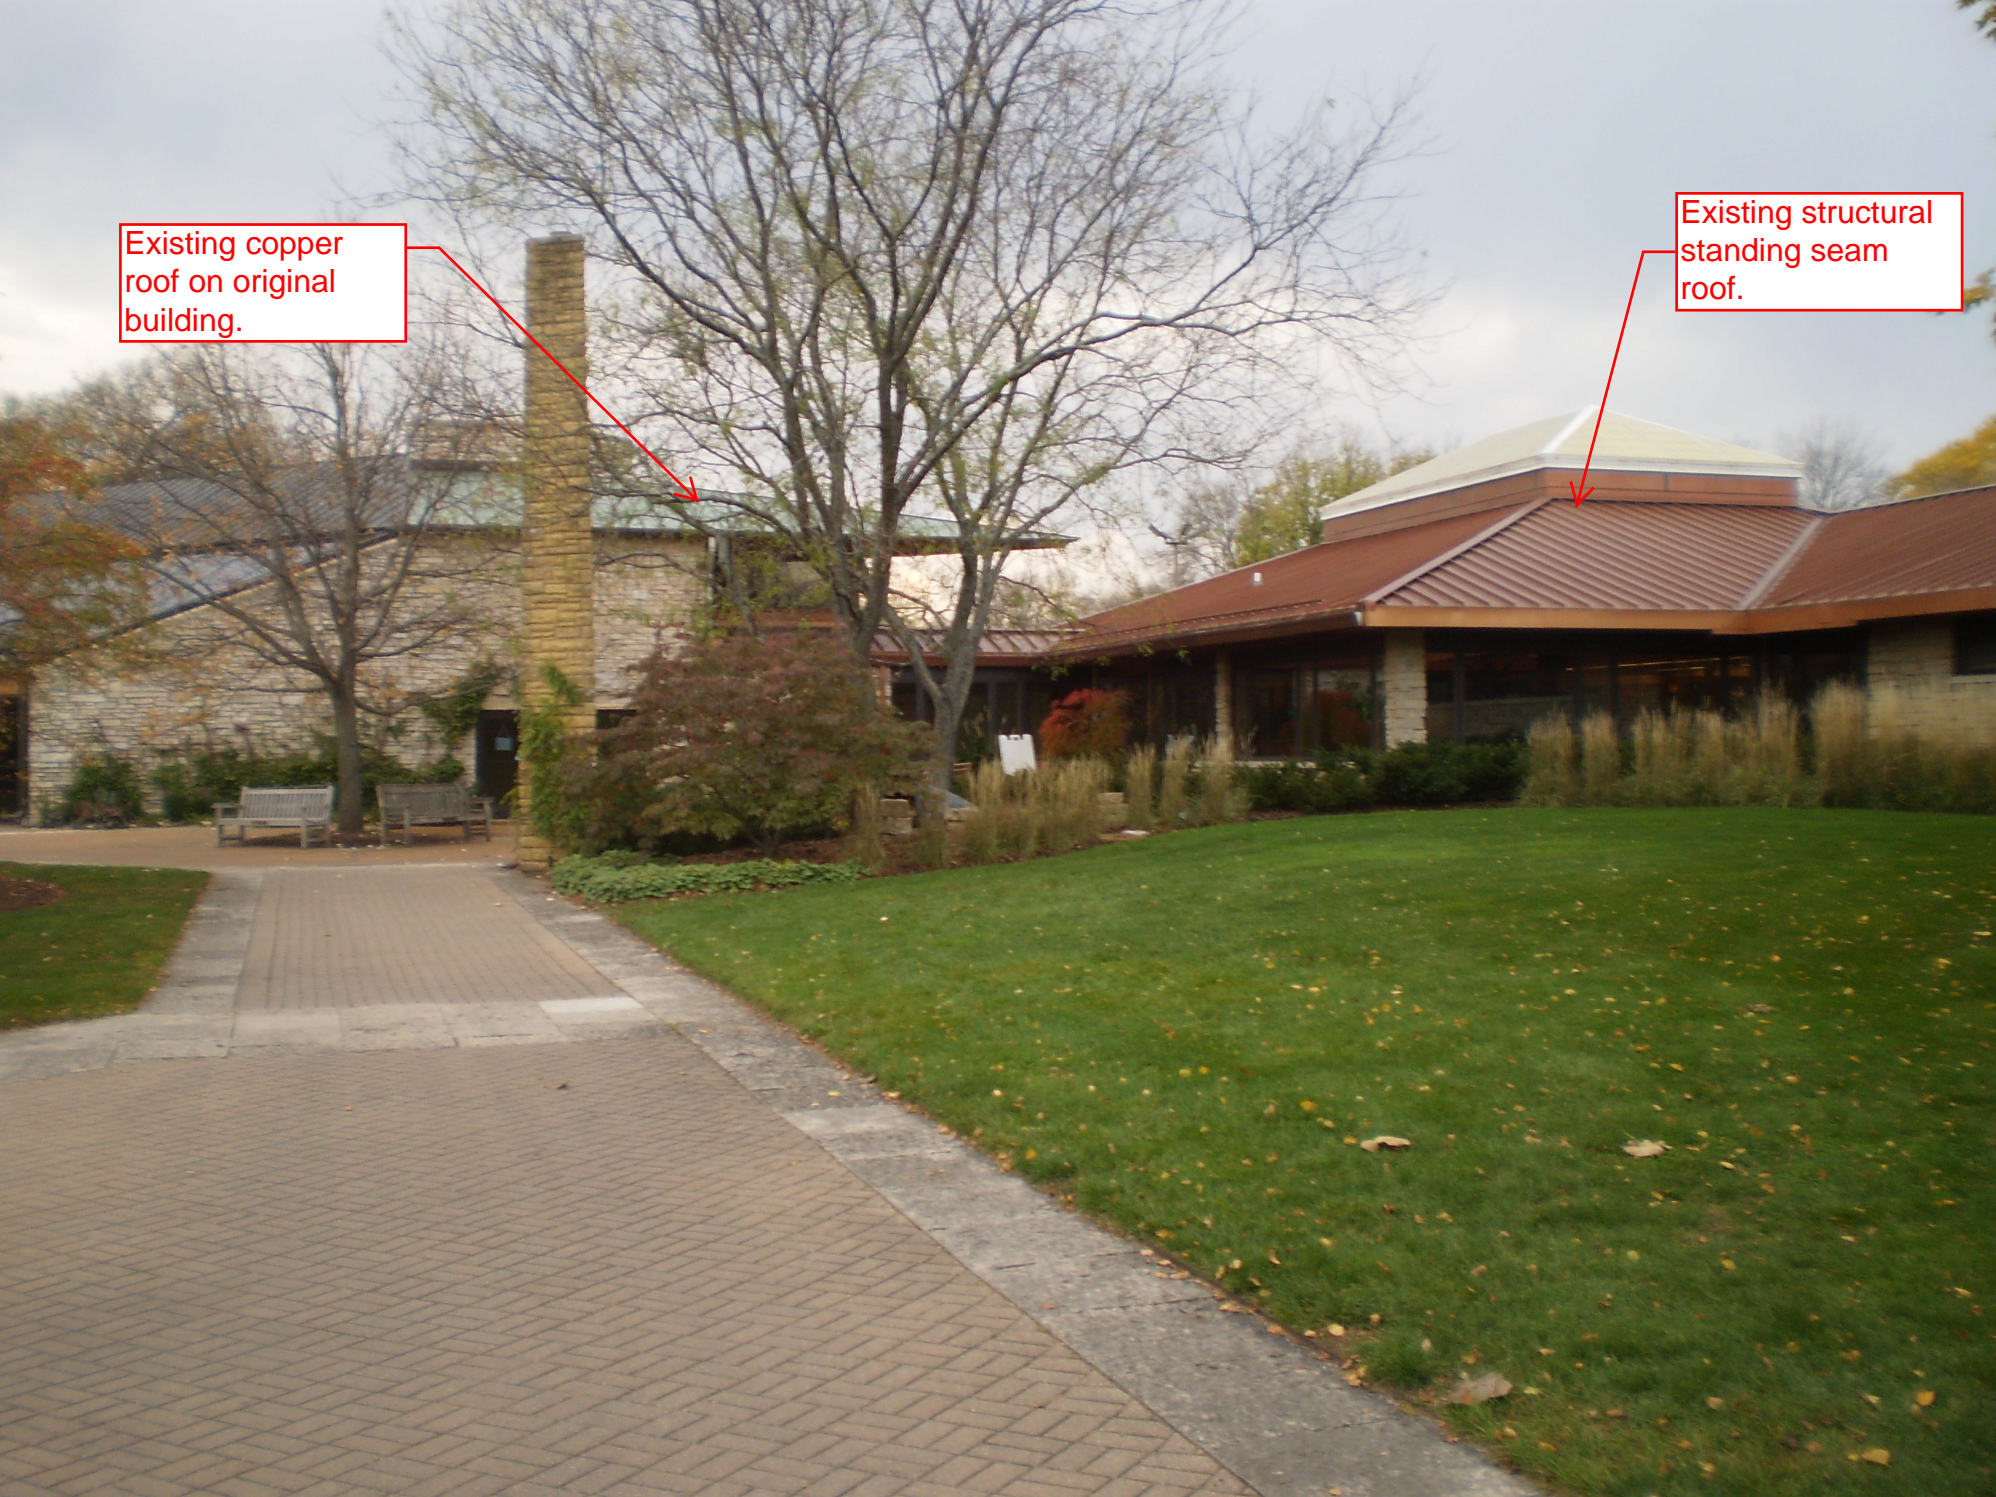
Existing copper
roof on original
building.

Existing structural
standing seam
roof.
