**FREIBURGER CONSTRUCTION CONSULTING, Inc.**  
**5438 County Highway M**  
**Fitchburg, WI 53575**  
**(608) 835-0001**

Woodland Montessori School  
1124 Colby St.  
Madison, WI 53715

## 114 Van Deusen

**Photo Log: 114 Van Deusen Street**

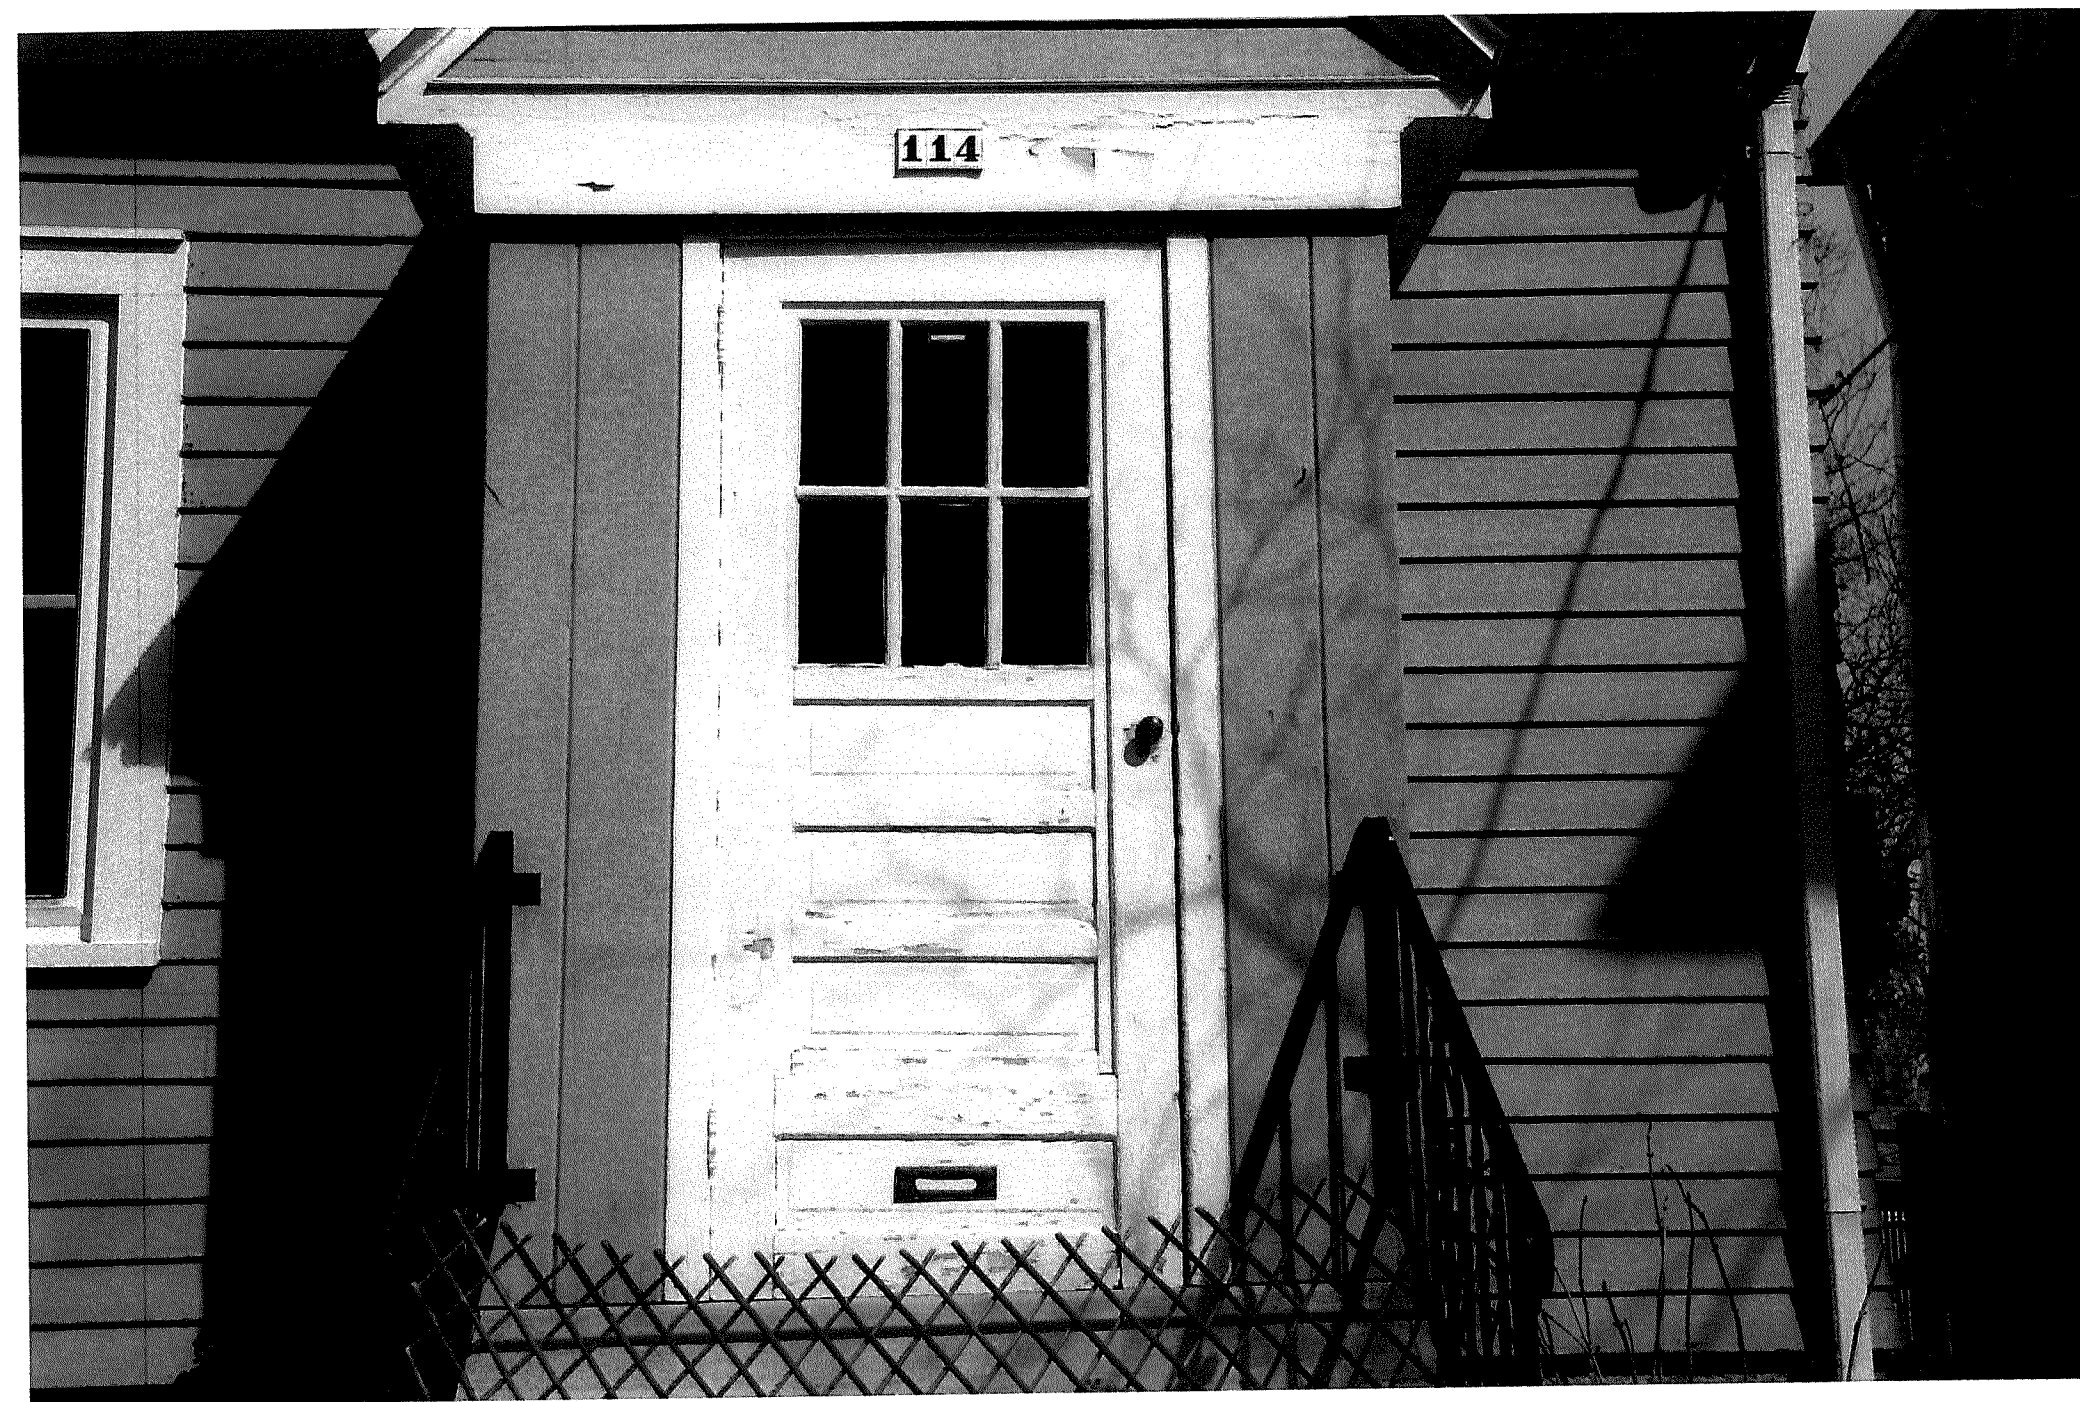
58

- Photo 37:** Establishing photo of south or front elevation.
- Photo 38:** Entry porch is subsiding. The door lacks the required landing at the top of the steps.

Shaky settling  
door w/peelings

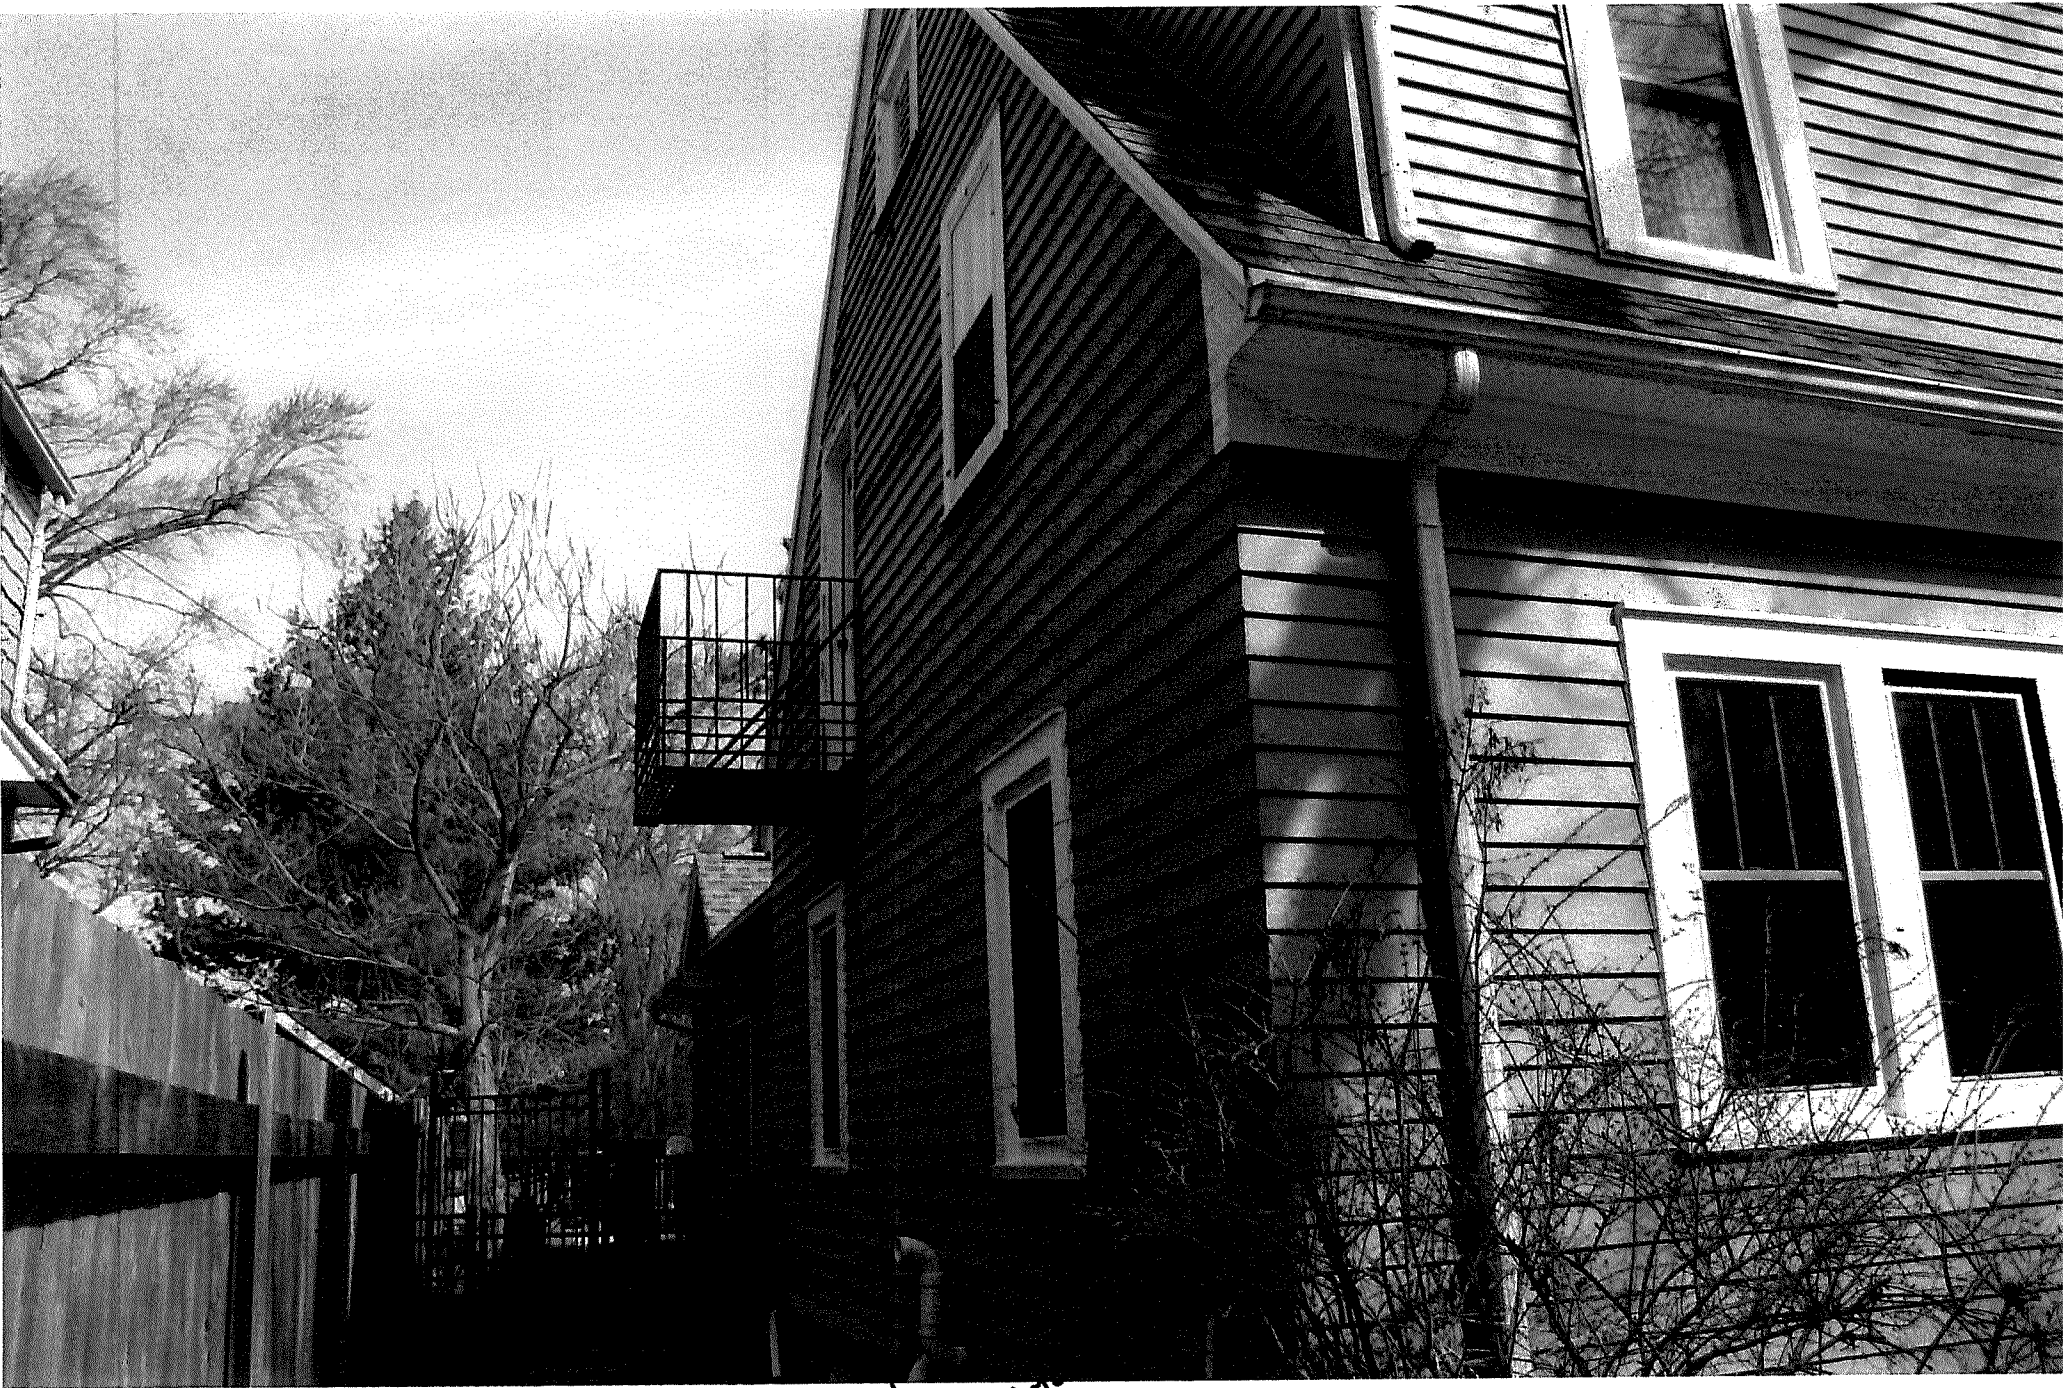
(39)

There is also a rescue platform bolted to the house on the second floor west elevation. The metal is rusted and needs to be painted. We could not study the attachments, but there is no evidence of current movement.

- Photo 39:** West side of Toddler House. Note rescue platform.
- Photo 40:** Closer look at rusty platform and paint peeling from siding that may contain lead.

leaking into  
wall below

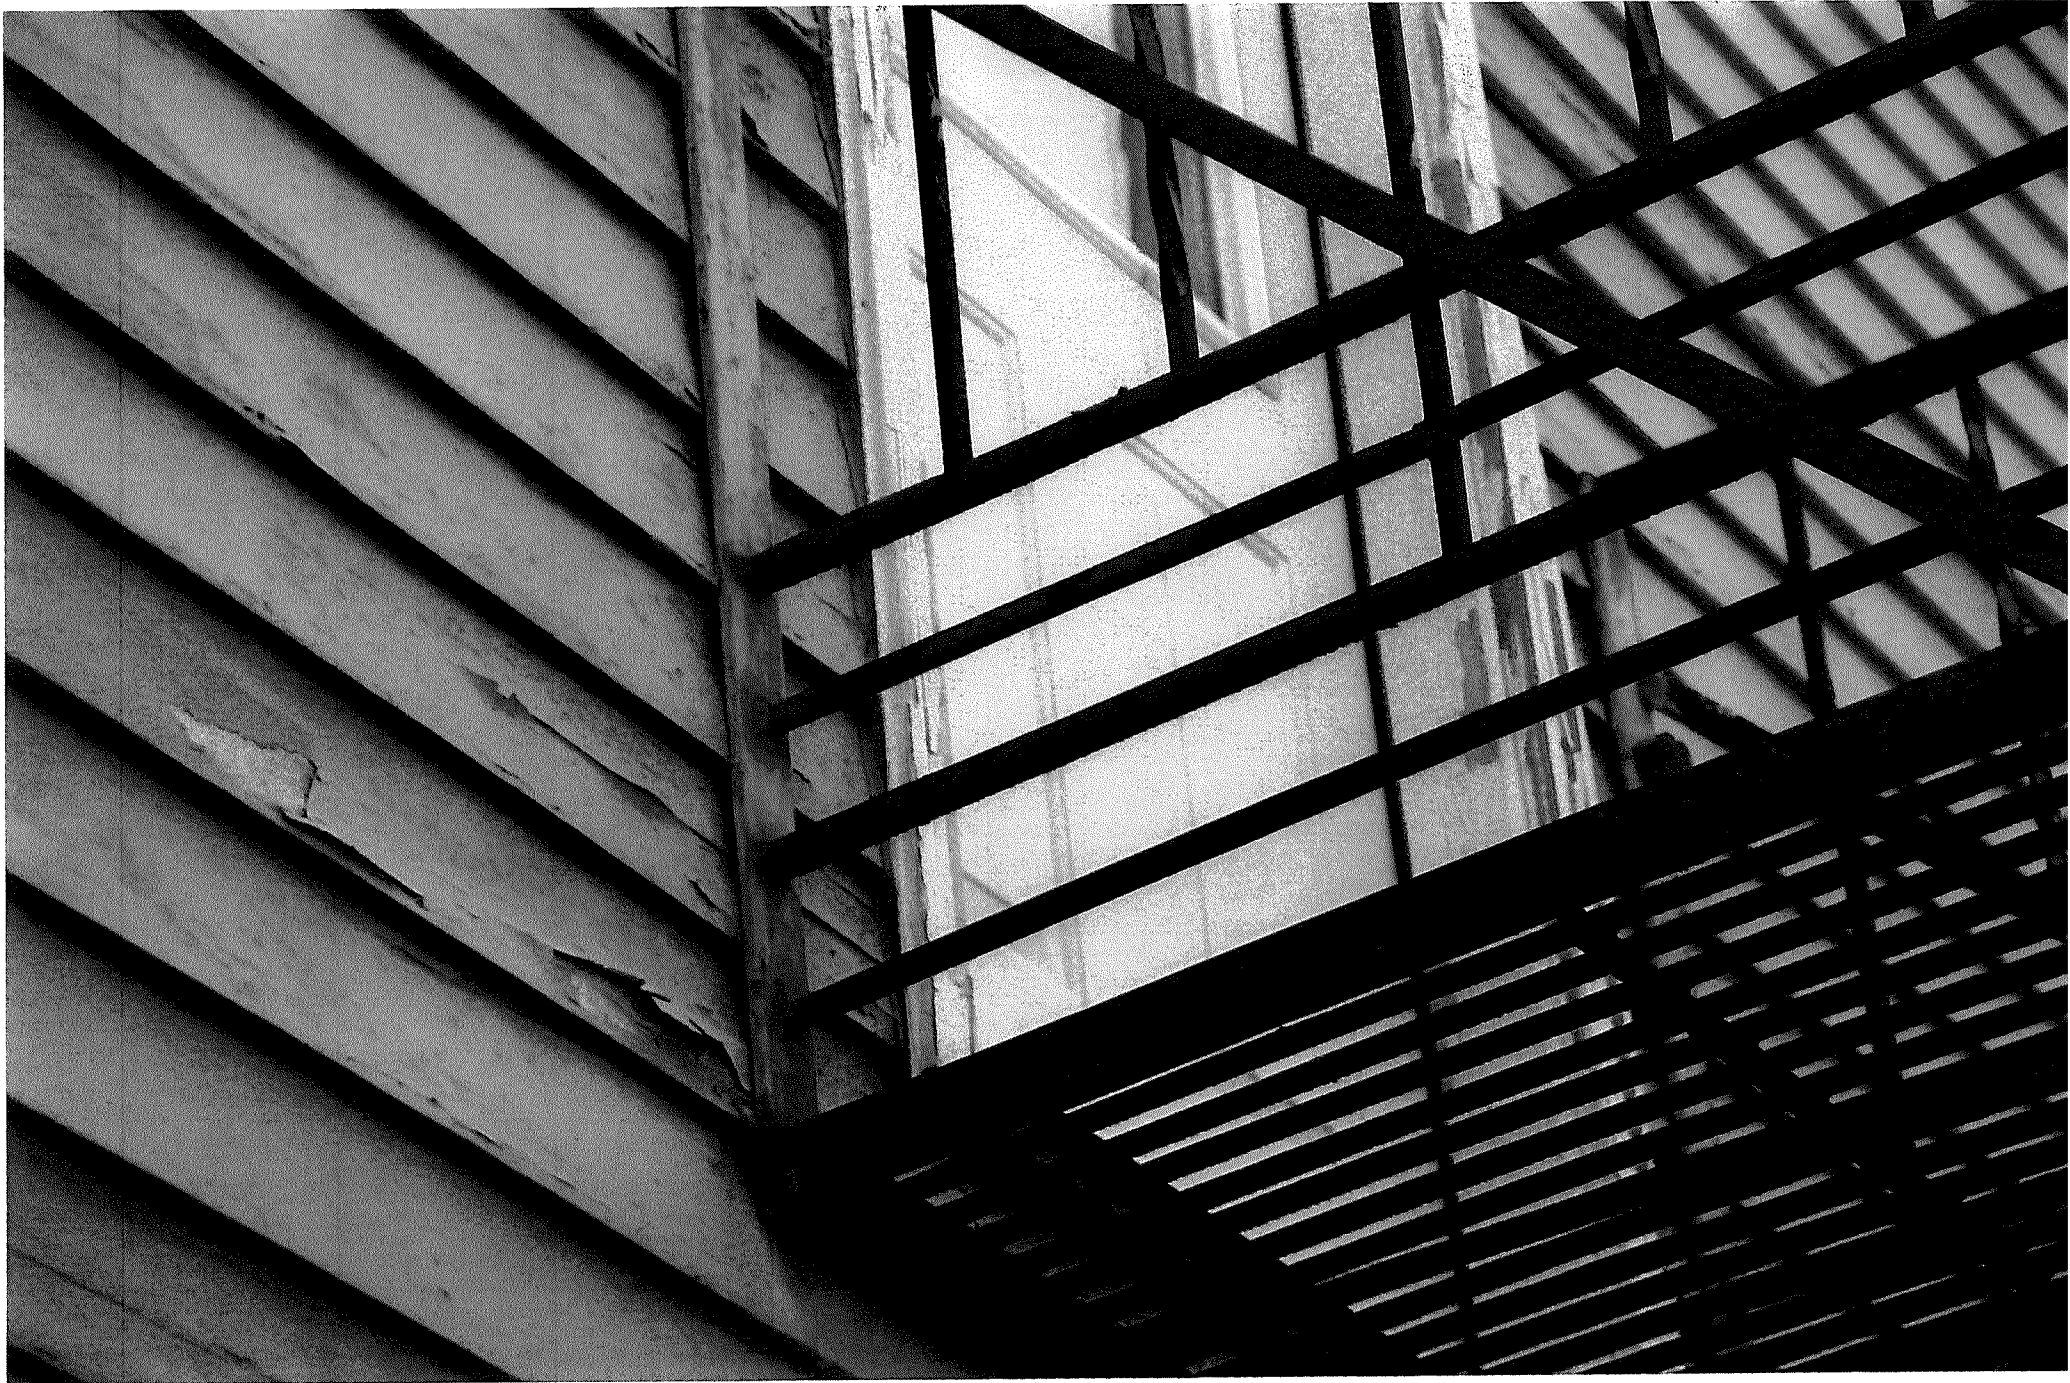
40

The door added for the second floor jump platform was never completely installed. Open areas exist where water can and does enter the wall system. The stain on the west first floor wall is due to leaking at and around the second floor exist door. This door does not appear to have been correctly flashed and reinstallation or replacement is recommended.

- Photo 41:** Threshold of platform access door where leak exists. Note that jamb is deteriorated.
- Photo 42:** Stain on wall to ceiling interface below platform door leak.

- 9.2 Reinstall the second floor platform door with appropriate flashing and casing.
  - 9.3 Mount all detectors as required by code in the correct locations.

put in new good door

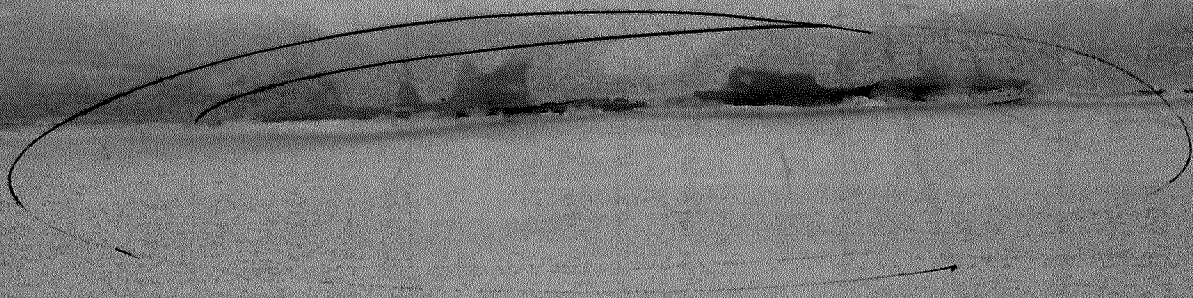
\* (42)

- 8.4 Stains were noted on the second floor where the wall meets the ceiling. These are most likely ice dam caused. The age of the stains is not known.

possible mold

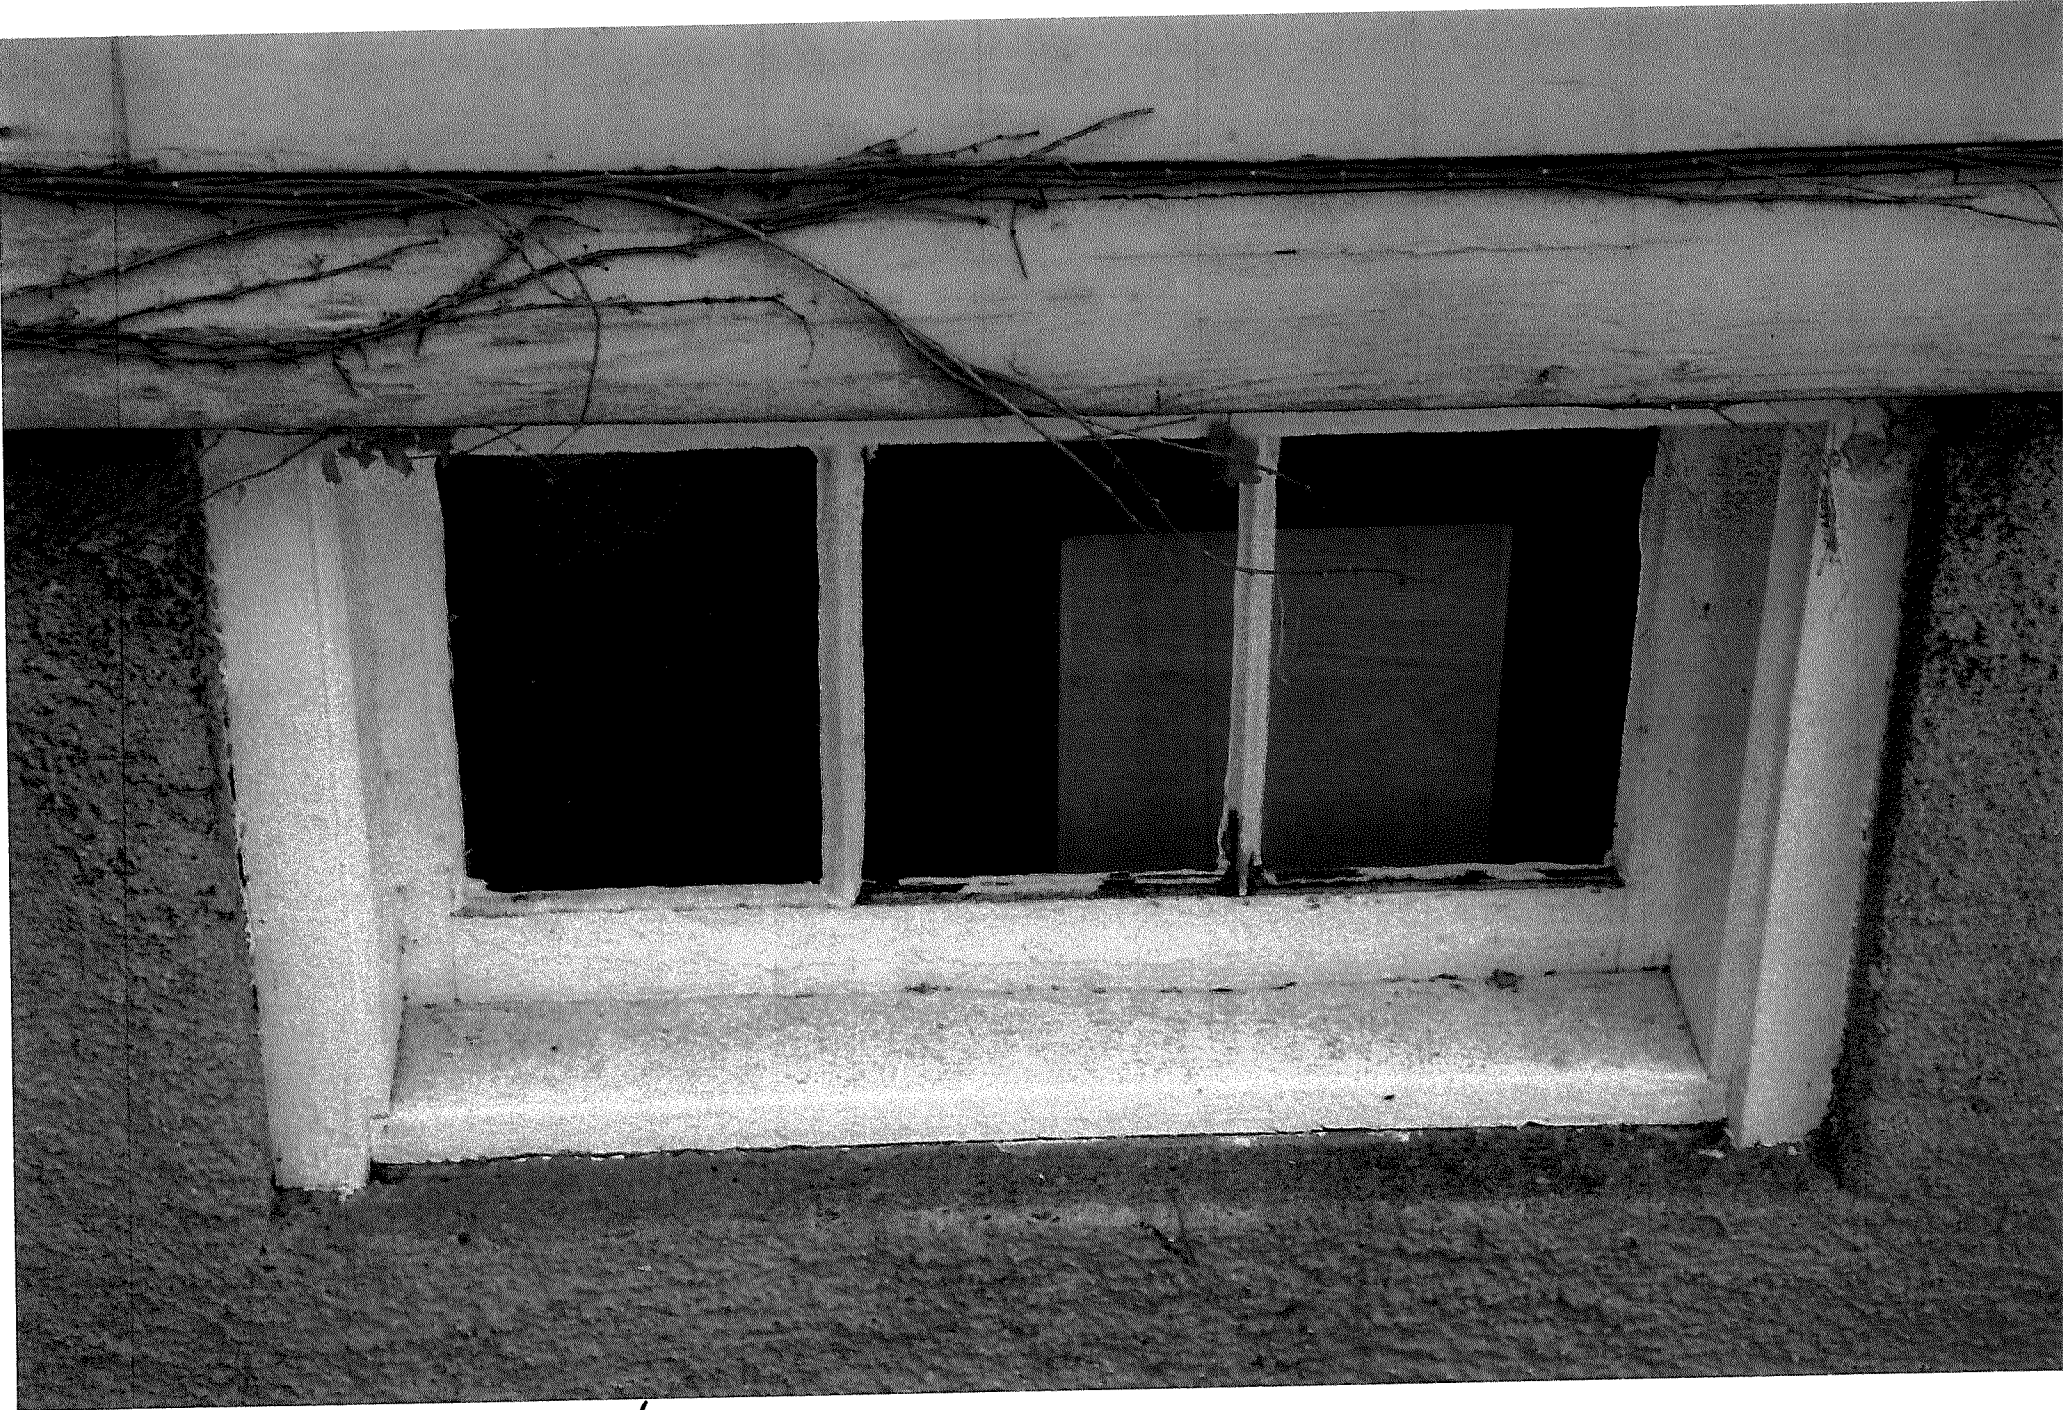
(43)

The basement windows are single glazed wood units. Cracked glass was noted at one of these windows.

- Photo 43:** Basement window that need glazing, paint and a storm.
- Photo 44:** Missing downspout on north second floor elevation.
- Photo 45:** Ice damming damage on second floor north of Toddler House.

*needs a storm*

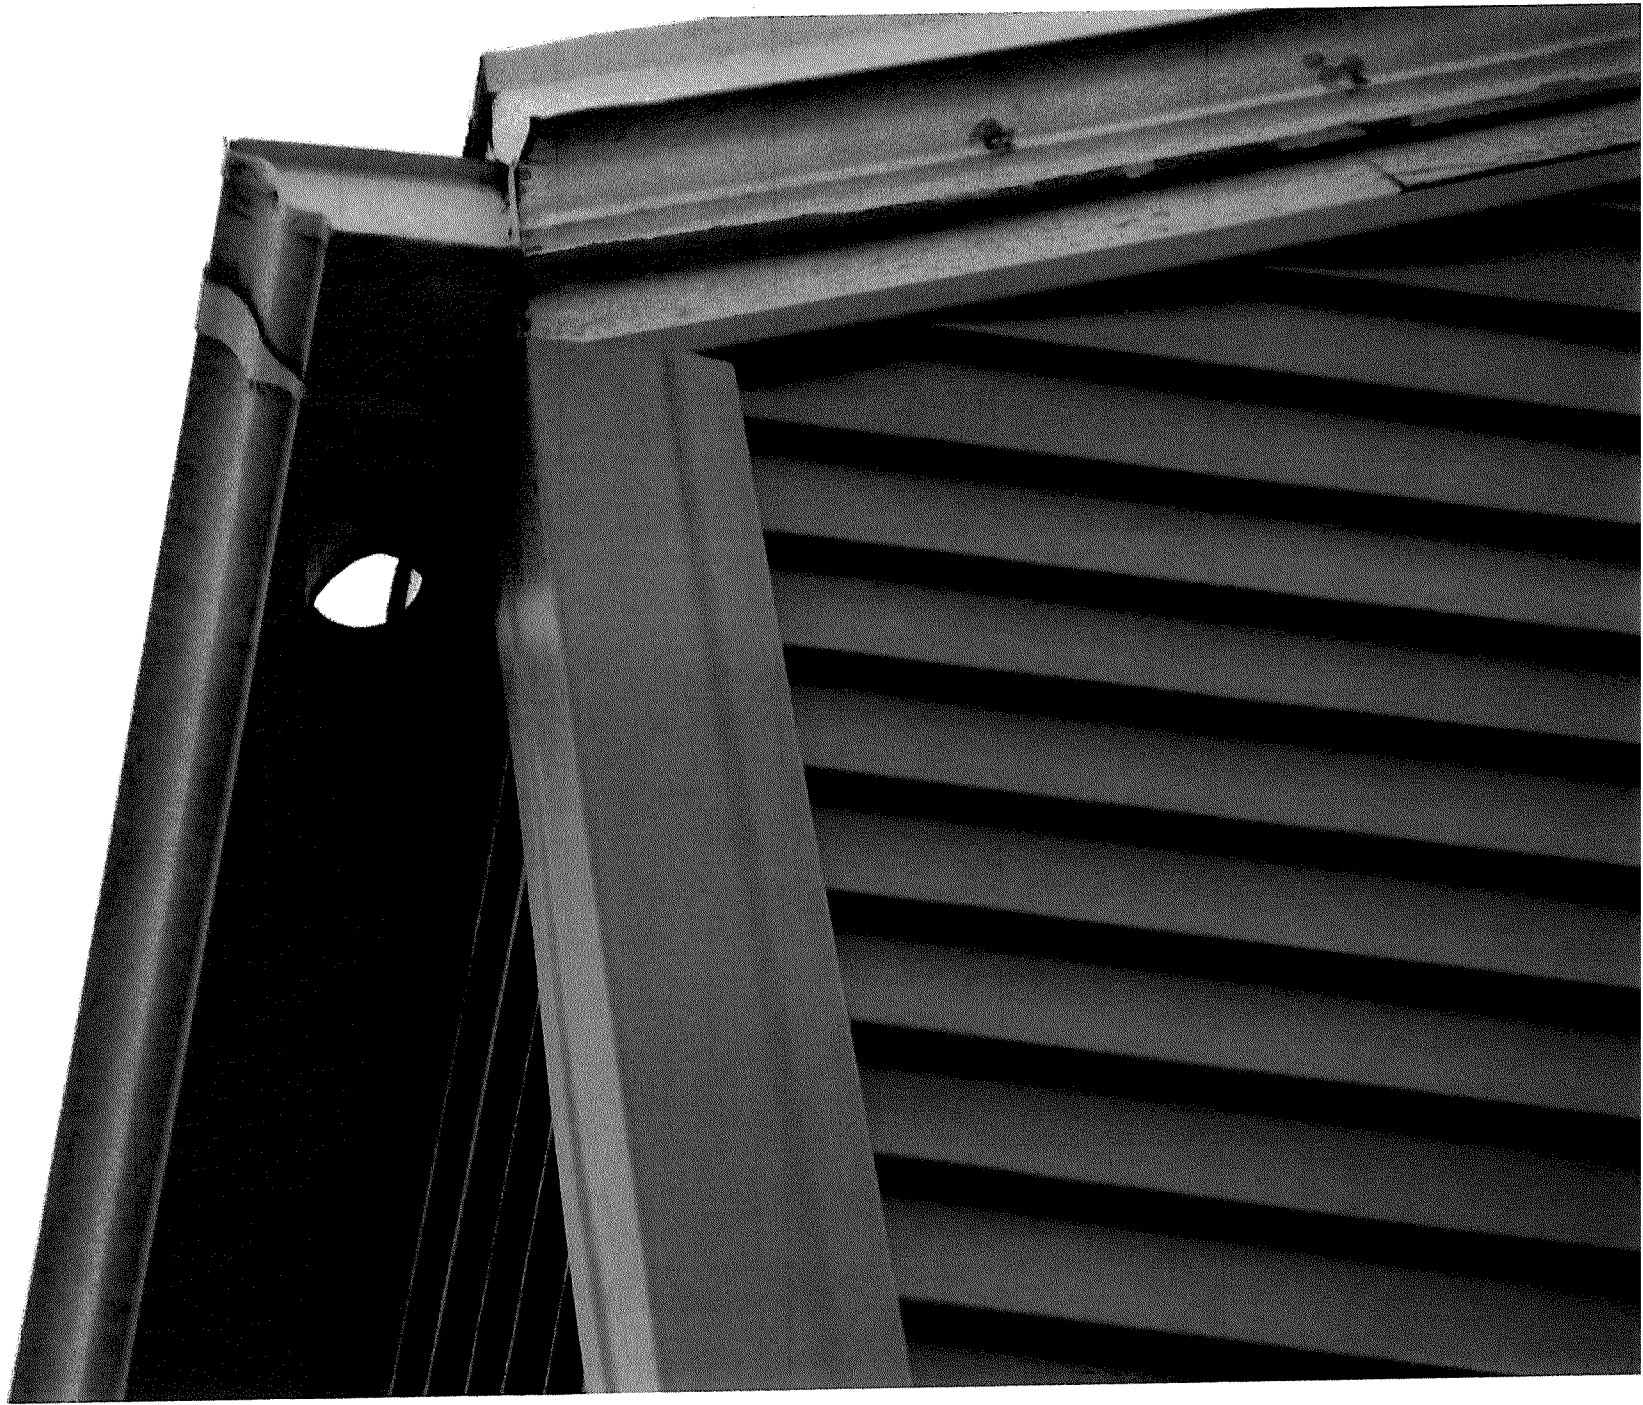
44

- 2.1 Shingles: The roof is covered with laminated shingles of good quality, appearing to be in serviceable condition at sixteen to eighteen years of age. Such shingles typically have a thirty year useful life. We do not know if Ice and Water Shield was applied. Your records may indicate.
- 2.2 Siding: The addition siding is all vinyl while the house has a mix of original wood siding and 1990s vintage vinyl. Some siding nails have lost their galvanized finish and now project rust through the paint. Portions of the wood siding and trim may contain lead painted. Paint is peeling down to the wood in some areas and repairs are required.
- 2.3 Trim: Much of the trim has been clad with metal, but some exposed wood trim still exists.
- 2.4 Gutters: A portion of the north side down spout is absent, allowing uncontrolled flow from the second floor north gutter.

missing downspout

- 9.4 Plan to replace the west side addition entry structure with a well flashed replacement.
  - 9.5 Replace the missing downspout and direct spout discharge as far from the foundation as possible.

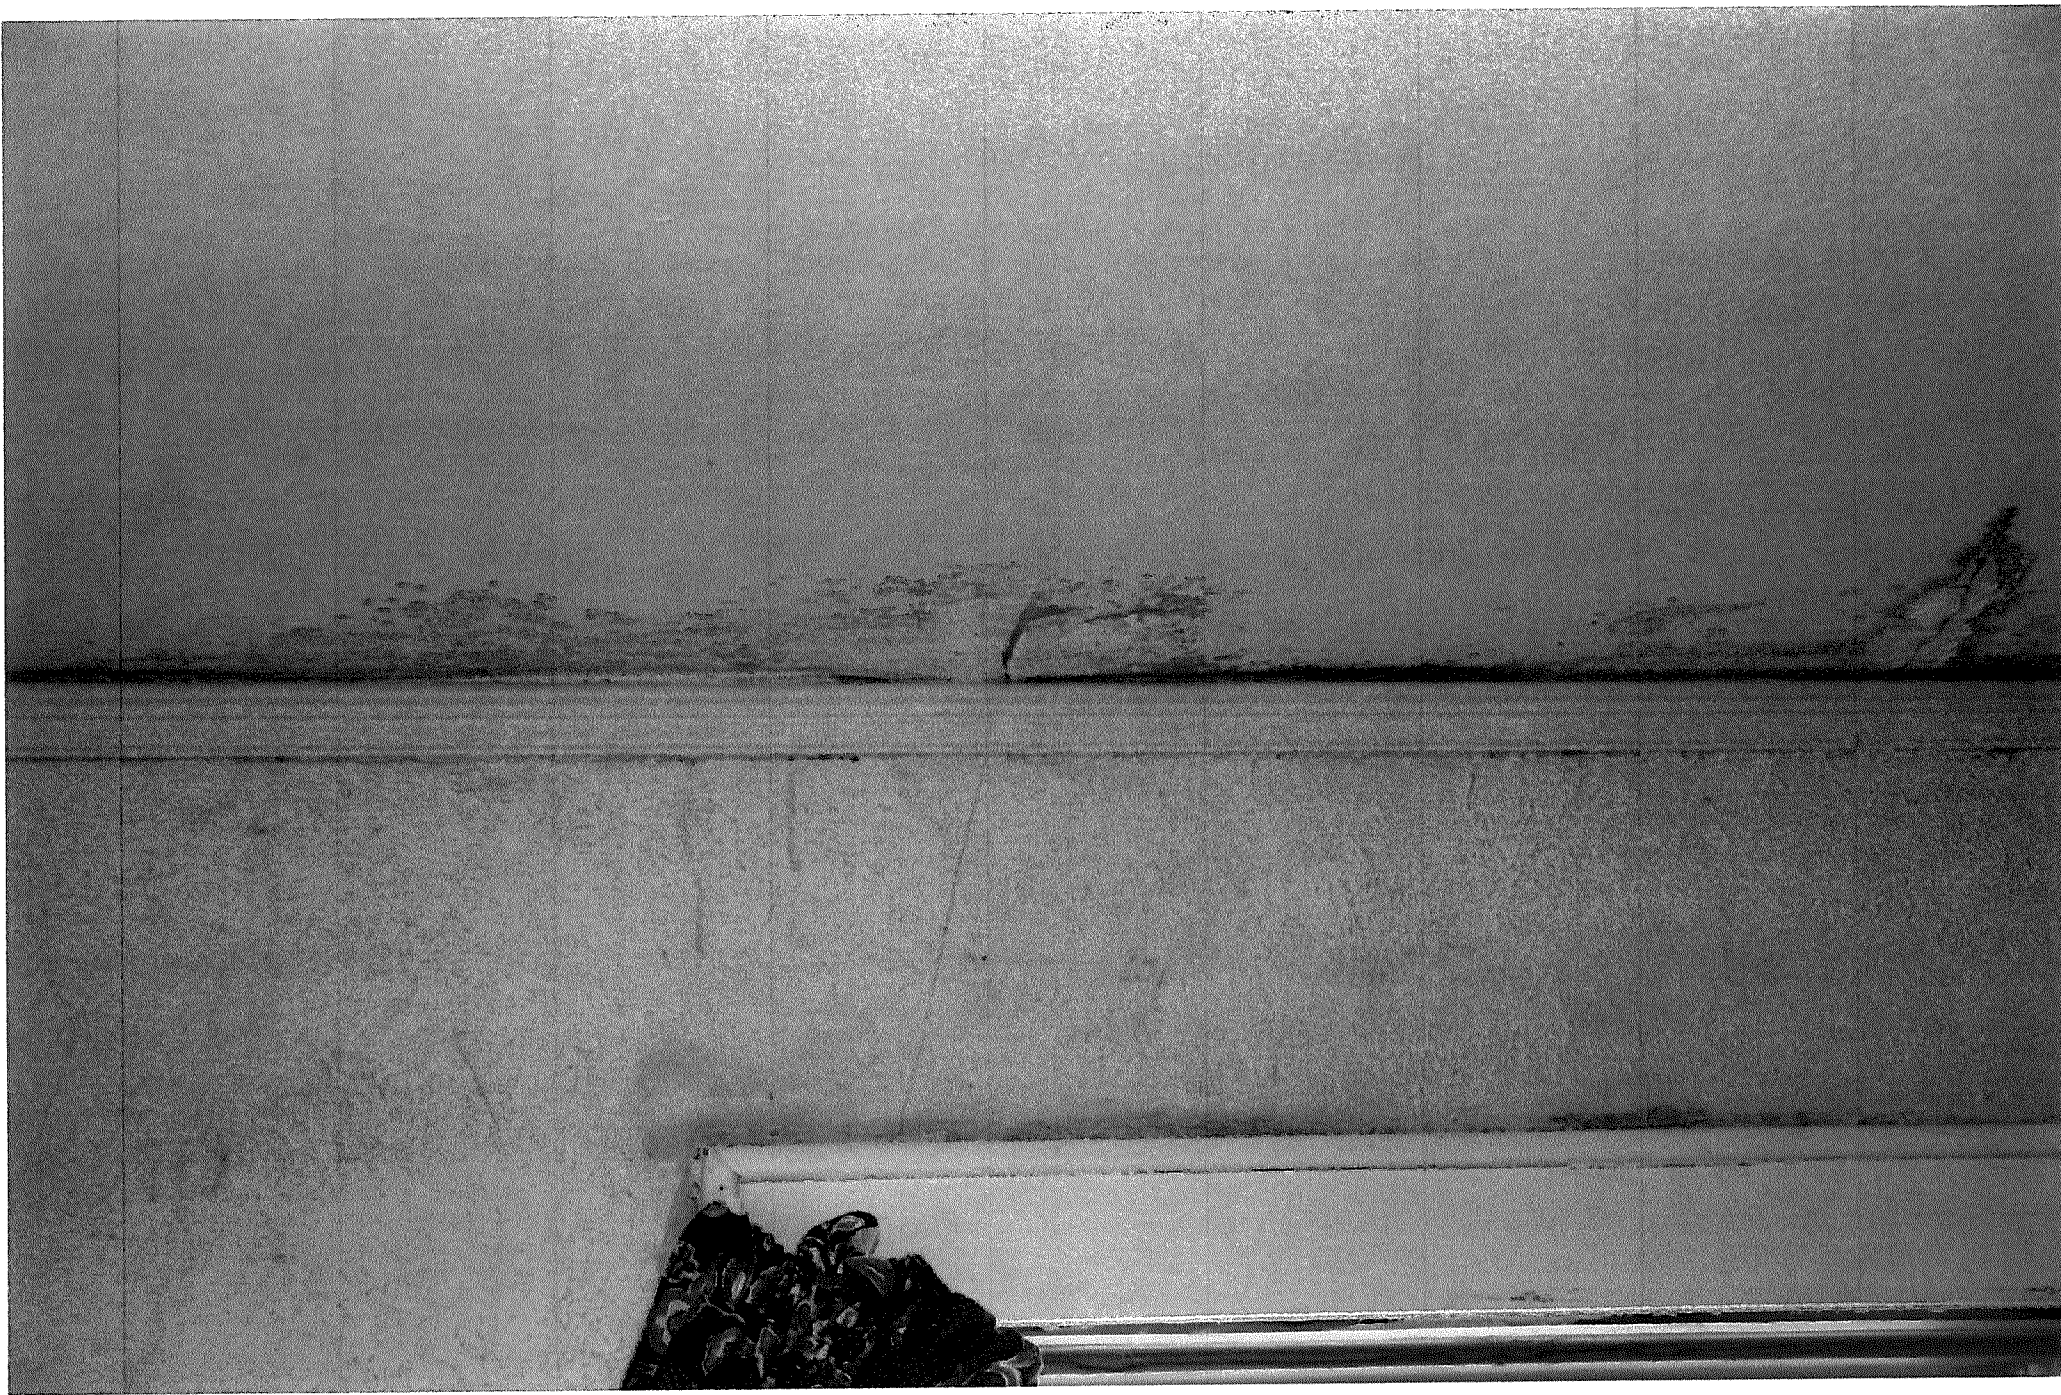
(45)

ice damming

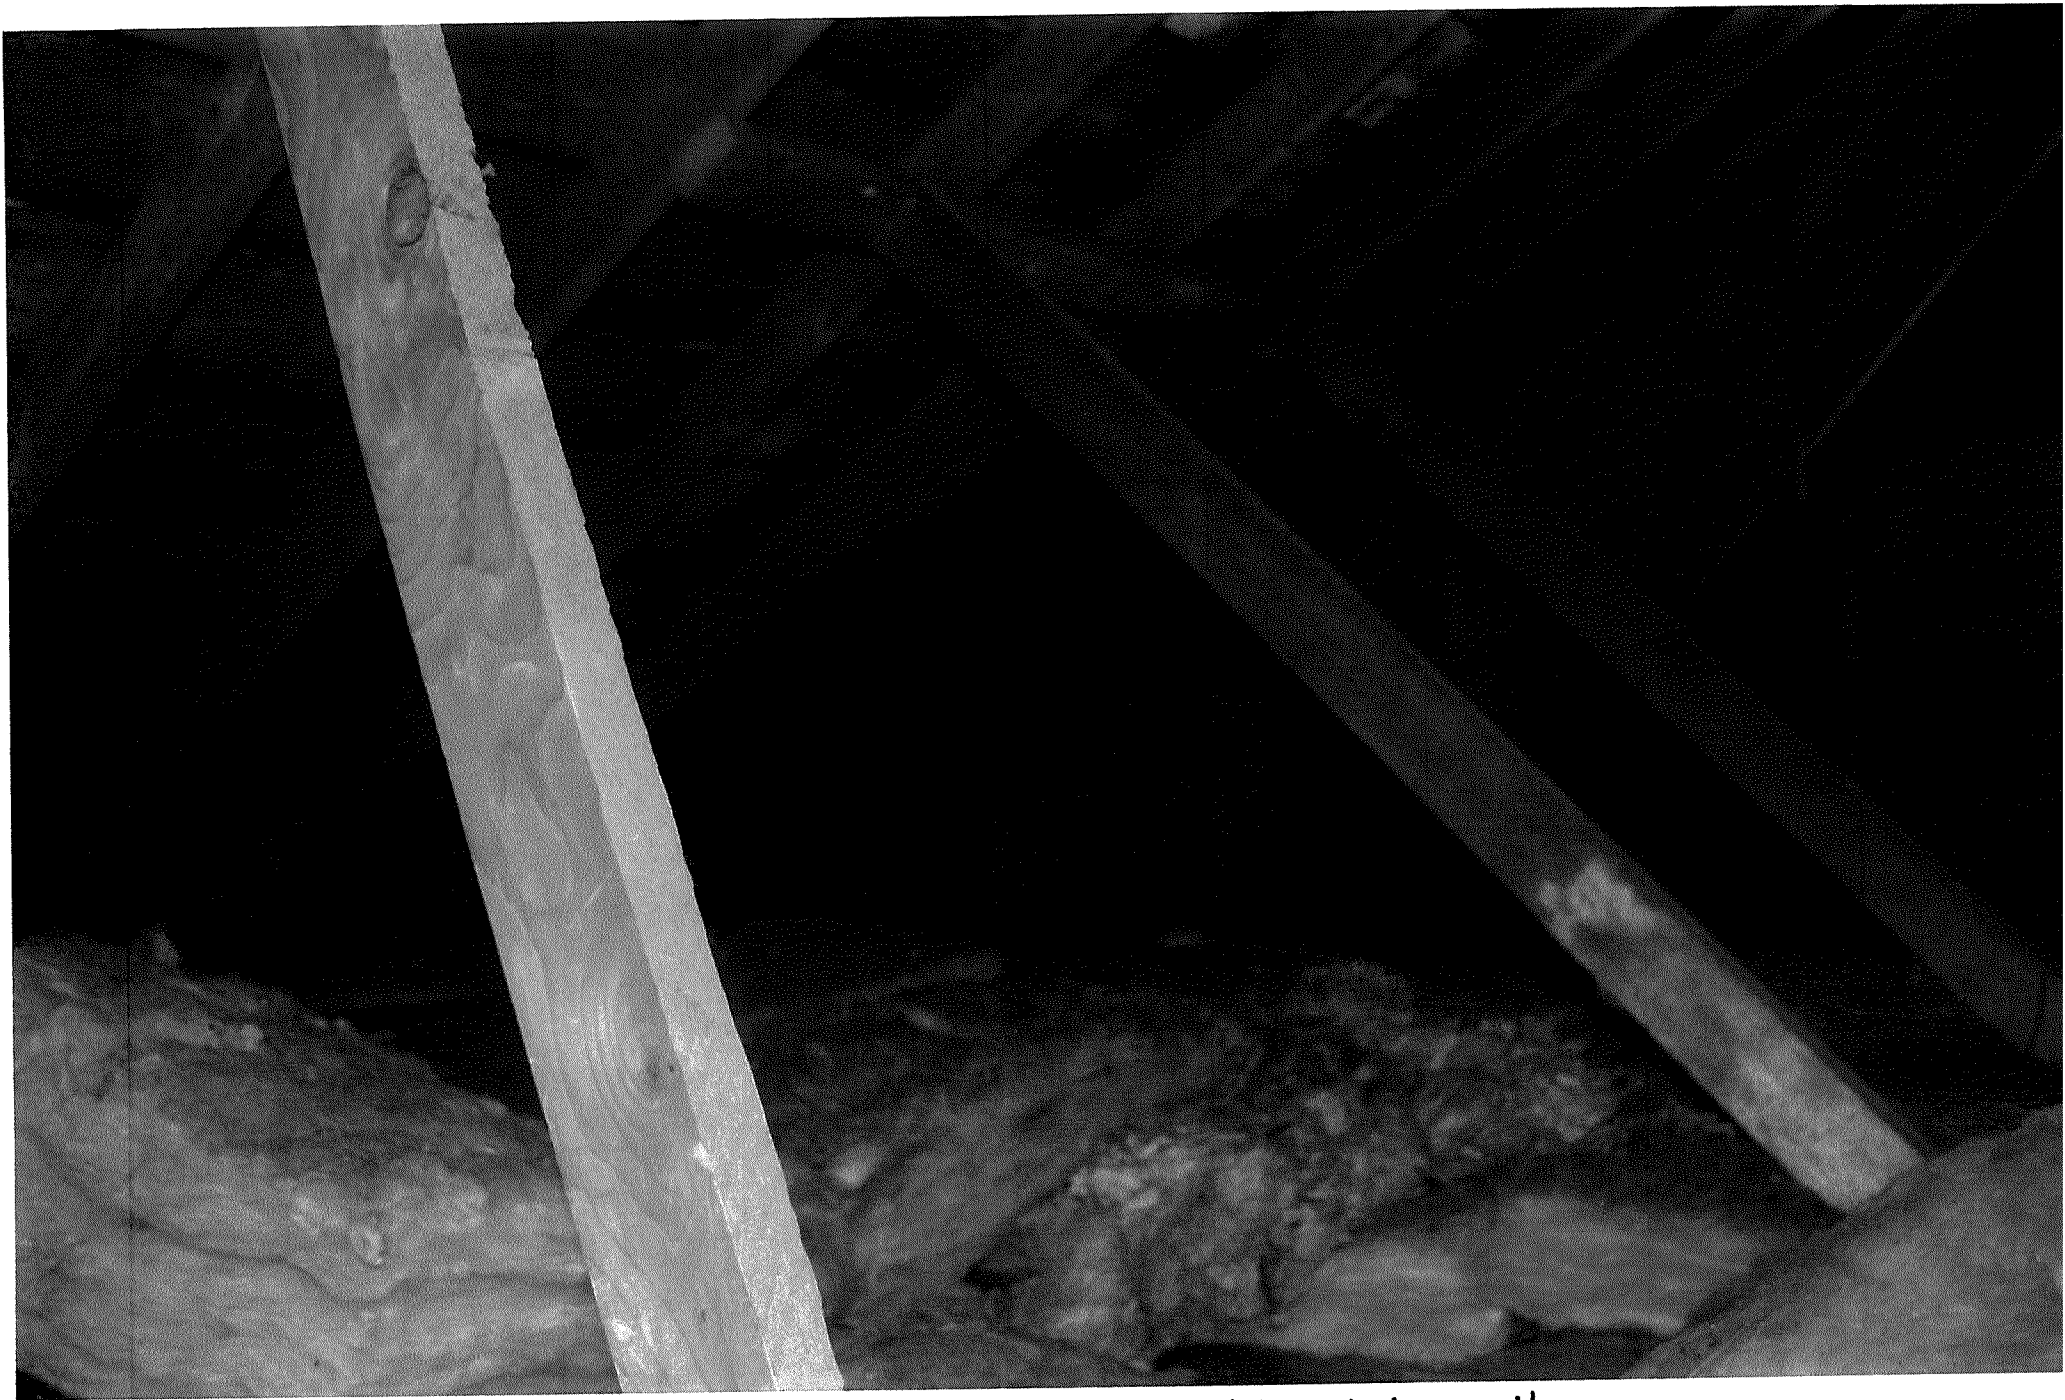
46

- 1.3 Framing: The floors are framed in a typical residential manner and no deflection due to dead or live loading was noted. The house attic was entered to view the lightly constructed house roof. The rafters are only two by fours and fairly long spans. Bracing has been added to reduce the deformation of the roof. This bracing causes roof loads to develop onto the house framing and main basement beam. We consider the house framing to be structurally serviceable, but if the house is retained for more than a few more years, further study is recommended.

- Photo 46:** Braced two by four rafters constitute a weak system. Note irregular insulation.
- Photo 47:** Condensation staining on rafters in attic.
- Photo 48:** Condensation staining on sheathing due to inadequate attic venting.

not challenging load capacity  
roof framing crappy

- 9.8 Consider an insulation and attic venting plan if the house is to remain in service.
  - 9.9 If the house remains in service, study the roof framing and reinforce before insulation is added
