**FREIBURGER CONSTRUCTION CONSULTING, Inc.**  
**5438 County Highway M**  
**Fitchburg, WI 53575**  
**(608) 835-0001**

Woodland Montessori School  
1124 Colby St.  
Madison, WI 53715

## 114 Van Deusen

**Photo Log: 114 Van Deusen Street**

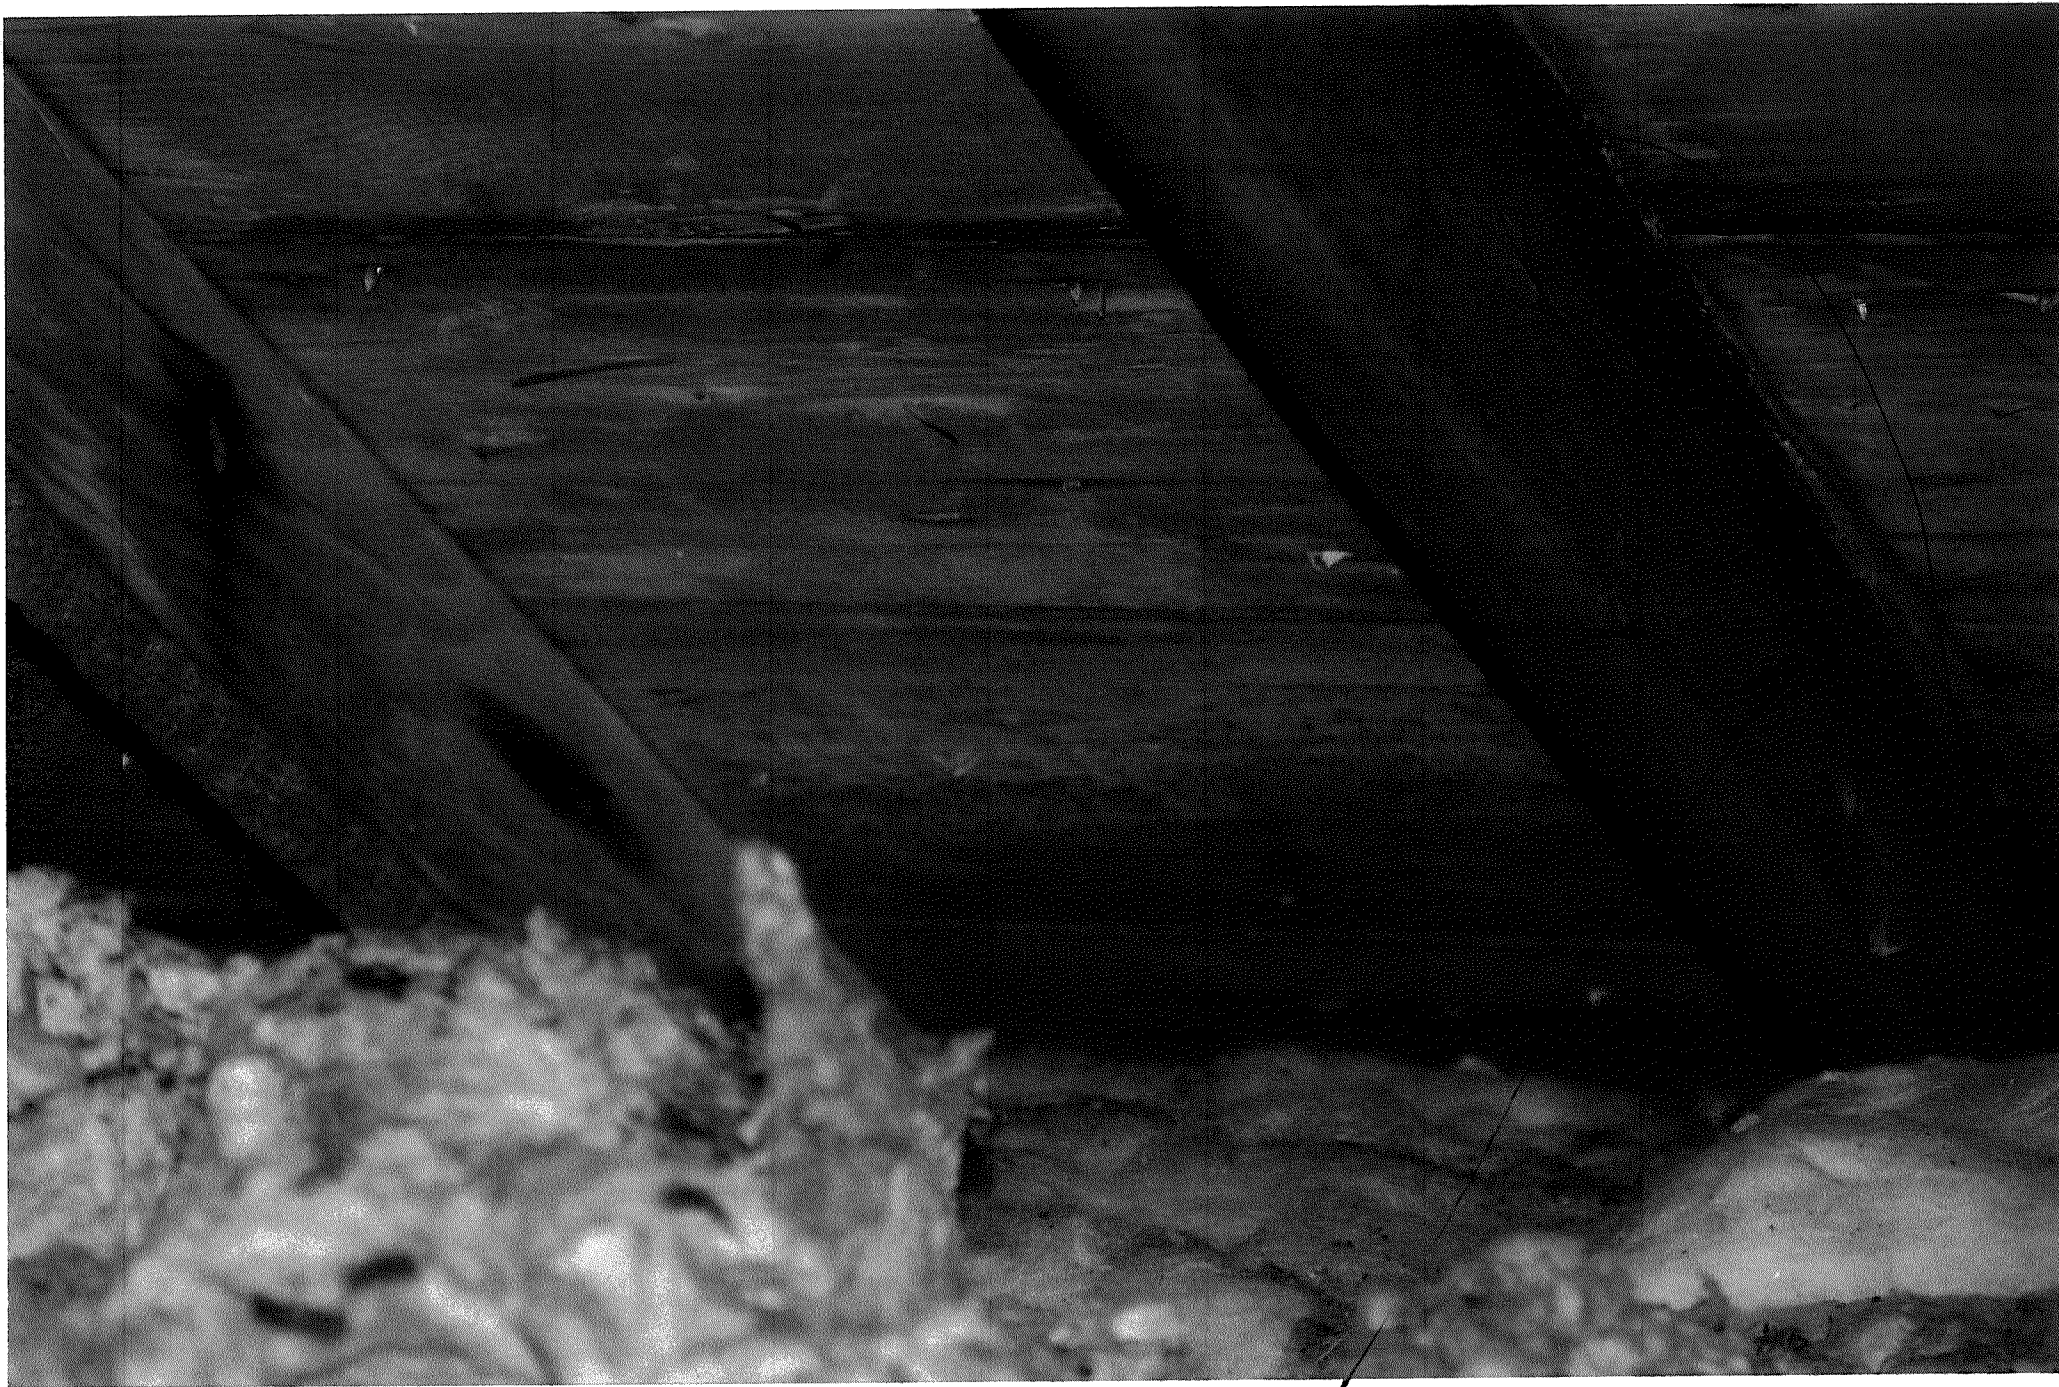
(47)

- Photo 46:** Braced two by four rafters constitute a weak system. Note irregular insulation.
- Photo 47:** Condensation staining on rafters in attic.
- Photo 48:** Condensation staining on sheathing due to inadequate attic venting.

Condensation

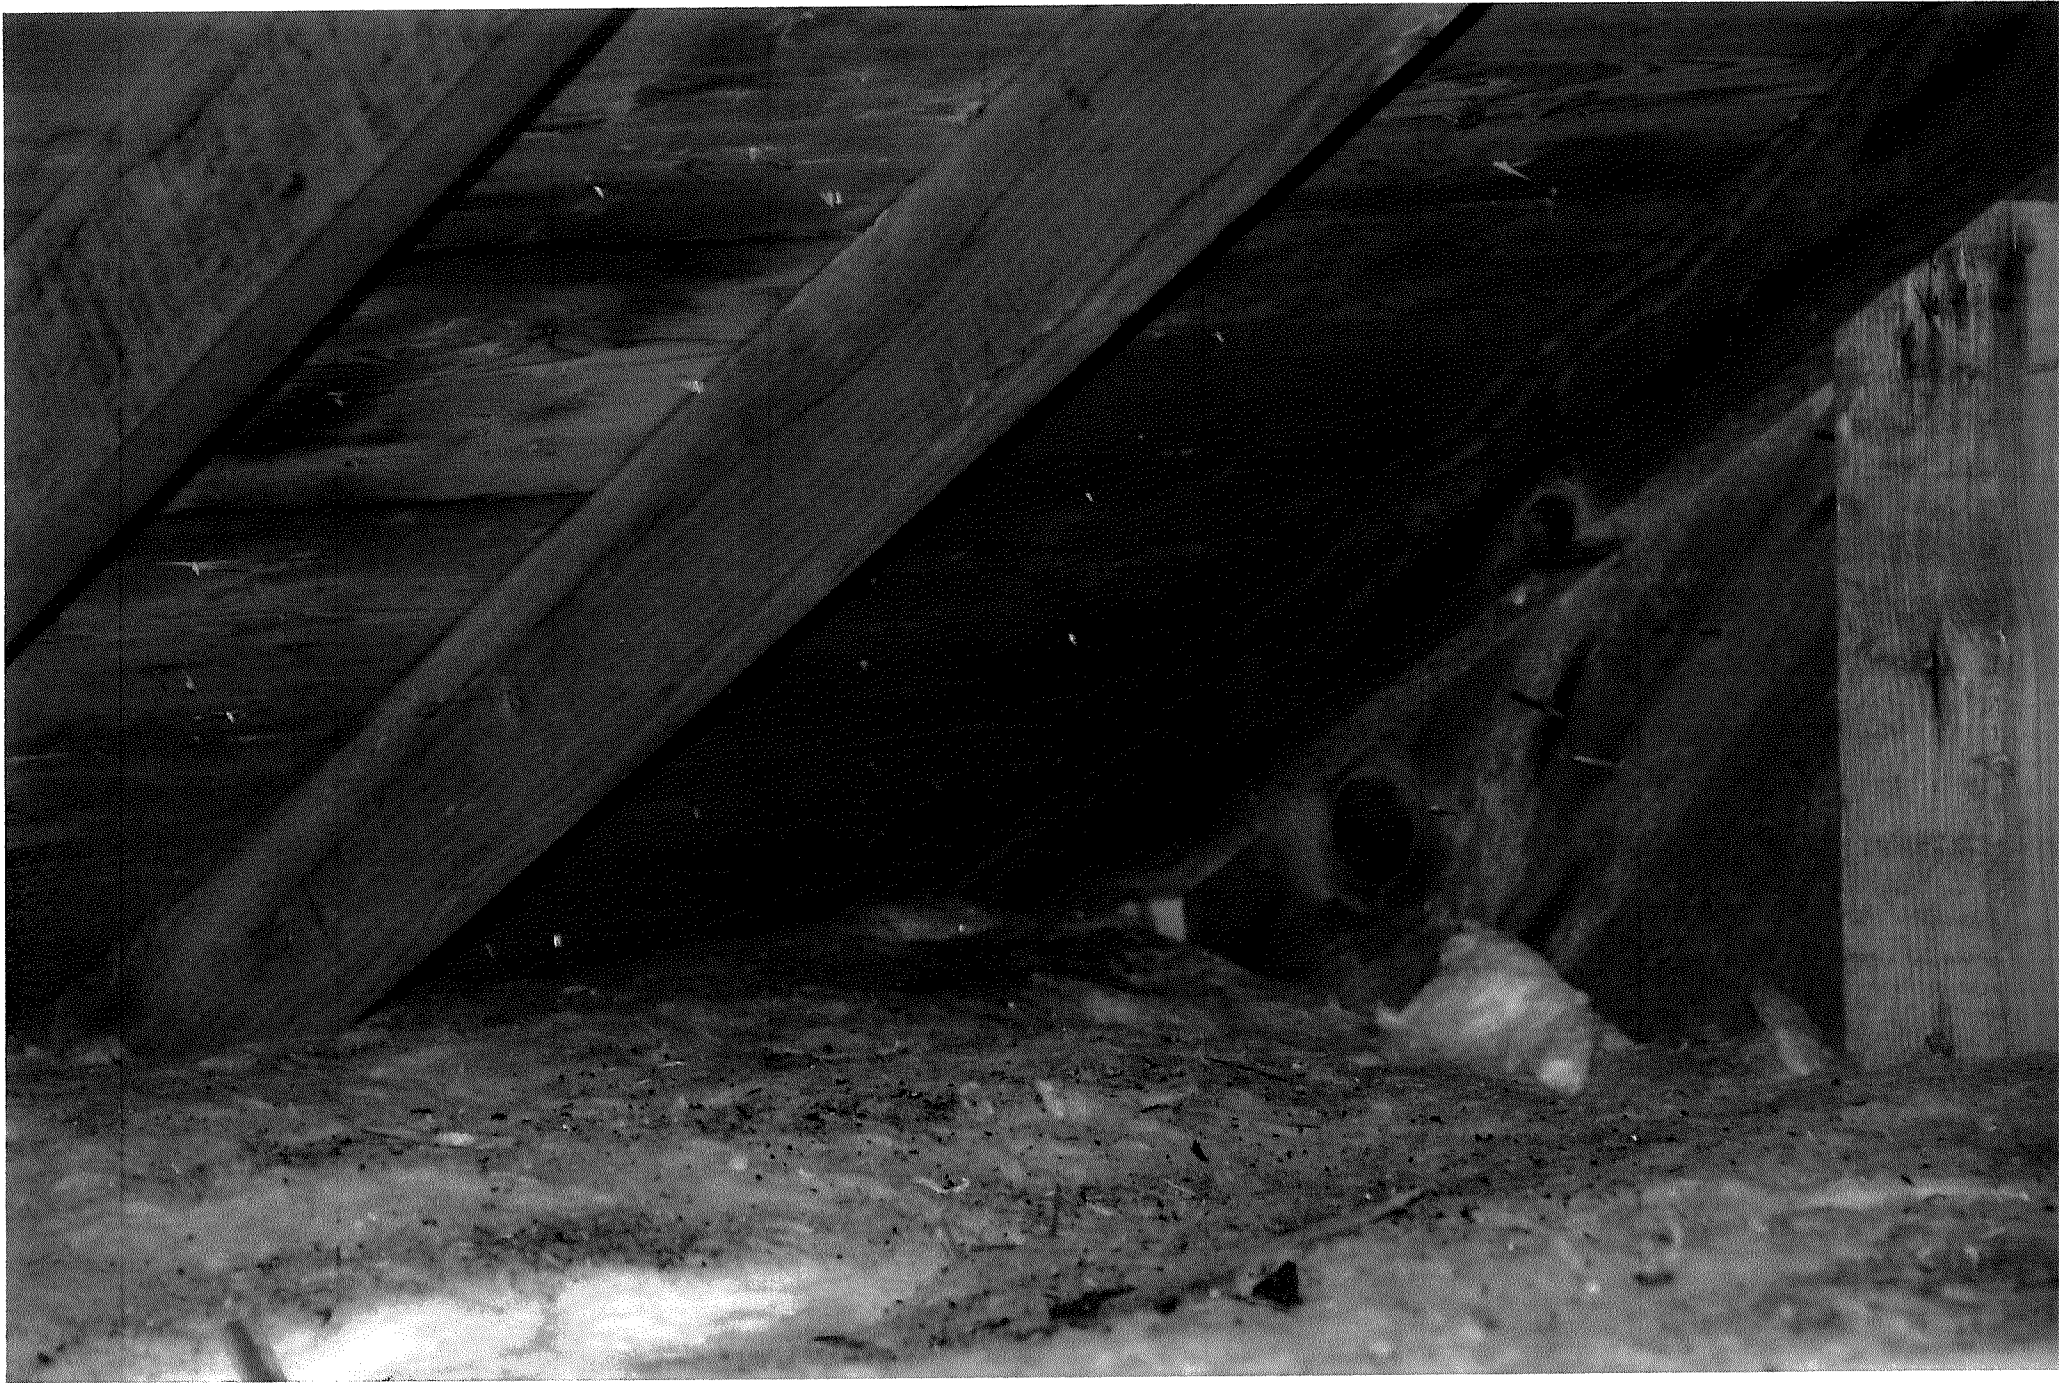
(48)

Weak  
Structure

mold + mildew - needs new roof total new roof  
25 - 25 - thousand

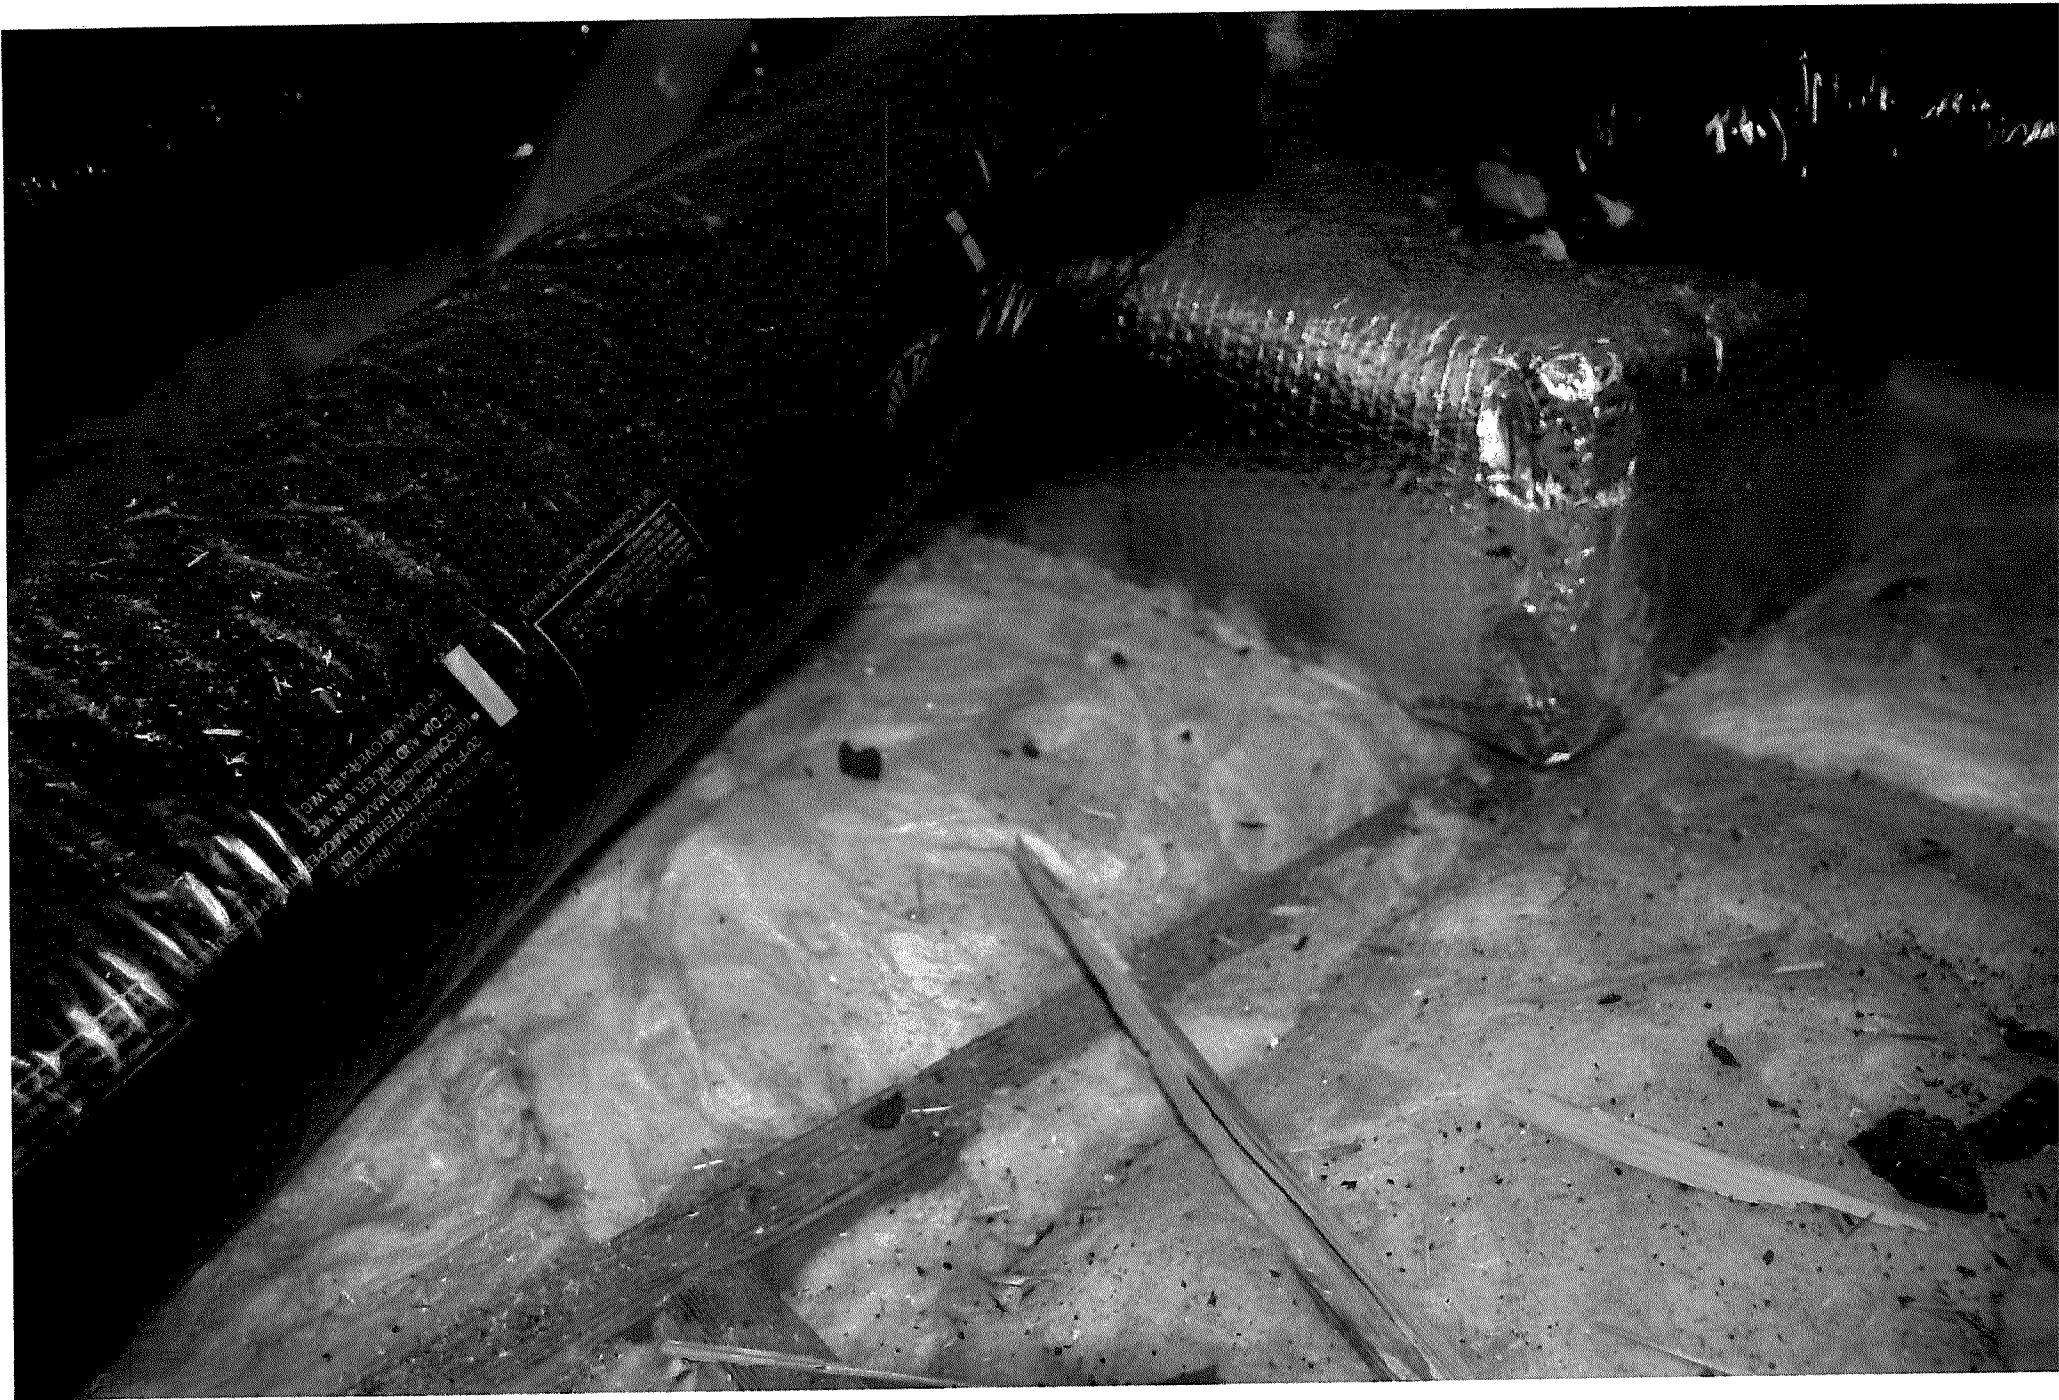
49

- 4.1 Attic insulation: The attic is poorly insulated with fiberglass. There are also heat ducts run in the attic and they have the minimal R-5 insulation covering. The attic insulation allows significant heat loss, which can cause ice damming. If the building is to be kept in use, a retrofitted air sealing, venting and insulation plan should be devised.

- Photo 49:** Poorly insulated heat runs in the attic contribute to heat loss and ice damming.
- Photo 50:** View of a portion of the west elevation of Toddler House at addition.

needs insulated - heated attic → melts snow → leaks air

- 9.8 Consider an insulation and attic venting plan if the house is to remain in service.
  - 9.9 If the house remains in service, study the roof framing and reinforce before insulation is added

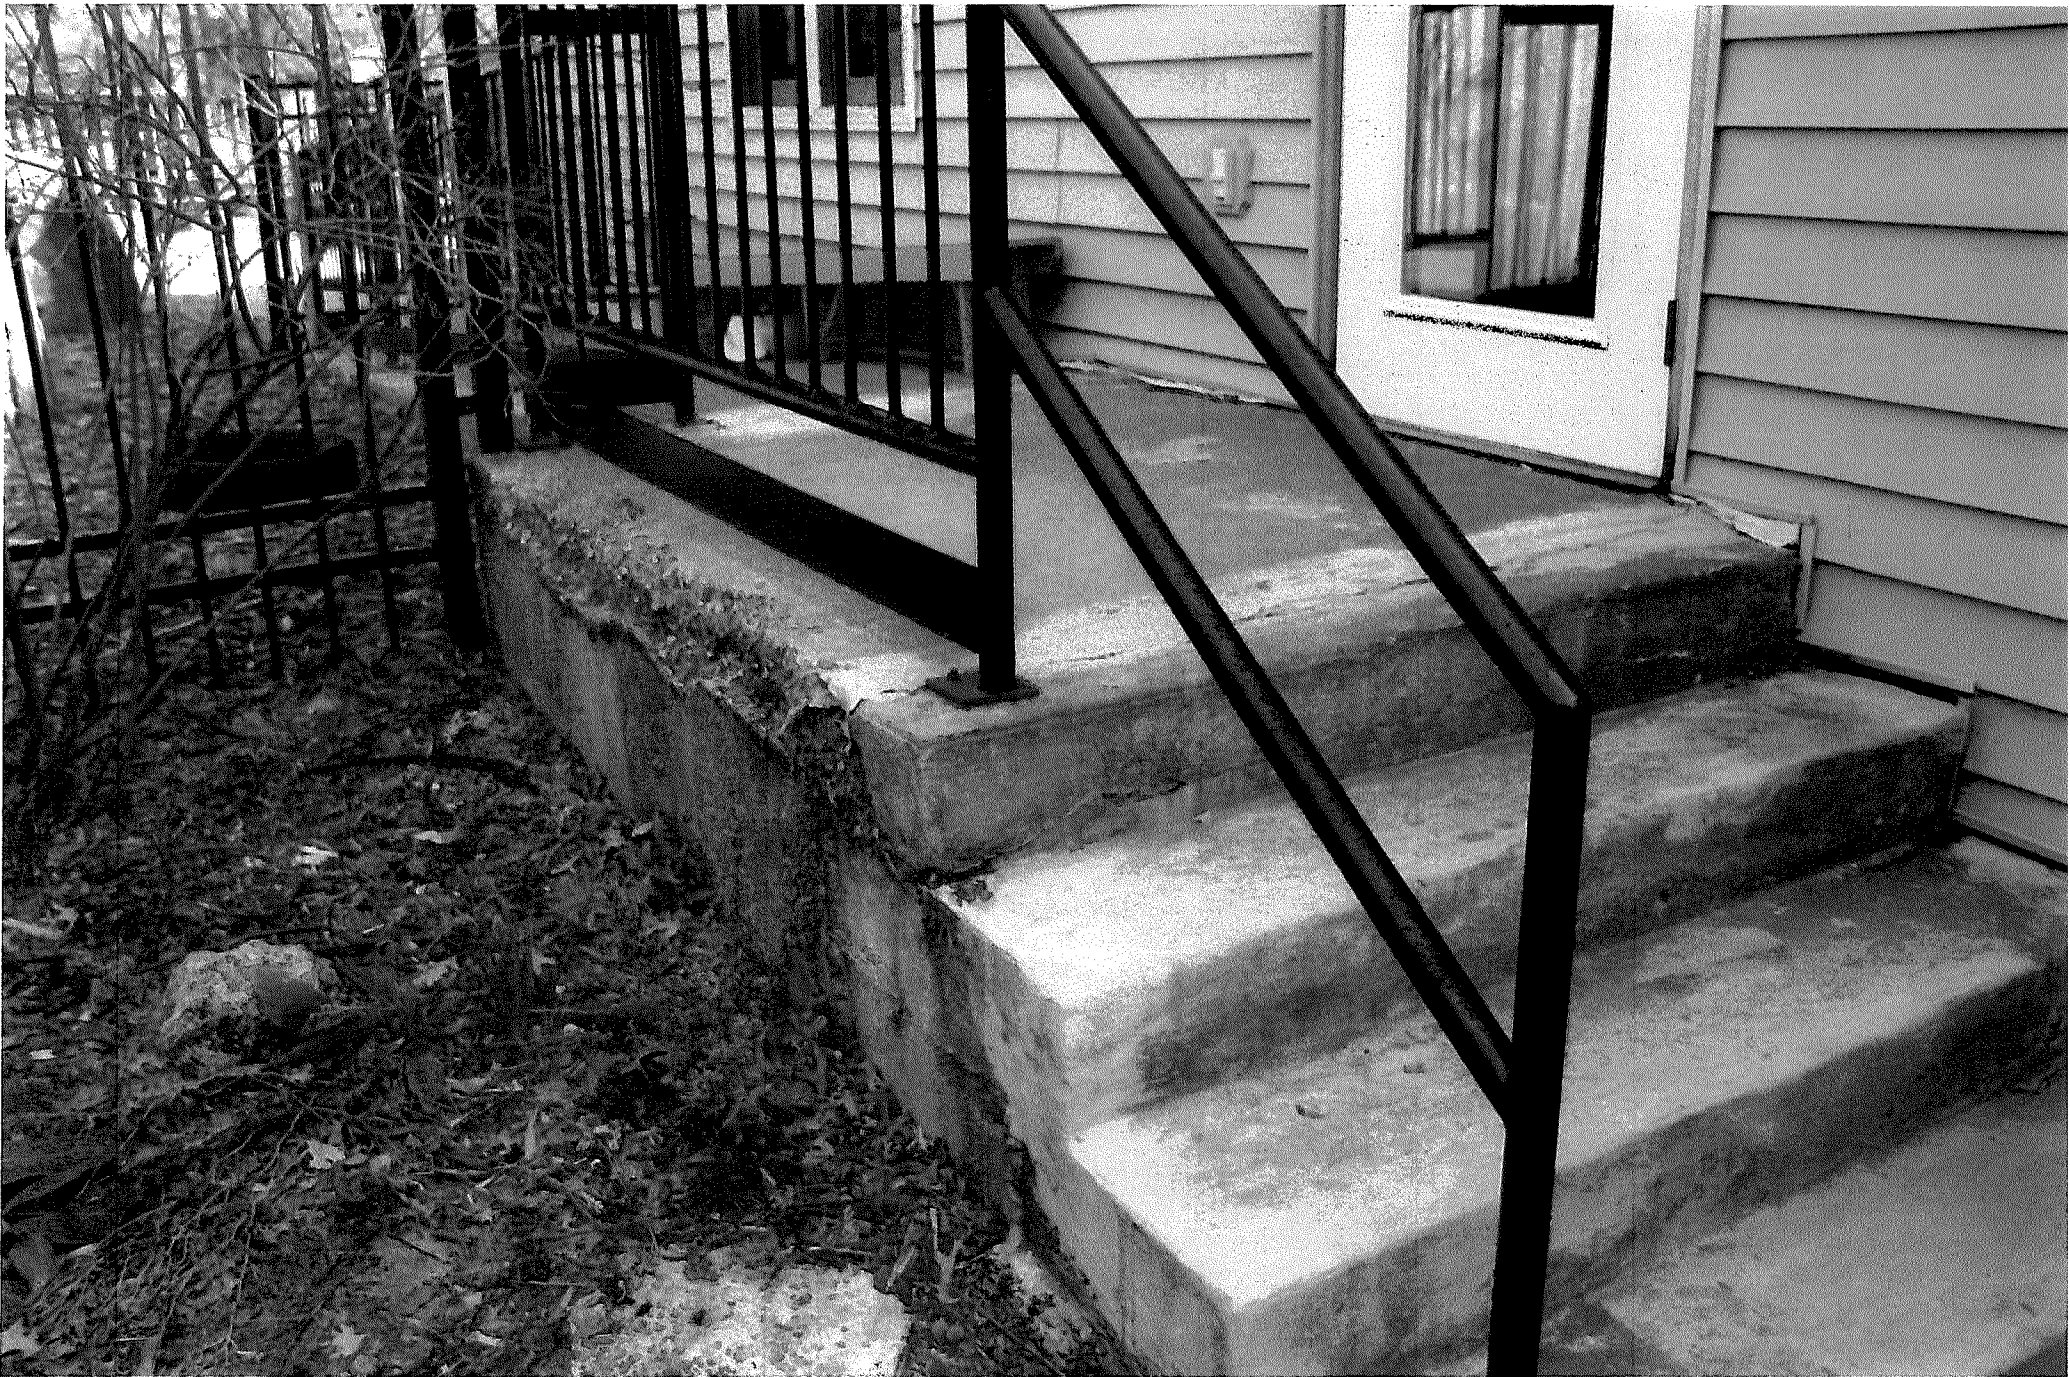
(51)

The addition has a poured concrete steps, landing and ramp system that is deteriorating. The concrete is badly spalled and the long cracks may indicate rust jacking by corroding reinforcement bar. The entry has a limited future life. It may also have been poured up to the level where un protected or inadequately protected framing and sheathing exist on the west exterior wall.

- Photo 51:** Deterioration of concrete entry structure.
- Photo 52:** Corrosion of door jamb due to salt and water. Replacement will eventually be required.

- 9.4 Plan to replace the west side addition entry structure with a well flashed replacement.
  - 9.5 Replace the missing downspout and direct spout discharge as far from the foundation as possible.

patch every 5 years

\$45,000 - replace stairs

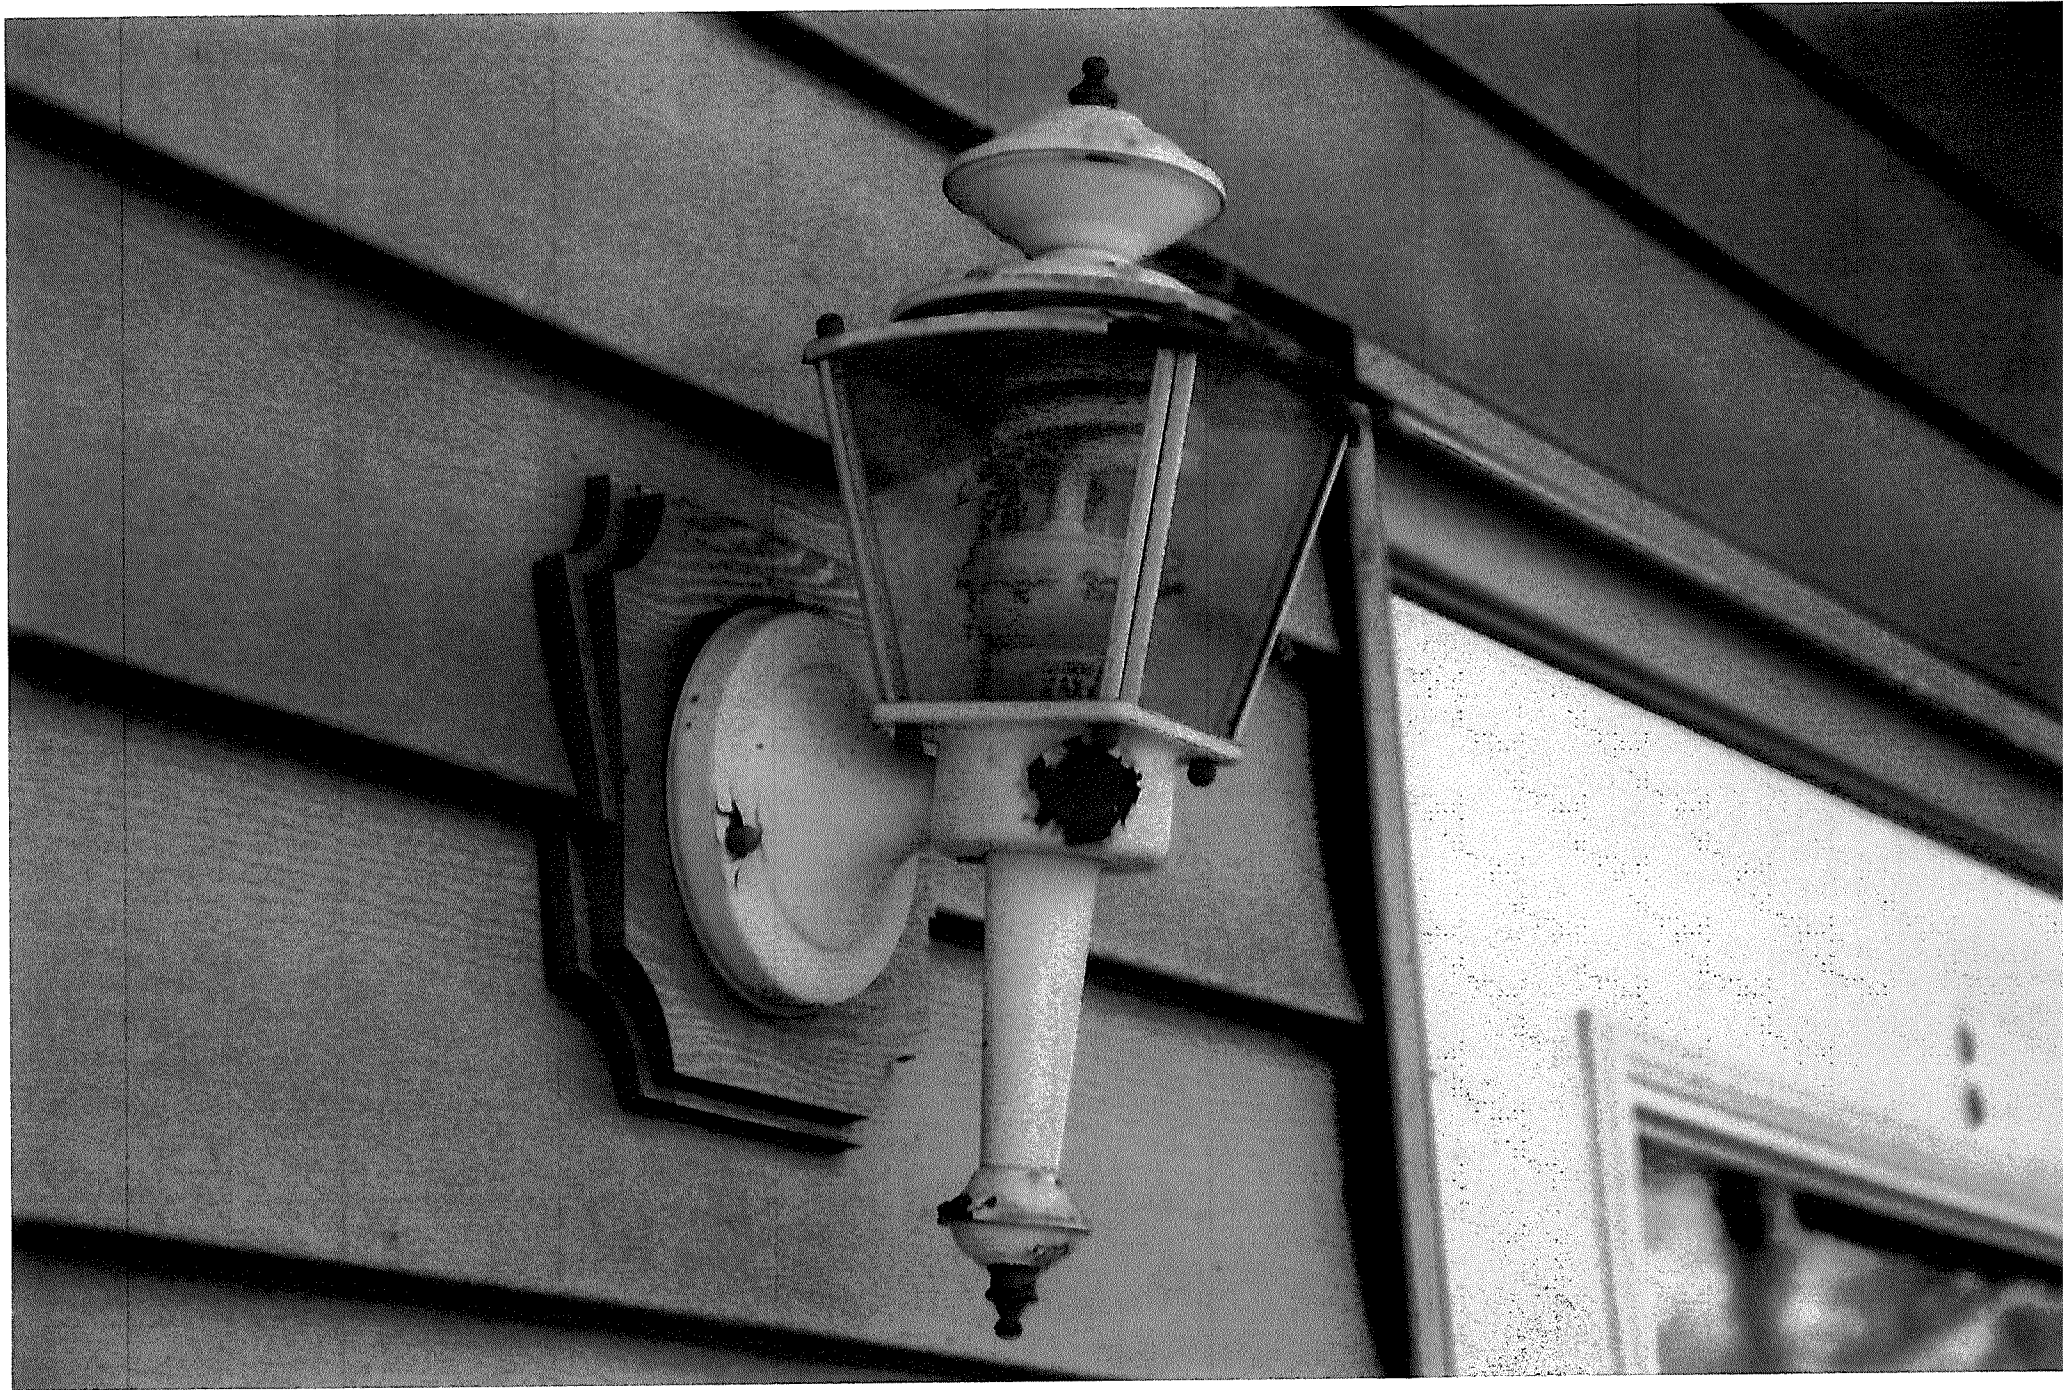
53

- Photo 53:** Corroded light fixtures should be replaced. Weather tight fixtures are recommended.
- Photo 54:** Missing drywall thermal barrier for basement insulation.

\* Change light fixture

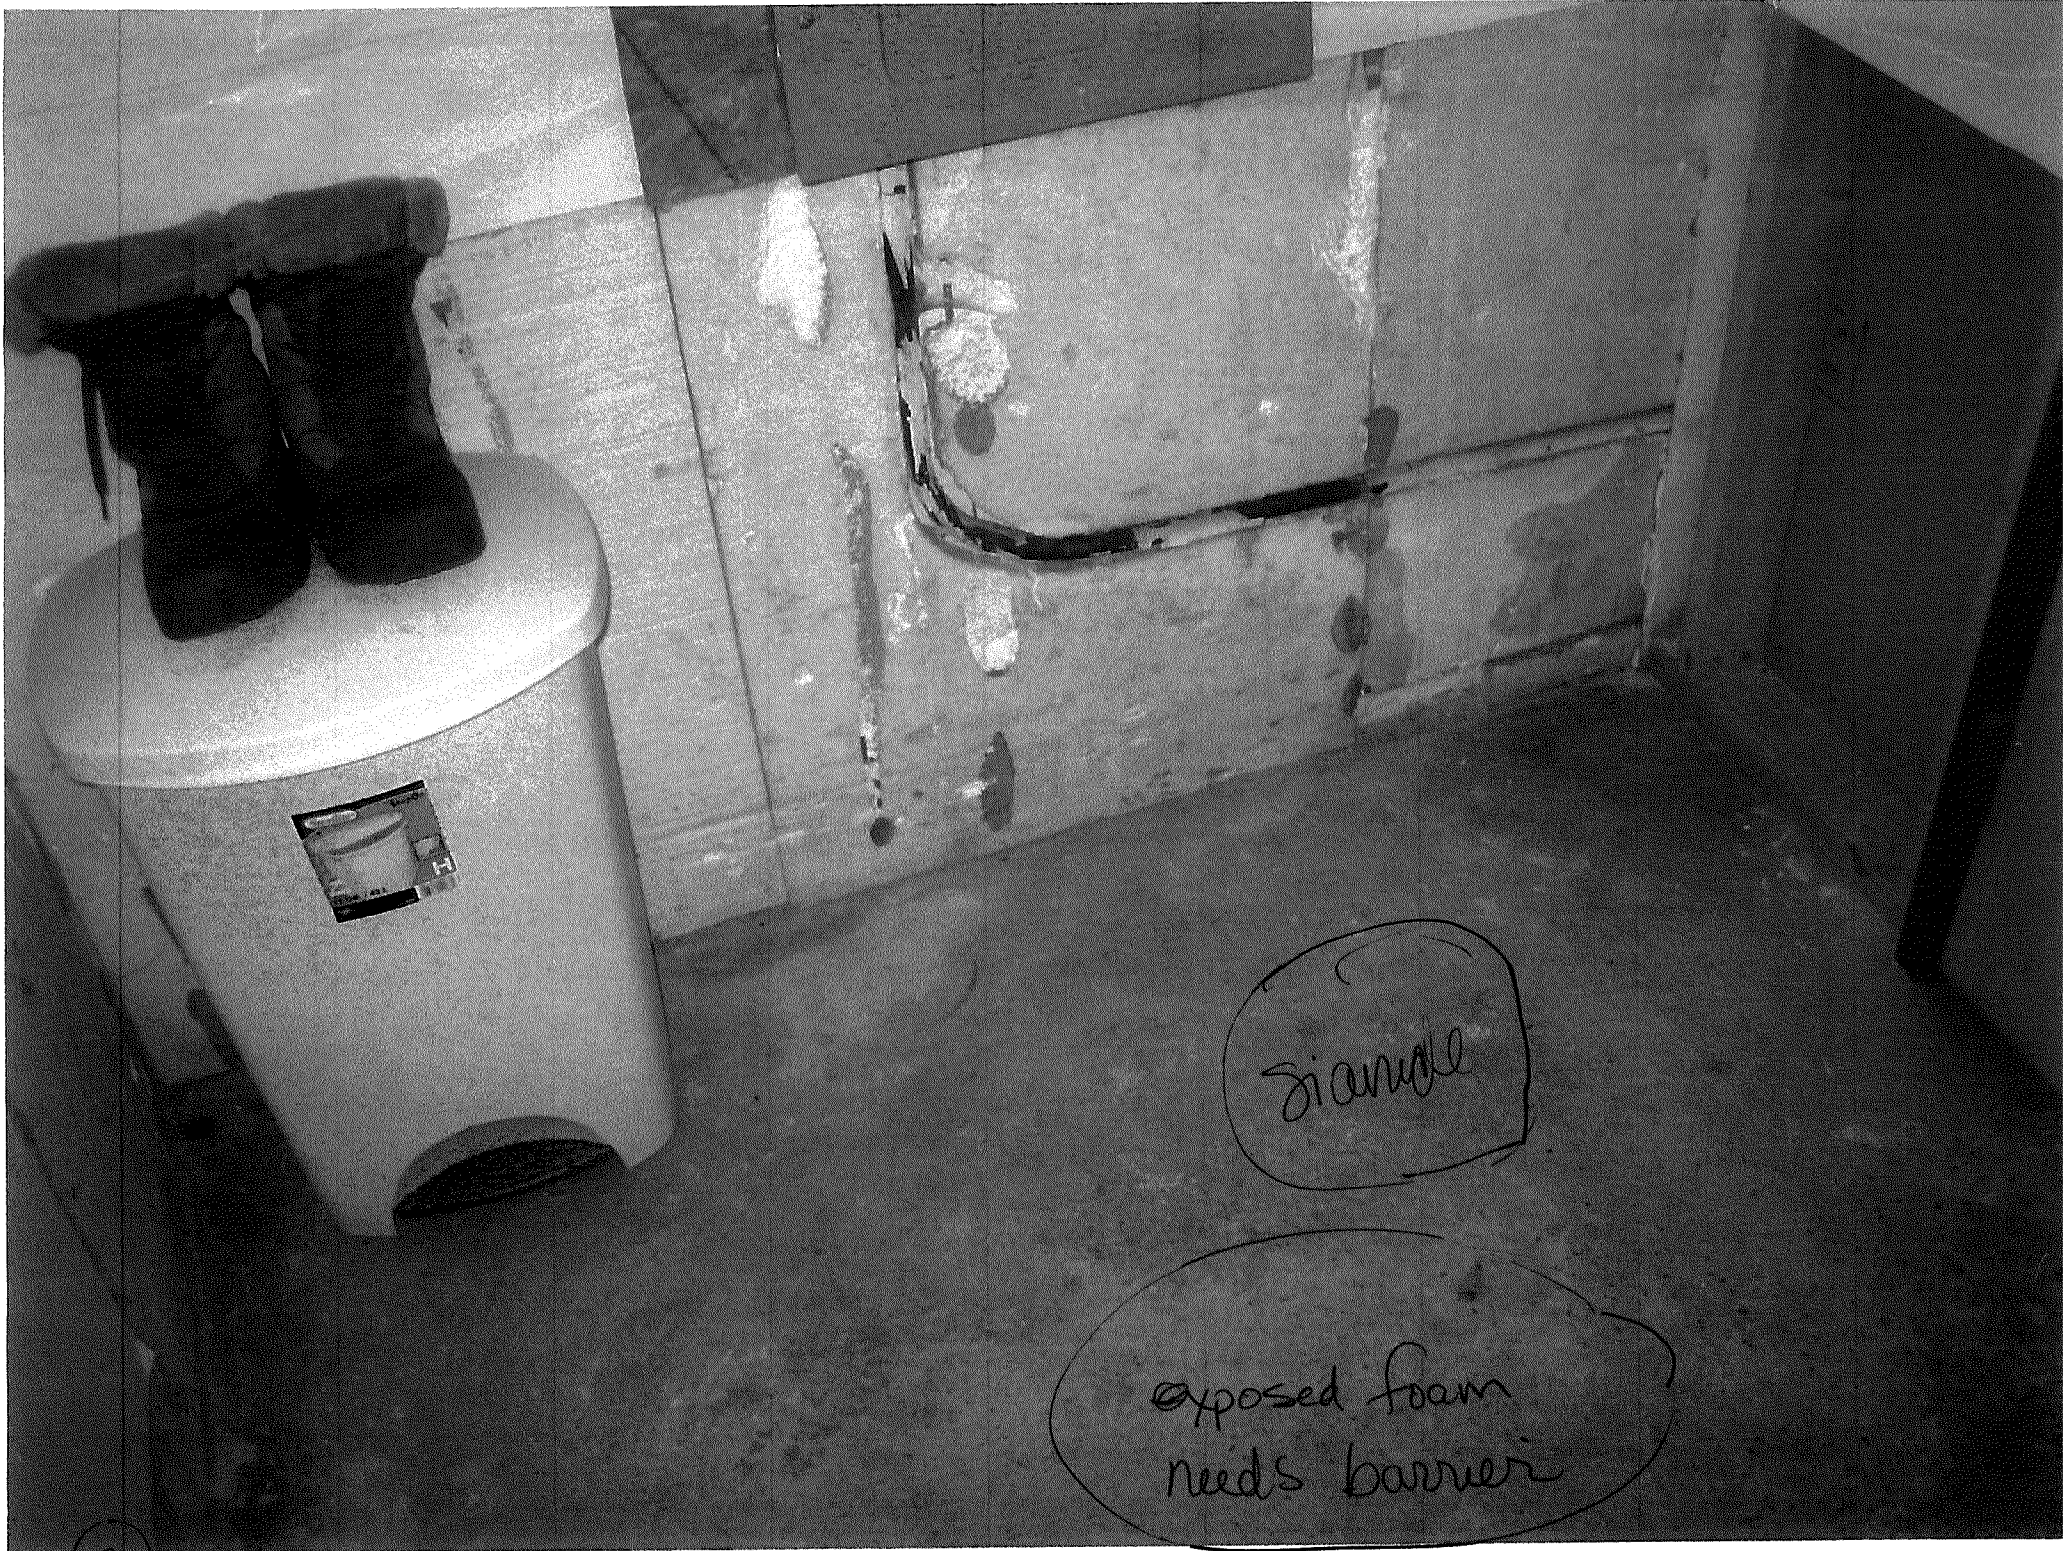
The basement had foam insulation applied which was covered with drywall to meet the flame spread code. Due to seepage, it appears some of the drywall was removed, causing a non-compliance situation.

exposed foam  
needs barrier

9. **Forward planning:**
- 9.1 Exposed foam: The basement exposed foam needs to be covered. You should also determine if the addition foundation insulation foam is a type allowed by code without a thermal barrier.
