**Breese Stevens Field
Facility Plan**

April 2017

PART II- EXISTING CONDITIONS

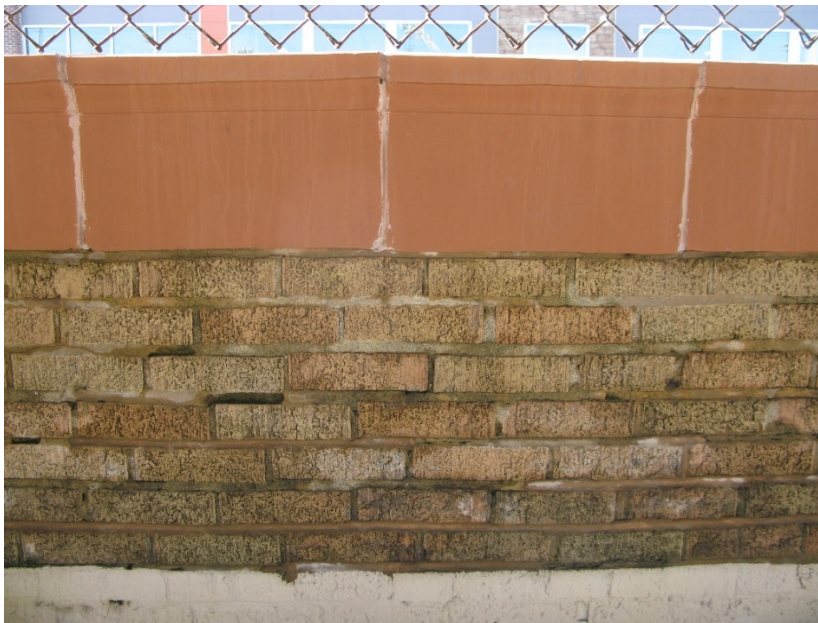
The exterior grandstand perimeter walls are made of brick and terra cotta constructed in 1925 are in fair to poor condition. Wind driven and poorly drained rainwater from the canopy has resulted in continual latent moisture within the masonry walls. Latent moisture has resulted in discoloration of the brick and mortar, crazing and spalling of terra cotta decorative elements. This condition is particularly evident along the top of the walls despite previous repair of joints at terra cotta caps with sealant. It is also evident at the pilasters where terra cotta elements protrude and take on moisture. Roof runoff infiltrates the outer wall due to its unfortunate alignment and lack of a roof gutter or downspouts. Many horizontal masonry components lack proper flashing and/or sealant joints required to adequately prevent water from entering the masonry wall.

Exterior Wall of 1925 Grandstand

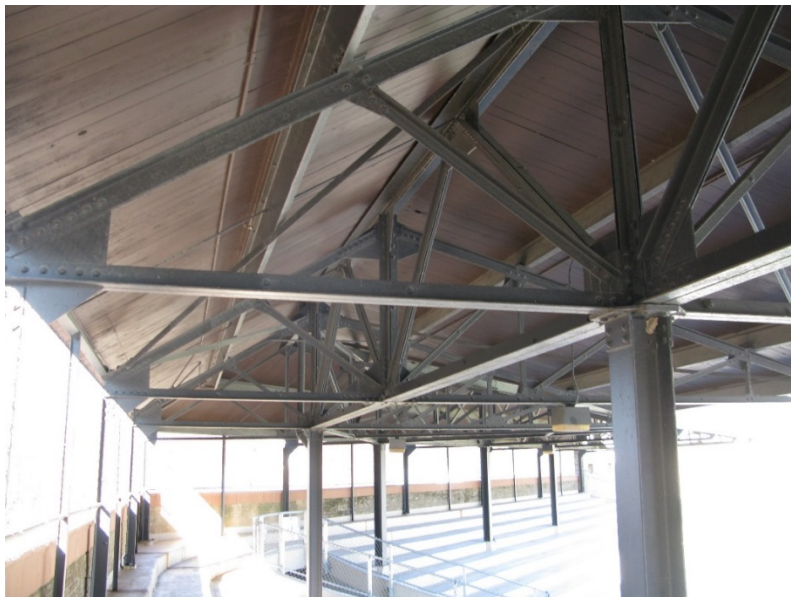
The steel truss canopy is in fair condition. The primary area of concern is prevention of further rusting of the steel members at the base connections to the seating deck. Rusting of these members has caused staining to the seating deck. The steel should be cleaned and coated to slow the oxidation and prevent future staining. The roof deck was observed to be in fair condition. A portion of the shingles at the eastern most end of the roof have been blown loose.

1925 Steel Truss Canopy

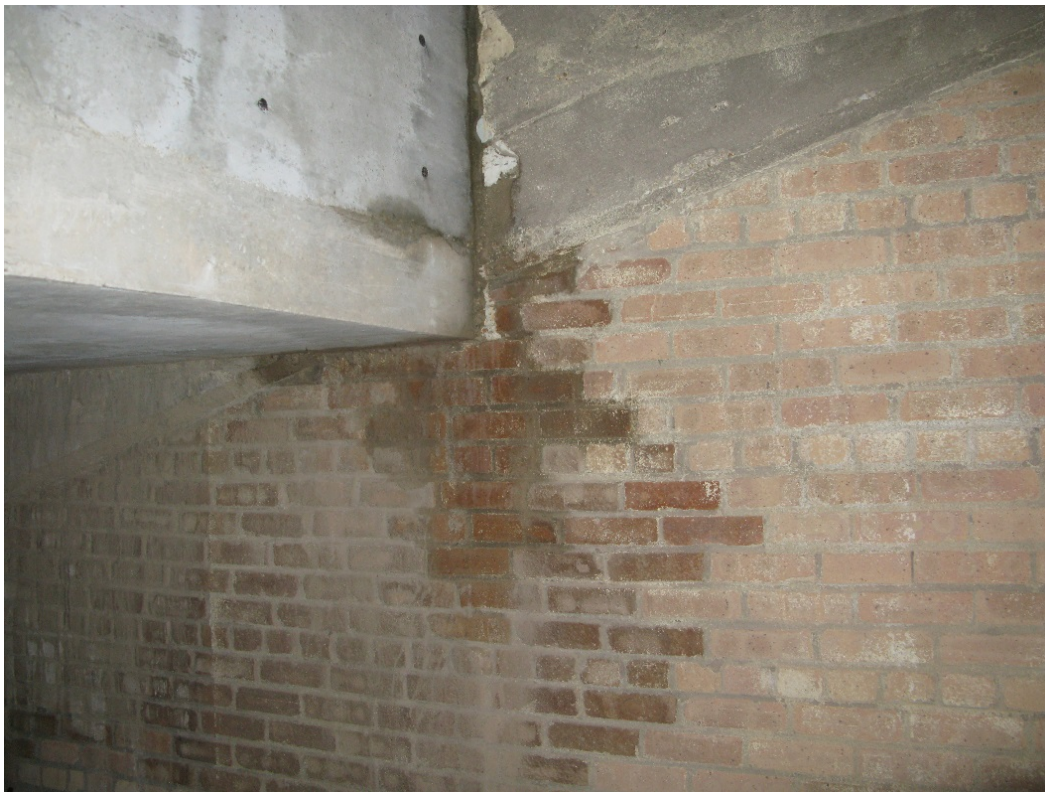
The exterior grandstand walls and all site walls constructed in 1934 were observed to be in fair condition requiring little immediate repairs. The walls facing Mifflin Street receive little to no direct sunlight due to the orientation and proximity to shaded tree cover. It appears that moisture properly drains and does not linger on or in the wall system. Significant area is in need of re-pointing as a matter of cyclical maintenance. Horizontal joints along the tops of site and parapet walls seem to be functional but could be improved through the use of sealant over mortar.

The areas of significant movement within the stone walls appear to have occurred in two locations. Both are large step cracks. One is located directly adjacent to the original light tower located near the northeast gate entrance to the field. The other is in the southwest corner near the large stone facing East Washington Avenue indicating the date of construction and its designation as a Civil Works Administration project.

The overhead doors, windows and gates in this area are not original, and are in poor condition, or have been in-filled or painted over during subsequent remodeling projects. These elements detract from the historic integrity of the structure. Large iron gates for control of entry and exit are original and in fair condition.

1934 Grandstand Walls

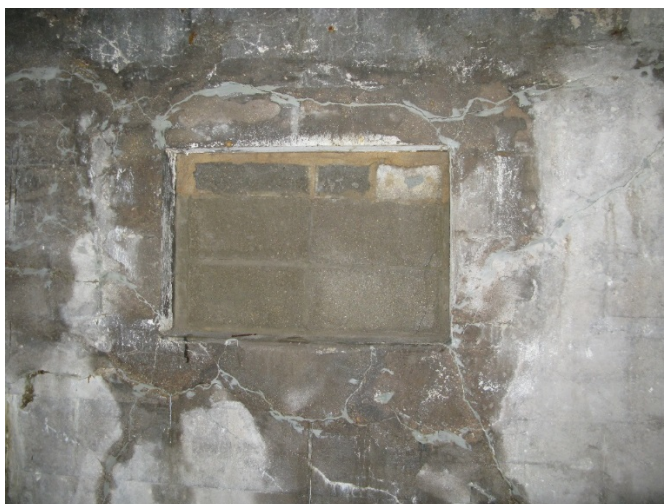
The north dugout, and the space directly inside that dugout, appear to have a couple conditions to make note of. Possibly, as a result of the 2009 report, this dugout has a drain in the bottom floor slab (west dugout does not). The slab appears to have cracked since that install and slopes steadily toward the drain. The field wall waterproof membrane applied in the 2009 repair now has stair step cracking in it, reflecting through from the block wall behind it. The interior wall, closed in window block, and floor in this area are all very damp showing signs of significant water penetration. Settlement of the raker beam for the stands has imposed load on a small wall section not intended for loading causing damage to that interior wall. The cracking and movement in this area would commonly result from a settlement of the foundation. The 2009 report recommended roofing and drainage to remove storm water from this area, so the issues seen here may have begun long ago, however, since the repairs and drain were added in 2009, the waterproof membrane has cracked, indicating that movement has occurred since 2009. Further investigation should try to determine the source of the water (leaking water or sewer lines, ground water, etc) before making any further repairs.

Field Wall at North Dugout

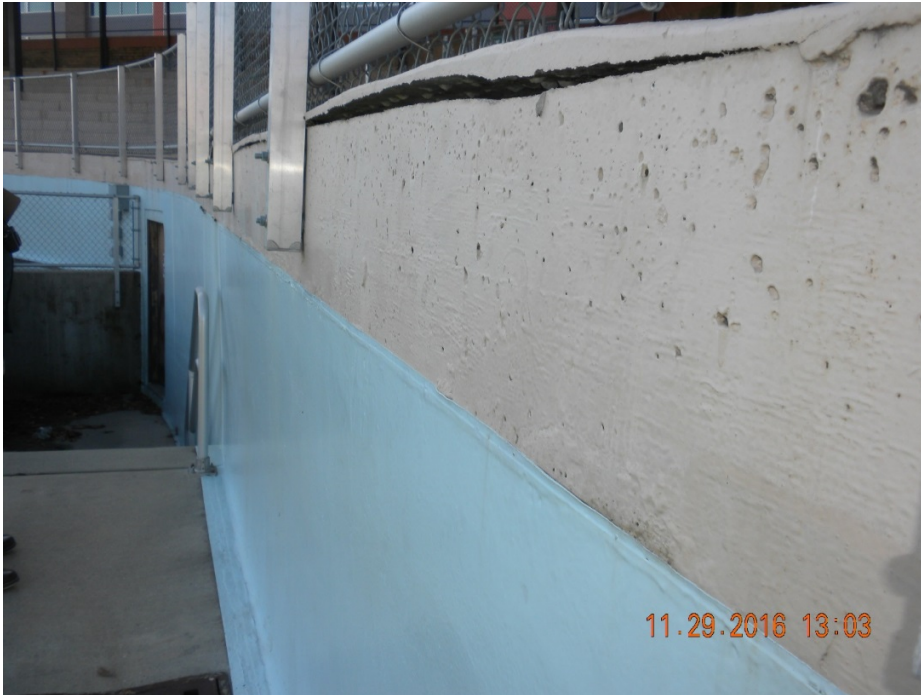
Showing Delamination of the overlay from the 1929 base concrete

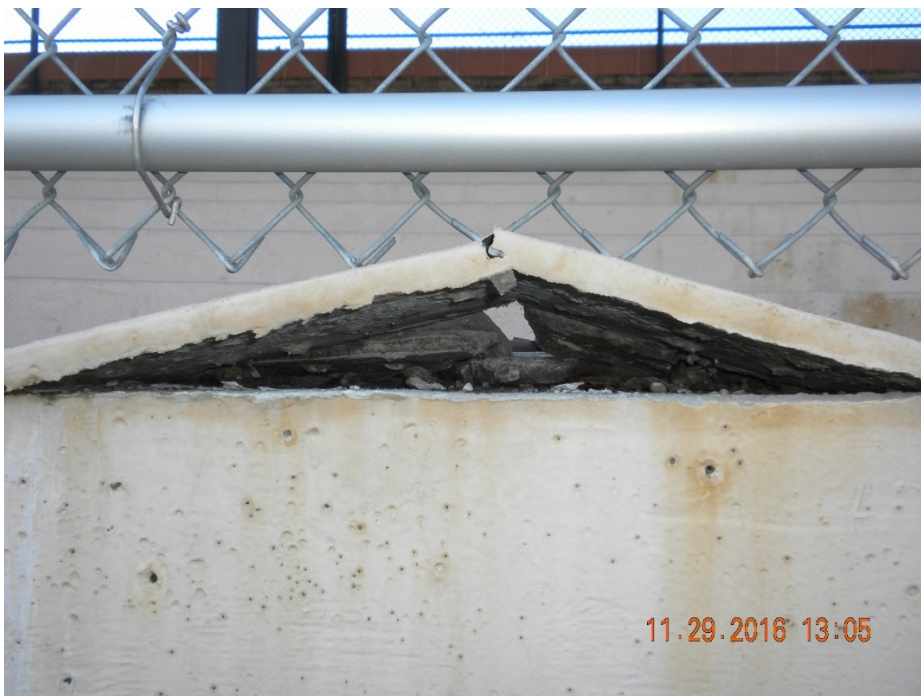
Delamination caused by moisture trapped under the walking surface membrane

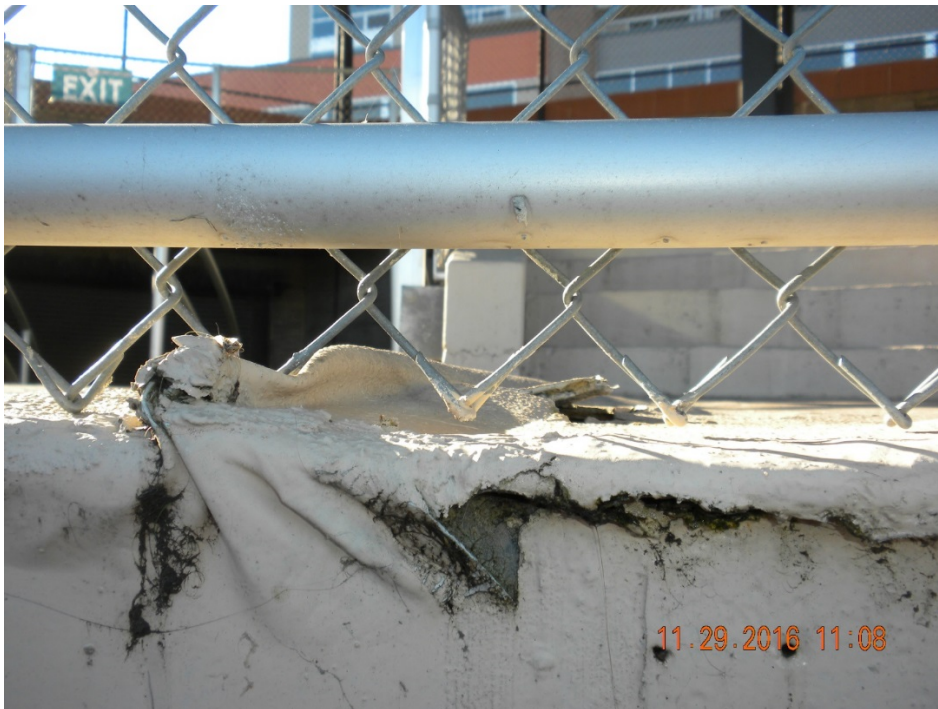
Repairs completed in 2009 included an overlay to provide positive drainage off the runners, and a membrane to prevent water penetration. Unfortunately, the materials and installation did not provide for movement of the joints and materials that this application would require. The deterioration of the membrane has also delaminated the overlay, primarily along the walkway/runner and field wall interface. We recommend that the repairs or replacement to the membrane includes corrections to the expansion joints. They should be cut wider to provide for more movement and the proper installation of an expansion joint designed for exterior uses.

Membrane damage where membrane is placed over a construction joint.

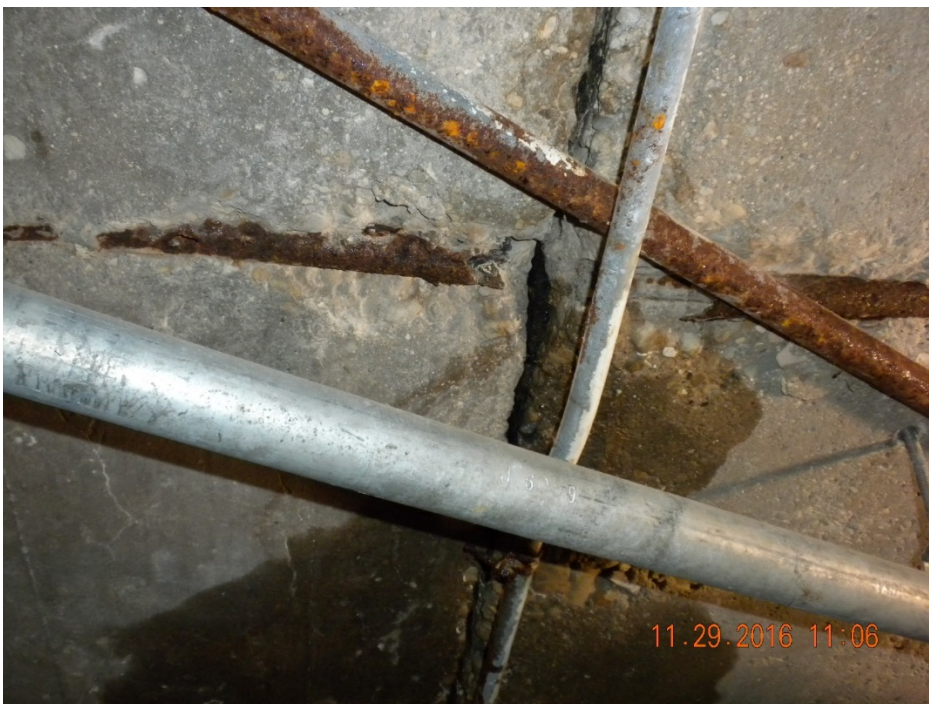
Water getting through the membrane at construction joint, causing damage to reinforcing steel and utility conduits.

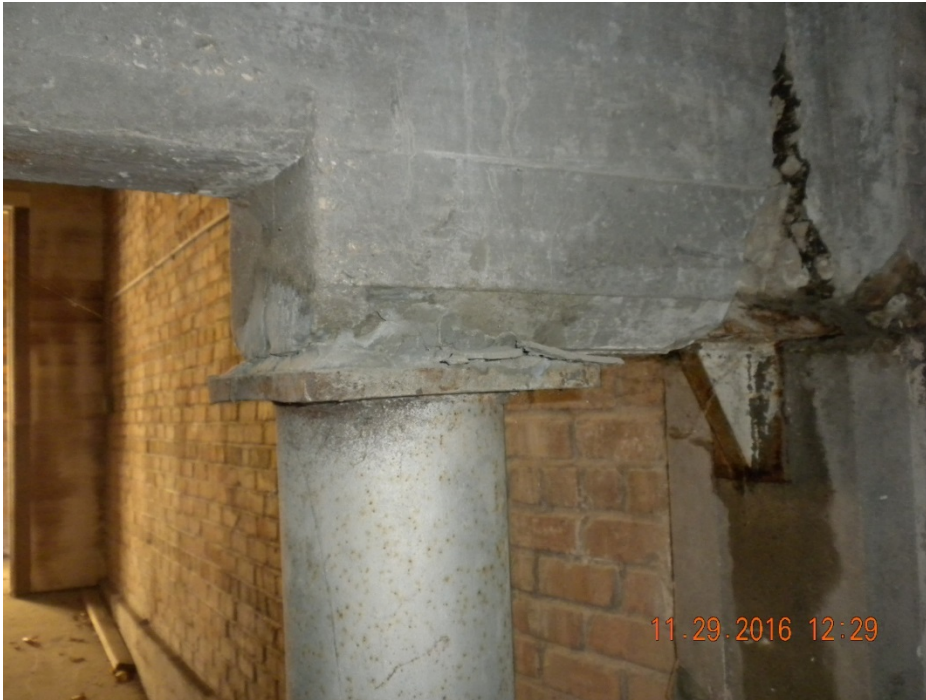
Previous damage to bearing end of concrete beam. Since supported.
Support is adequate and in good condition.

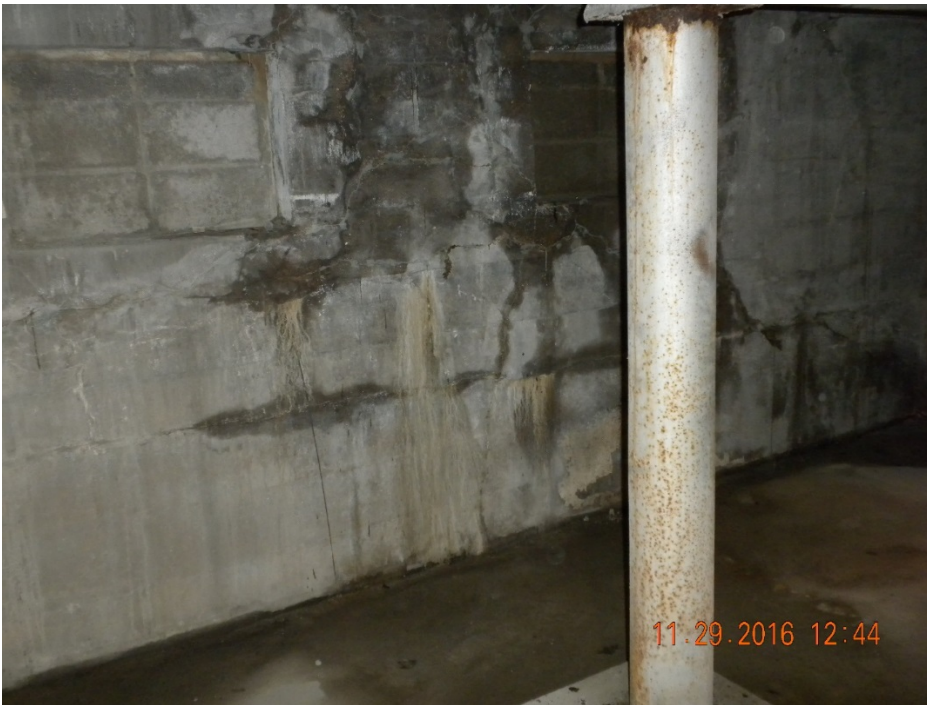
Moisture inside wall at North Dugout. Cracking in exterior wall membrane indicates
this area is moving and is required to be stabilized once settlement cause is determined.
