Roof Inspection and Condition Report for:

**Madison Department of Public Works
Motor Equipment Division
200 North First Street
Madison, WI 53704**

Re: Transportation Garage—200 N. 1st Street—Madison, WI

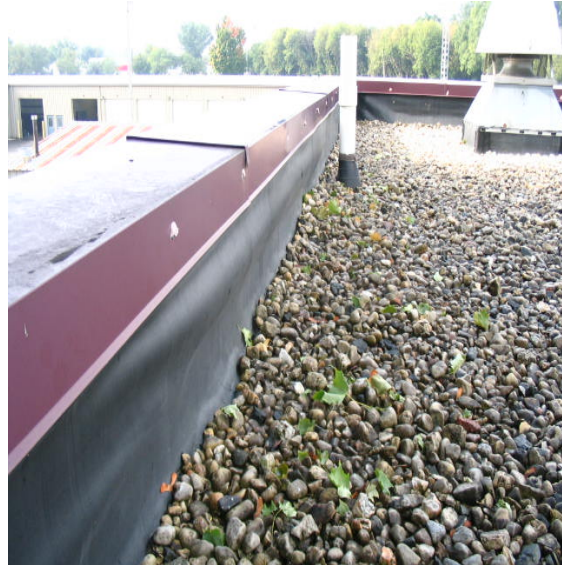
Roof Section One Deficiencies

Priority Level "A" - High Priority Repair

Component Count..... 326 lineal feet
Photo Reference..... 23
Category..... Flashings
Deficiency..... The wall flashings have become detached from the roof system.

Cause..... Age
Cost to repair..... \$5,868.00

Cut membrane at the base of wall. Remove old flashing material. Install new base termination. Add a piece of EPDM membrane that extends a minimum of 6" beyond the area of repair.

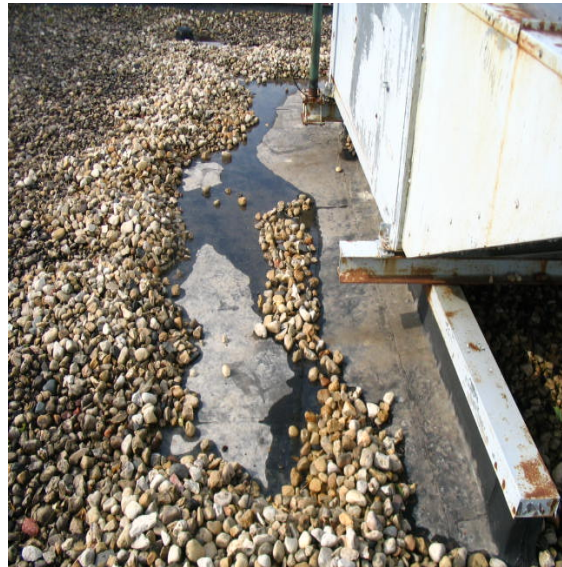
Roof Section One Deficiencies

Priority Level “B” - Medium Priority Repair

Component Count..... Some
Photo Reference..... 24
Category..... Surfacing
Deficiency..... The ballast stone has been removed from the roof membrane.

Cause..... Workmanship
Cost to repair..... \$150.00

Repair Recommendation
Redistribute ballast stone as required.

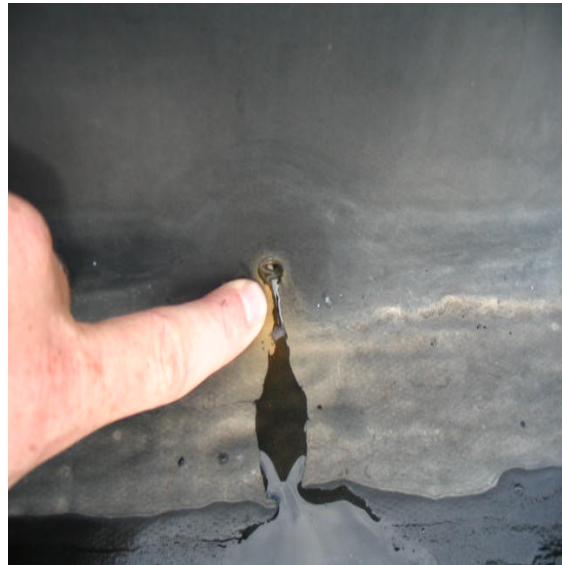
Roof Section Two Deficiencies

Priority Level “A” - High Priority Repair

Component Count..... Several
Photo Reference..... 28
Category..... Flashings
Deficiency..... There are holes in the wall flashings.

Cause..... Material Failure
Cost to repair..... \$600.00

Clean and prepare area for repair. Apply adhesive as required. Install patch that extends a minimum of three inches beyond hole.

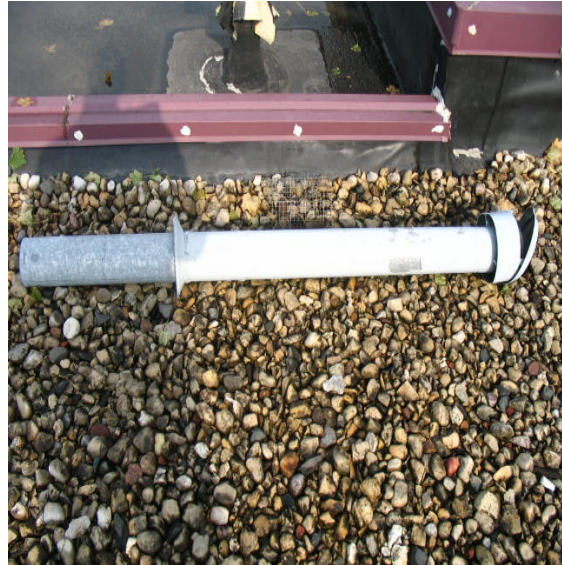
Roof Section Two Deficiencies

Priority Level “B” - Medium Priority Repair

Component Count..... 1
Photo Reference..... 26
Category..... Penetrations
Deficiency..... There is an unused roof penetration.

Cause..... Other
Cost to repair..... \$400.00

Remove unused roof penetration, and roof area in as required.

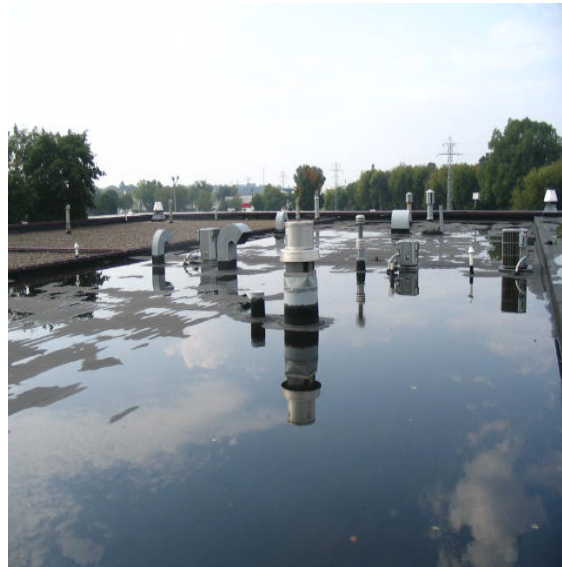
Roof Section Two Deficiencies

Priority Level “C” - Good Maintenance

Component Count..... Some
Photo Reference..... 09
Category..... Membrane
Deficiency..... There is water ponding on the roof system.

Cause..... Drainage
Cost to repair..... \$0.00

This ponding is not causing any problems at this time. We will keep an eye on this area and if the problem worsens we will take corrective measures at that time.

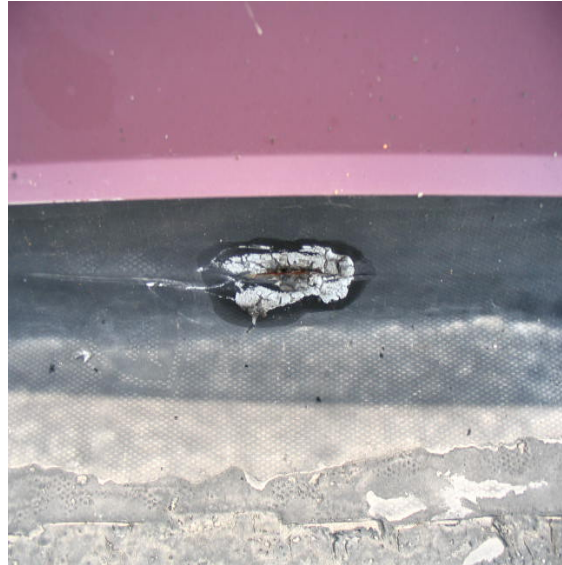
Roof Section Three Deficiencies

Priority Level “A” - High Priority Repair

Component Count..... 1
Photo Reference..... 30
Category..... Flashings

Deficiency..... There is a hole in the wall flash-
ing.

Cause..... Age
Cost to repair..... \$250.00

Clean and prepare area for repair. Apply adhesive as re-
quired. Install patch that extends a minimum of three
inches beyond hole.

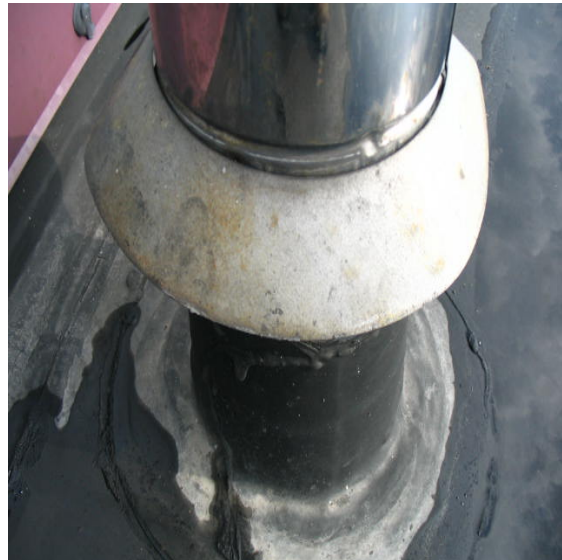
Component Count..... 2
Photo Reference..... 32
Category..... Penetrations
Deficiency..... The seal at the top of the storm
collar is deteriorated.

Cause..... Normal wear and tear
Cost to repair..... \$200.00

Install new sealant as required.

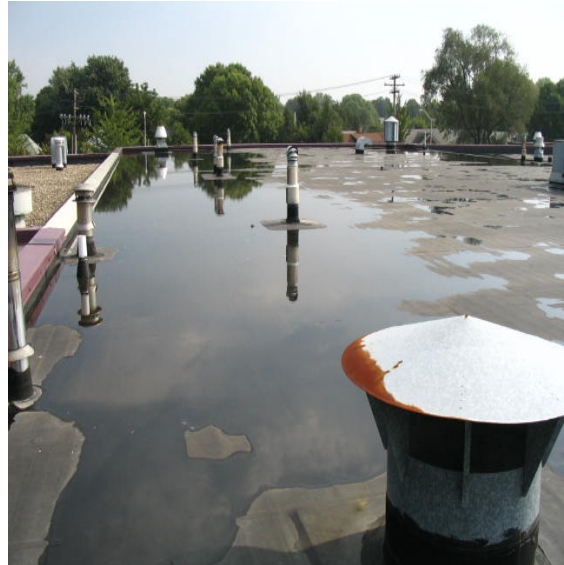
There are a few deficiencies that need to be corrected. As you will see in the photographs there is a hole in the wall flashing. There is some ponding water (water was 2" deep in some spots) along the west side of this roof area and I feel is the cause of the roof problems during the freeze thaw in the Spring. We feel that we can eliminate this by removing the metal coping and installing tapered insulation out far enough so the water makes it to the roof drains.

Roof Section Three Deficiencies

Priority Level “B” - Medium Priority Repair

Component Count..... 2,212 sq/ft
Photo Reference..... 31
Category..... Membrane
Deficiency..... There is ponding water on the roof system.

Cause..... Design
Cost to repair..... \$11,060.00

Remove metal coping. Install tapered insulation from wall out 14 feet. Install new membrane over insulation. Membrane to extend up and over parapet, and out past insulation a minimum of 6 inches.

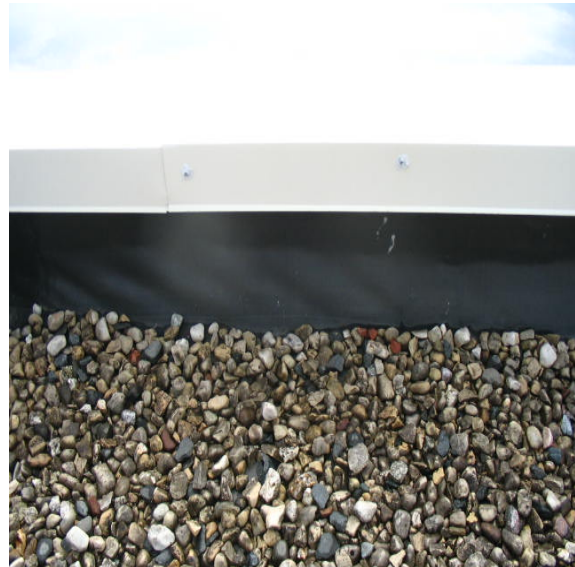
Roof Section Four Deficiencies

Priority Level “B” - Medium Priority Repair

Component Count..... 300 lineal feet
Photo Reference..... 36
Category..... Flashings
Deficiency..... The wall flashings have become detached from the roof system.

Cause..... Material Failure
Cost to repair..... \$5,400.00

Cut membrane at the base of wall. Remove old flashing material. Install new base termination. Add a piece of EPDM membrane that extends a minimum of 6” beyond the area of repair.

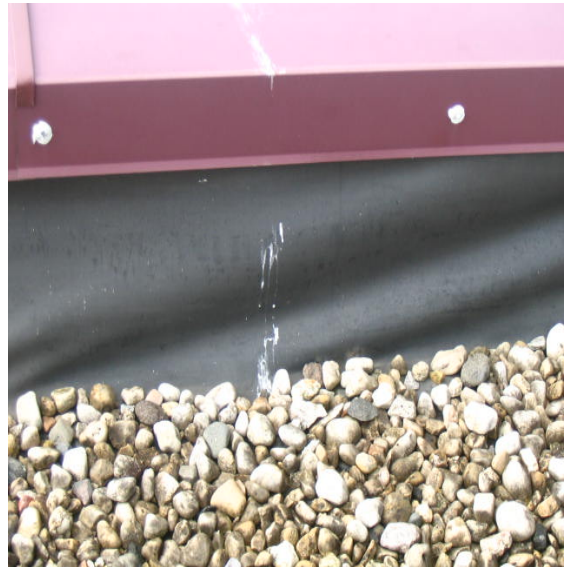
Roof Section Five Deficiencies

Priority Level “B” - Medium Priority Repair

Component Count..... 102 lineal feet
Photo Reference..... 36
Category..... Flashings
Deficiency..... The wall flashings have become detached from the roof system.

Cause..... Material Failure

Cut membrane at the base of wall. Remove old flashing material. Install new base termination. Add a piece of EPDM membrane that extends a minimum of 6” beyond the area of repair.
