## Proposed Demolition & Conditional Use

Location  
622-632 Howard Place

Project Name  
The Sophia

**SUBJECT: 622 & 632 Howard Avenue Apartments  
Structural Assessment  
MP-Squared Project No: 1310034WI**

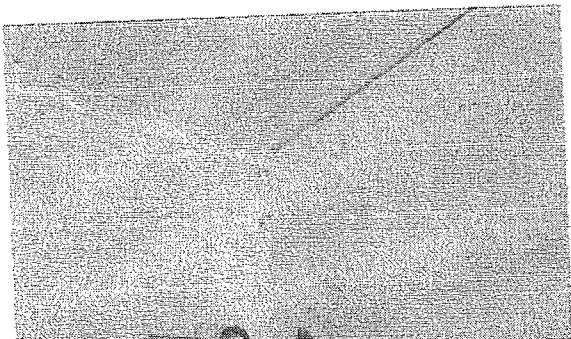
Nearly all the framing in the building is covered with wall/floor/ceiling sheathing; however, structural concerns are noticeable passively throughout the building. There are two "bump-outs" – one at the front of and one in the back of the building. Each bump-out appears to have once been an exterior, perhaps three season, porch that has been converted to livable space. There is a significant change in elevation between the main structure and the bump-out. Also, there appears to be differential movement between the bump-out and the main structure as seen by peeling paint at the intersection of the bump-out to the main building (see Photo 1); additionally, via conversations with the building

Photo 1: Peeling paint at joint between bump-out and main structure.

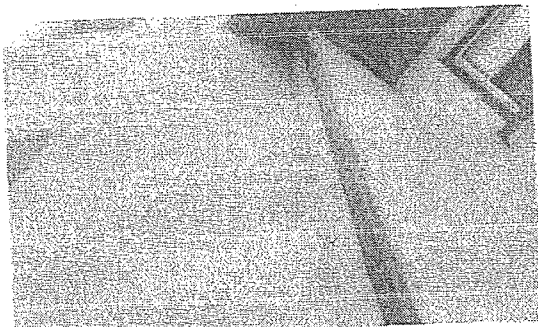
owner re caulking of exterior joint of the bump-out to the main structure, the caulking is replaced every one to two years because of visible separation (see Photo 2). The bump-out may not have a typical frost wall foundation which could be the cause of the relative movement.

Photo 2: Separation at exterior caulk joint between bump-out and main structure.

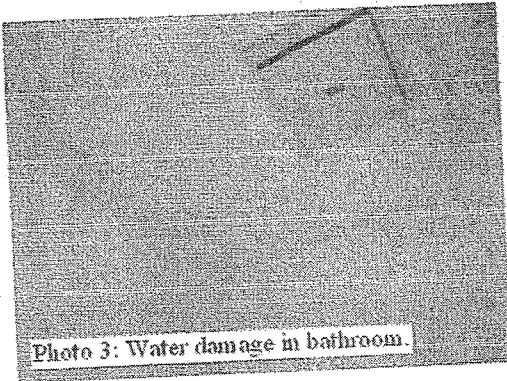
There are "soft" spots felt throughout the building. These may be due to localized water damage, undersized framing, or a combination of the two; however, without removing the sheathing and exposing the wall studs and/or floor framing it is not possible to determine how pervasive the damage is. Water damage of some degree can be assumed in nearly all bathrooms and kitchens (see Photo 3).

Photo 3: Water damage in bathroom.

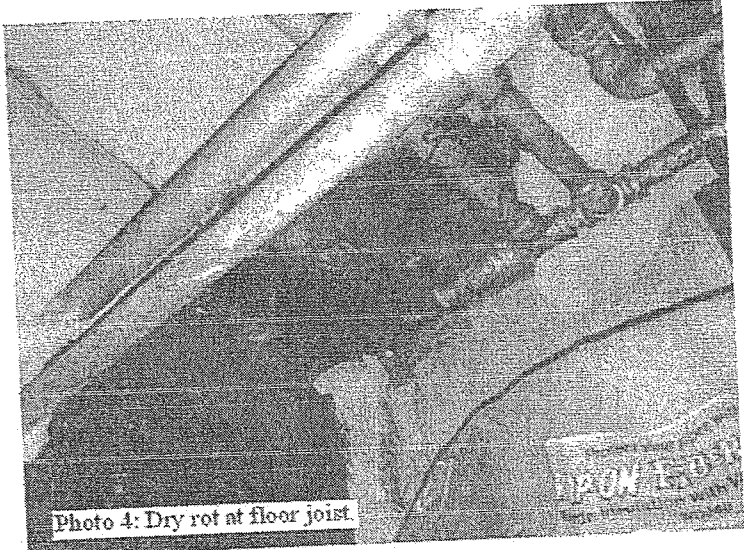
In the lower level some framing was exposed and dry rot was noted (see Photo 4). Again, without removing the sheathing and exposing the floor joists it is not possible to determine the extent of the rot.

Photo 4: Dry rot at floor joist.

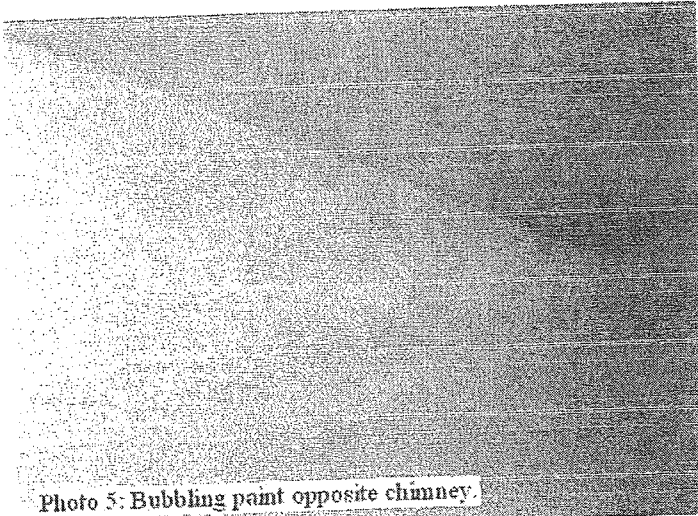
Photo 5: Bubbling paint opposite chimney.

Paint in the stairwell opposite the chimney has bubbled (see Photo 5). Per the Owner the bubbling paint has been repaired numerous times and a new liner has been installed in the chimney. It is our understanding the bubbling continued after the liner was installed. This may not indicate a structural issue; however, it is concerning and may be indicative of high heat.

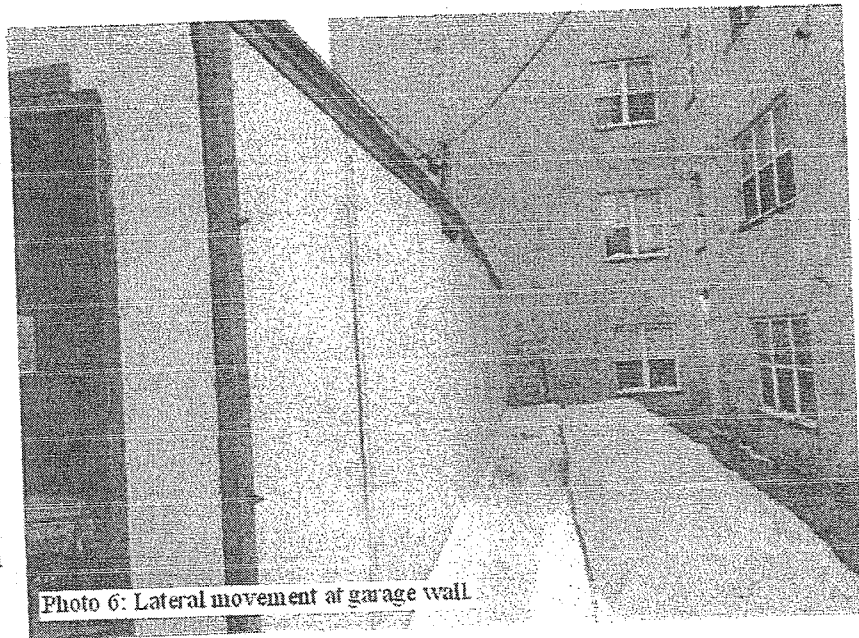
632's garage does not appear to have been originally designed per typical structural engineering standards. The trusses have not been properly fastened to the top of the wall. Steel tie rods have been installed to prevent the walls from kicking out; however, the structure appears generally unstable and possibly in danger of imminent collapse. See Photo 6.

Photo 6: Lateral movement at garage wall.

The garage at 632 Howard should be considered in danger of imminent collapse and should be repaired, shored, or demolished.

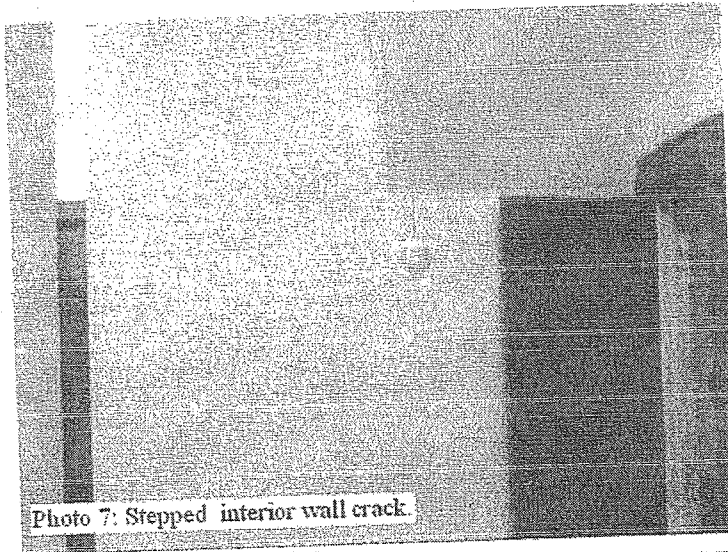
Photo 7: Stepped interior wall crack.

The most concerning structural behavior occurs approximately in-line with the ridge. The floor framing on the first and second floor significantly dips approximately 18'-0" from the front, exterior wall. On the second floor, there is a large, apparently active, stepped crack (see Photos 7 - 9). This is indicative of settlement. The exterior foundation and exterior wall framing show no signs of

distress. A possible origin may be due to the removal of an interior load bearing member, or perhaps continued settlement of an interior load bearing column/wall.

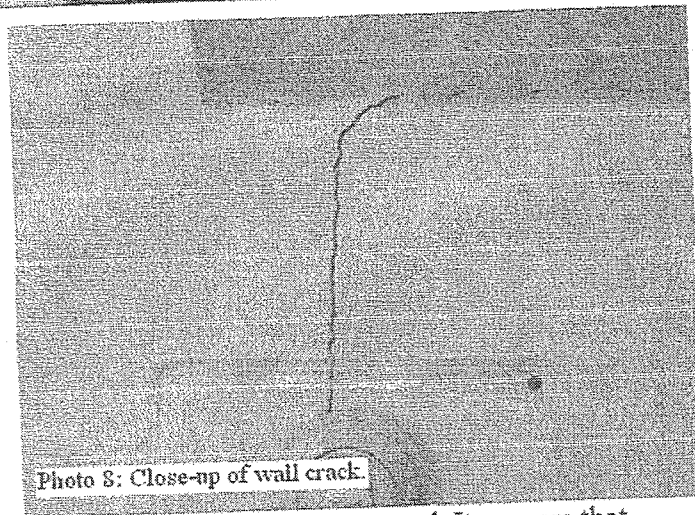
Photo 8: Close-up of wall crack.

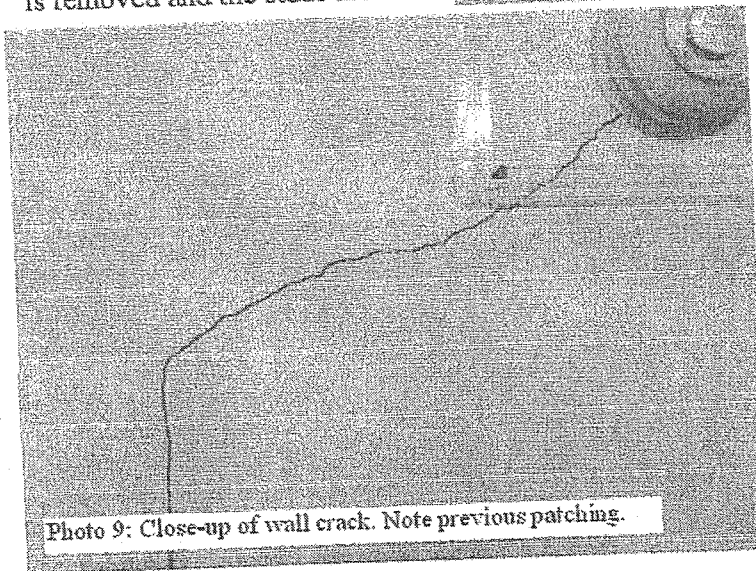
Photo 9: Close-up of wall crack. Note previous patching.

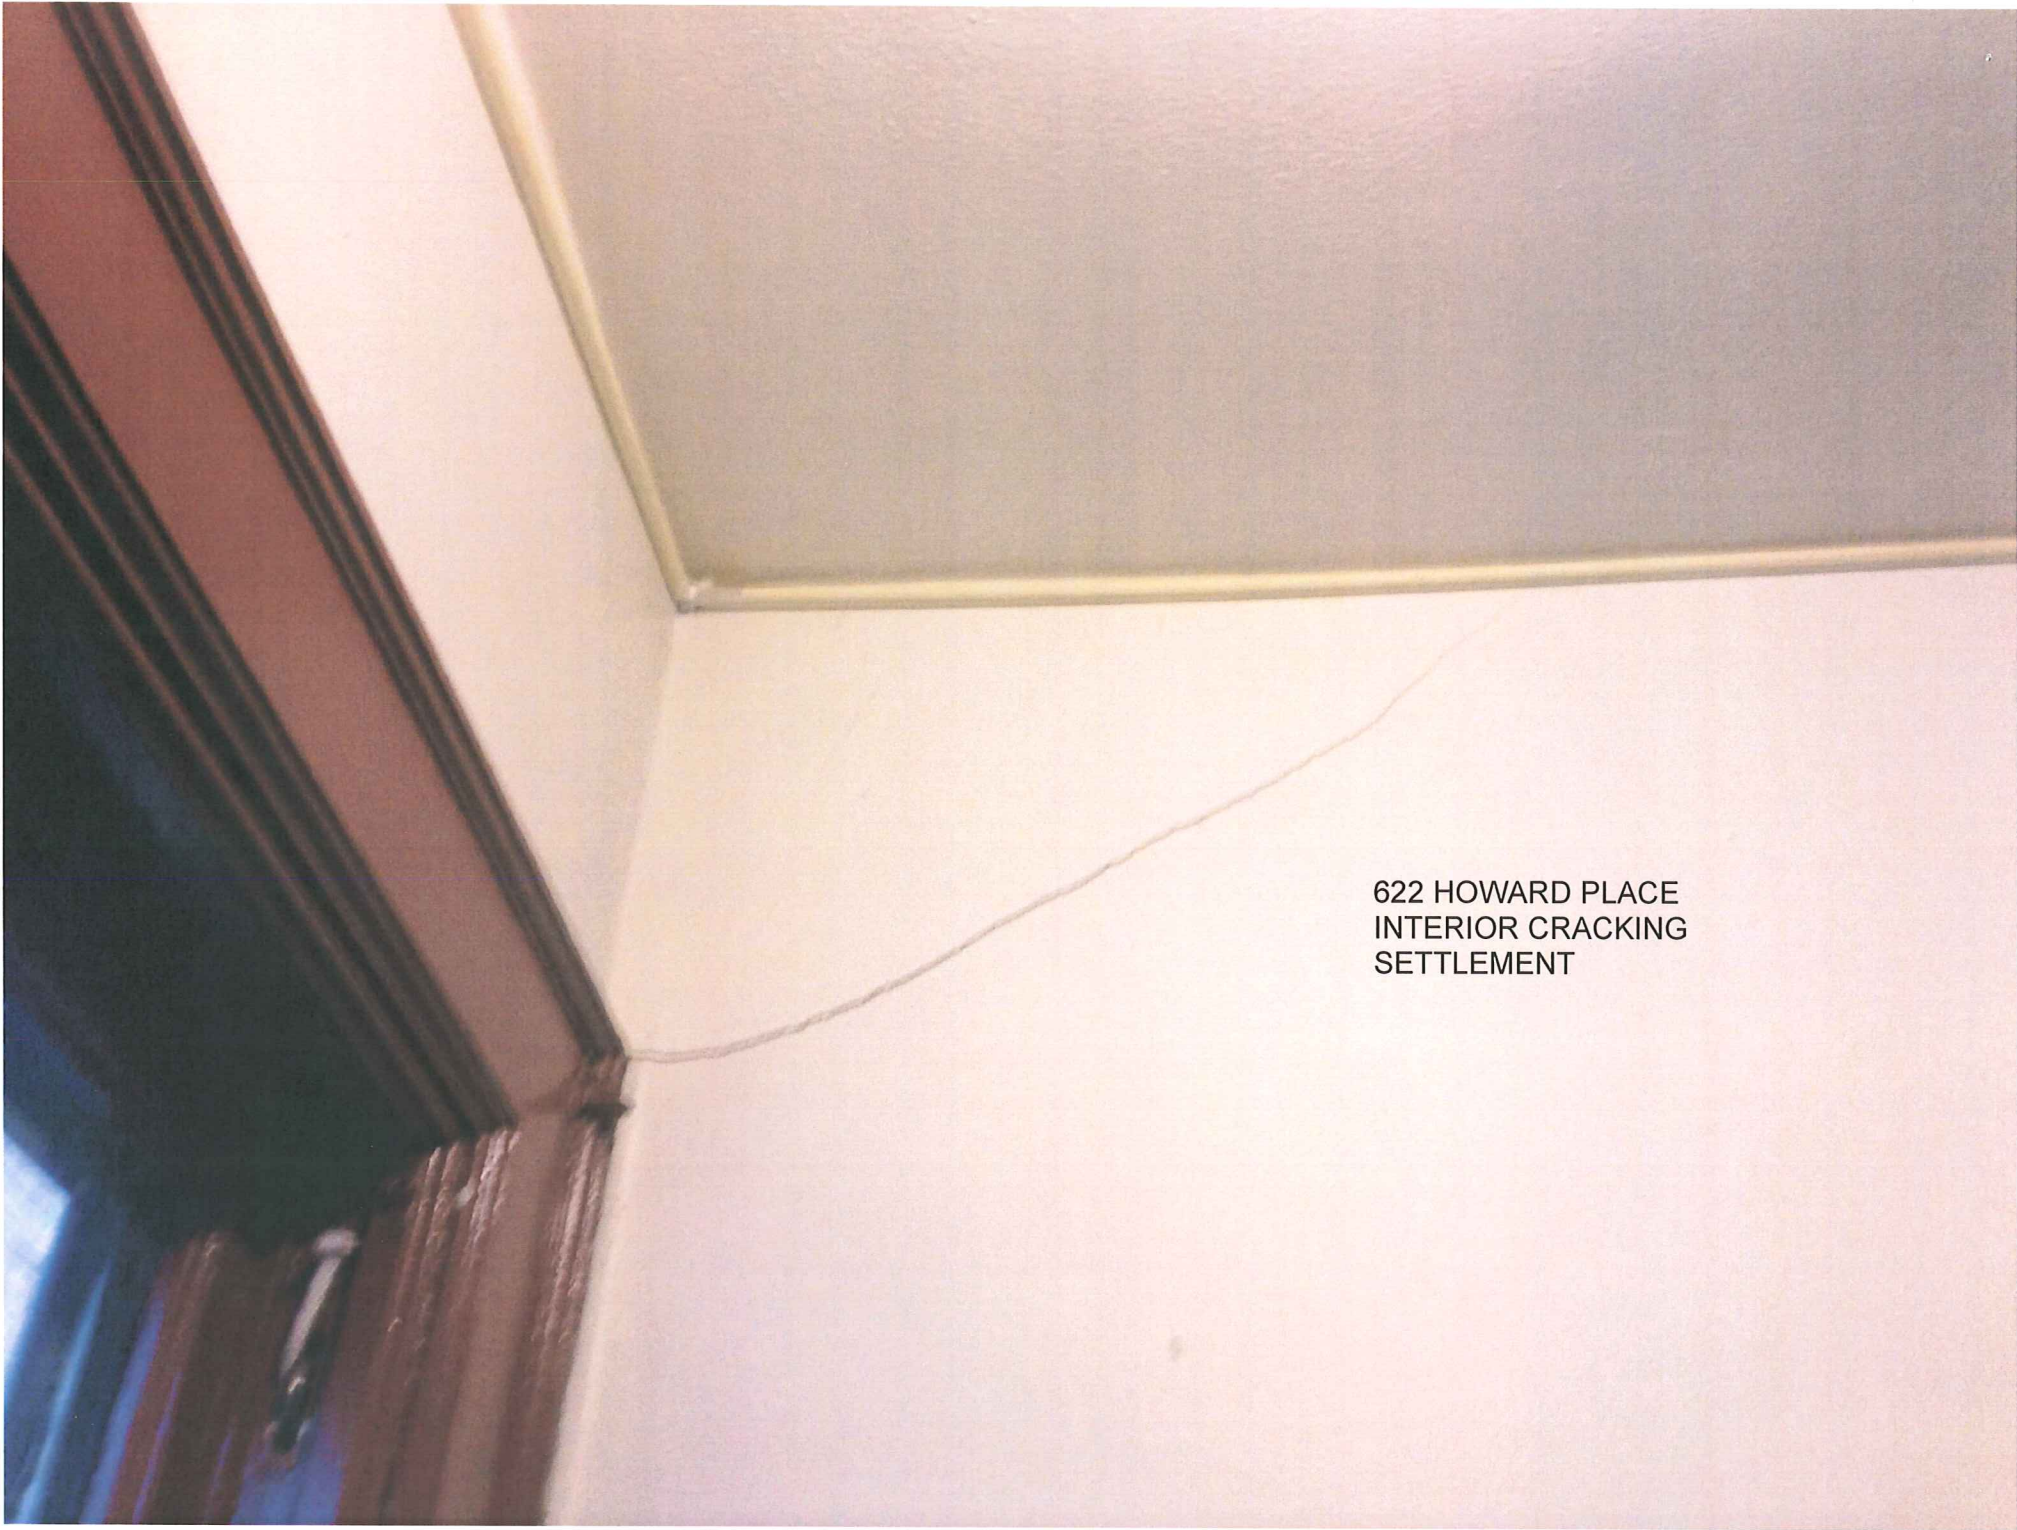
622 HOWARD PLACE  
INTERIOR CRACKING  
SETTLEMENT

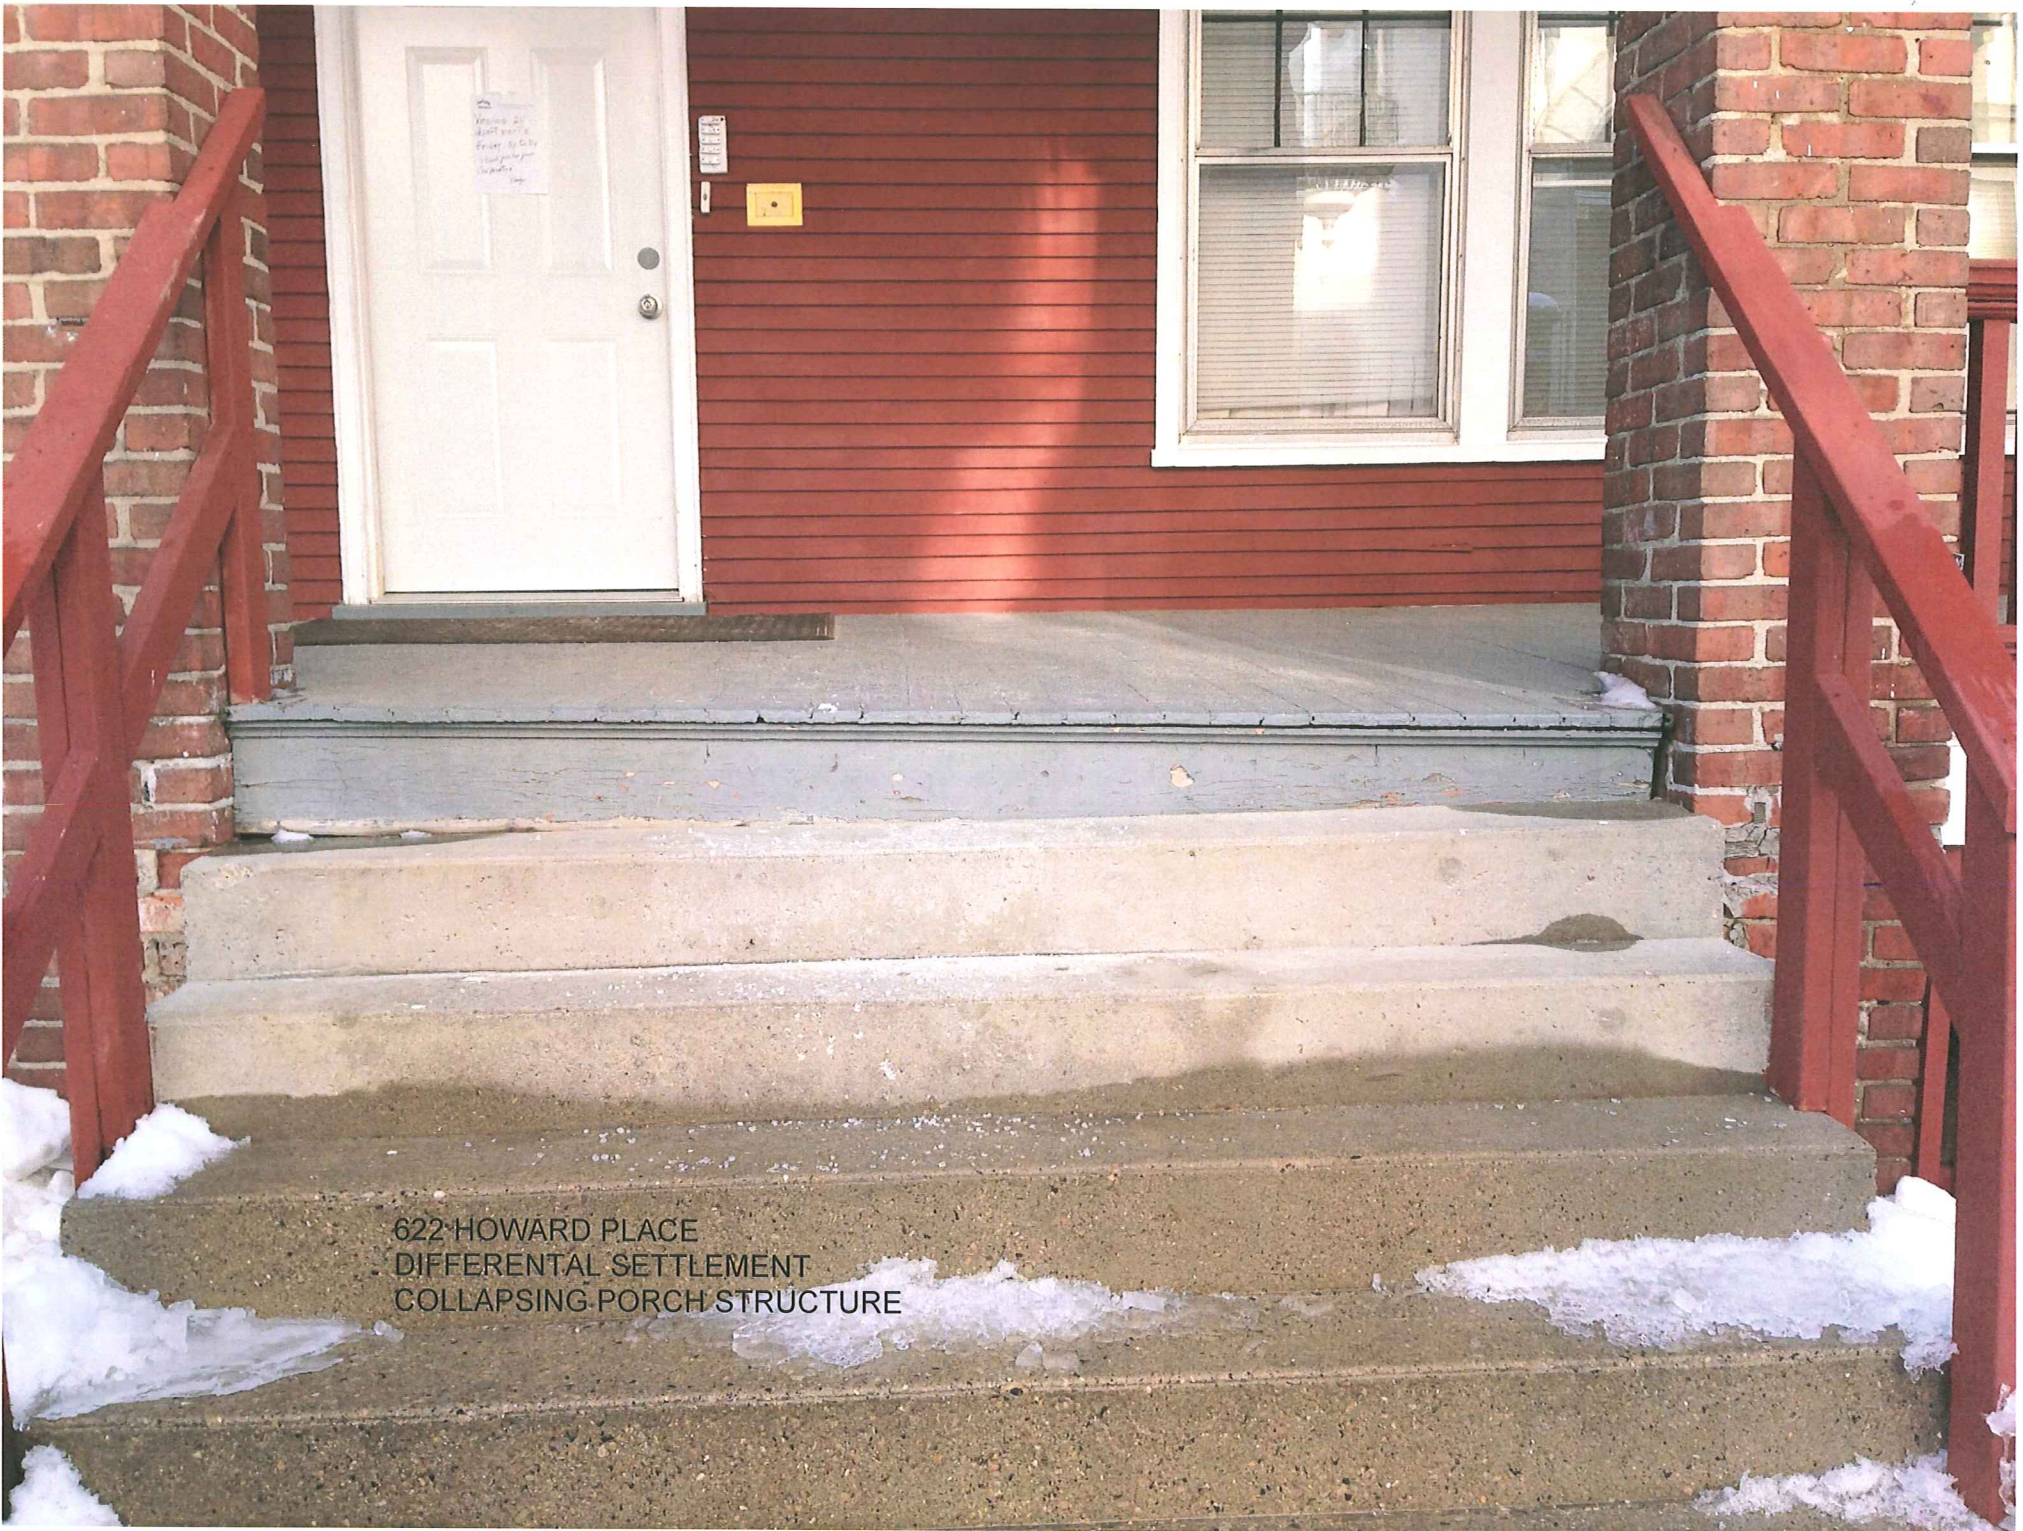
622 HOWARD PLACE  
DIFFERENTIAL SETTLEMENT  
COLLAPSING PORCH STRUCTURE

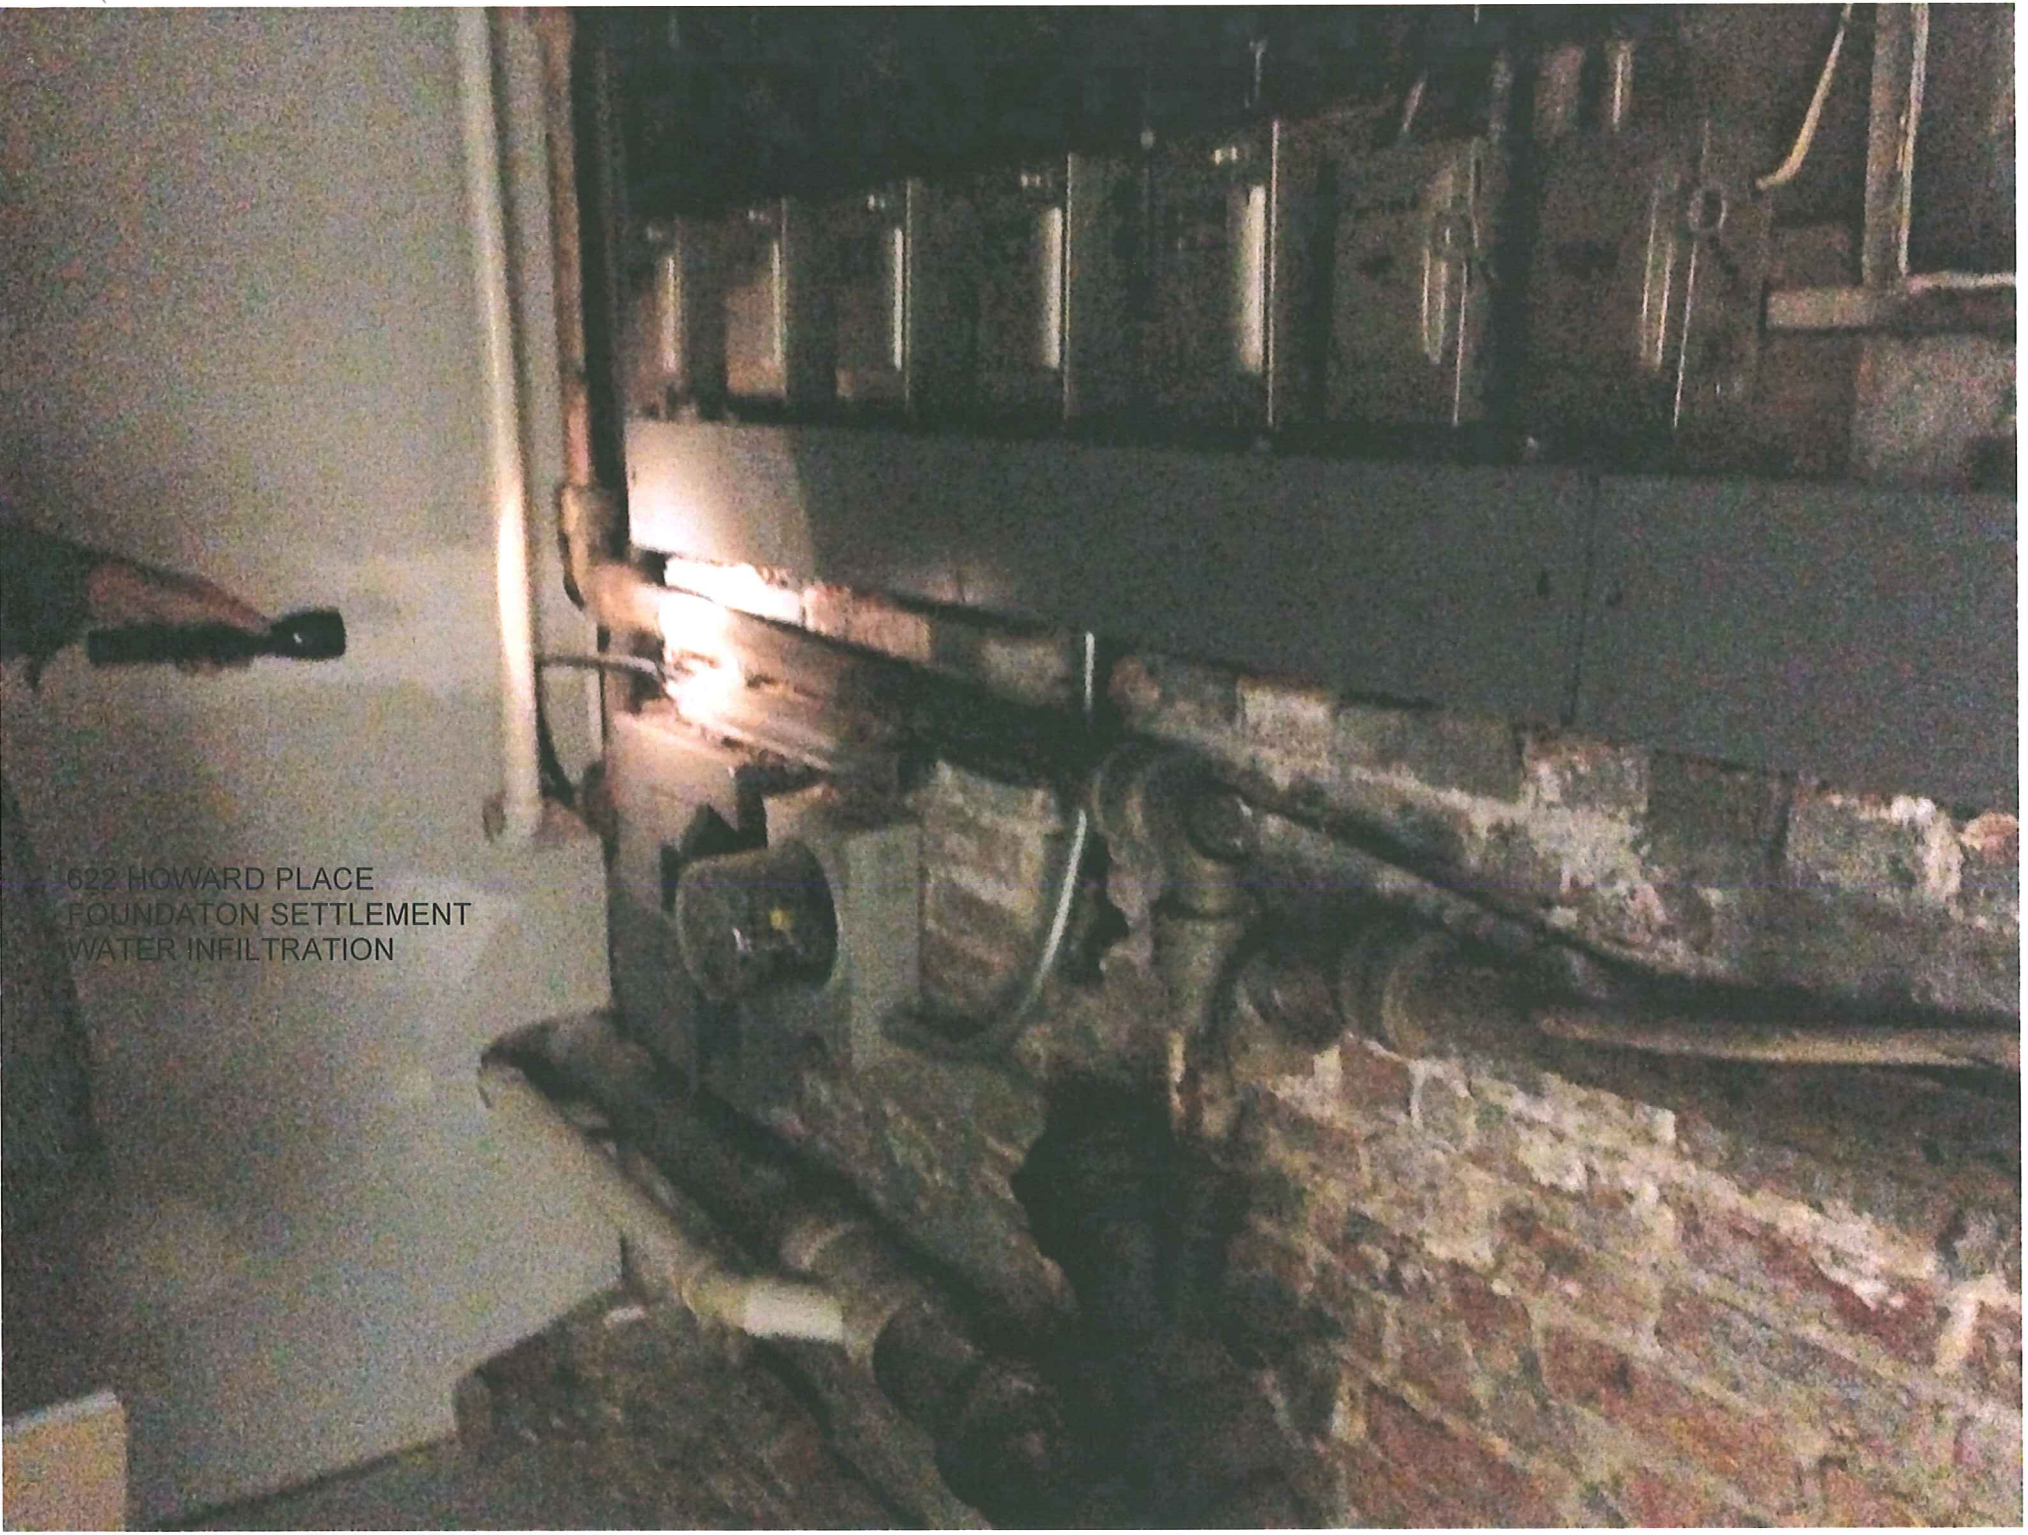
622 HOWARD PLACE  
FOUNDATON SETTLEMENT  
WATER INFILTRATION

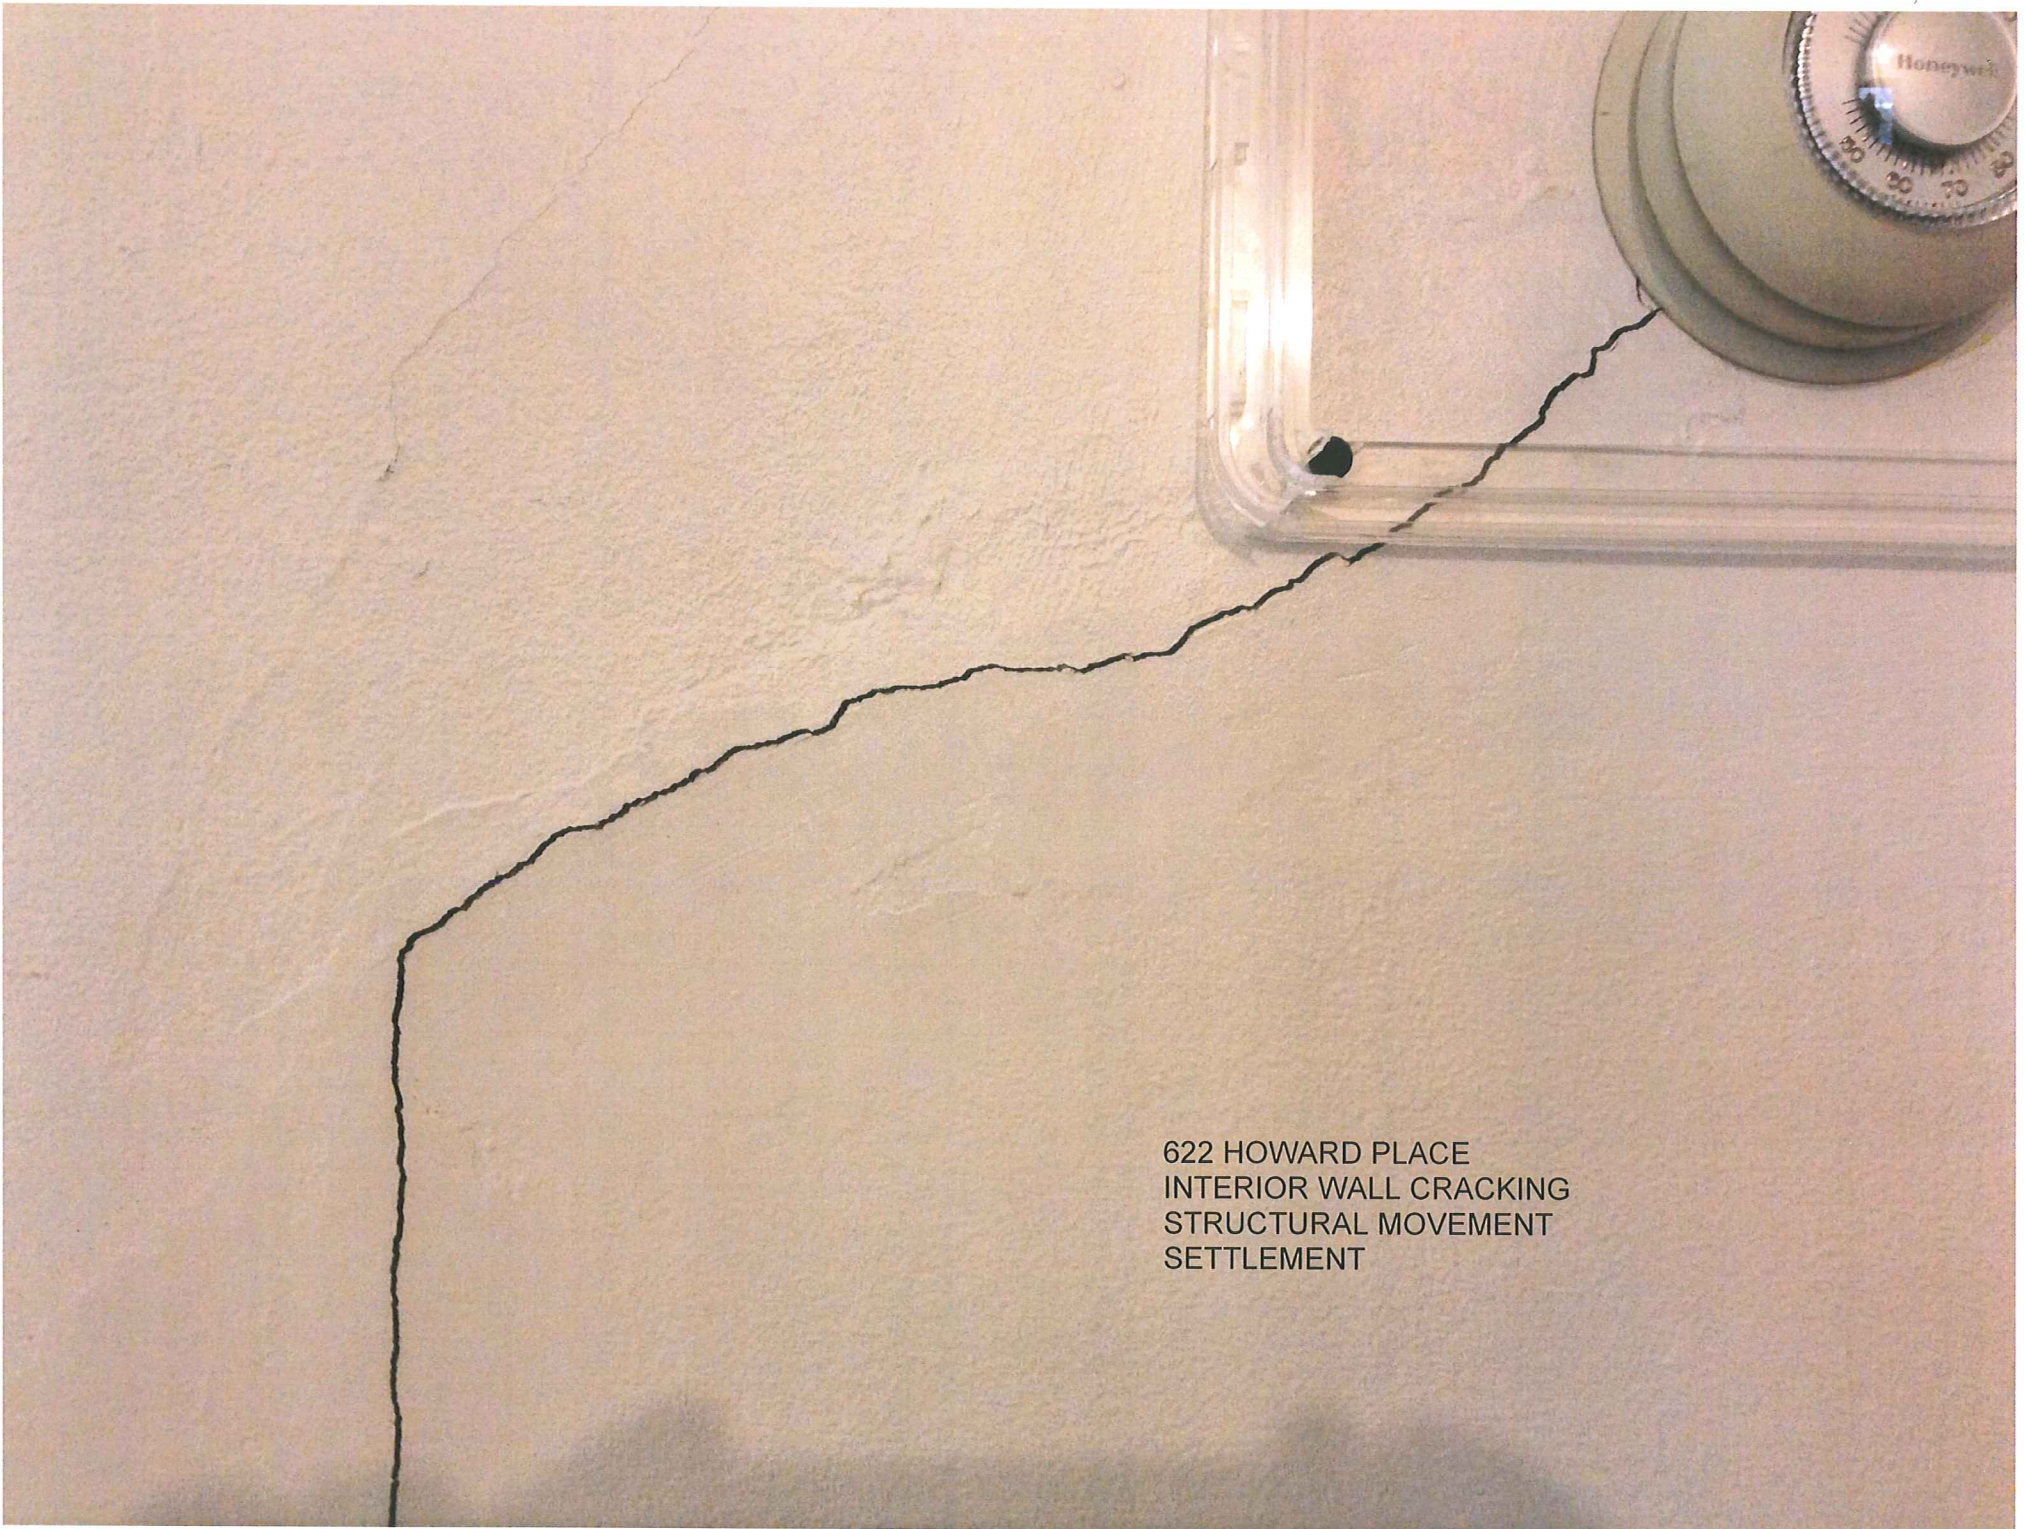
622 HOWARD PLACE  
INTERIOR WALL CRACKING  
STRUCTURAL MOVEMENT  
SETTLEMENT

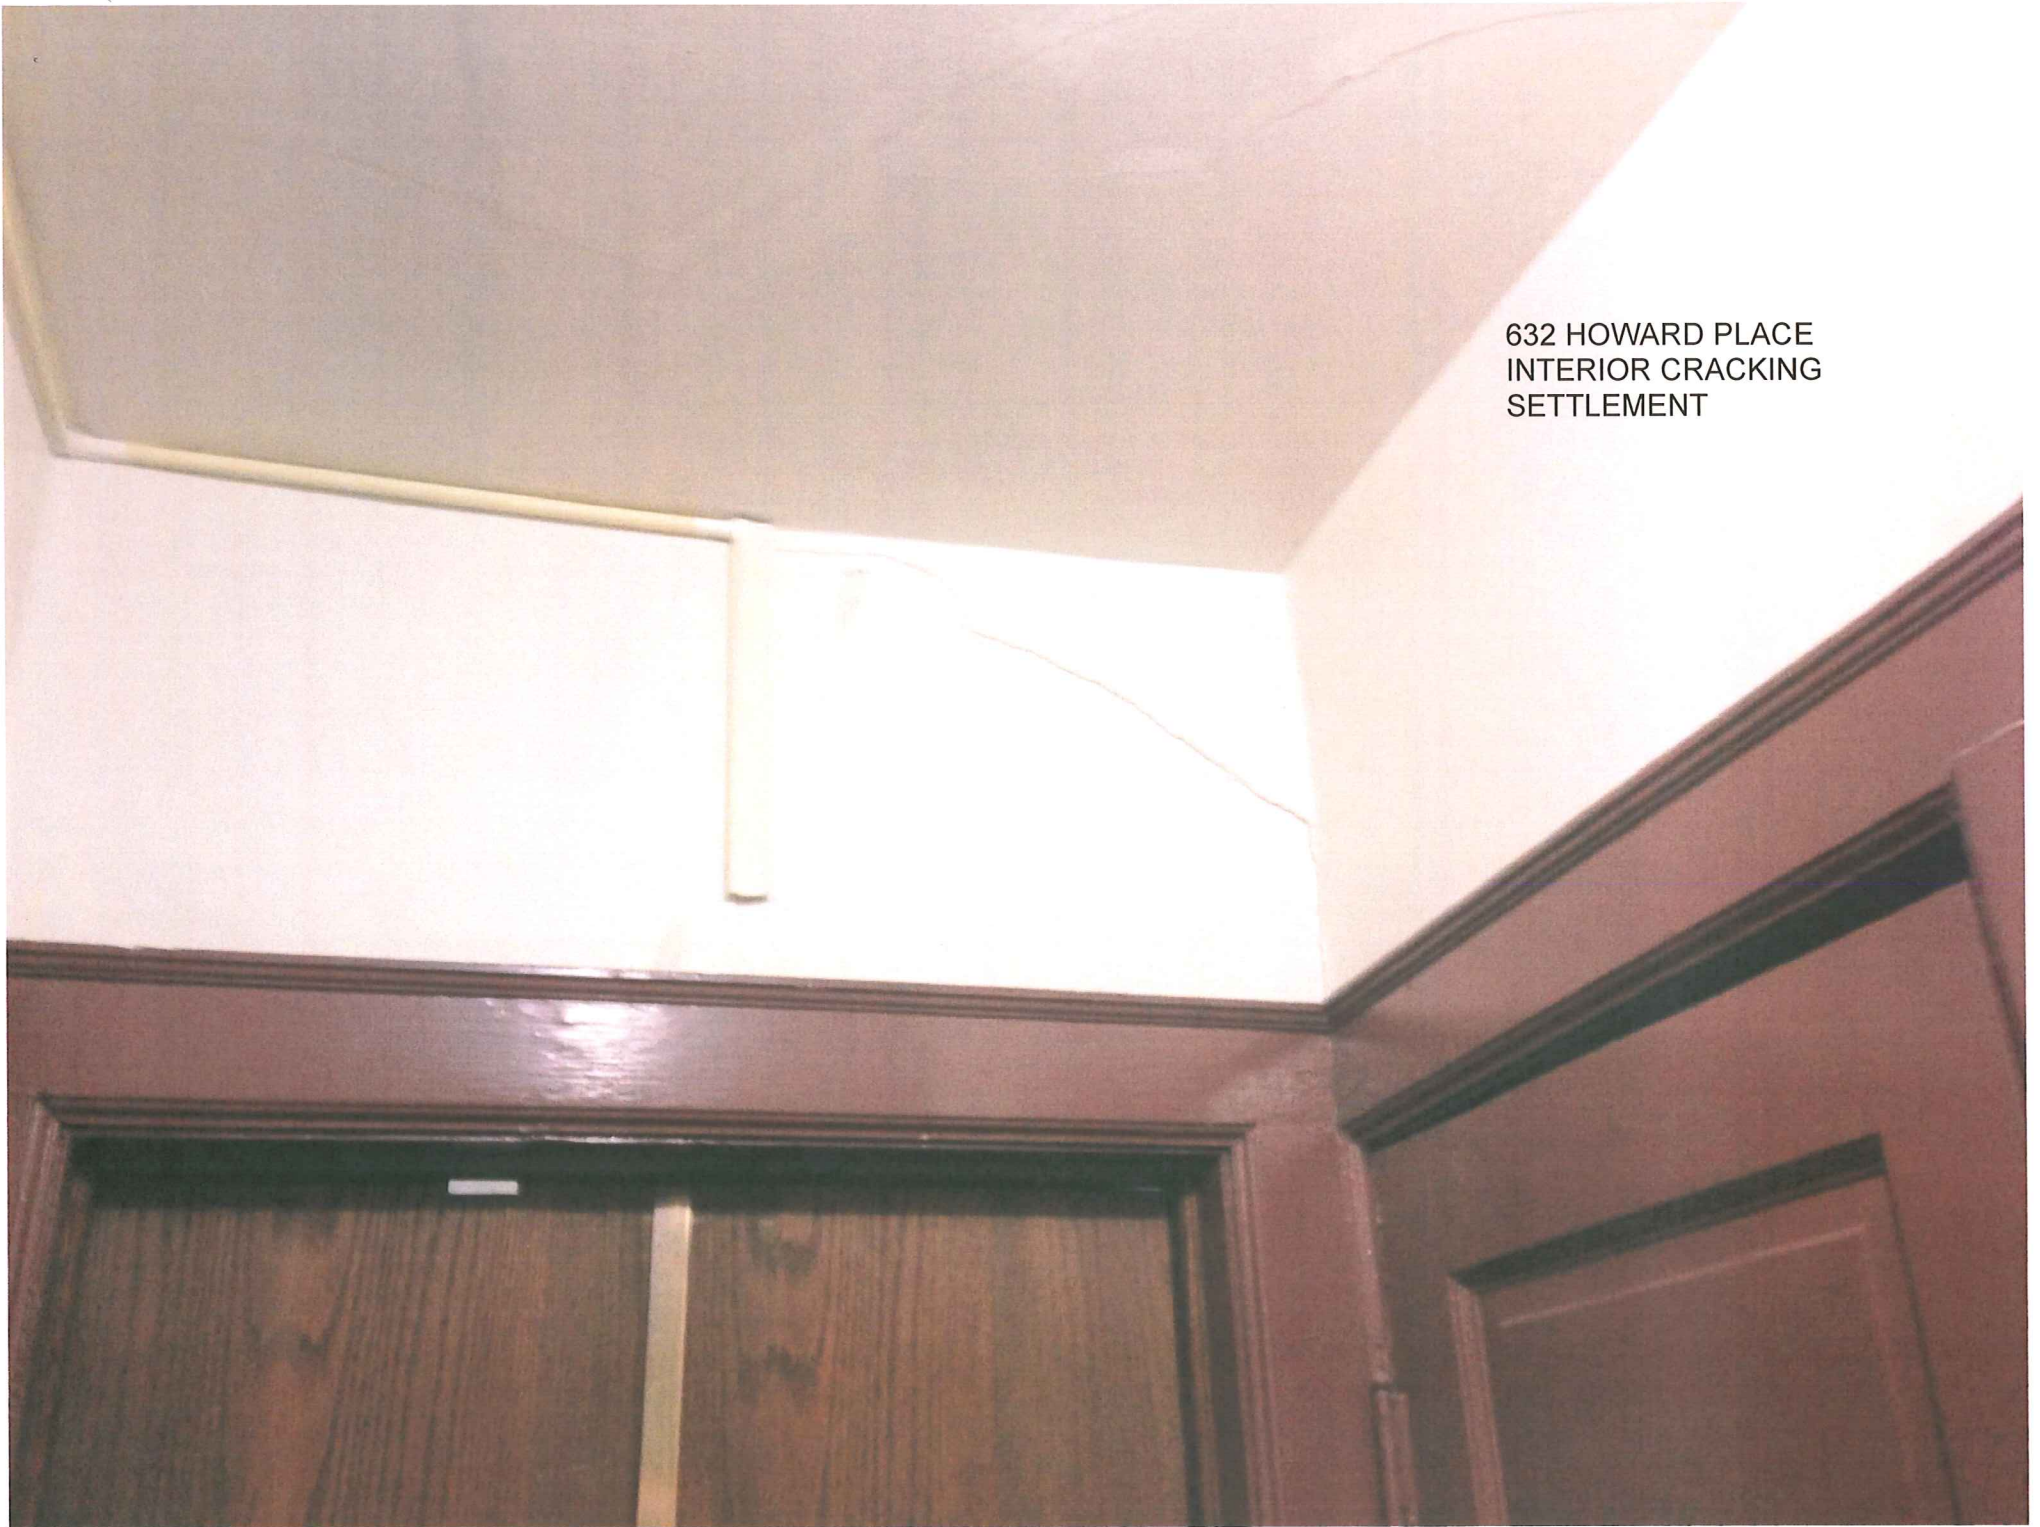
632 HOWARD PLACE  
INTERIOR WALL CRACKS  
SETTLEMENT

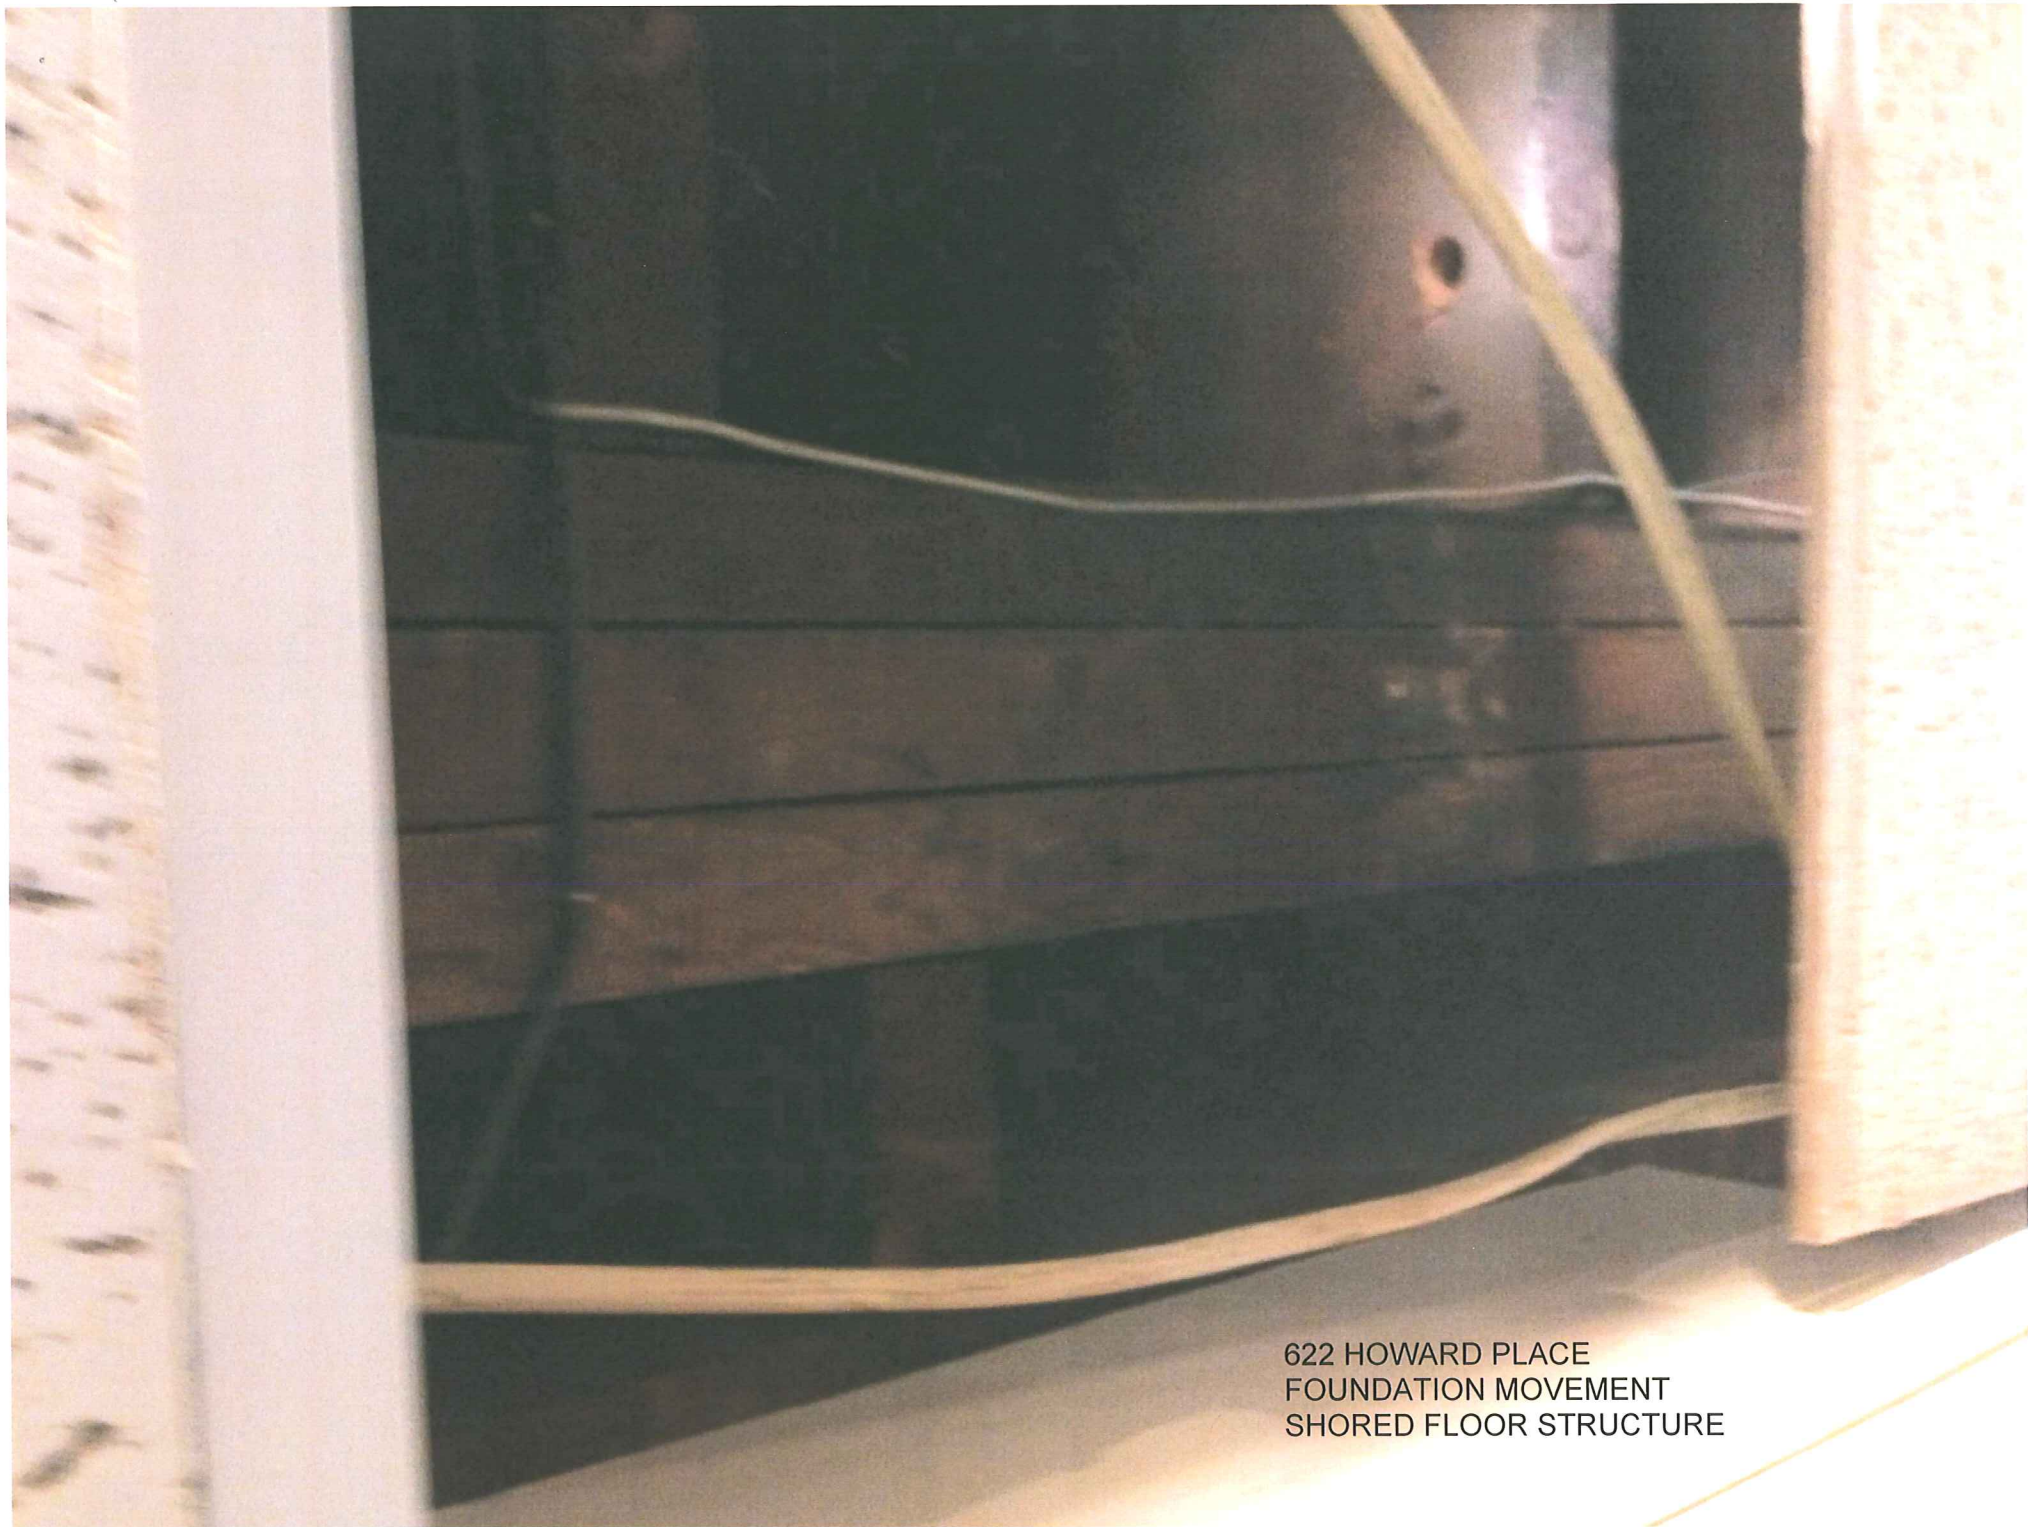
622 HOWARD PLACE  
FOUNDATION MOVEMENT  
SHORED FLOOR STRUCTURE
