## Proposed Demolition & Conditional Use

Location  
622-632 Howard Place

Project Name  
The Sophia

**SUBJECT: 622 & 632 Howard Avenue Apartments  
Structural Assessment  
MP-Squared Project No: 1310034WI**

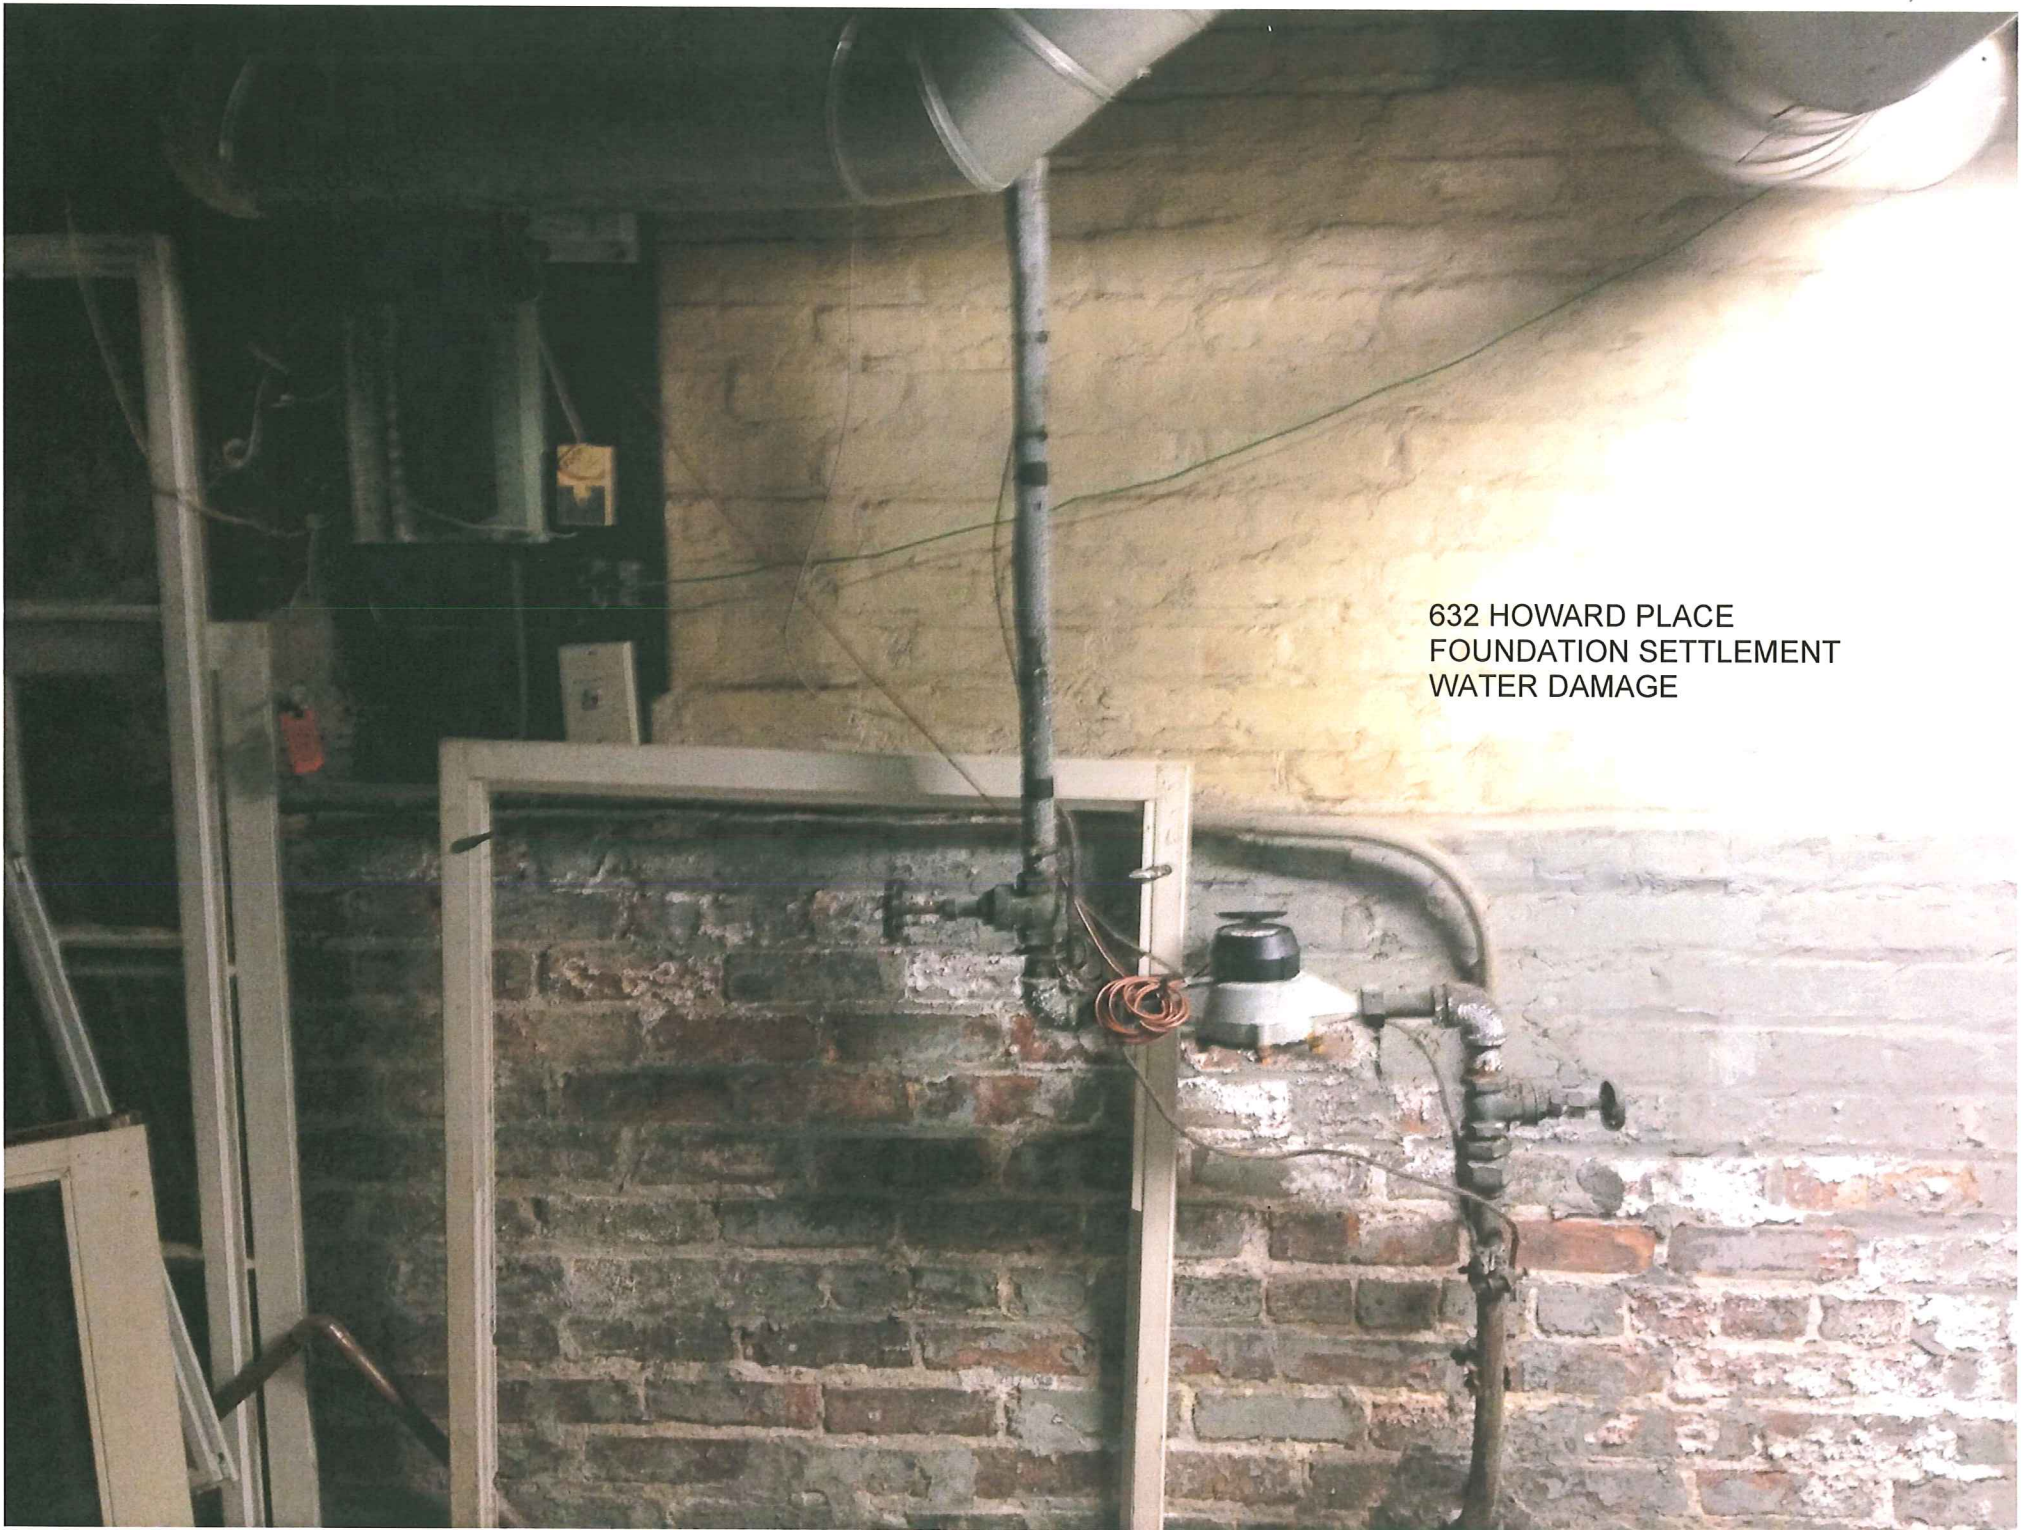
632 HOWARD PLACE  
FOUNDATION SETTLEMENT  
WATER DAMAGE

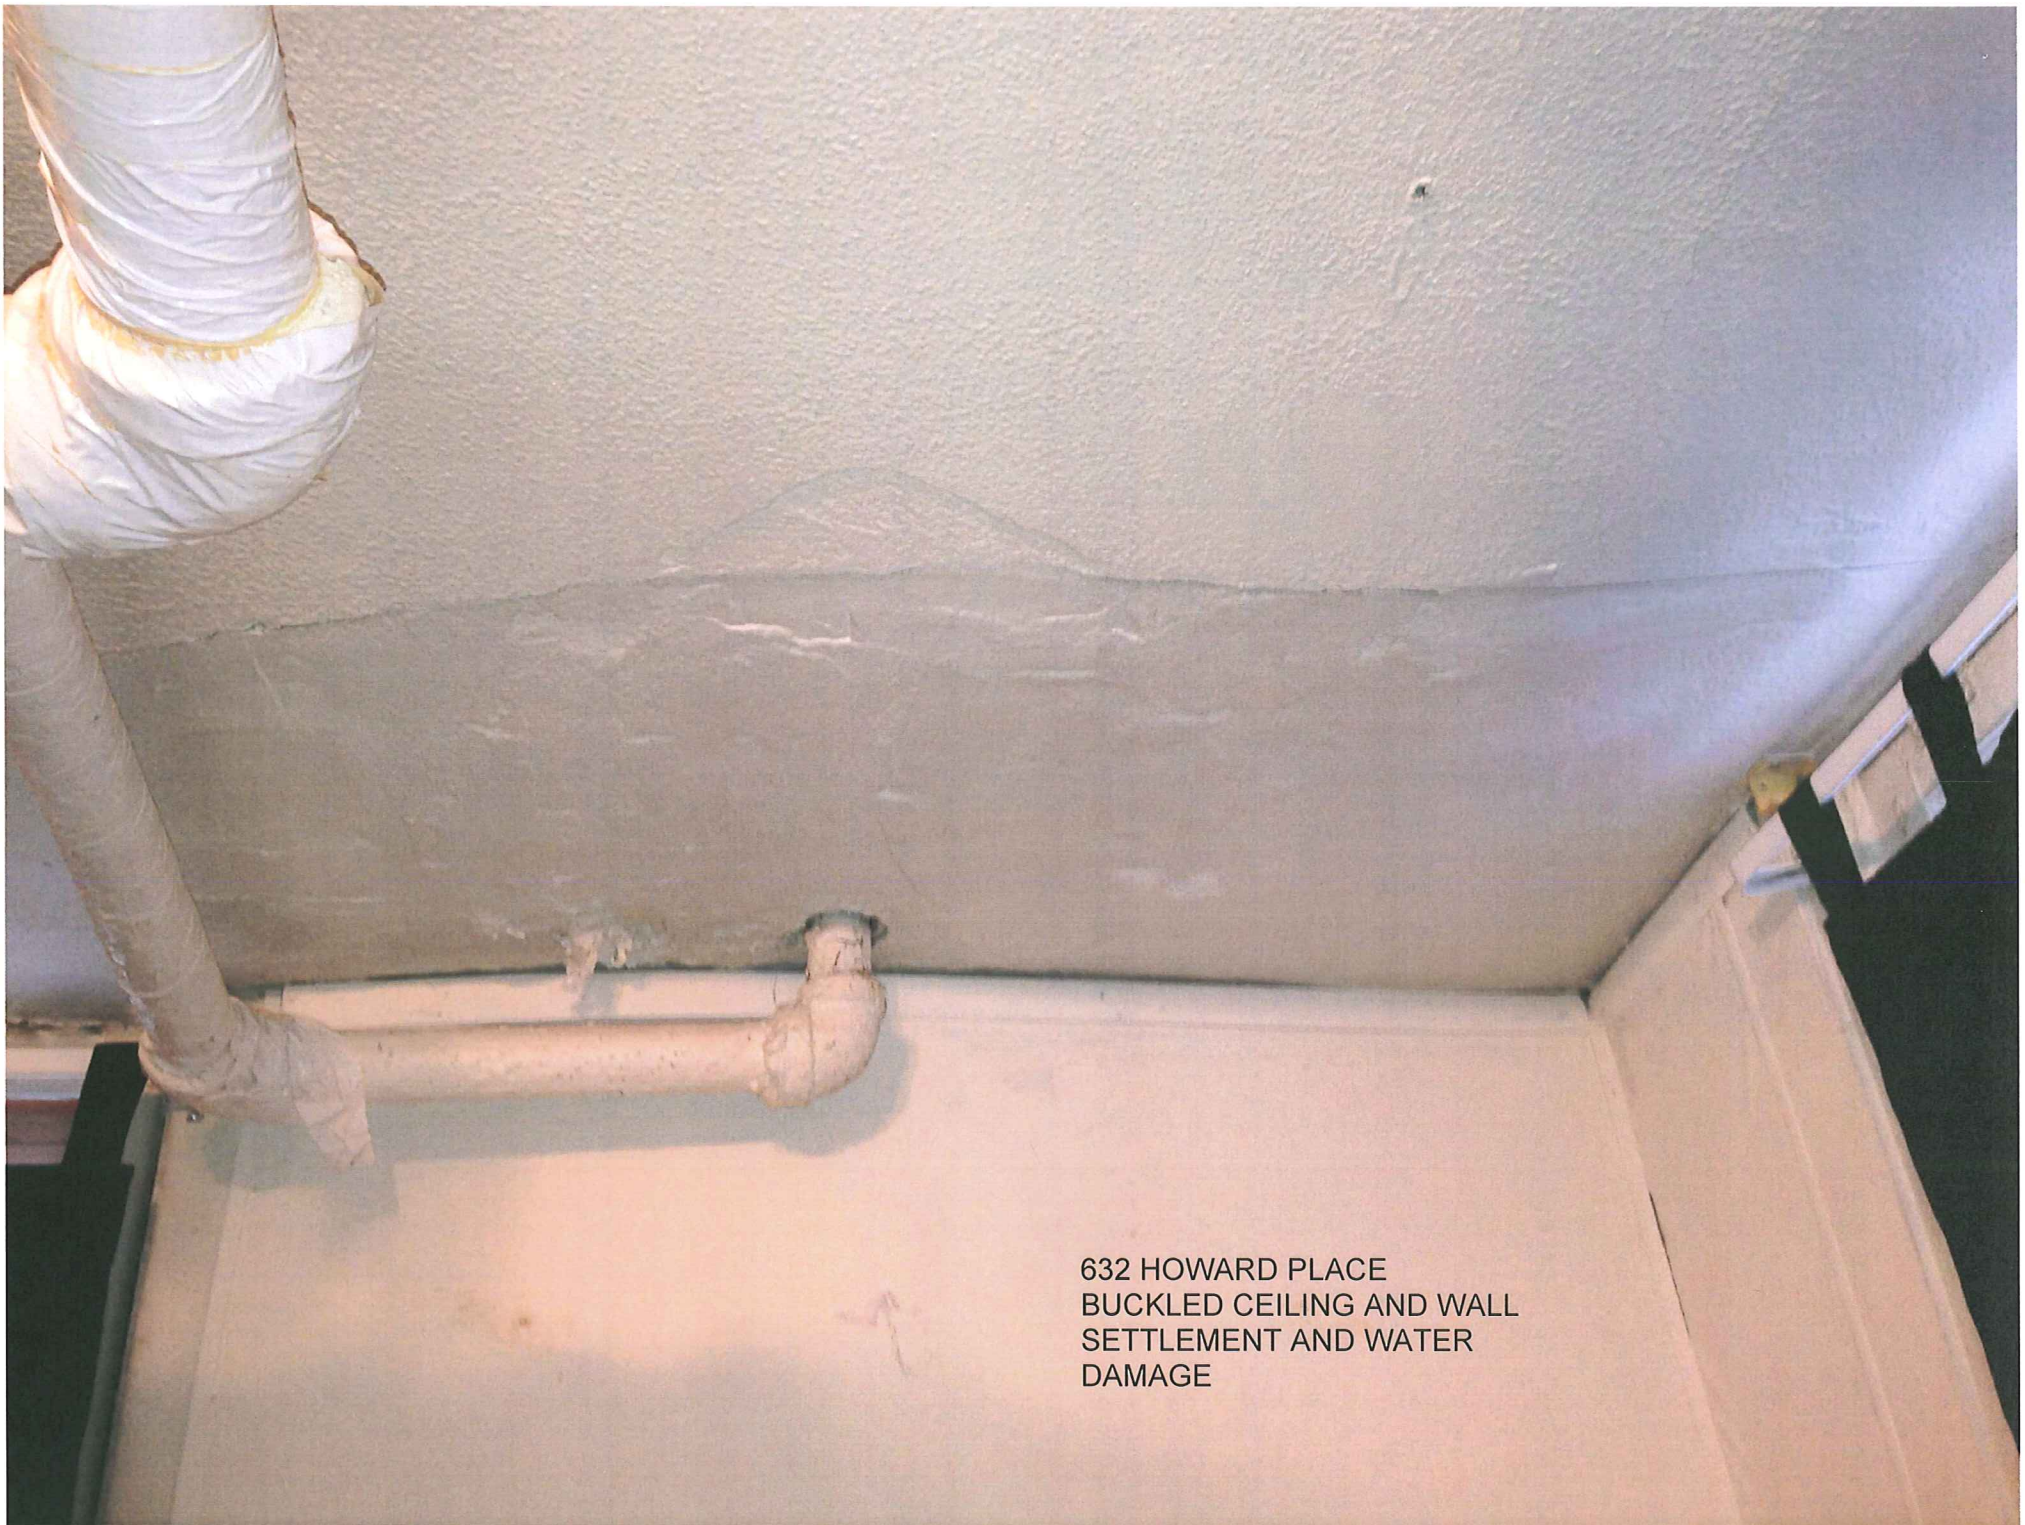
632 HOWARD PLACE  
BUCKLED CEILING AND WALL  
SETTLEMENT AND WATER  
DAMAGE

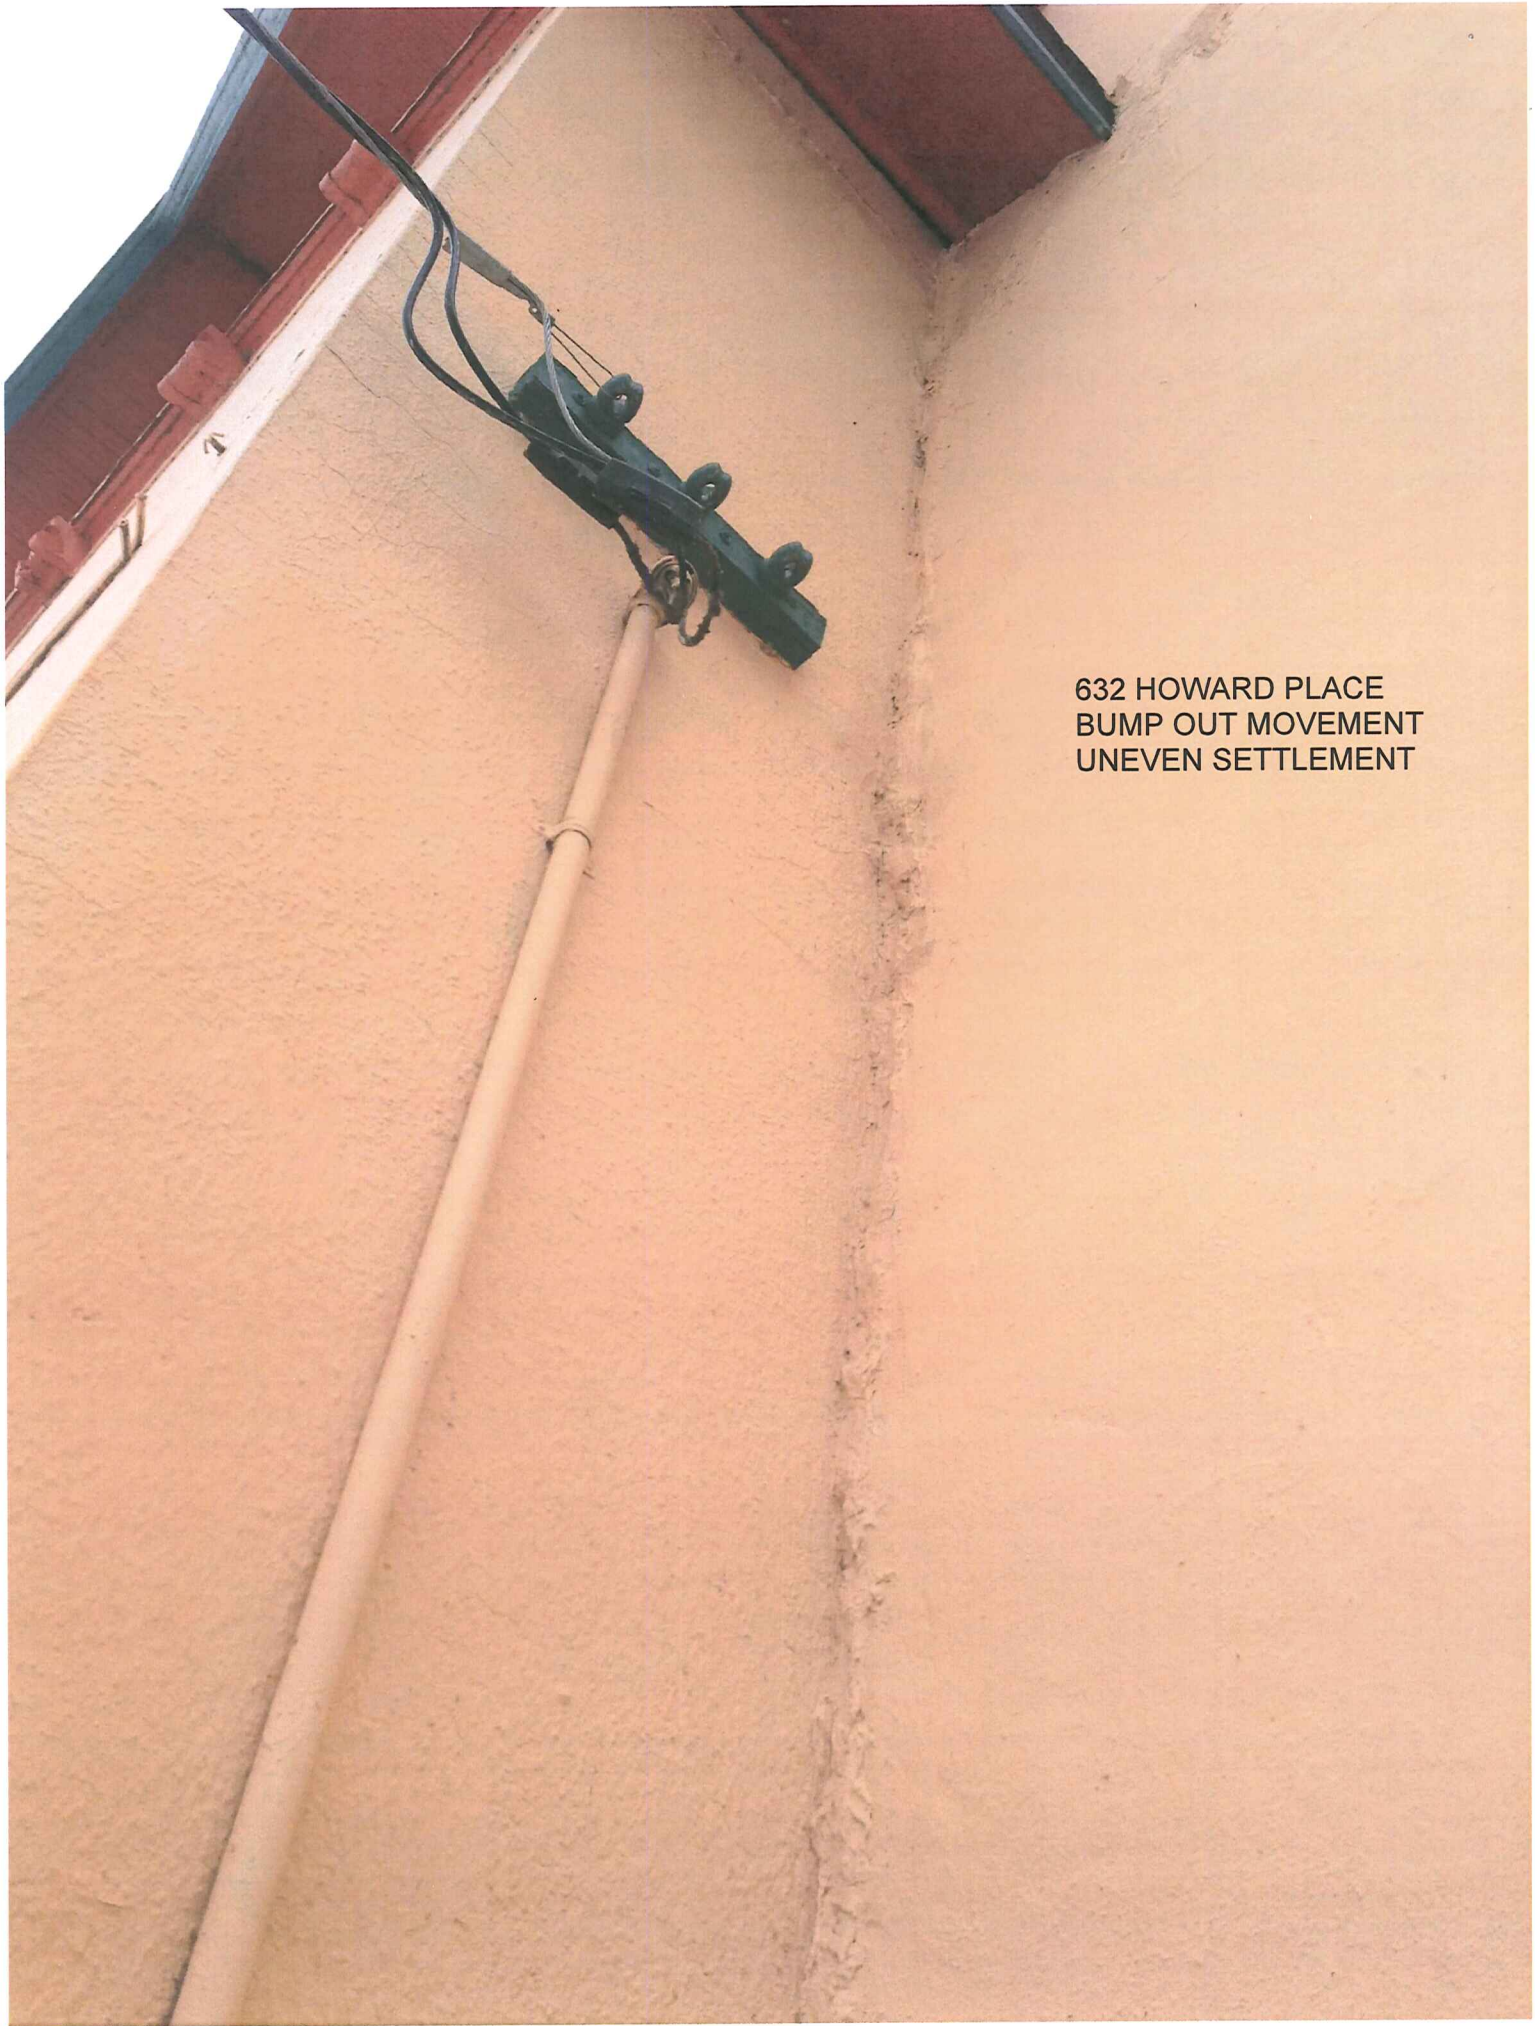
632 HOWARD PLACE  
BUMP OUT MOVEMENT  
UNEVEN SETTLEMENT

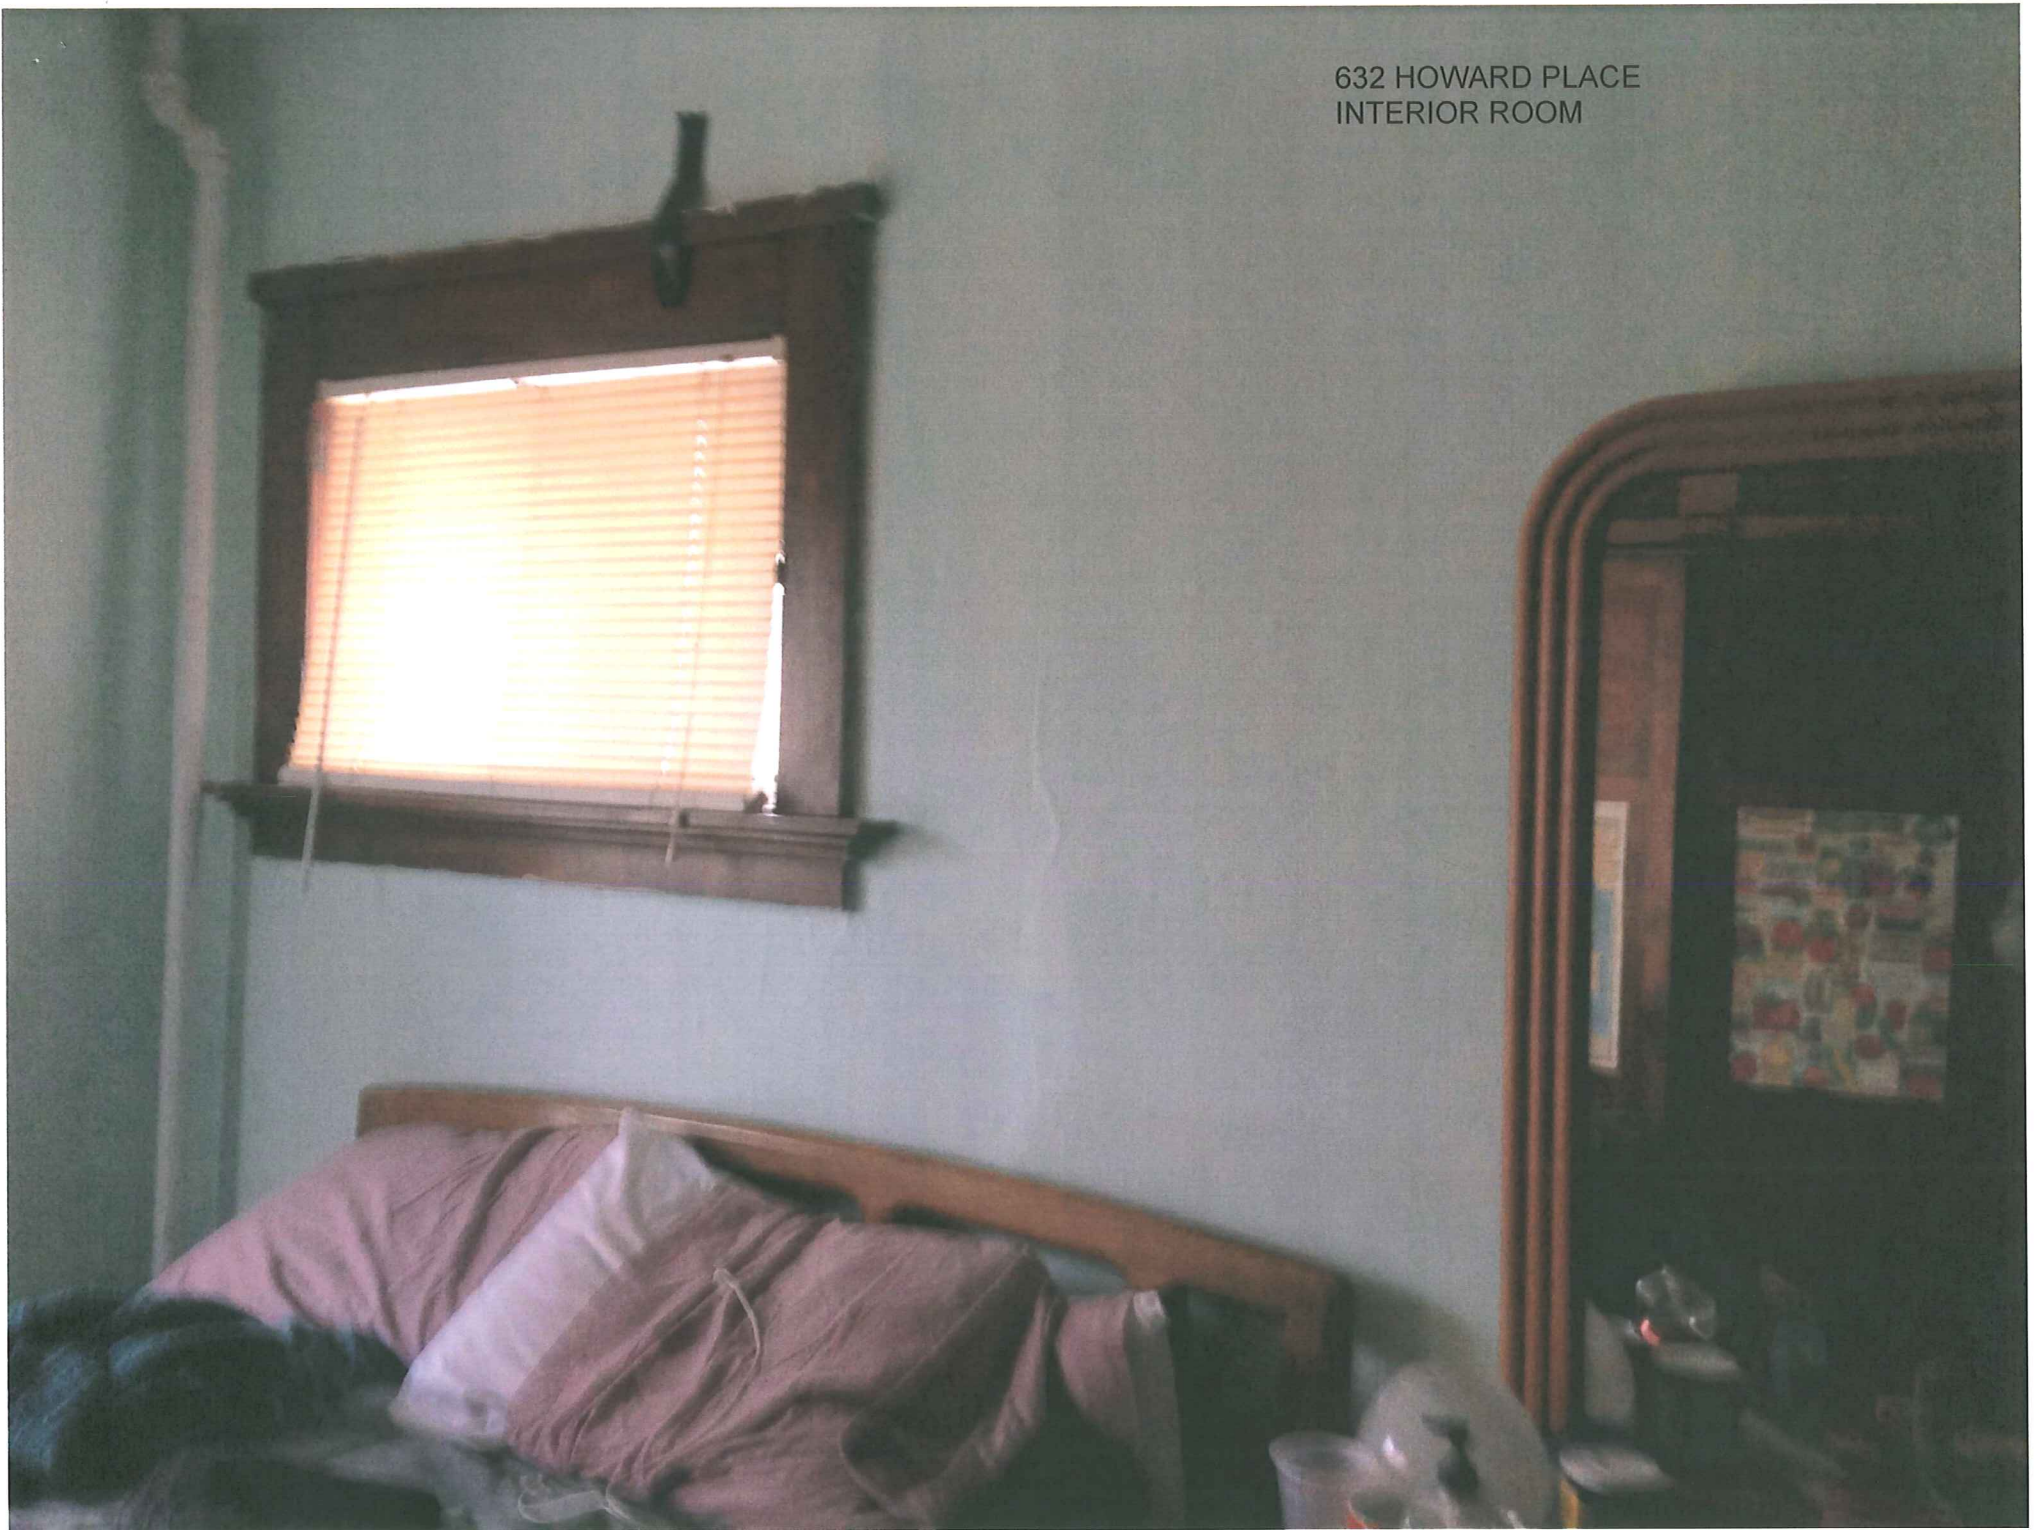
632 HOWARD PLACE  
WALL AND CEILING SETTLEMENT  
CRACKS - MOVEMENT

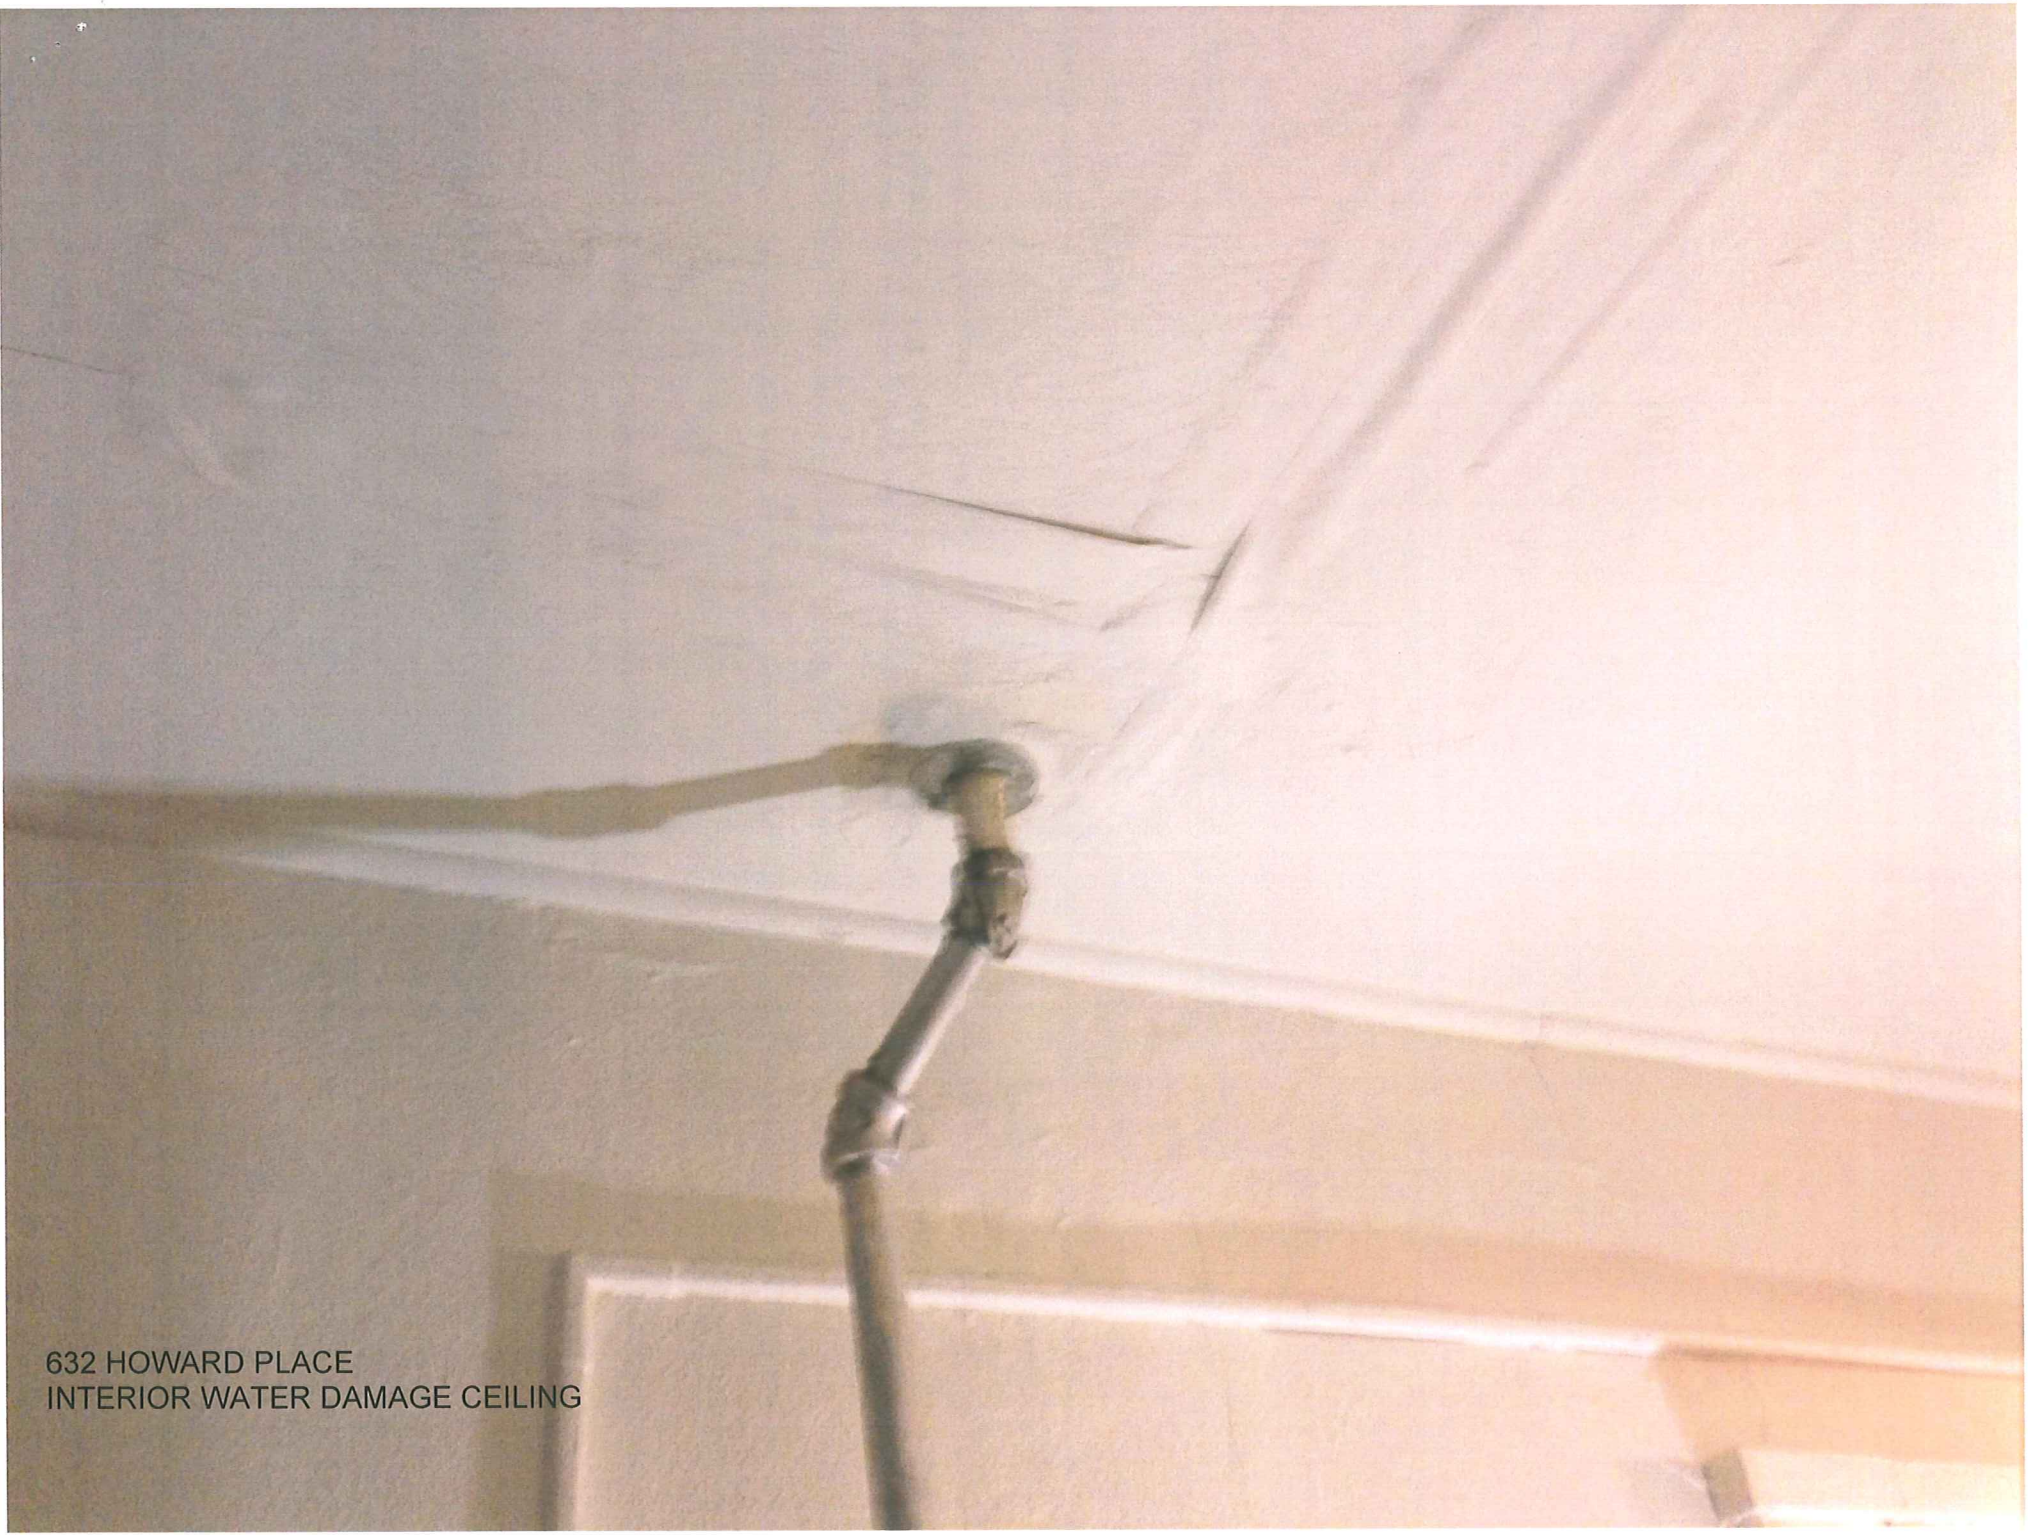
632 HOWARD PLACE  
INTERIOR WATER DAMAGE CEILING
