Regarding: 629 Spruce Street

We appreciate the opportunity to provide structural engineering services to you on this project. We understand the scope of services to be a structural review of the home noted above. The home is a two-story wood framed building. The foundations consist of concrete block masonry walls on concrete footings. Age of the existing home appeared to be approximately circa 1920's with a more recently placed addition at the front. We saw signs of other alterations (additional bedrooms and bathrooms placed on second floor, beams and columns added in the basement). The interior of the home appears to have been freshly painted.

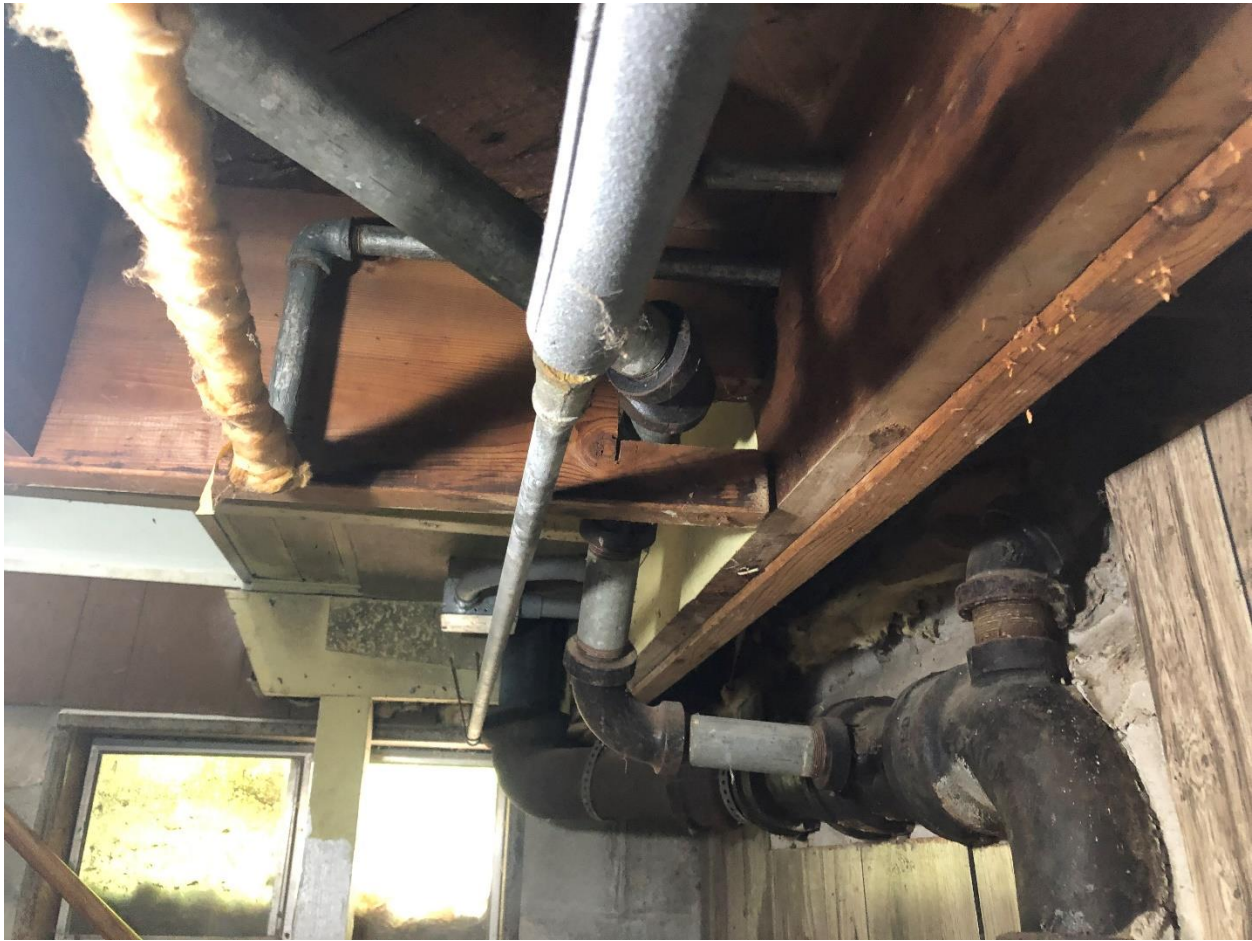
The supplemental framing in the basement is lacking some connections. It is important that posts be anchored to the foundations and to the wood framing. Wood columns did not appear to have foundations or base connections. Several notches were noted in original wood framing that should

be reinforced. Several supports needed to be addressed because hangers were not properly installed or their supporting members appeared to be insufficient in strength.

Image showing significant cut out notch at floor header/joist.

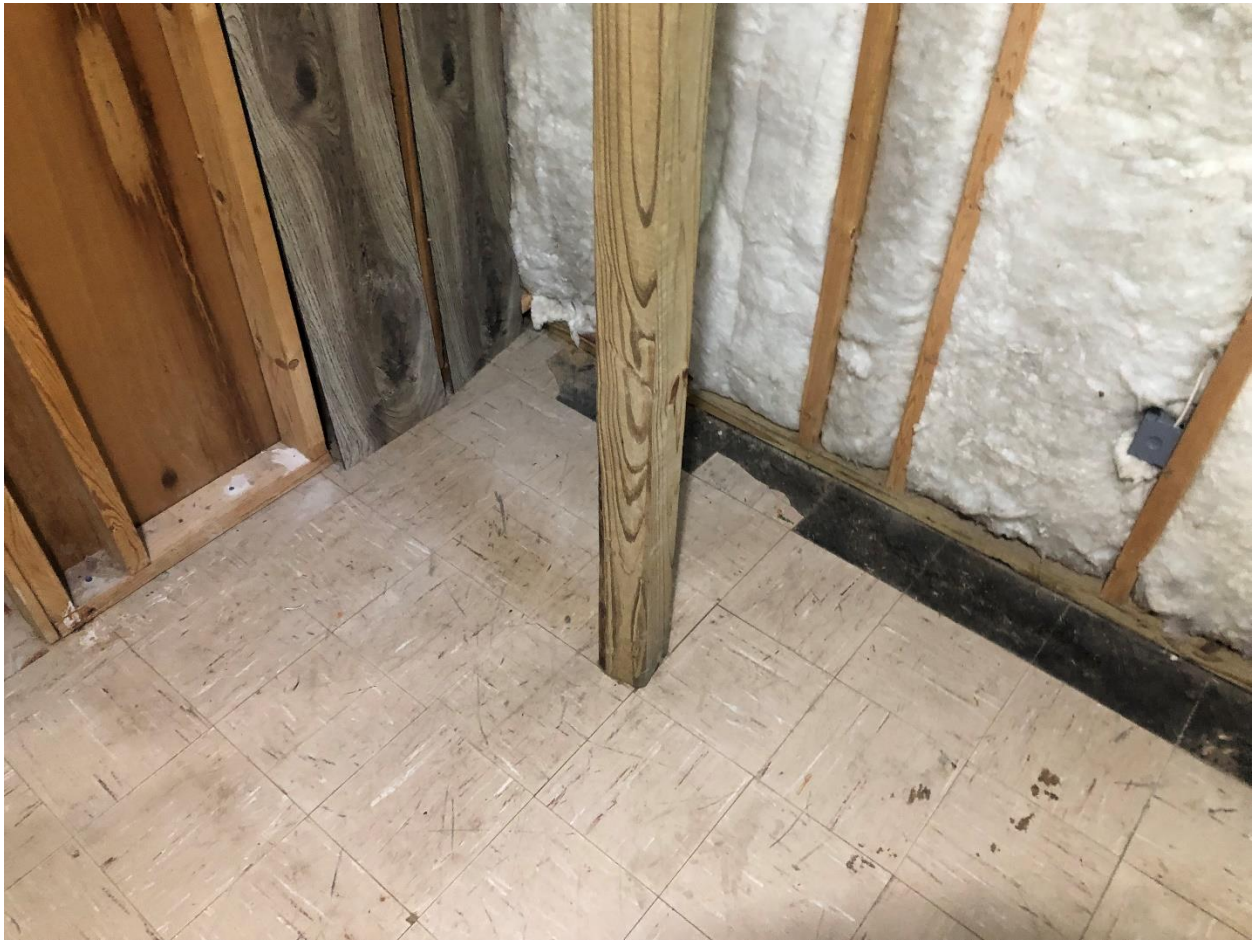
Image showing lack of attachment and lack of foundation at the base of wood columns.

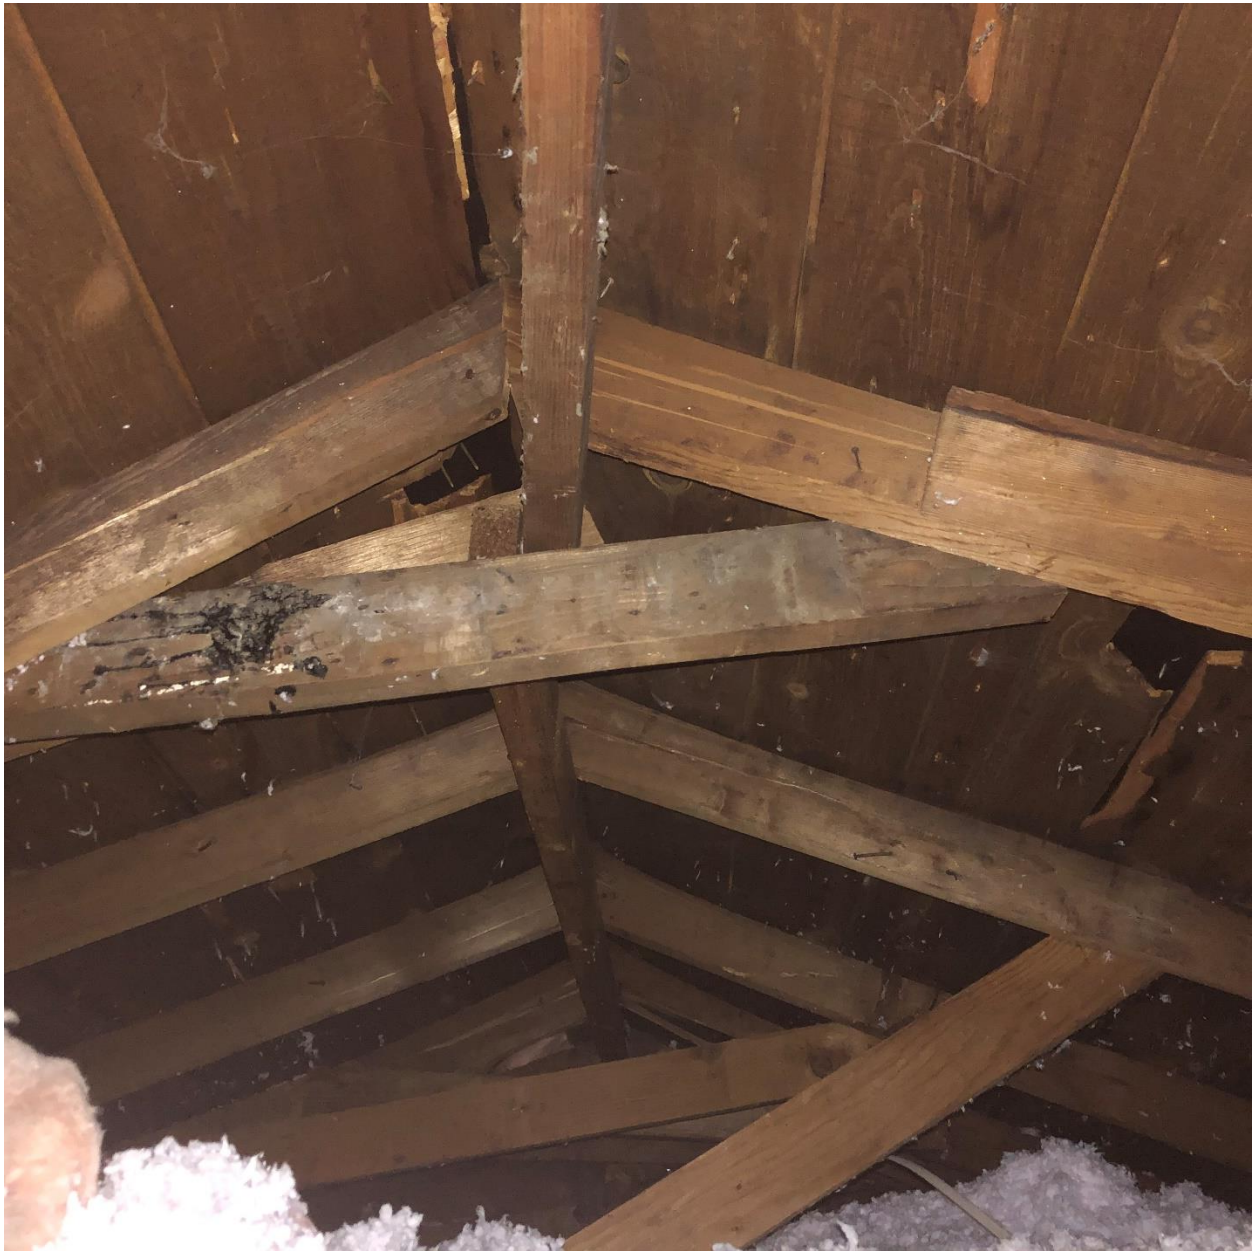
We noted from the access to the attic space that the roof framing was fractured and propped to the walls below with vertical 2x struts. The roof appears to once have been differently configured. We believe that the roof planes had originally extended from the location of the current ridgeline down to the level of the second floor. Some time in its history, the roof planes were changed, swinging the roof surfaces upward and propping the exterior ends with new second story bearing walls, making the roof less steep but attic space converted to space for the bedrooms, hallways and a bathroom. The evidence for this is located at the ridge where rafters meeting only bear against each other with their tips with a pie shaped gap now appearing keeping them from bearing against each other properly. Collar ties have been added to some help, but for the most part, these roof elements likely bear partially on second floor hall walls and load the framing of what was originally attic floor framing. The attic floor framing was not likely substantial; using the framing formally for residential loads may be beyond their safe capacity, not to mention that the framing is also supporting roof loads.

Image showing cracked rafters and cobbled roof framing

- We believe that the roof system is not capable of supporting itself. It should be replaced.
- We believe that the floor of the attic (current second floor) needs to be further evaluated in order to determine if it is strong and stiff enough to support residential loads. It is possible that the floor may need to be reinforced.
- At the very least, the first-floor needs attention to repair joist supports and notches. At the most, the floor system needs further reinforcement to correct possible damage apparent where significant deformations are present. It is likely that some middle ground can be achieved with some additional reinforcement and some understanding that some of the more minor floor sagging can be considered "normal" to older homes.
