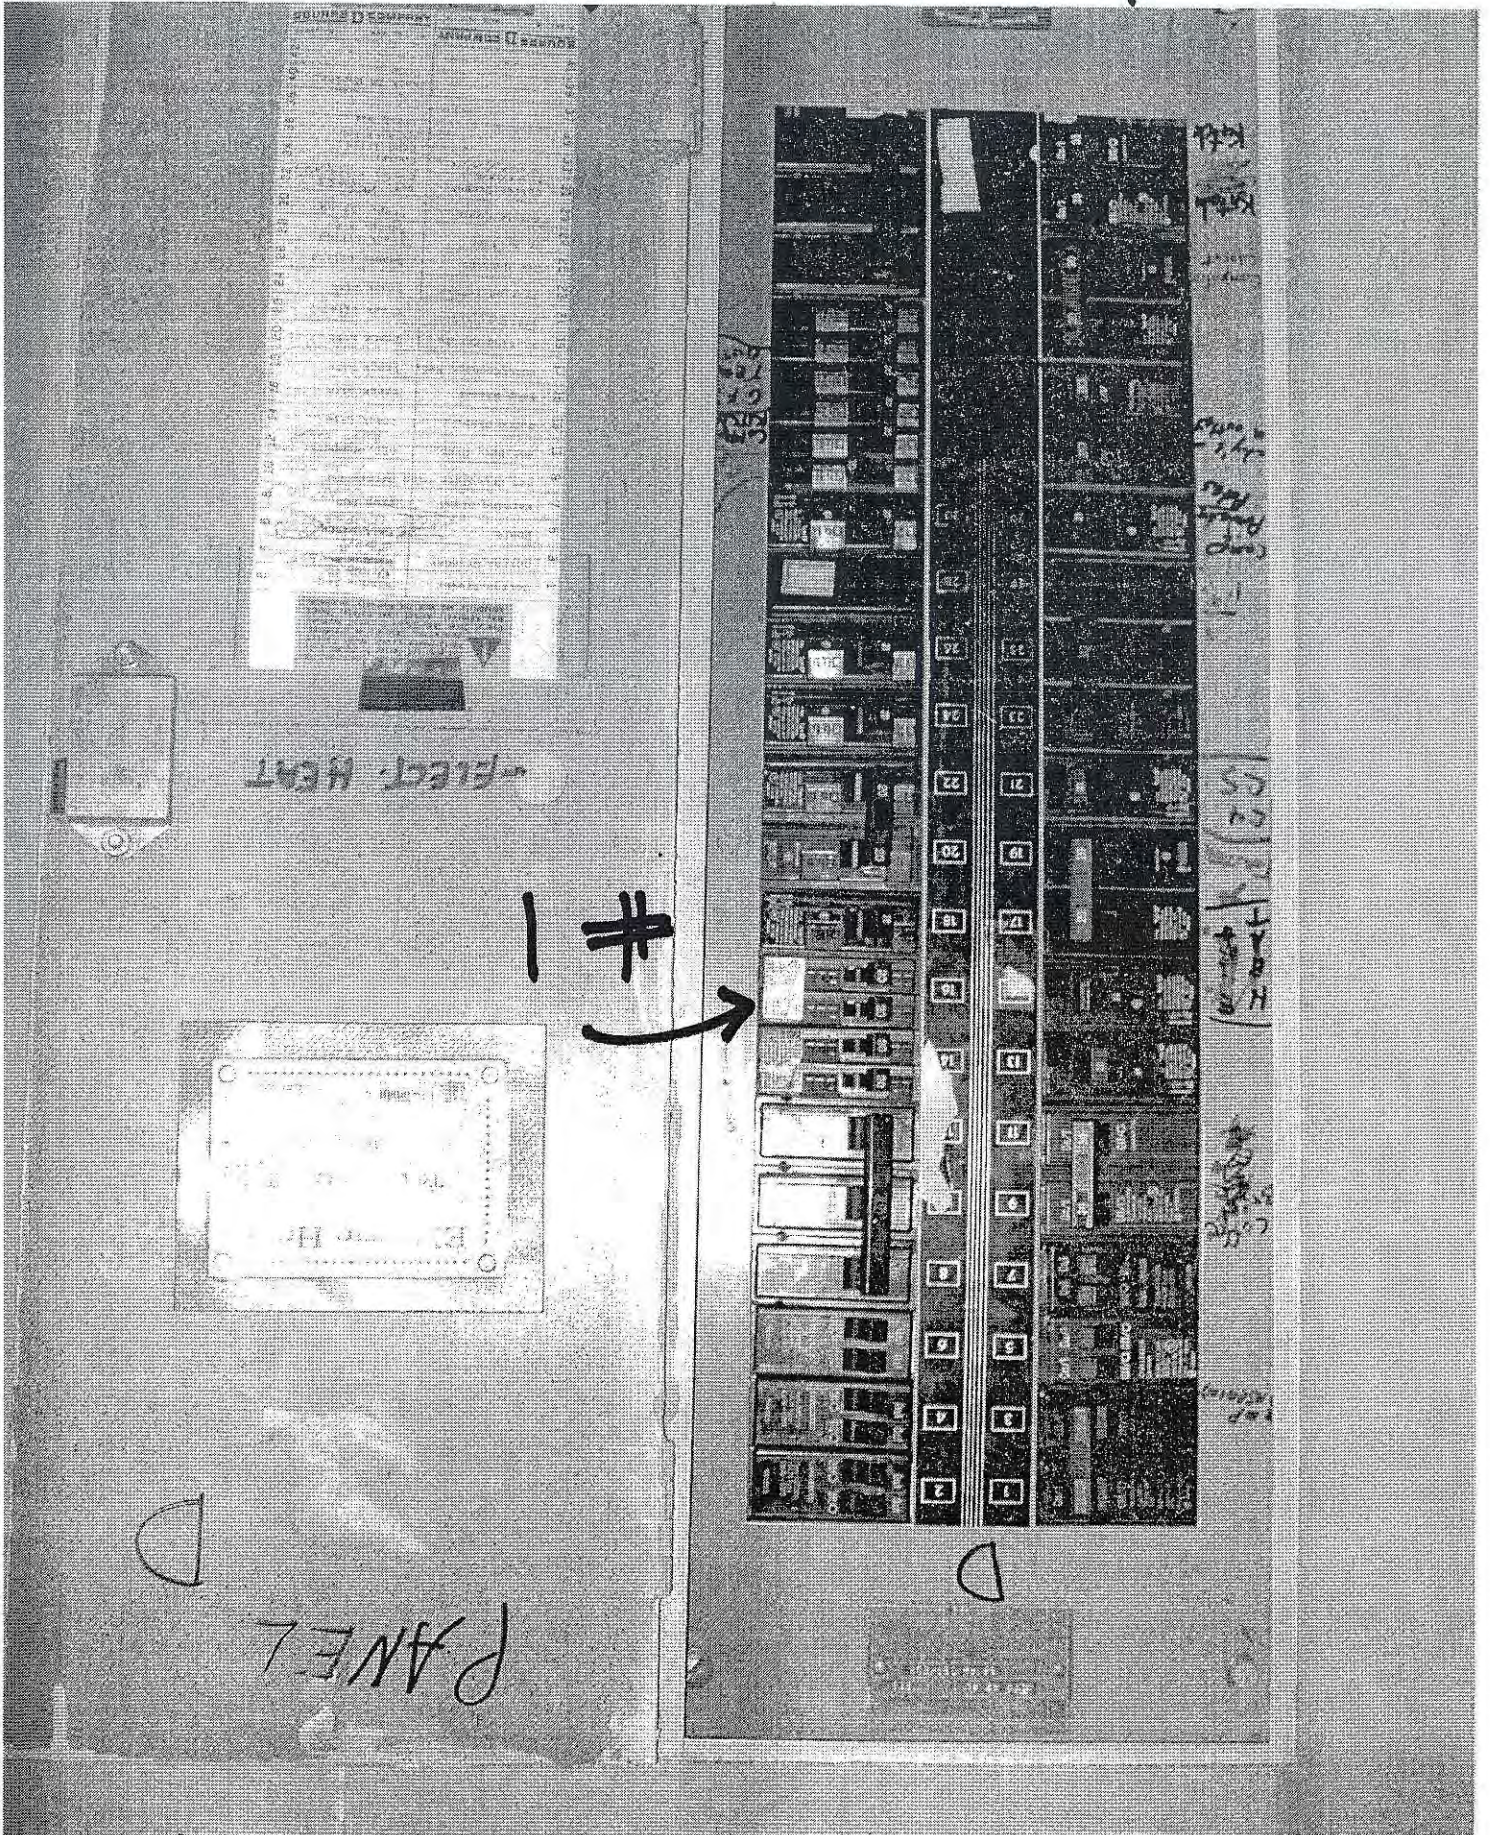
PHOTO # 15 ELECTRICAL
#1 UNDERSIZED SUB-PANEL - OVERLOADED

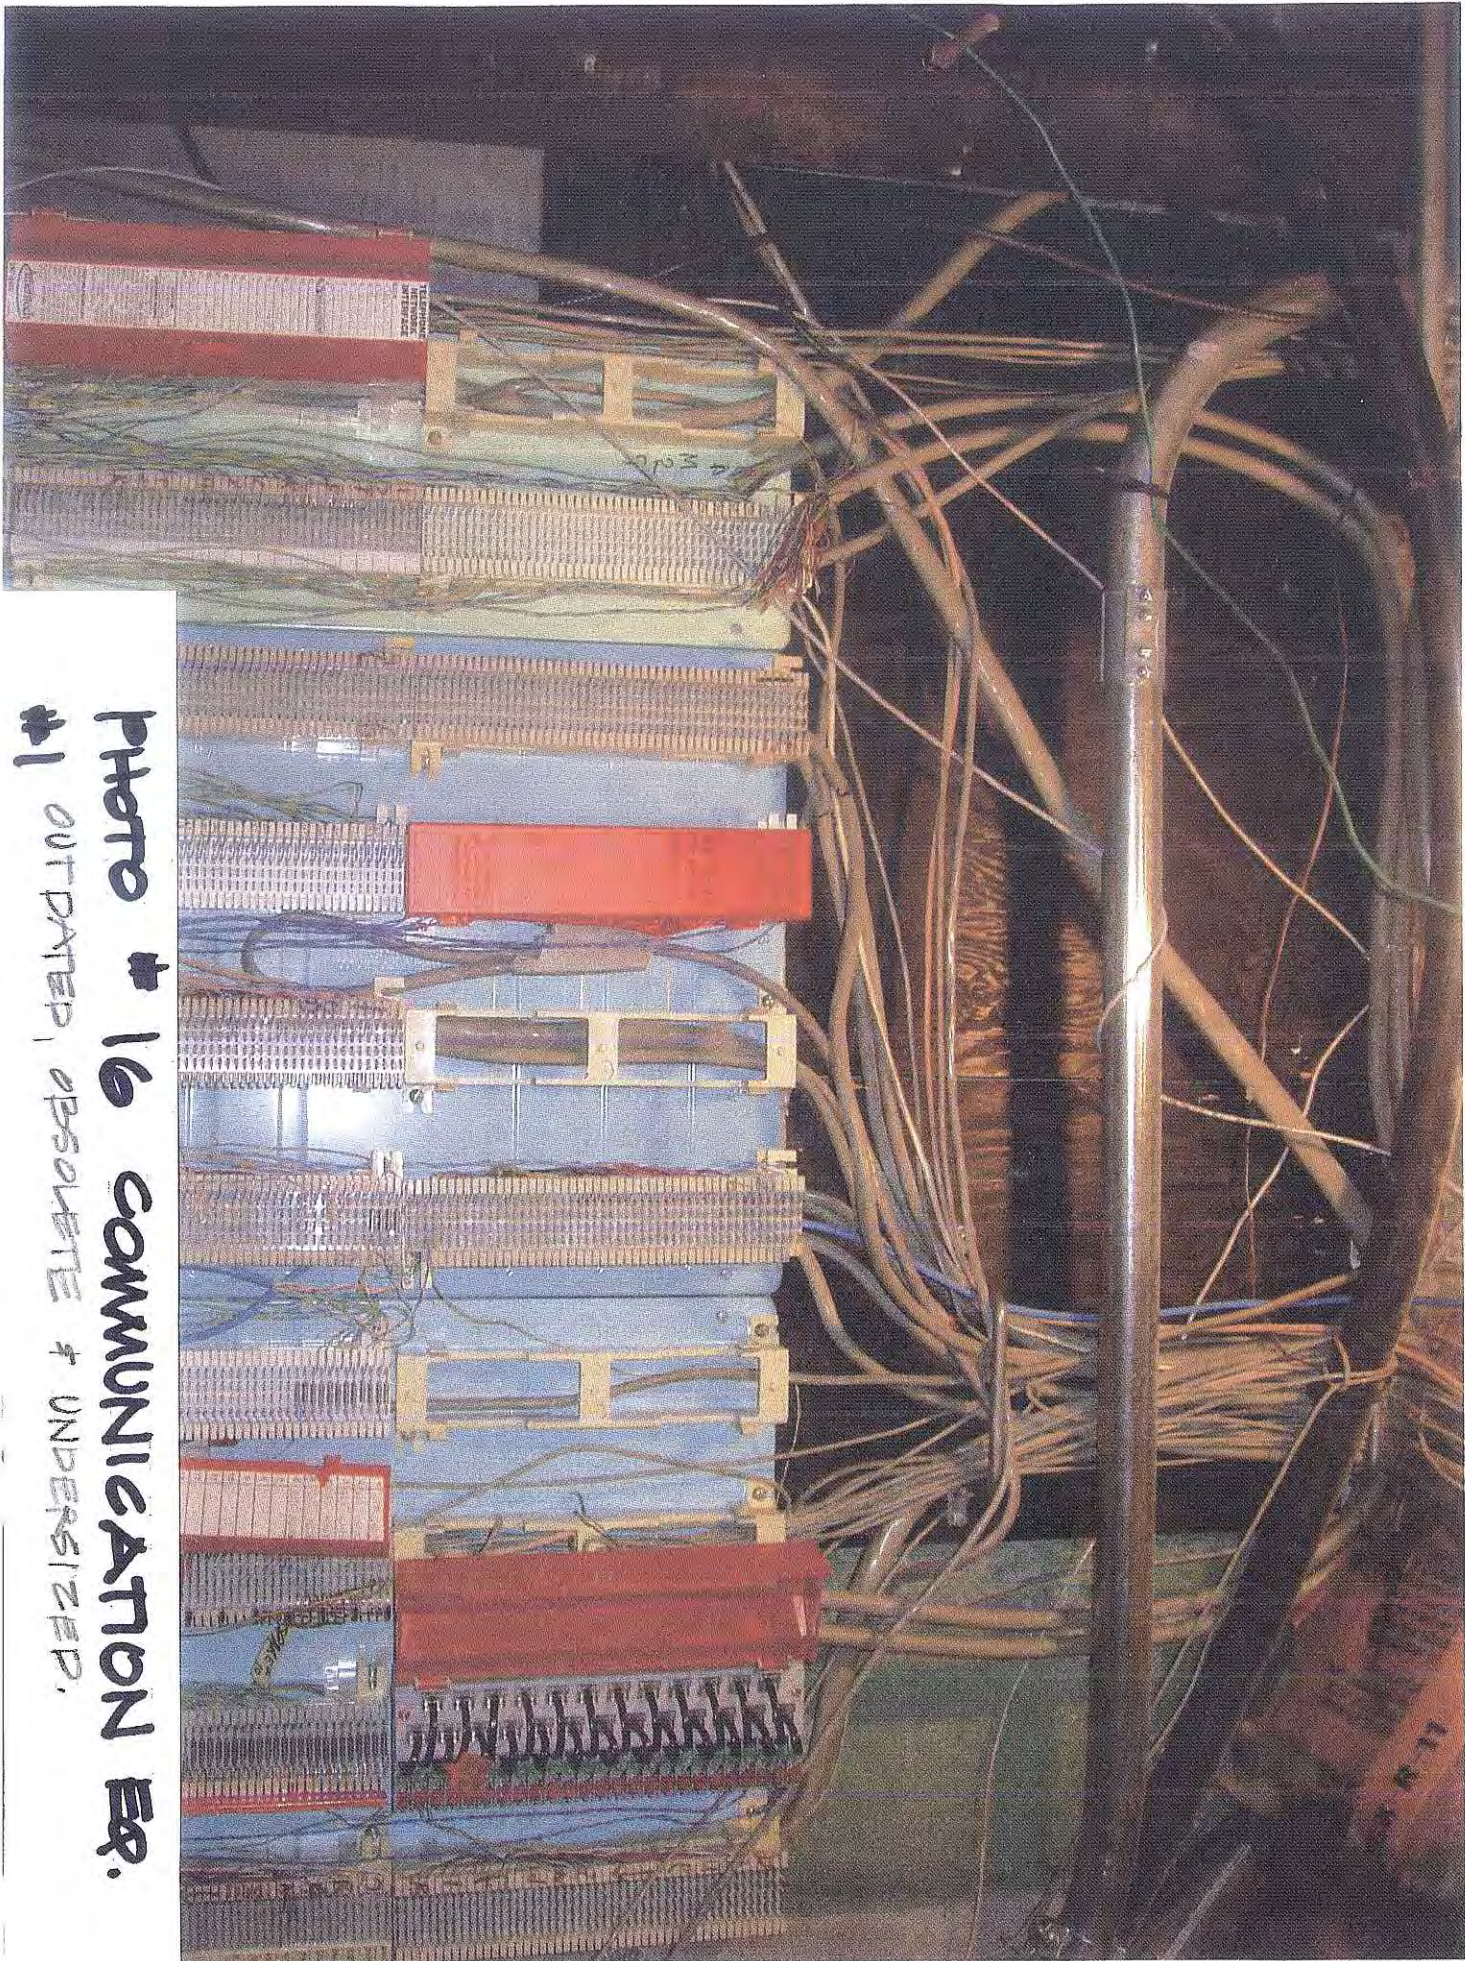
PHOTO # 16 COMMUNICATION EQ.
#1 OUTDATED, OBSOLETE & UNDERSIZED.

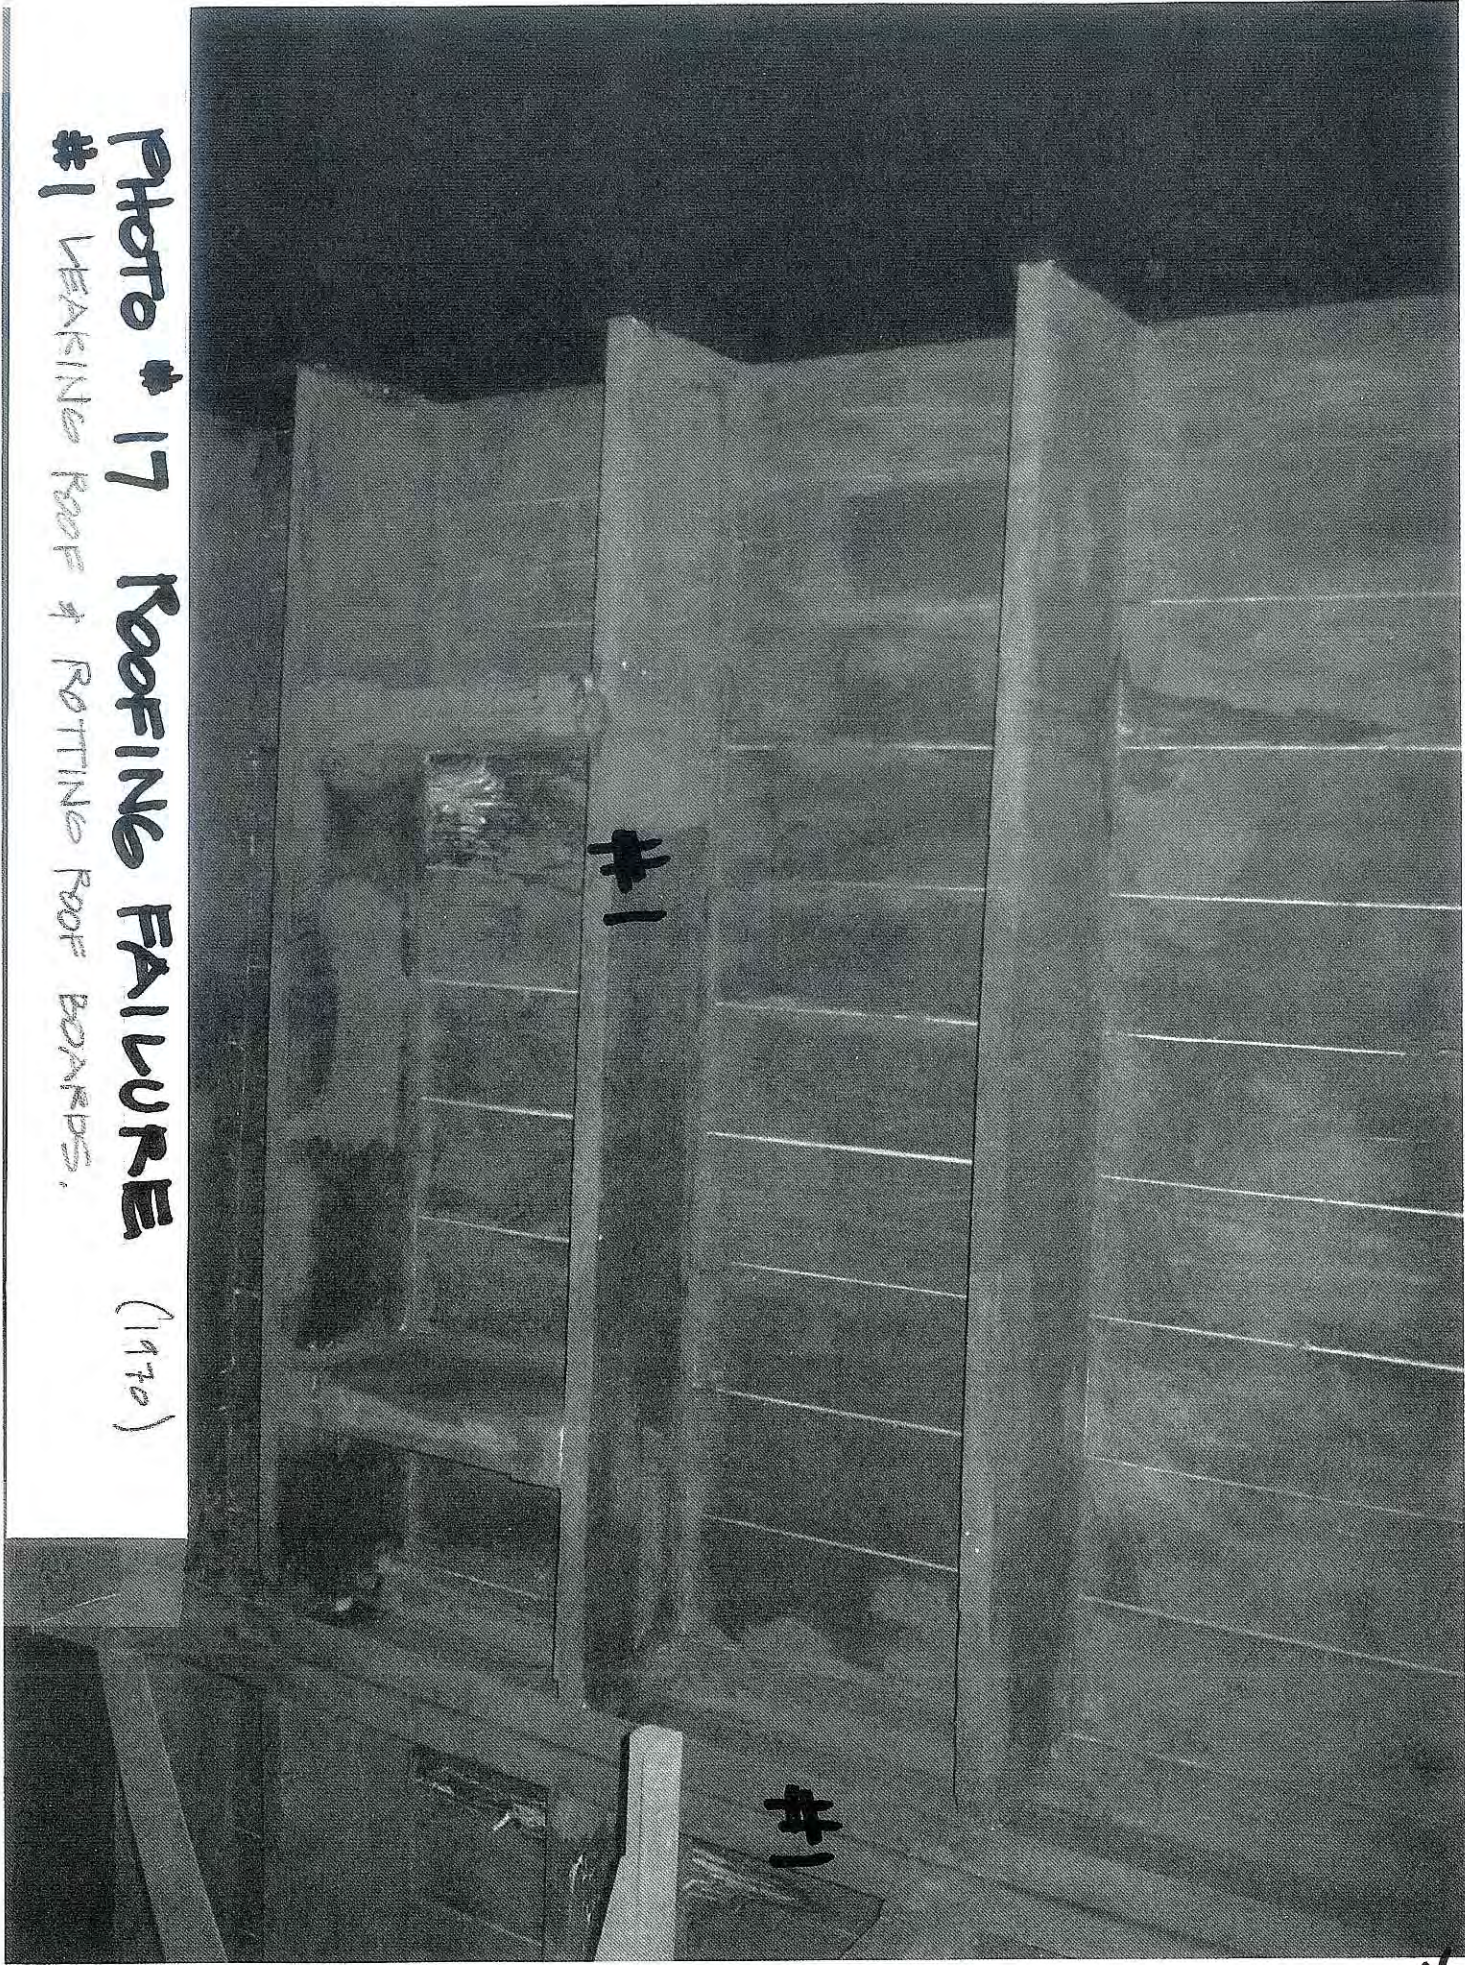
PHOTO # 17 ROOFING FAILURE (1970)
#1 LEAKING ROOF & ROTTING ROOF BOARDS.

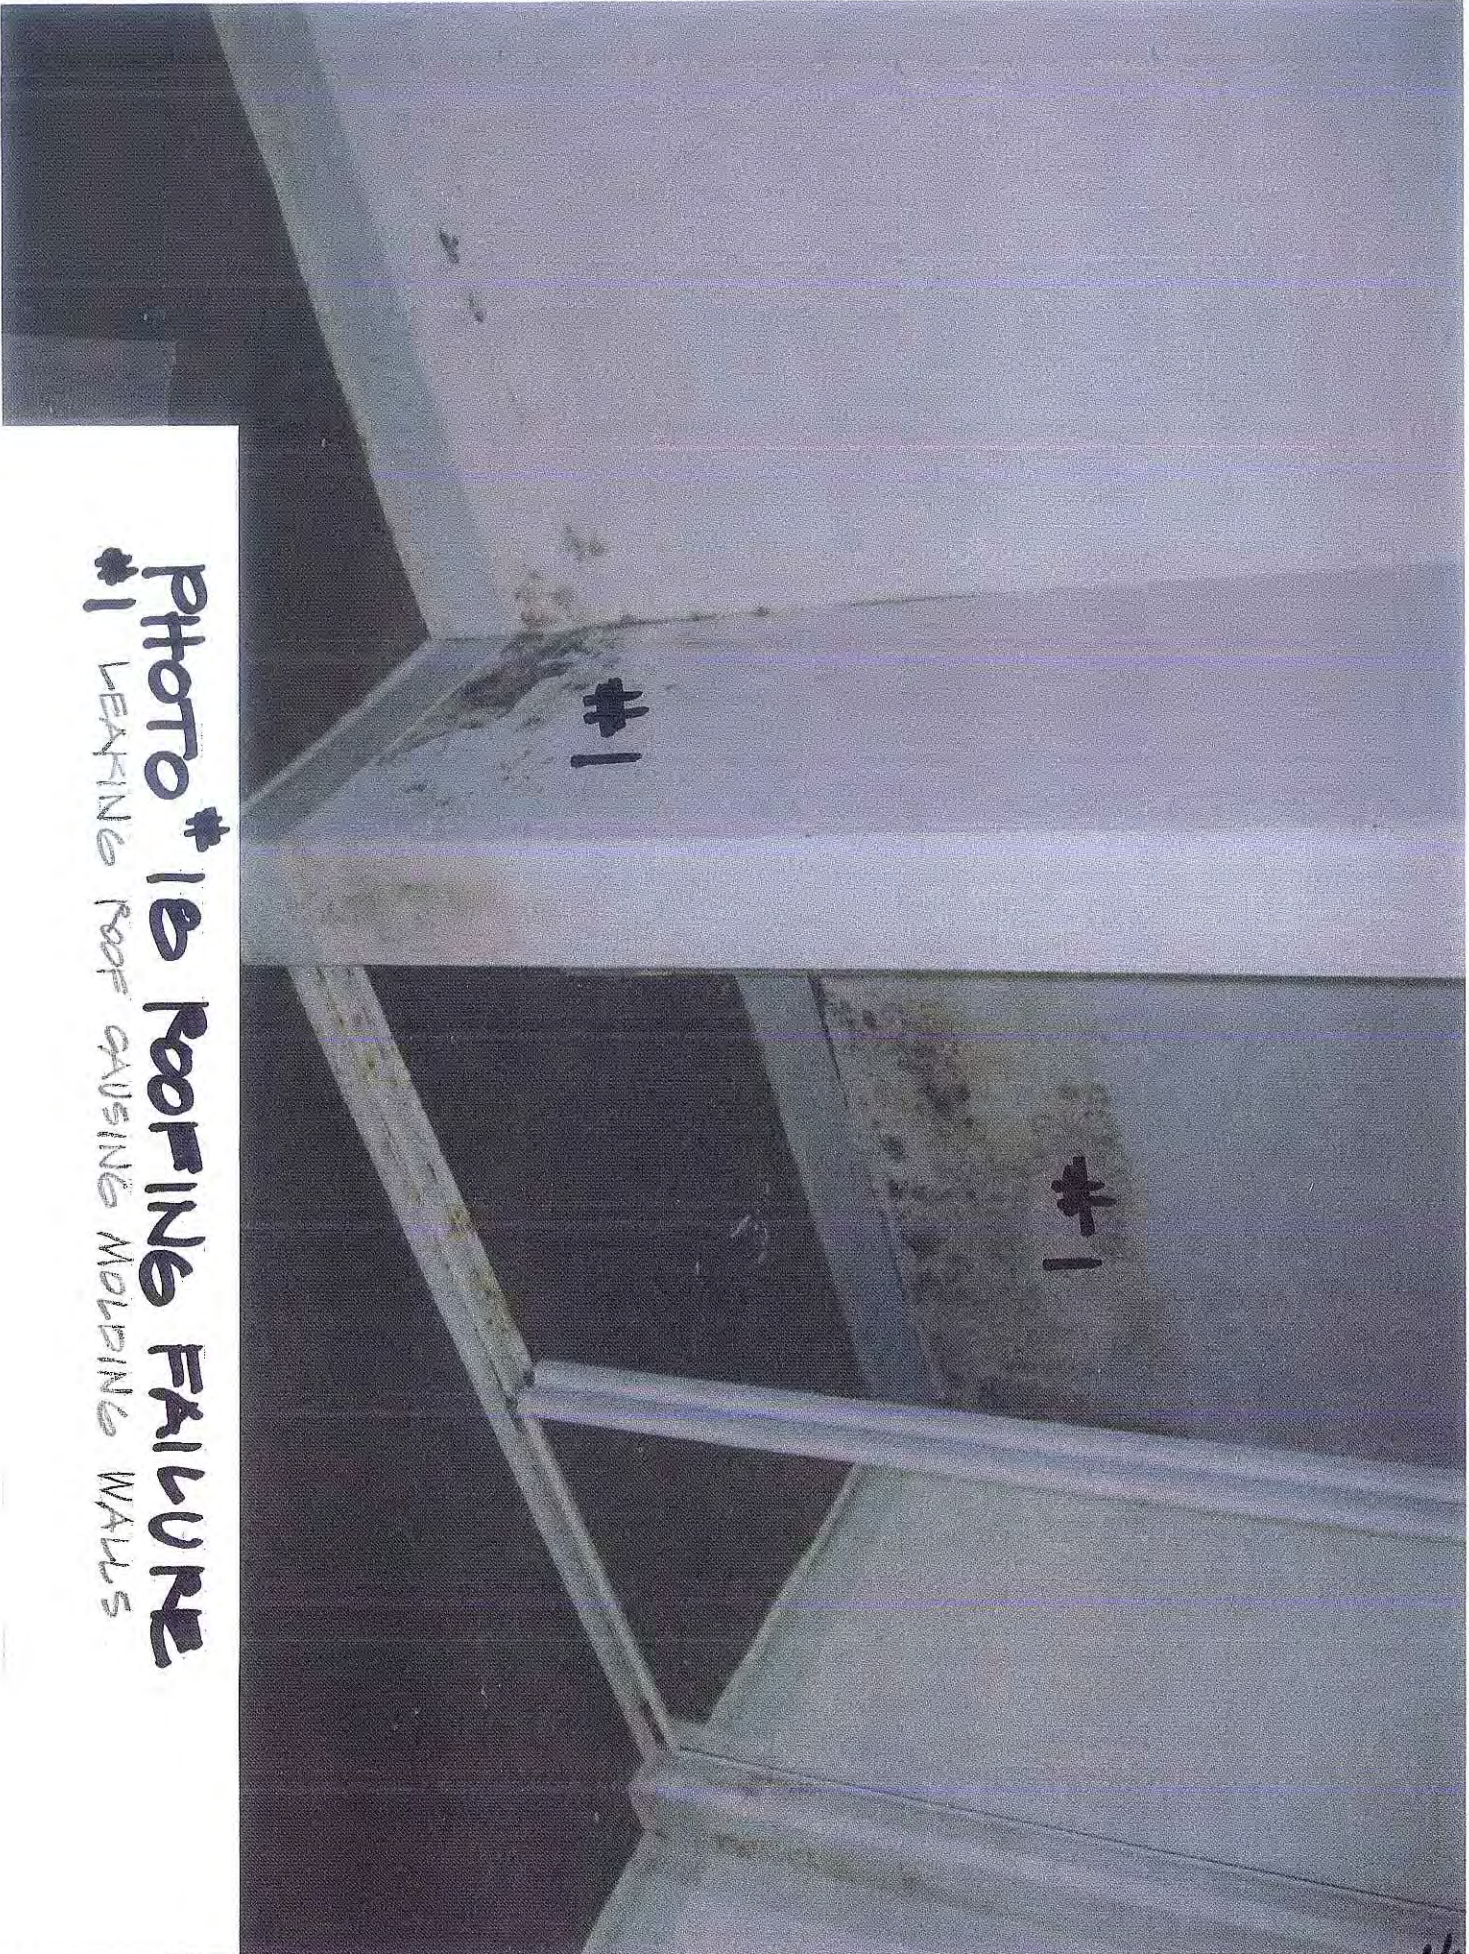
PHOTO #18 ROOFING FAILURE
#1 LEAKING ROOF CAUSING MOLDING WALLS

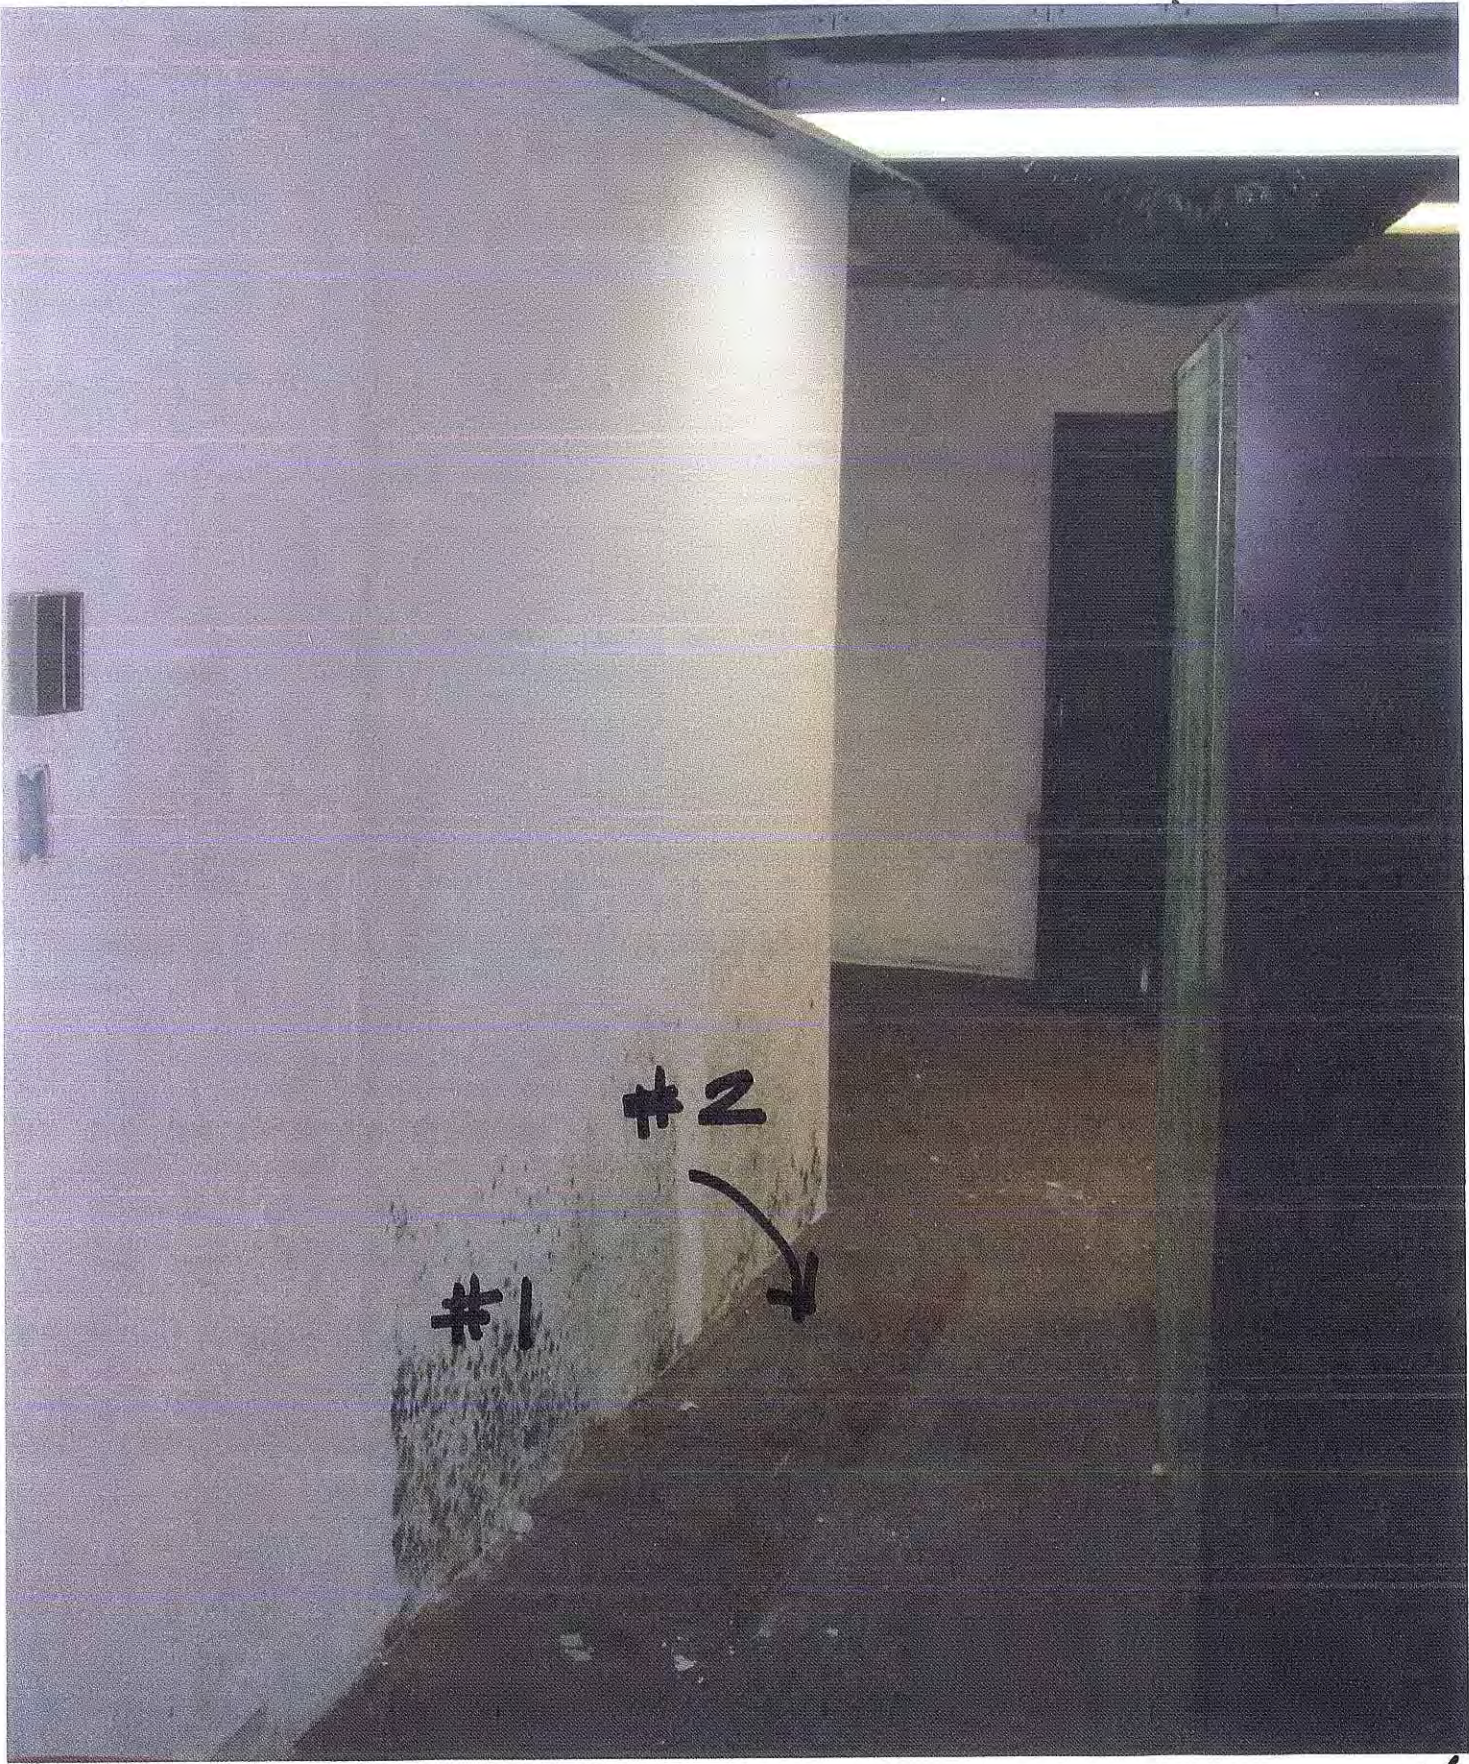
PHOTO #19 LEAKING ROOF

- #1 DAMAGE & MOLDING WALLS
- #2 ROTTED & MOLDED CARPET

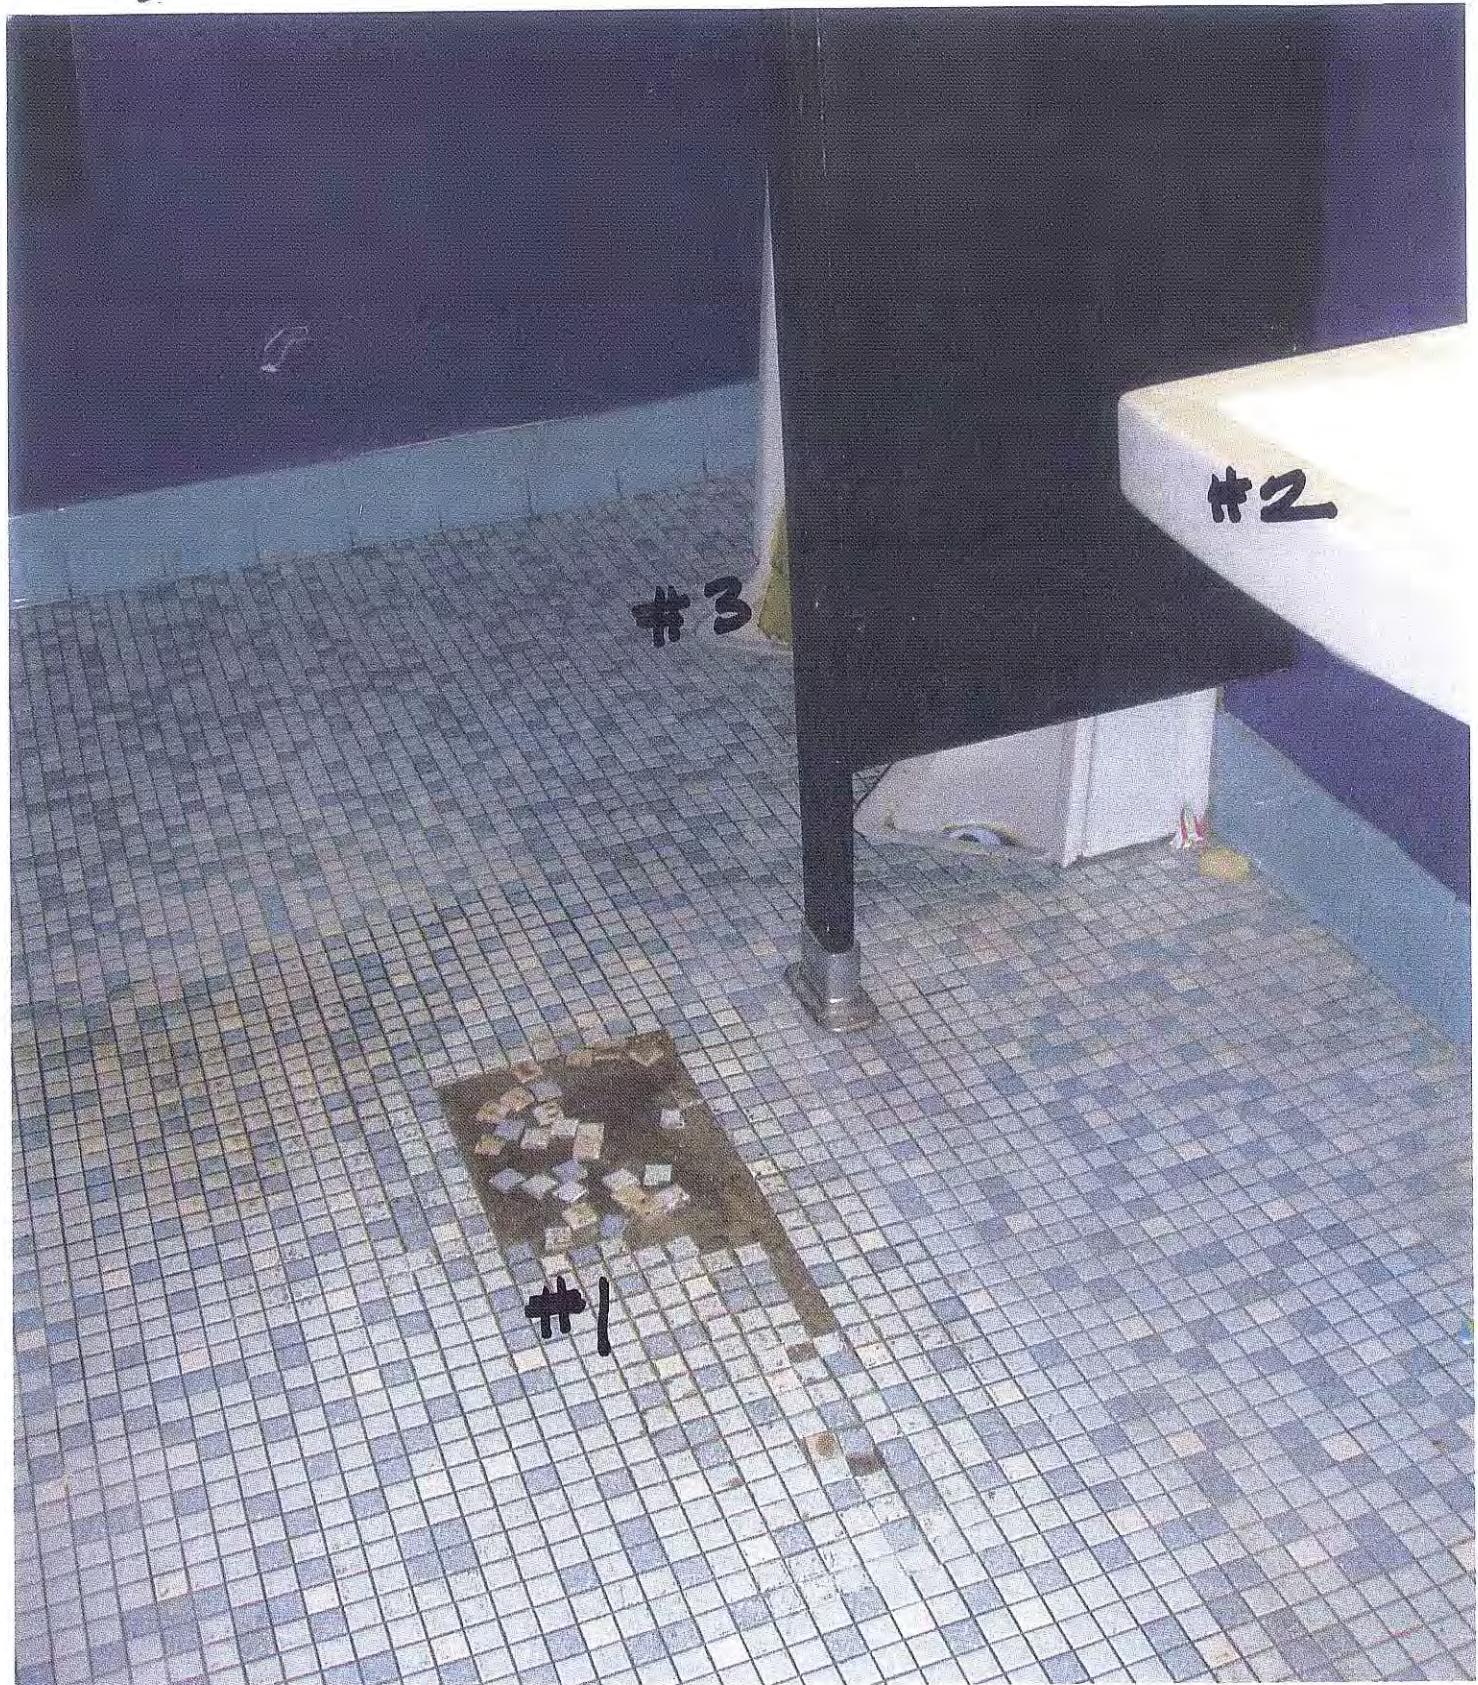
PHOTO # 20 MAIN TOILET 1ST FLR.

- #1 1970 TILE OBSOLETE & WORN-OUT
- #2 1970's TOILET FIXTURES OBSOLETE
- #3 1970's URINAL NON-FUNCTIONAL

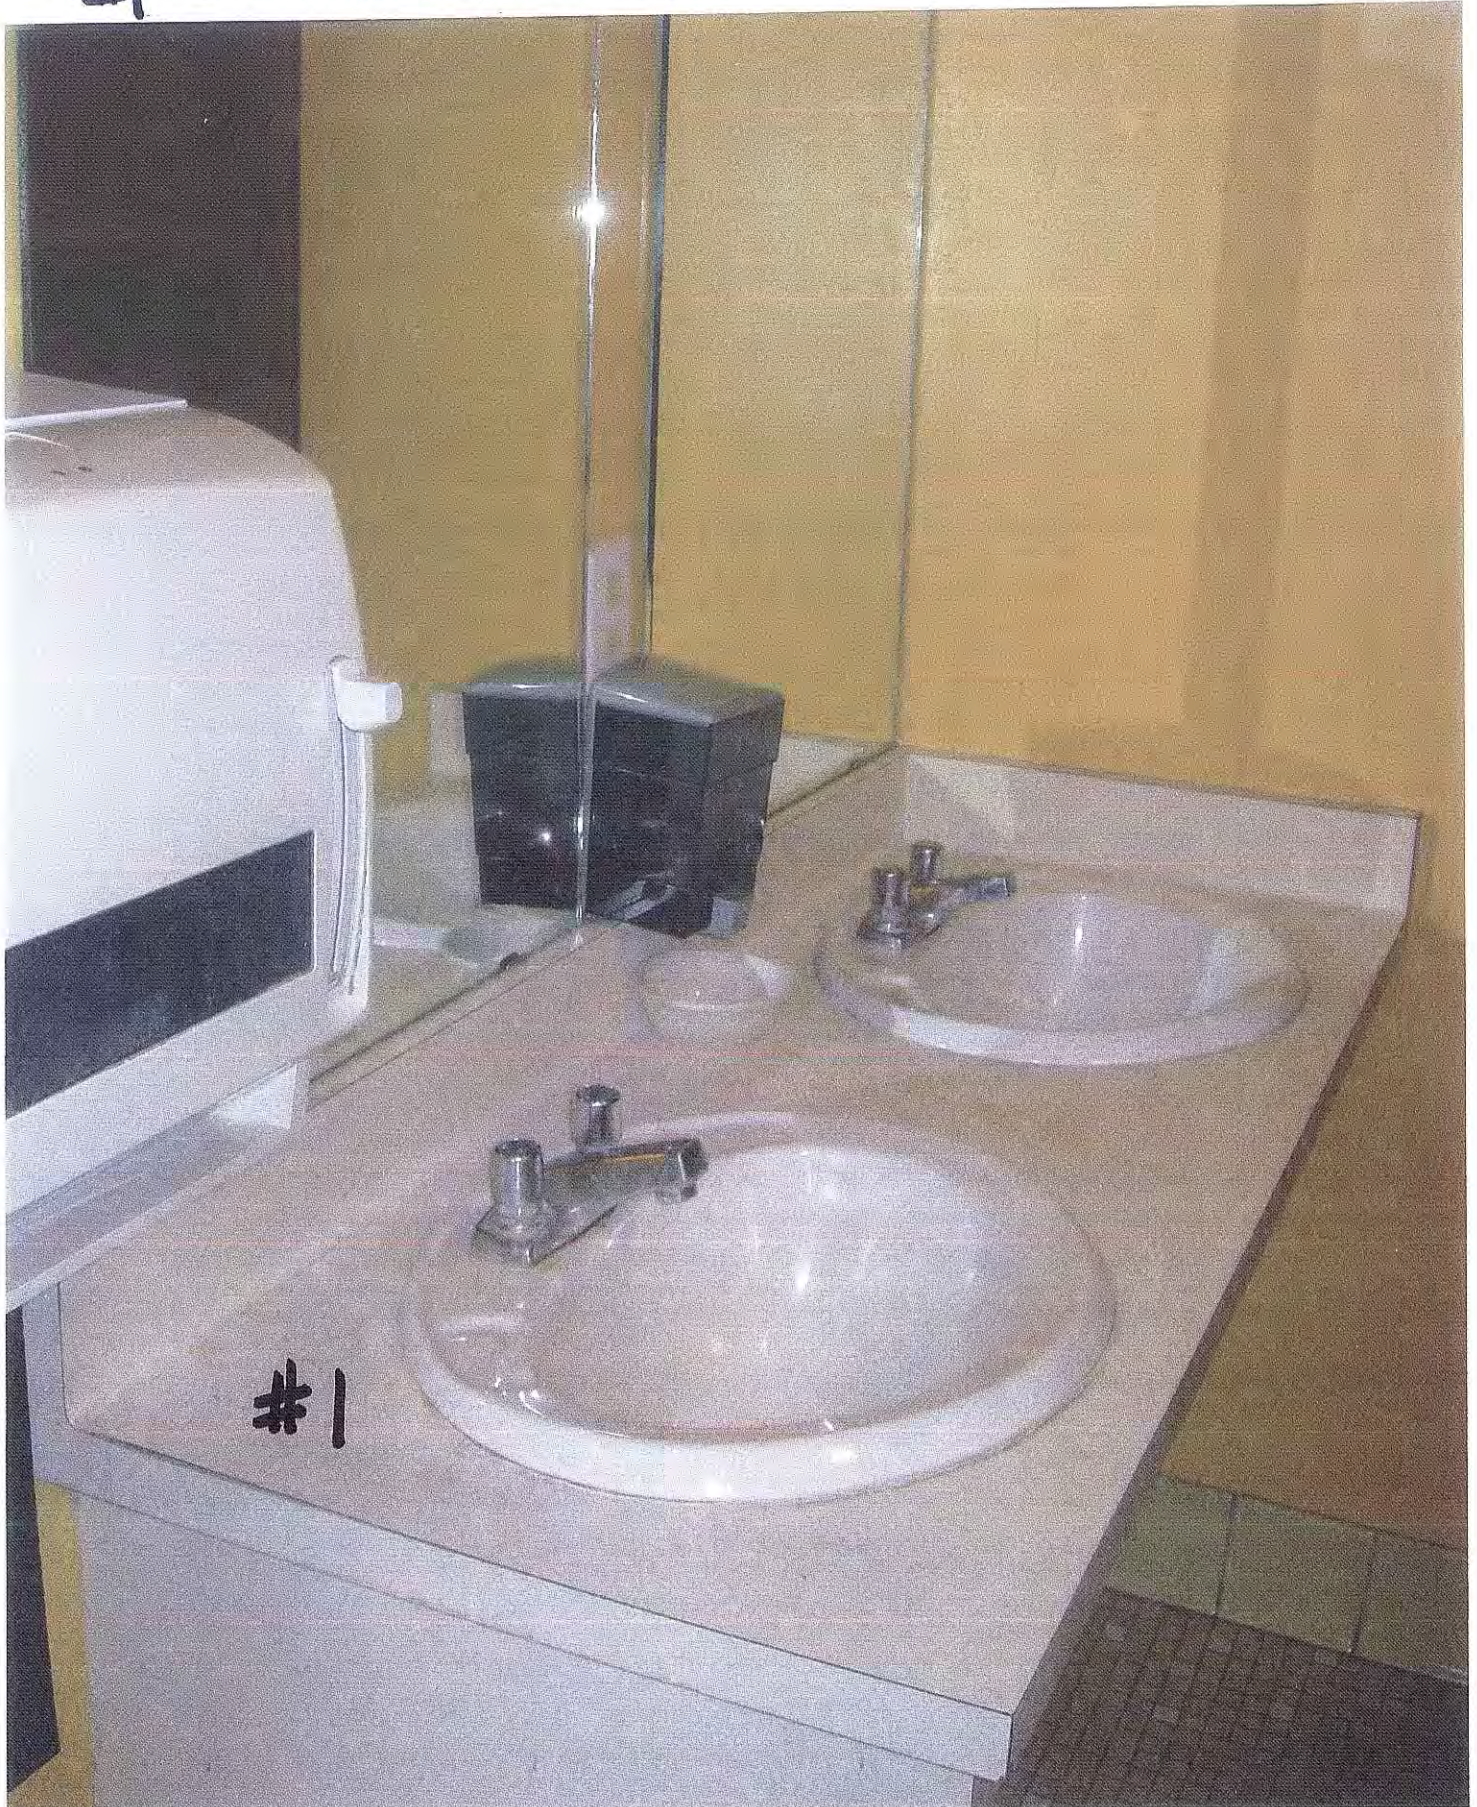
PHOTO # 21 MAIN TOILET. WOMEN
#1 OUTDATED & NON-FUNCTIONING FIXTURES.

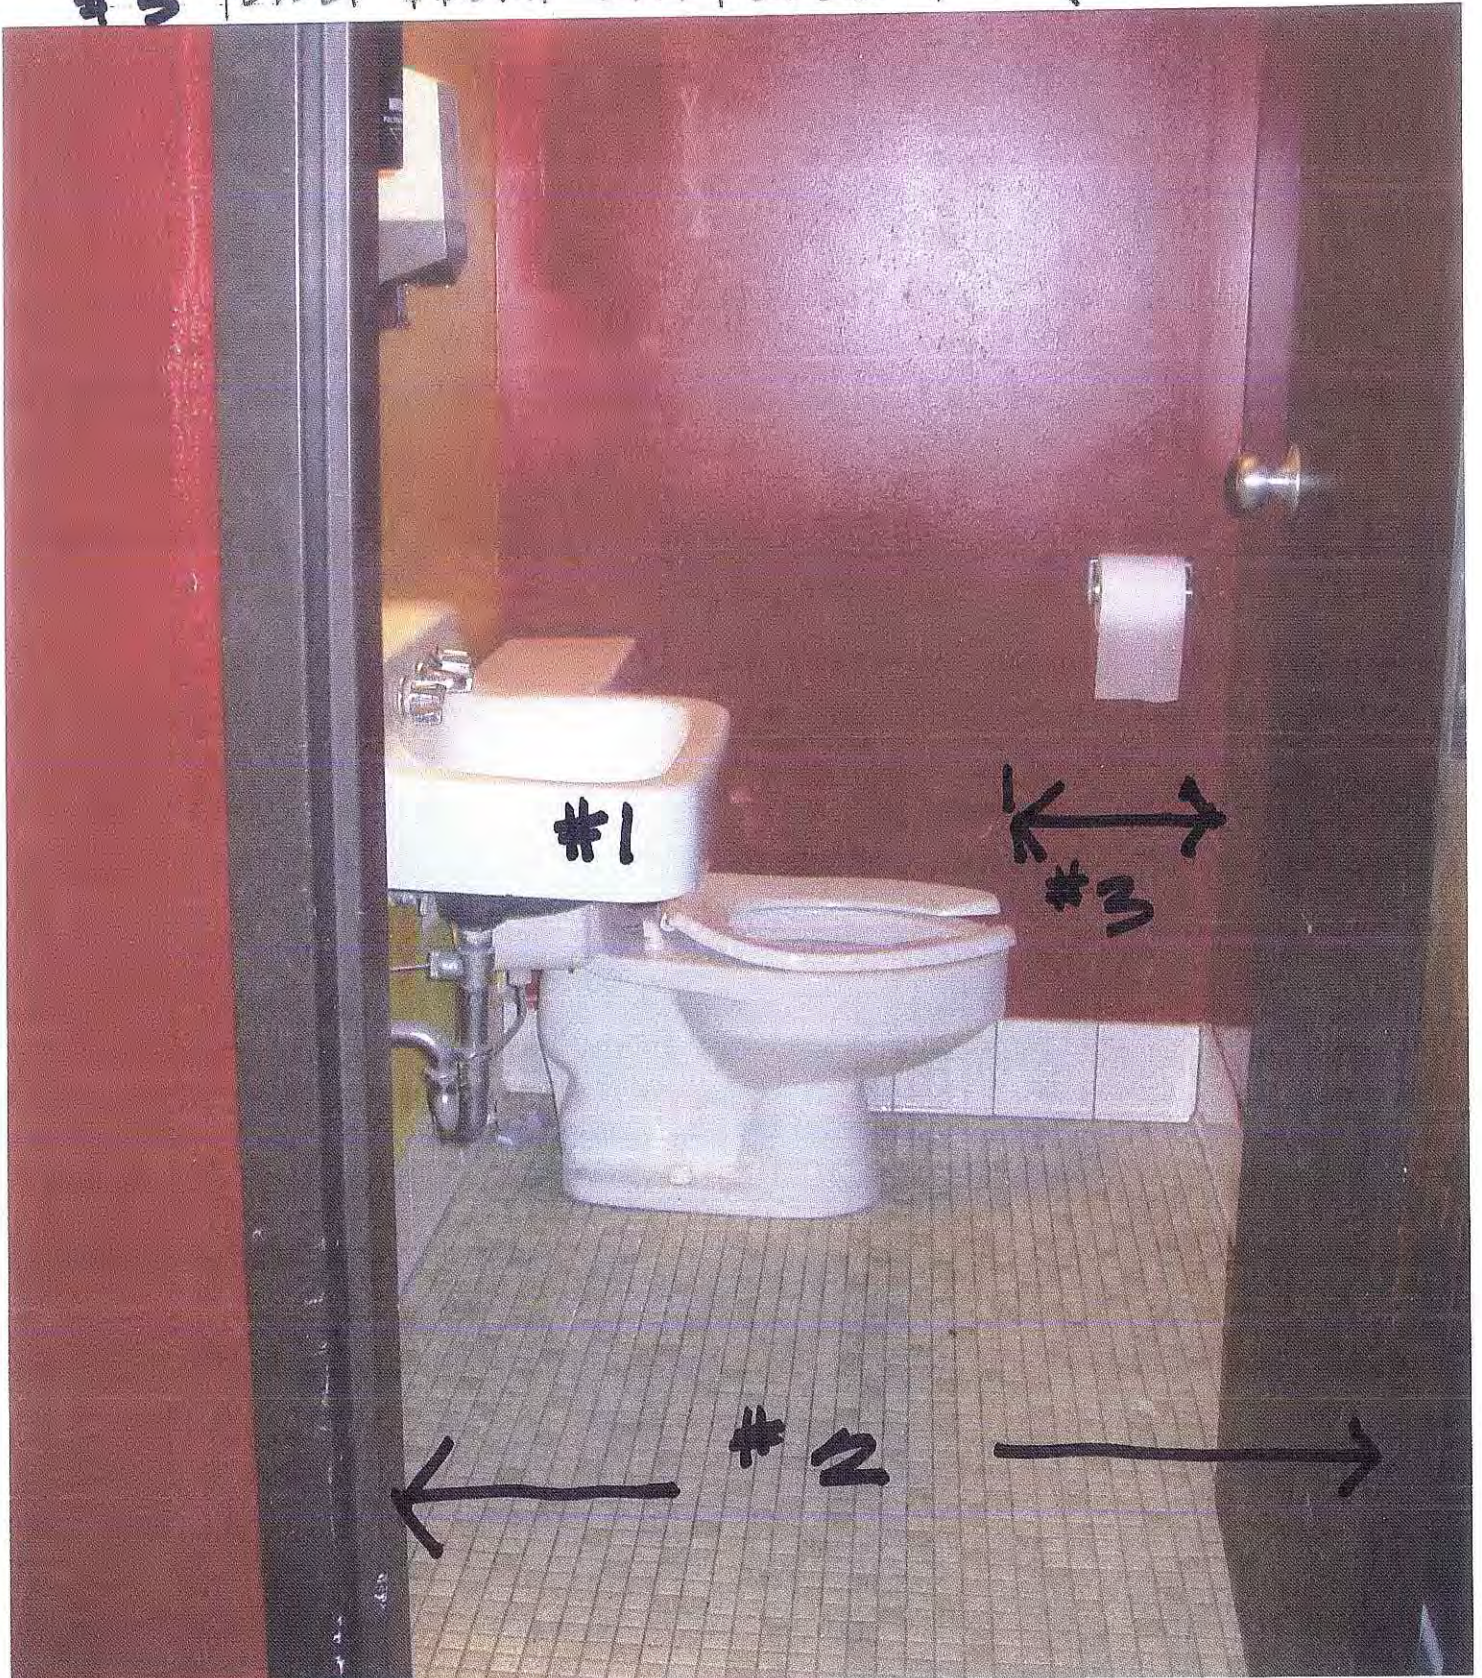
PHOTO # 22 LOWER LEVEL TOILET

#1 OUTDATED FIXTURES (NON CODE CONFORMING)

#2 DOOR WIDTH 2'-0" / HANDICAP REQUIRES 2'-10"

#3 TOILET FRONT CLEARANCE 1'-6" (3'-0" REQ'D)
