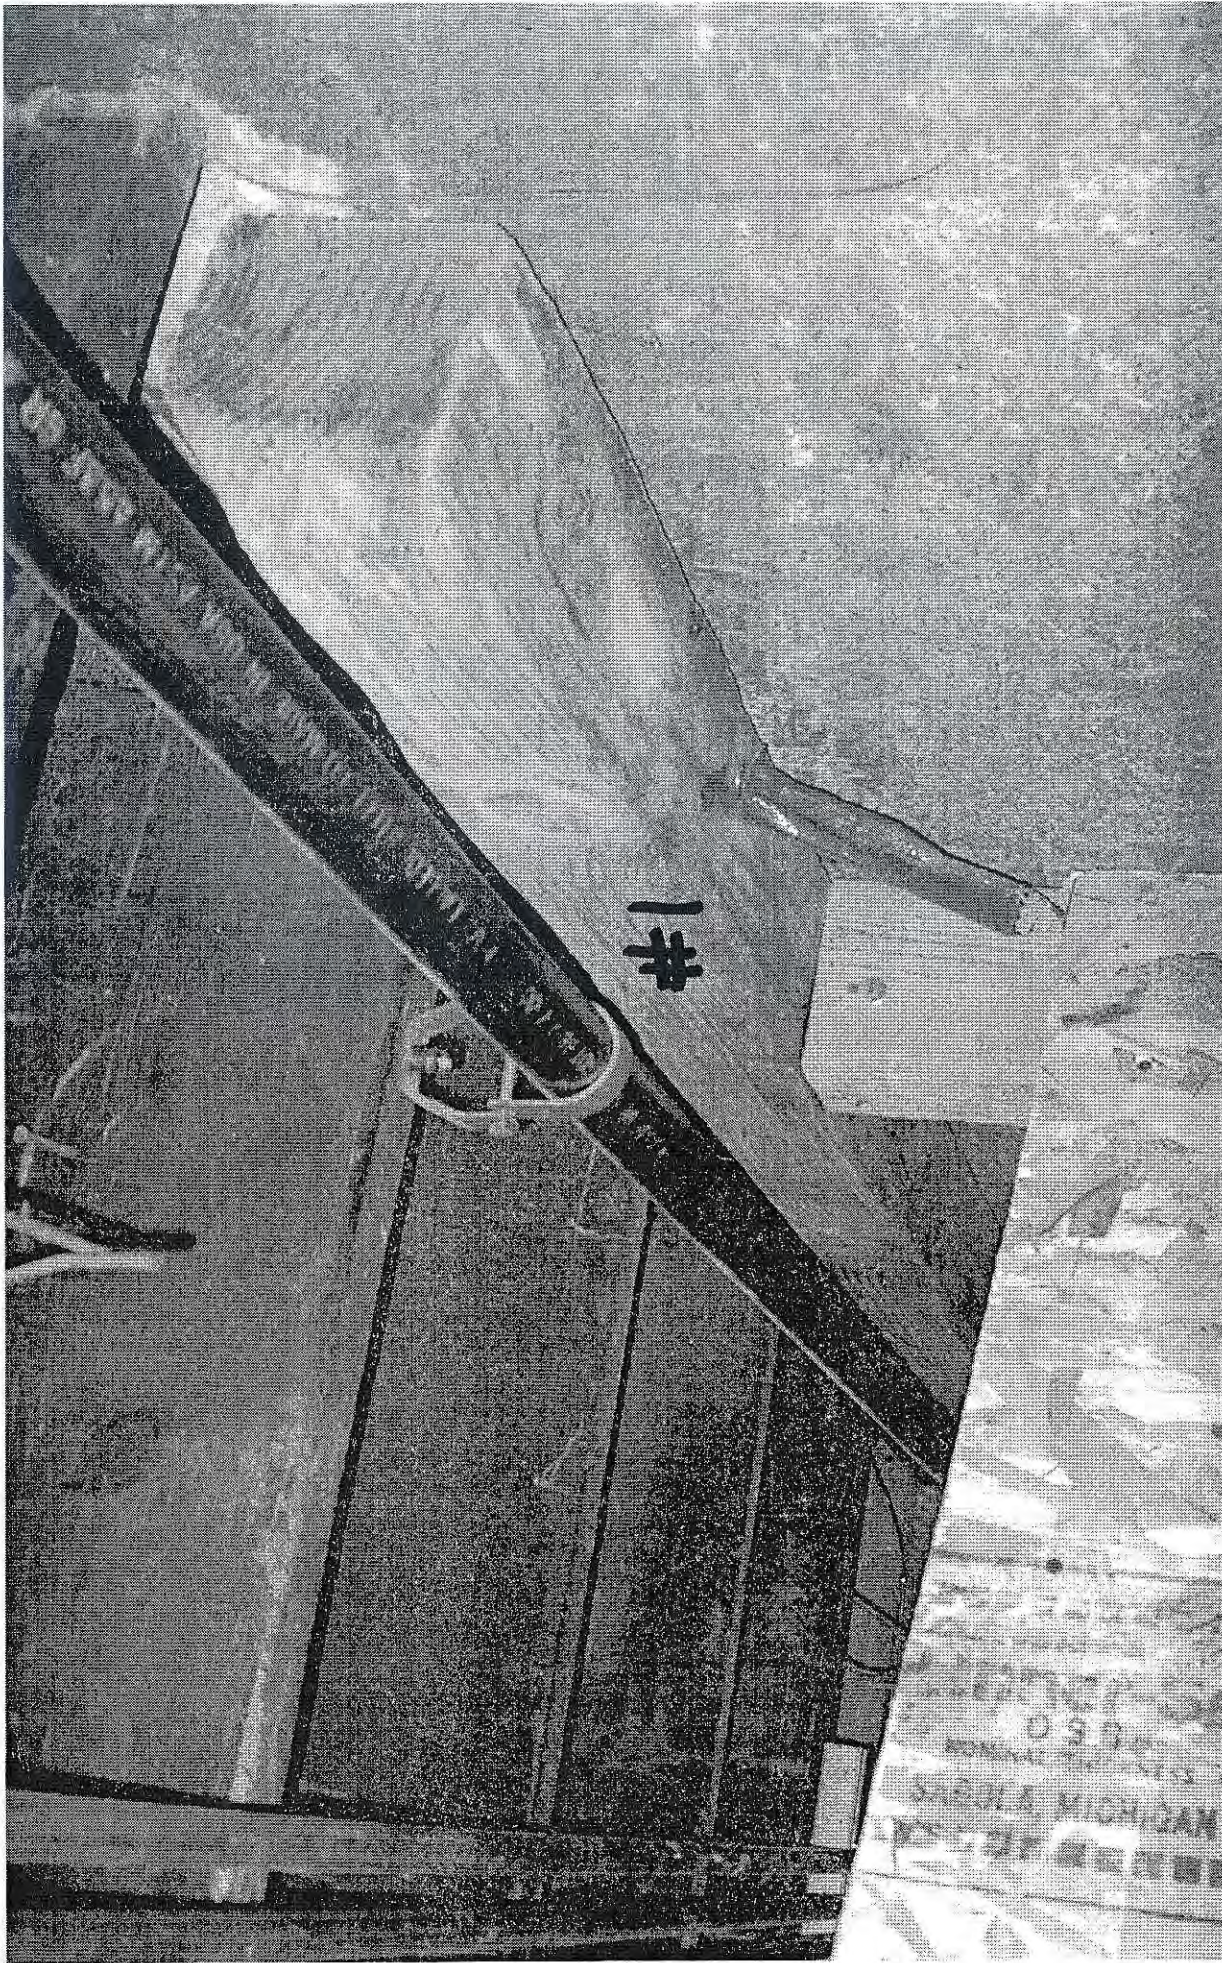
PHOTO # 23 FINISHES.

#1 TYPICAL TENANT SPACE FLOOR FINISHES - WORN BEYOND USE ... REQUIRE REPLACEMENT

#2 TYPICAL FIXTURES REQUIRE REPLACEMENT 14-

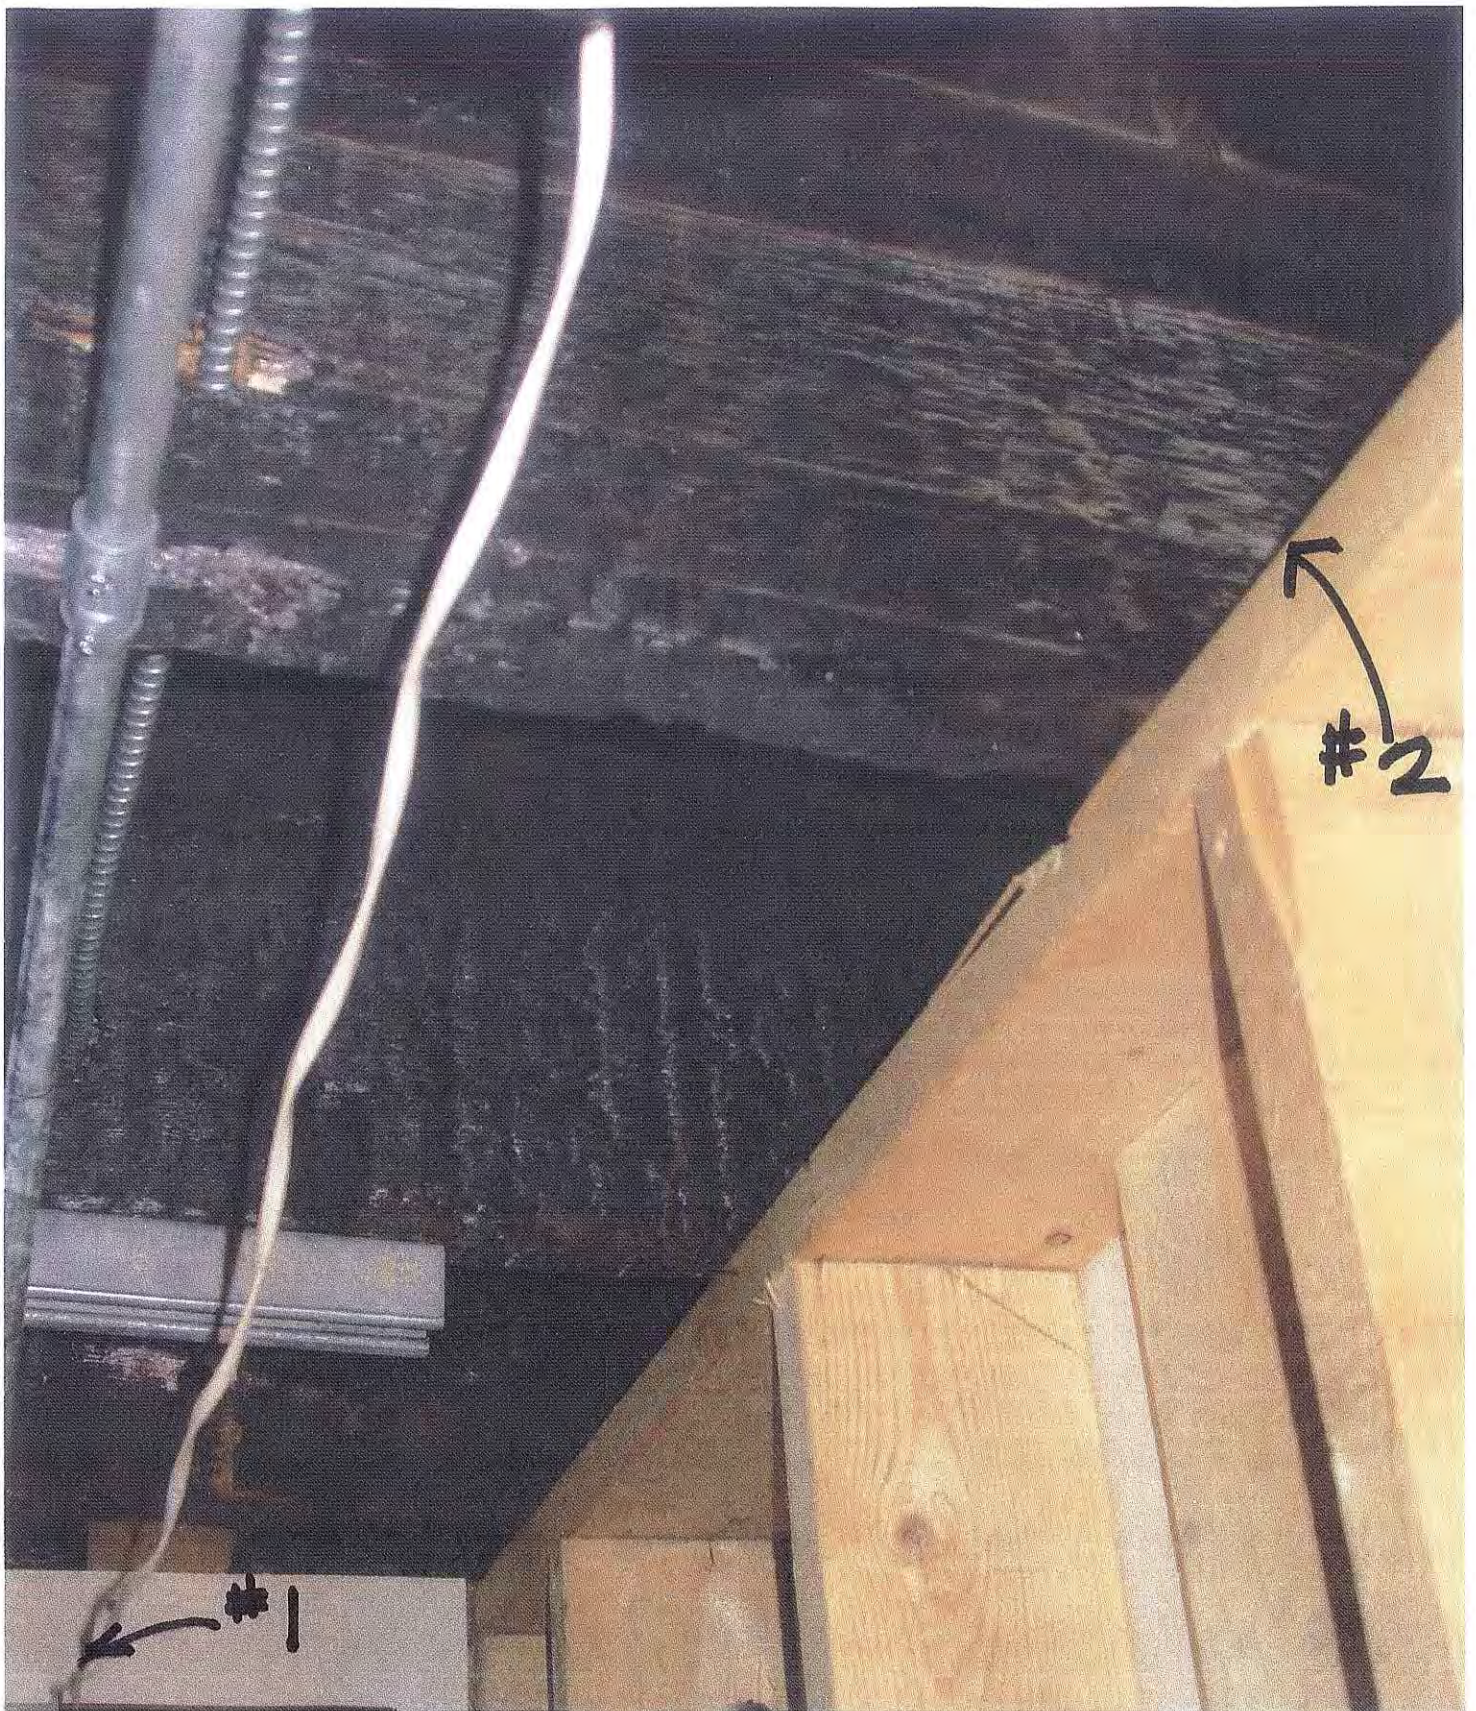
PHOTO # 24 1509 STRUCTURAL

← #1 FLOOR JOIST REINFORCED BEARING - TEMPORARY

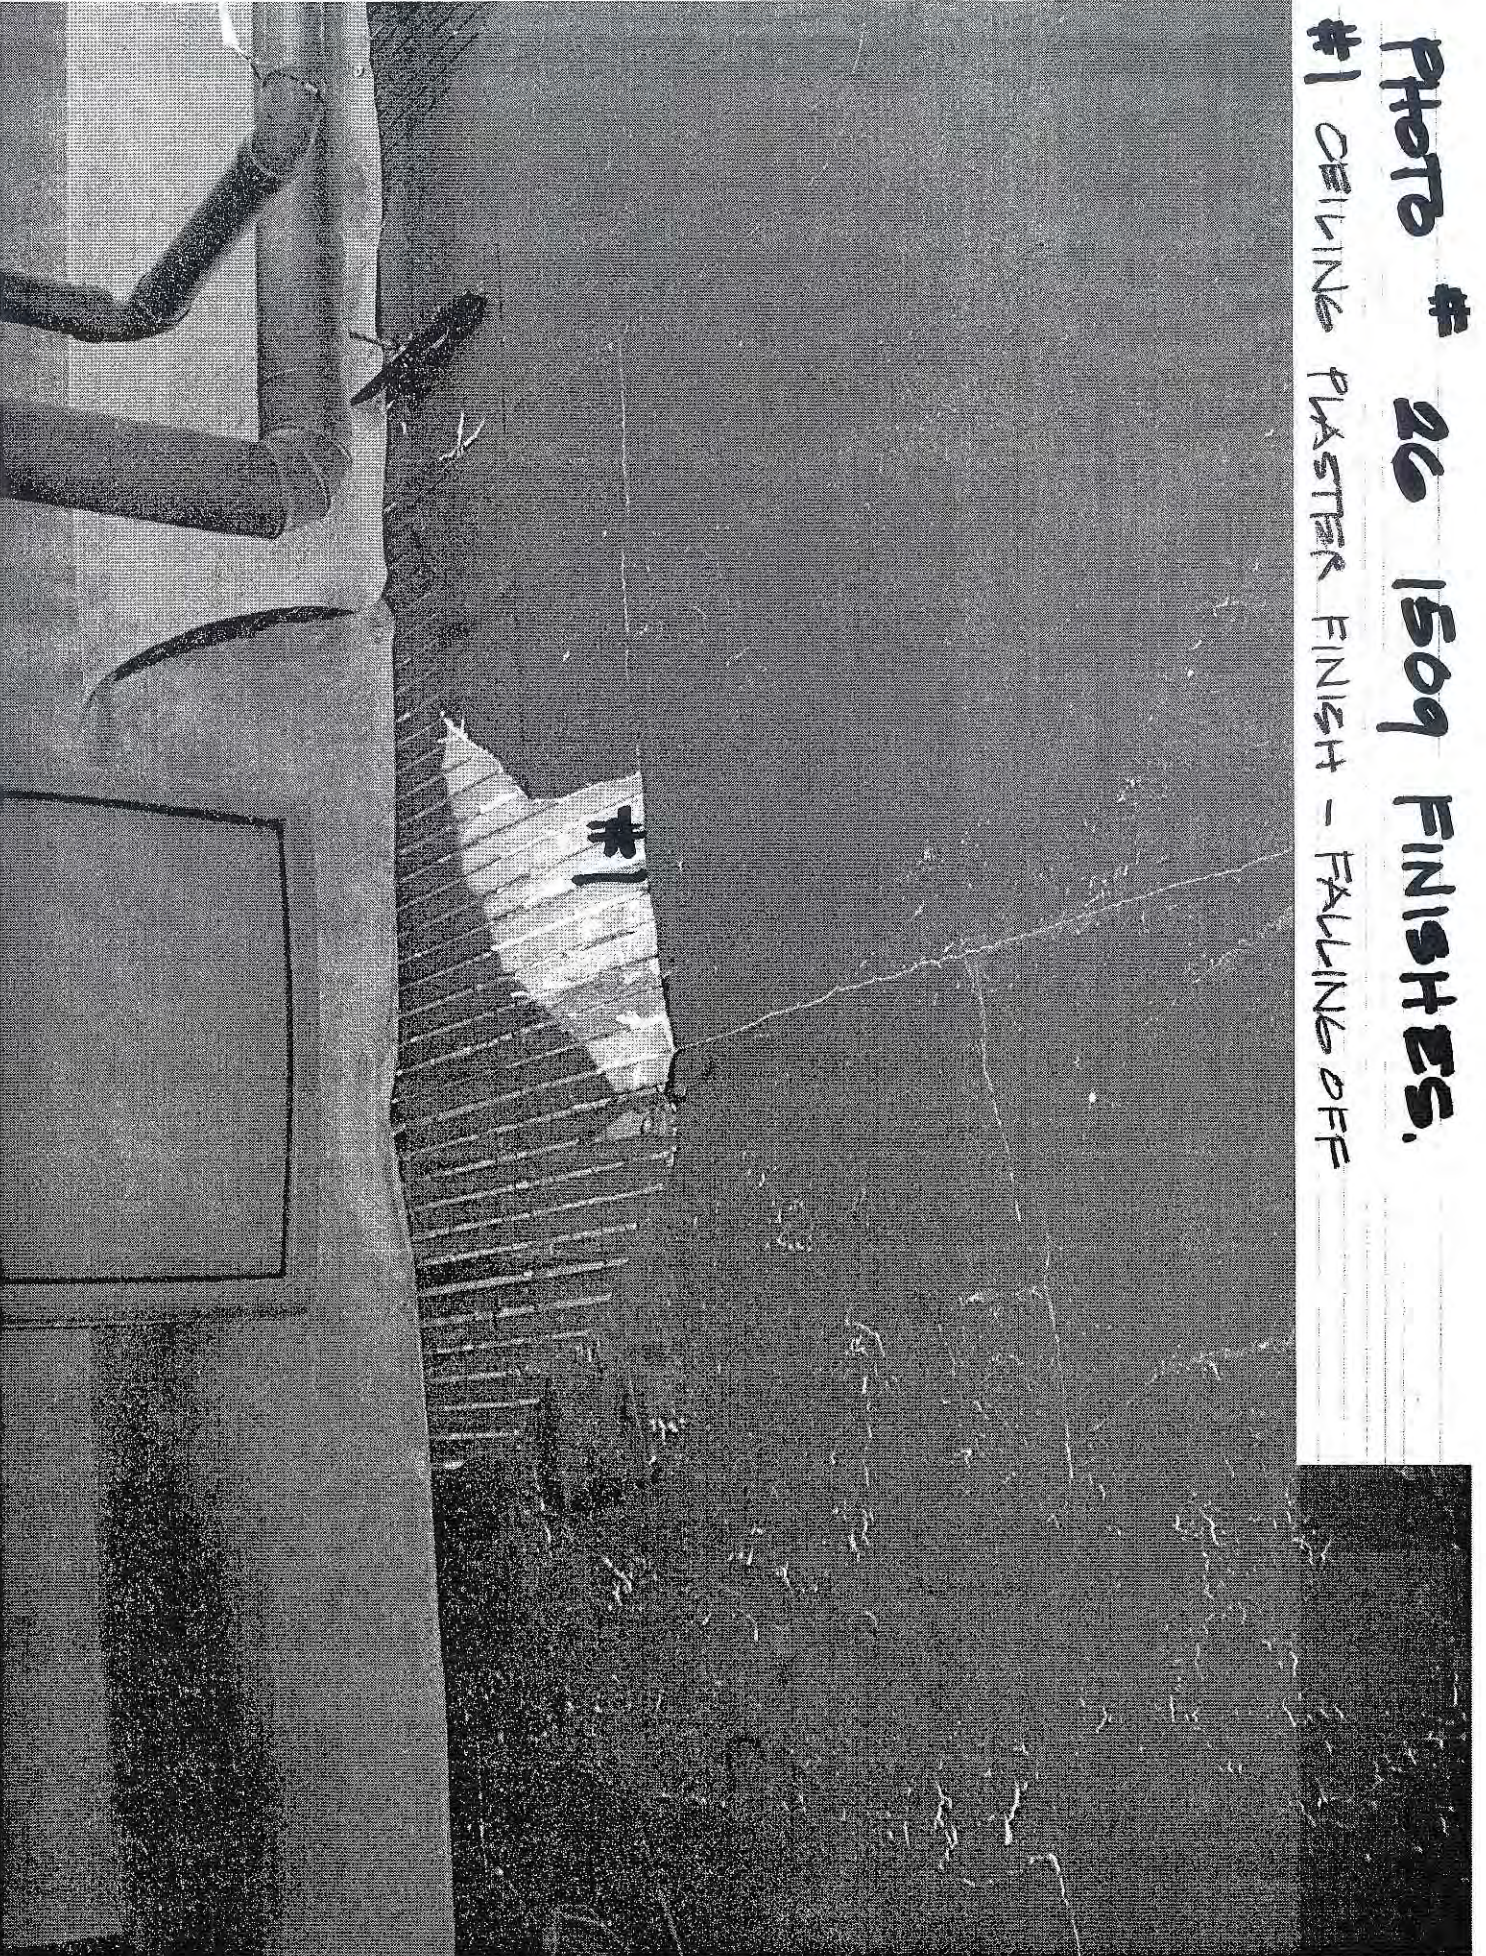
PHOTO # 25 1509 STRUCTURAL/MECH.

#1 TEMPORARY WIRING THROUGH-OUT

#2 30% FLOOR JOISTS BURNT IN 1970 FIRE

PHOTO # 20 1509 FINISHES.
#1 ORIGINAL PLASTER FINISH - FALLING OFF

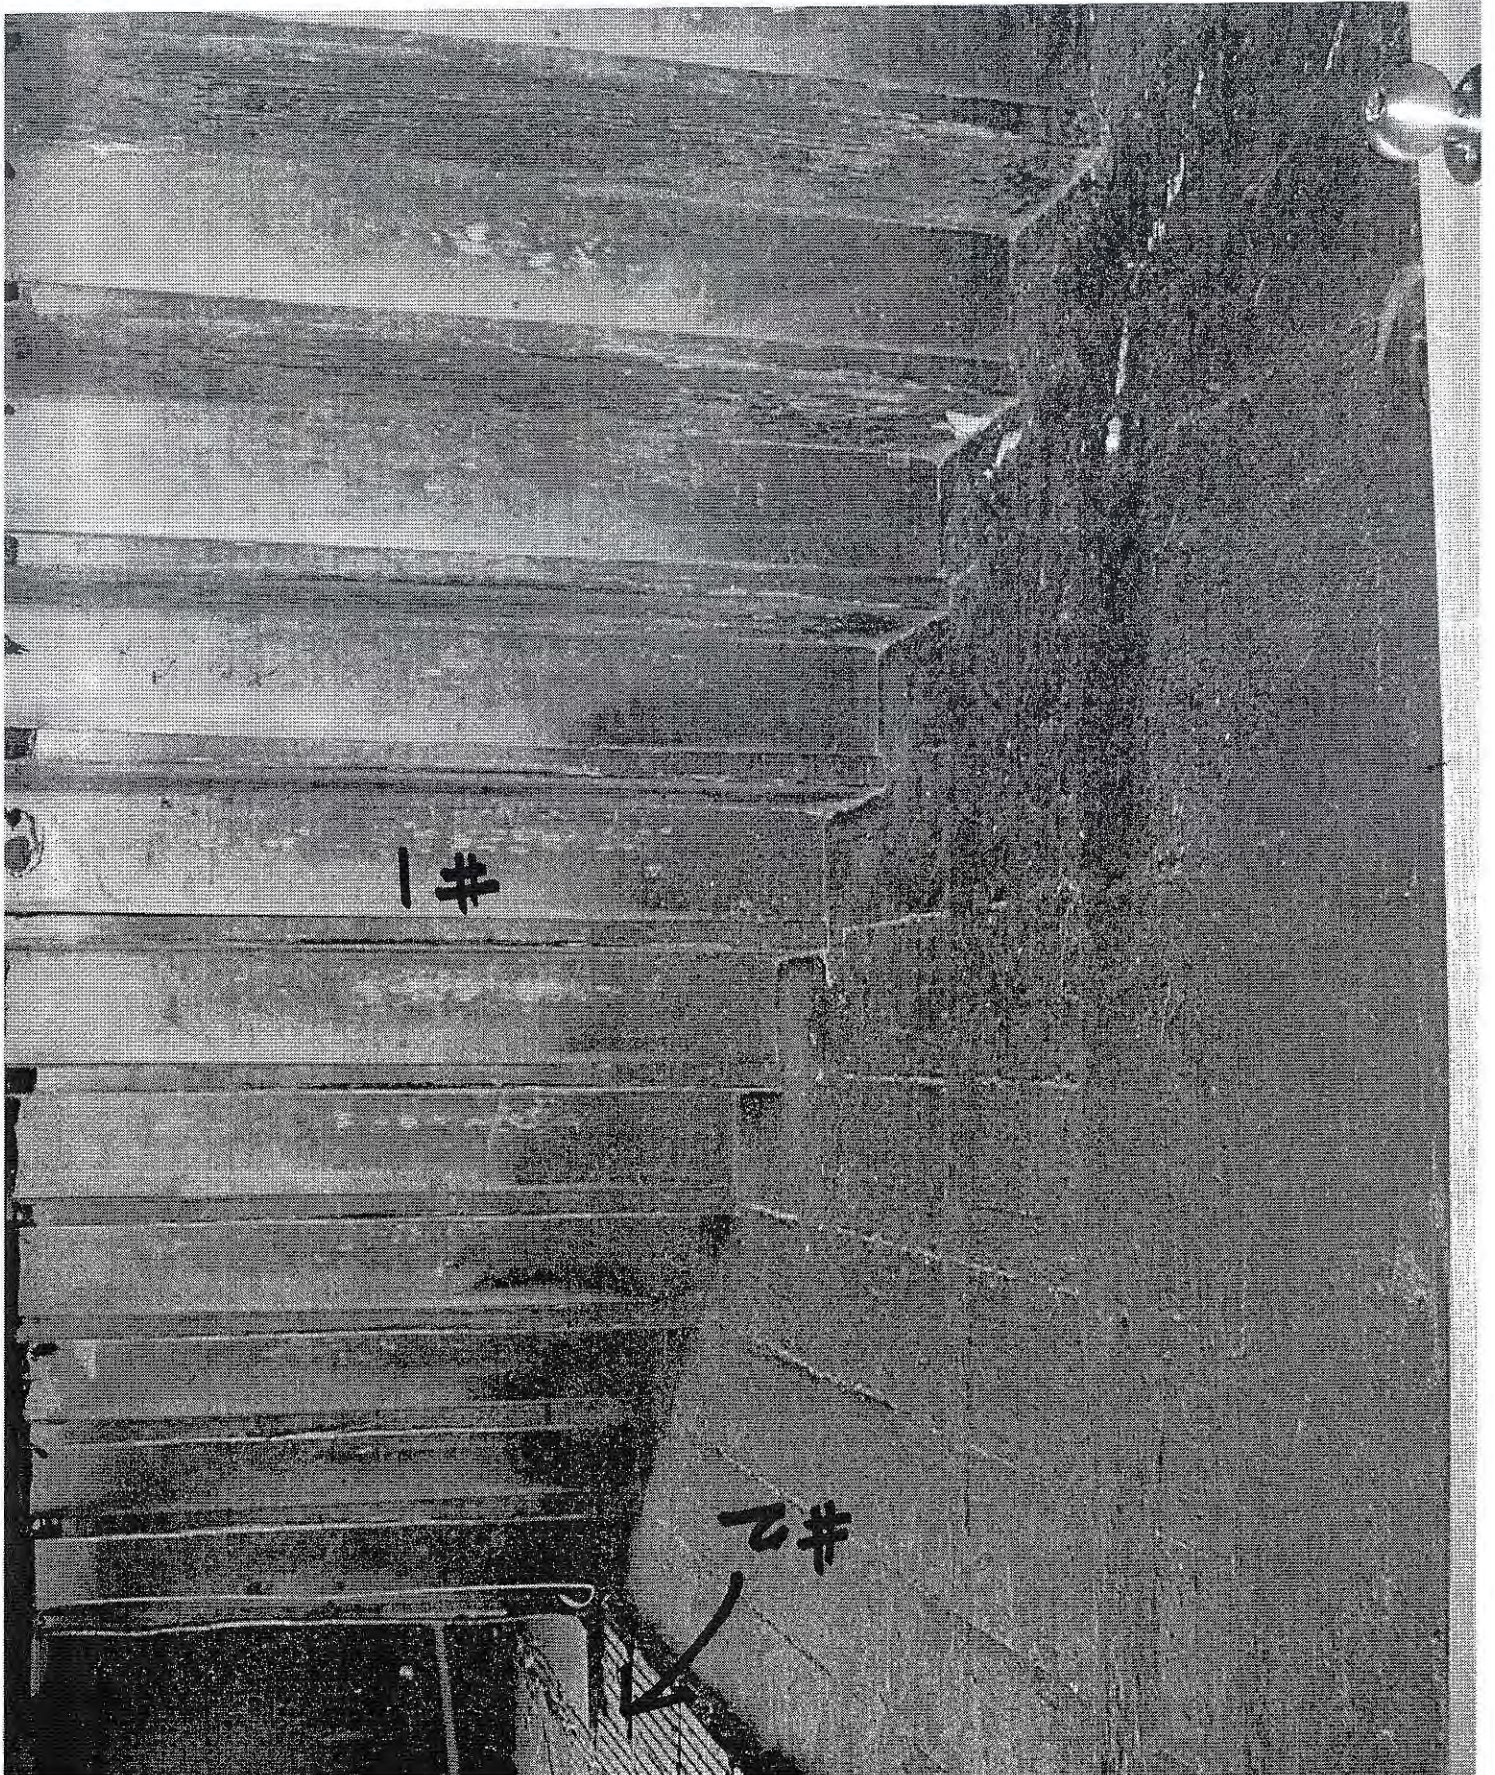
PHOTO # 27 1509 FINISHES.
#1 WORK & ROTTED 1930 STAIRS.
#2 PLASTER & WALL FINISH FALLEN OFF THRU-OUT

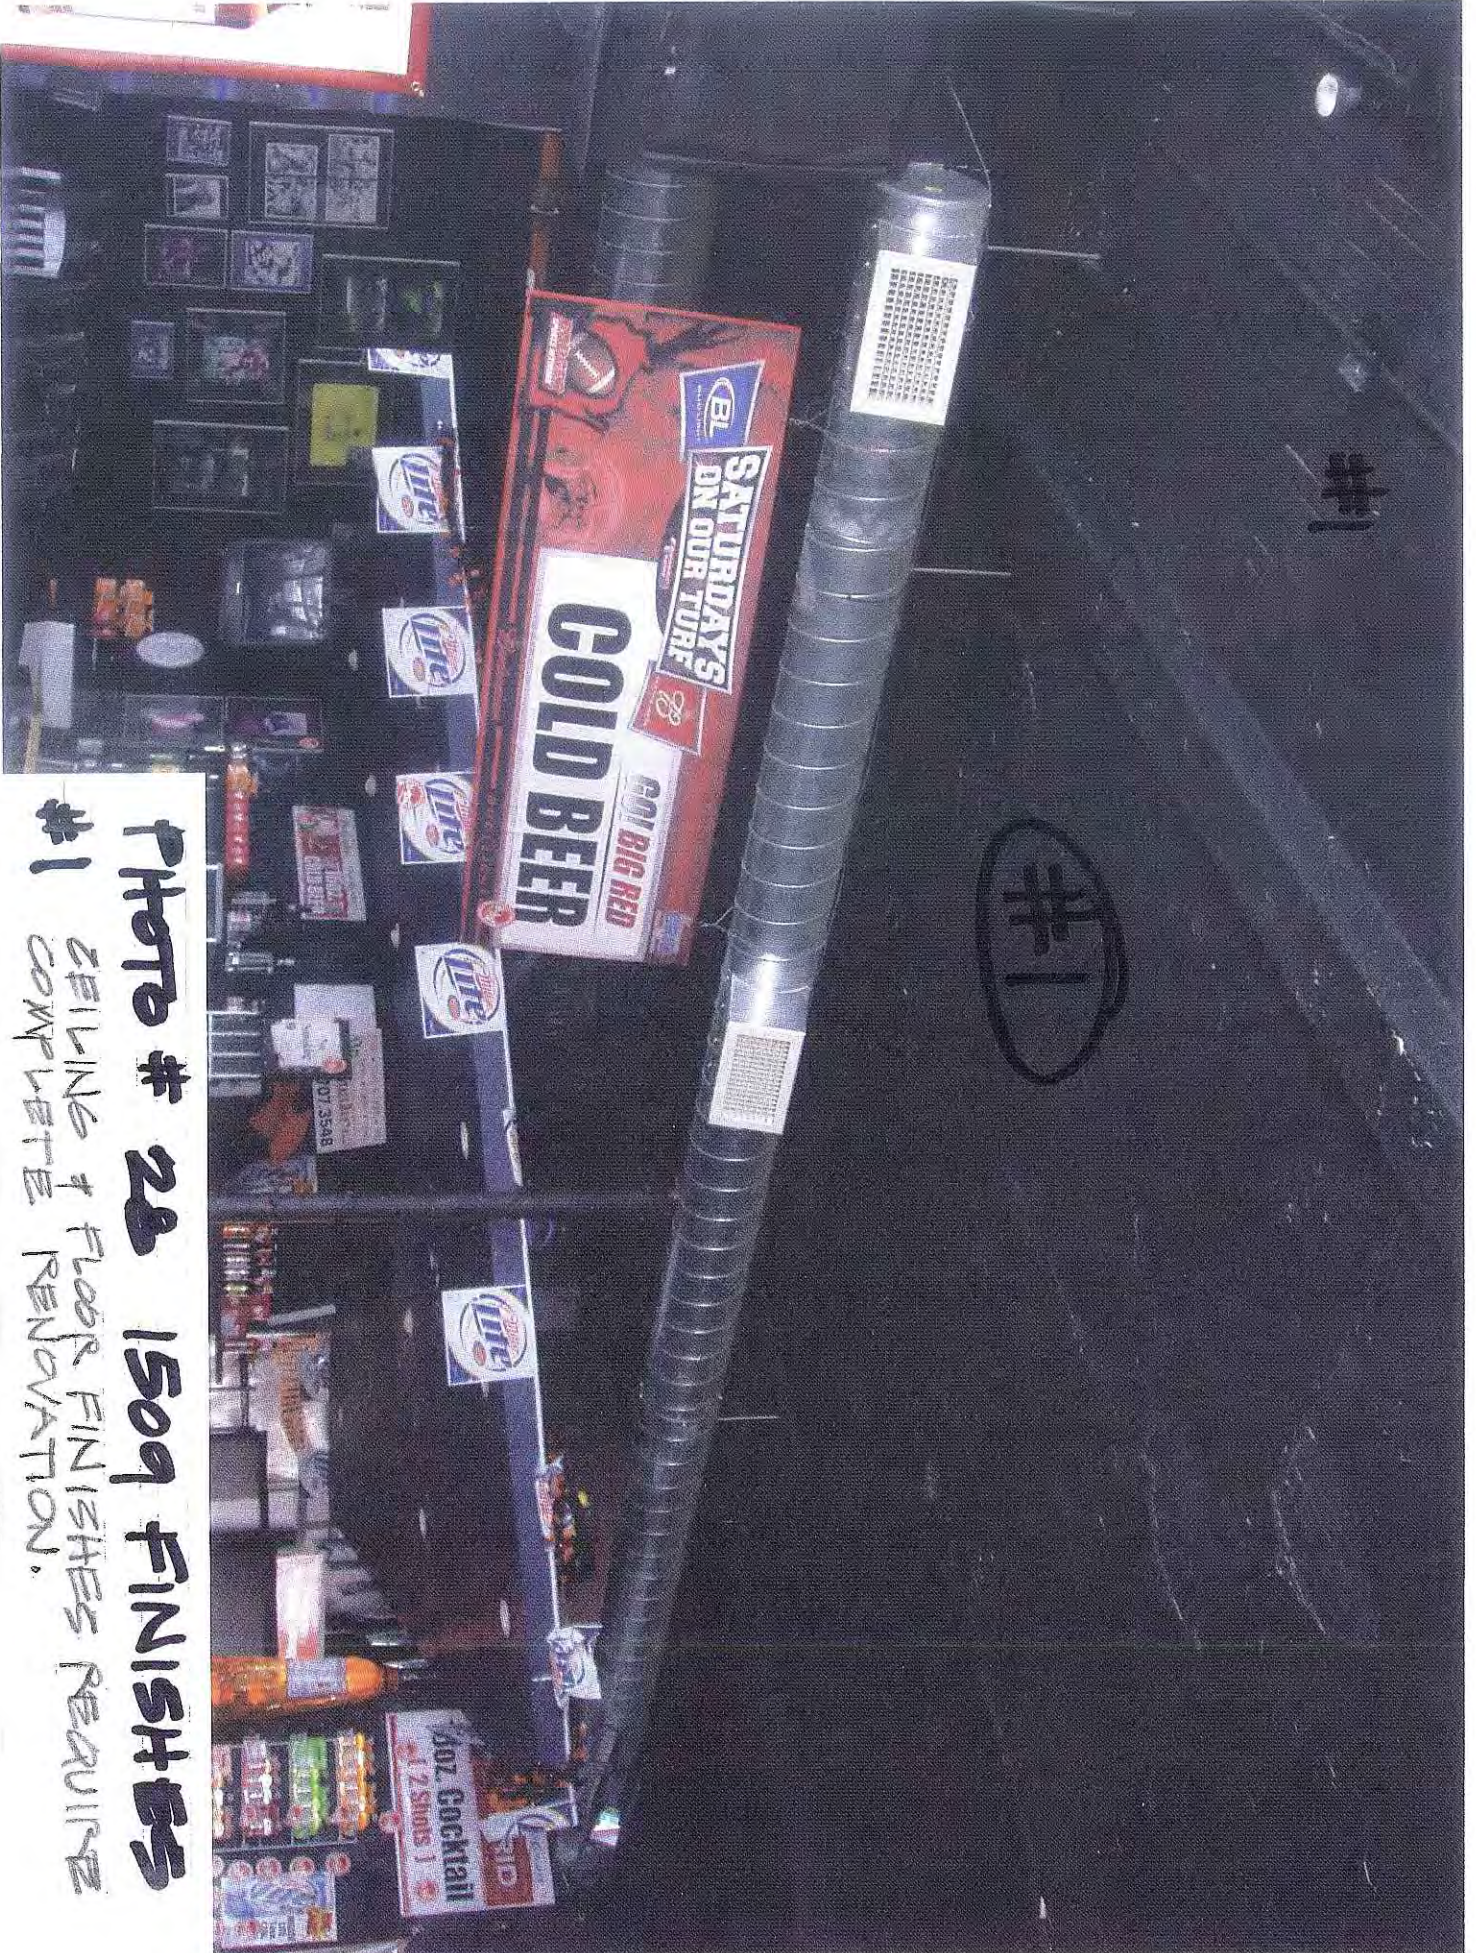
PHOTO # 28 1509 FINISHES
#1 CEILING & FLOOR FINISHES REQUIRE
COMPLETE RENOVATION.
