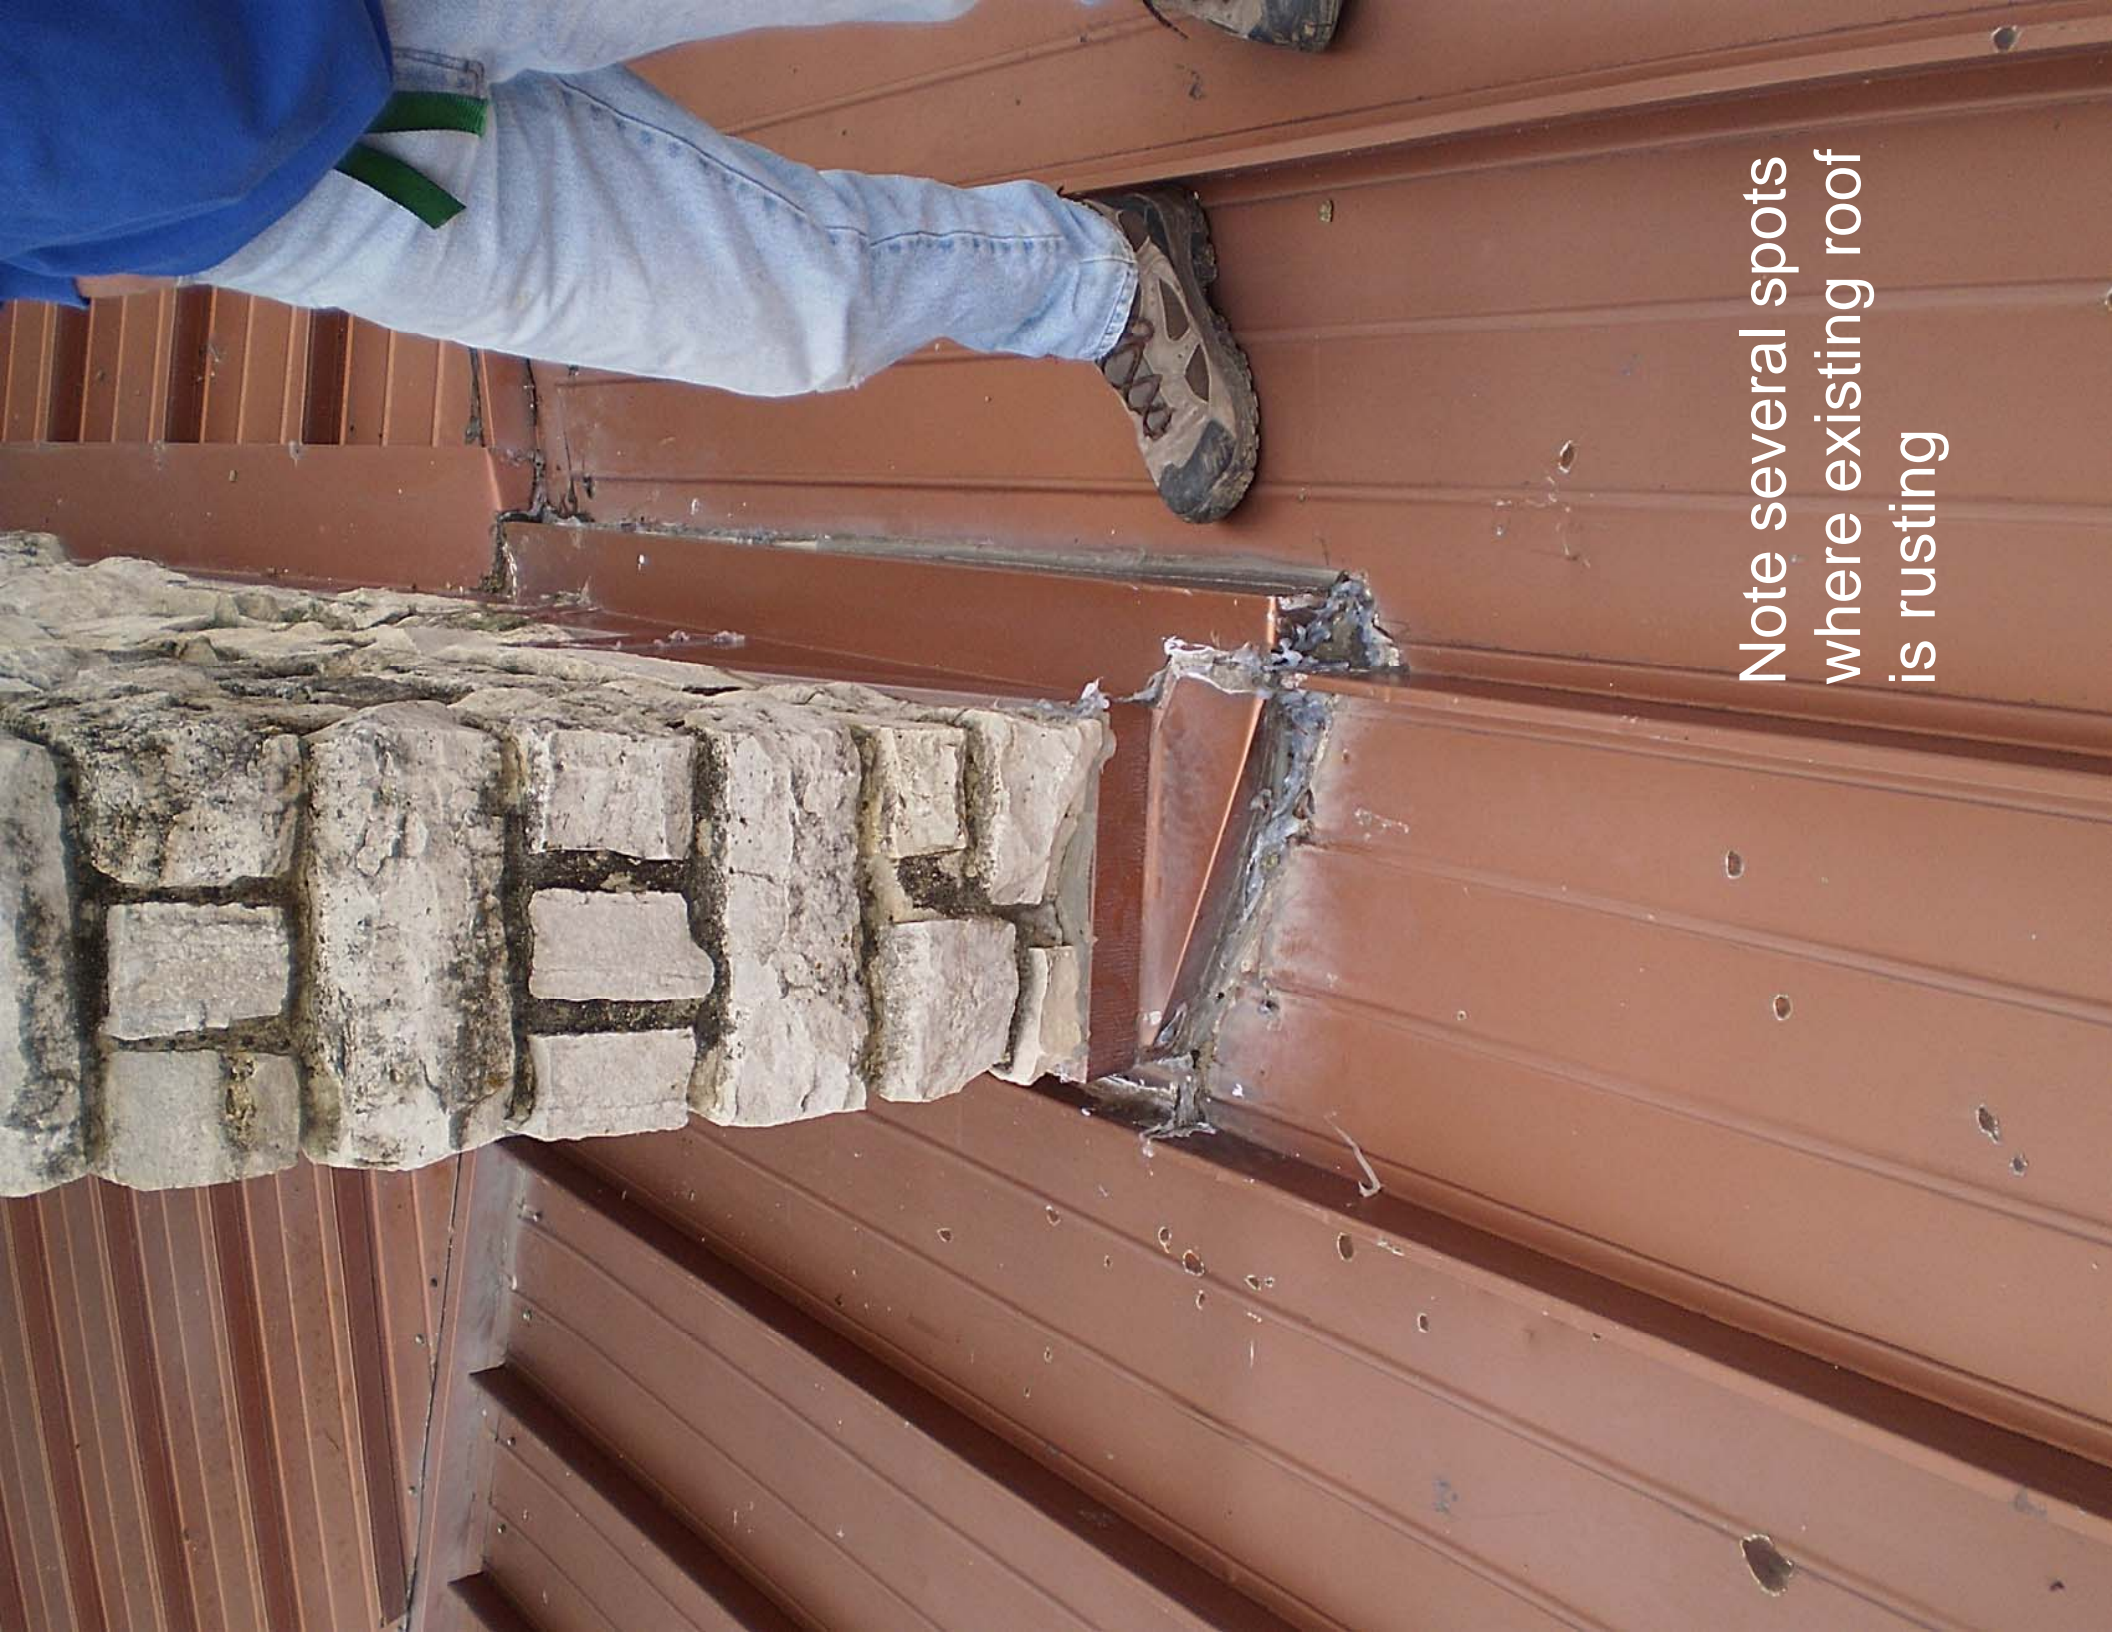
Note several spots where existing roof is rusting
