**PIERCE ENGINEERS INC**  
CONSULTING STRUCTURAL ENGINEERS  
10 West Mifflin St, Suite 205 | Madison, WI 53703  
Phone: 608.256.7304 | Fax: 608.256.7306

**SUBJECT: Structural Evaluation Report  
127 W. Gilman St  
Madison, Wisconsin**

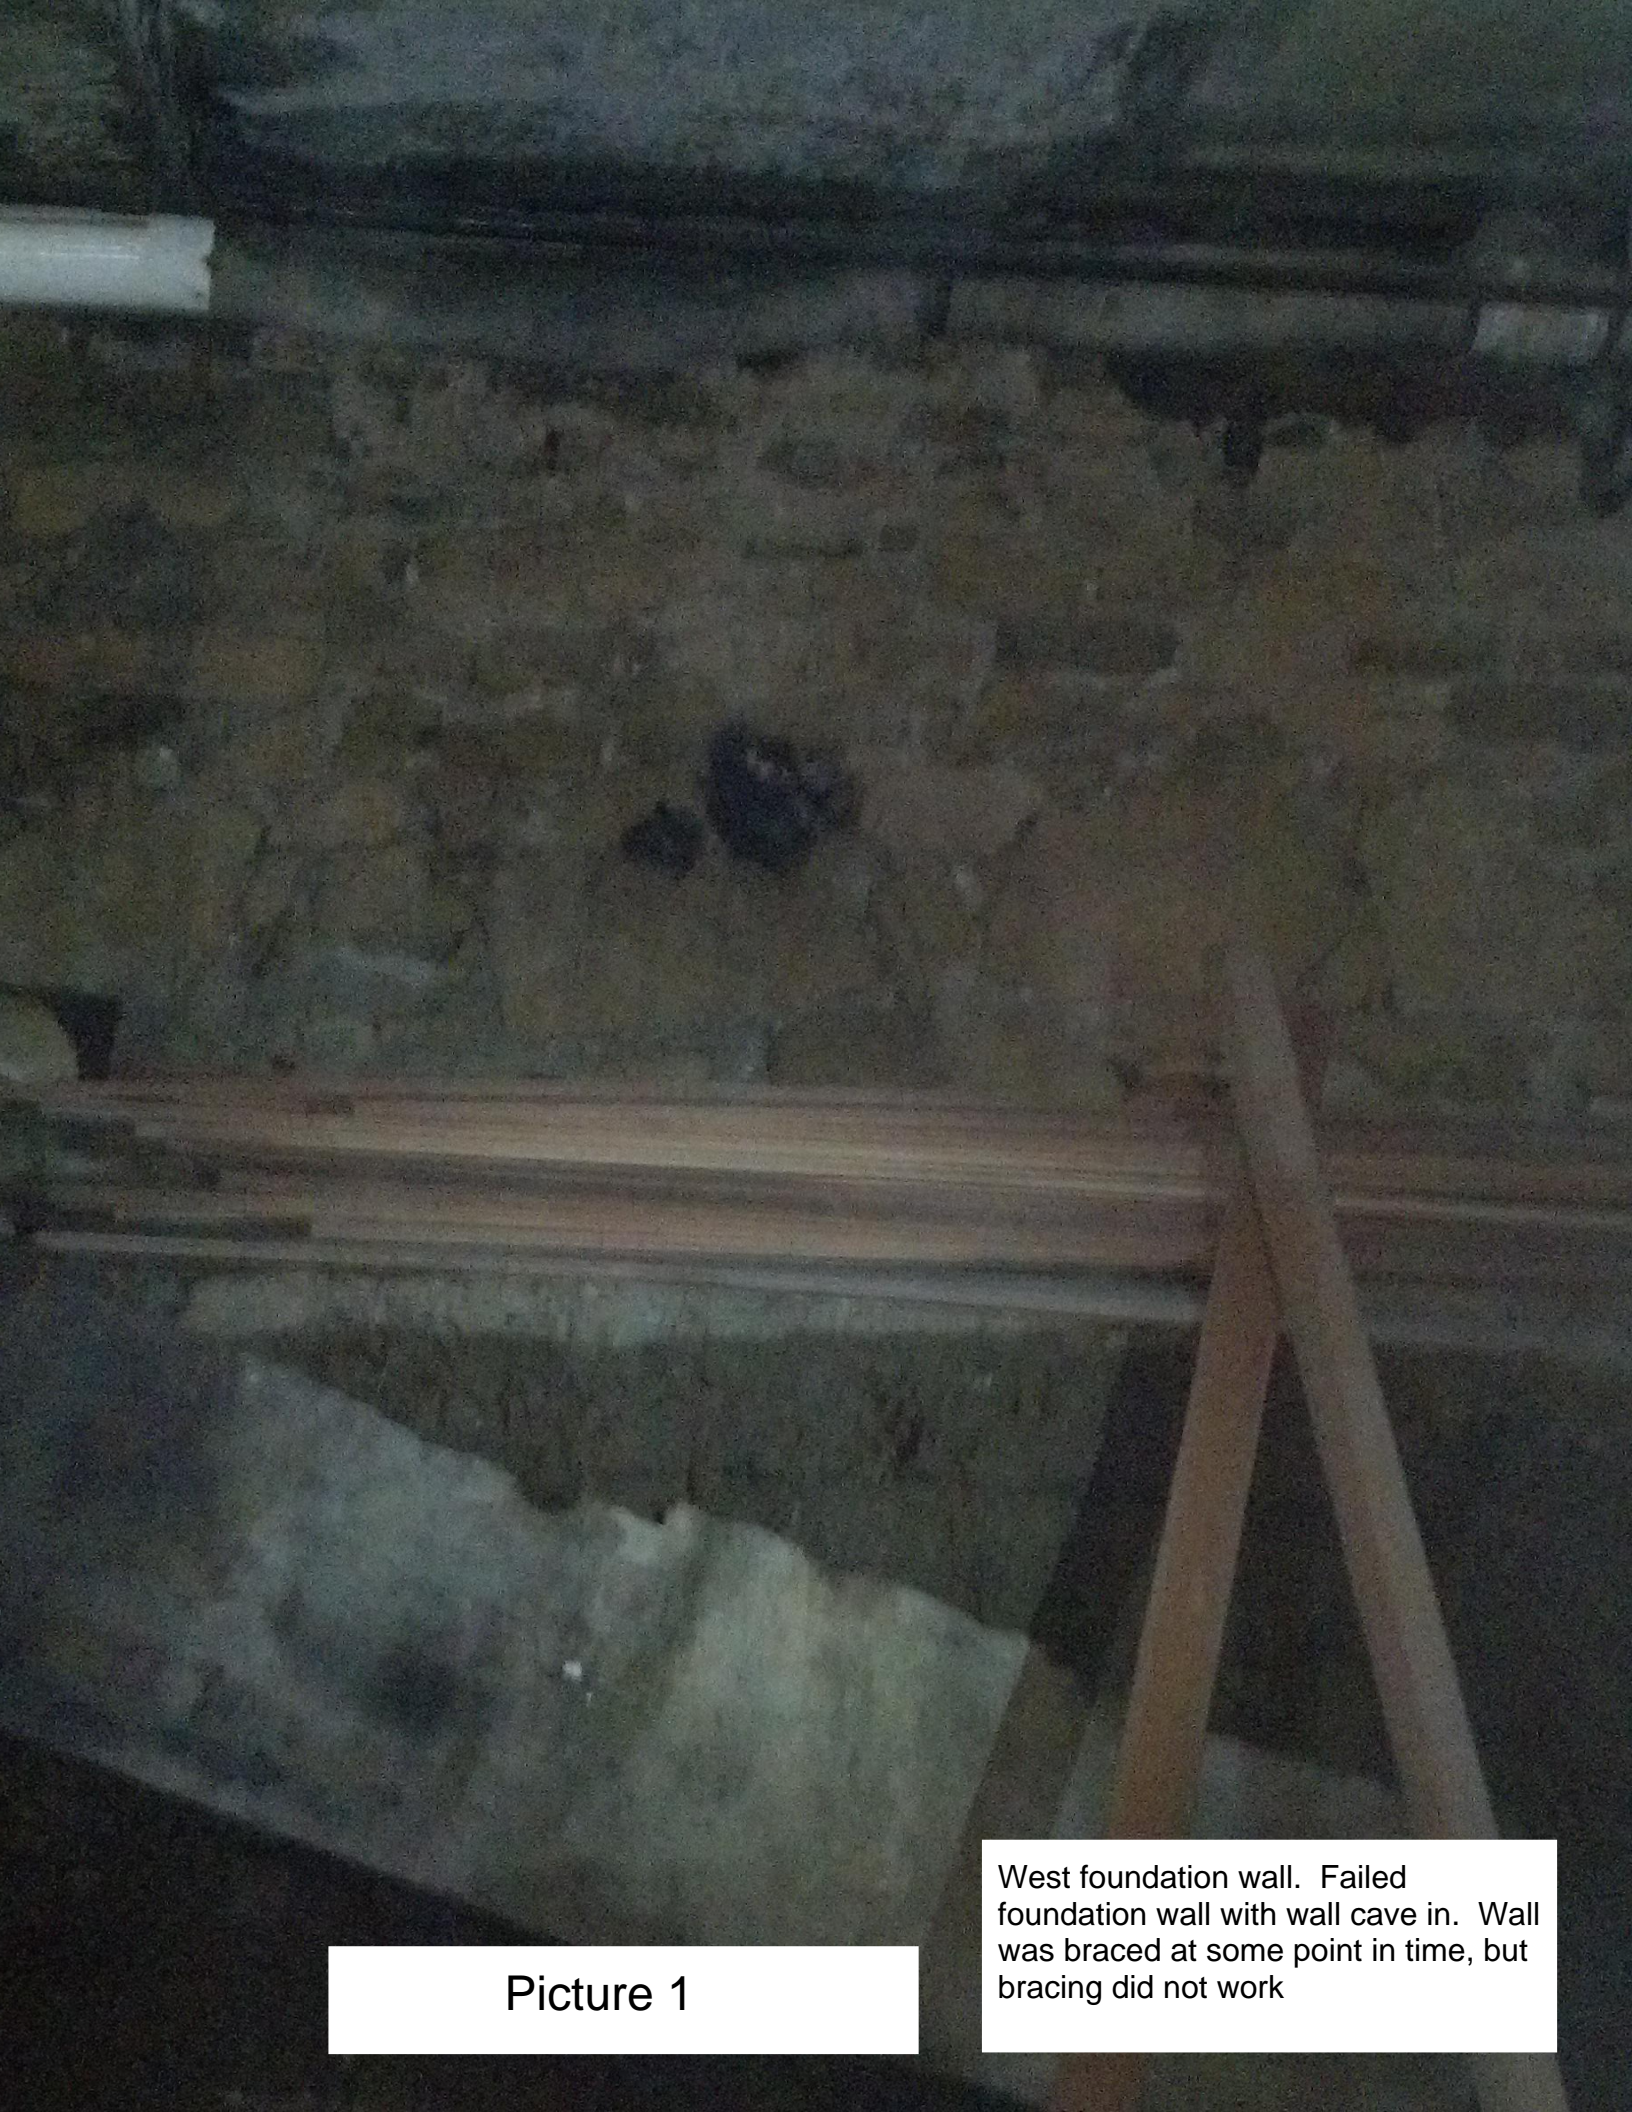
Picture 1

- a. Complete failure of the north foundation wall (See Picture 1). It is my understanding this wall has been previously shored once or twice previously and repairs made. It is also my understanding that this shoring and repairs were made prior to the purchase of the property by the current owner. The primary distressed condition related to deteriorated extreme distressed areas primarily consisted of in a state of severe distress and / or failure in some areas.

West foundation wall. Failed foundation wall with wall cave in. Wall was braced at some point in time, but bracing did not work

1. Complete replacement of the foundation.
2. Removal and replacement; including improving the foundation bearing for the deteriorated wood posts in the basement.

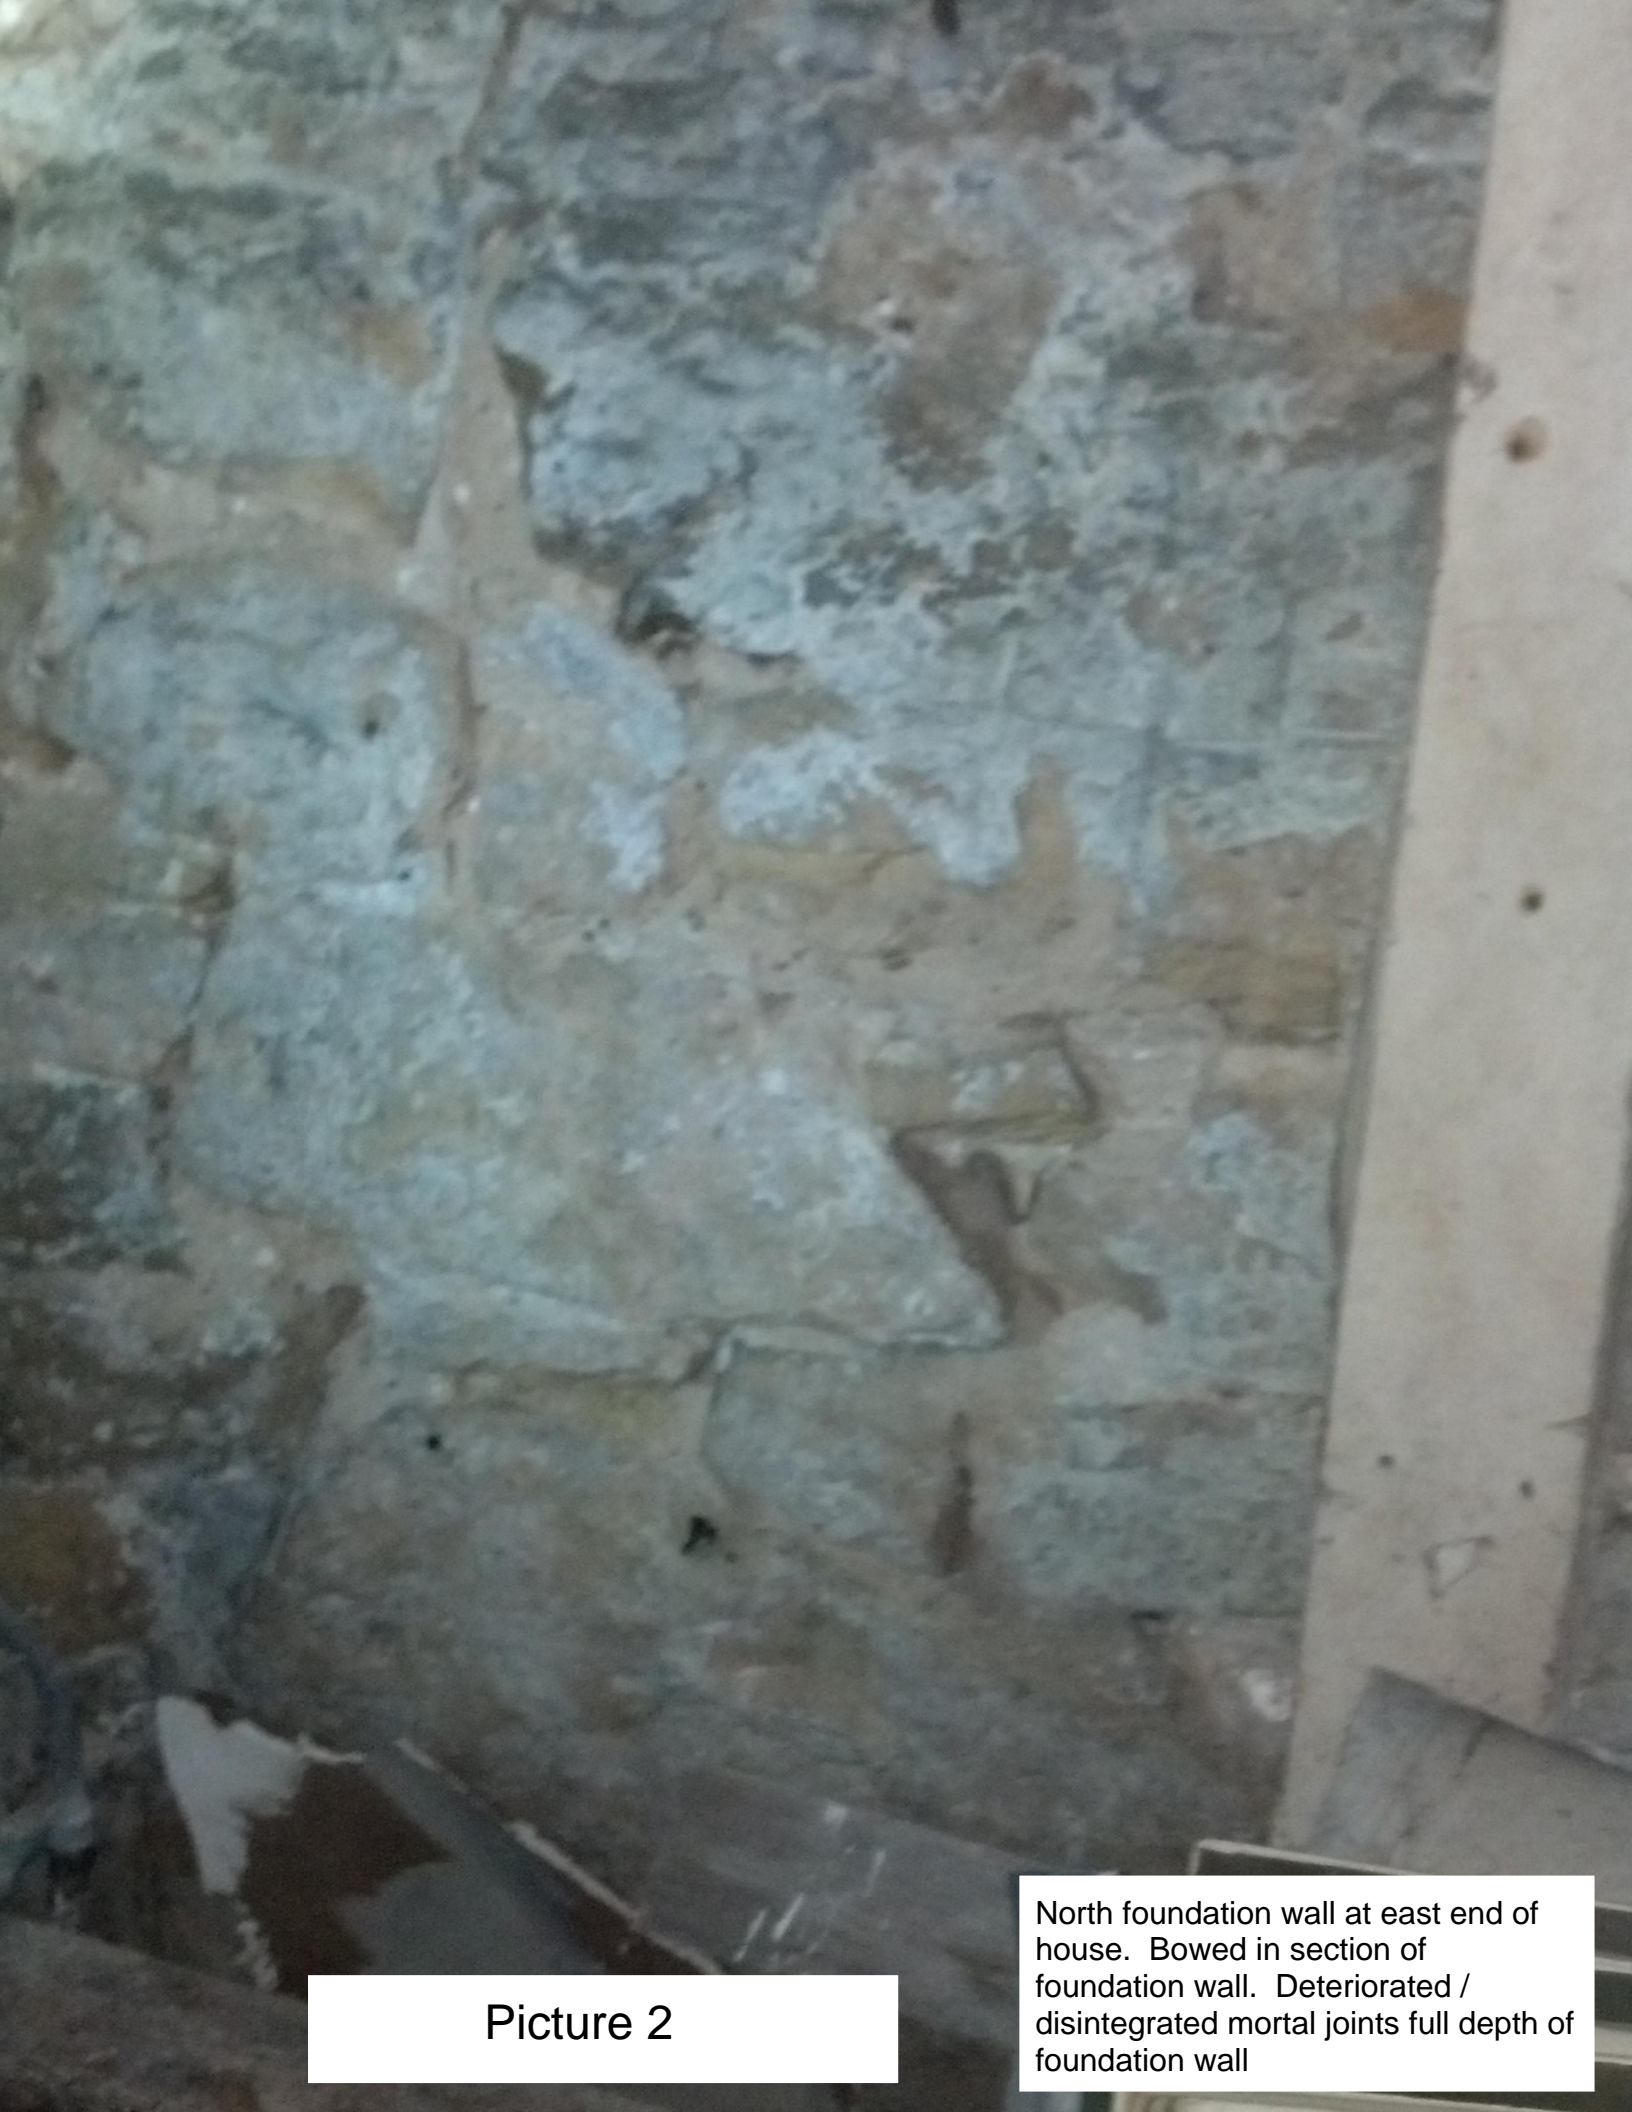
Picture 2

- b. Bowing in of a section of wall located along the north foundation wall (Picture 2). At this section of wall the mortar joints have completely disintegrated and you can see thru the wall in some spots. Pictures 3 thru 6 show various sections of the foundation wall where there is significant deterioration / disintegration of the mortar joints.

North foundation wall at east end of house. Bowed in section of foundation wall. Deteriorated / disintegrated mortar joints full depth of foundation wall

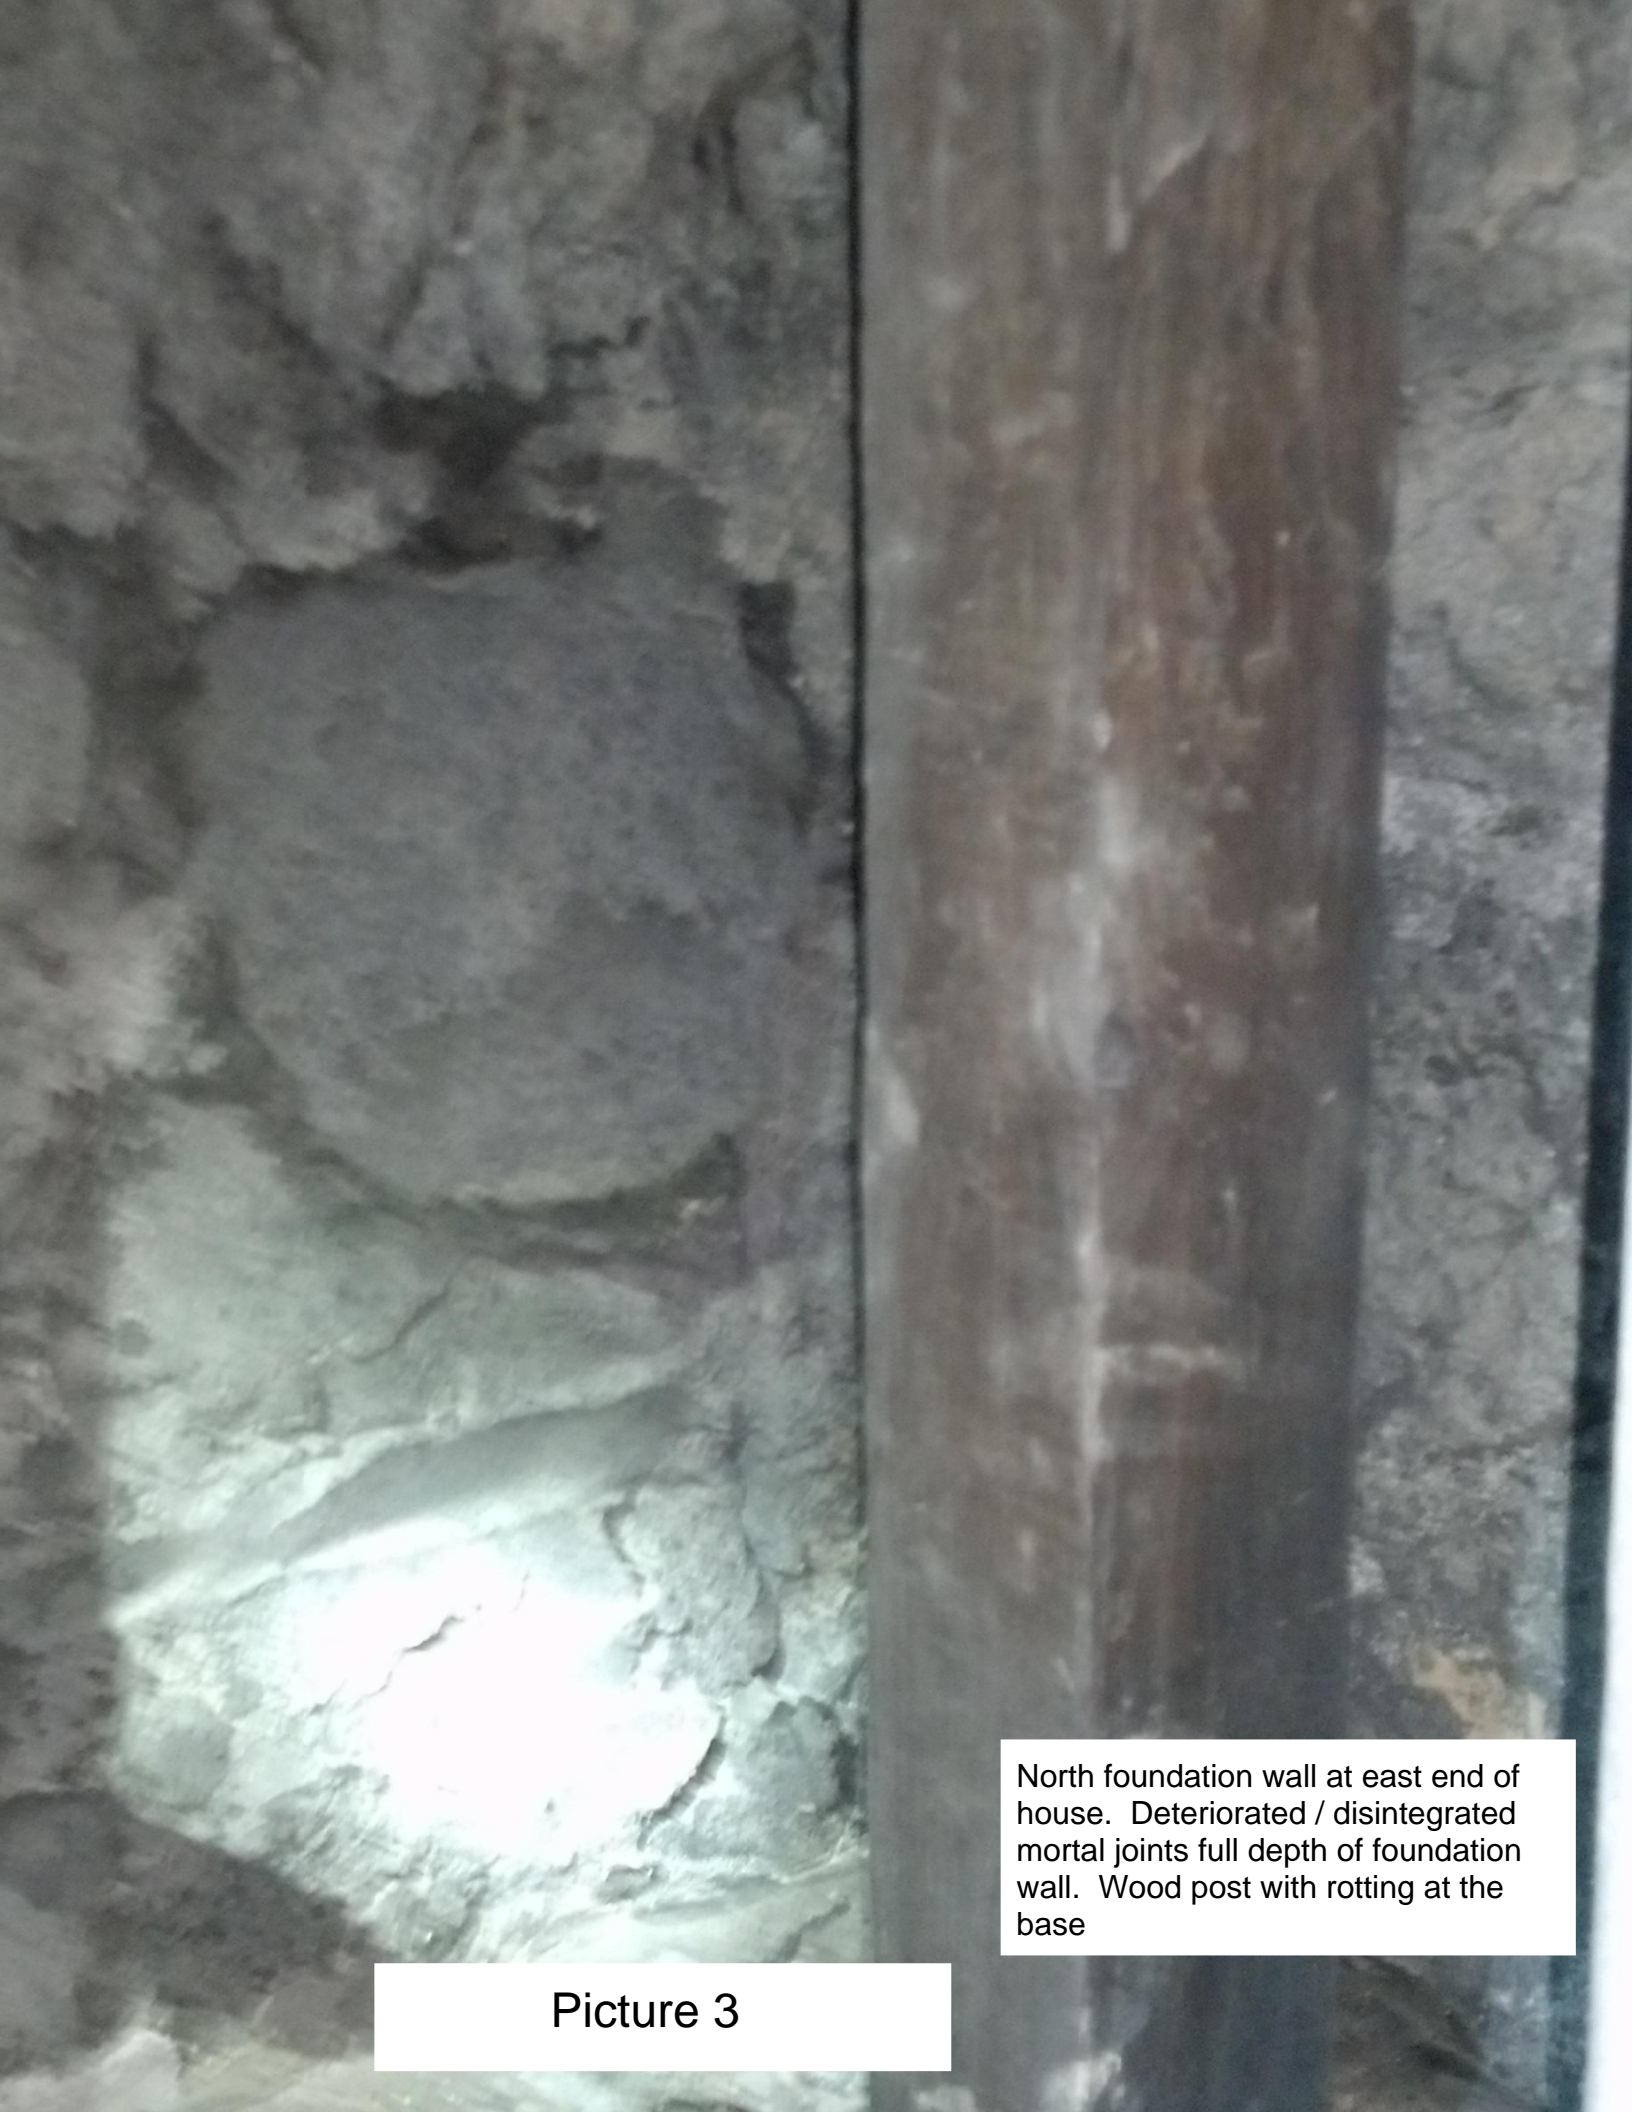
Picture 3

North foundation wall at east end of house. Deteriorated / disintegrated mortar joints full depth of foundation wall. Wood post with rotting at the base

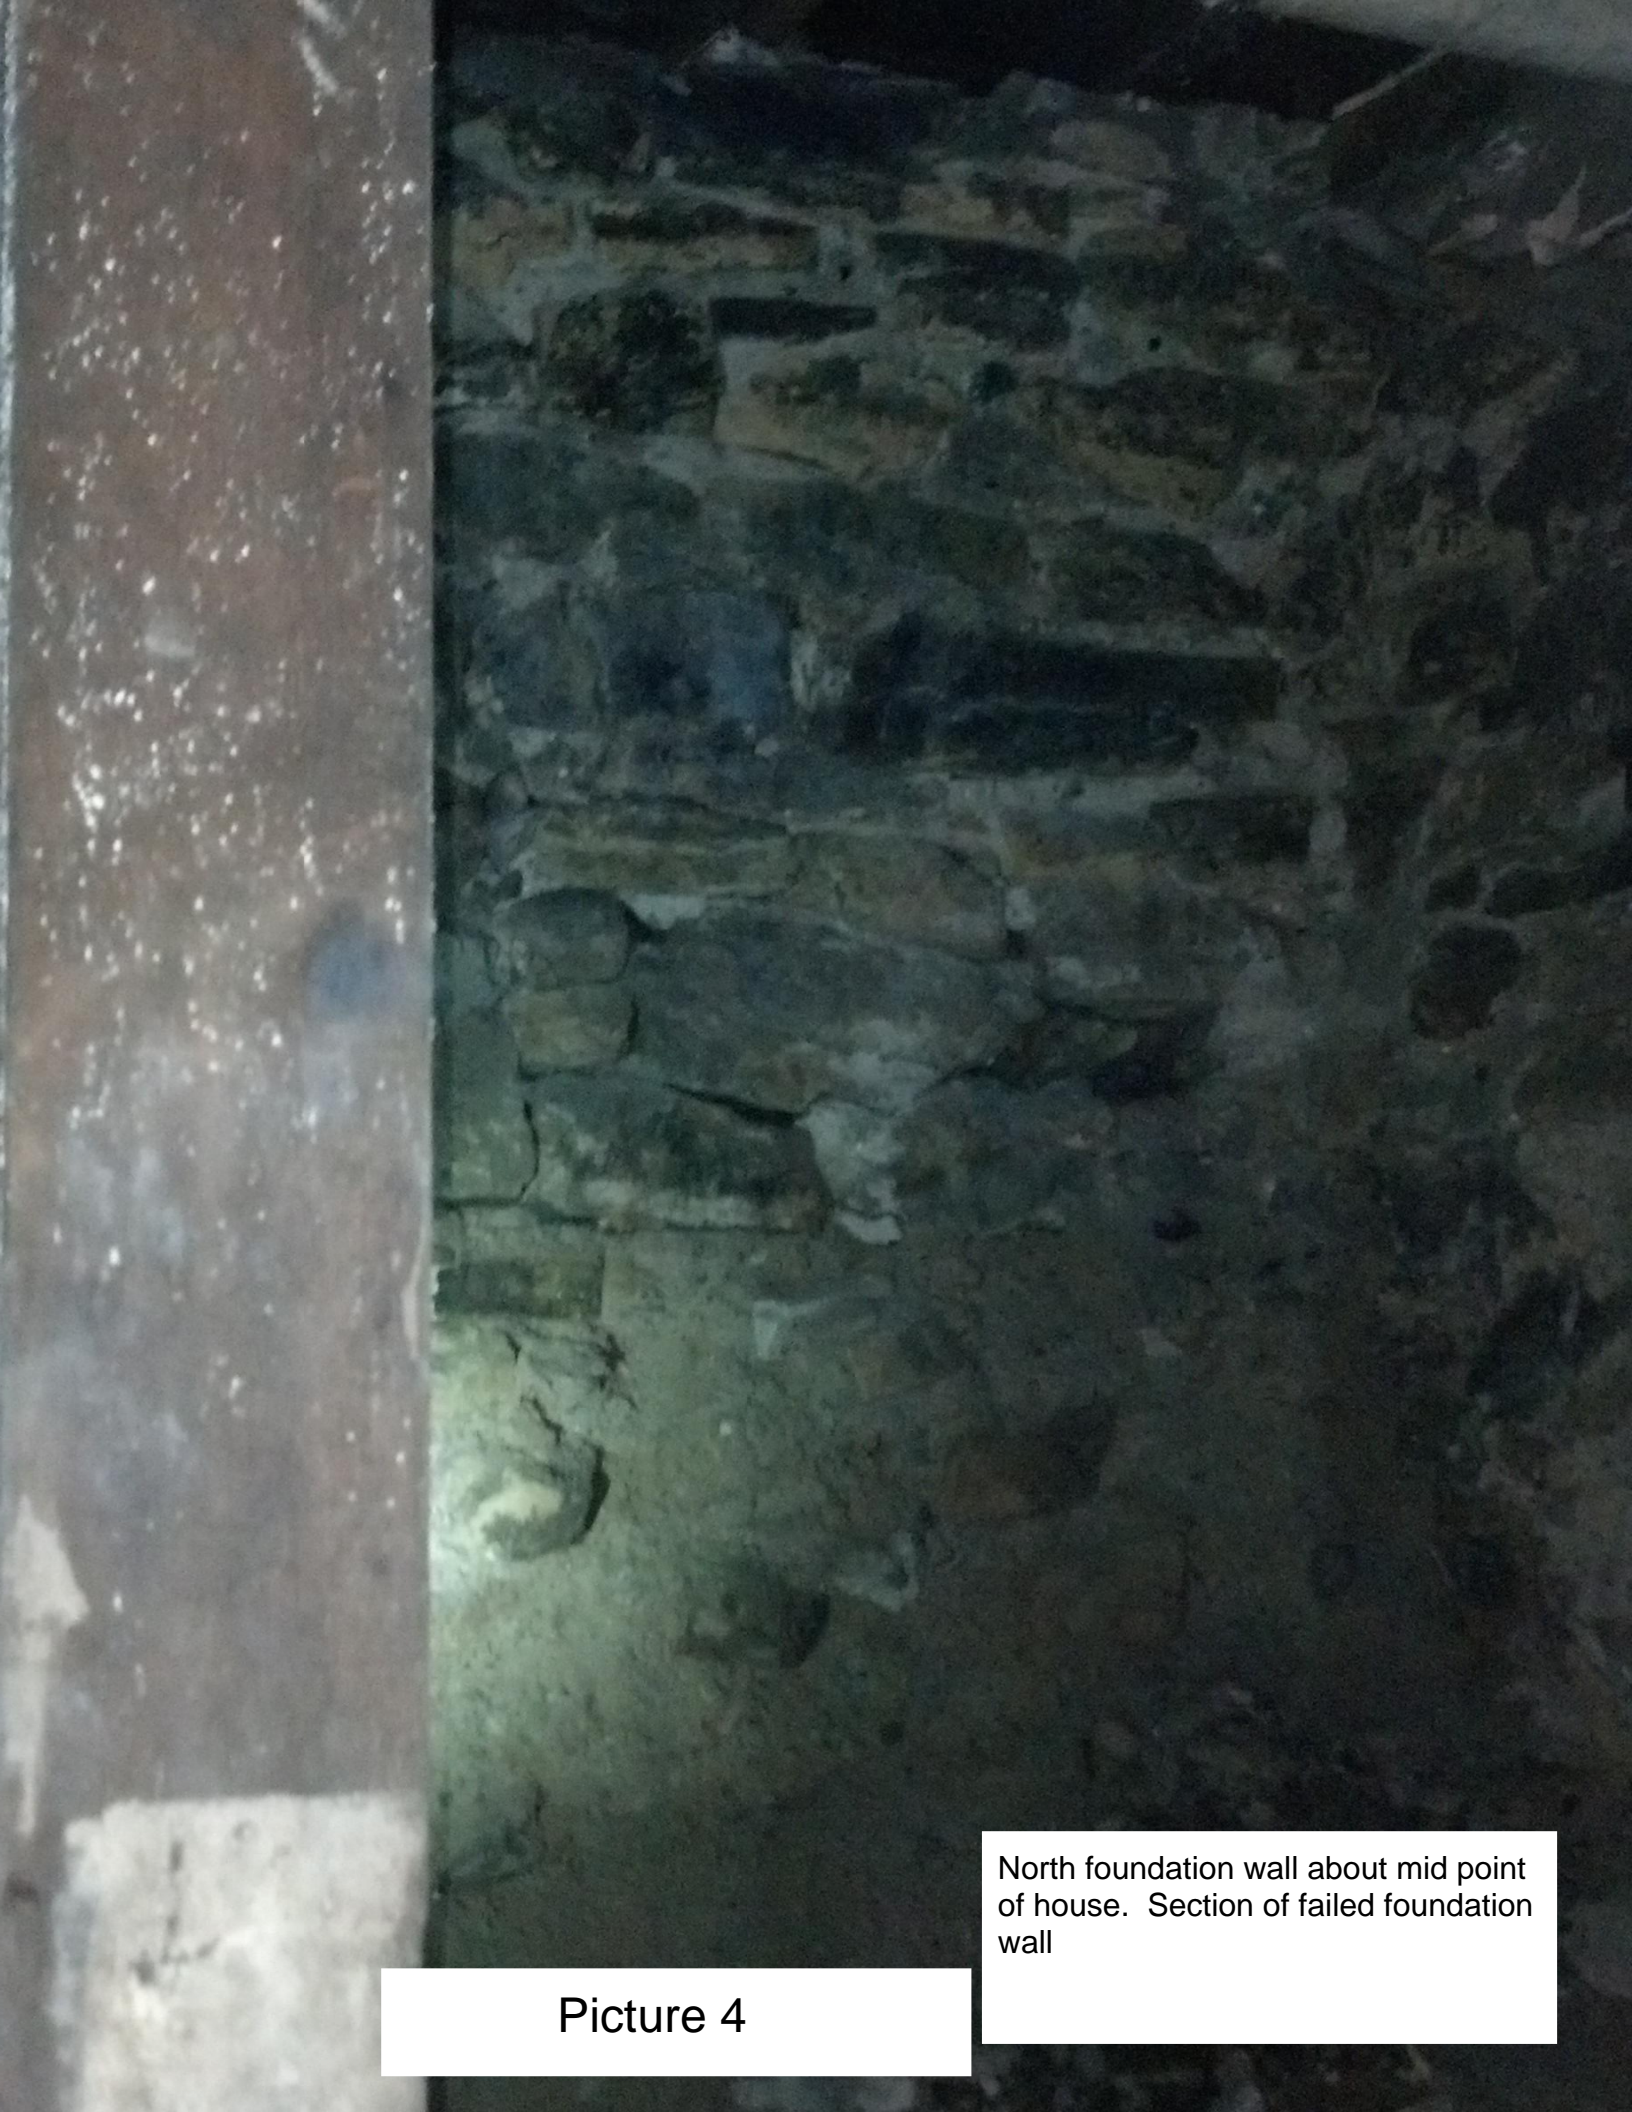
Picture 4

North foundation wall about mid point of house. Section of failed foundation wall

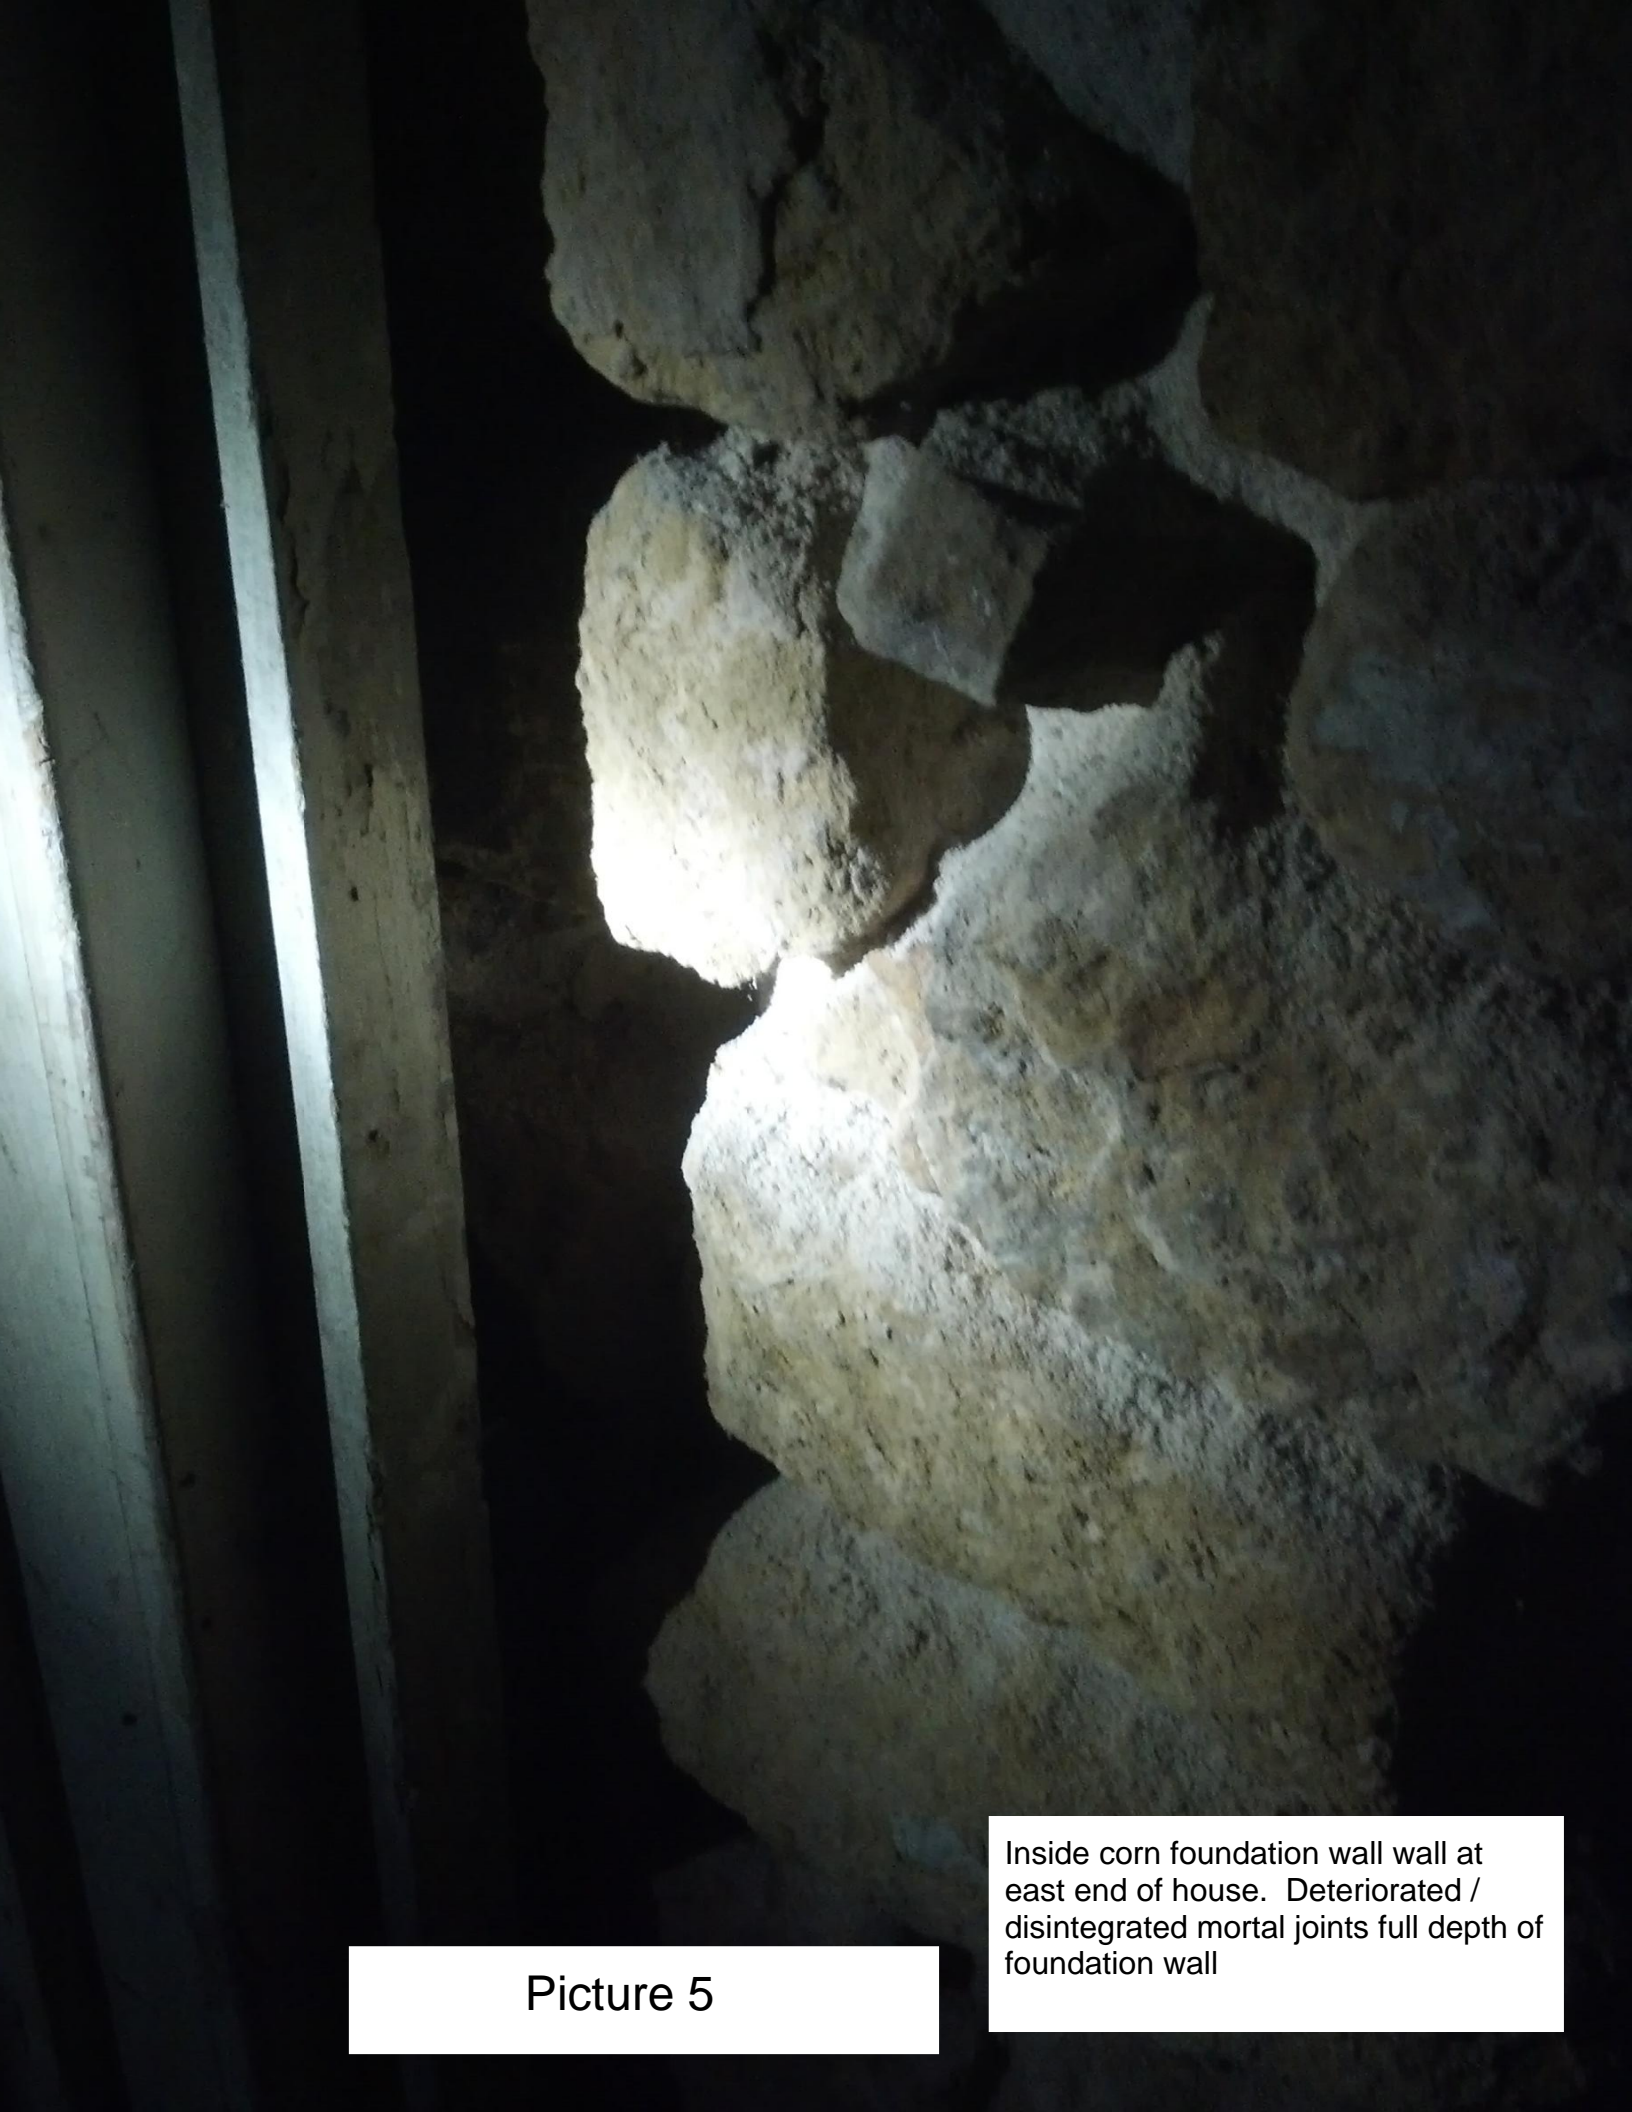
Picture 5

Inside corn foundation wall wall at east end of house. Deteriorated / disintegrated mortal joints full depth of foundation wall

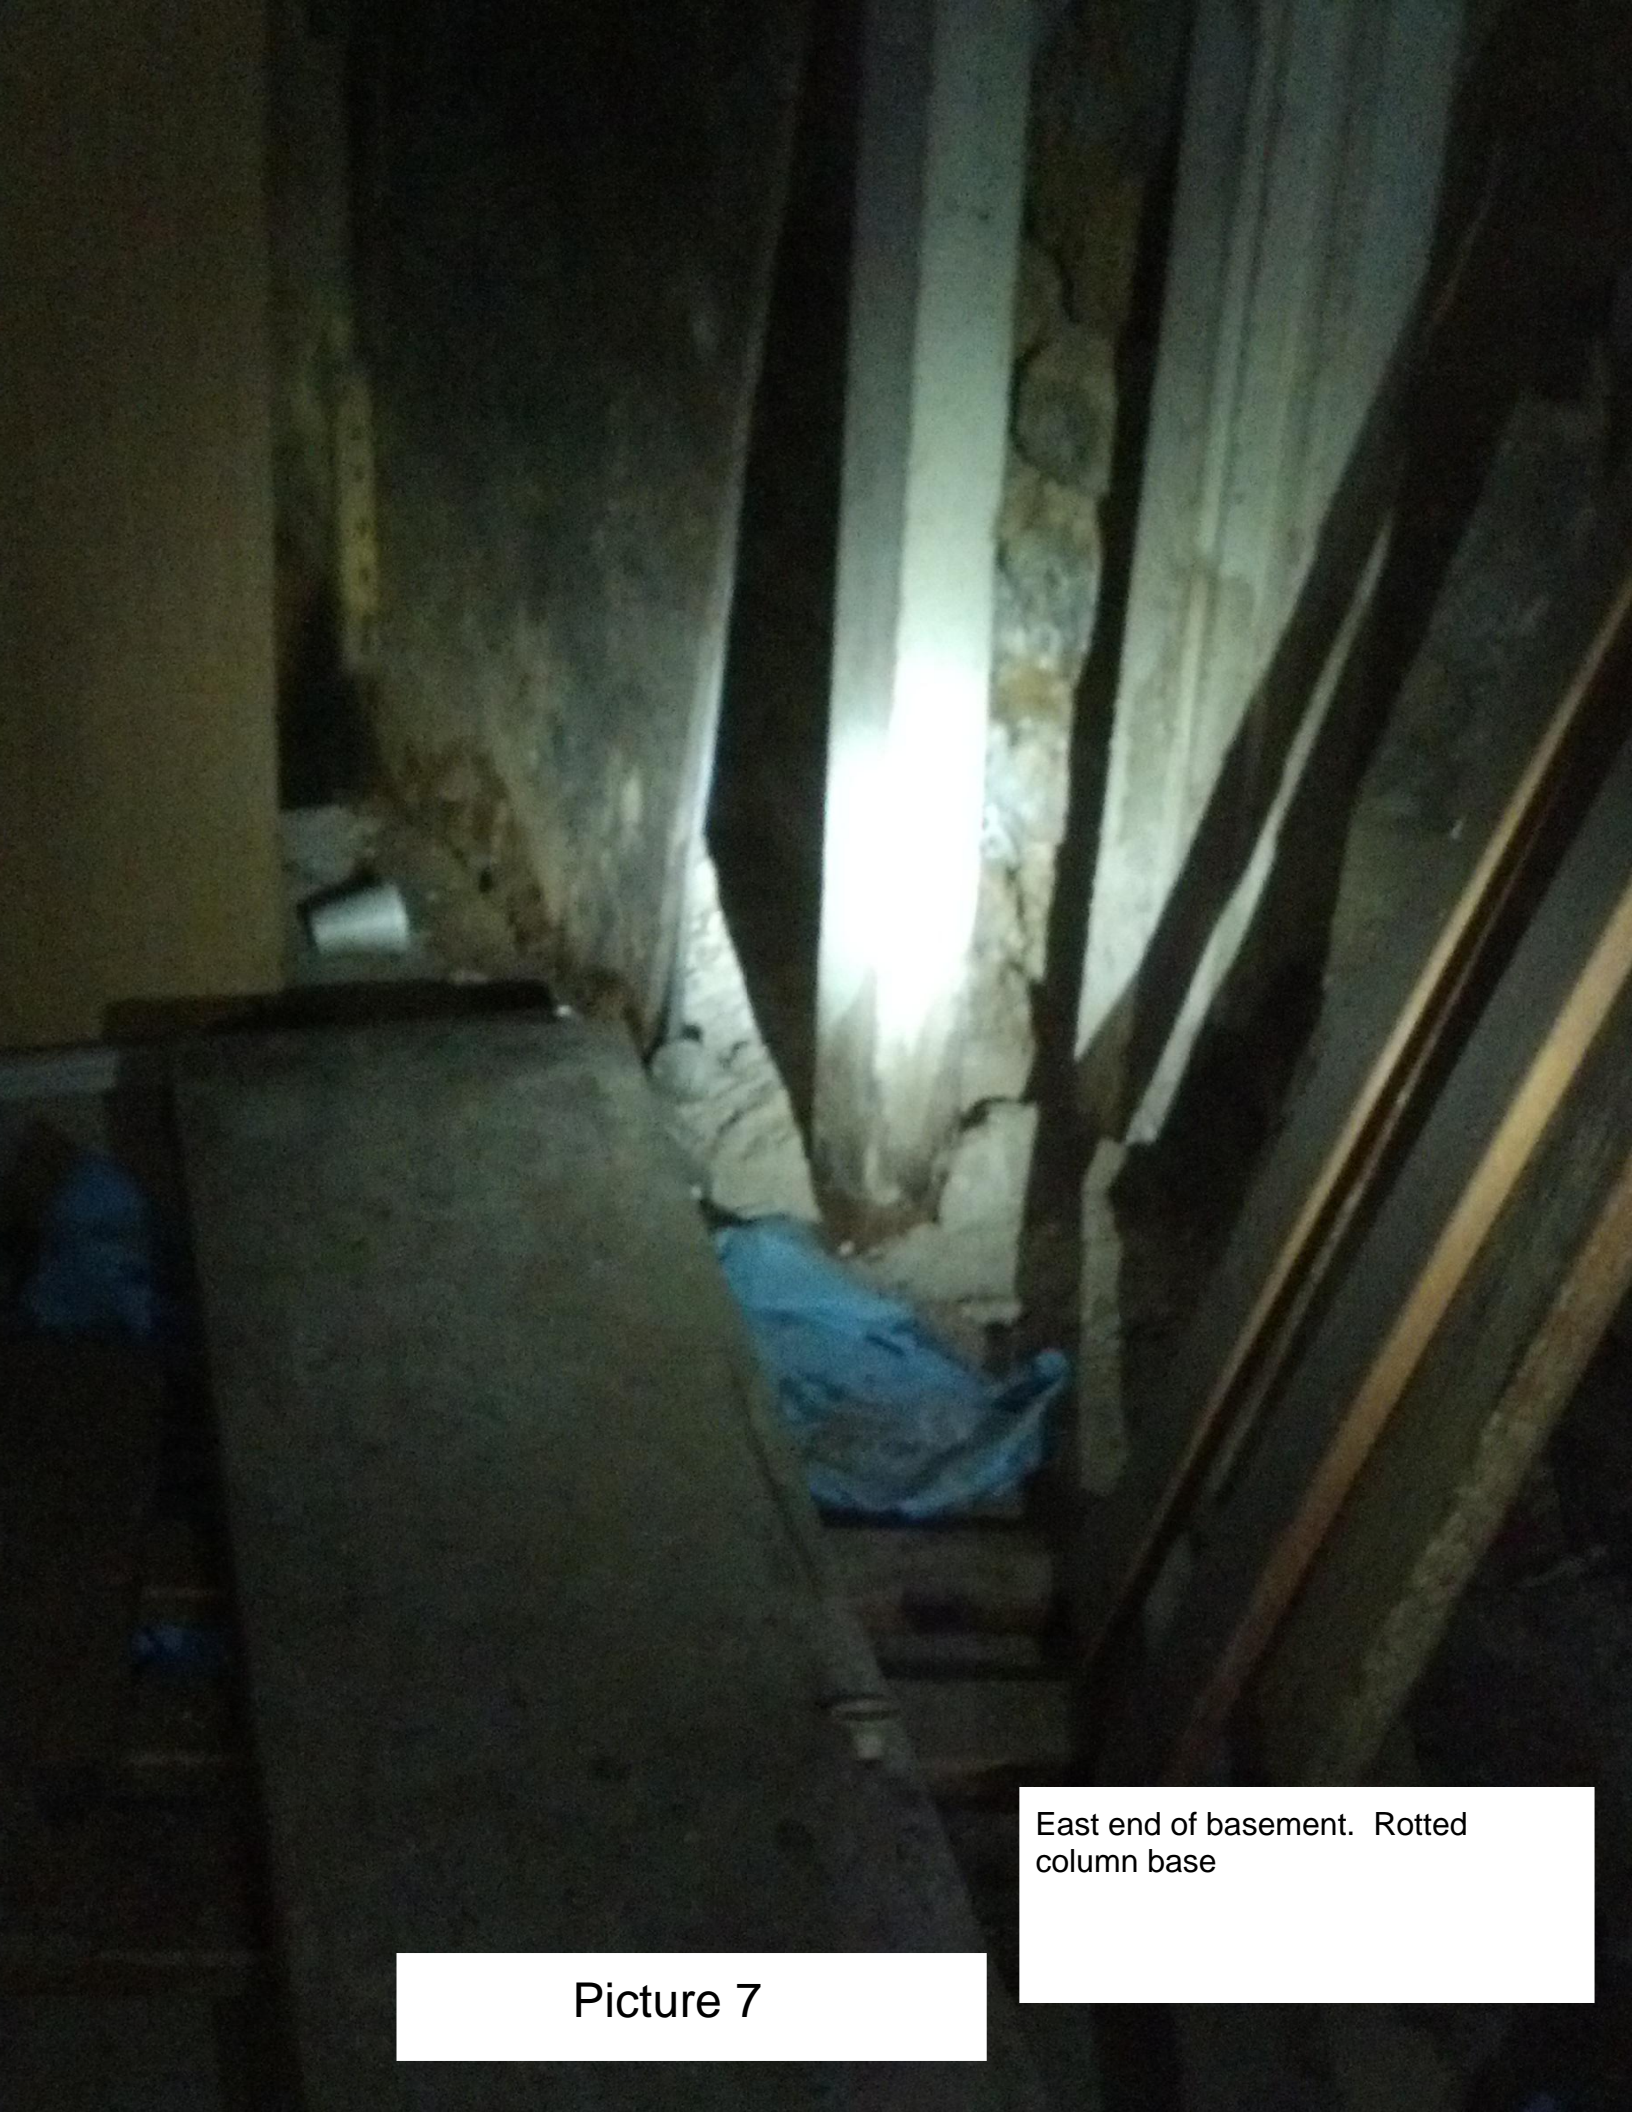
Picture 7

2. There are several wood posts in the basement which support the first floor beams, and these first floor beams are under bearing walls above. The bearing walls above support the second, third, and attic floor framing. Over time due to moisture, the bases of these columns have rotted. Some have been repaired, but many have not and significant rotting has occurred at the base. This degree of rotting has significantly diminished the structural capacity of the post. Pictures 7 thru 9 show typical rotted base conditions.

East end of basement. Rotted column base
