**PIERCE ENGINEERS INC**  
CONSULTING STRUCTURAL ENGINEERS  
10 West Mifflin St, Suite 205 | Madison, WI 53703  
Phone: 608.256.7304 | Fax: 608.256.7306

**SUBJECT: Structural Evaluation Report  
127 W. Gilman St  
Madison, Wisconsin**

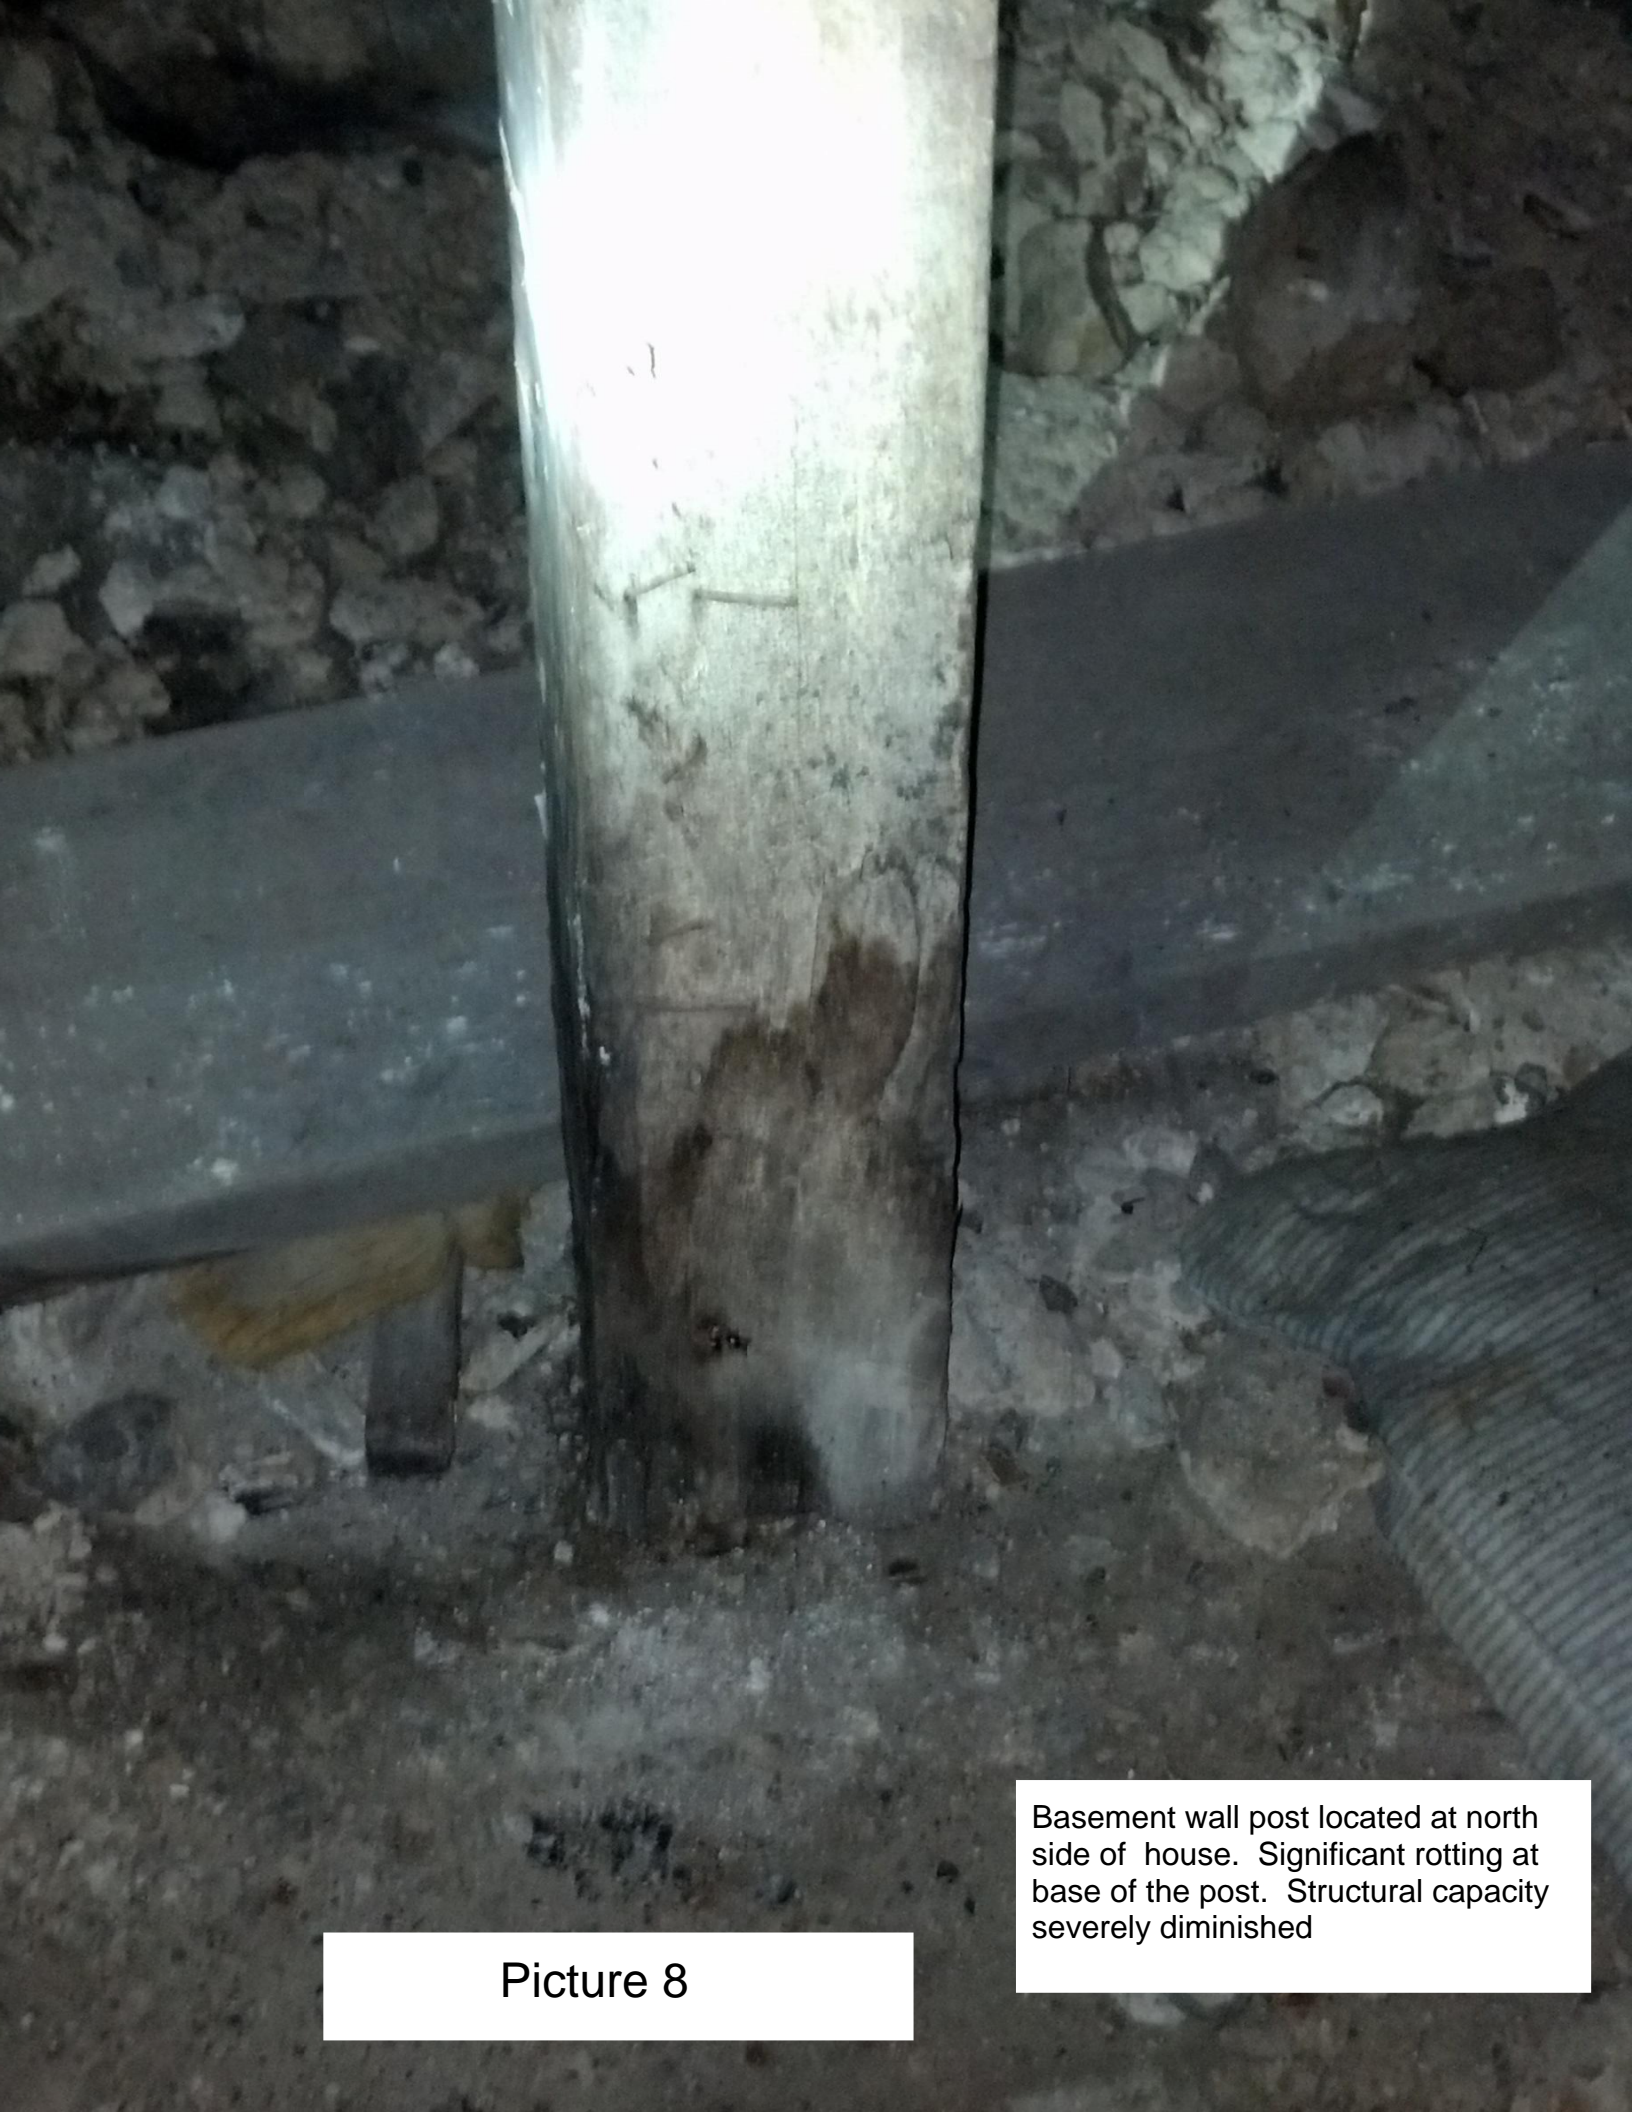
Picture 8

Basement wall post located at north side of house. Significant rotting at base of the post. Structural capacity severely diminished

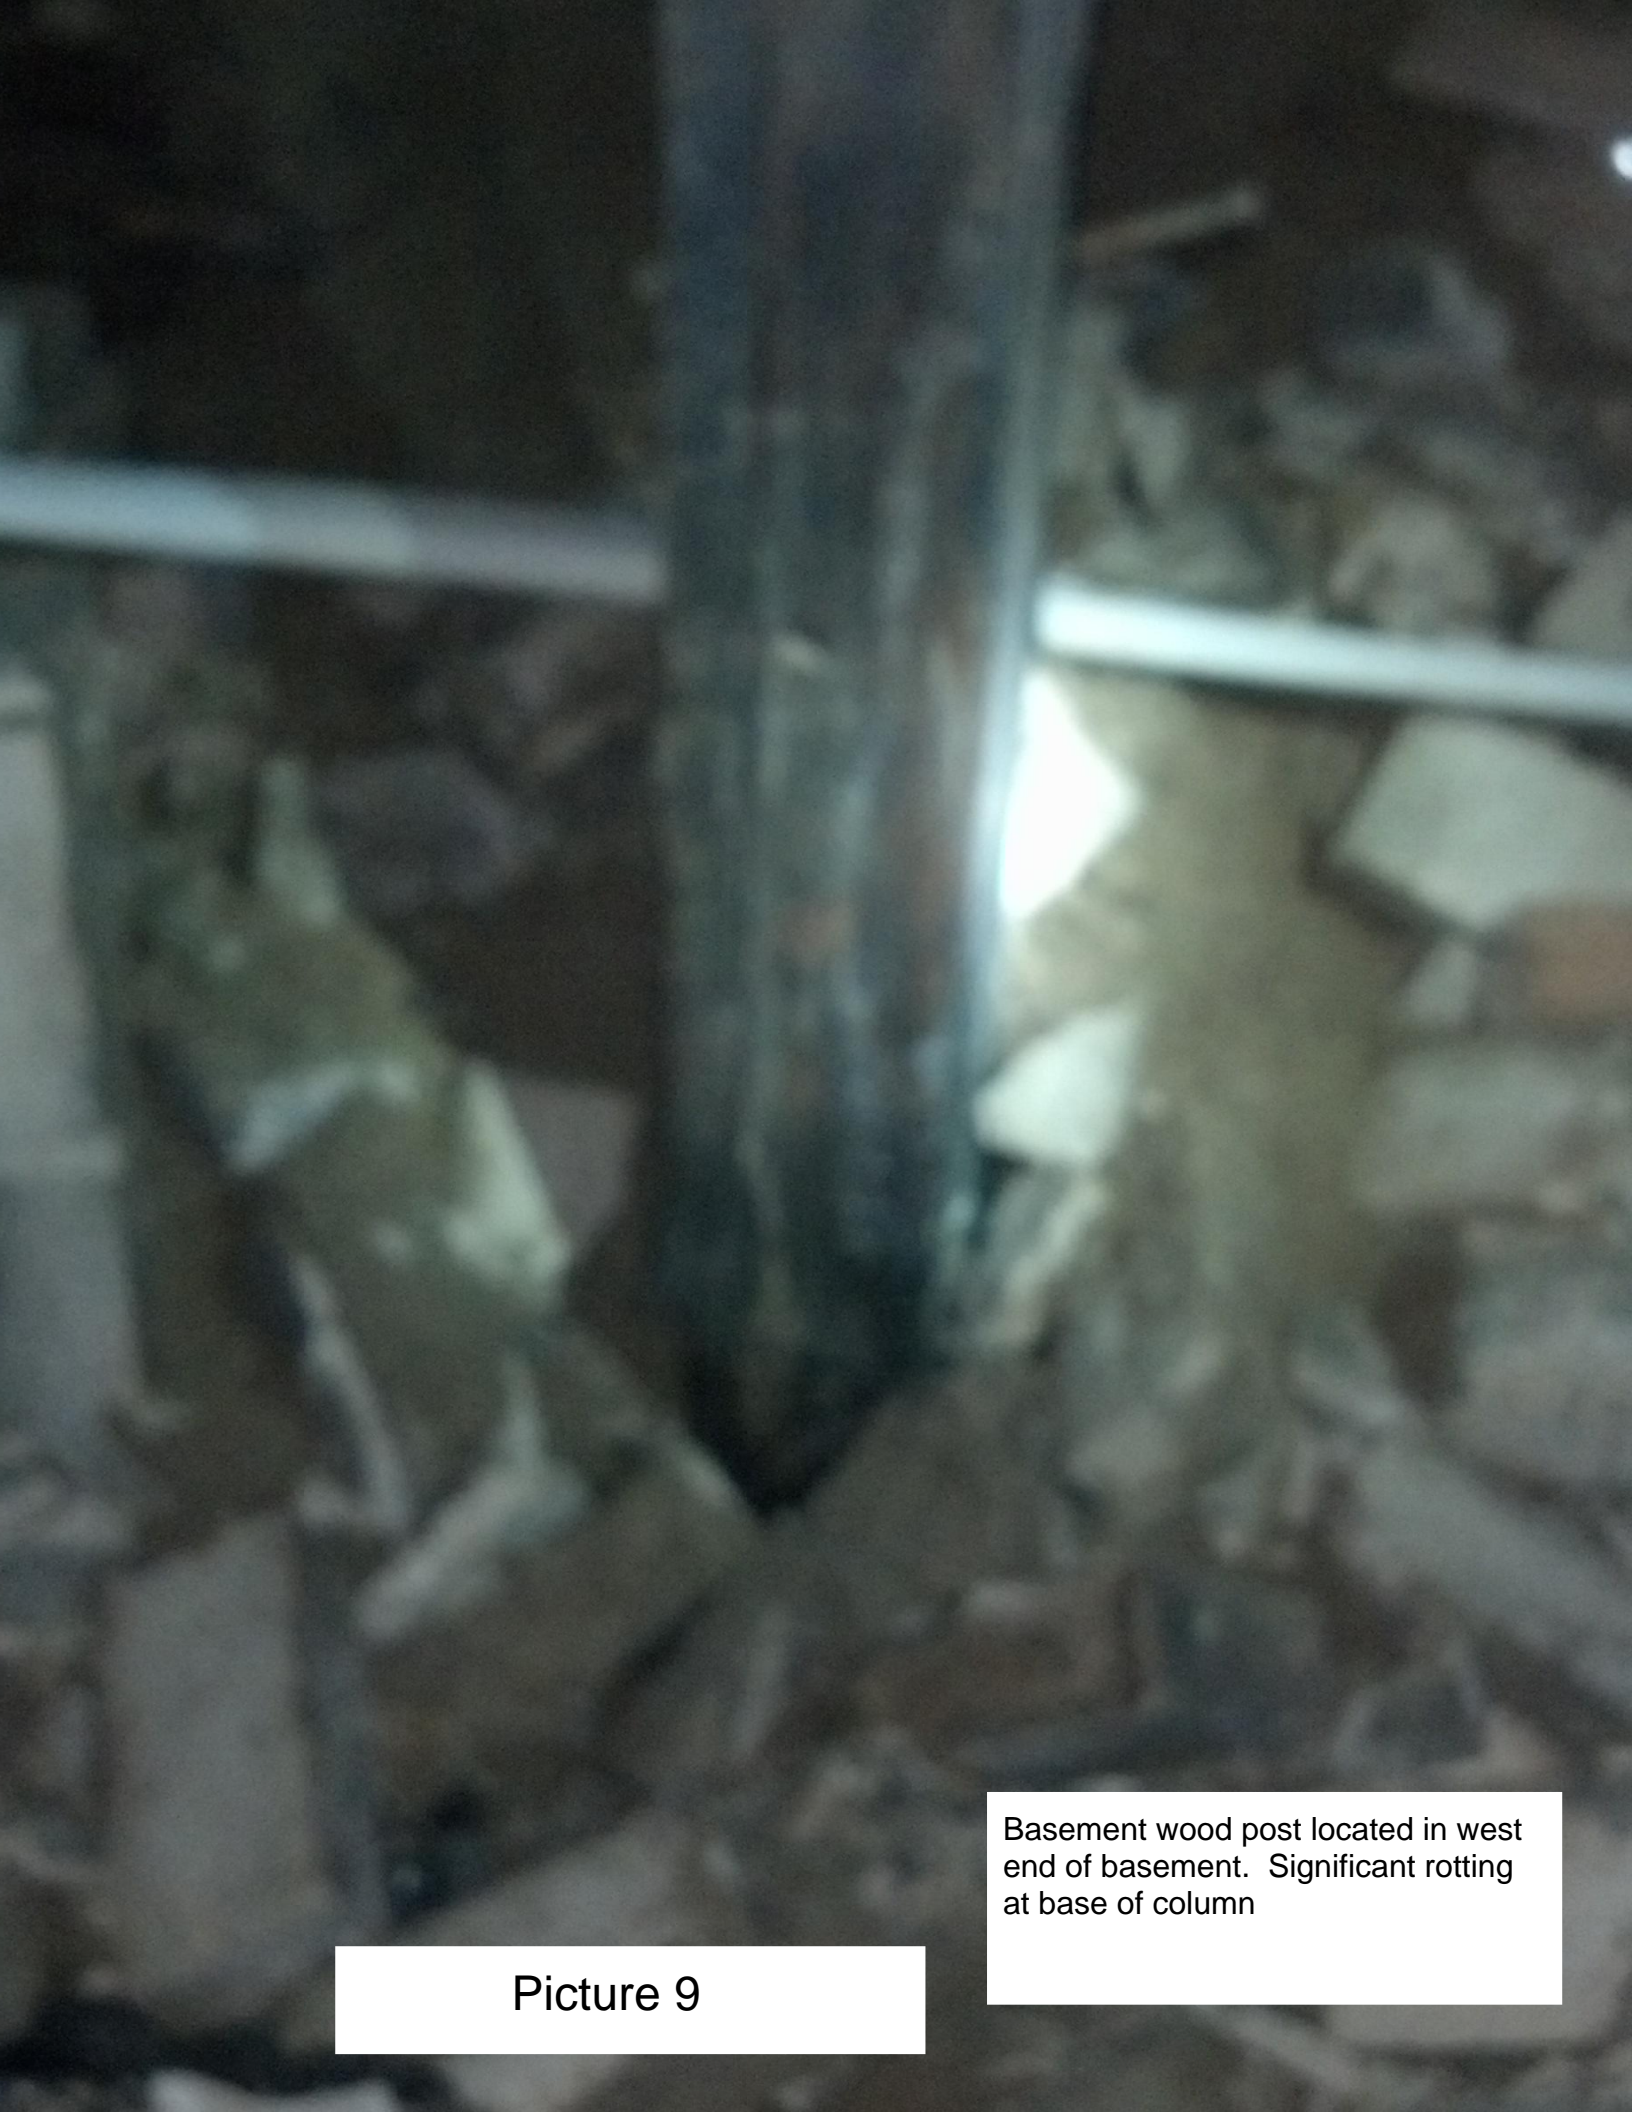
Picture 9

Basement wood post located in west end of basement. Significant rotting at base of column

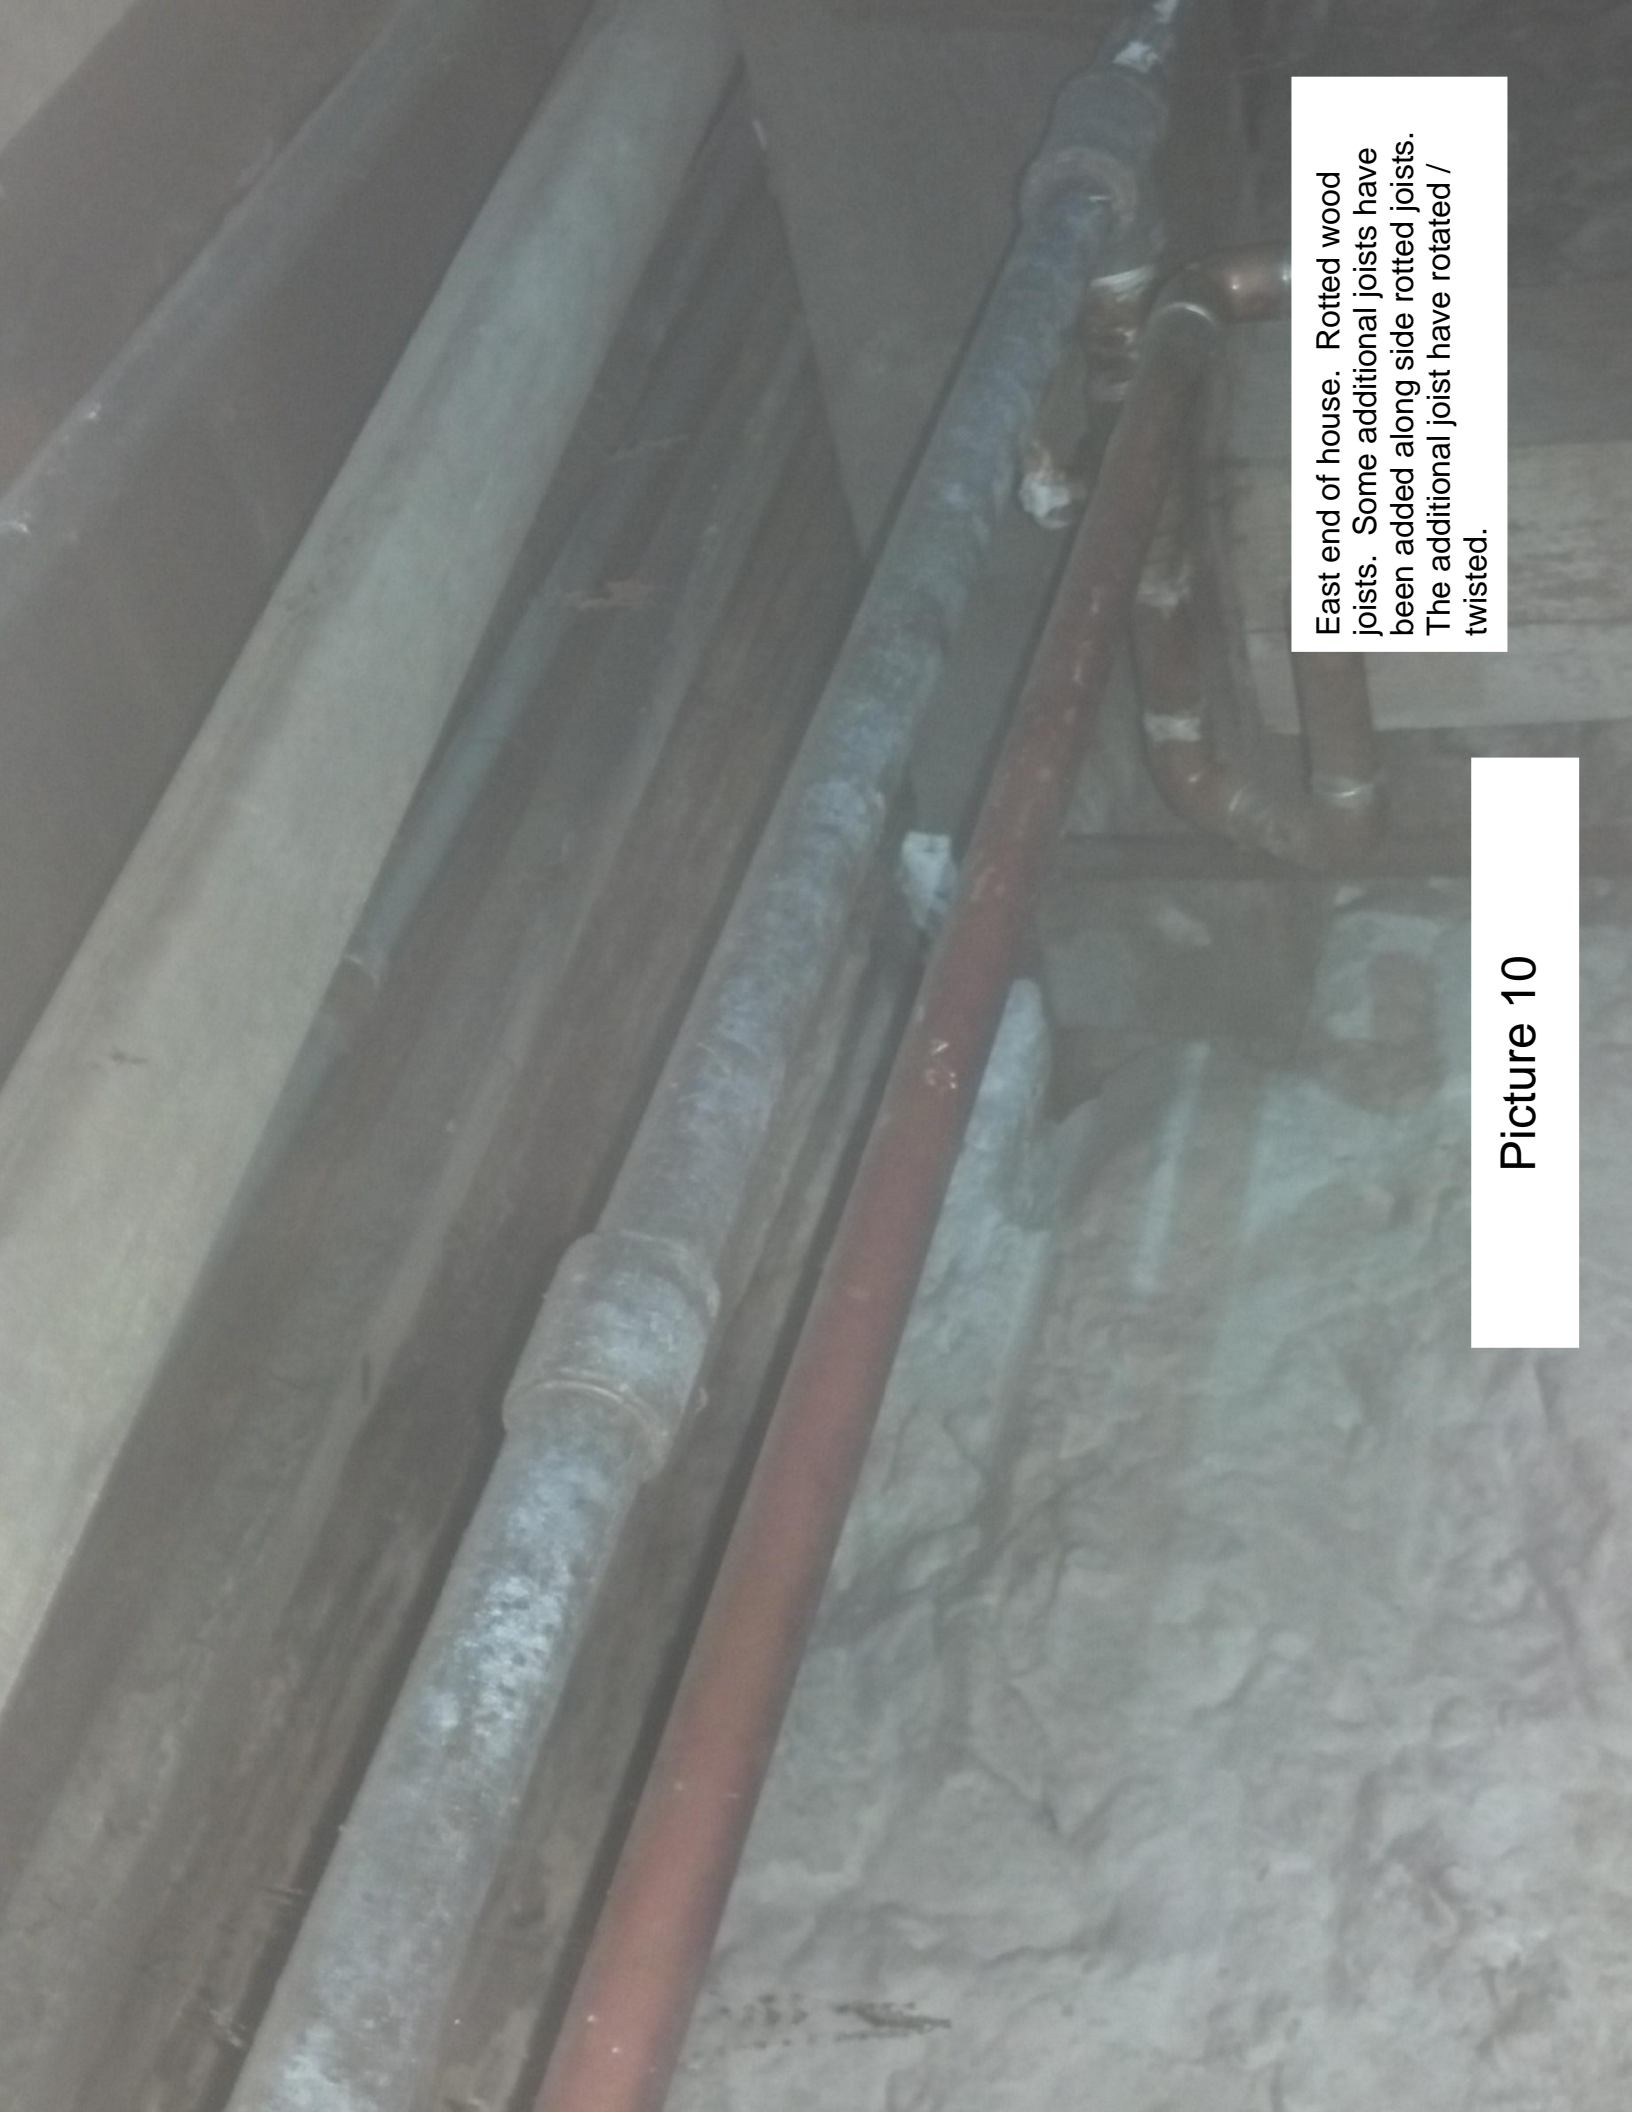
Picture 10

East end of house. Rotted wood joists. Some additional joists have been added along side rotted joists. The additional joist have rotated / twisted.

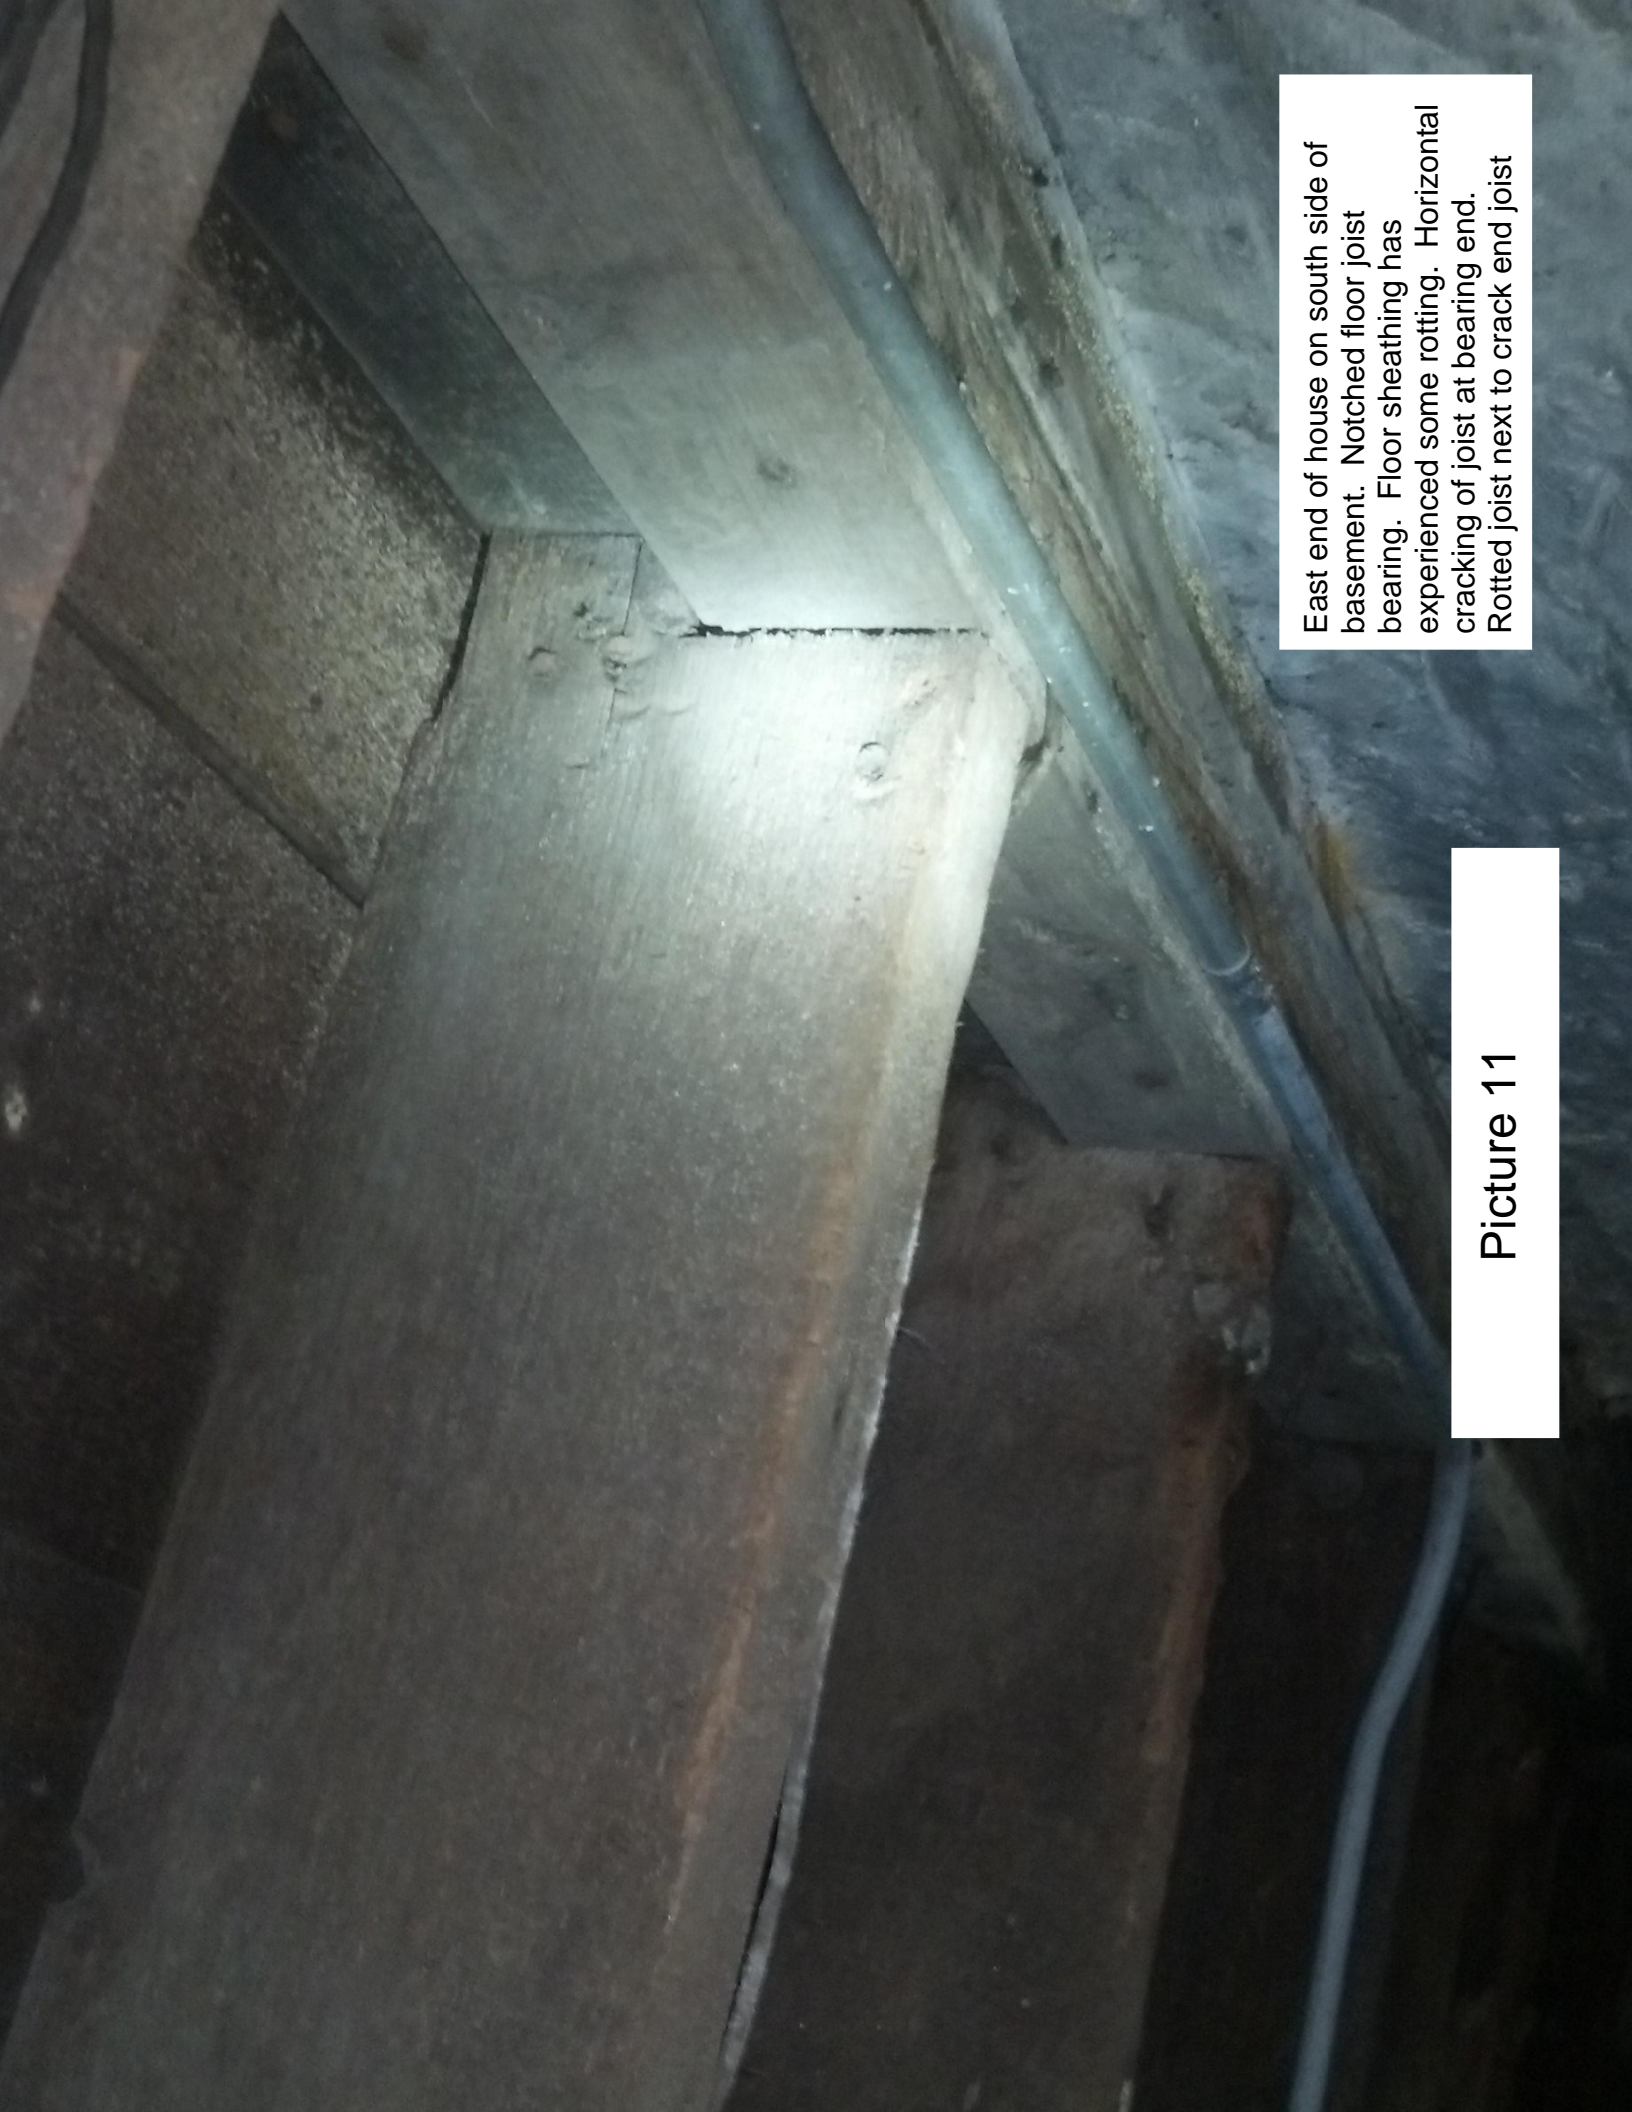
Picture 11

3. Much of the first floor framing was concealed to view in the basement, except for the east end on the south side of the house. The floor structure in this area has experienced some distress and deterioration that has compromised the structural capacity of the framing system. In this area floor some floor beams and joists have experienced rotting (Pictures 10 thru 12) and construction connections of the joist to beams (Pictures 11 and 12) are not of good practice and have diminished the structural capacity of the members.

East end of house on south side of basement. Notched floor joist bearing. Floor sheathing has experienced some rotting. Horizontal cracking of joist at bearing end. Rotted joist next to crack end joist

3. Reinforcement or replacement of rotted and compromised framing members (Pictures 11 and 12) at the first floor framing level. It is estimated that the majority of the first floor framing would need to be corrected in some manner by either; removal and replacement of the structure or reinforcement of the existing structure.
4. Replace the fire damaged structure.
5. Further exploration of the structure at the water leaking areas to check for additional structure deterioration due to rotting.

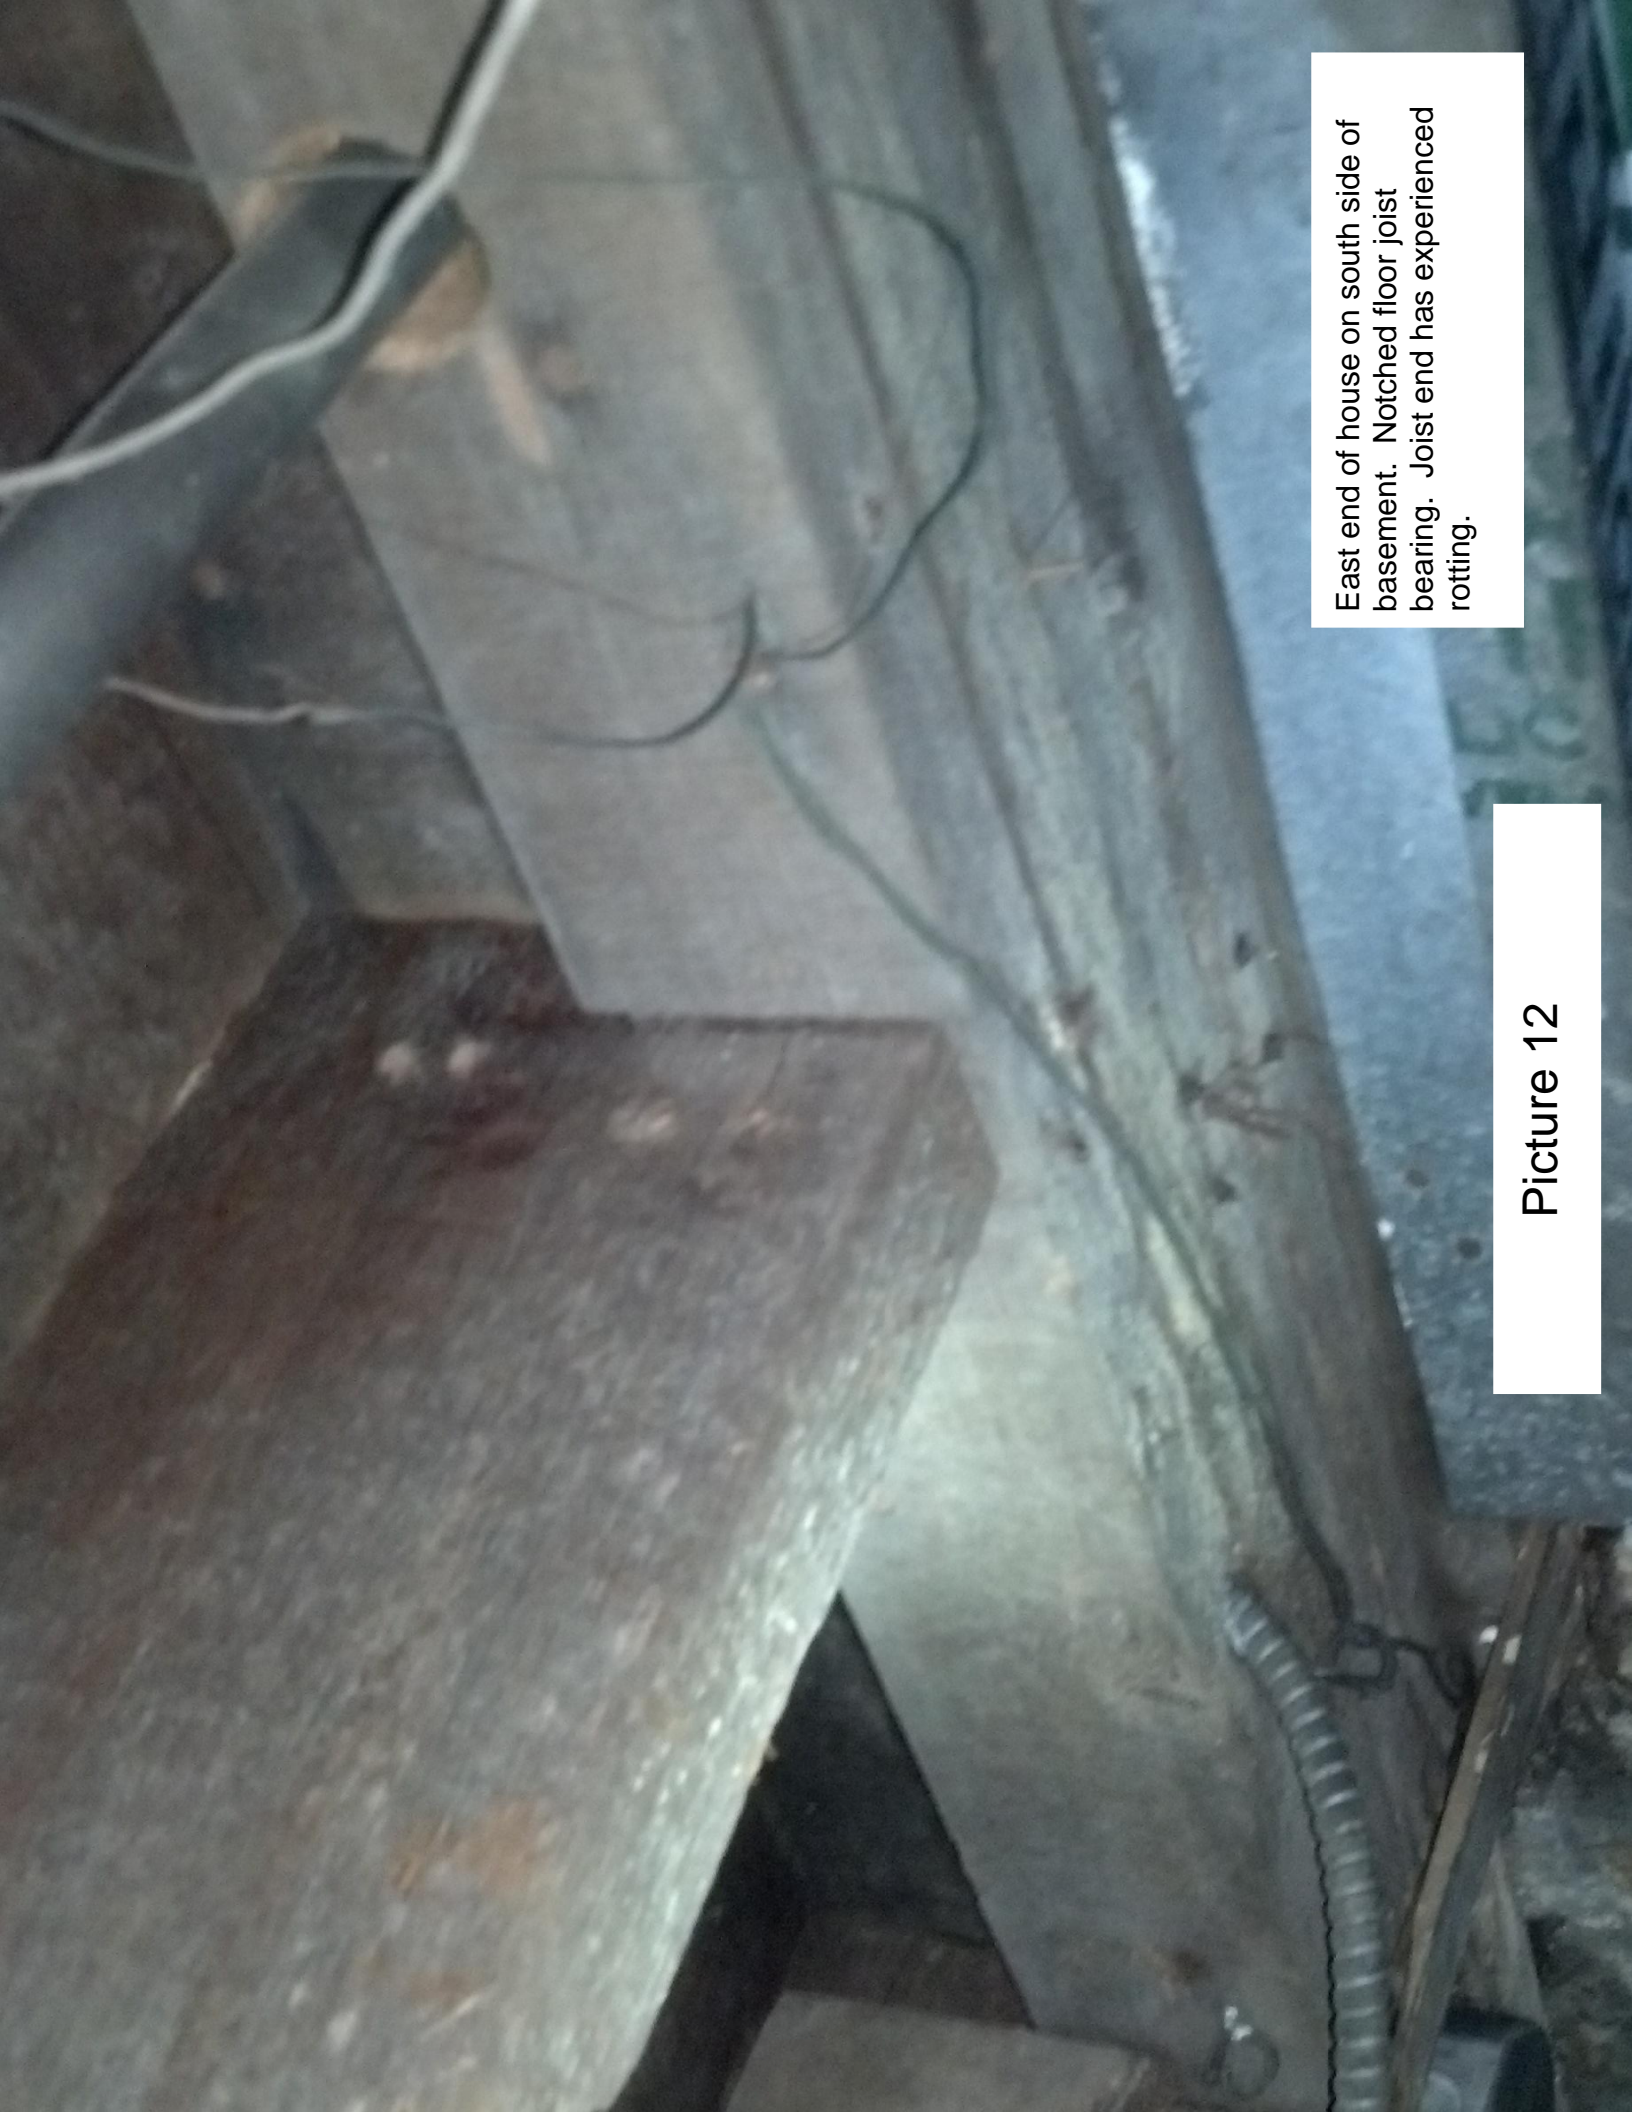
Picture 12

East end of house on south side of basement. Notched floor joist bearing. Joist end has experienced rotting.

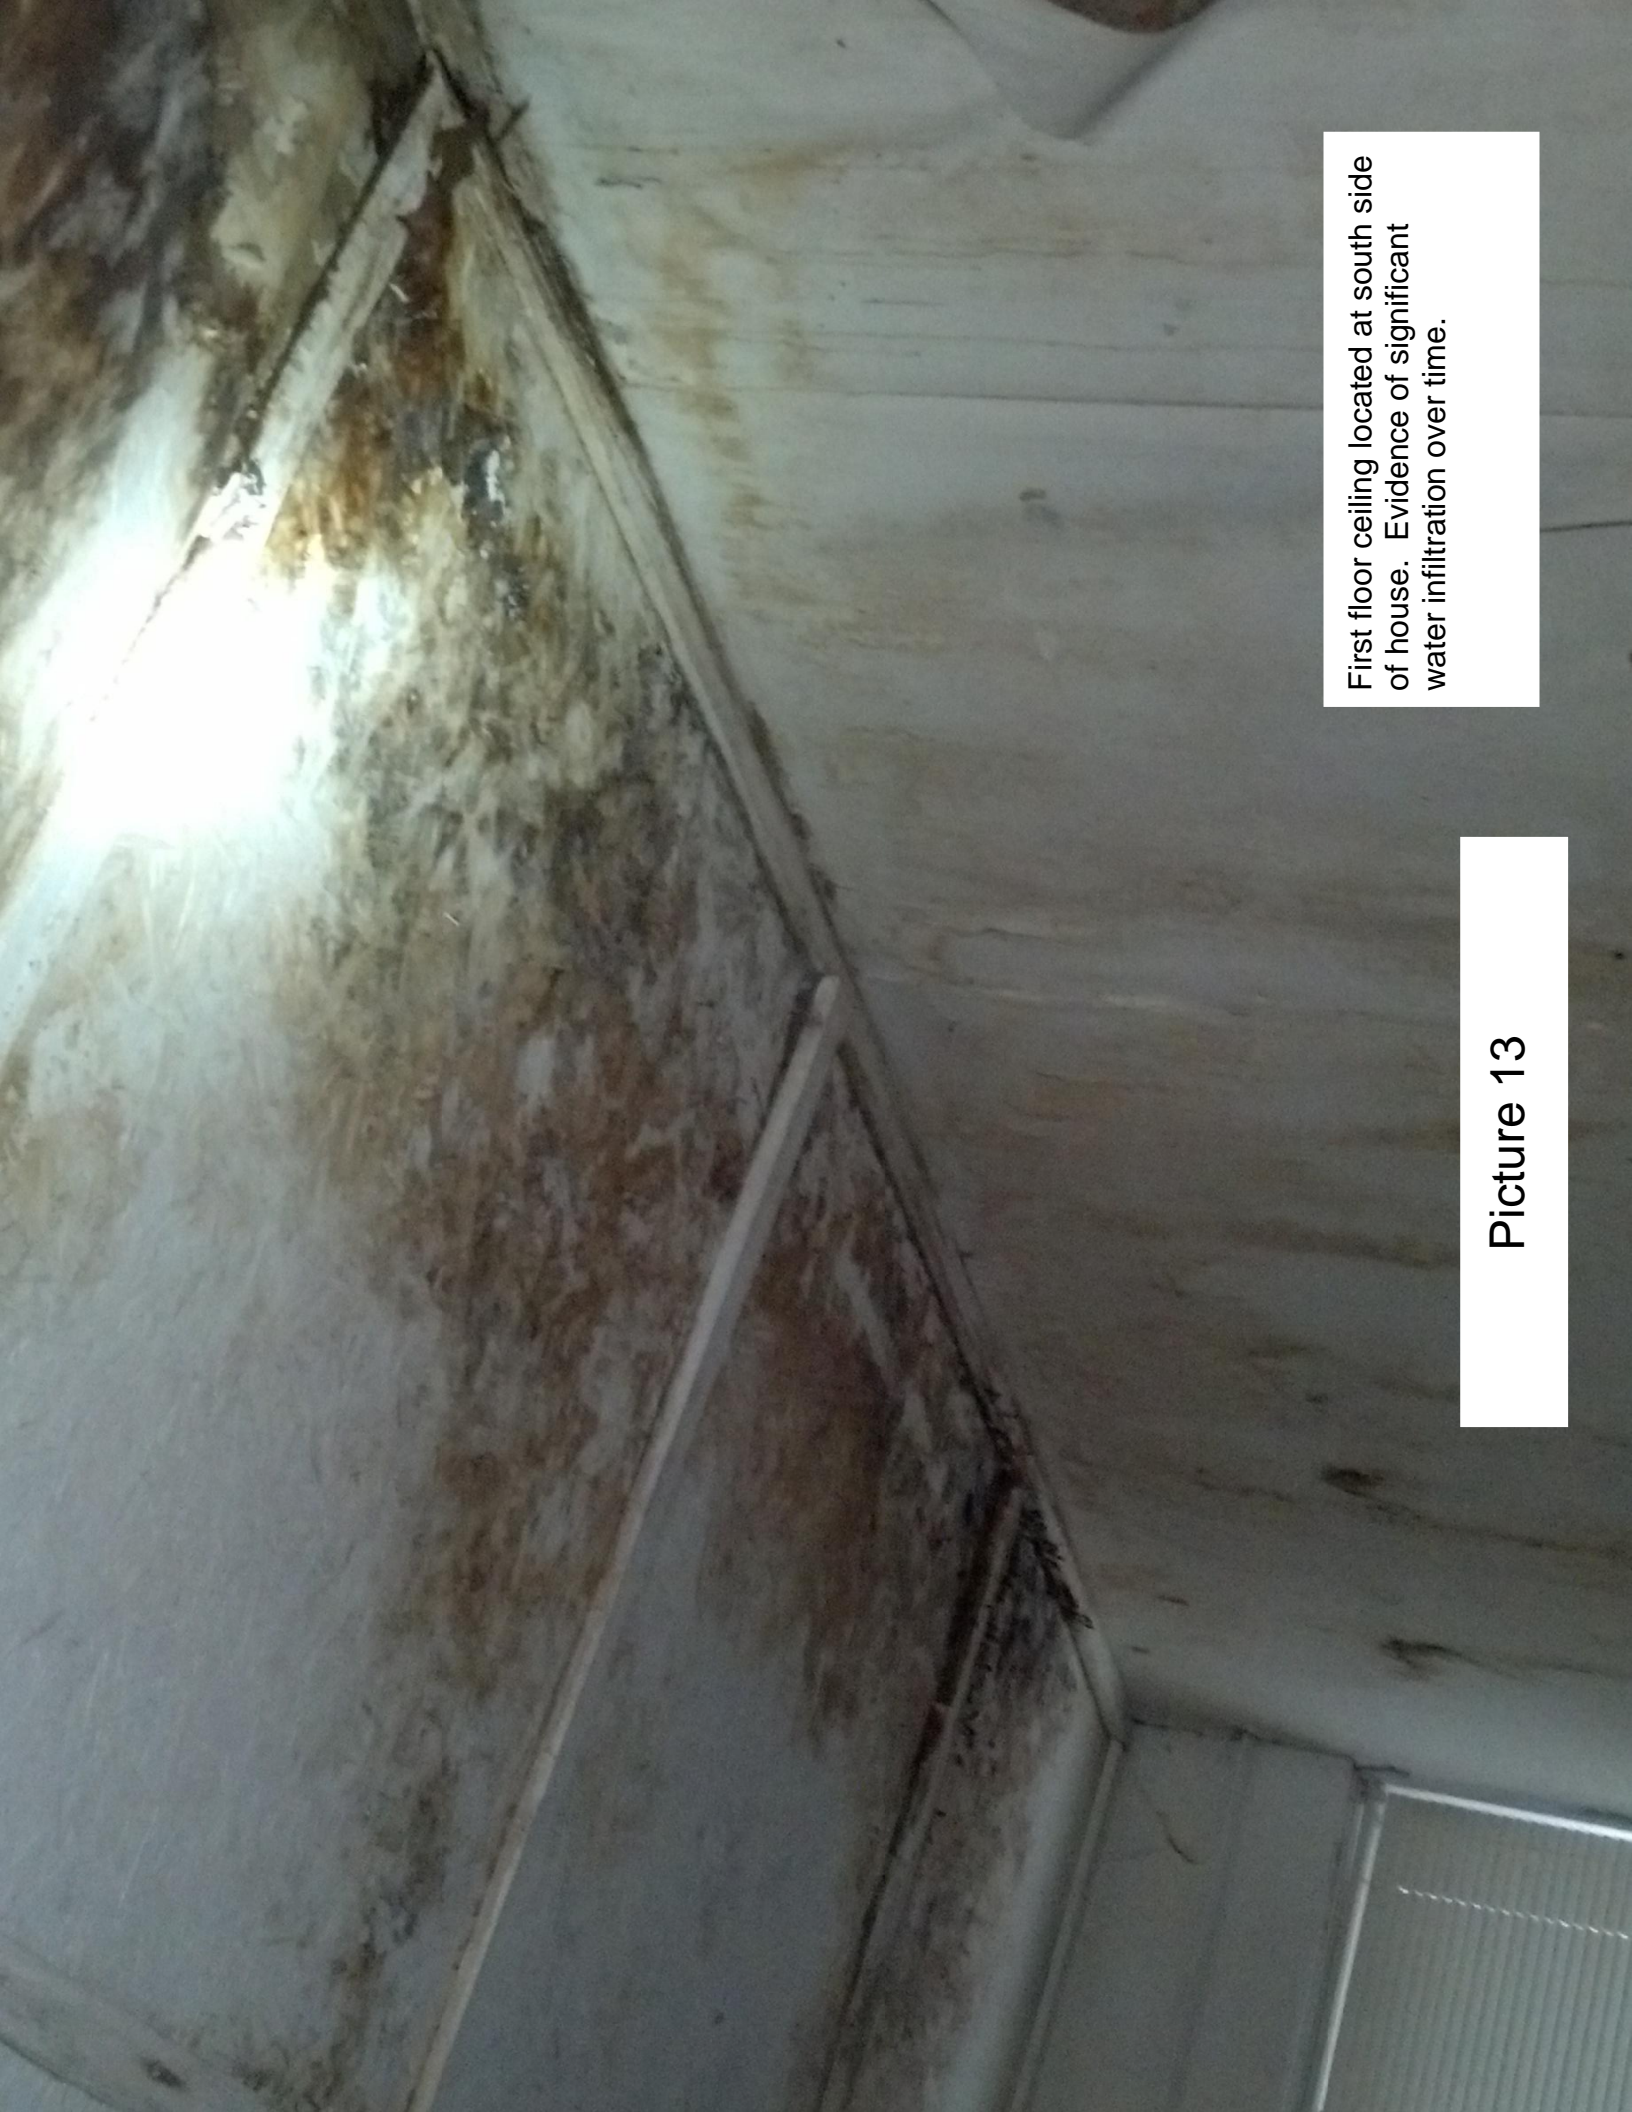
4. The second and third floor framing was mostly concealed to view and assessment of the structural integrity of the framing members could not be made. However, there are areas where the structural integrity may be compromised. These areas are where water leaking has occurred for a significant period of time. The water leaking could lead to rotting of the structure in these areas. Picture 13 and 14 are two such areas where water leaking has occurred for a significant period of time.

First floor ceiling located at south side of house. Evidence of significant water infiltration over time.
