**PIERCE ENGINEERS INC**  
CONSULTING STRUCTURAL ENGINEERS  
10 West Mifflin St, Suite 205 | Madison, WI 53703  
Phone: 608.256.7304 | Fax: 608.256.7306

**SUBJECT: Structural Evaluation Report  
127 W. Gilman St  
Madison, Wisconsin**

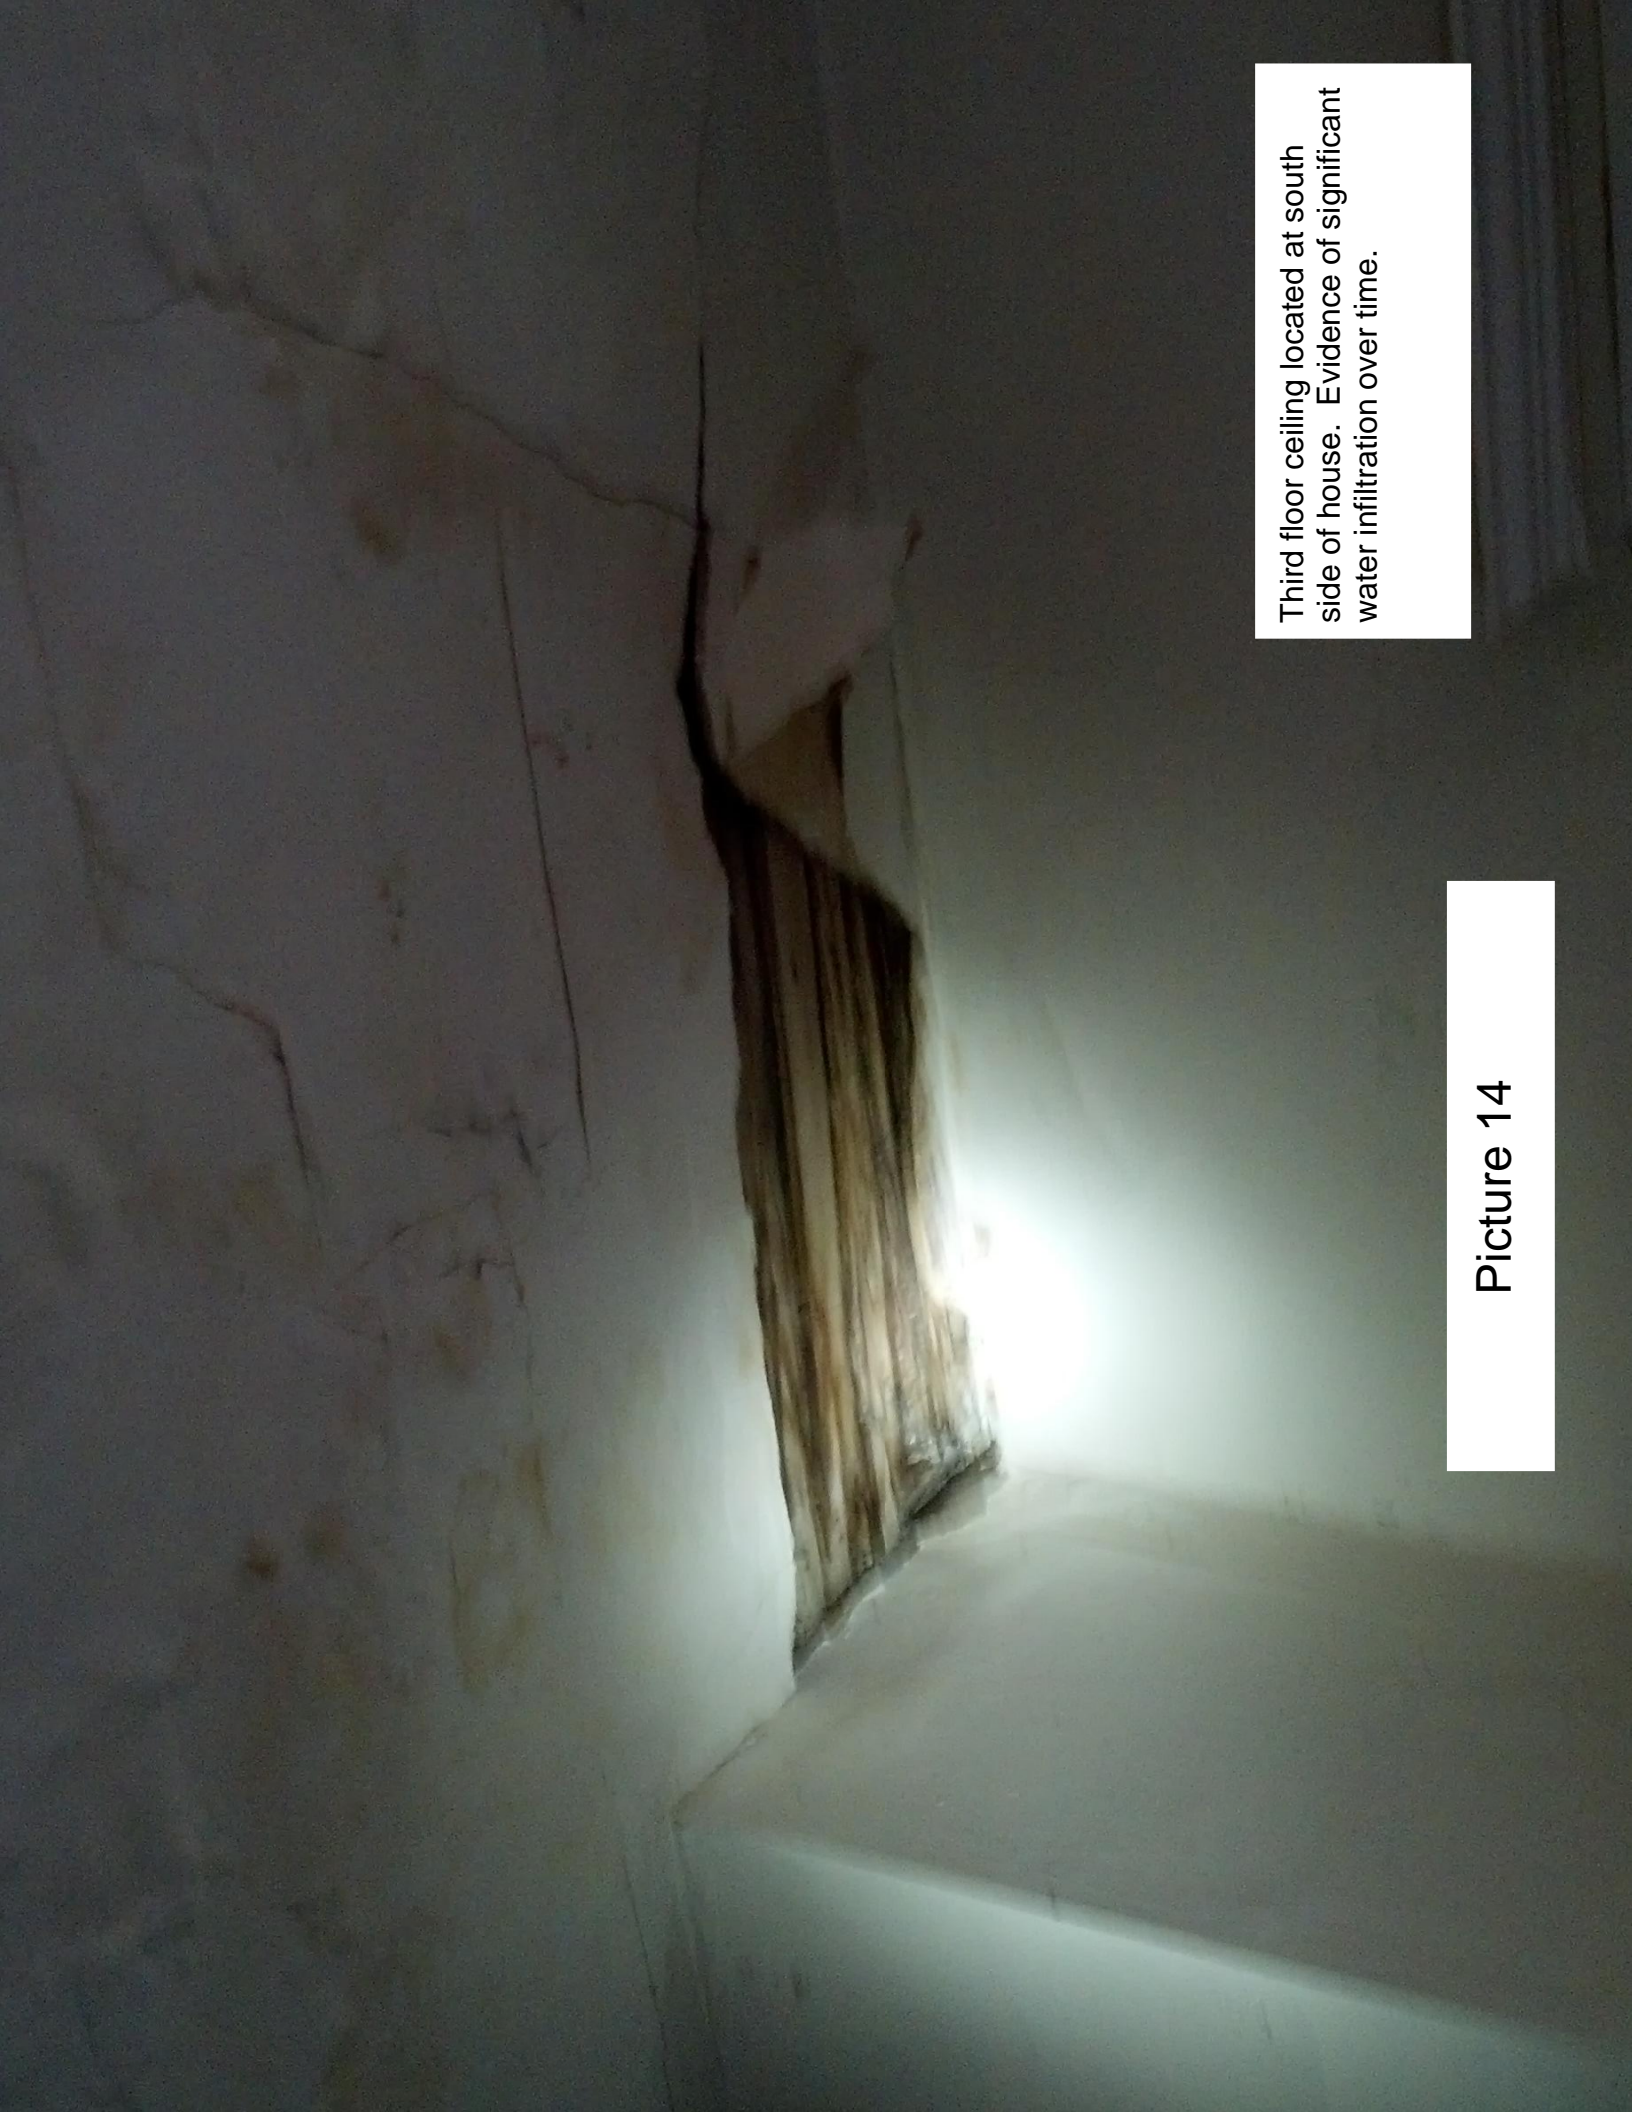
Picture 14

Third floor ceiling located at south side of house. Evidence of significant water infiltration over time.

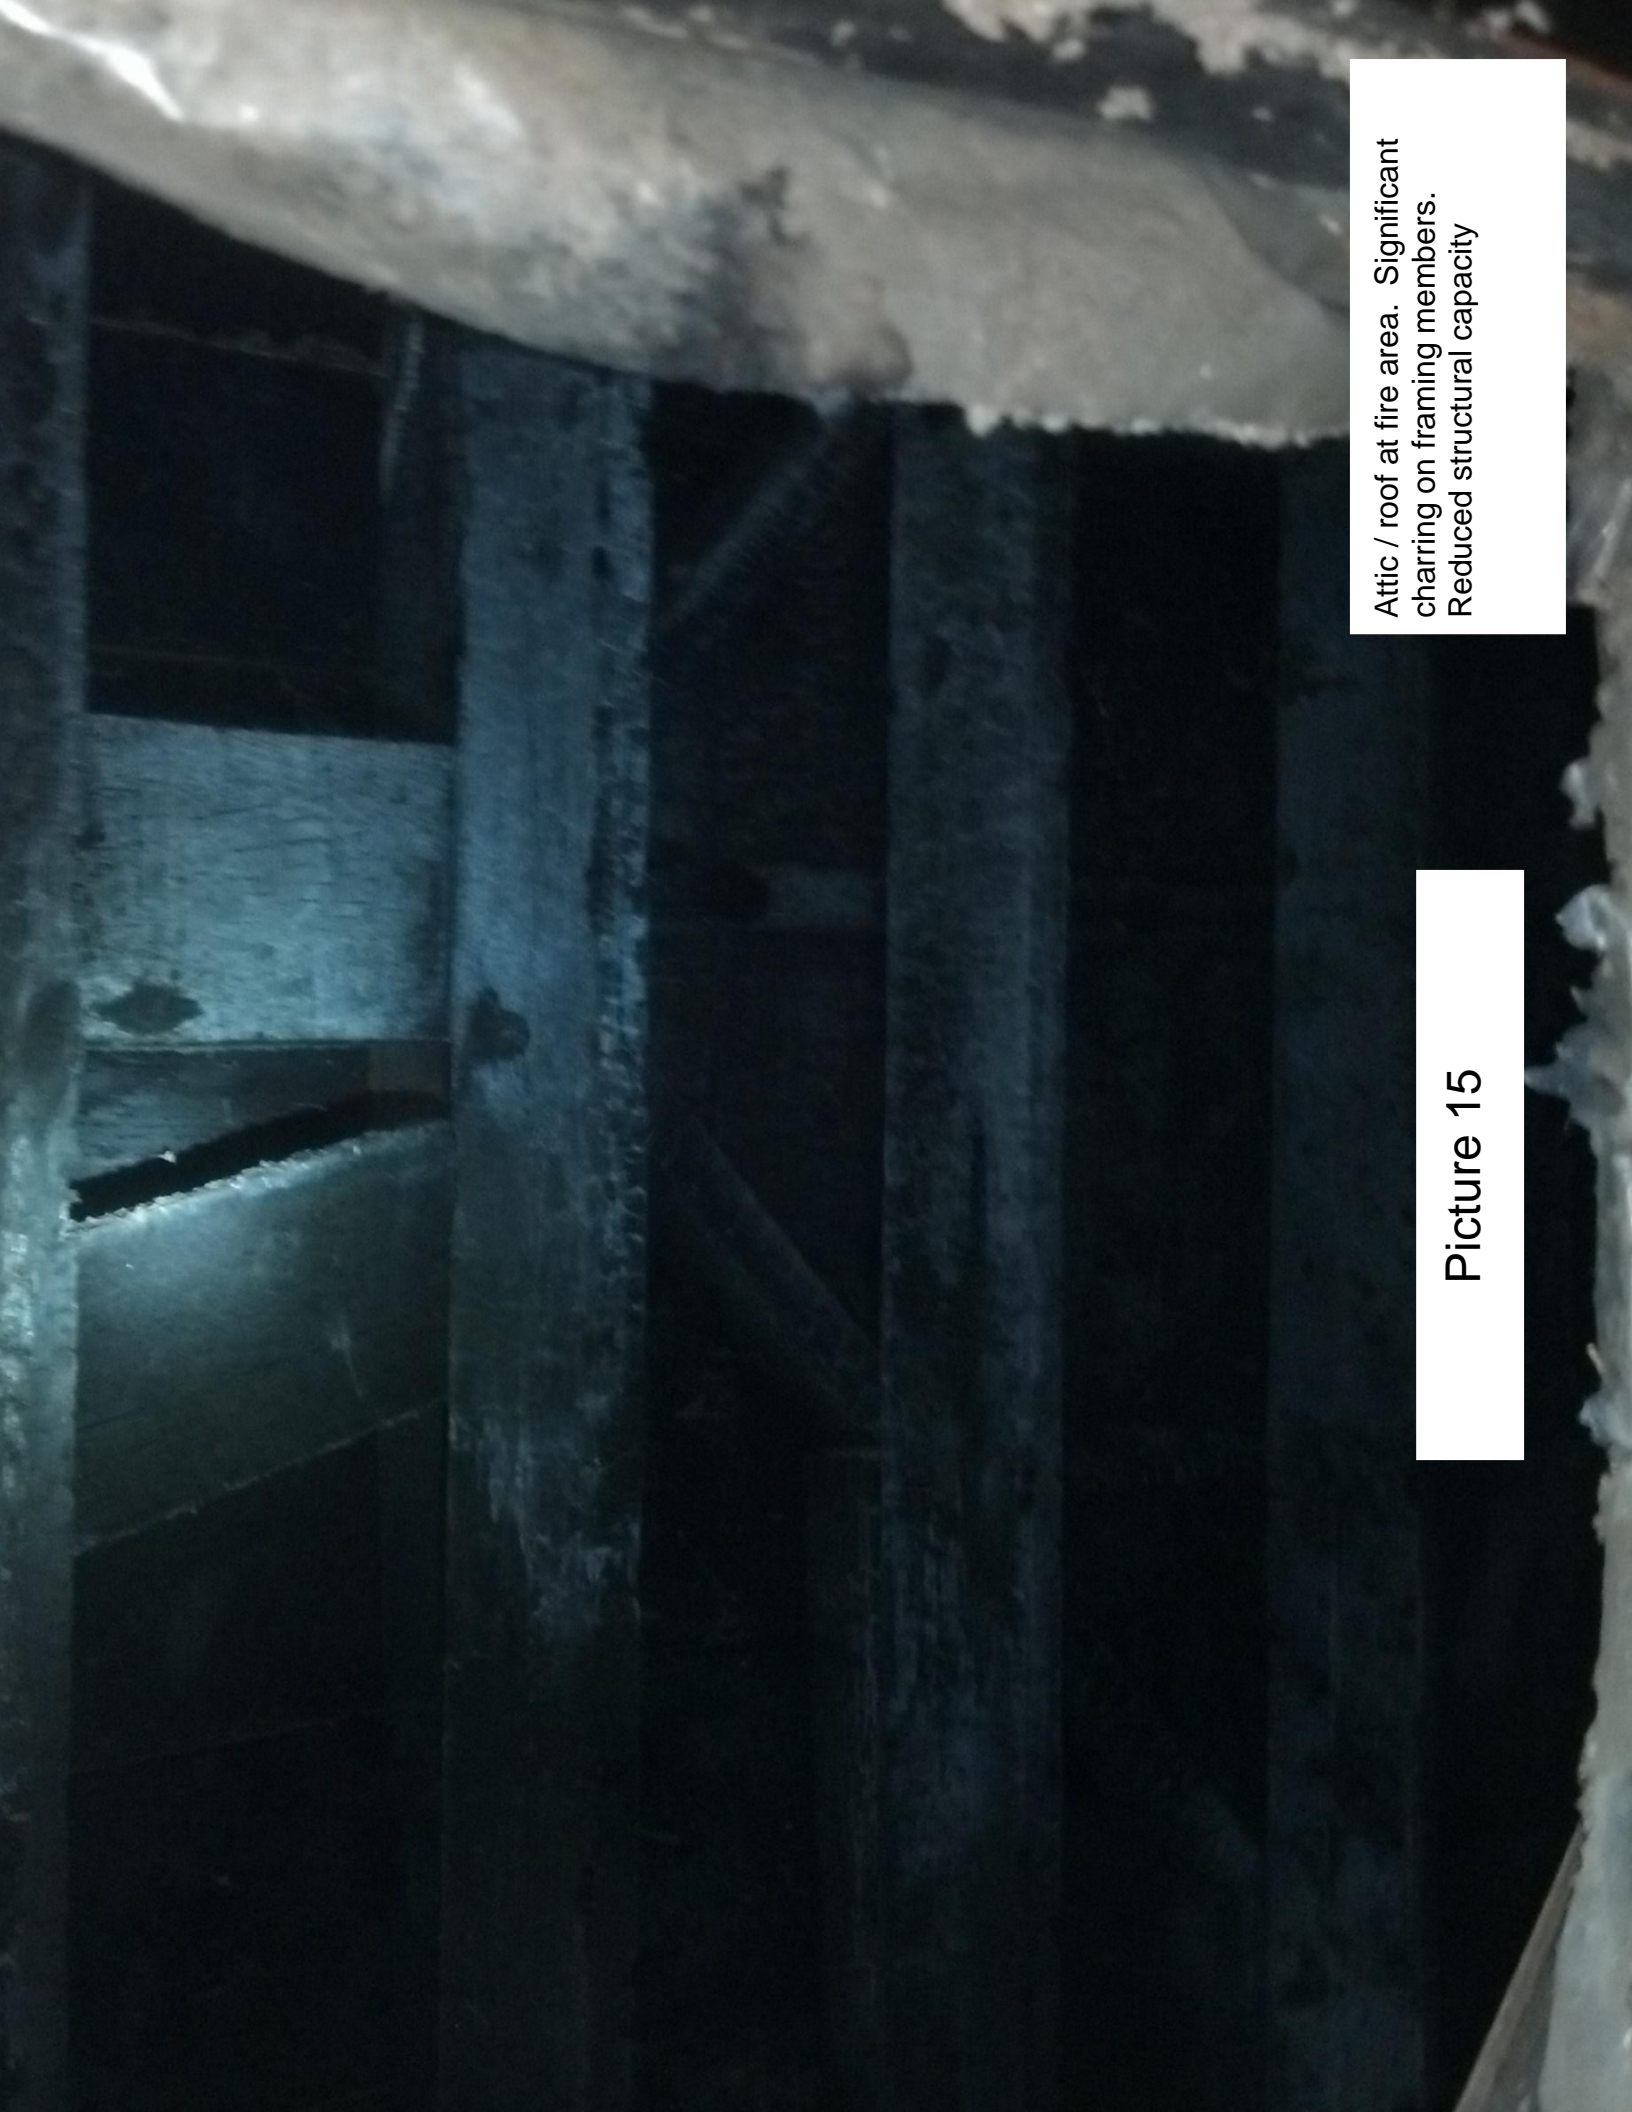
Picture 15

16 are of the attic / roof structure where fire damage has occurred. The fire was of significant intensity that severe charring has occurred to some of the attic / roof framing members reducing their structural capacity. Picture 17 is of the fire damage at the second floor bathroom. The intensity of the this fire does not appear to have been as damaging as the attic fire, but charring of the framing members has occurred, and it is suspected the structural capacity of the charred framing members has been reduced.

Attic / roof at fire area. Significant charring on framing members. Reduced structural capacity

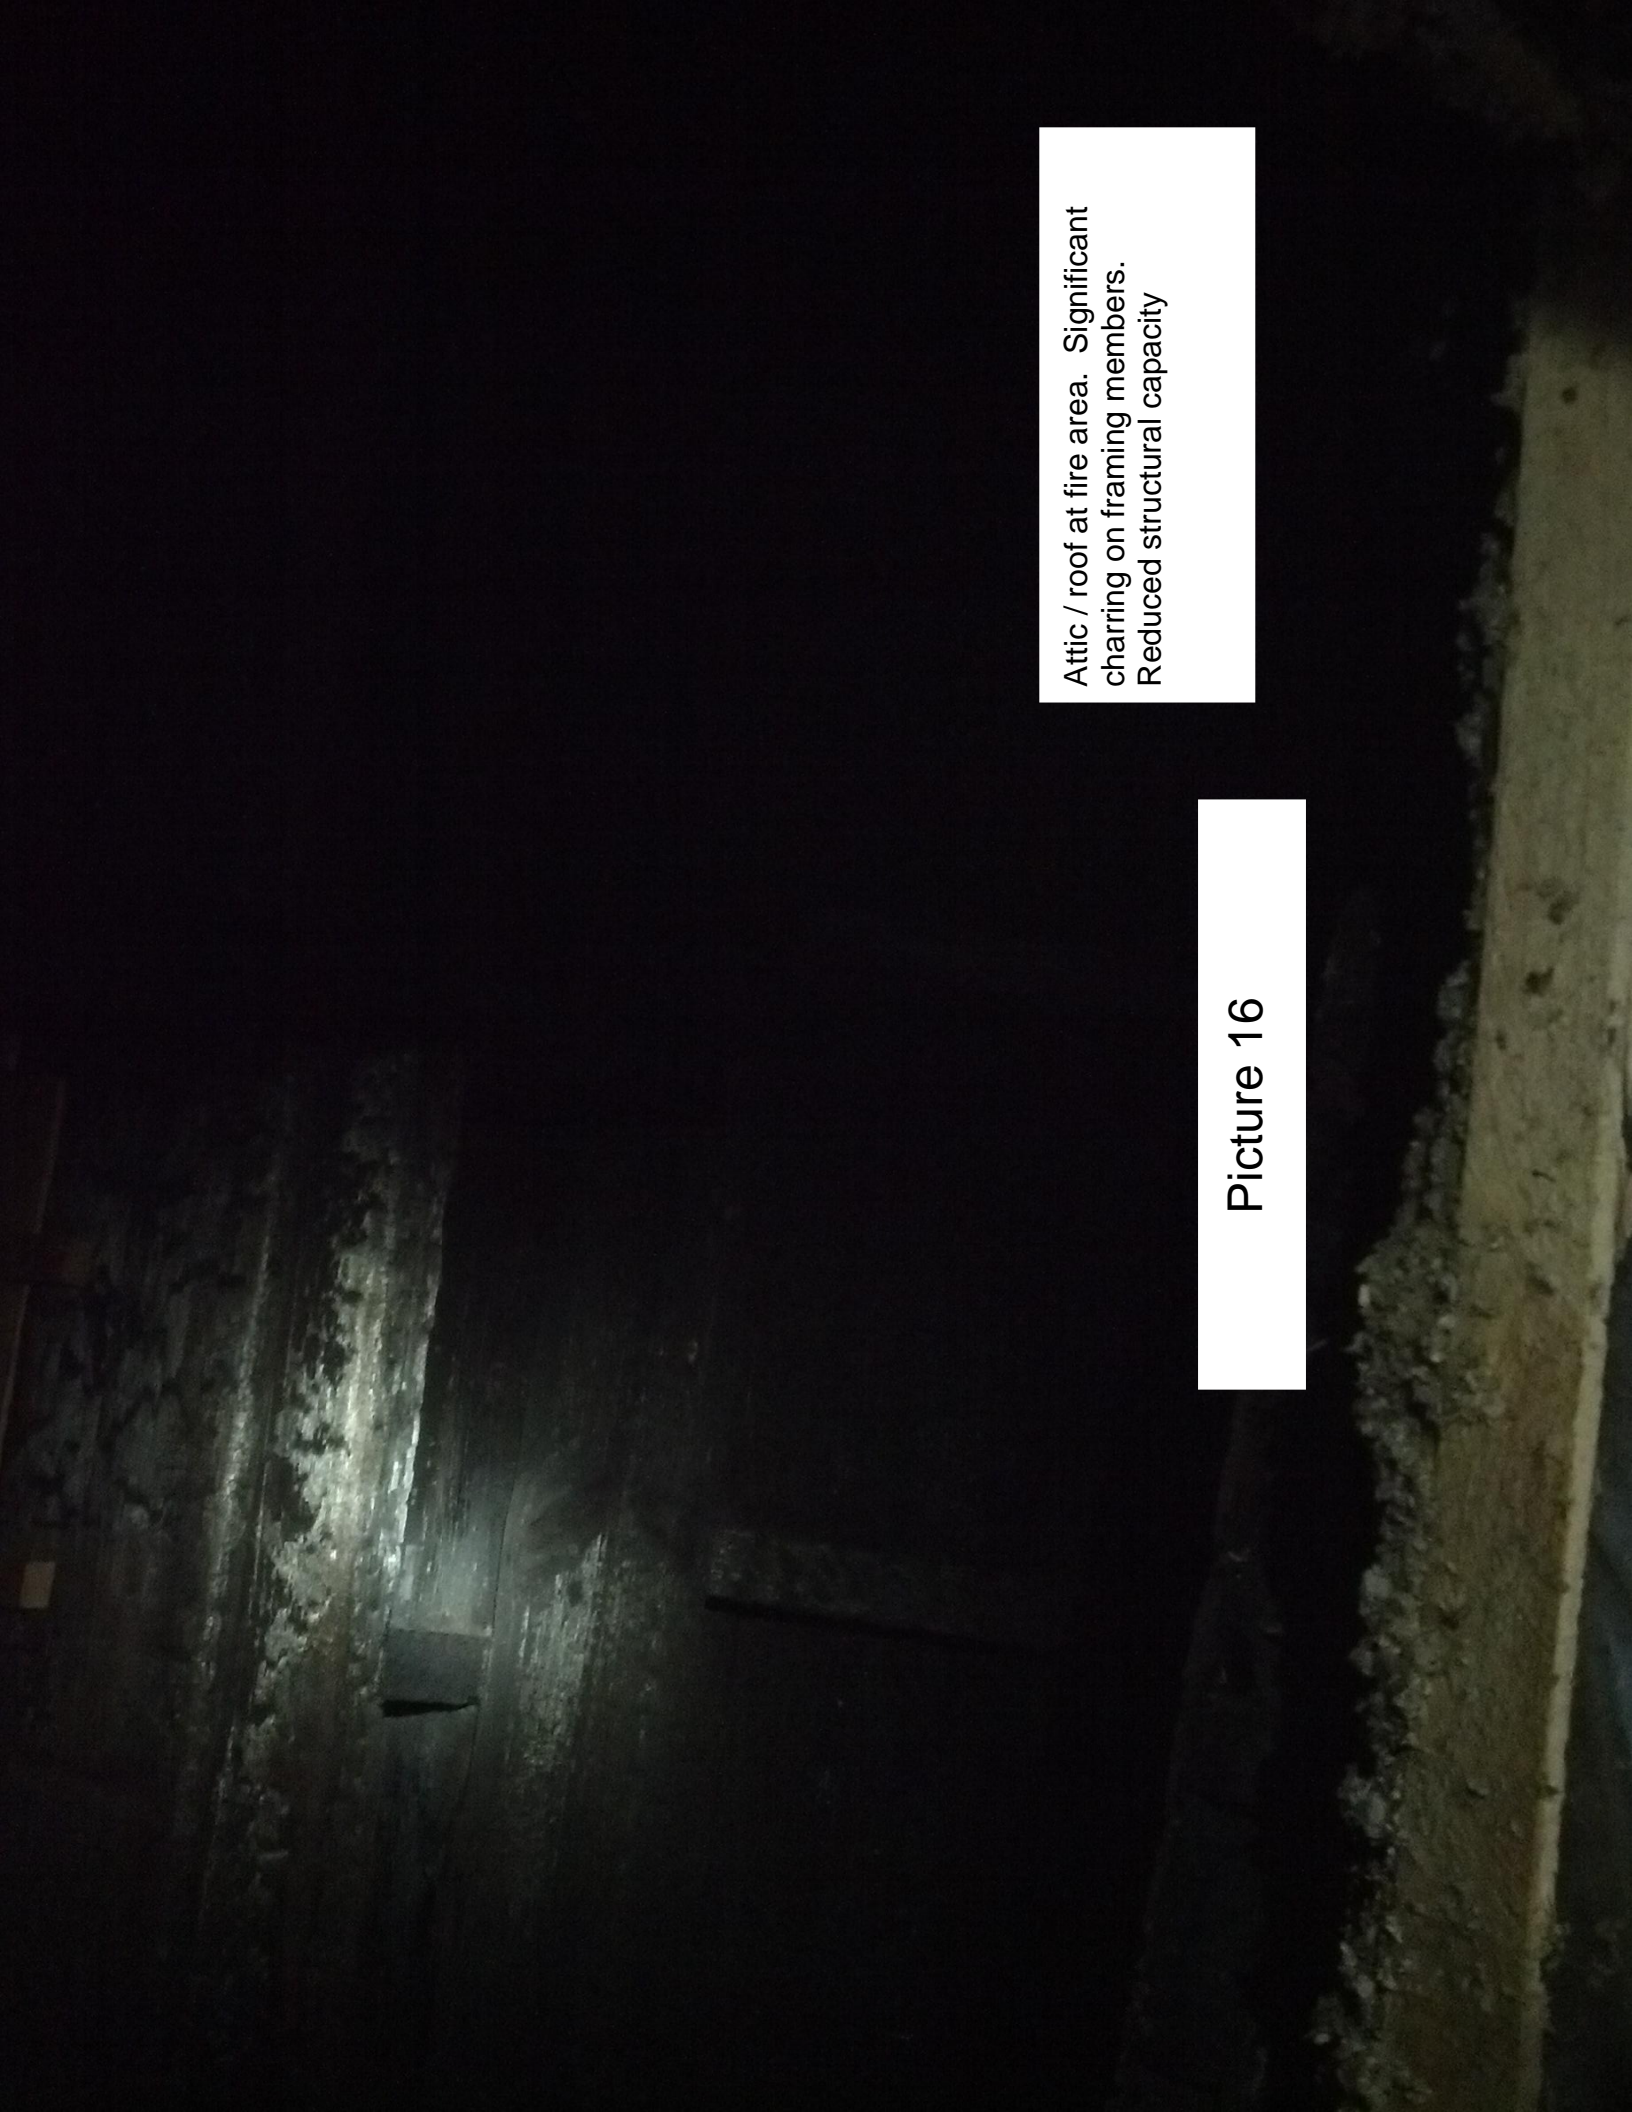
Picture 16

Attic / roof at fire area. Significant charring on framing members. Reduced structural capacity

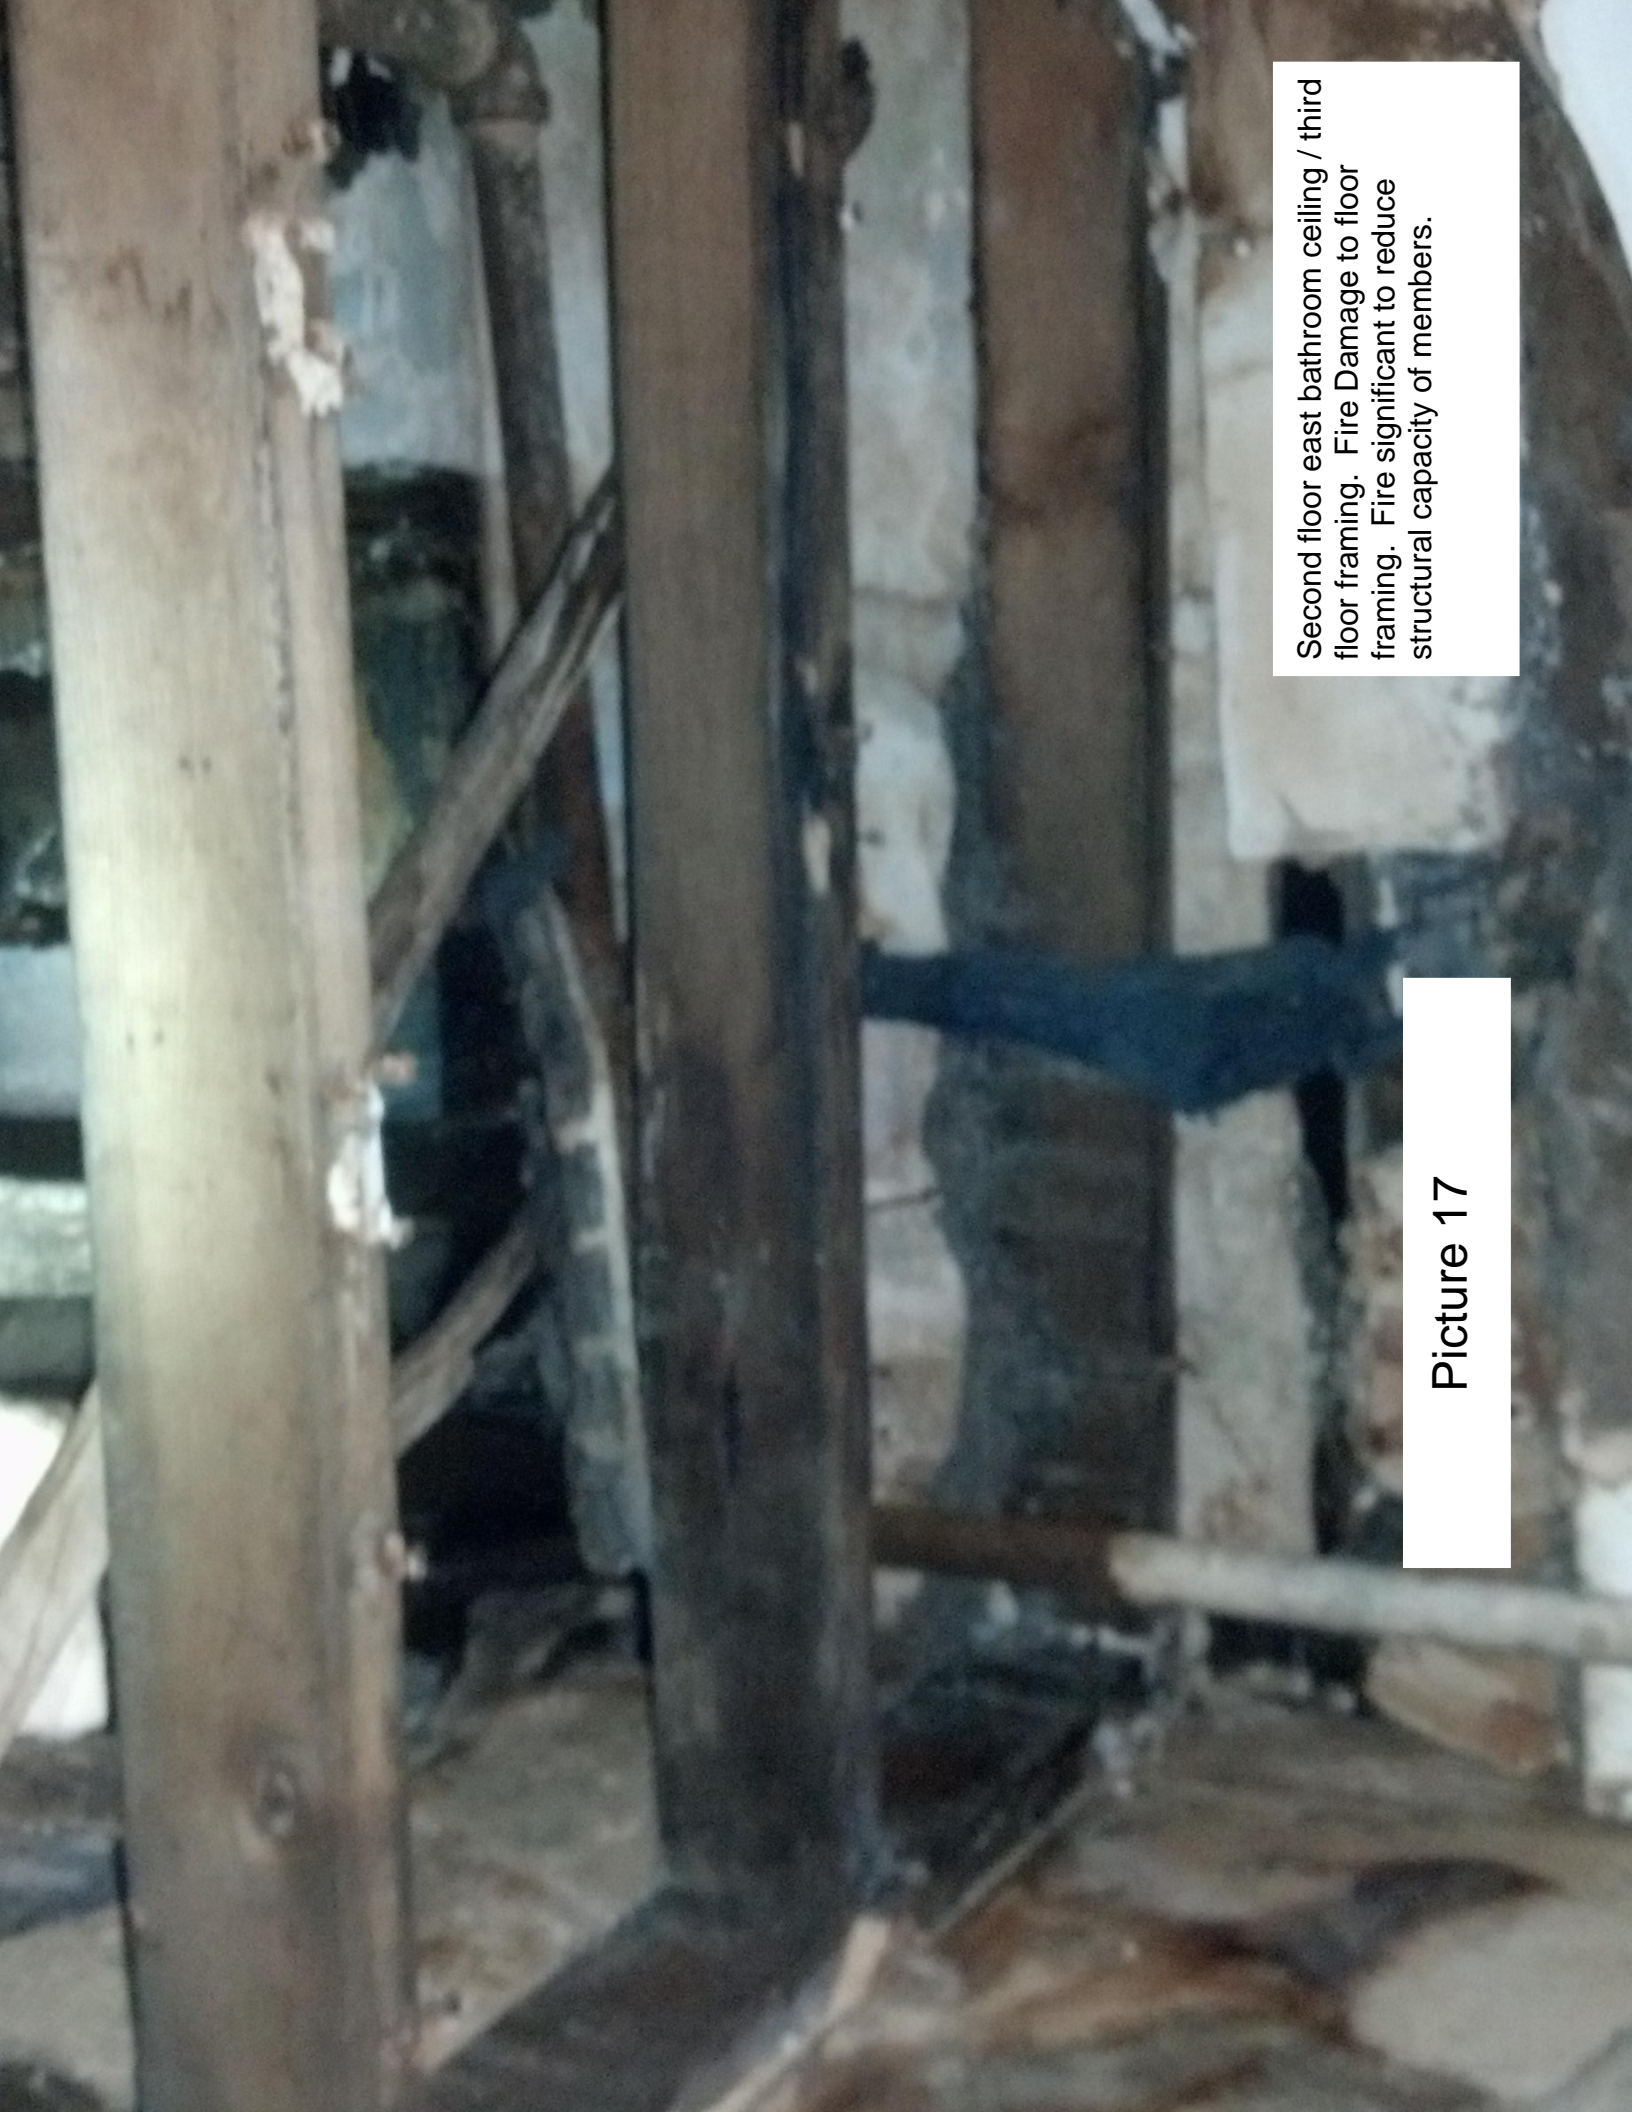
Picture 17

Second floor east bathroom ceiling / third floor framing. Fire Damage to floor framing. Fire significant to reduce structural capacity of members.

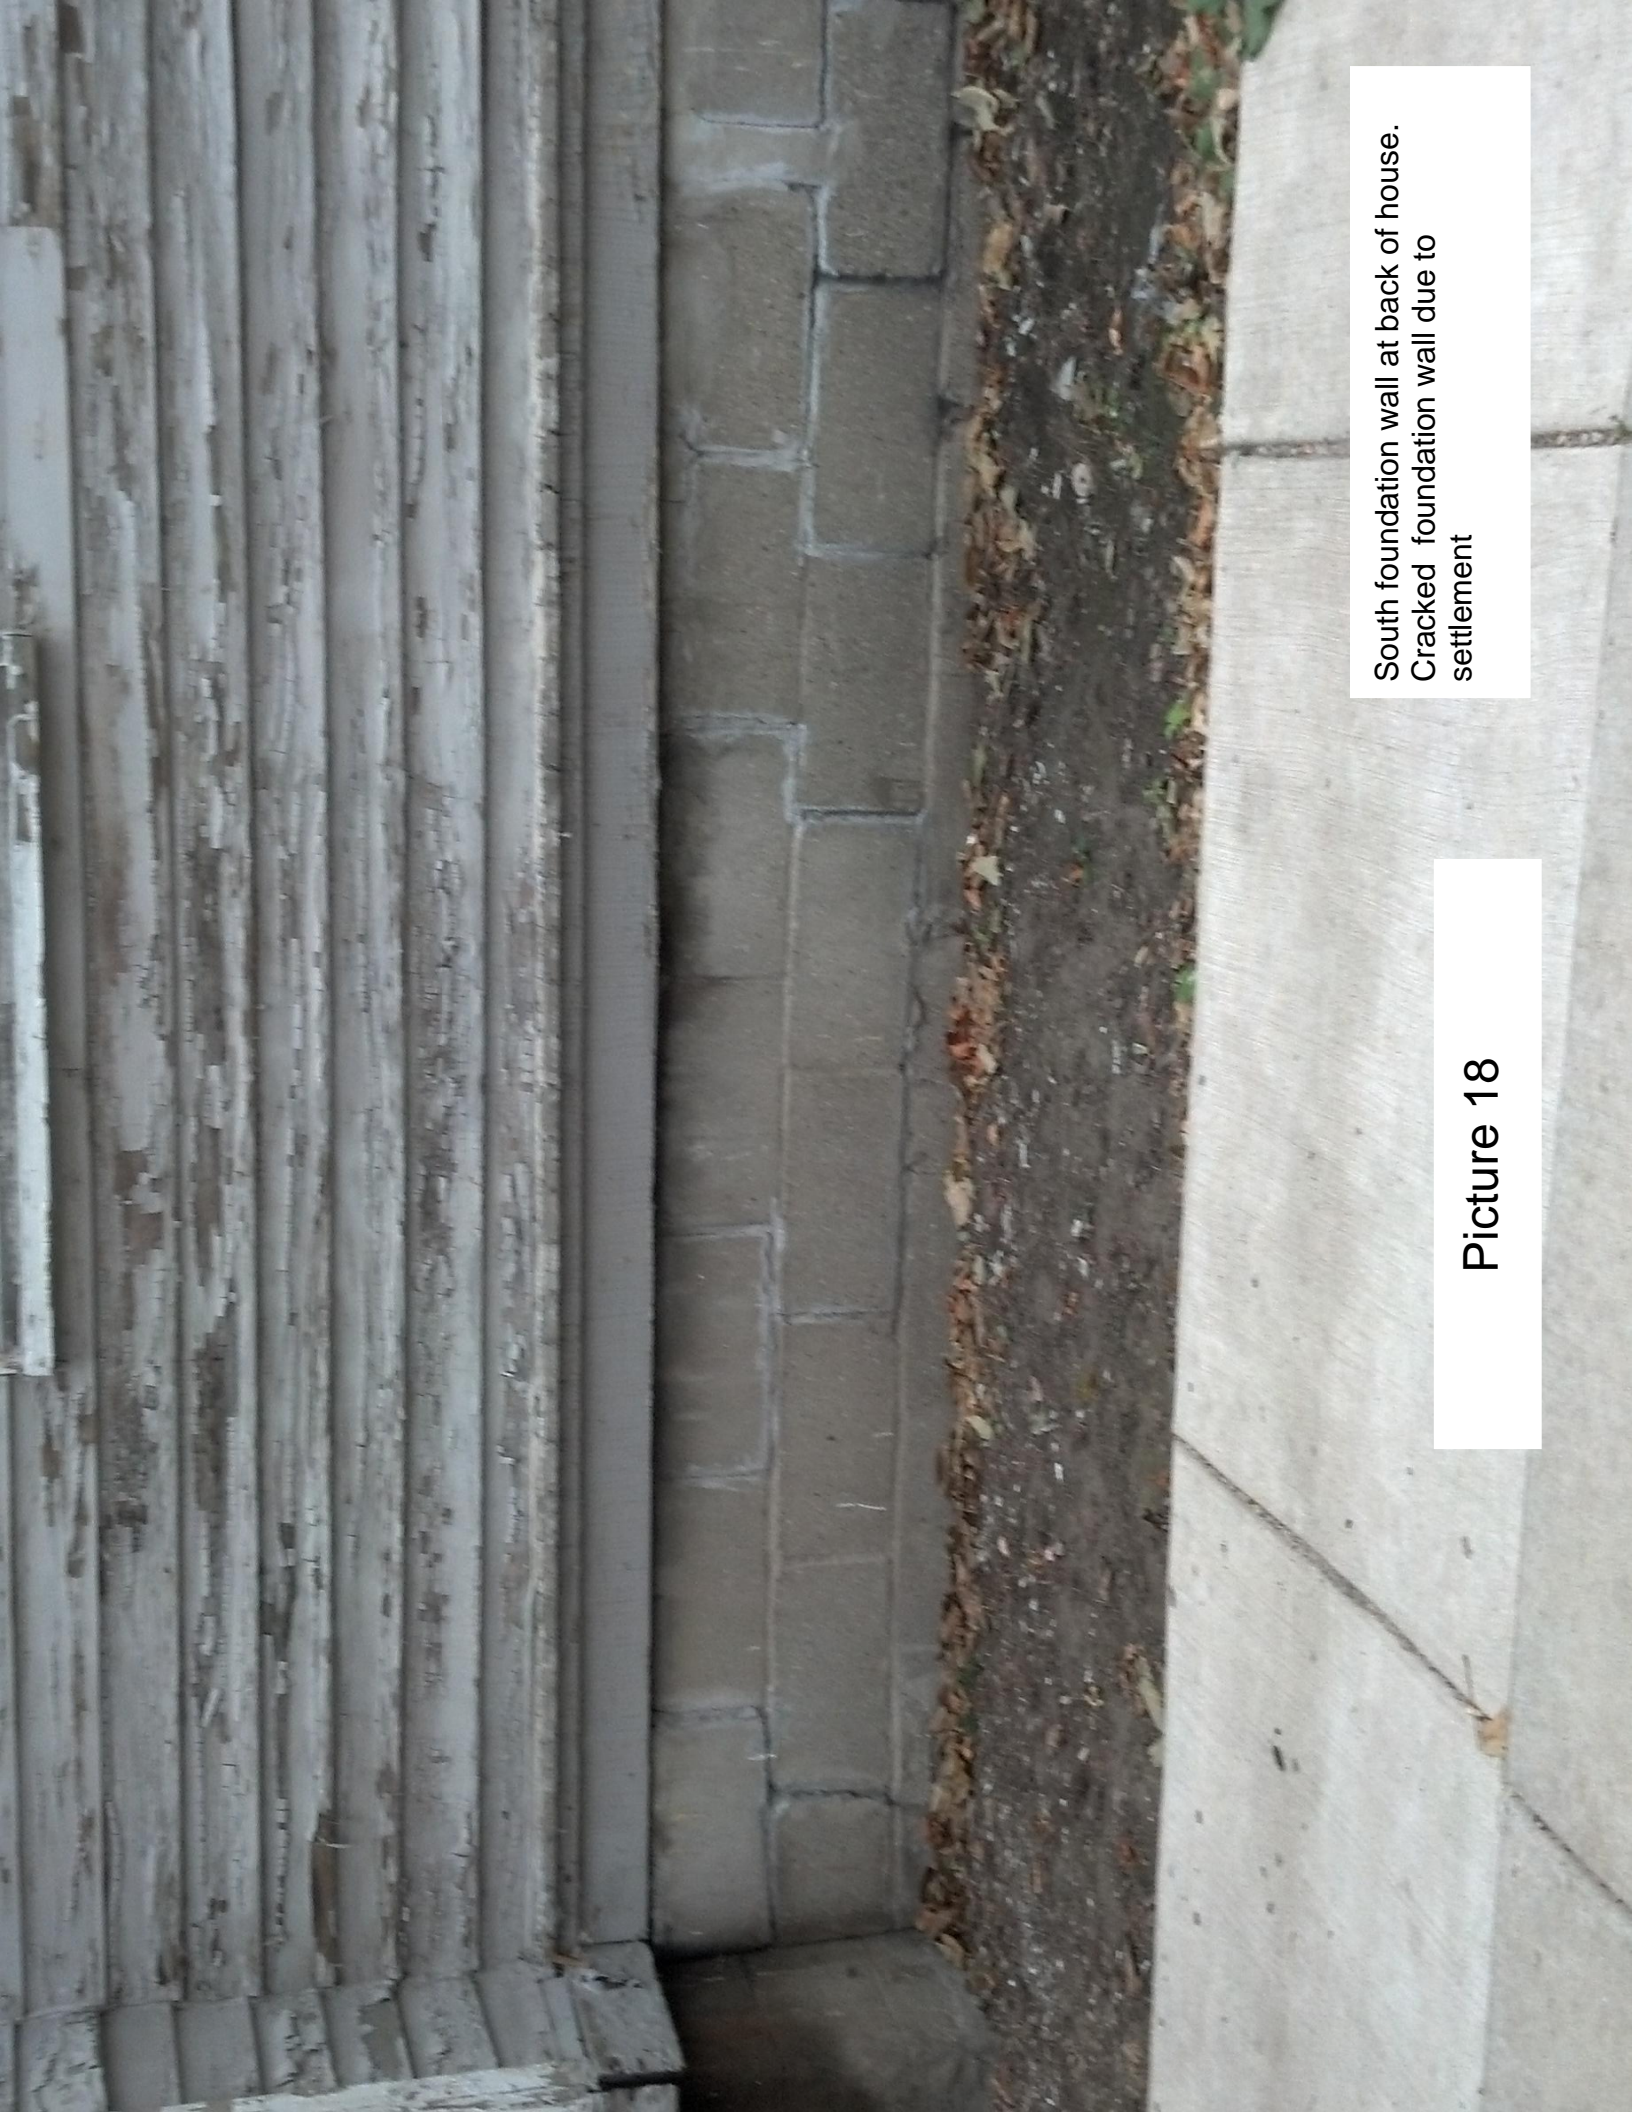
Picture 18

6. The house has also experienced some movement and settlement over time. It is believed this movement has not reduced the structural integrity of the framing, but is one of serviceability of the structure. Pictures 18 thru 20 show evidence of building movement. Sloping of the floor framing has also occurred and this is noticeable when walking the floors. This movement has caused diagonal cracking in the walls, Picture 20, which leads to mis-aligned doors and window. Other affects as a result of the movement are buckled flooring and sloped floors.

South foundation wall at back of house.  
Cracked foundation wall due to  
settlement

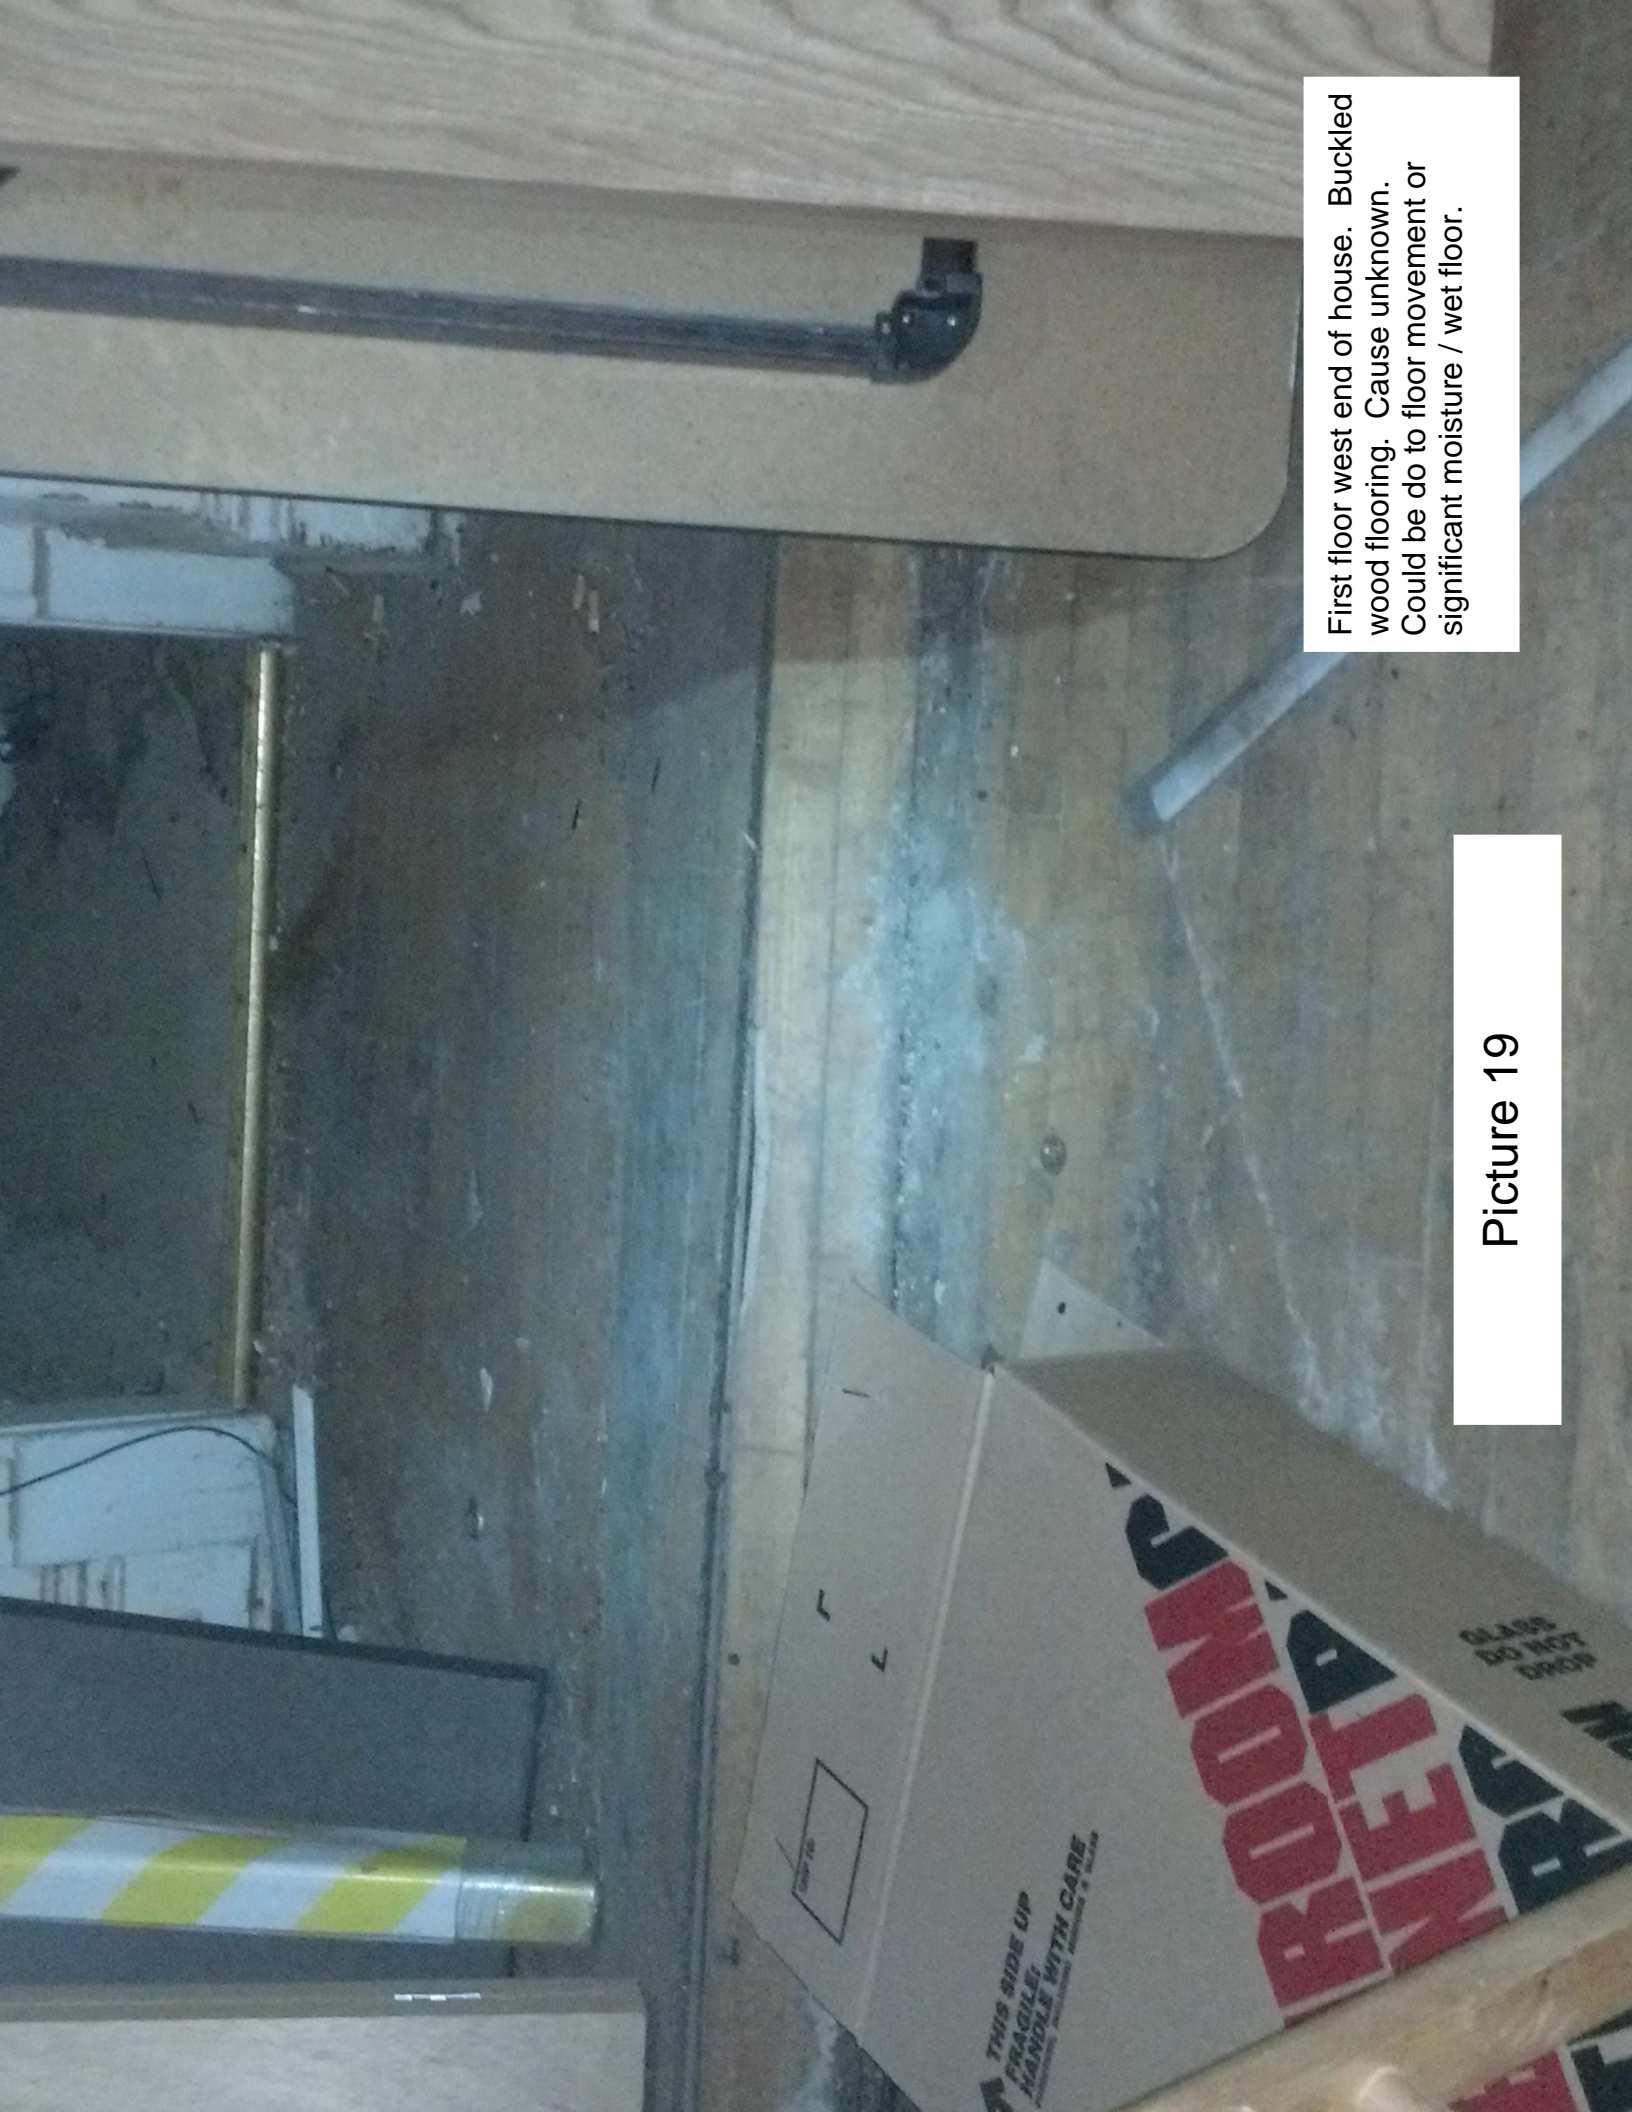
Picture 19

First floor west end of house. Buckled wood flooring. Cause unknown. Could be do to floor movement or significant moisture / wet floor.
