**PIERCE ENGINEERS INC**  
CONSULTING STRUCTURAL ENGINEERS  
10 West Mifflin St, Suite 205 | Madison, WI 53703  
Phone: 608.256.7304 | Fax: 608.256.7306

**SUBJECT: Structural Evaluation Report  
127 W. Gilman St  
Madison, Wisconsin**

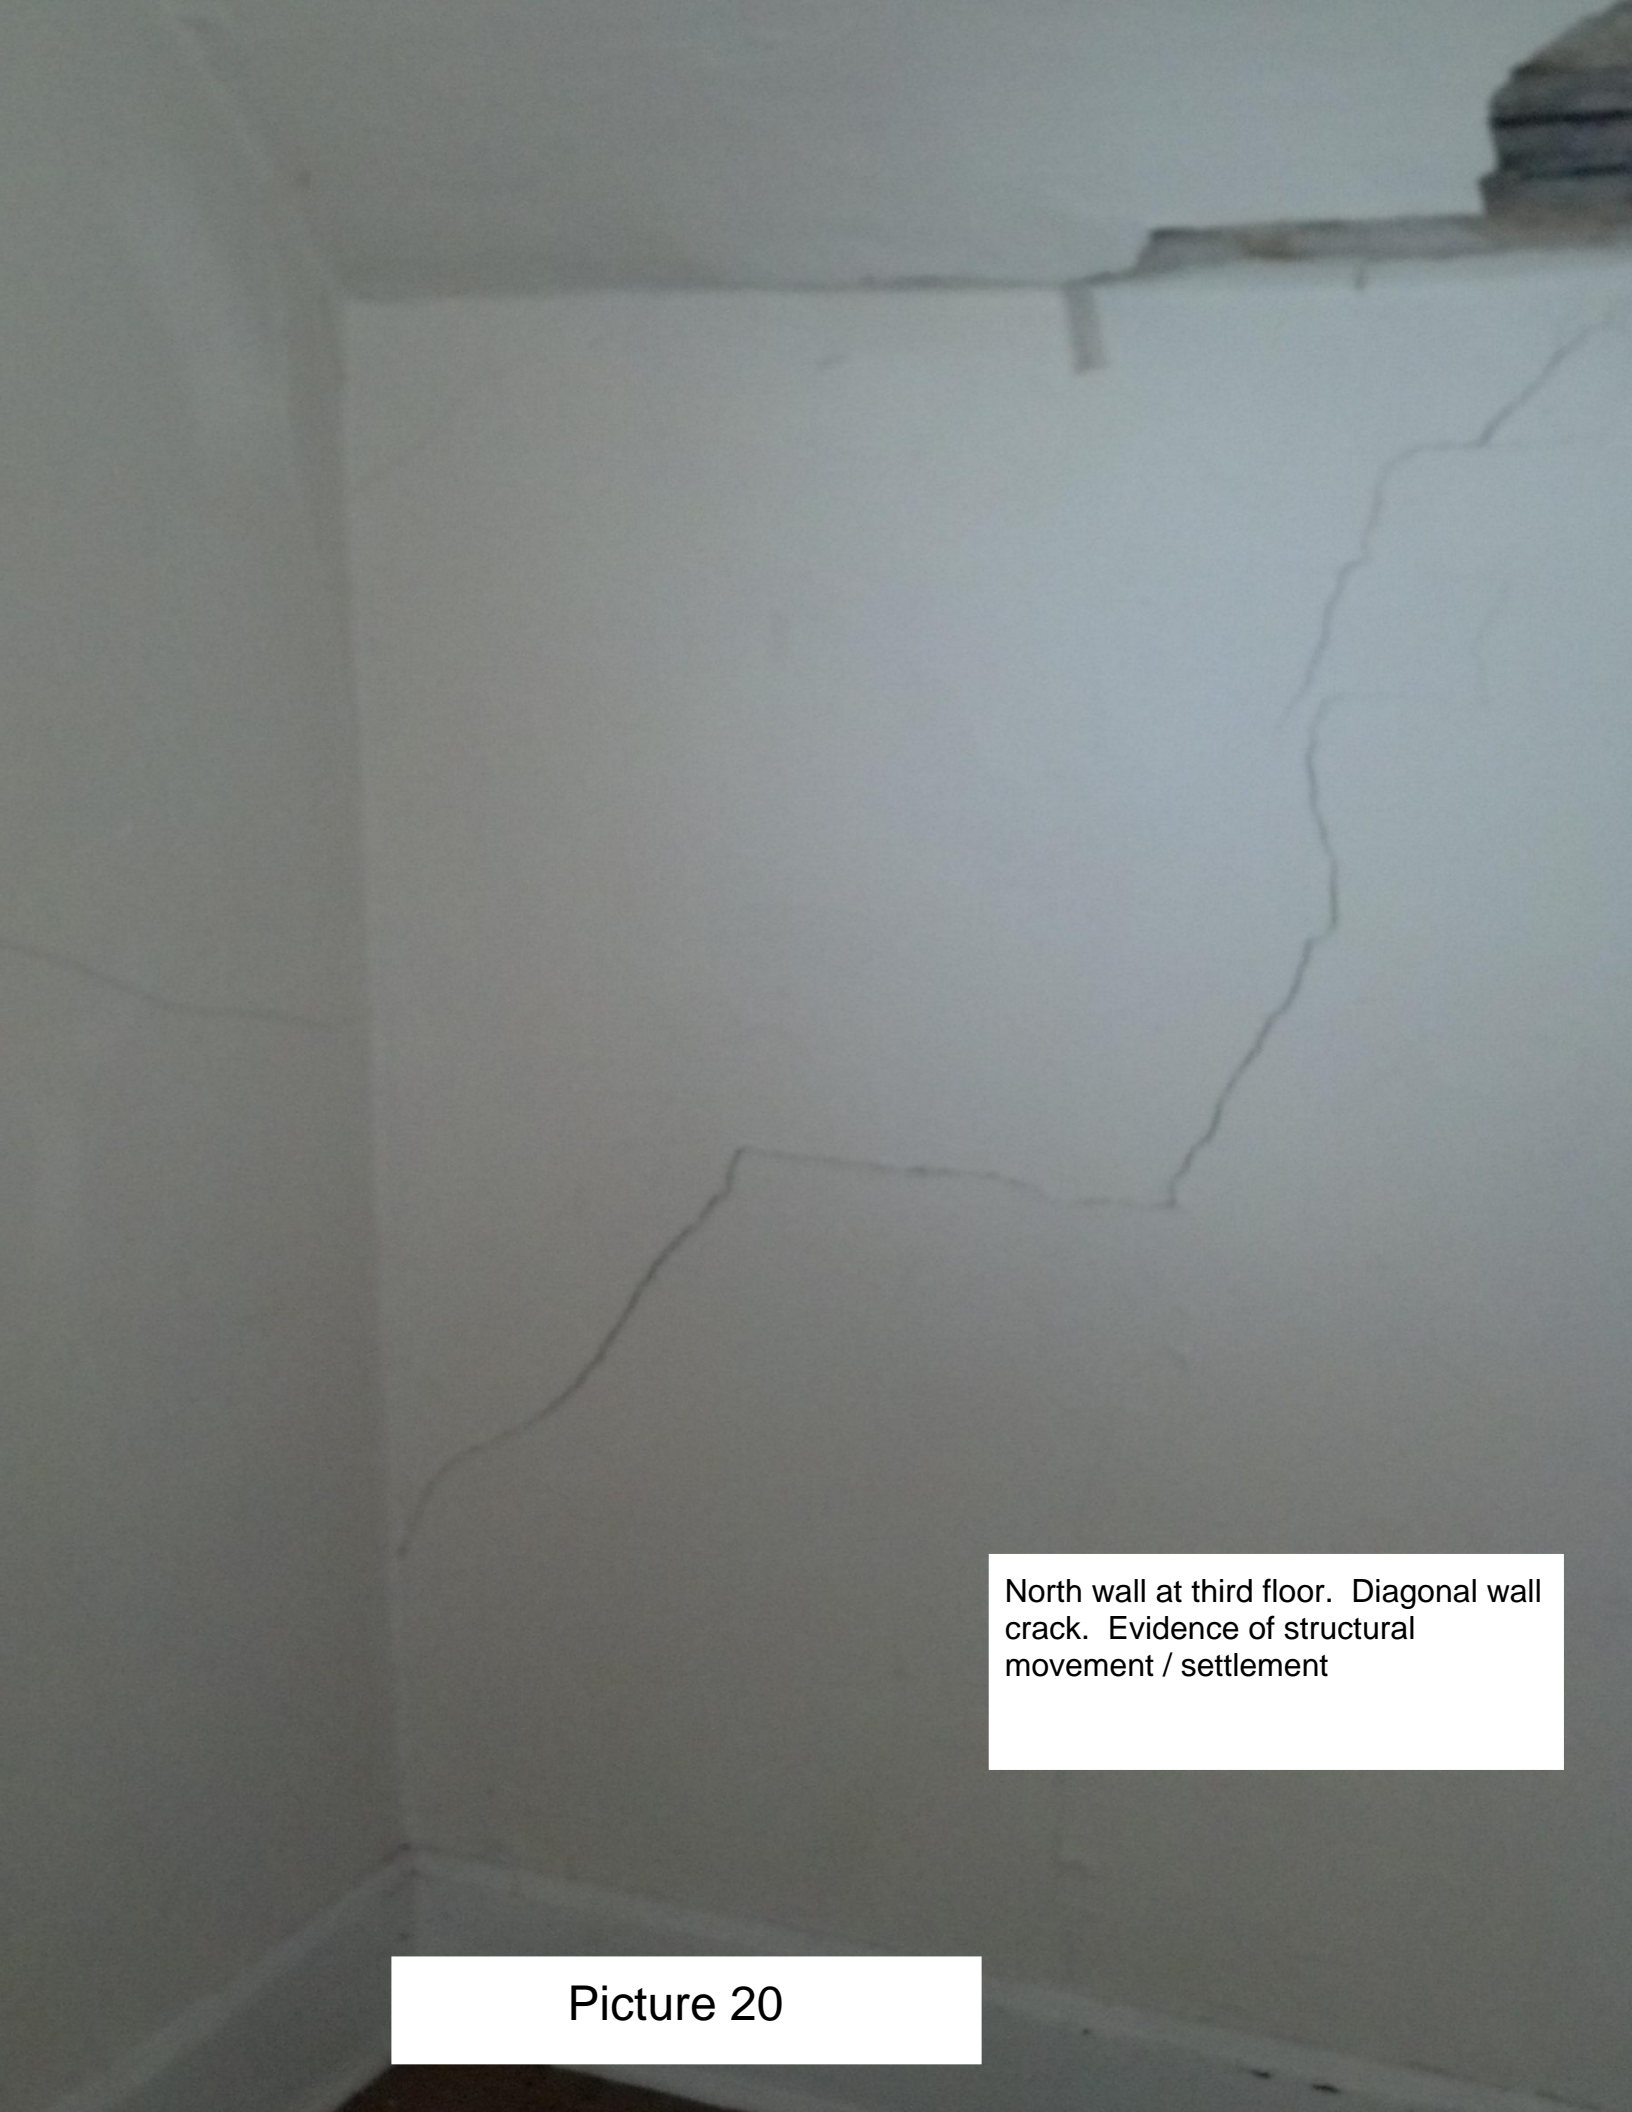
Picture 20

North wall at third floor. Diagonal wall crack. Evidence of structural movement / settlement
