Addendum: 1311 Jenifer Street

This Addendum provides additional information in support of the request to replace window sashes on five downstairs windows. I apologize for not providing this information in my initial application.

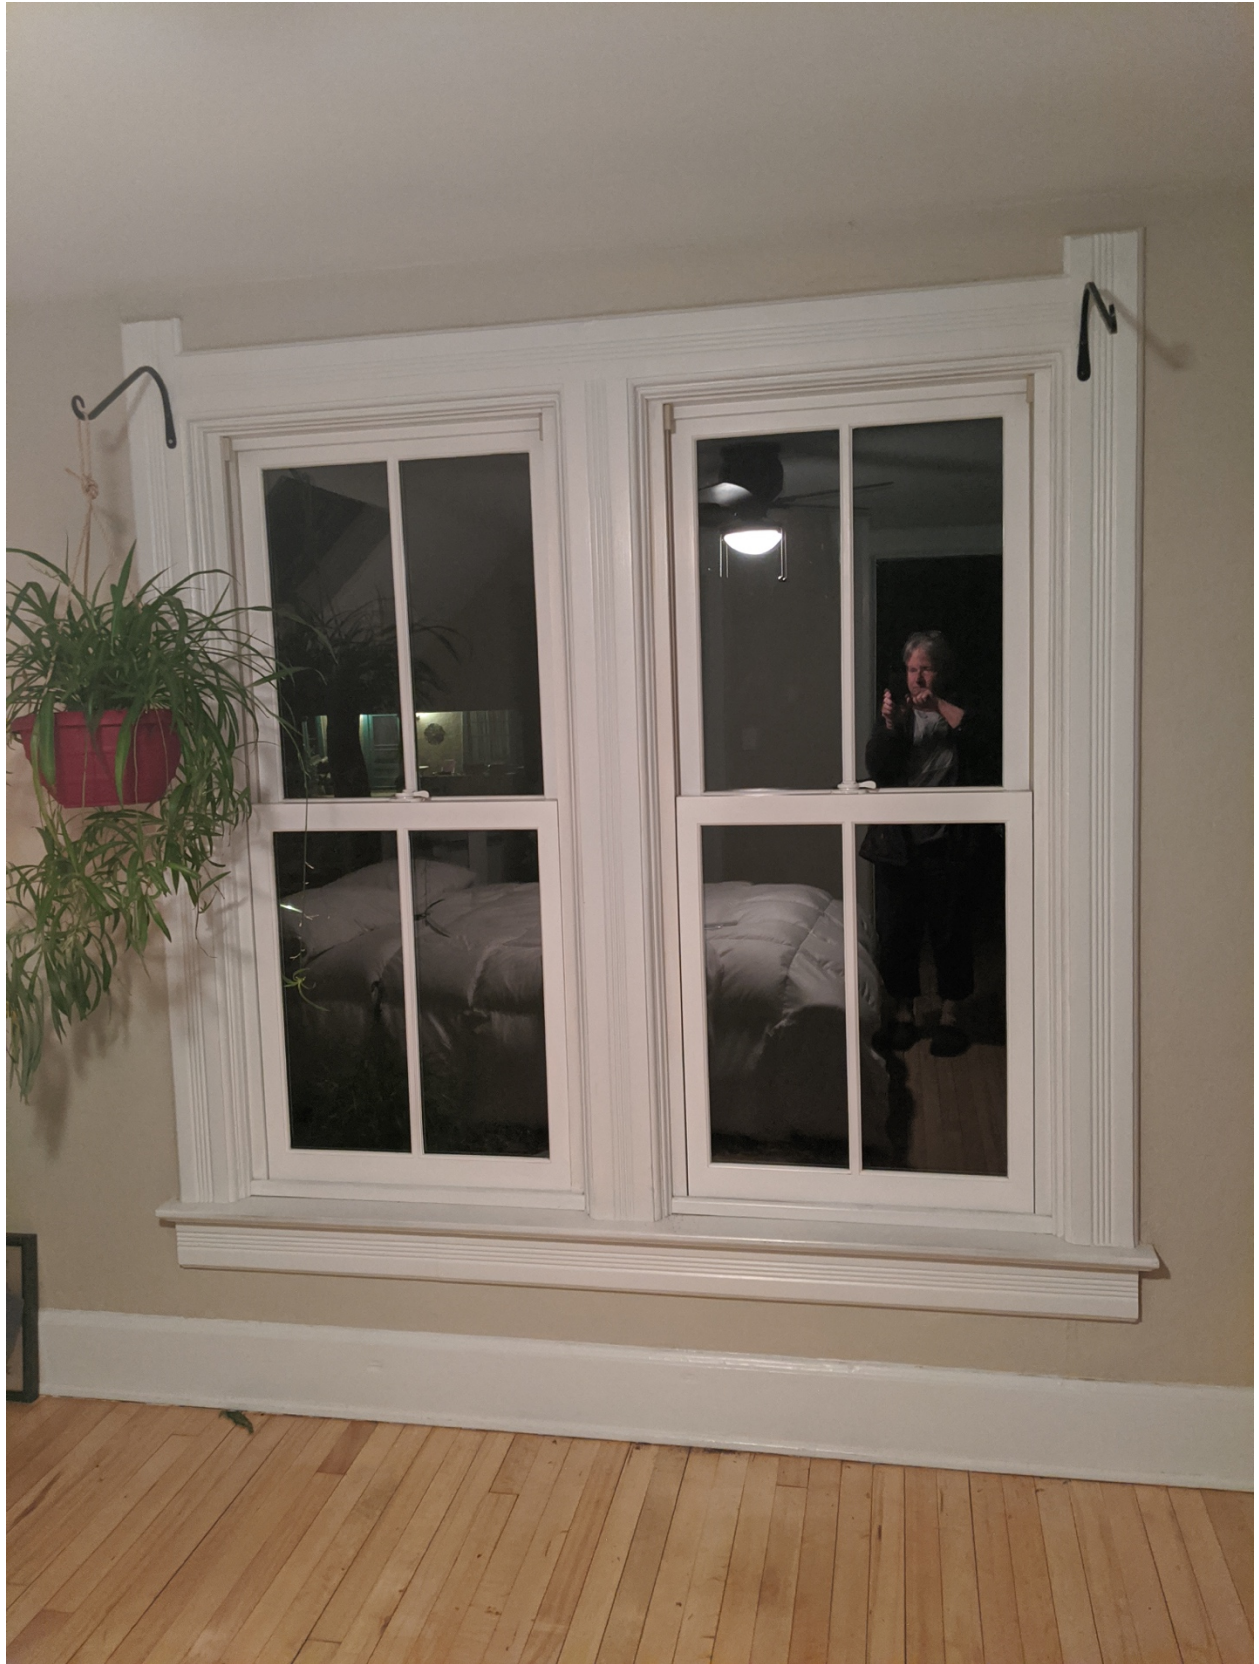
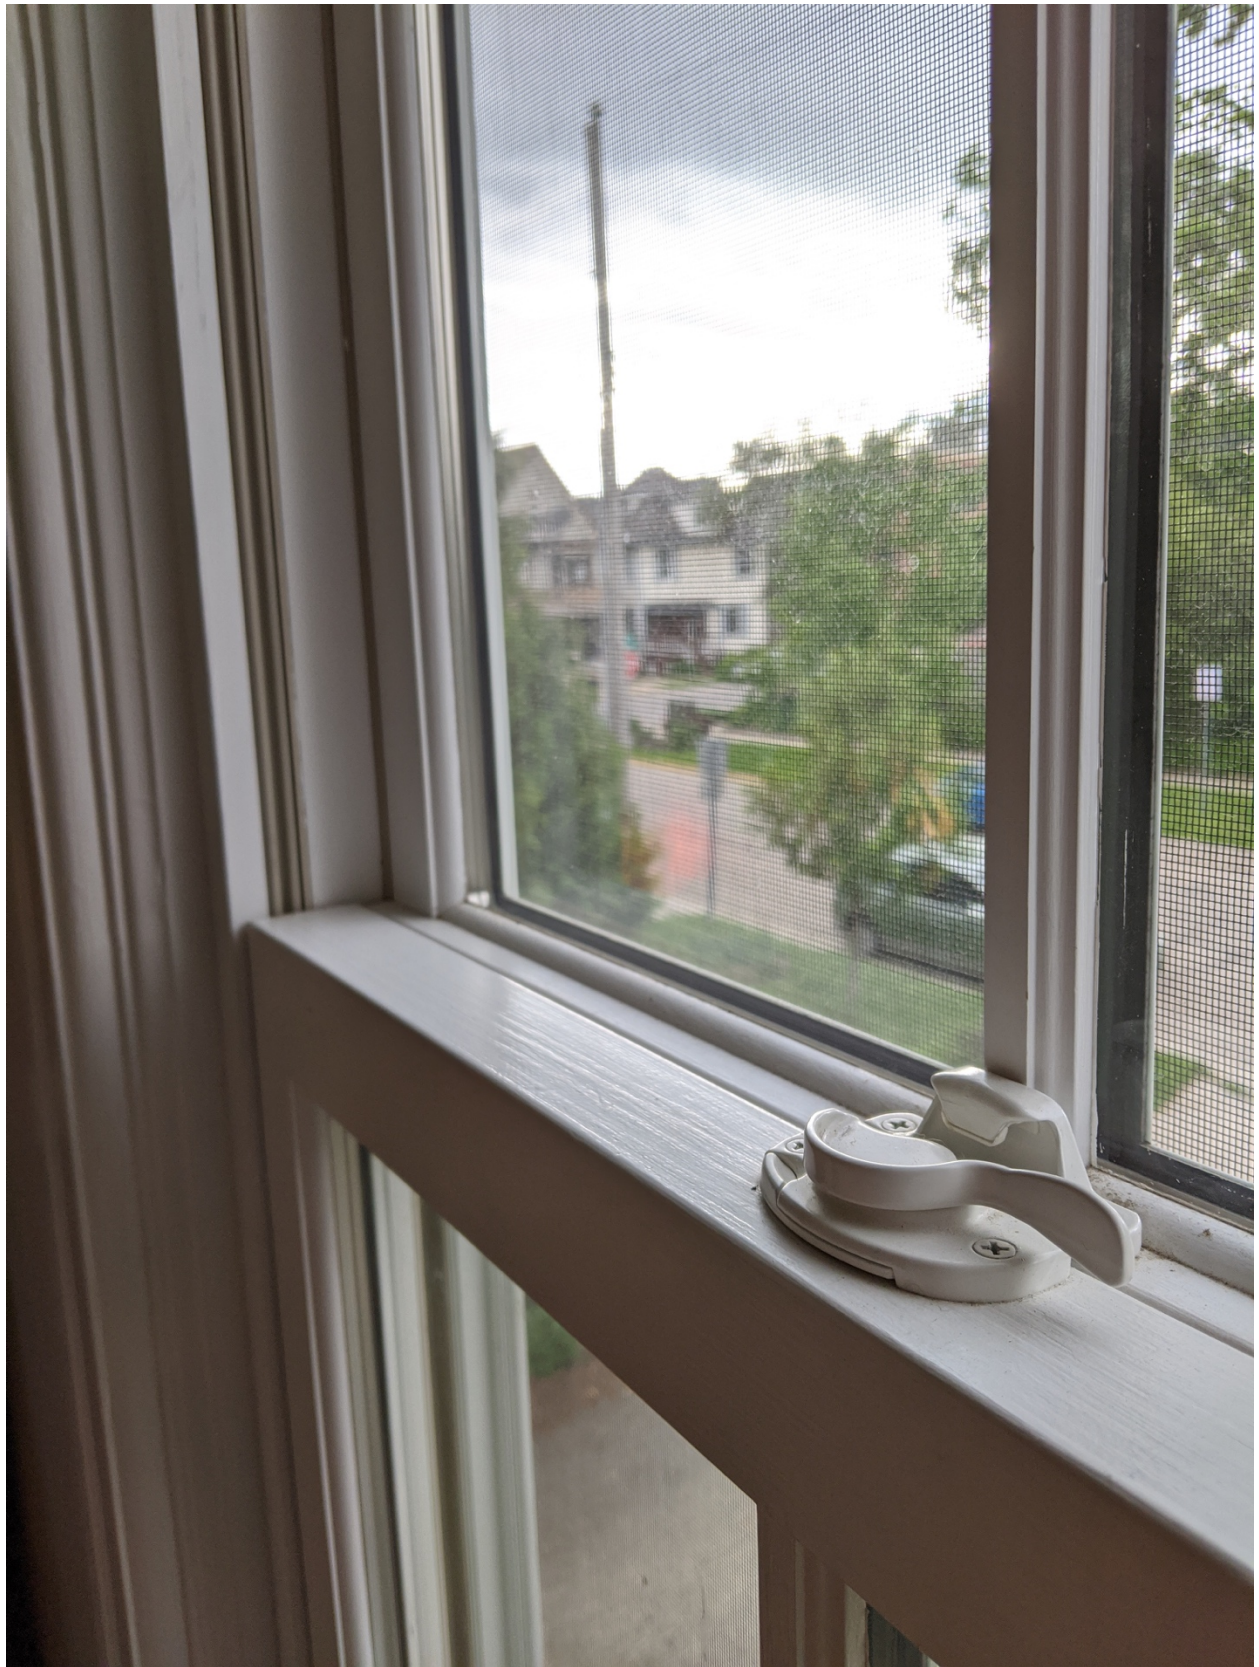
Upstairs: 3 of the upstairs windows are probably part of the original structure and 6 have been modified or replaced. The sashes on 4 of these windows (2 in the front, 2 in the back) were replaced with Marvin double-hung wood inserts; the external frames and trim are intact. (photos attached).
