## **EXISTING BUILDING REVIEW**

### **127-129 State Street**

Name: Frances Vallender Building

## **127–129 State Street – Architectural Review**

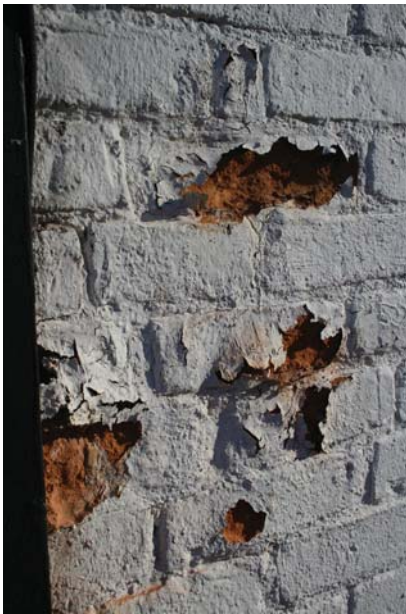
Exterior: View of damaged brick veneer

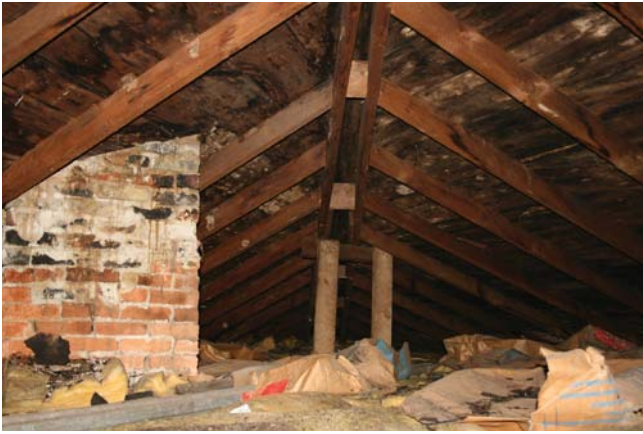
Attic: View toward flat iron corner showing damage to chimney

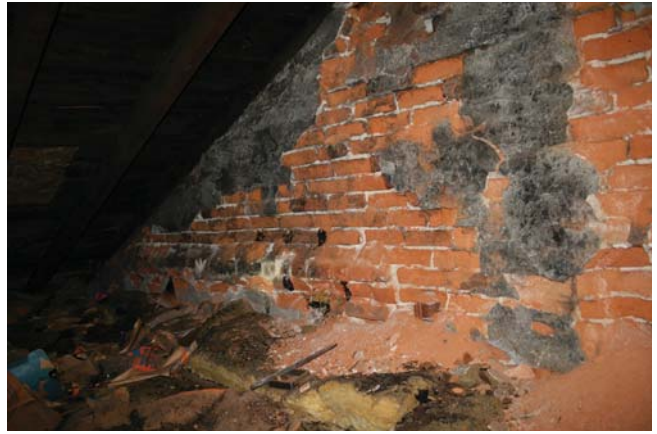
Attic: View toward wall between 127-129 state street and the castle and doyle building showing significant damage to existing brick

3. Areas of Compromised Structure
  - a. Water infiltration was noted in the basement. Brick damage due to moisture infiltration is noted at the attic at the east gable wall.

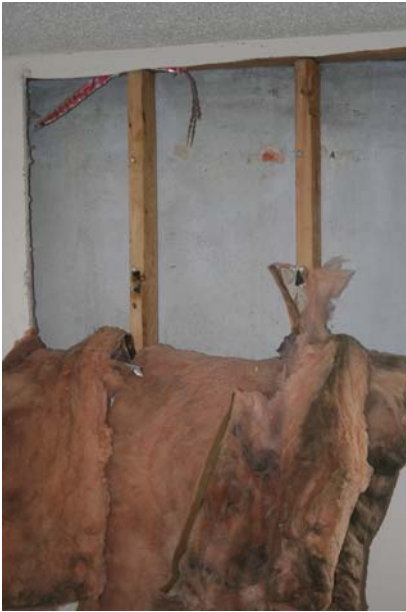
Third Floor: Section of exterior wall exposed showing back of brick and moisture within the insulation space

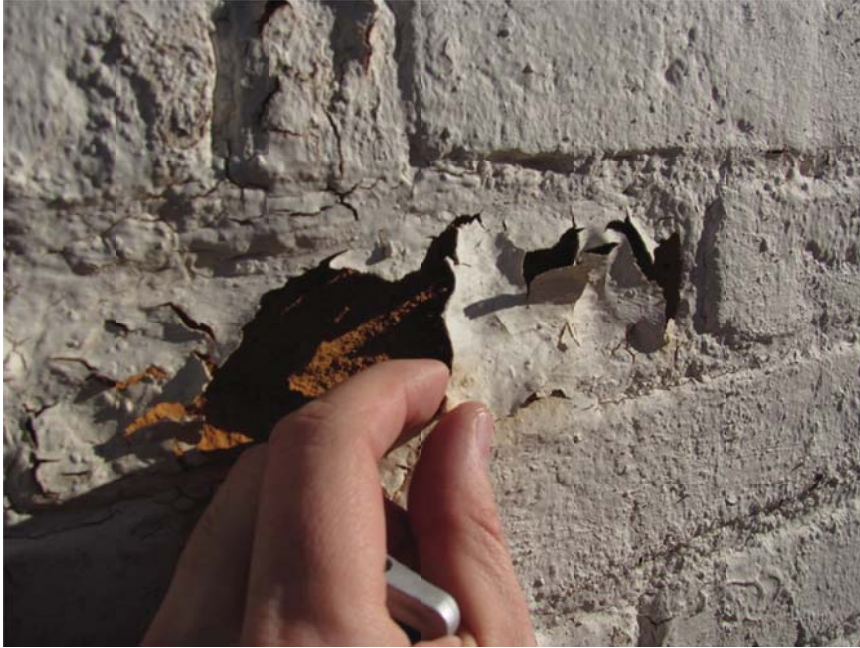
The brick masonry is generally in very poor condition, with extensive previous spalling and erosion of brick faces and open mortar joints. This masonry distress has been exacerbated by the application of multiple coating layers, some of which were applied over unrepaired deteriorated masonry. At many locations, loss of the coating has revealed severe deterioration and disintegration of the underlying brick and mortar (Figure 3 through Figure 6). Near the middle of the Fairchild Street elevation, interior finishes at the first floor had been previously removed, exposing the backup masonry to view. The brickwork at the lowest 30 inches of the wall in this area is severely deteriorated, with deep erosion and deterioration of the brick and mortar (Figure 7).

*Figure 3. Loss of the coating reveals severely deteriorated brick units.*

The brick masonry has deteriorated over time, and coatings and cementitious parging have been applied to the surface of the wall rather than addressing the underlying masonry distress. The build-up of coating layers has exacerbated and accelerated the deterioration of the brick masonry. Deterioration of the brick and mortar appears to be so widespread that extensive reconstruction of the exterior walls is now required. The quality and condition of the masonry materials appears to be relatively consistent across the facades; therefore, 100 percent replacement of the outer wythe of brick masonry of the facades should be assumed. Since the majority of the exterior walls are only 8 inches thick, reconstruction of the outer wythe only may not be feasible, especially considering the deterioration of the back-up wythe of brick in the portions near grade. Rather, reconstruction of the full thickness of substantial portions or all portions of the wall will likely be necessary. Development of an appropriate approach requires further investigation and coordination with the results of the structural survey recently undertaken by others. Inspection openings should be made to confirm the exact thickness of the wall in various locations and to review the condition of concealed portions of the wall.

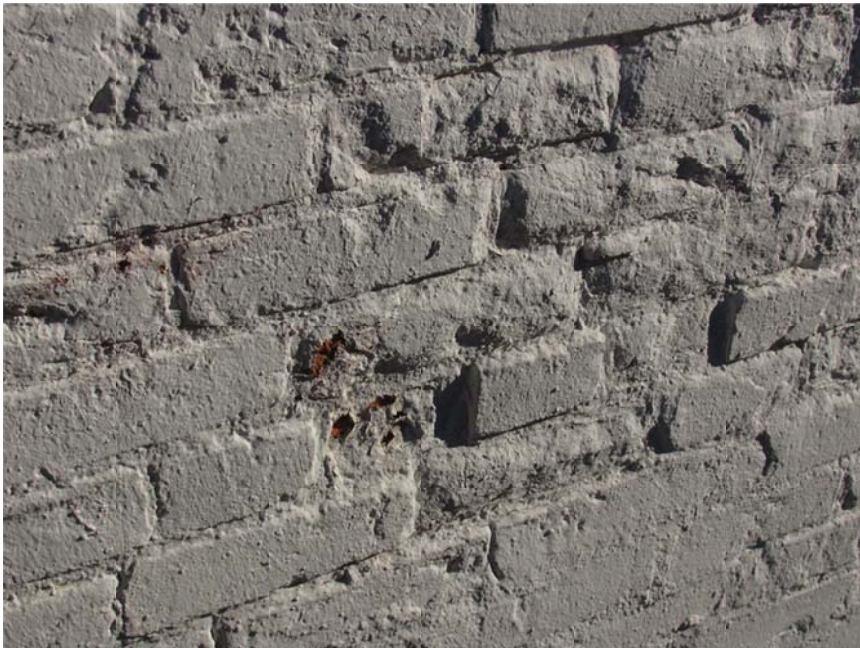
*Figure 4. The coating layers were applied over unrepaired deteriorated masonry.*

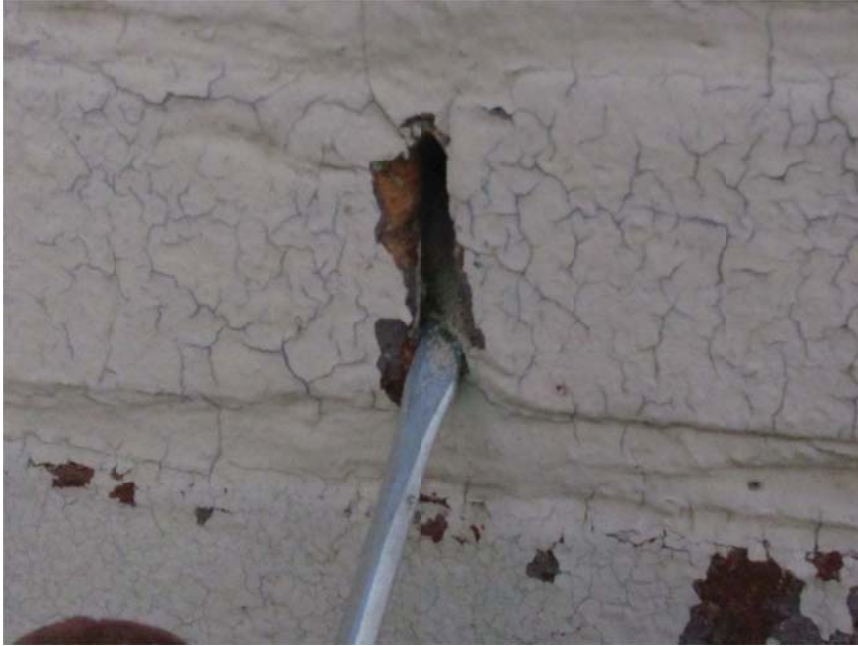
*Figure 5. Mortar behind the coating layers is friable and has disintegrated.*

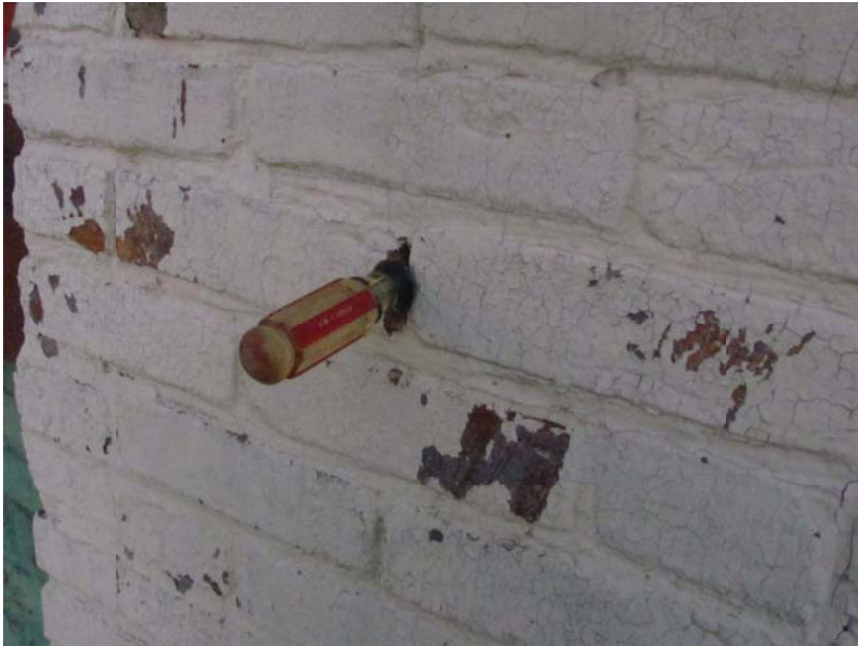
*Figure 6. Mortar behind the coating layers has disintegrated, resulting in voids within the masonry construction.*

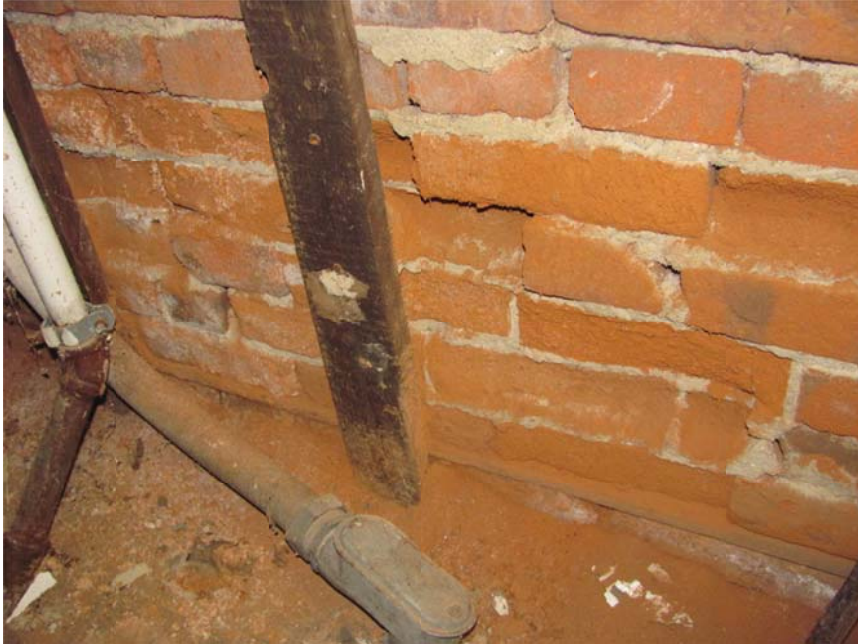
*Figure 7. Deterioration of the back-up masonry at the interior of the building.*

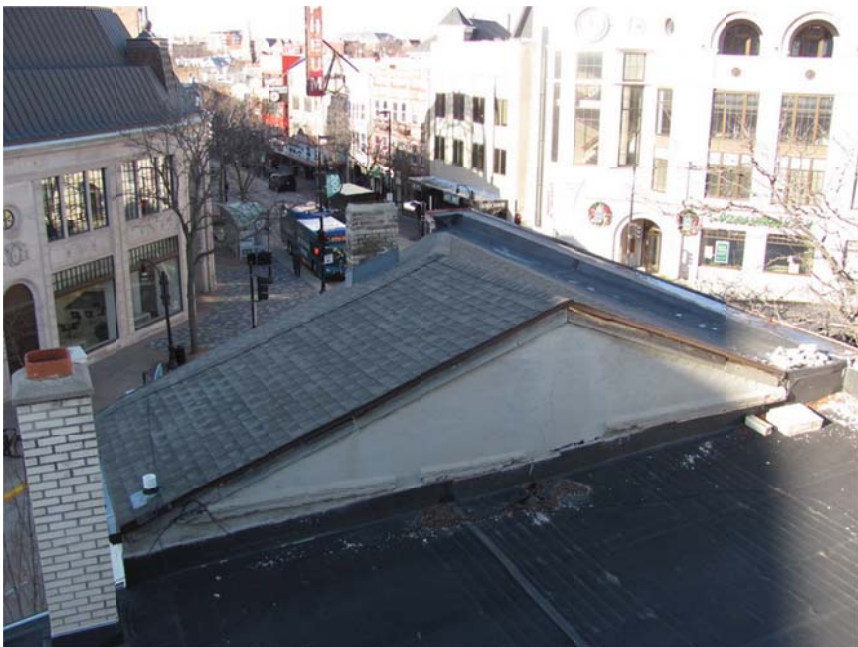
The building roof was not accessible for close-up inspection but was viewed from a nearby higher building (Figure 8). The existing roof covering is asphalt shingle that appears relatively new and intact. Along State Street, there is a low parapet wall and built-in gutter lined with EPDM rubber membrane. Along Fairchild Street, there is a hanging galvanized metal gutter. When viewed from below in the building attic, widespread water staining was apparent on the wood framing (Figure 9). Also, debris and remnants of roofing material were scattered over the insulation in the attic. It appears likely that much of the existing staining is from old water leakage that is not currently active, given the apparently good condition of the existing roofing.

*Figure 8. Overview of the roof.*

The existing roof system is likely relatively new and intact, based on its appearance as viewed from adjacent buildings, although the perimeter detailing and provisions for drainage should be reviewed in greater detail.

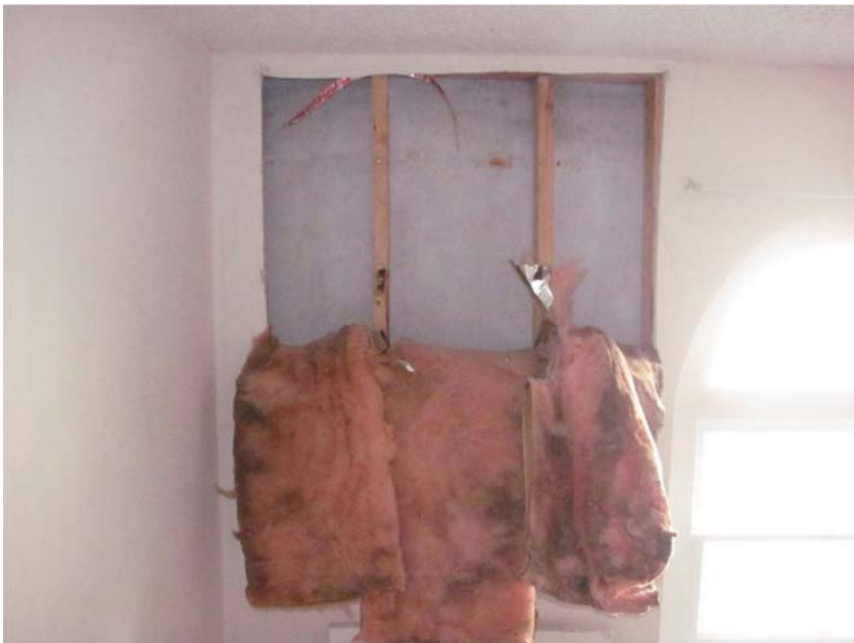
The second and third floors together constitute one three-bedroom rental apartment. The apartment is accessed via a separate entrance vestibule and stair from the south corner of the building on Fairchild Street. The apartment interior finishes include carpeting, sheet vinyl flooring, wood paneling, and gypsum board walls and ceilings (Figure 11). Several inspection openings were made during the site inspection at the exterior walls of the third floor. From interior to exterior, the exterior construction consists of gypsum board supported on 2x4 studs with batt insulation between the studs, installed inside the original brick masonry wall. Previous plaster finishes were observed directly applied to the inside face of the brick masonry. Staining and evidence of moisture penetration was observed on the batt insulation and plaster (Figure 12).

*Figure 12. Staining and evidence of moisture penetration was observed on the batt insulation and plaster at an inspection opening created at the third floor during the site visit.*

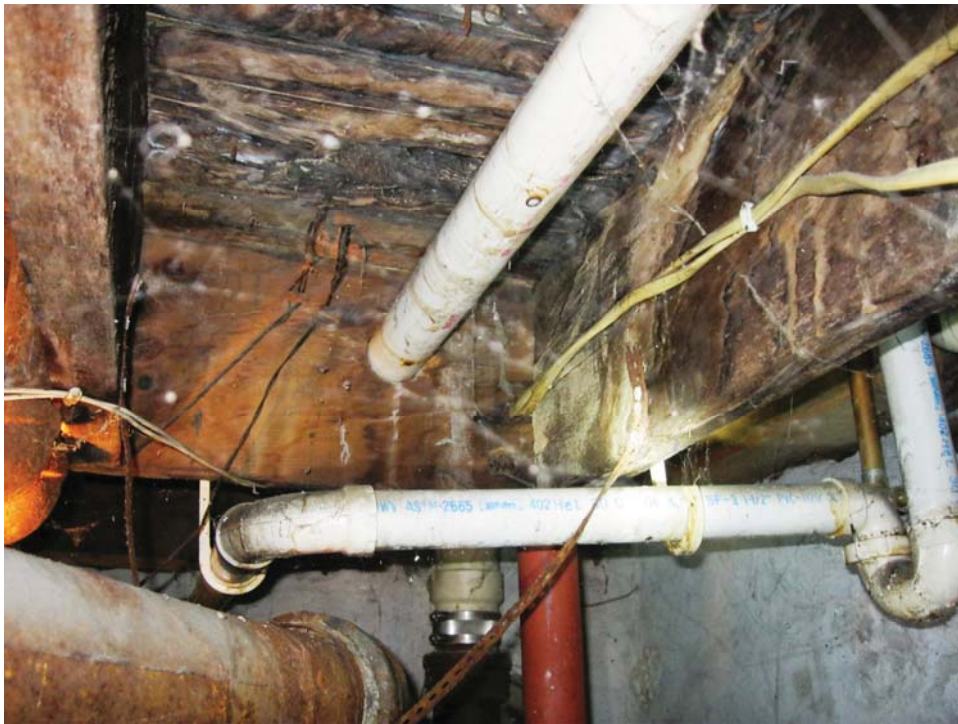
The floor is wood framed. There are two locations where shoring has been added to re-support the floor. The shores bear on wooden boards on the floor with no added footing present and as such should be considered temporary. The floor framing has been modified over the years to accommodate revised plumbing runs. The 2x framing has been cut as needed to allow the piping to pass. There are rotted 2x 's noted near the piping indicating unresolved leaks. No load capacity is assigned to this floor as it has excessive defects and needs to be replaced.

**Photo 7** – 1<sup>st</sup> floor framing with water damage

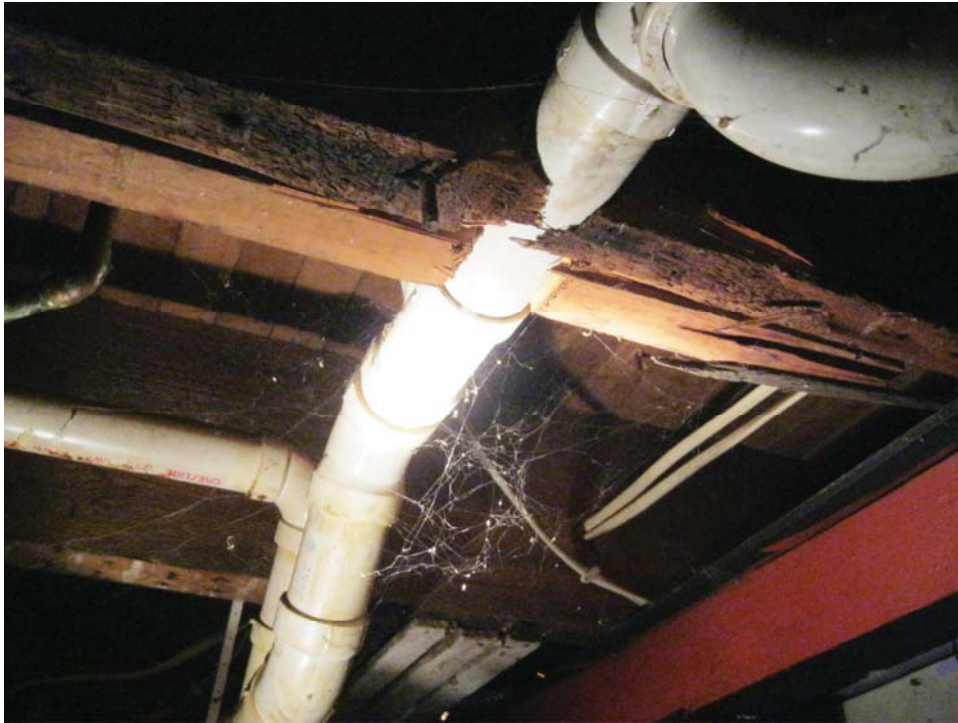
- b. Piping revisions over the years have damaged the first floor structure rendering the floor unusable.
4. Floor. Roof Loading
  - a. Existing Structure Capacity. First floor live load capacity-none specified, replacement needed. Second floor live load capacity 35 psf. Third floor live load capacity of 45 psf. Roof live load capacity 21 psf.

**Photo 8** – 1<sup>st</sup> floor framing notched for plumbing

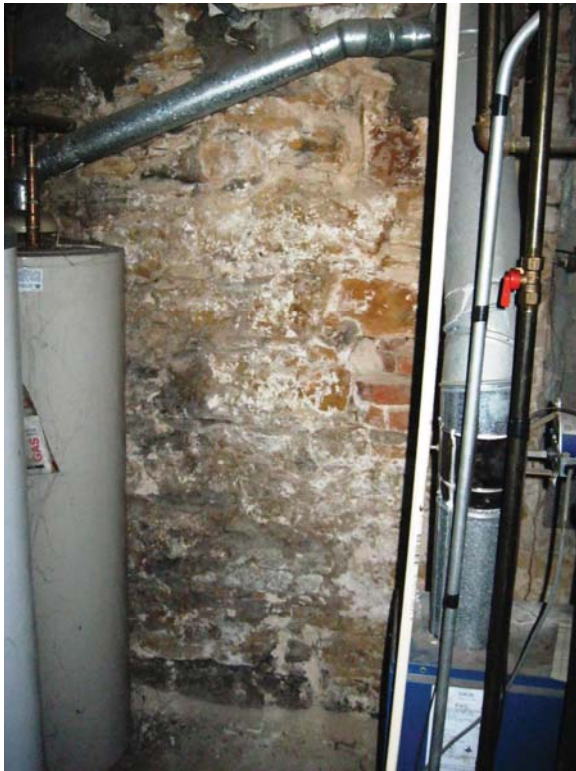
The exterior walls are thru the wall brick. In the basement, the exposed face shell of the brick basement wall have spalled and windrowed on the floor. This indicates significant water entry to this wall and makes one suspicious as the condition of the unobservable inner wythe of the wall. The inside surface of the gable end wall exposed in the attic was observed have been damaged by moisture entry. The wall is exposed above the adjacent roof. The wall has been parged presumably to resist water entry. The brick faces have been eroded away on the inner surface in the attic and are windrowed on the ceiling.

**Photo 9** – Basement wall along Fairchild Street

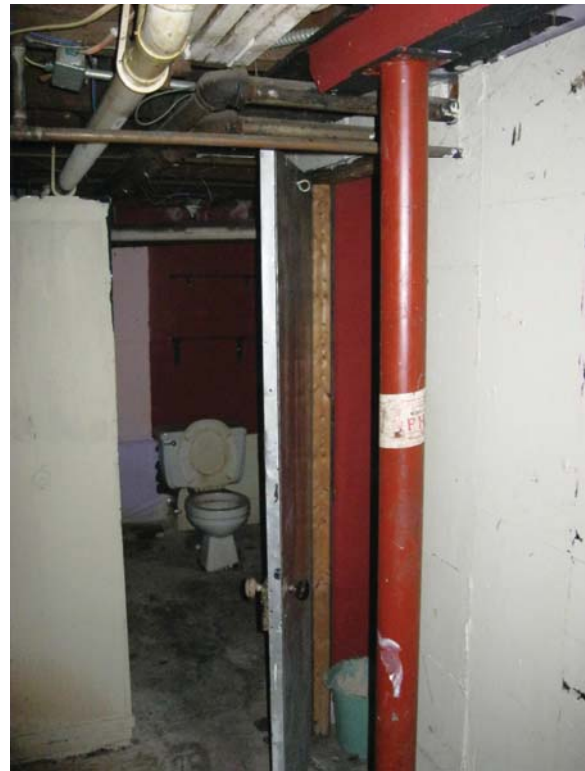
**Photo 10** – 1<sup>st</sup> floor shoring beam and post

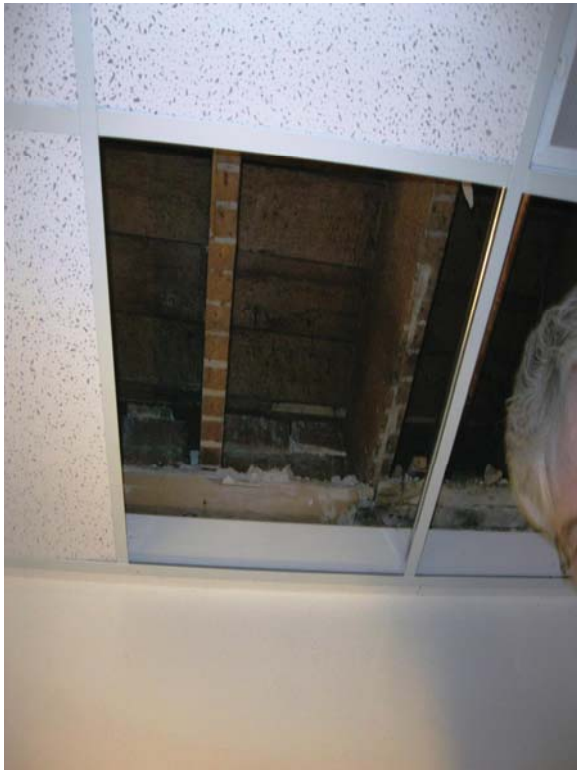
The framing for the second floor was observed from the 129 space. The second floor framing is full size 2x8 @16" oc spanning 17' and paralleling State Street. The calculated live load capacity of the second floor for the noted joists would be 35 psf. Present day code would require 40 psf for apartment occupancy.

**Photo 12** – 2<sup>nd</sup> floor joist framing observed from 1<sup>st</sup> floor retail space

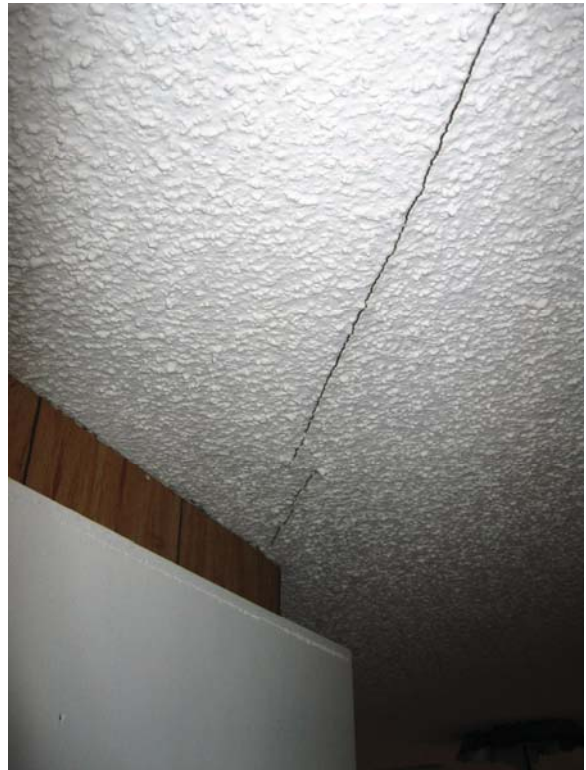
**Photo 13** – Ceiling finish distress beneath roof

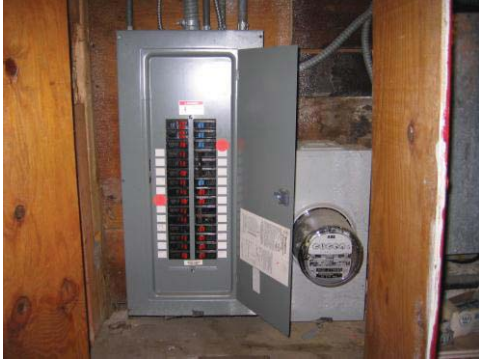
The current wiring device locations in the apartment do not comply with accessibility requirements. Receptacle quantity and locations in the apartment do not comply with current NEC requirements. Compliance with current codes for these items would require branch circuit and receptacle replacement. The majority of the service equipment and one electrical panel is installed in a cabinet, which does not meet current NEC required working space clearance.

Part of the electrical service in a constructed cabinet.

The cabinet around the service equipment would need to be removed to make the equipment accessible.
