SUMMARY

Attached you will find calculations done by a structural engineer indicating that the steel reinforcement, in the long walls of the screen treatment structure constructed as part of the Arboretum Pond 3 reconstruction, is insufficient.

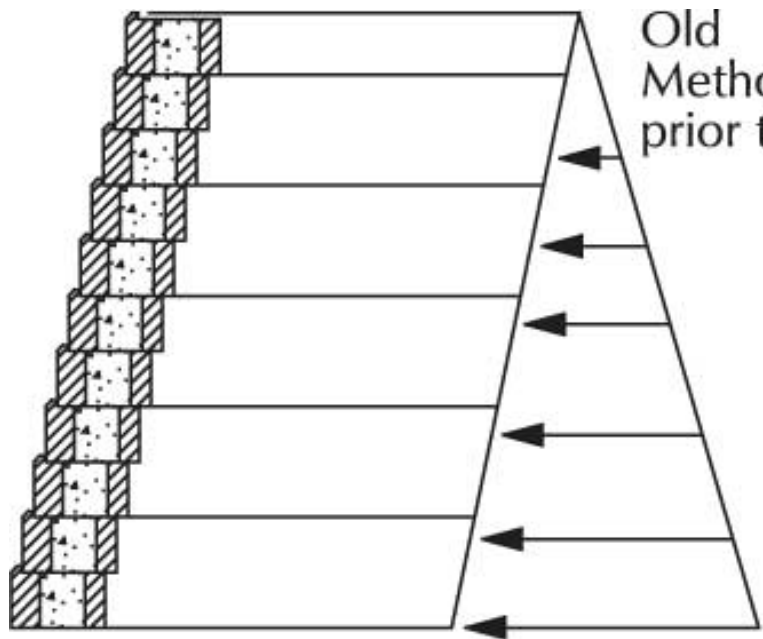
Static active pressure distribution

Old Methodology prior to testing

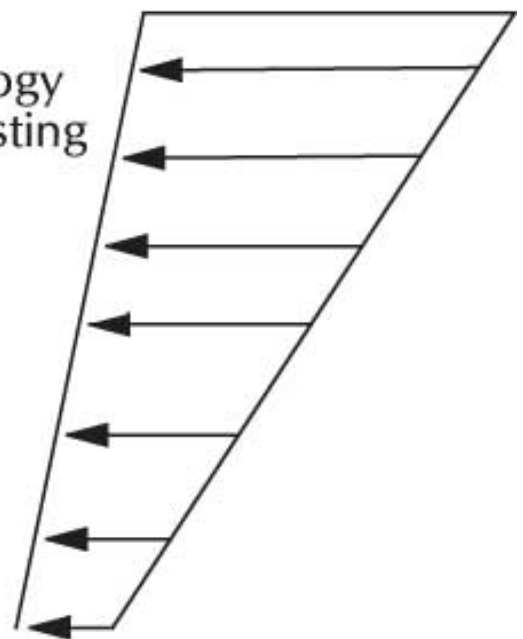
Dynamic active pressure distribution
