## ANNIE C. STEWART MEMORIAL FOUNTAIN ASSESSMENT REPORT AND RECOMMENDATIONS

| <b>Date of Work:</b> | May 2022 | <b>Project Name and Location:</b> | Annie C. Stewart Memorial Fountain<br>Madison, WI |
| <b>Date of Report:</b> | June 22, 2023 (draft)<br>Jamie Morris | <b>Owner/Client:</b> | City of Madison |
| <b>Project Goal:</b> | To perform conservation assessment and develop treatment options with estimated pricing. | | |

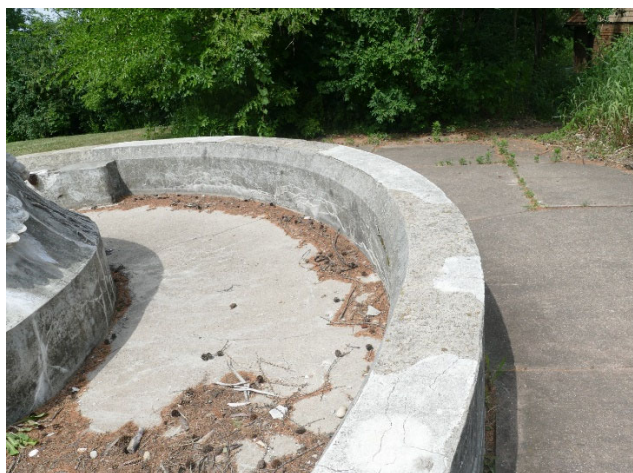
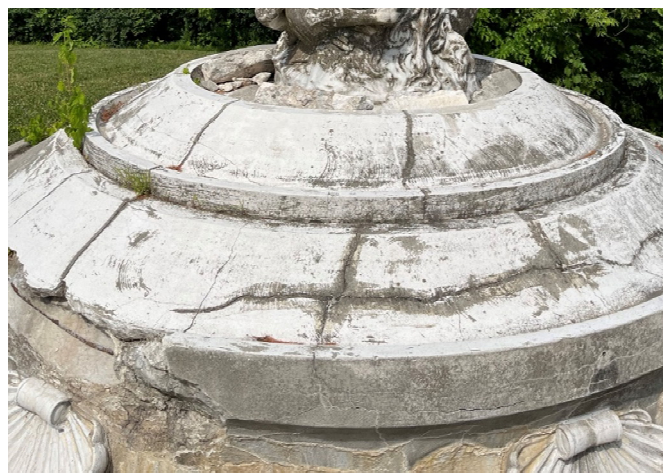
Patches, coatings, added materials. CSOS is unaware of any documented previous repair campaigns, however, many types of repair materials were observed in situ. Based on the number of previous repairs and the lack of documentation it is possible that repairs maybe have been implemented by well meaning activists without knowledge of how the two materials would interact. Mortar patches that are stronger than the masonry they are used to patch can contribute to degeneration of surrounding original materials. Many apparent mortar patches are present on the lower bowl. As shown in the photographs below, the pedestal includes apparent patch material as well as remnants of a coating applied to the top two tiers.

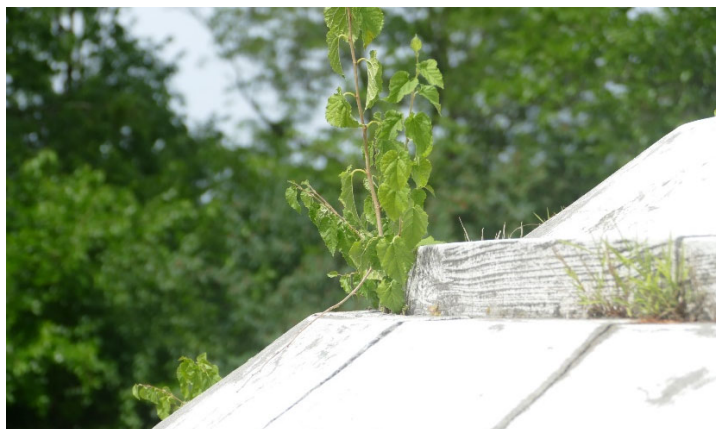
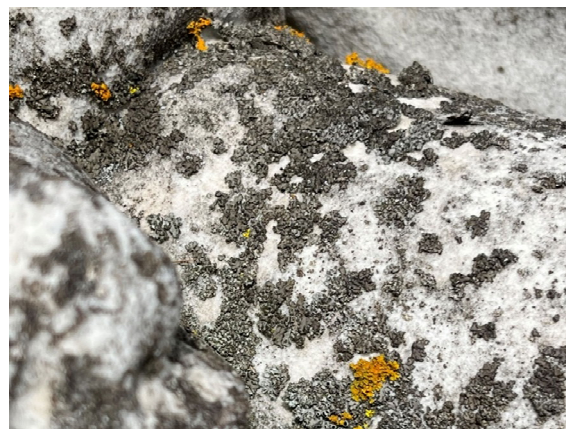
Vegetation and bio growth were observed in micro scale and macro scale with micro scale biological growth such as lichen primarily on the marble figures and large-scale vegetation (large weeds) growing out of crevices in the pedestal. The growth of large-scale vegetation exerts outward pressure that can exacerbate the formation of cracks while also holding on to moisture which contributes to freeze/thaw distress. Micro scale biological growth obstructs the ability to visually distinguish the features of the sculpture and some types of biological growth can secrete acids which can slowly chemically dissolve calcite-based stone. Additionally, biological growth absorbs and holds moisture to the stone surface potentially contributing to freeze/thaw distress. Examples of macro and micro scale biological growth are shown below.
