Proposed Associated Bank – Mineral Point
Northeast Corner of South High Point Road and West Mineral Point Road: Madison, WI

Tree & Vegetation Assessment:

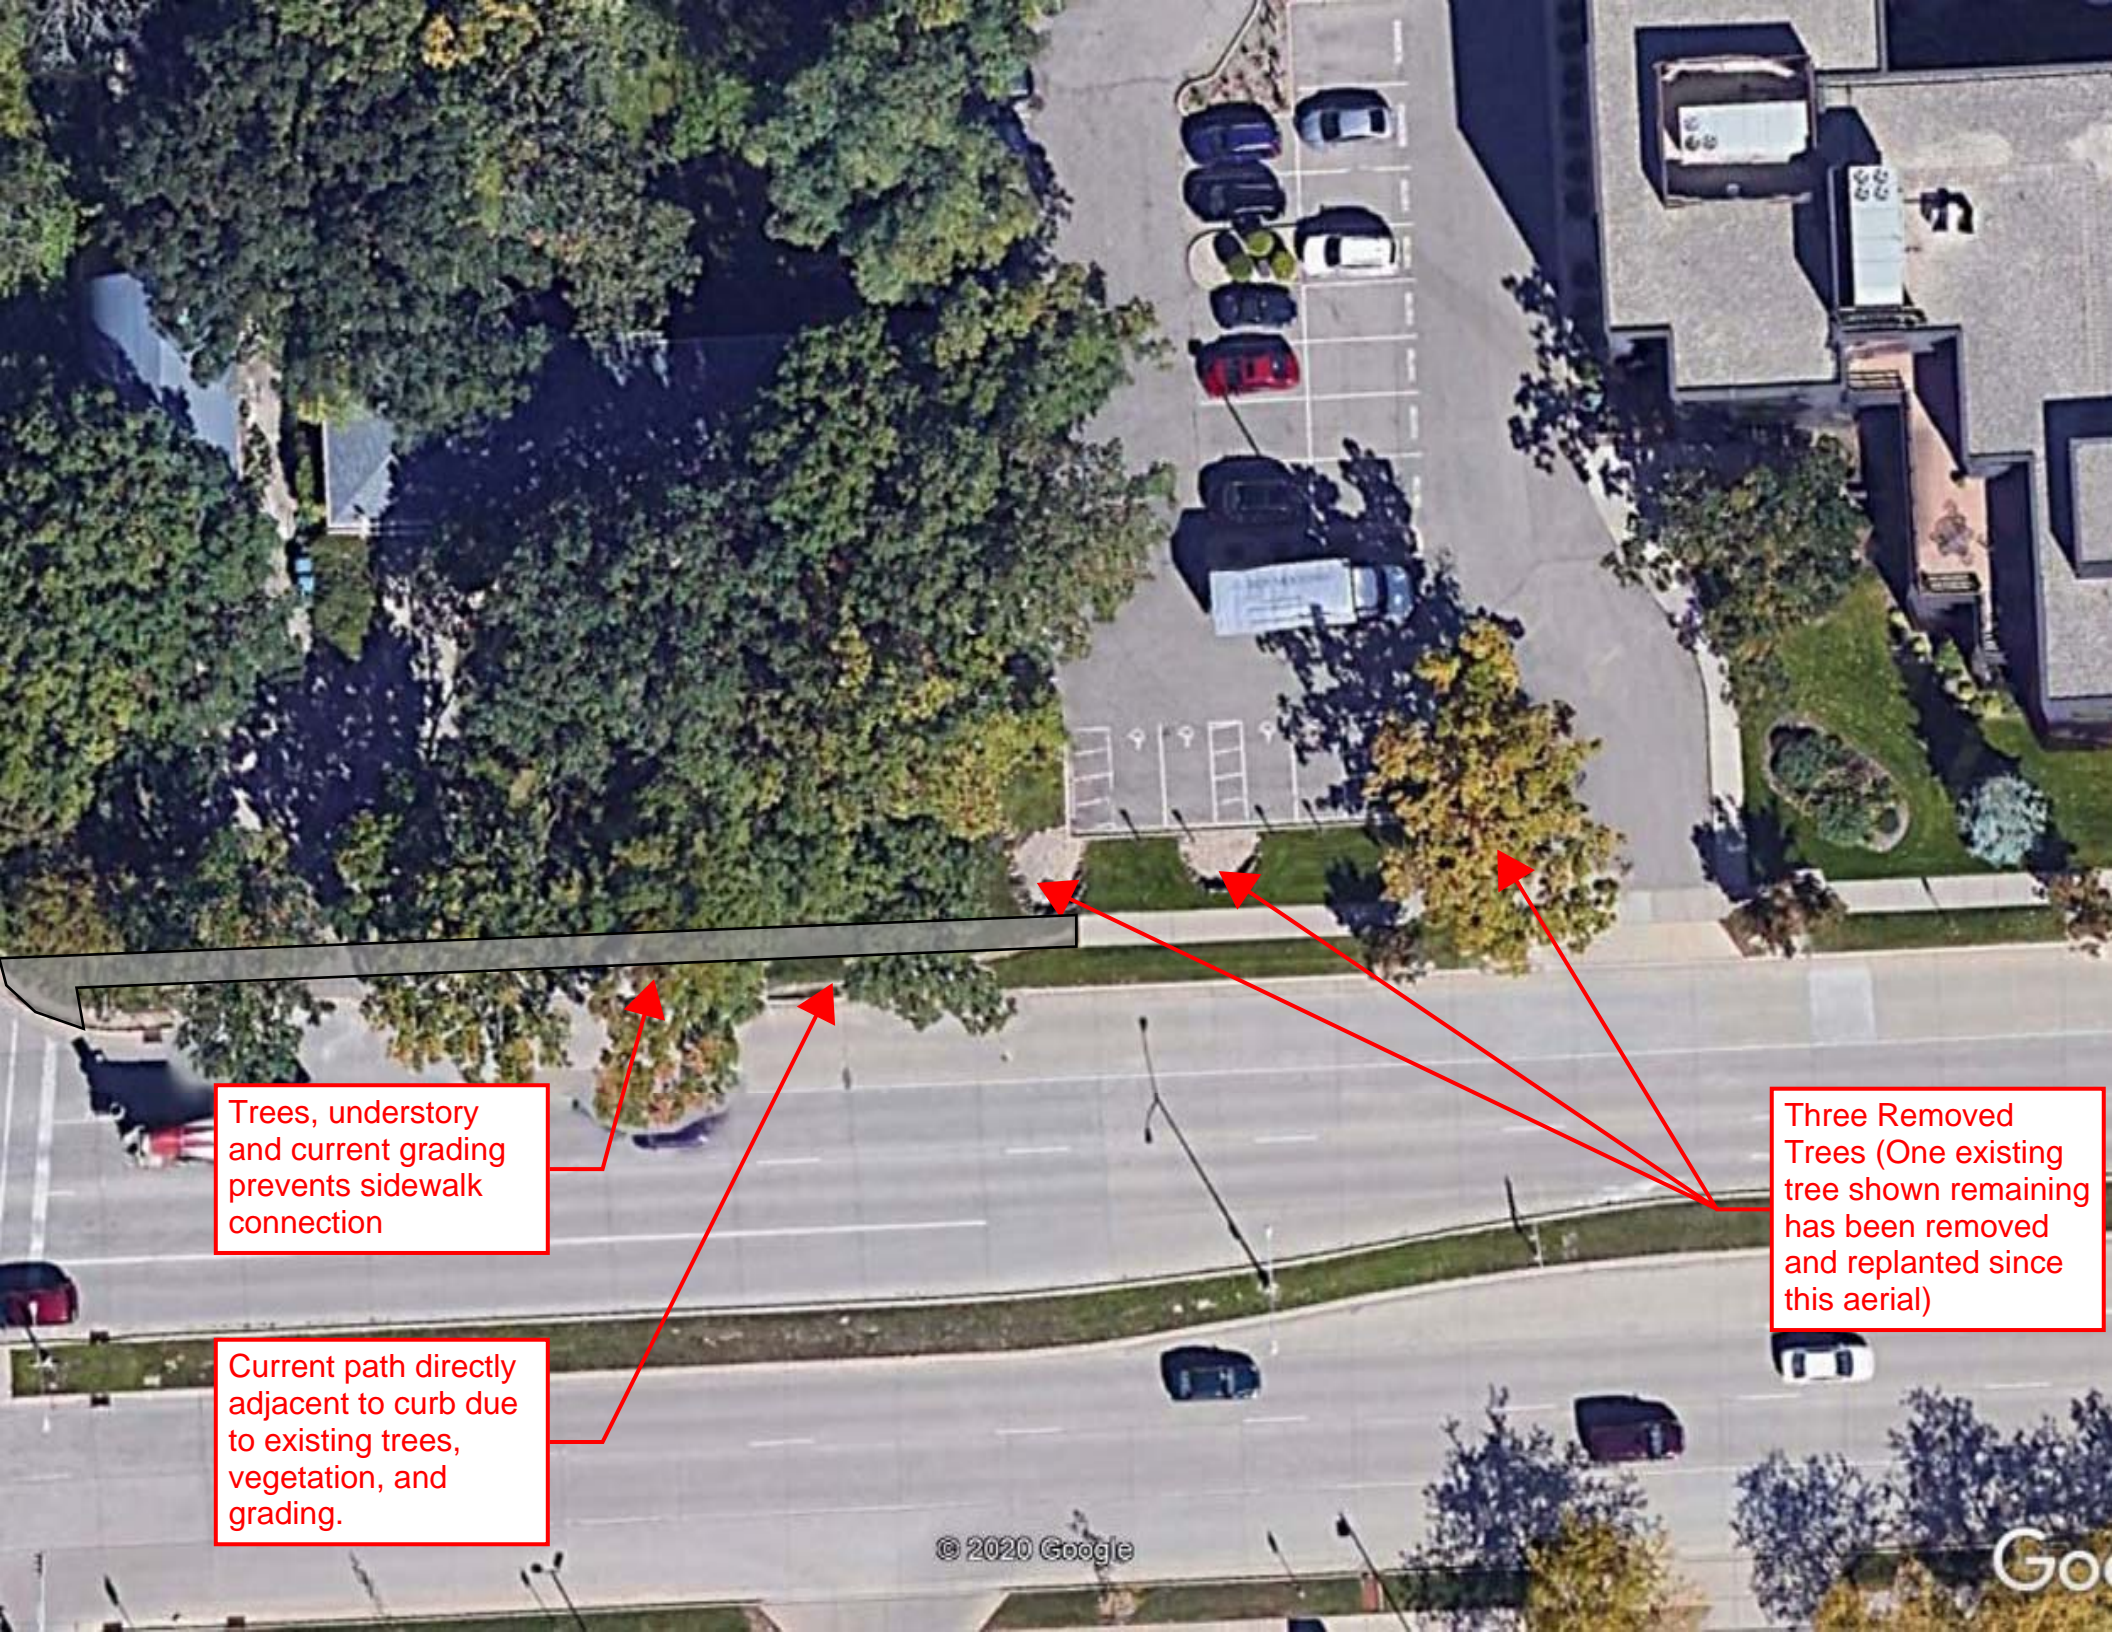
Trees, understory and current grading prevents sidewalk connection

Current path directly adjacent to curb due to existing trees, vegetation, and grading.

Three Removed Trees (One existing tree shown remaining has been removed and replanted since this aerial)

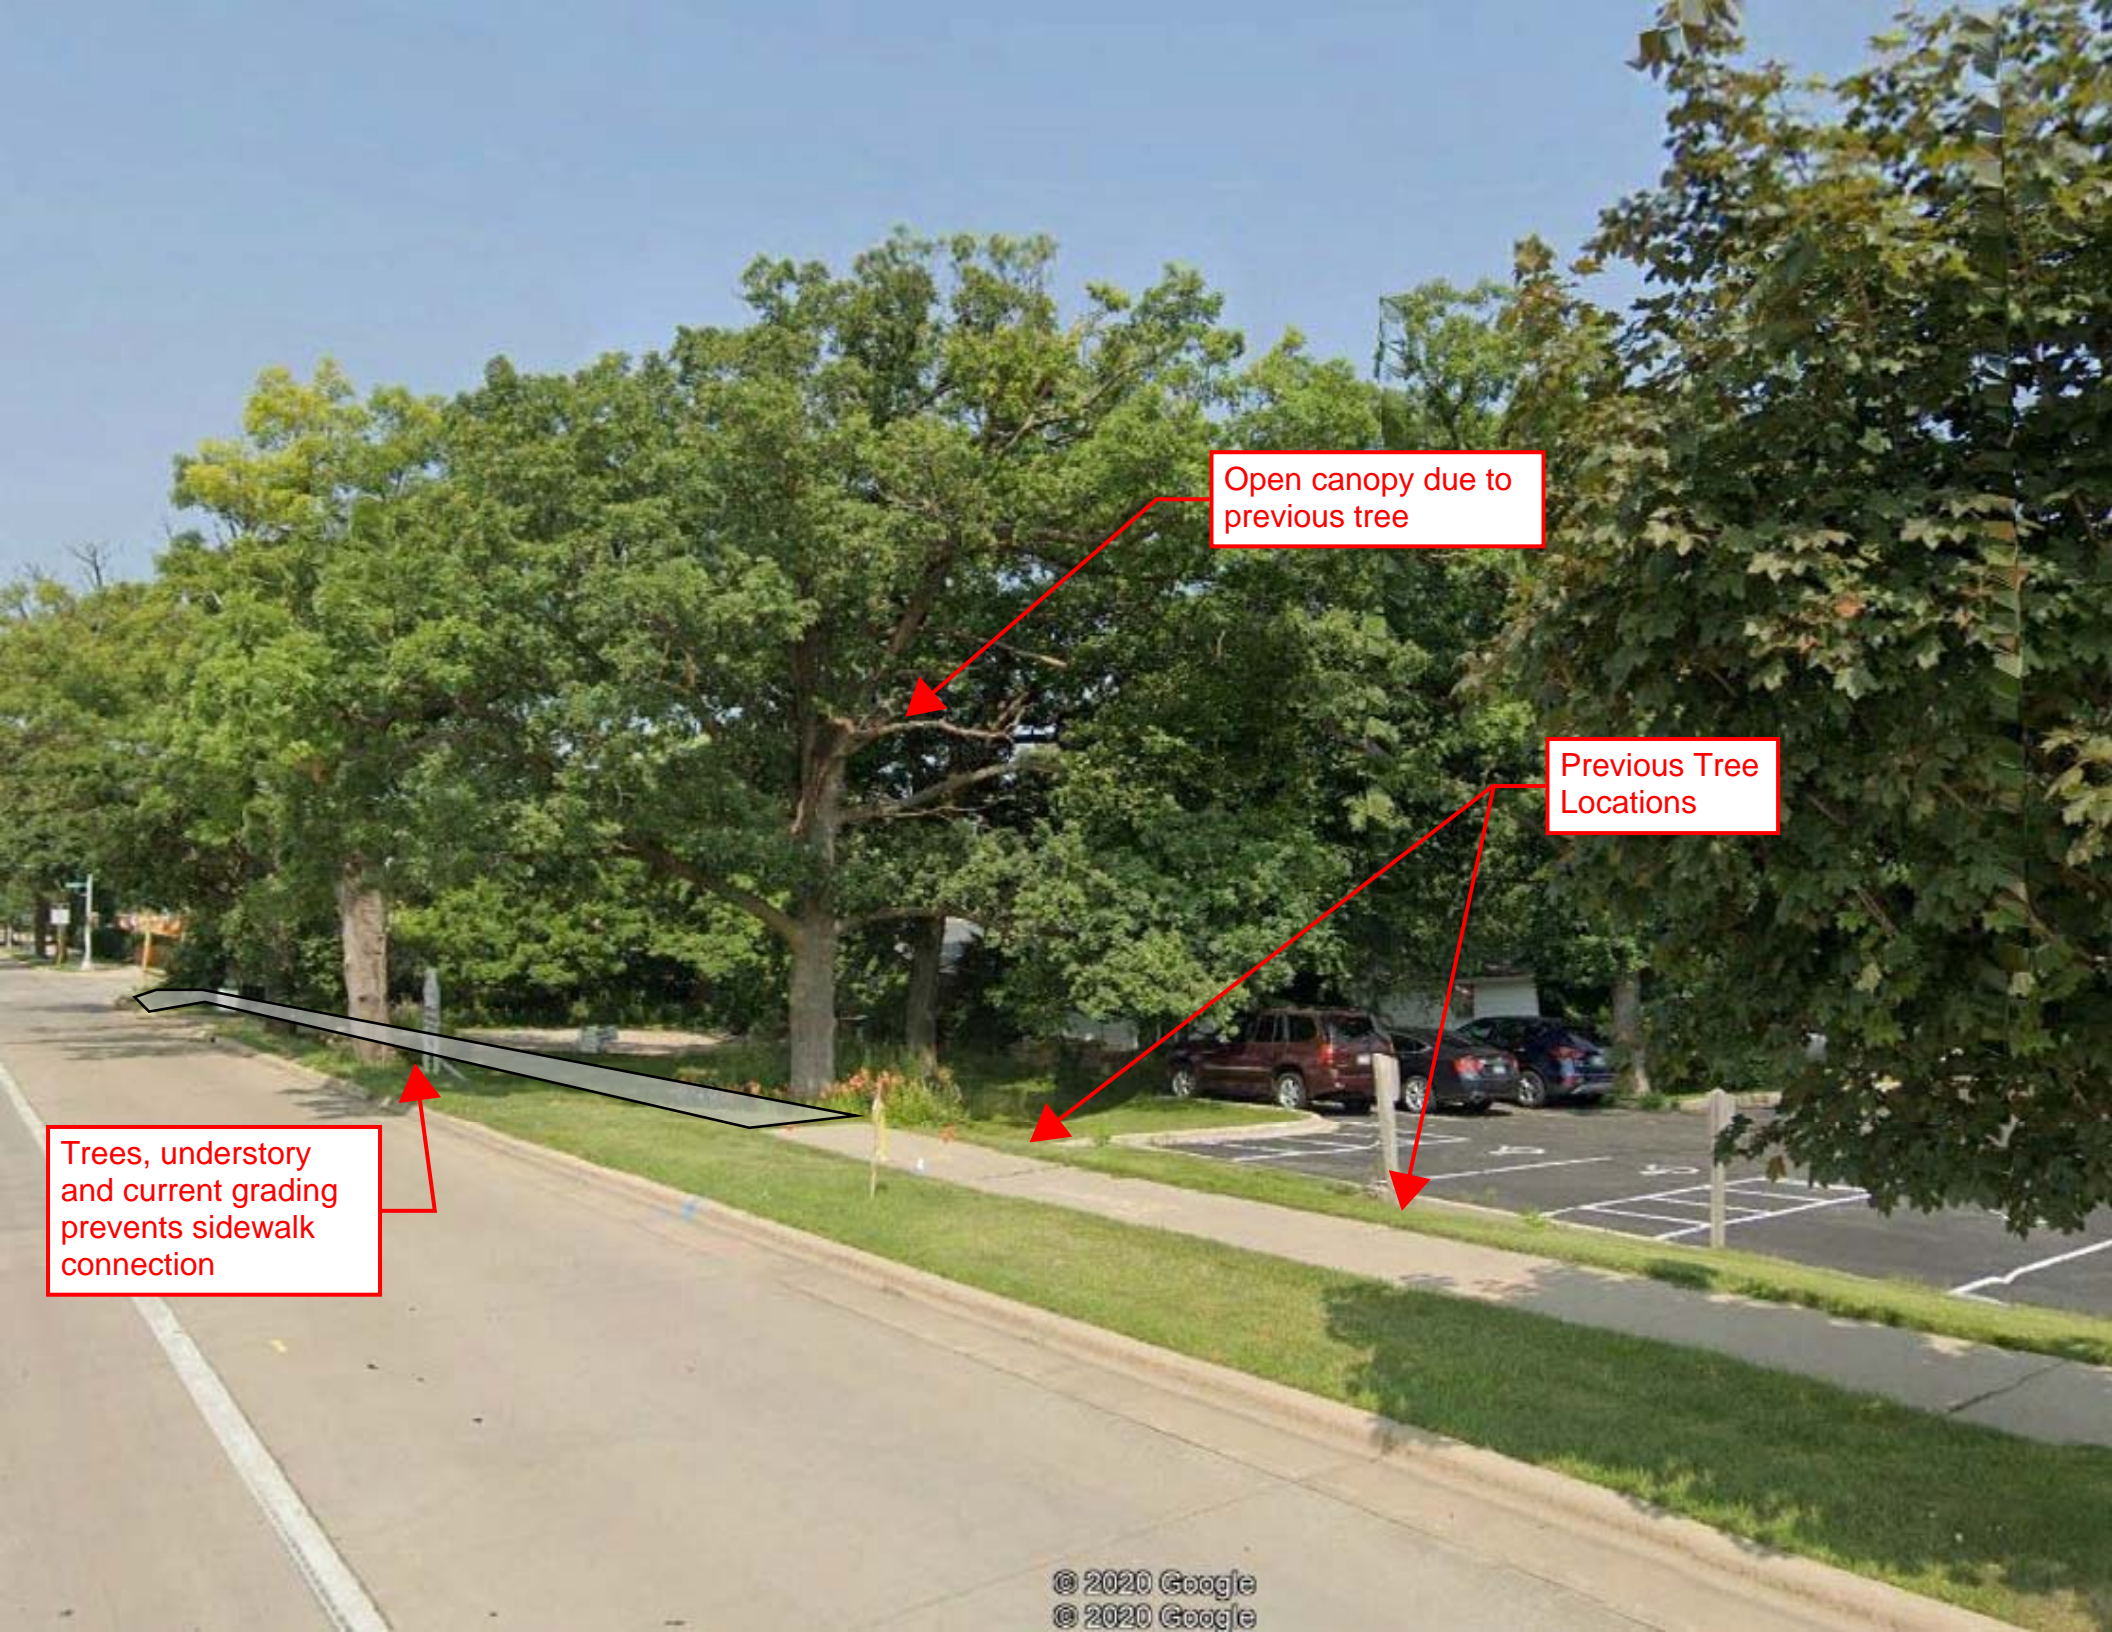
Open canopy due to previous tree

Previous Tree Locations

Trees, understory and current grading prevents sidewalk connection

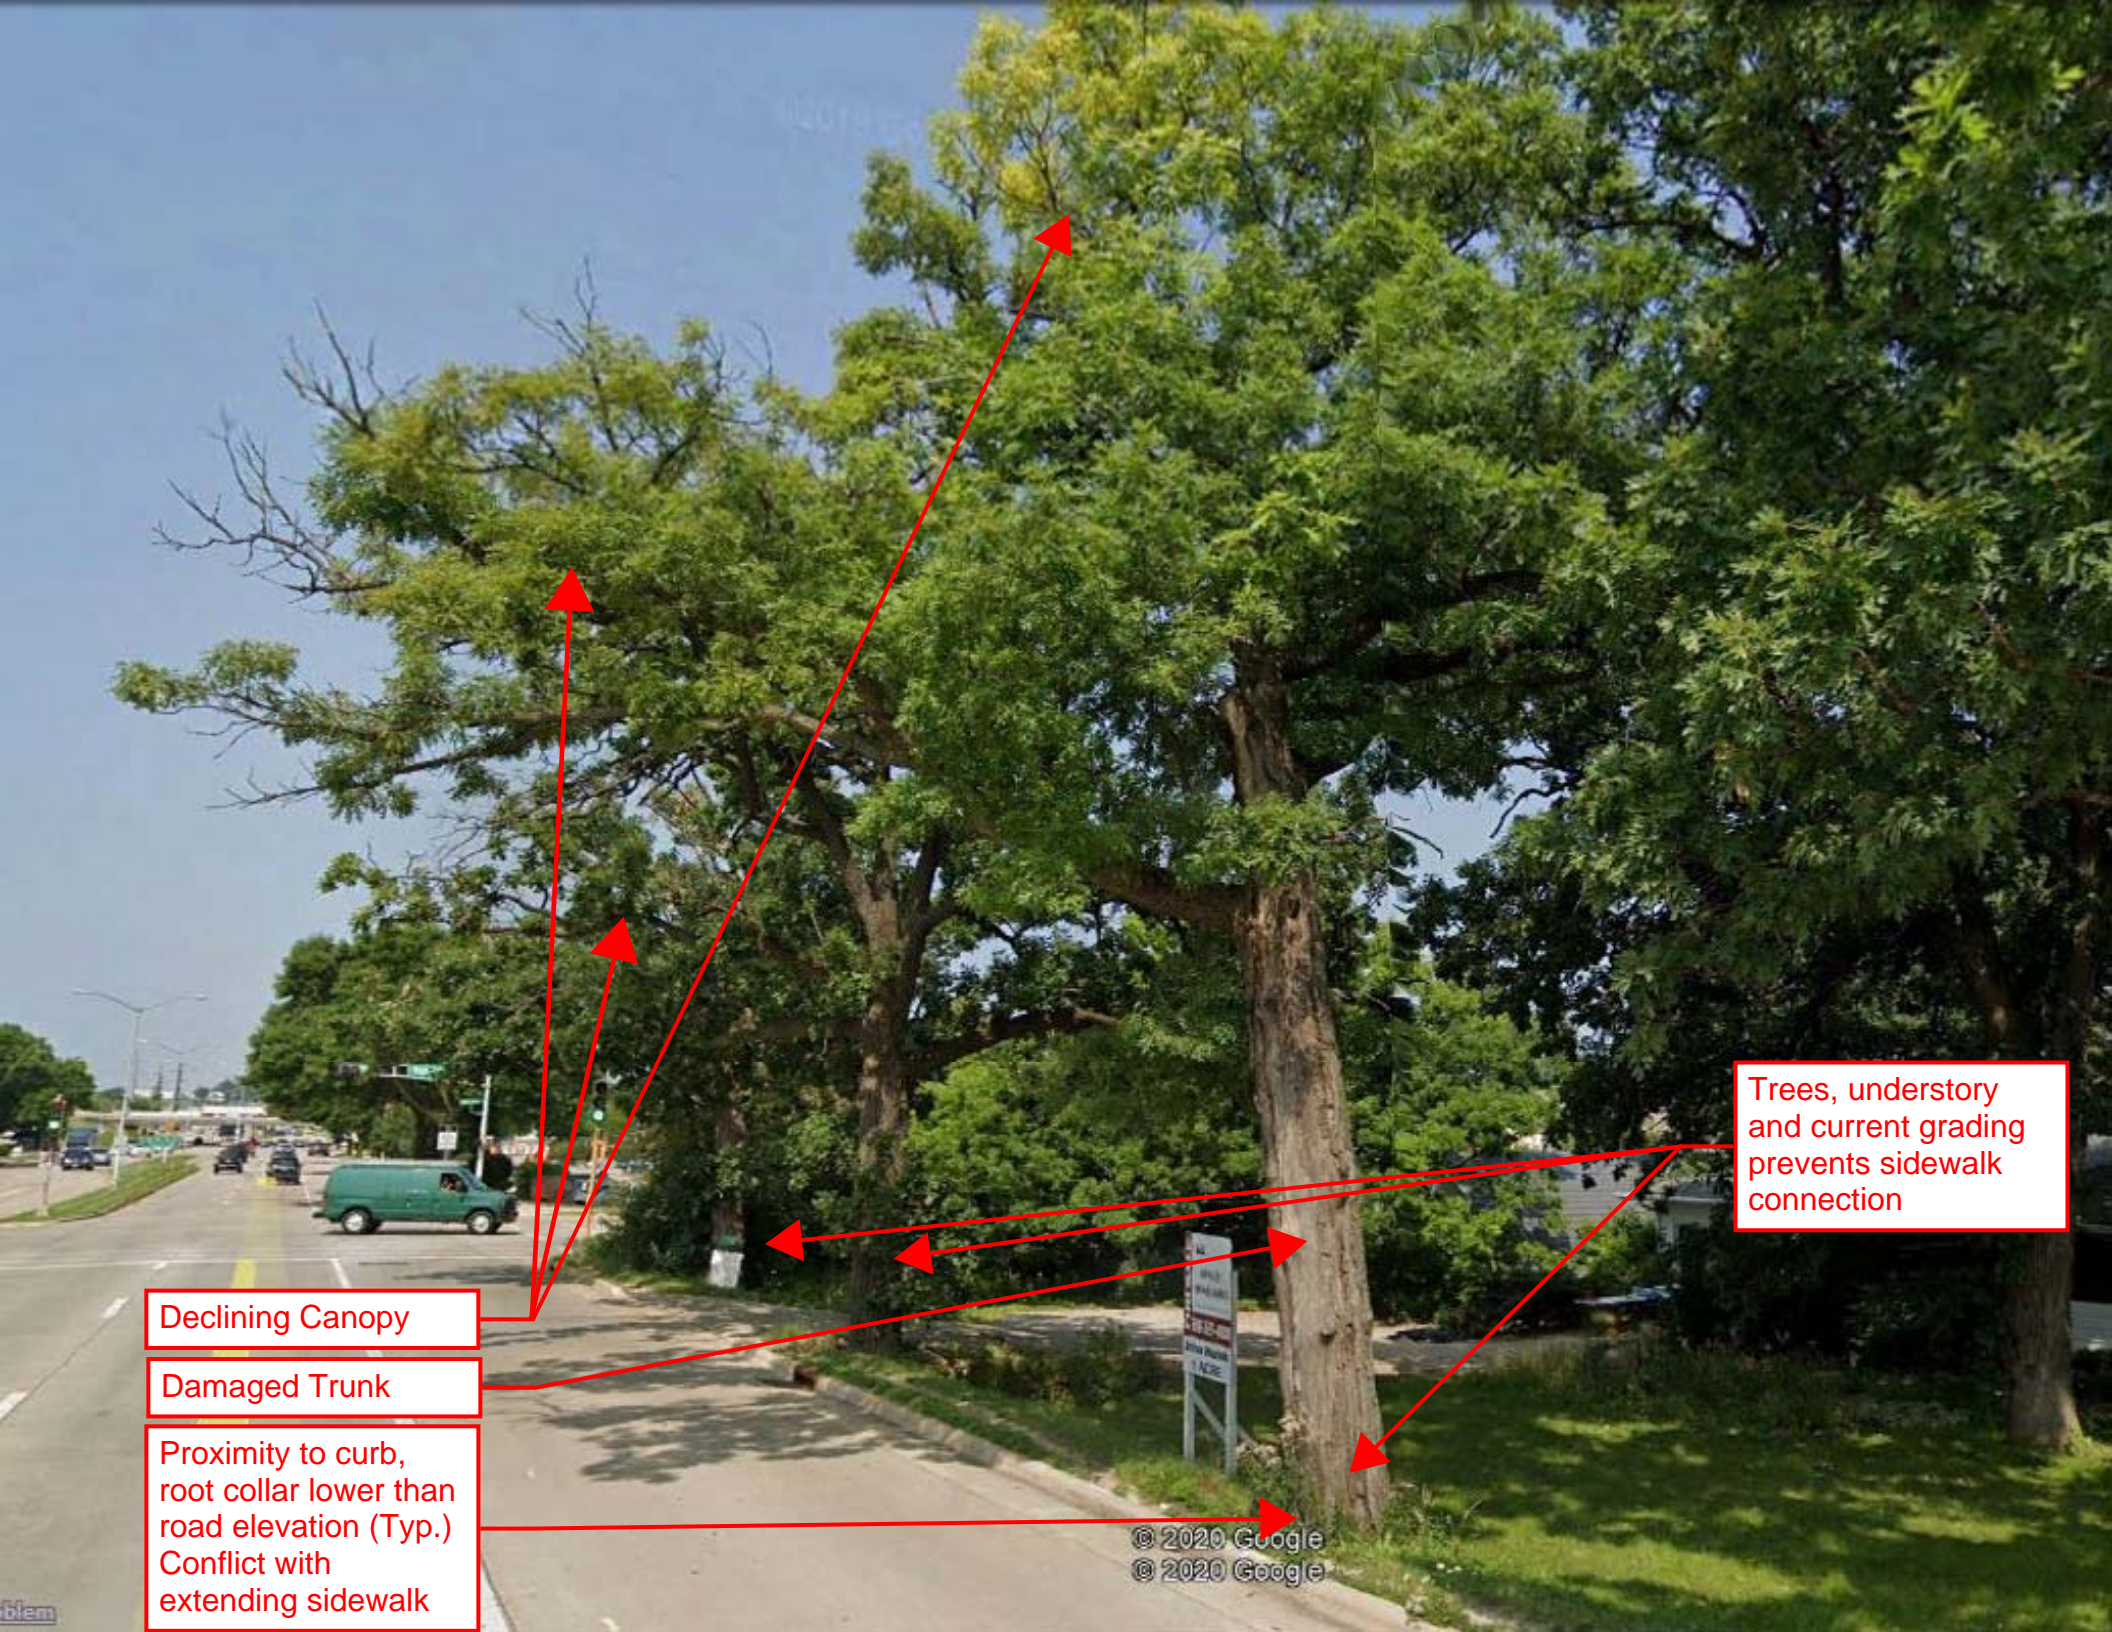
Declining Canopy

Damaged Trunk

Proximity to curb,
root collar lower than
road elevation (Typ.)
Conflict with
extending sidewalk

Trees, understory
and current grading
prevents sidewalk
connection

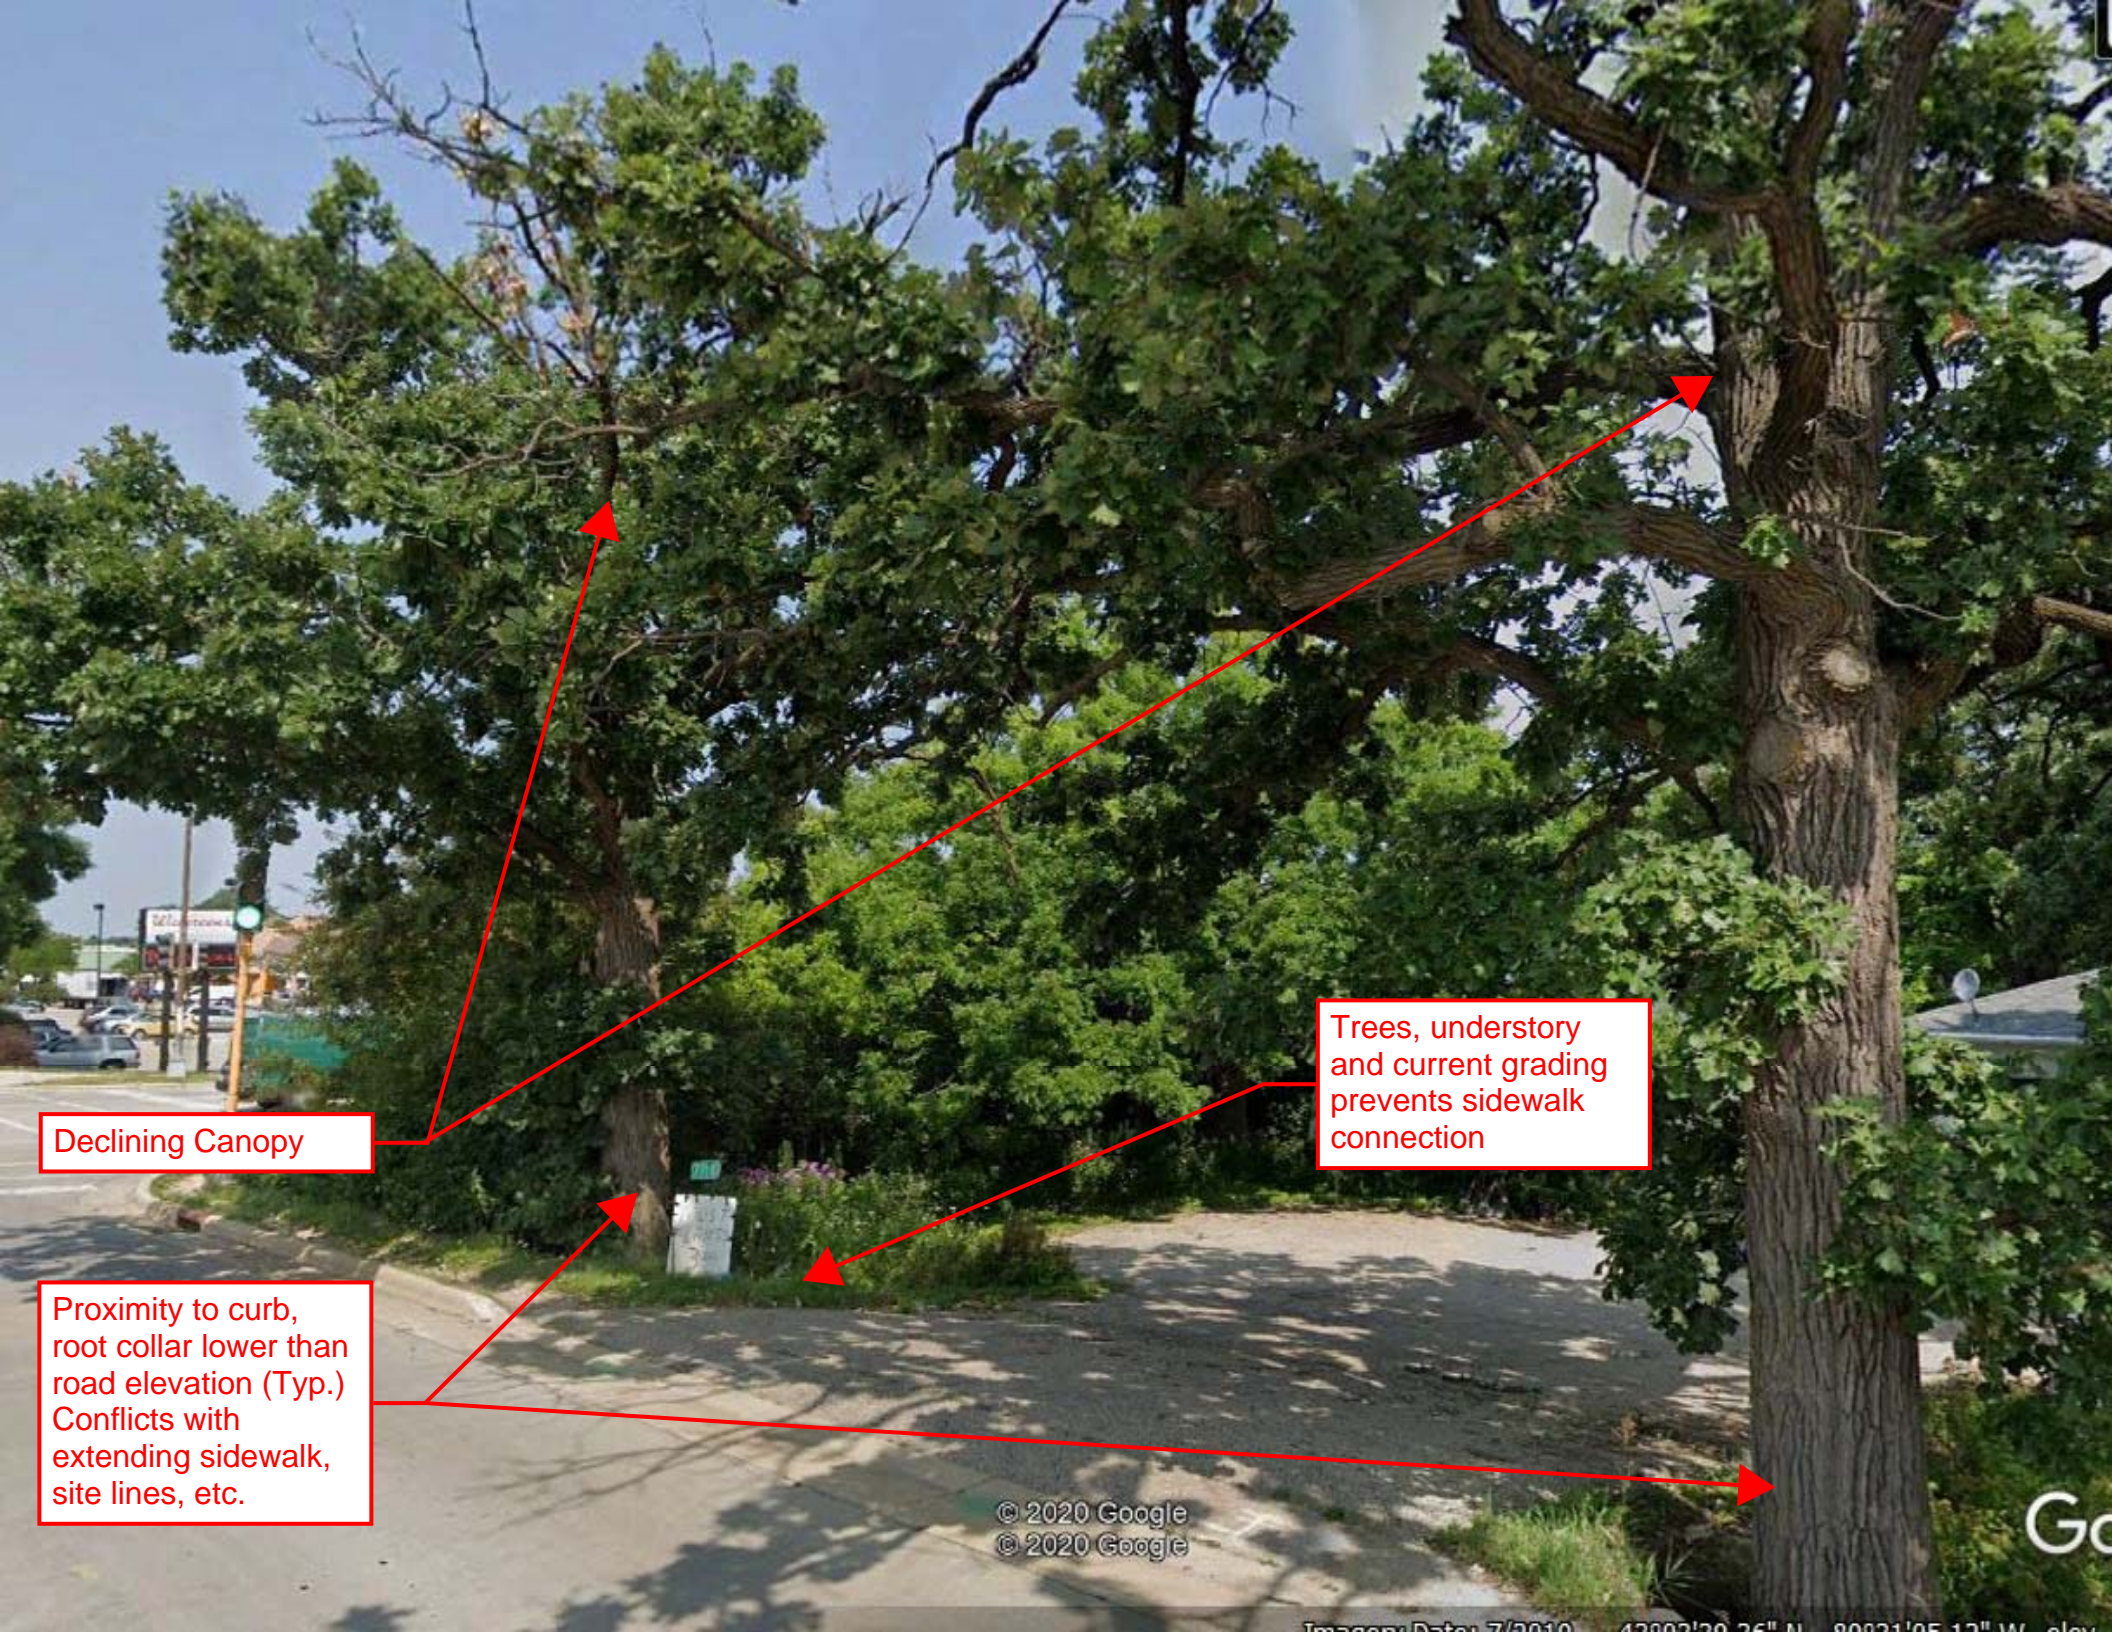
Declining Canopy

Proximity to curb, root collar lower than road elevation (Typ.) Conflicts with extending sidewalk, site lines, etc.

Trees, understory and current grading prevents sidewalk connection

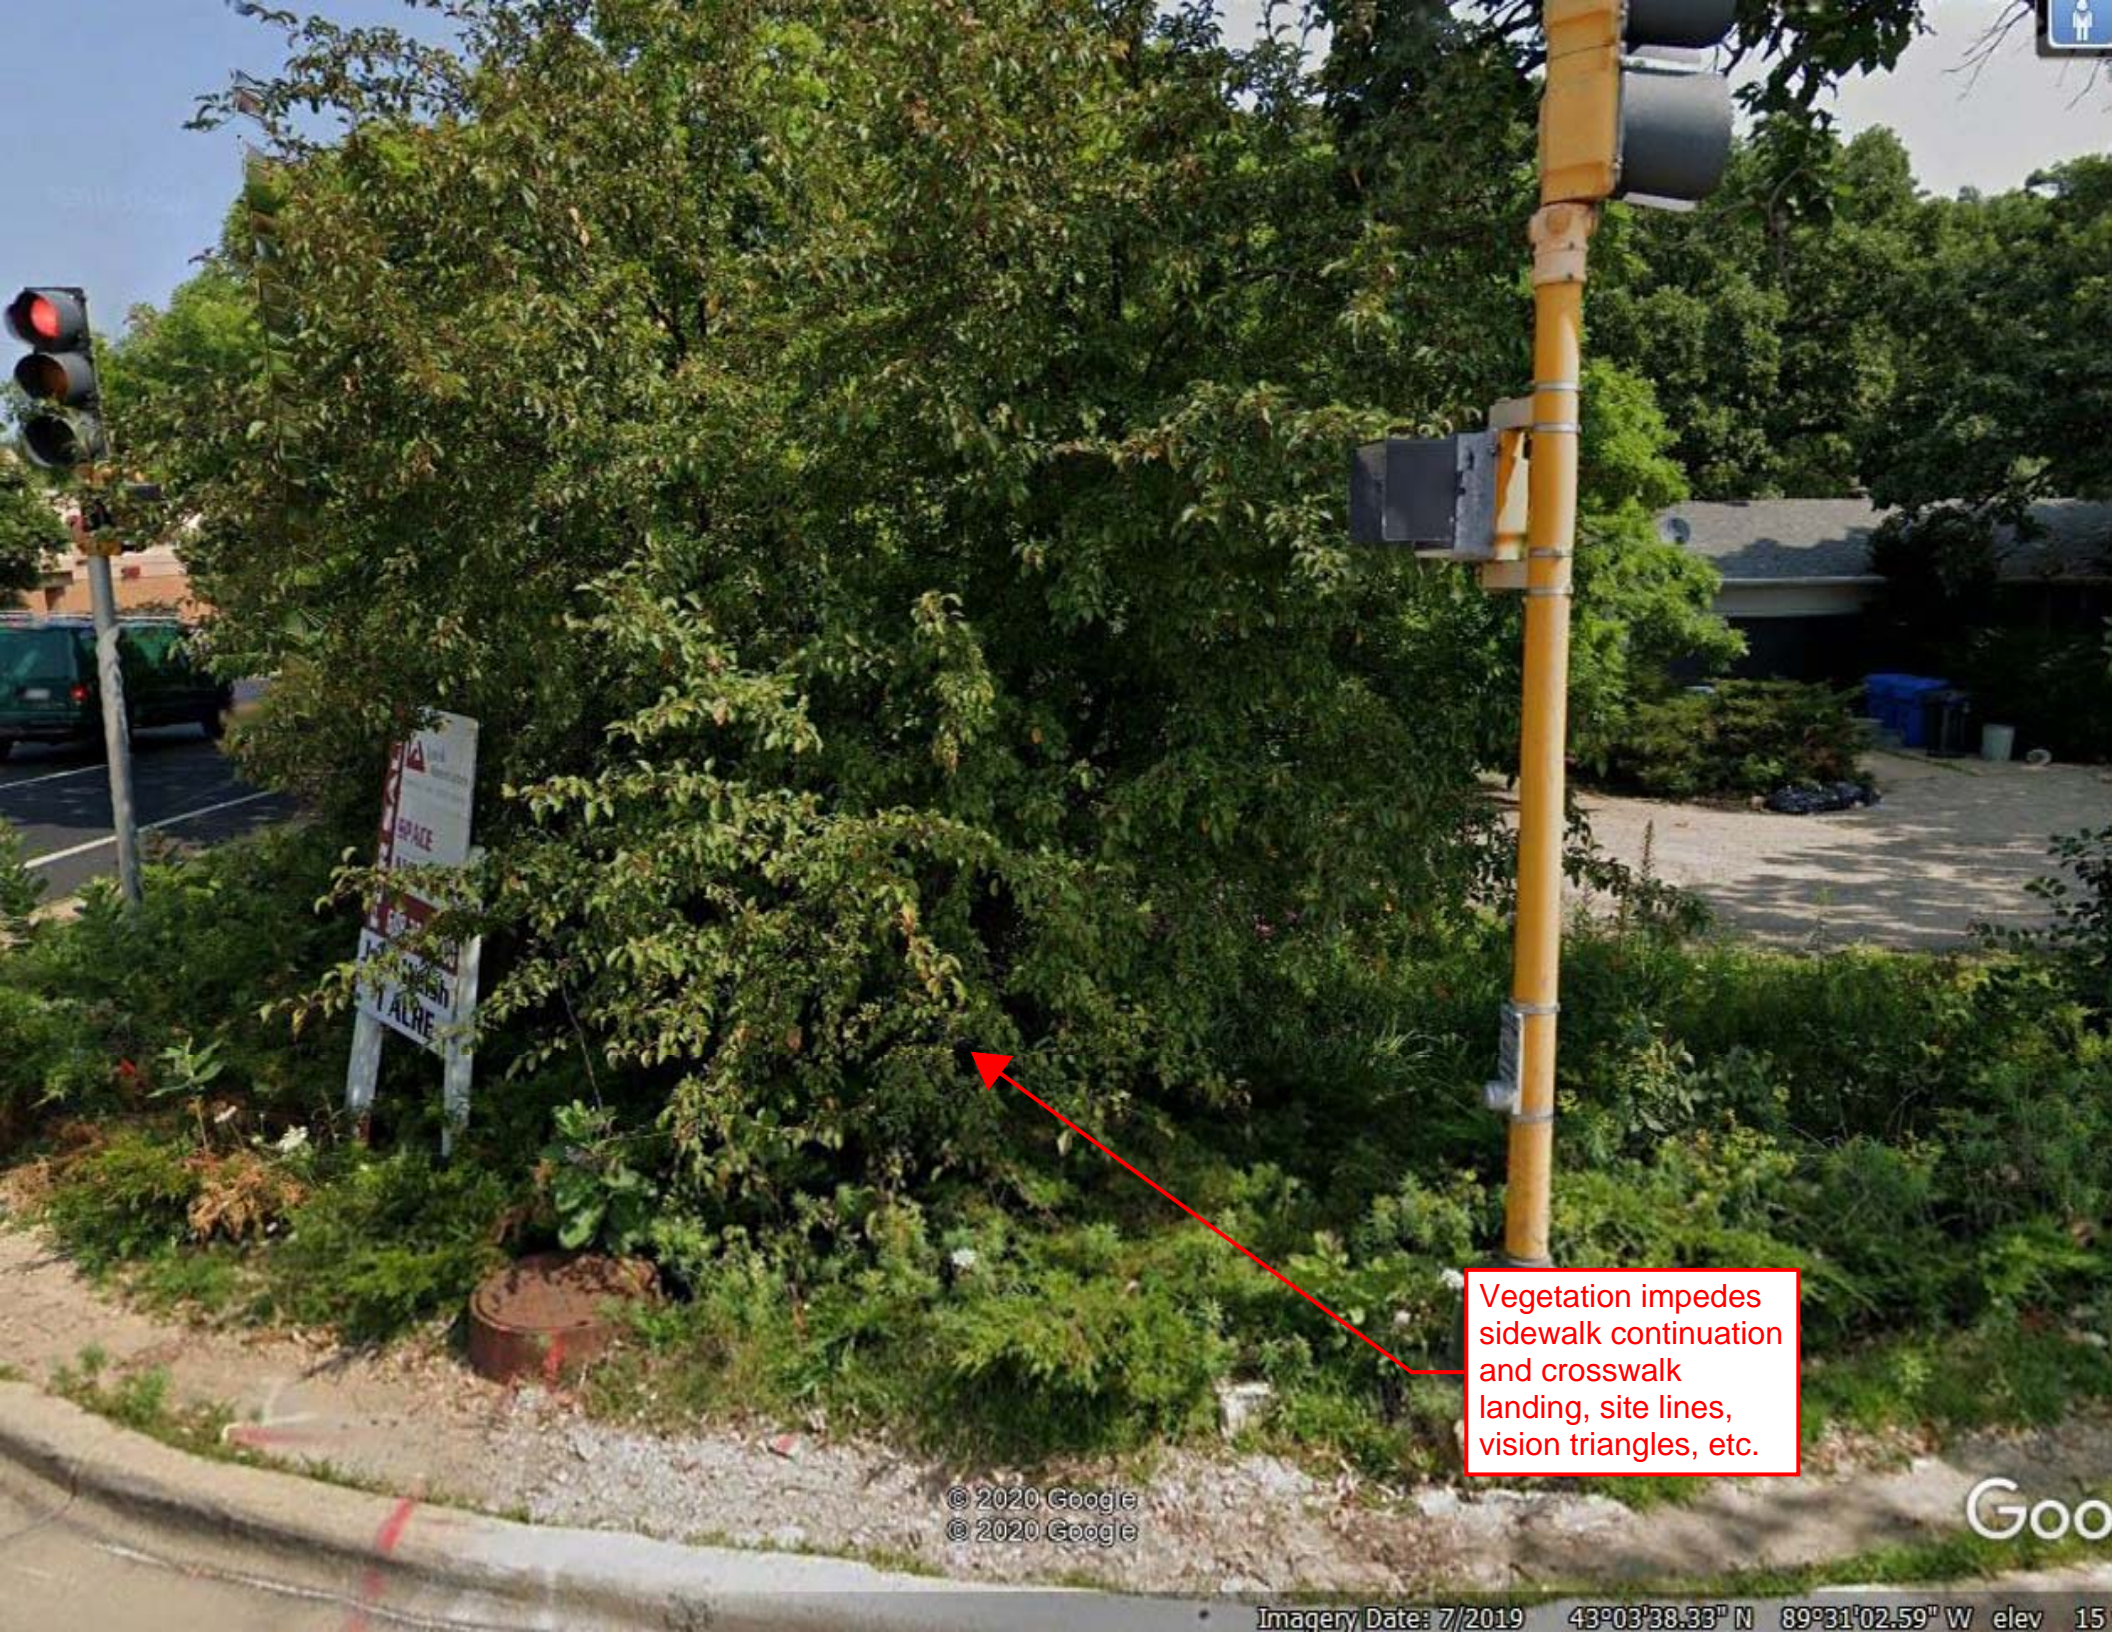
Vegetation impedes sidewalk continuation and crosswalk landing, site lines, vision triangles, etc.

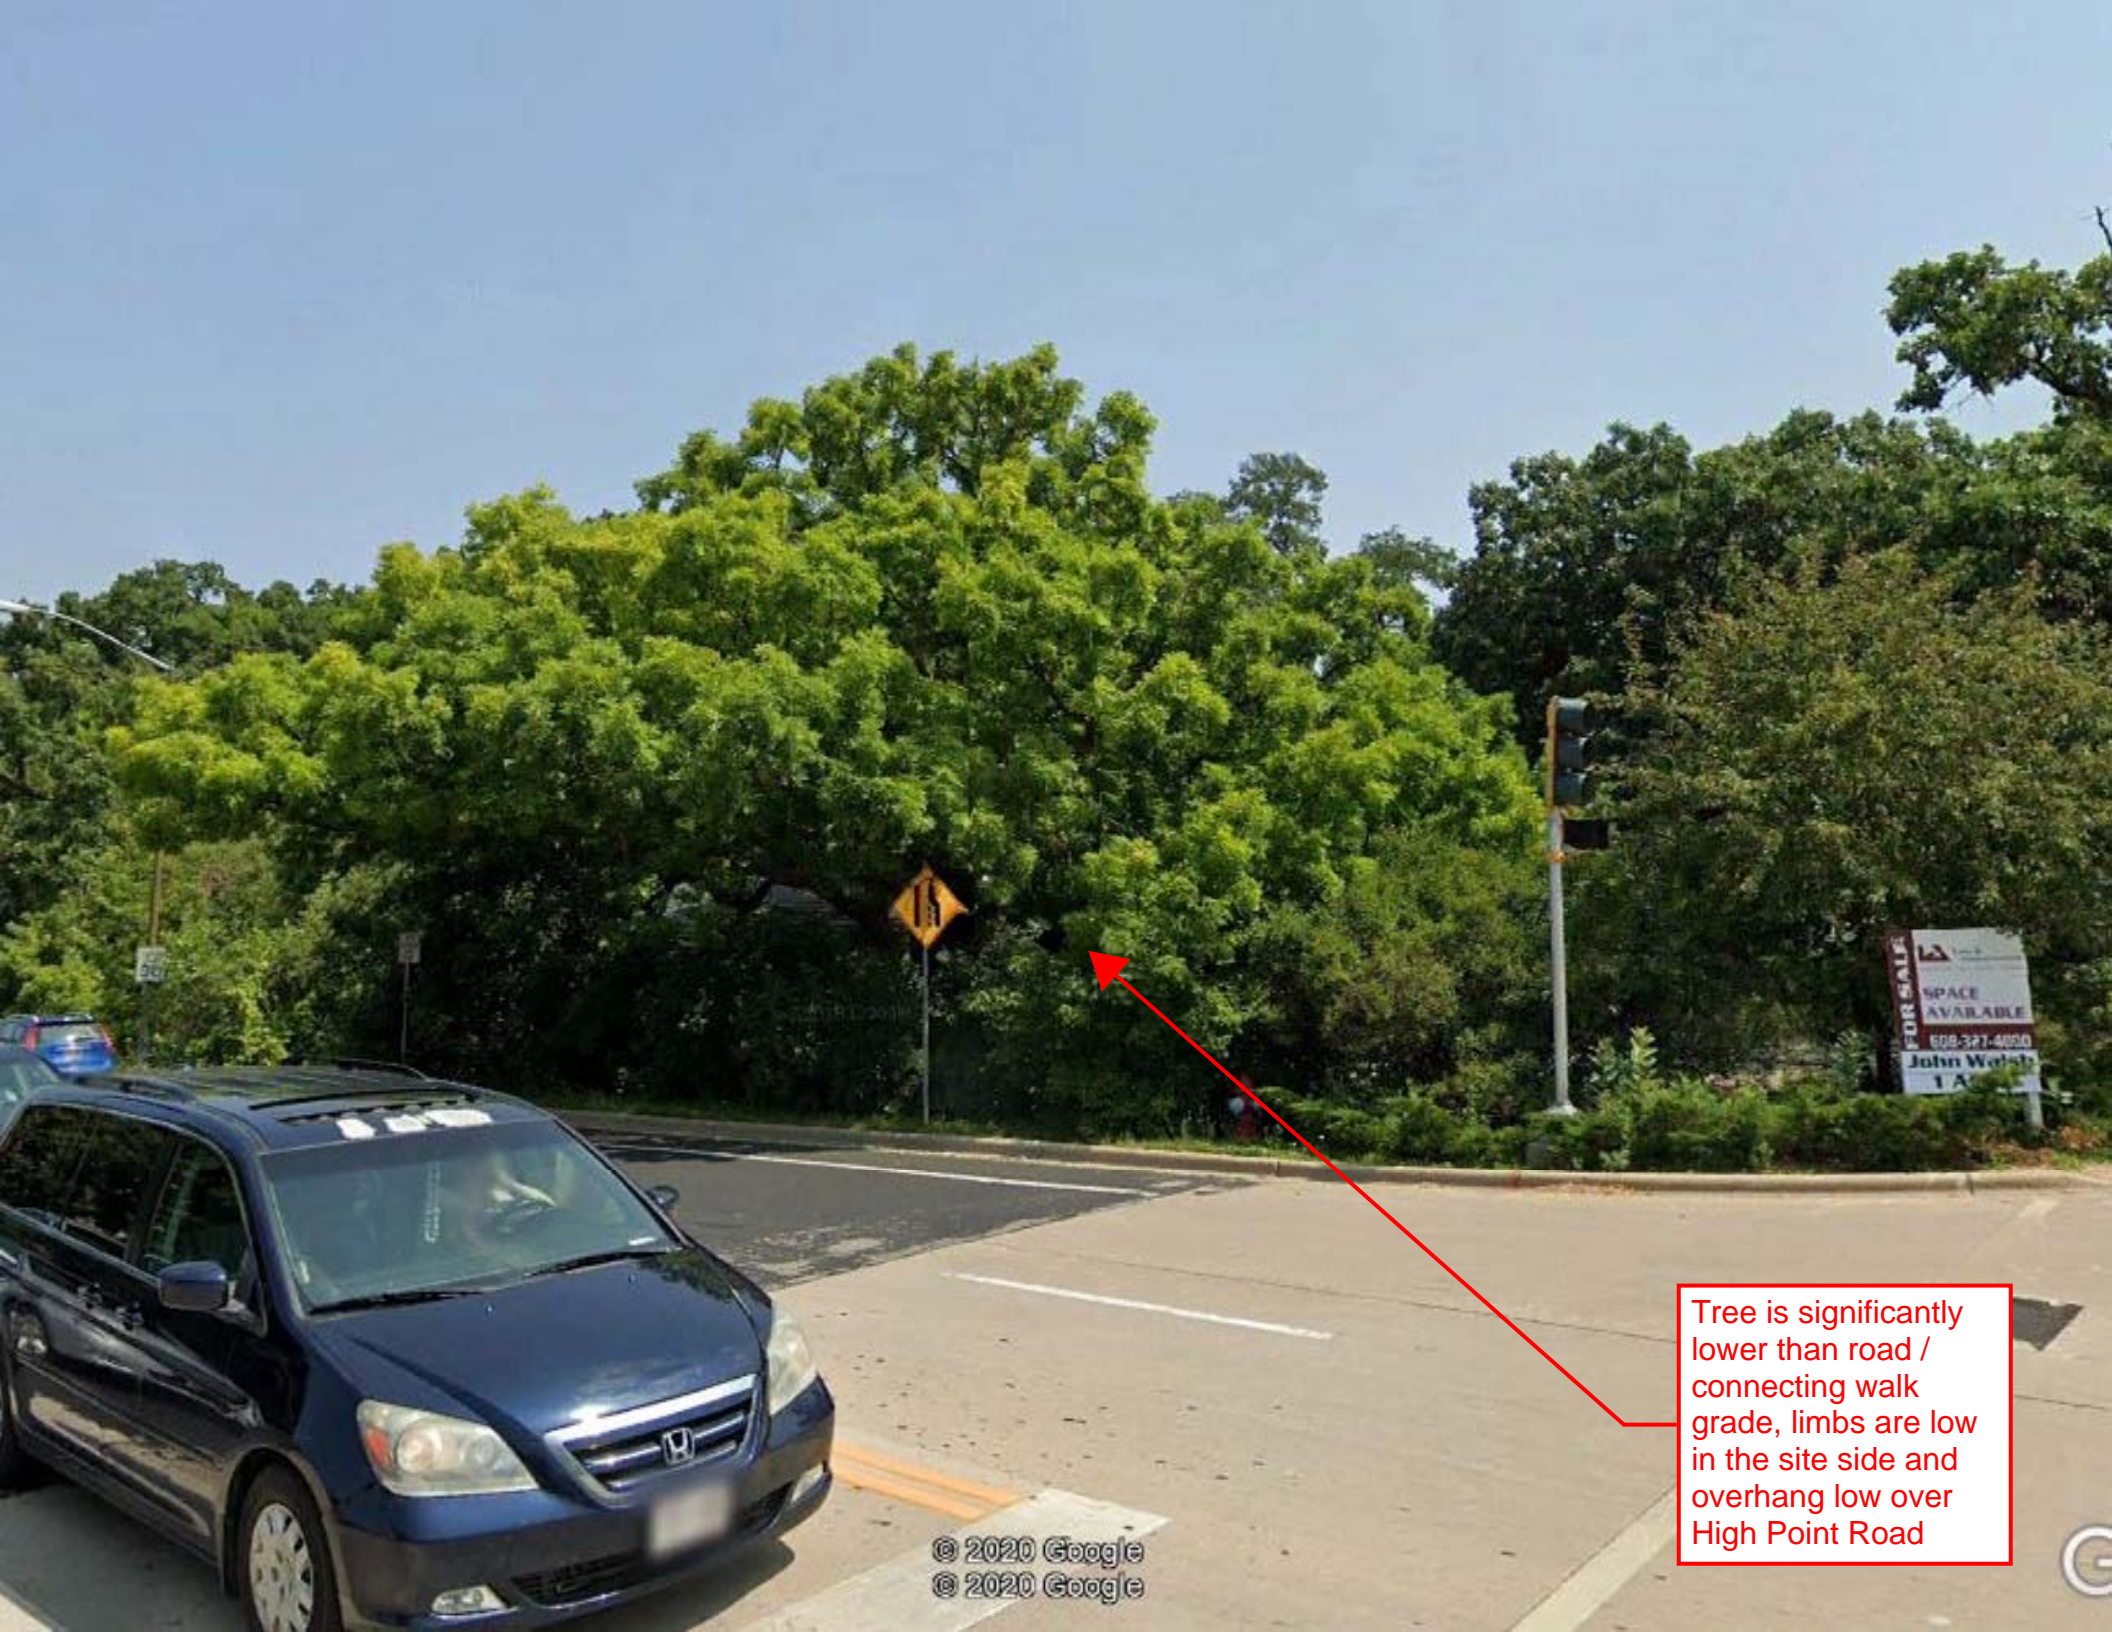
Tree is significantly lower than road / connecting walk grade, limbs are low in the site side and overhang low over High Point Road

Declining canopy

Understory and current grading prevents sidewalk connection
