Archaeological Examination of Mound Disturbance at Edgewood College
January 2, 2014
Robert Birmingham

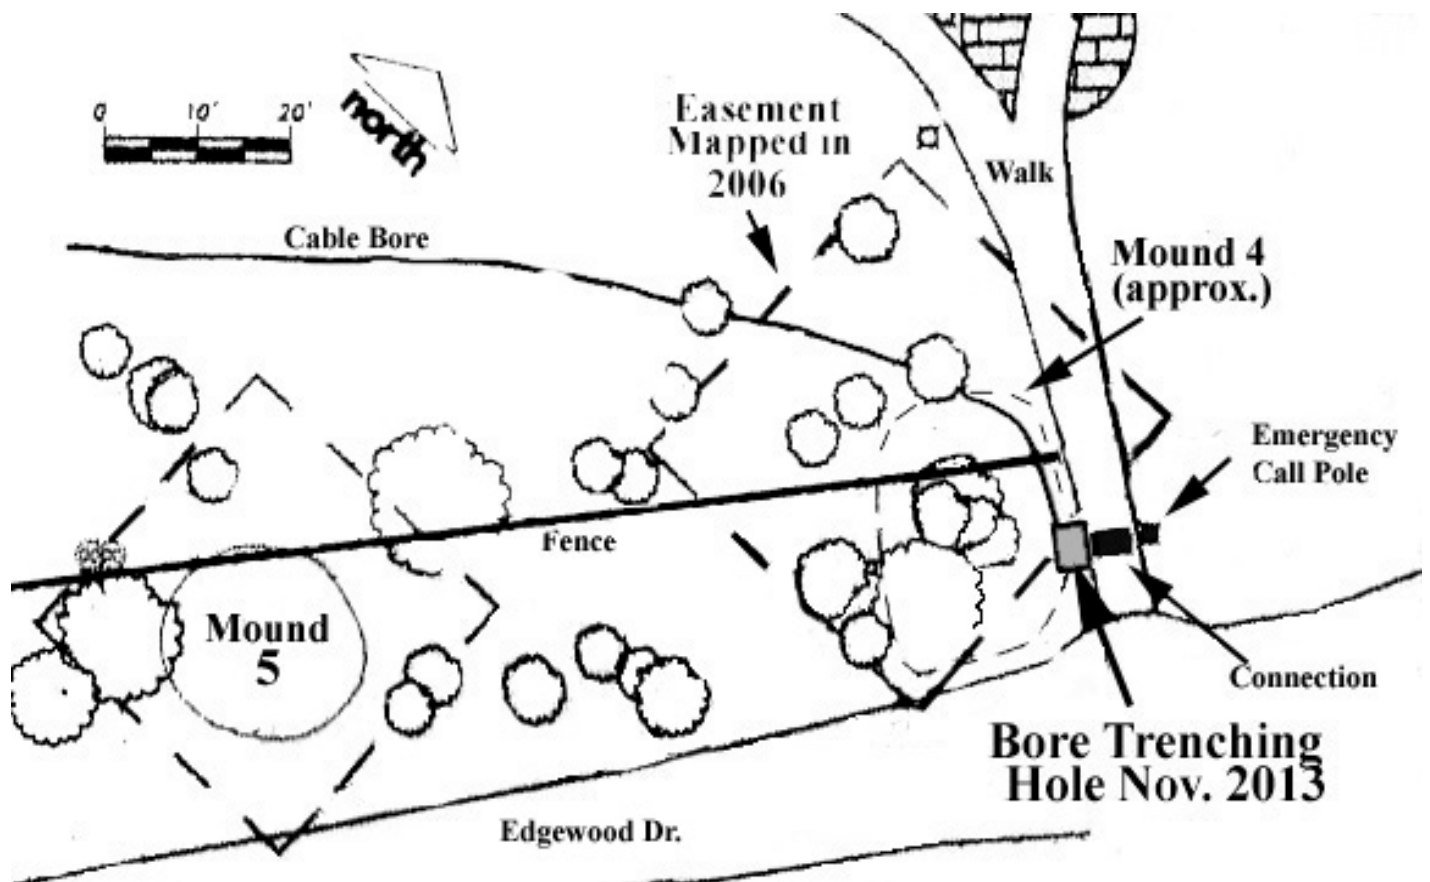
There is a discrepancy between the mound easement as shown on College maps in 2006 and the WHS map made in 1990.

Figure 2: Area of Mound 4 and 2013 disturbance based on a 2006 Existing Facilities map made by JSD Professional Services.

On these bases, three recommendations are made. First, a soil scientist with archaeological expertise should determine the modern extent of the mound using soil cores placed along the perimeter of the mound area. Second, a rectilinear easement with at least a 5 ft. buffer around edges of the remaining

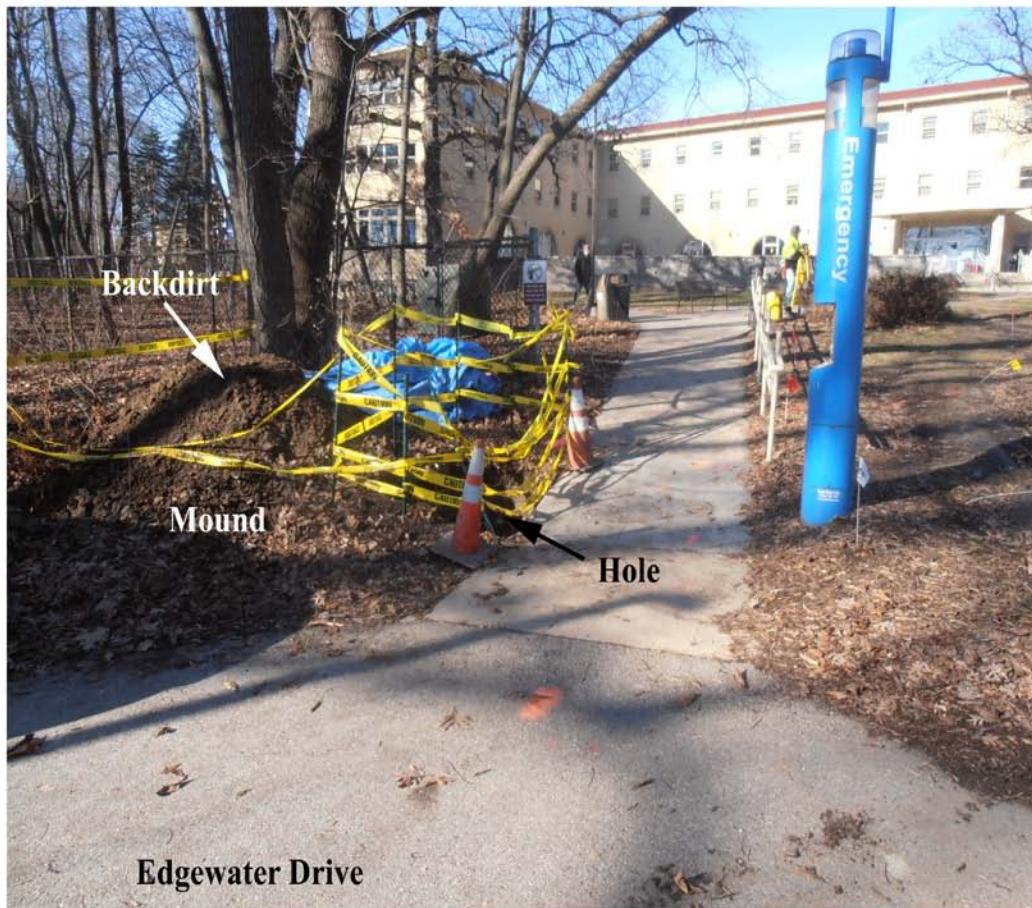
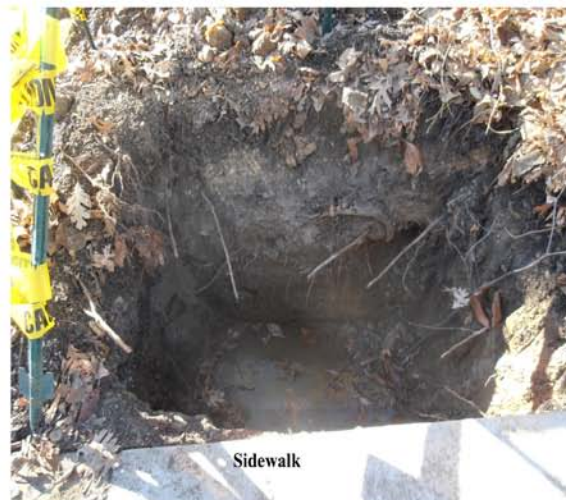
The recent work was in an area greatly disturbed by past activities, but the bore trenching hole excavation may have disturbed a small edge of the original mound. The boring was made below this in sterile soil. There was no evidence that burials or human remains were disturbed. Elsewhere, the extent of Mound 4 was determined on the basis of low rises in the ground and reference to the 1990 map. The center of mound can be determined by a rise between 1 and 2 feet above the surrounding landscape, but the edges of the original mound, or what is left of it, are unclear, partly as a result of disturbance in the past. On the northwest, the area of mound blends with the grassed landscape and some other parts of the detectable rise may be the result of the addition of fill as documented by this study, as well as large tree roots.

Figure 3: Above, area of disturbance looking northwest; below, bore trenching hole, looking southwest.

mound remnant similar to that in Figure 6 should be reset by professional surveyor and the college should ensure that this information be included in the appropriate facilities and planning maps. Lastly, considering the amount of disturbance that has already taken place, the Wisconsin Historical Society should consider allowing the College to carefully complete the cable connection as originally planned and this should be monitored by an archeologist. If this considered inappropriate, an alternative would be run the cable on the east side of the sidewalk where it would not further impact the mound area.
