**SURVEY OF CONDITIONS FOR PROPOSED
BADGER ROAD/ANN STREET/PARK STREET
REDEVELOPMENT PROJECT**

Report on Blight Determination

**Prepared by:
Mid-America Planning Services, Inc.
621 N. Sherman Ave.
Madison, WI 53704
608-249-2514**

July 12, 2005

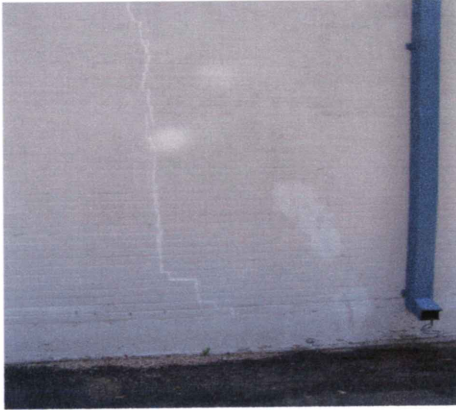
1818 South Park St
Cracked Wall
October 25, 2003

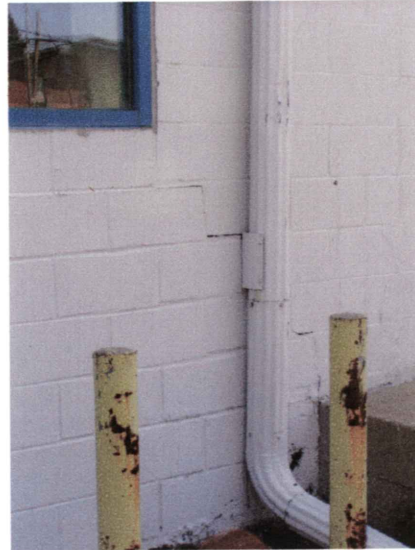
2216 South Park St
Cracked Wall
May 25, 2003

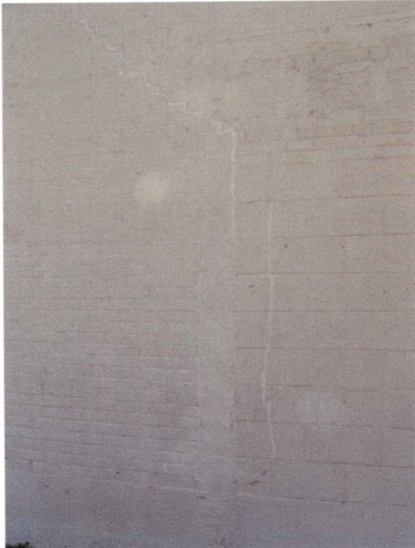
1818 South Park St
Cracked Wall
October 25, 2003

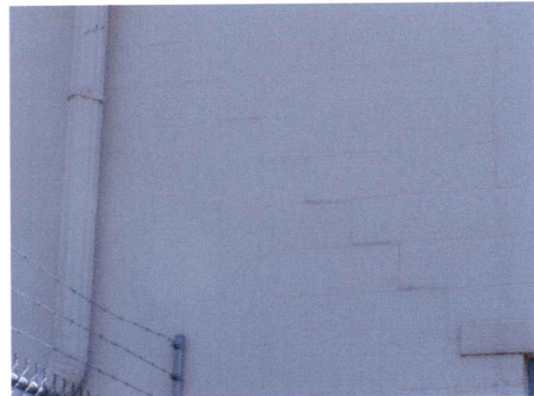
1818 South Park Street
Cracked Wall
October 25, 2003

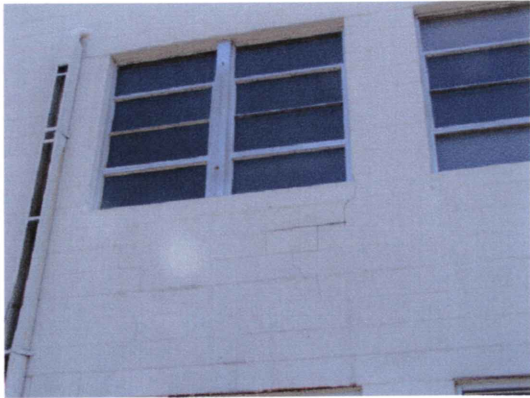
2216 South Park Street
Cracked Wall
May 25, 2003

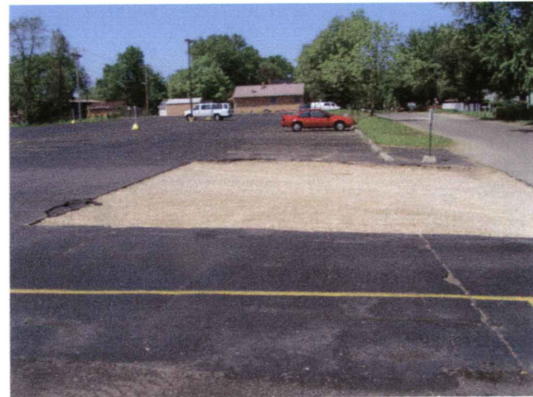
1202 Ann Street
Blighted Parking Lot
October 25, 2003

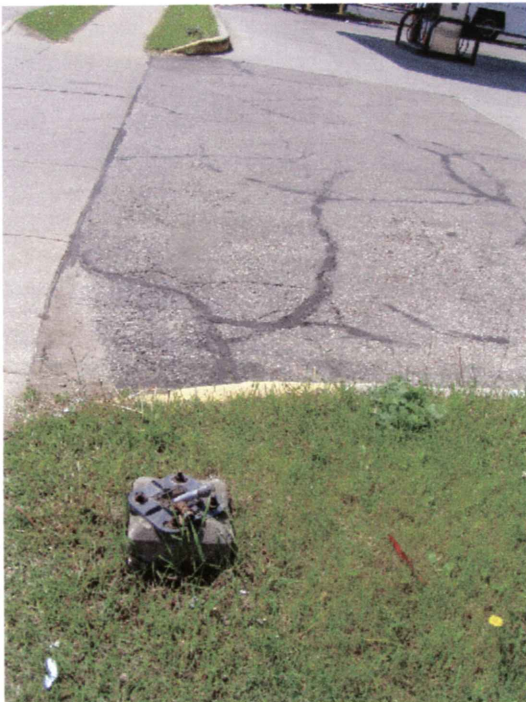
2200 South Park Street
Obsolete sign base and cracked
driveway
May 25, 2003

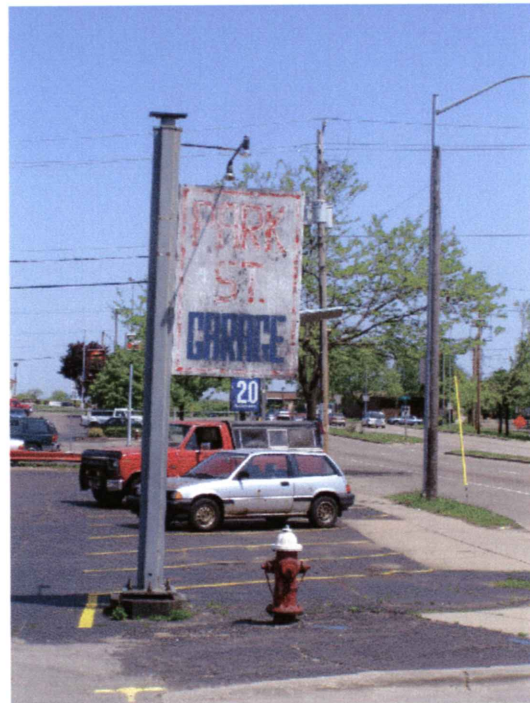
2116 South Park Street
Blighted sign and blighted parking lot
May 25, 2003

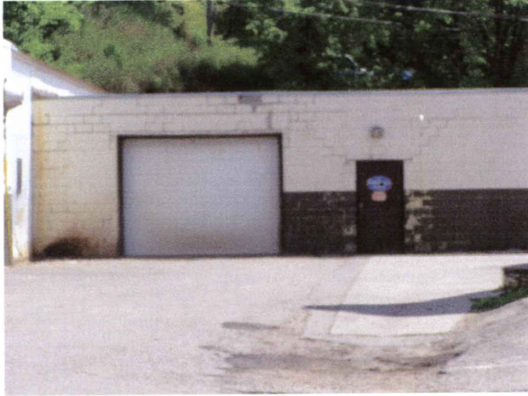
2431 South Park Street
Cracked wall, blighted parking lot
May 25, 2003

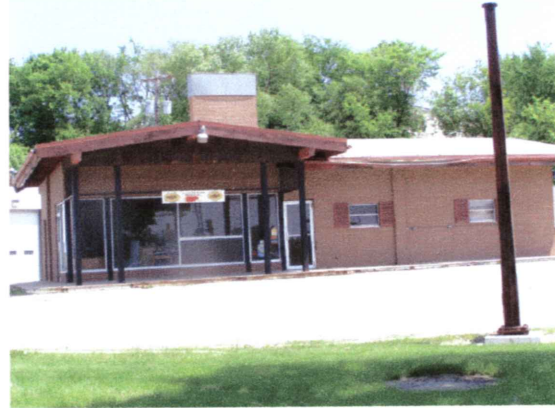
2421 South Park Street
Vacant building, sagging eave trough
May 25, 2003

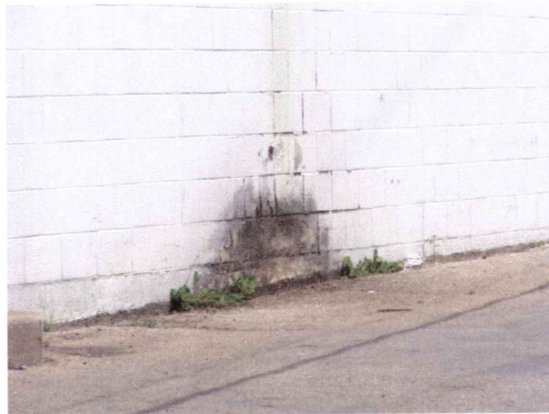
2431 South Park Street
Cracked and water damaged wall,
May 25, 2003

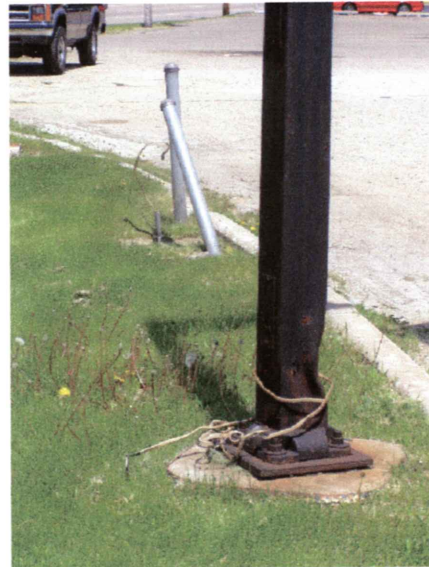
2421 South Park Street
Exposed wiring, bent and dented
posts
May 25, 2003

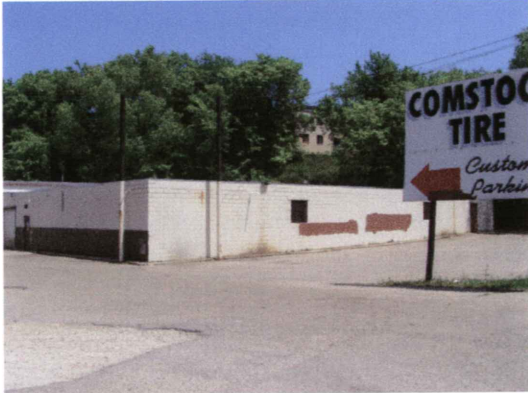
2421 South Park Street
Blighted driveway and parking lot,
water damaged wall
May 25, 2003

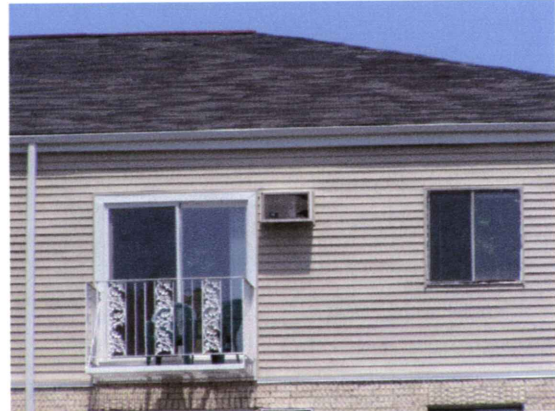
700 West Badger Road
Deteriorated roof and window frame
May 25, 2003

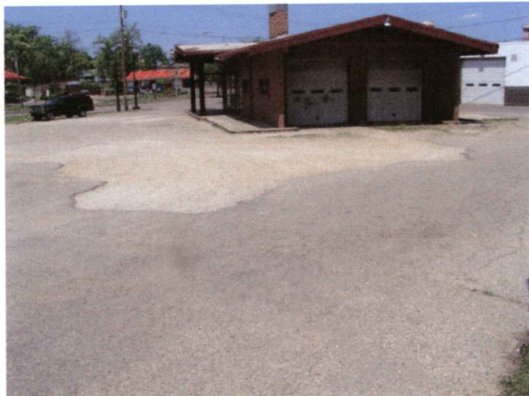
2421 South Park Street
Blighted driveway and parking lot
May 25, 2003

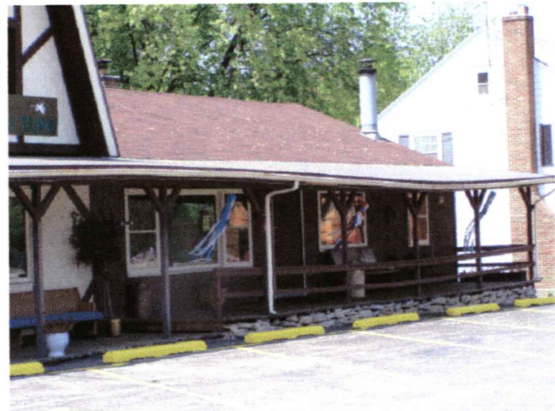
2465 South Perry Street
Sagging Roof
May 25, 2003

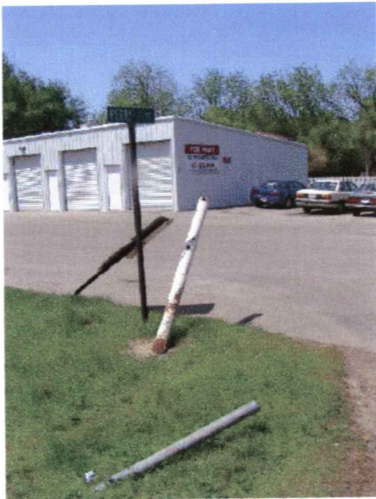
2505 South Perry St
Bent Posts
May 25, 2003

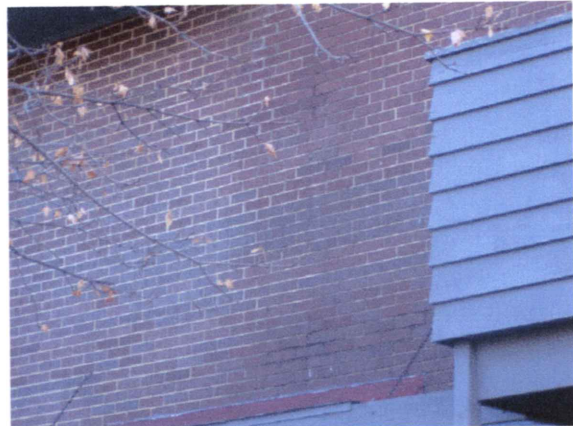
1850 Beld Street
Cracked wall with water damage
October 25, 2003

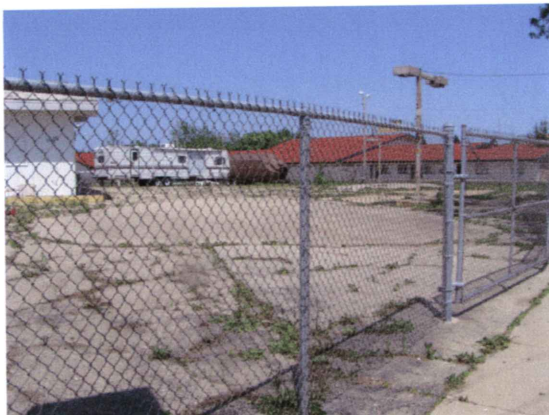
1010 Ann Street
Blighted Parking Area
October 25, 2003

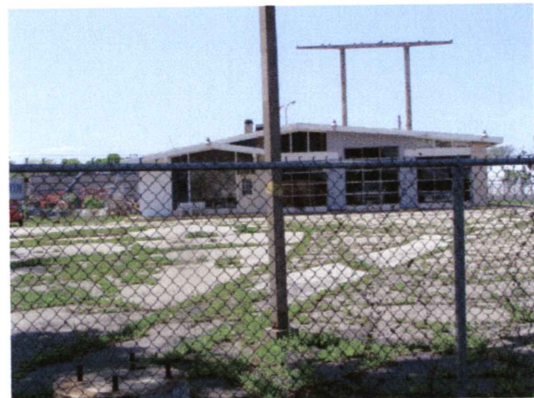
1010 Ann Street
Abandoned sign posts, blighted
parking areas
October 25, 2003

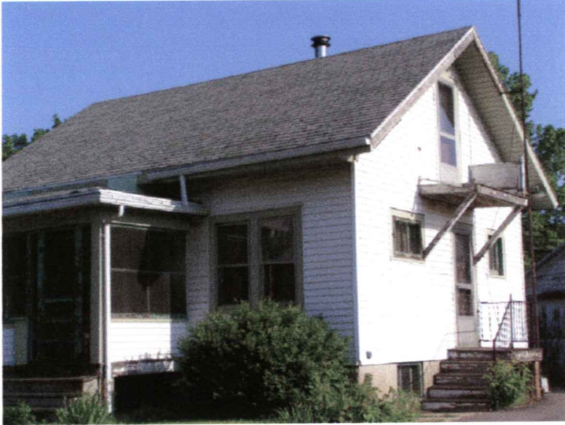
836 Hughes Place
Deteriorated porches and roof at
May 25, 2003

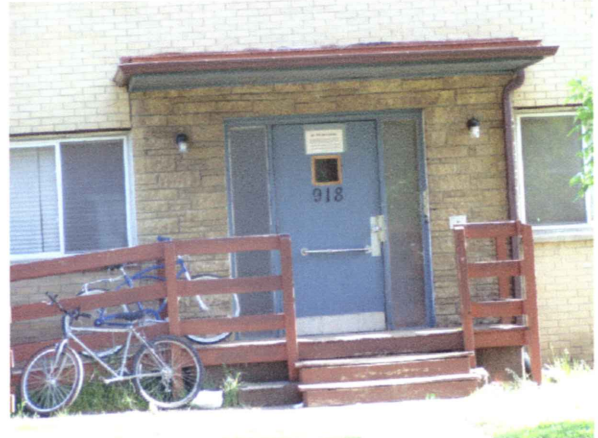
918 Magnolia Lane
Deteriorated porch, steps and unsafe
steps
May 25, 2003

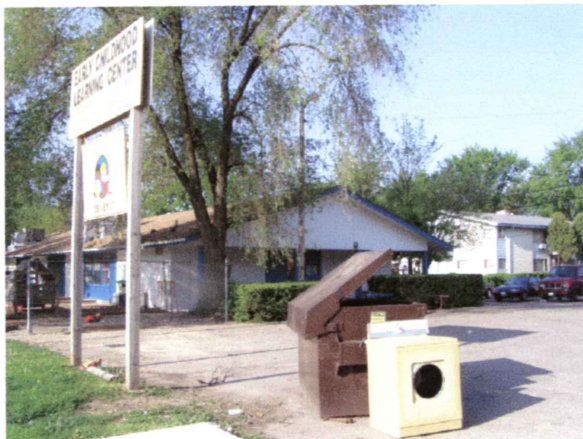
833 Hughes Place
Lack of trash container screening
May 25, 2003

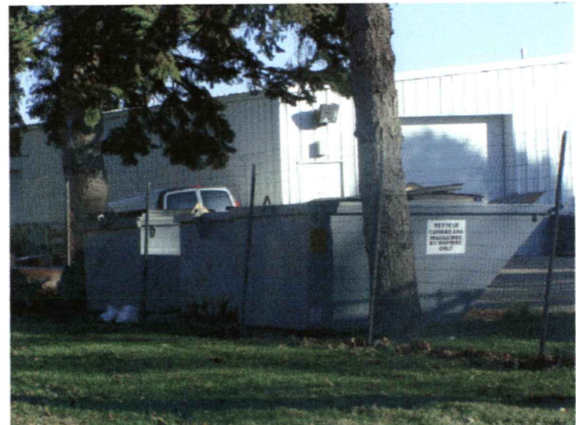
1114 Ann Street
Unscreened trash container
October 25, 2003

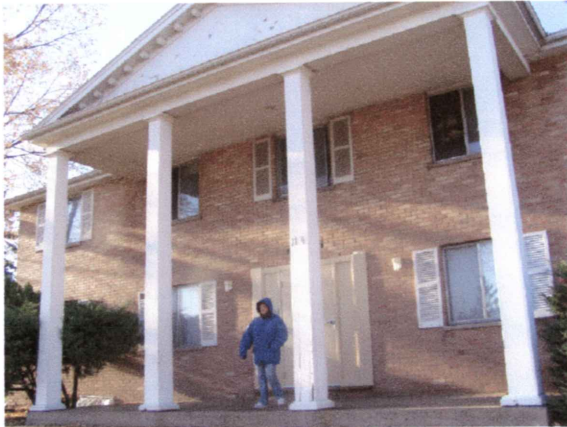
1114 Ann Street
Deteriorated porch posts
October 25, 2003

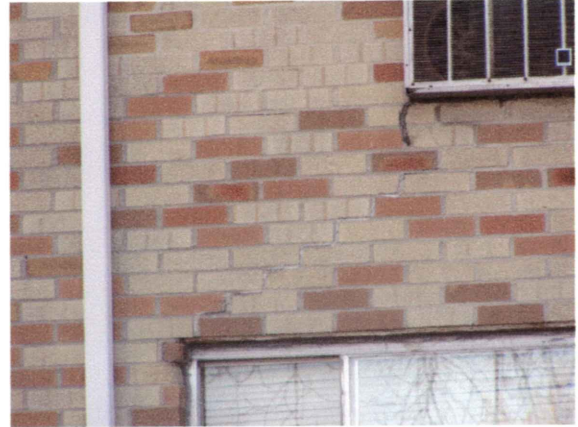
1114 Ann Street
Cracked Wall
October 25, 2003

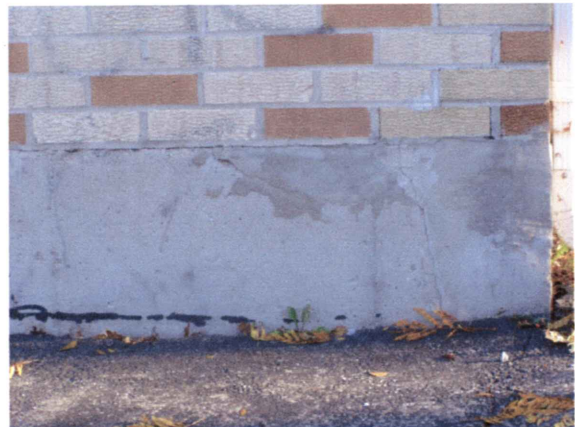
1114 Ann Street
Cracked foundation
October 25, 2003

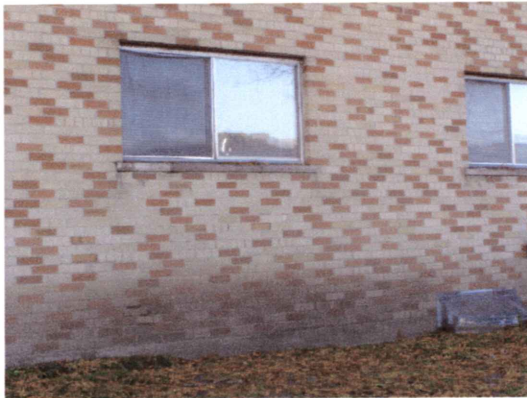
1114 Ann Street
Water damaged wall
October 25, 2003

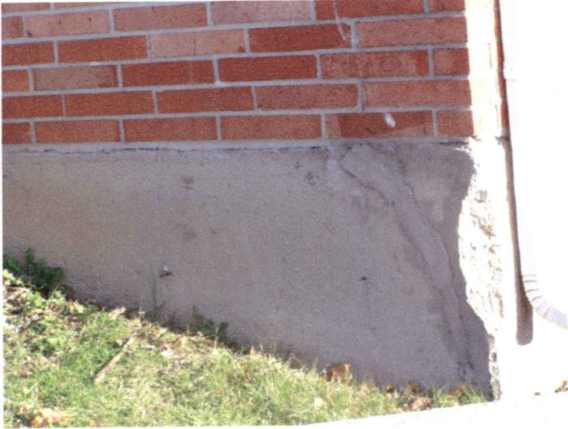
1114 Ann Street
Cracked foundation
October 25, 2003

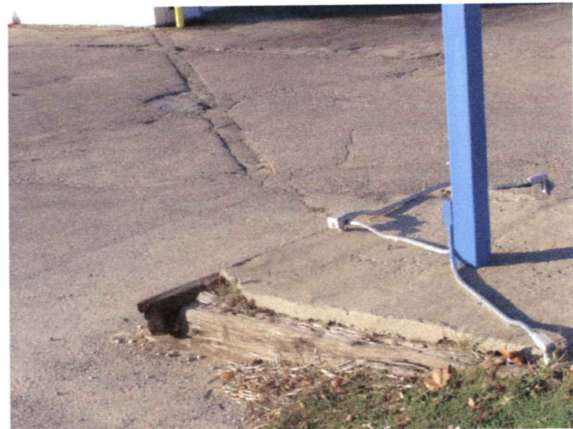
1824 South Park Street
Deteriorated sign base
October 25, 2003

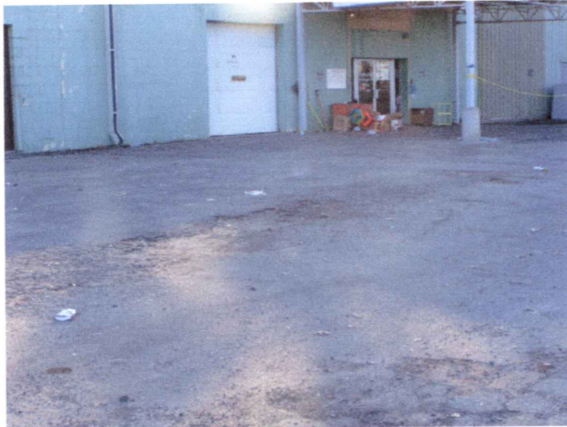
1500 South Park Street
Deteriorated drive
October 25, 2003

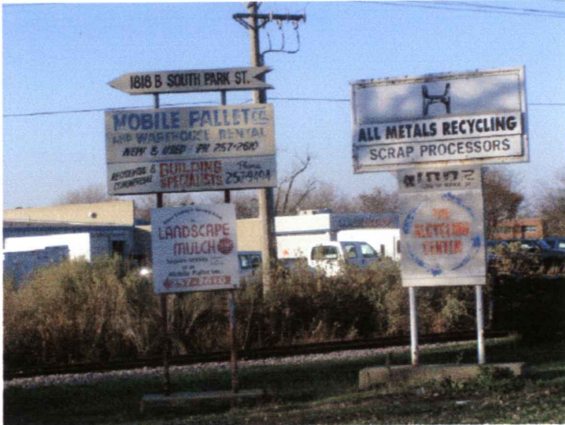
1800 South Park Street
Signs in disrepair
October 25, 2003

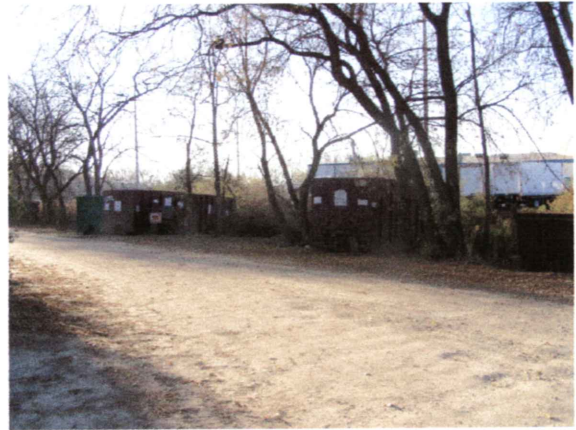
1800 South Park Street
Non-functional trash containers
October 25, 2003

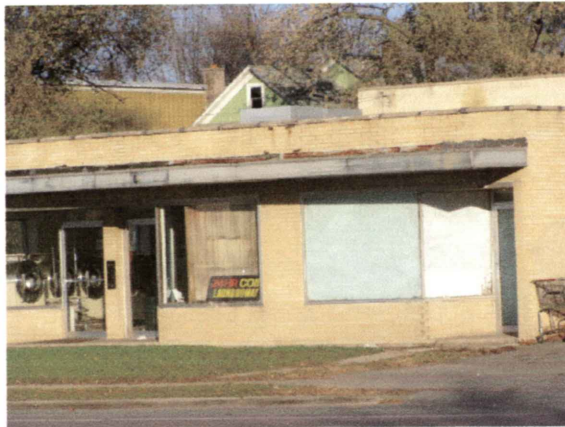
1817 South Park Street
Deteriorated roof
October 25, 2003

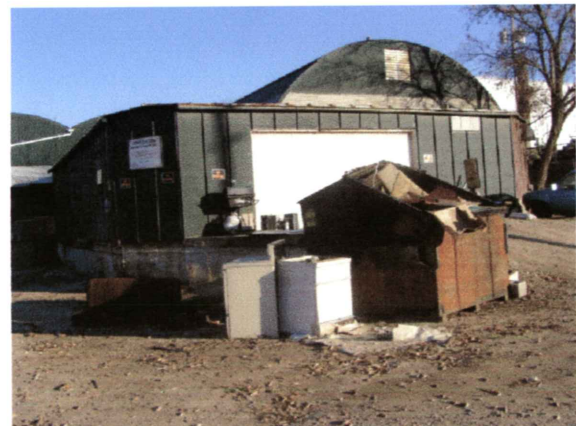
1818 South Park Street
Trash/unscrapped trash containers
October 25, 2003

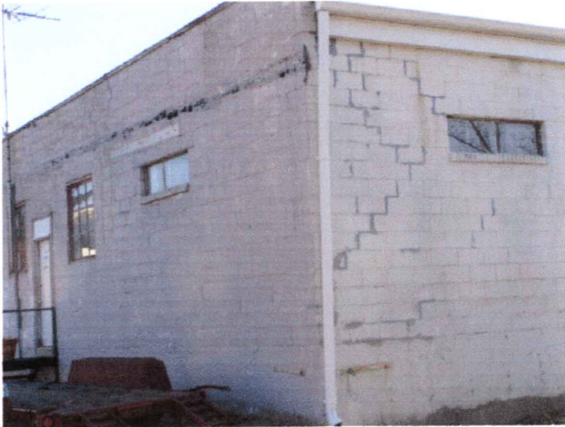
1818 South Park Street
Cracked wall and foundation
October 25, 2003

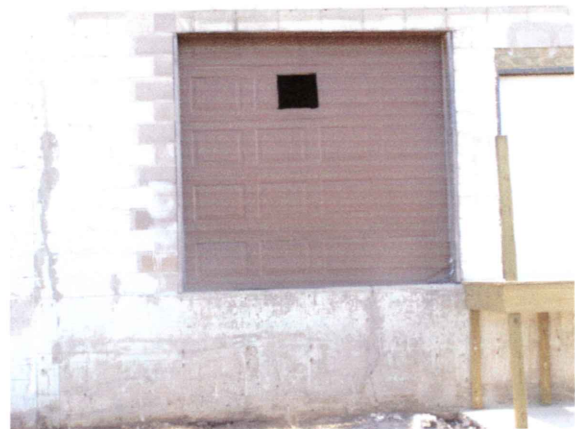
1818 South Park Street
Cracked wall and foundation
October 25, 2003

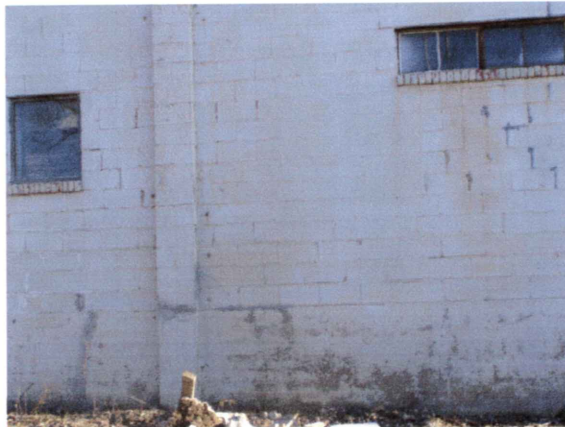
1818 South Park Street
Cracked wall and foundation
October 25, 2003

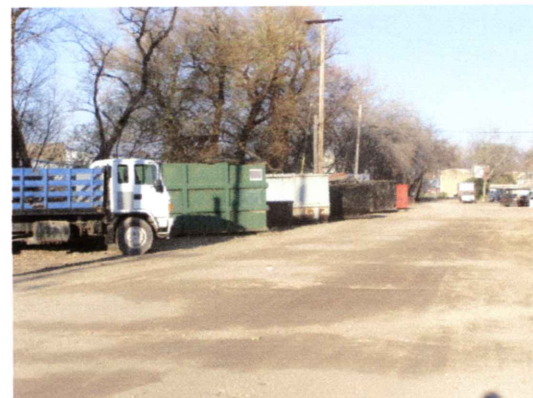
1800 South Park Street
Deteriorated Containers
October 25, 2003

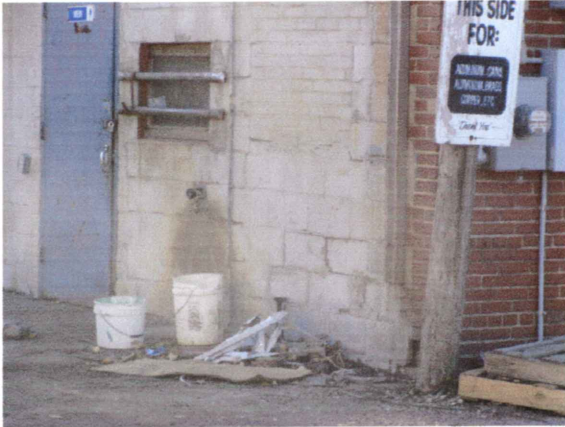
1818 South Park Street
Trash and cracked wall, deteriorated
door and window
October 25, 2003

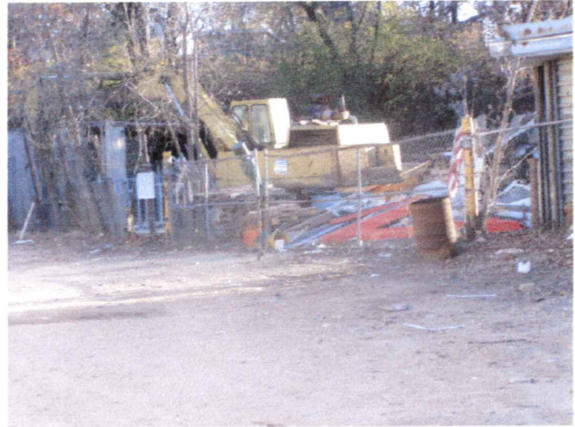
1818 South Park Street
Deteriorated fence/trash
October 25, 2003

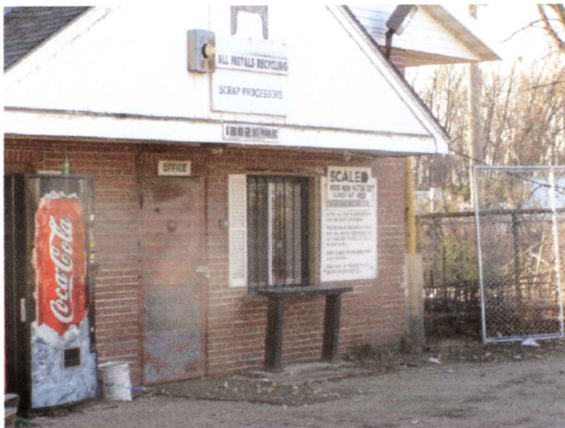
1818 South Park Street
Deteriorated door
October 25, 2003

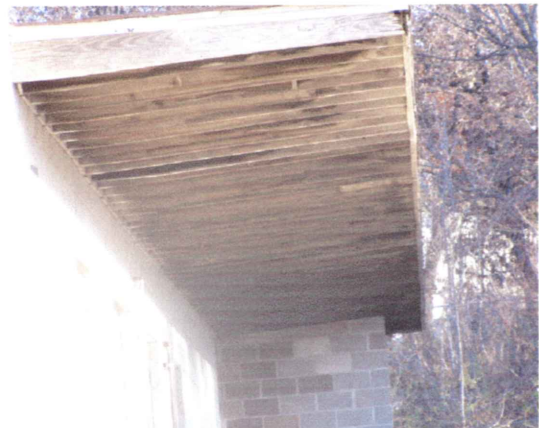
1818 South Park Street
Rotten fascia and roof joists
October 25, 2003

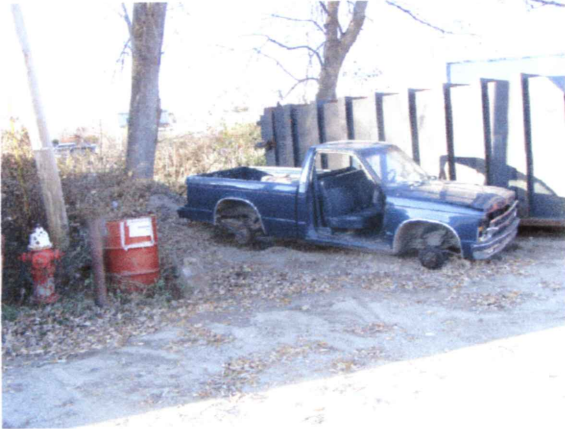
1800 South Park Street
Junked, abandoned truck
October 25, 2003

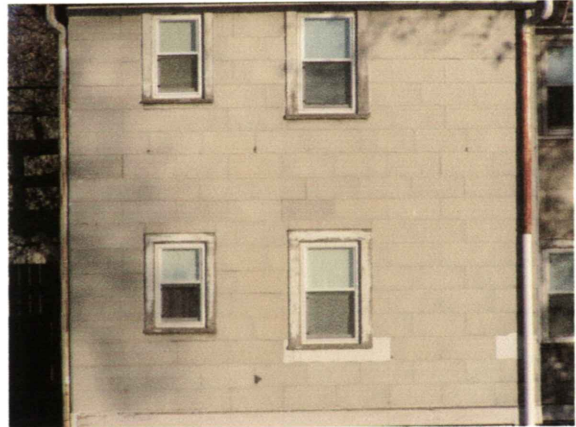
1810 Beld Street
Deteriorated wall and window frames
October 25, 2003

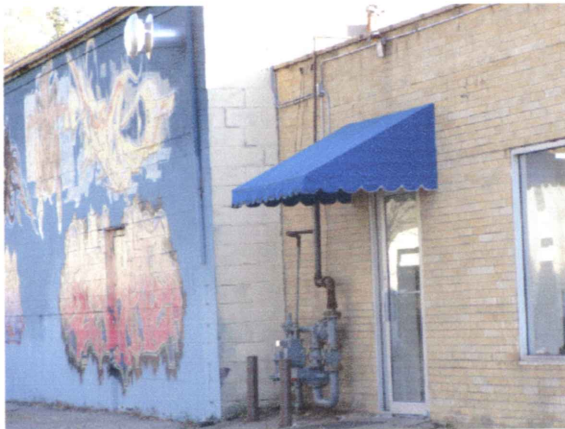
1817 South Park Street
Cracked wall
October 25, 2003

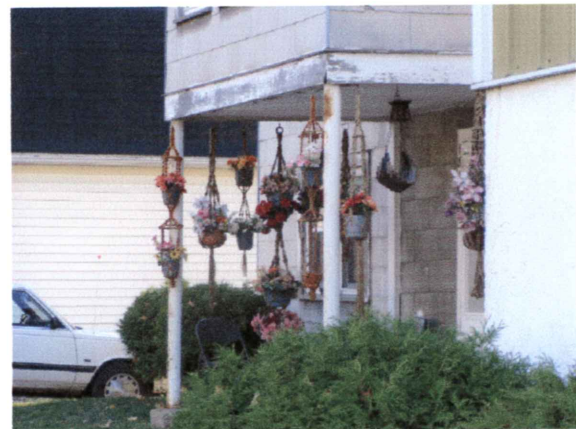
1810 Beld Street
Rotted porch
October 25, 2003

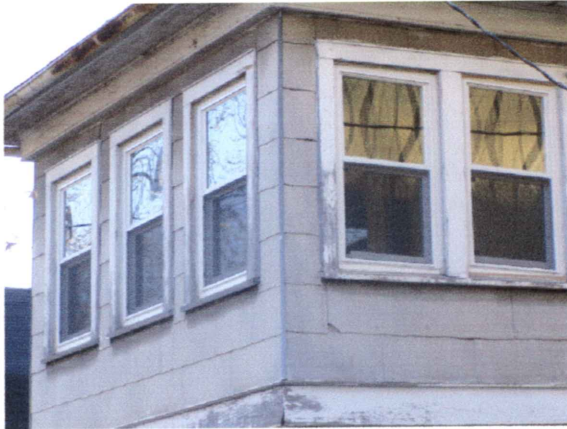
1810 Beld Street
Deteriorated windows
October 25, 2003

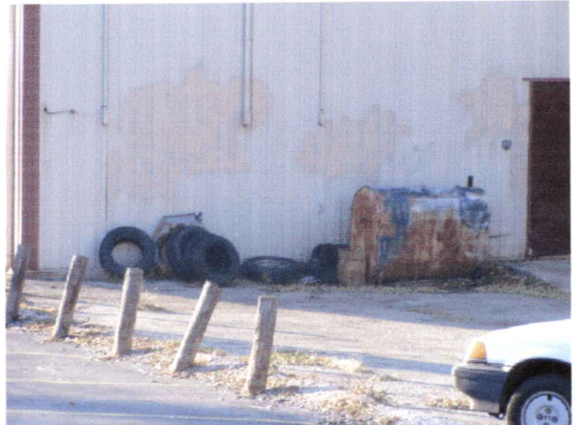
1817 South Park Street
Trash, bent posts
October 25, 2003

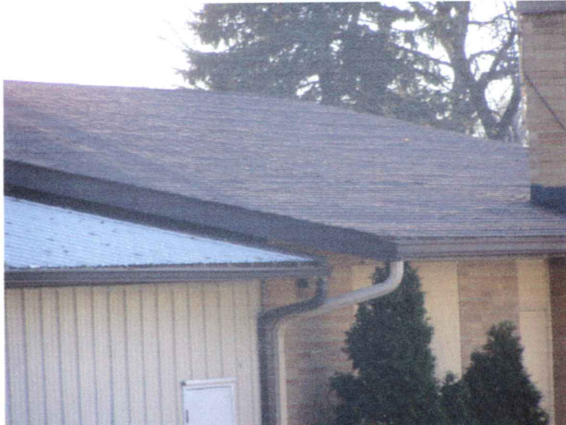
1823 South Park Street
Deteriorated shingles and boarded
windows
October 25, 2003

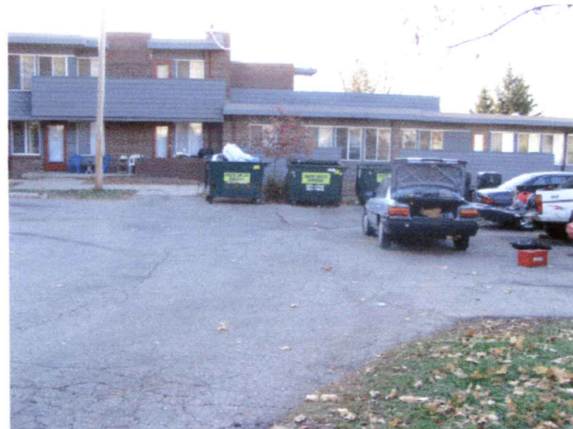
1850 Beld Street
Cracked drive, unsecured trash
containers
October 25, 2003

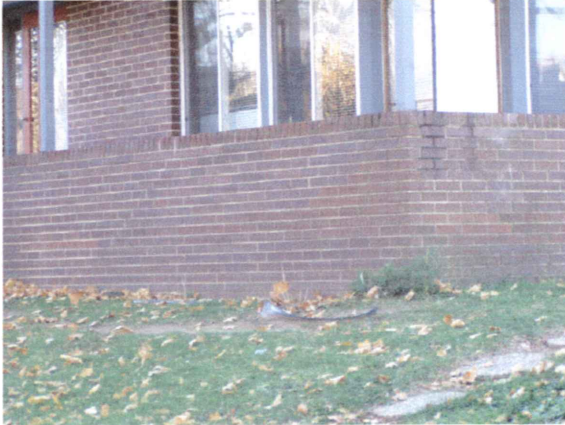
1850 Beld Street
Cracked wall
October 25, 2003

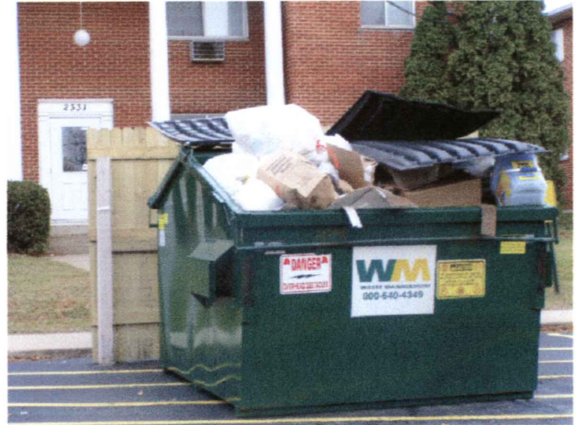
2331 Badger Parkway
Unscreened trash containers
October 25, 2003

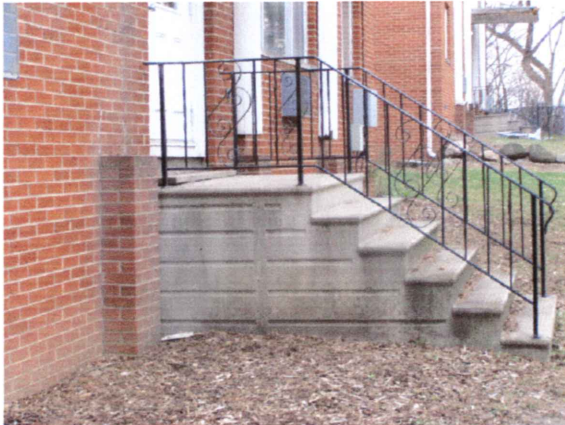
2306 Badger Parkway
Uneven porch
October 25, 2003

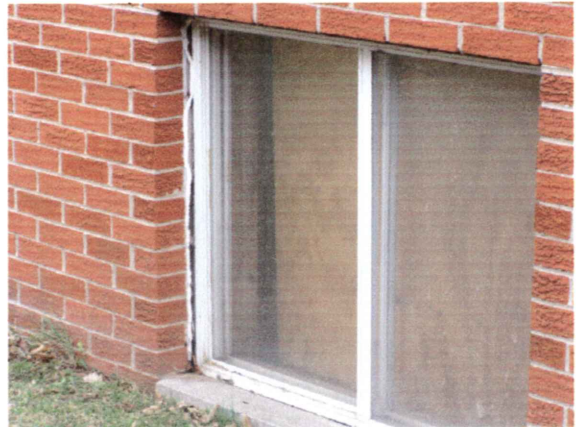
2306 Badger Parkway
Deteriorated window frame
October 25, 2003

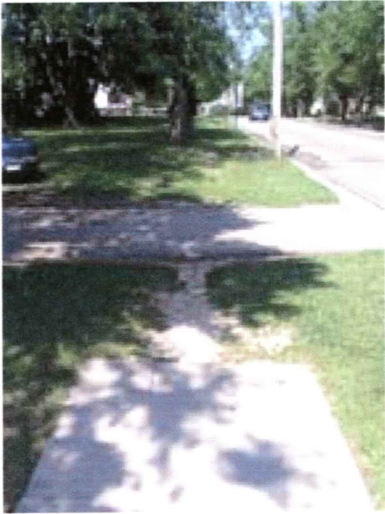
Badger road
Missing Sidewalk
July 7, 2005

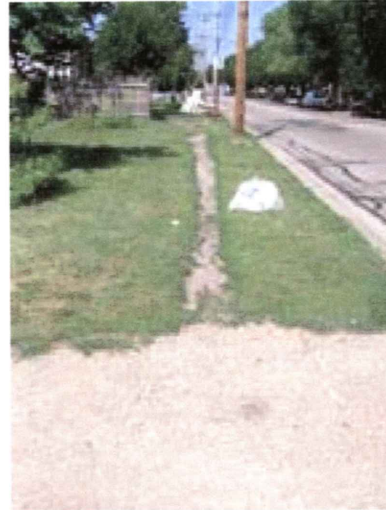
Badger Road
Missing Sidewalk
July 7, 2005

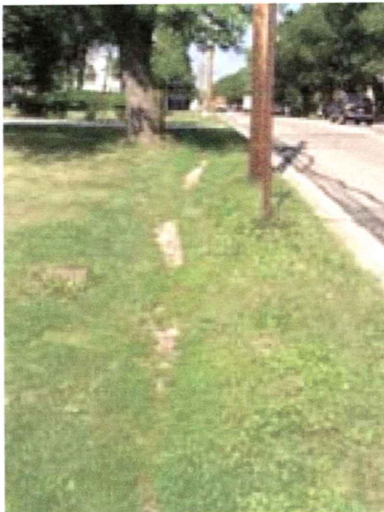
Badger Road
Missing Sidewalk
July 7, 2005

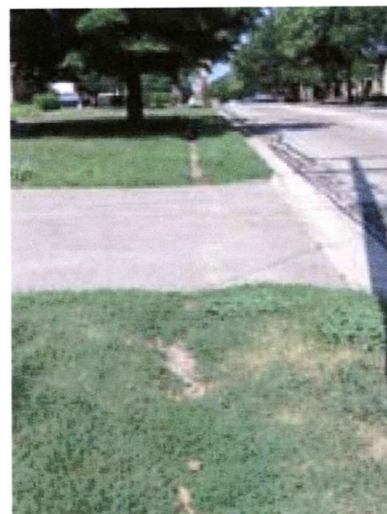
Badger Road
Missing Sidewalk
July 7, 2005

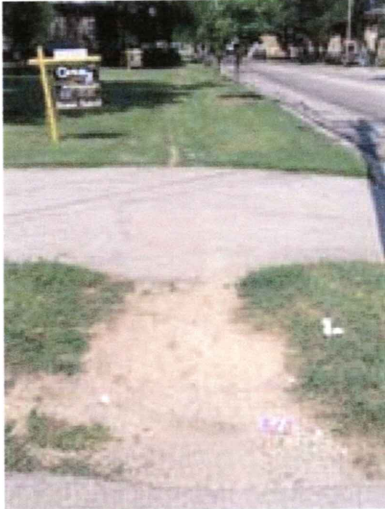
Badger Road
Missing Sidewalk
July 7, 2005

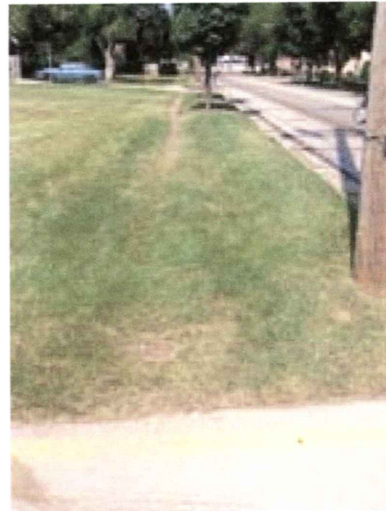
Badger Road
Missing Sidewalk
July 7, 2005

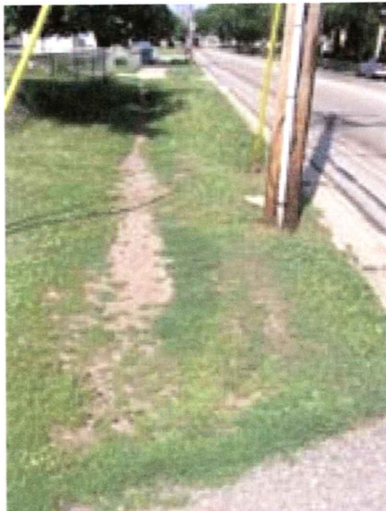
Missing Sidewalk
Badger Road
July 7, 2005

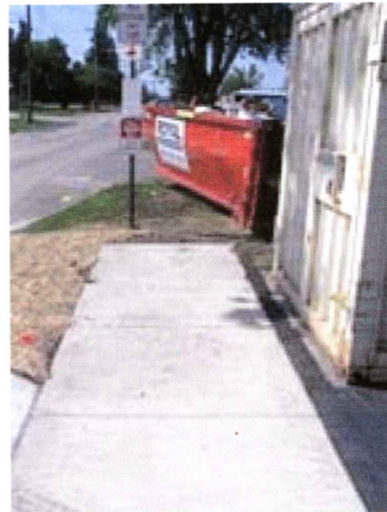
Missing Sidewalk
Perry Street
July 7, 2005

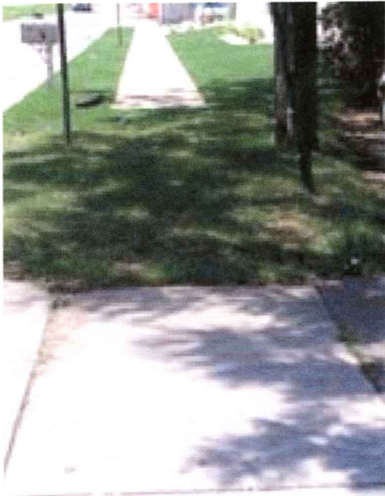
Perry Street
Missing Sidewalk
July 7, 2005

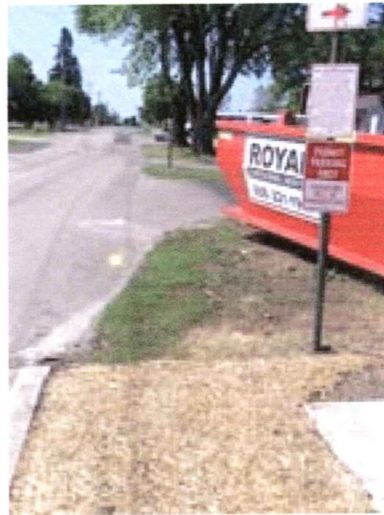
Perry Street
Missing Sidewalk
July 7, 2005

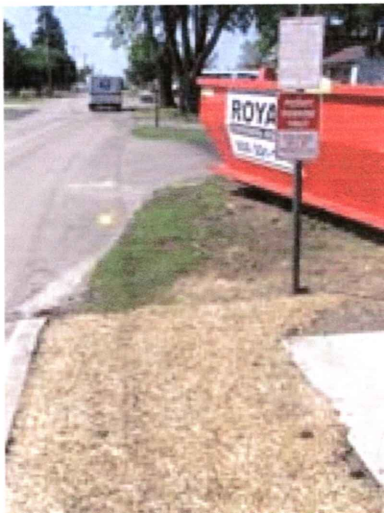
Perry Street
Missing Sidewalk
July 7, 2005

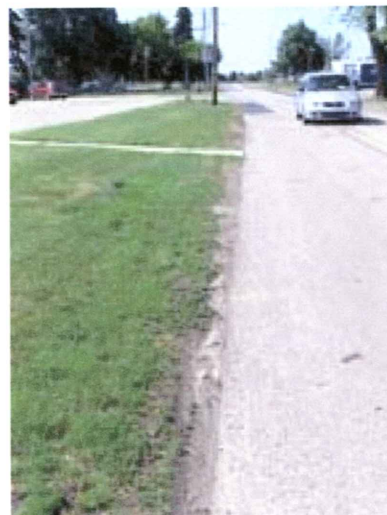
Perry Street
Missing Sidewalk
July 7, 2005
